**Credit River Erosion Control Project from
Dundas Street West to Highway 403
ONLINE PUBLIC INFORMATION CENTRE
June 14, 2023**

Credit River Erosion Control EA & Detailed Design
Dundas Street West to Highway 403

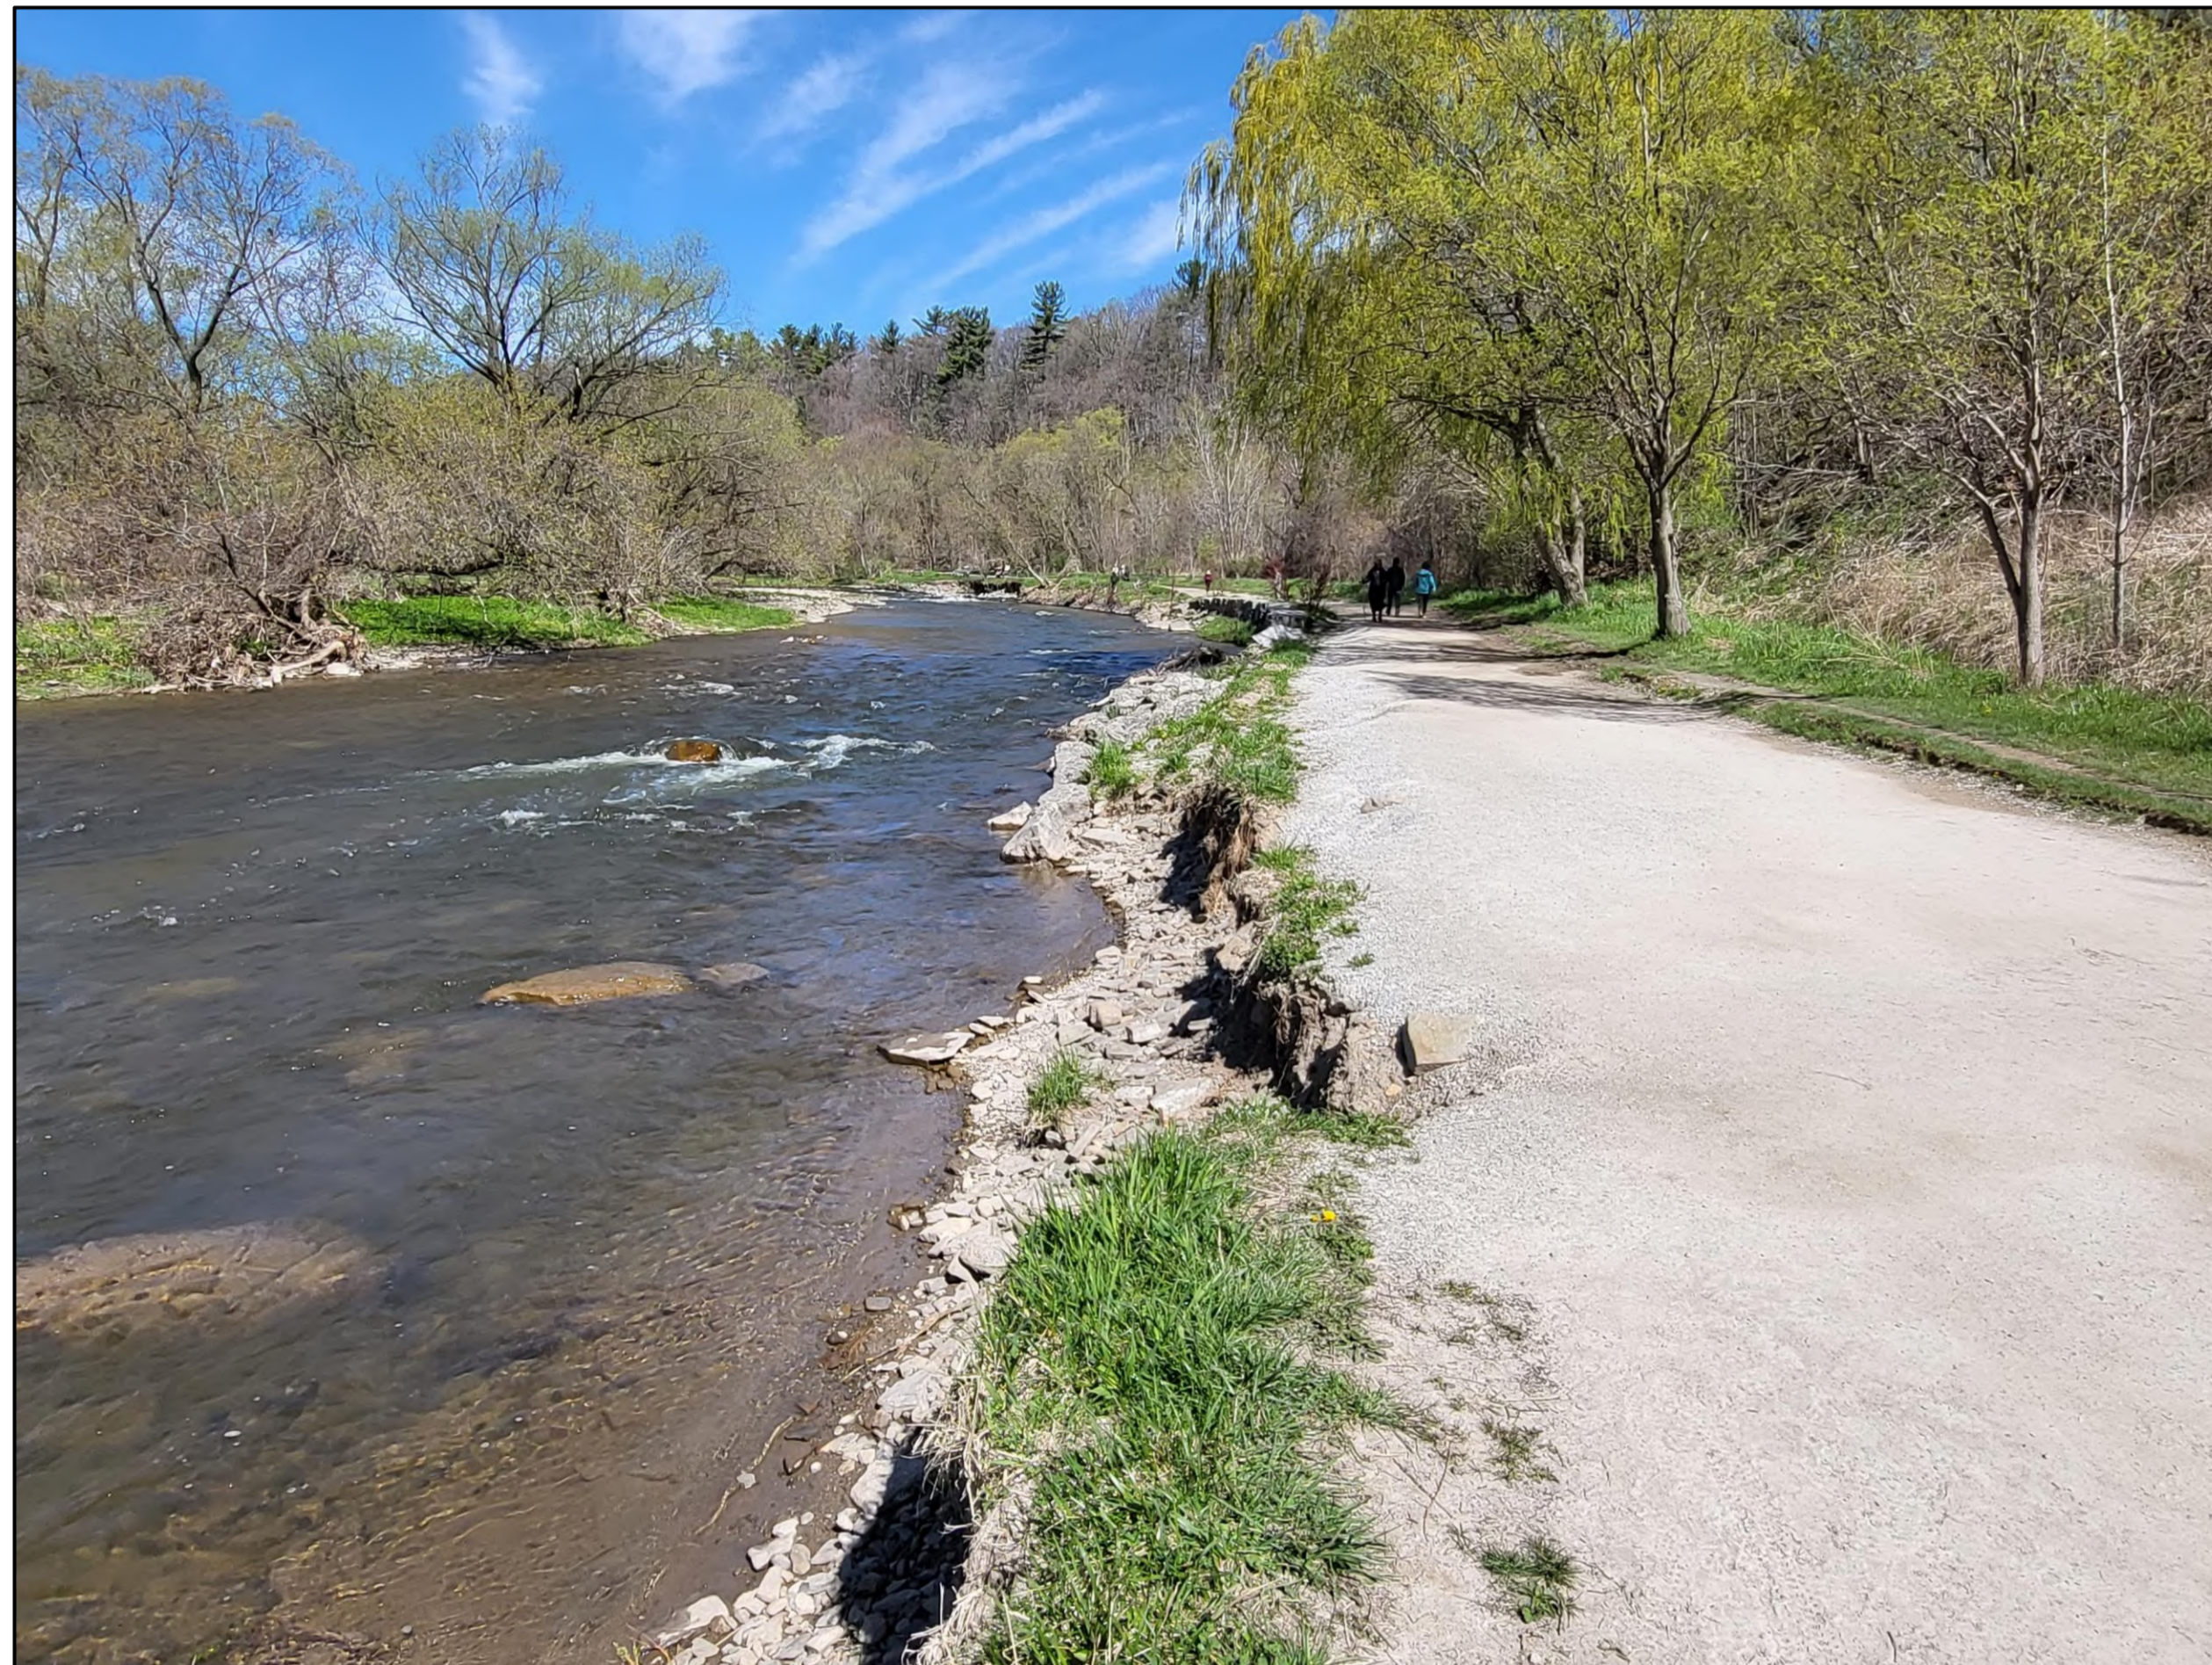
Within the study area, Credit River is generally characterized by active erosion, with localized channel bank protection measures such as armourstone walls and gabion baskets. In some locations these channel engineering structures are failing.

Bank Erosion Along Culham Trail

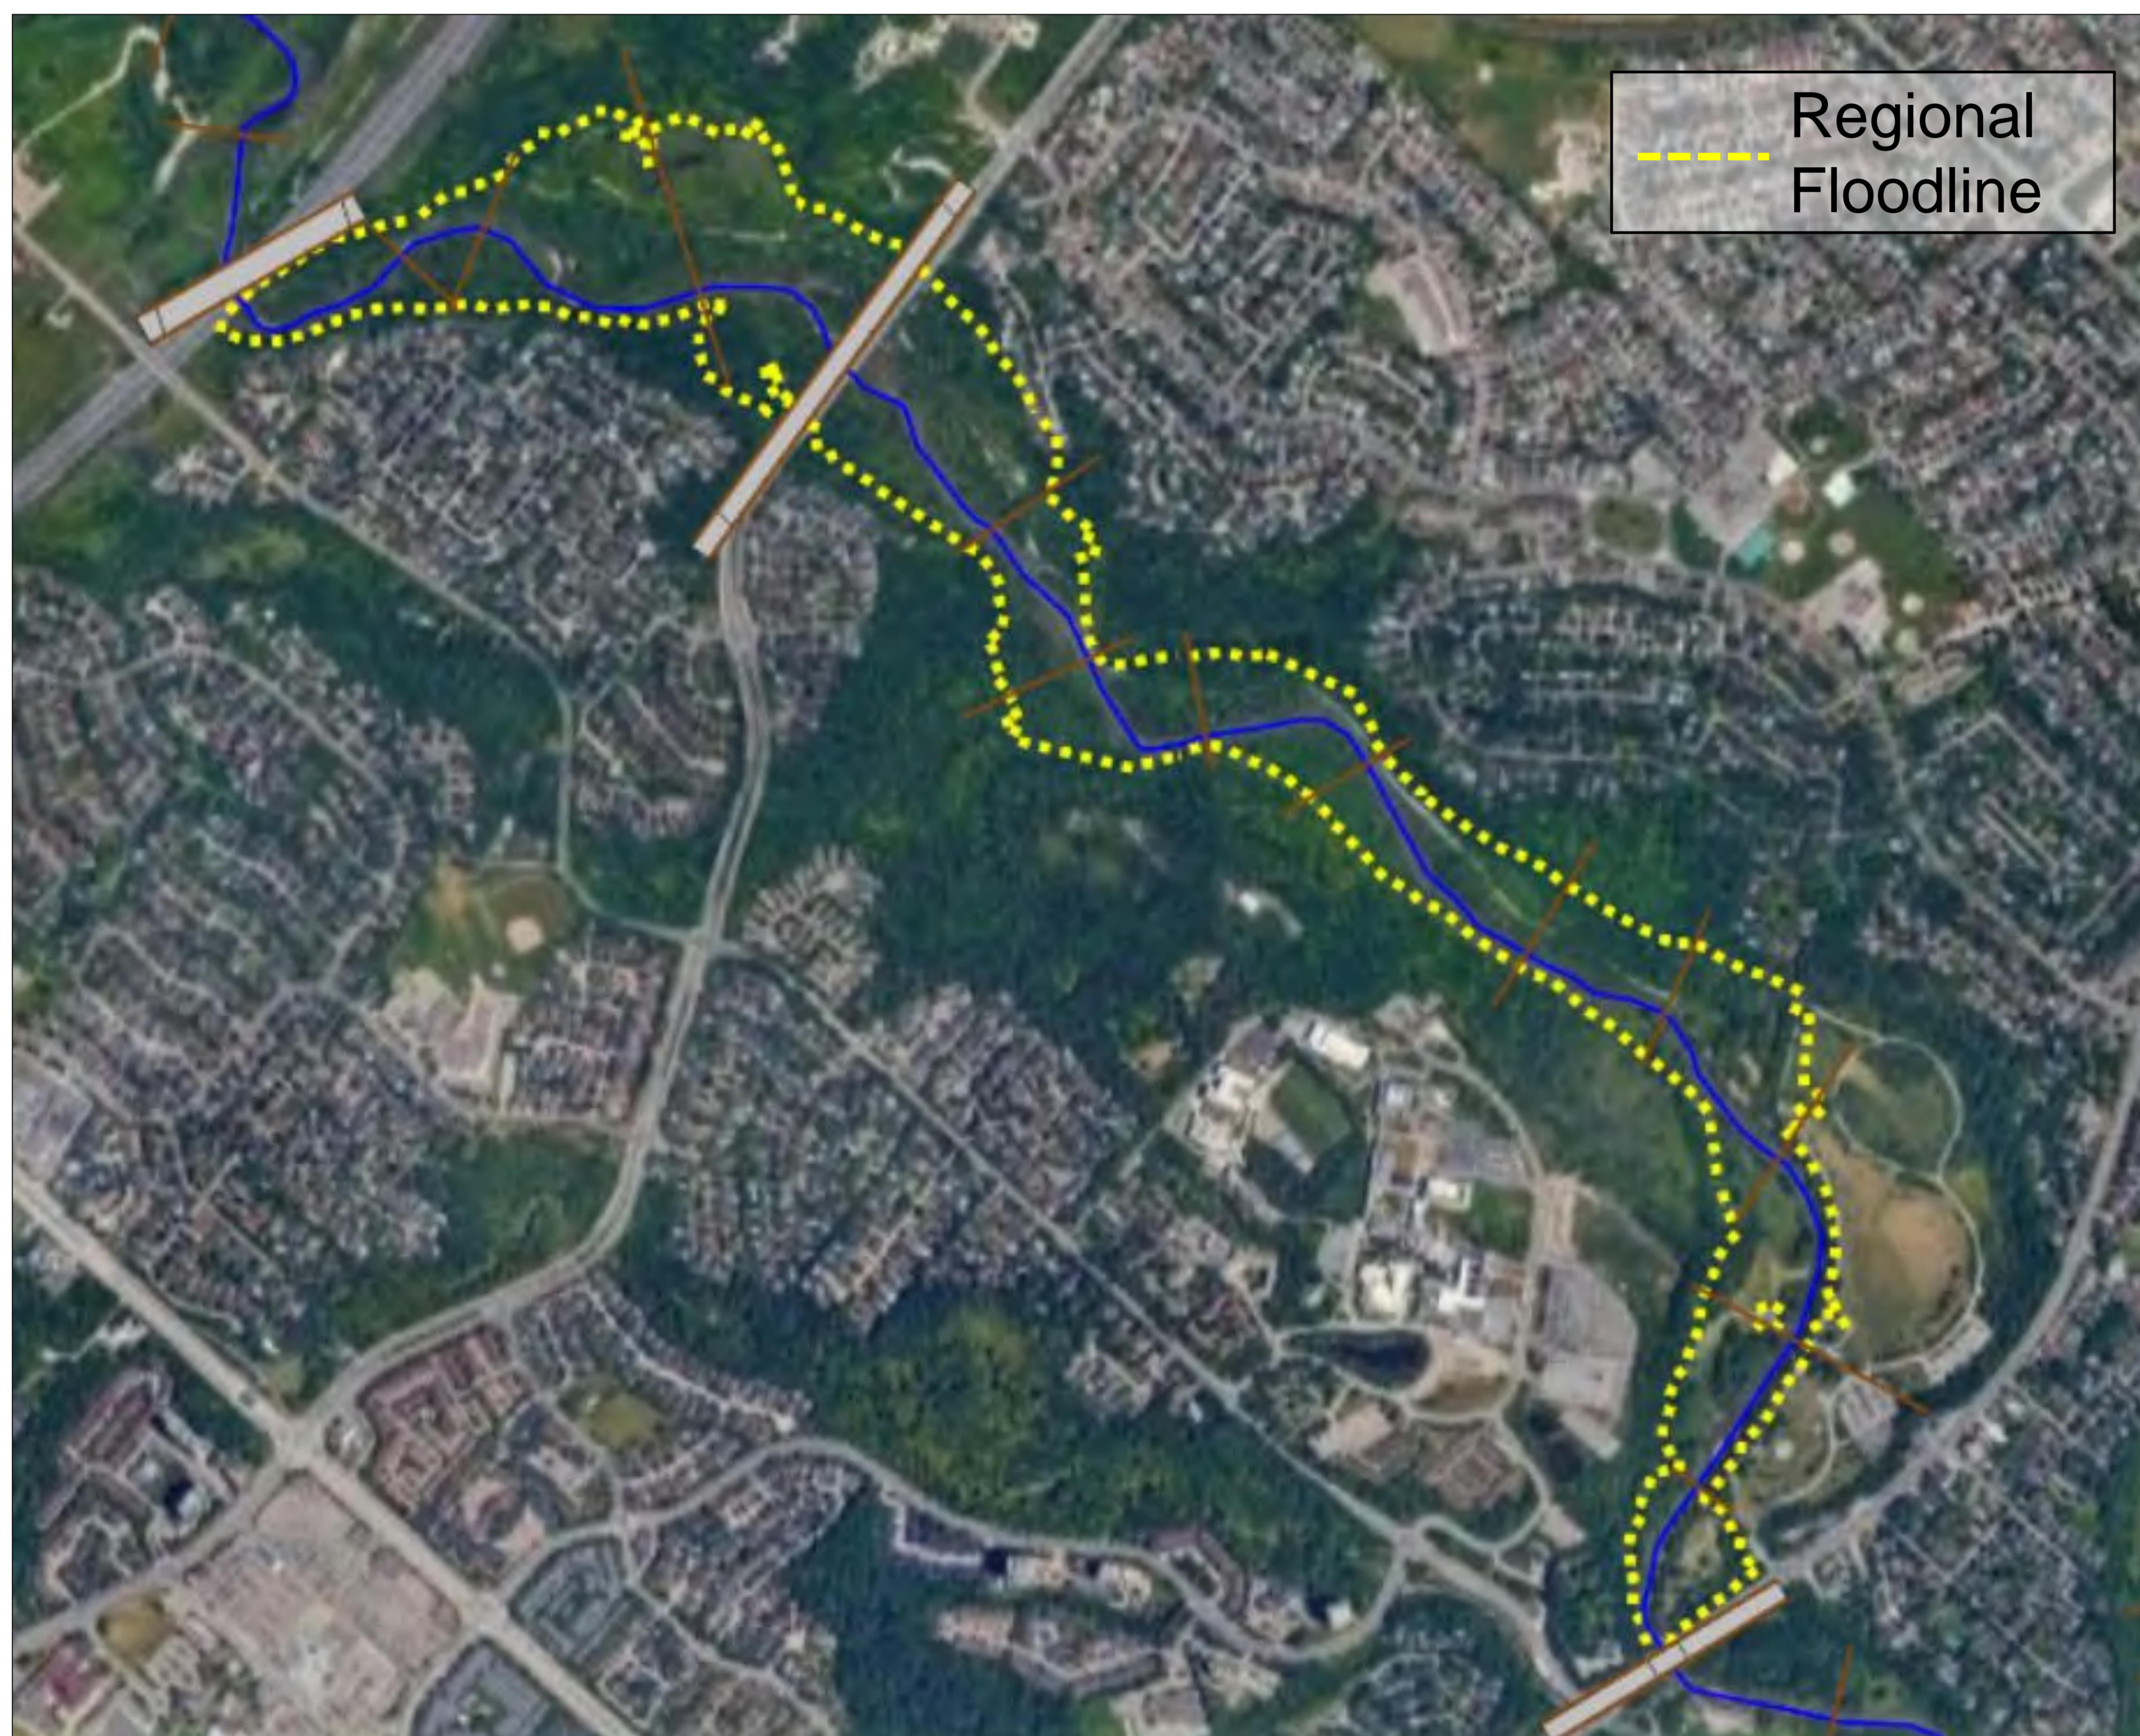
Flows under various rainfall events are presented in the figure below along with the Regional floodline extents.

The existing floodplain is generally contained within parklands between Dundas Street West and Highway 403.

Profile	Flow Rate (m ³ /s)
2-Year	90
5-Year	202
10-Year	264
25-Year	353
50-Year	428.2
100-Year	510.8
Regional	732.6

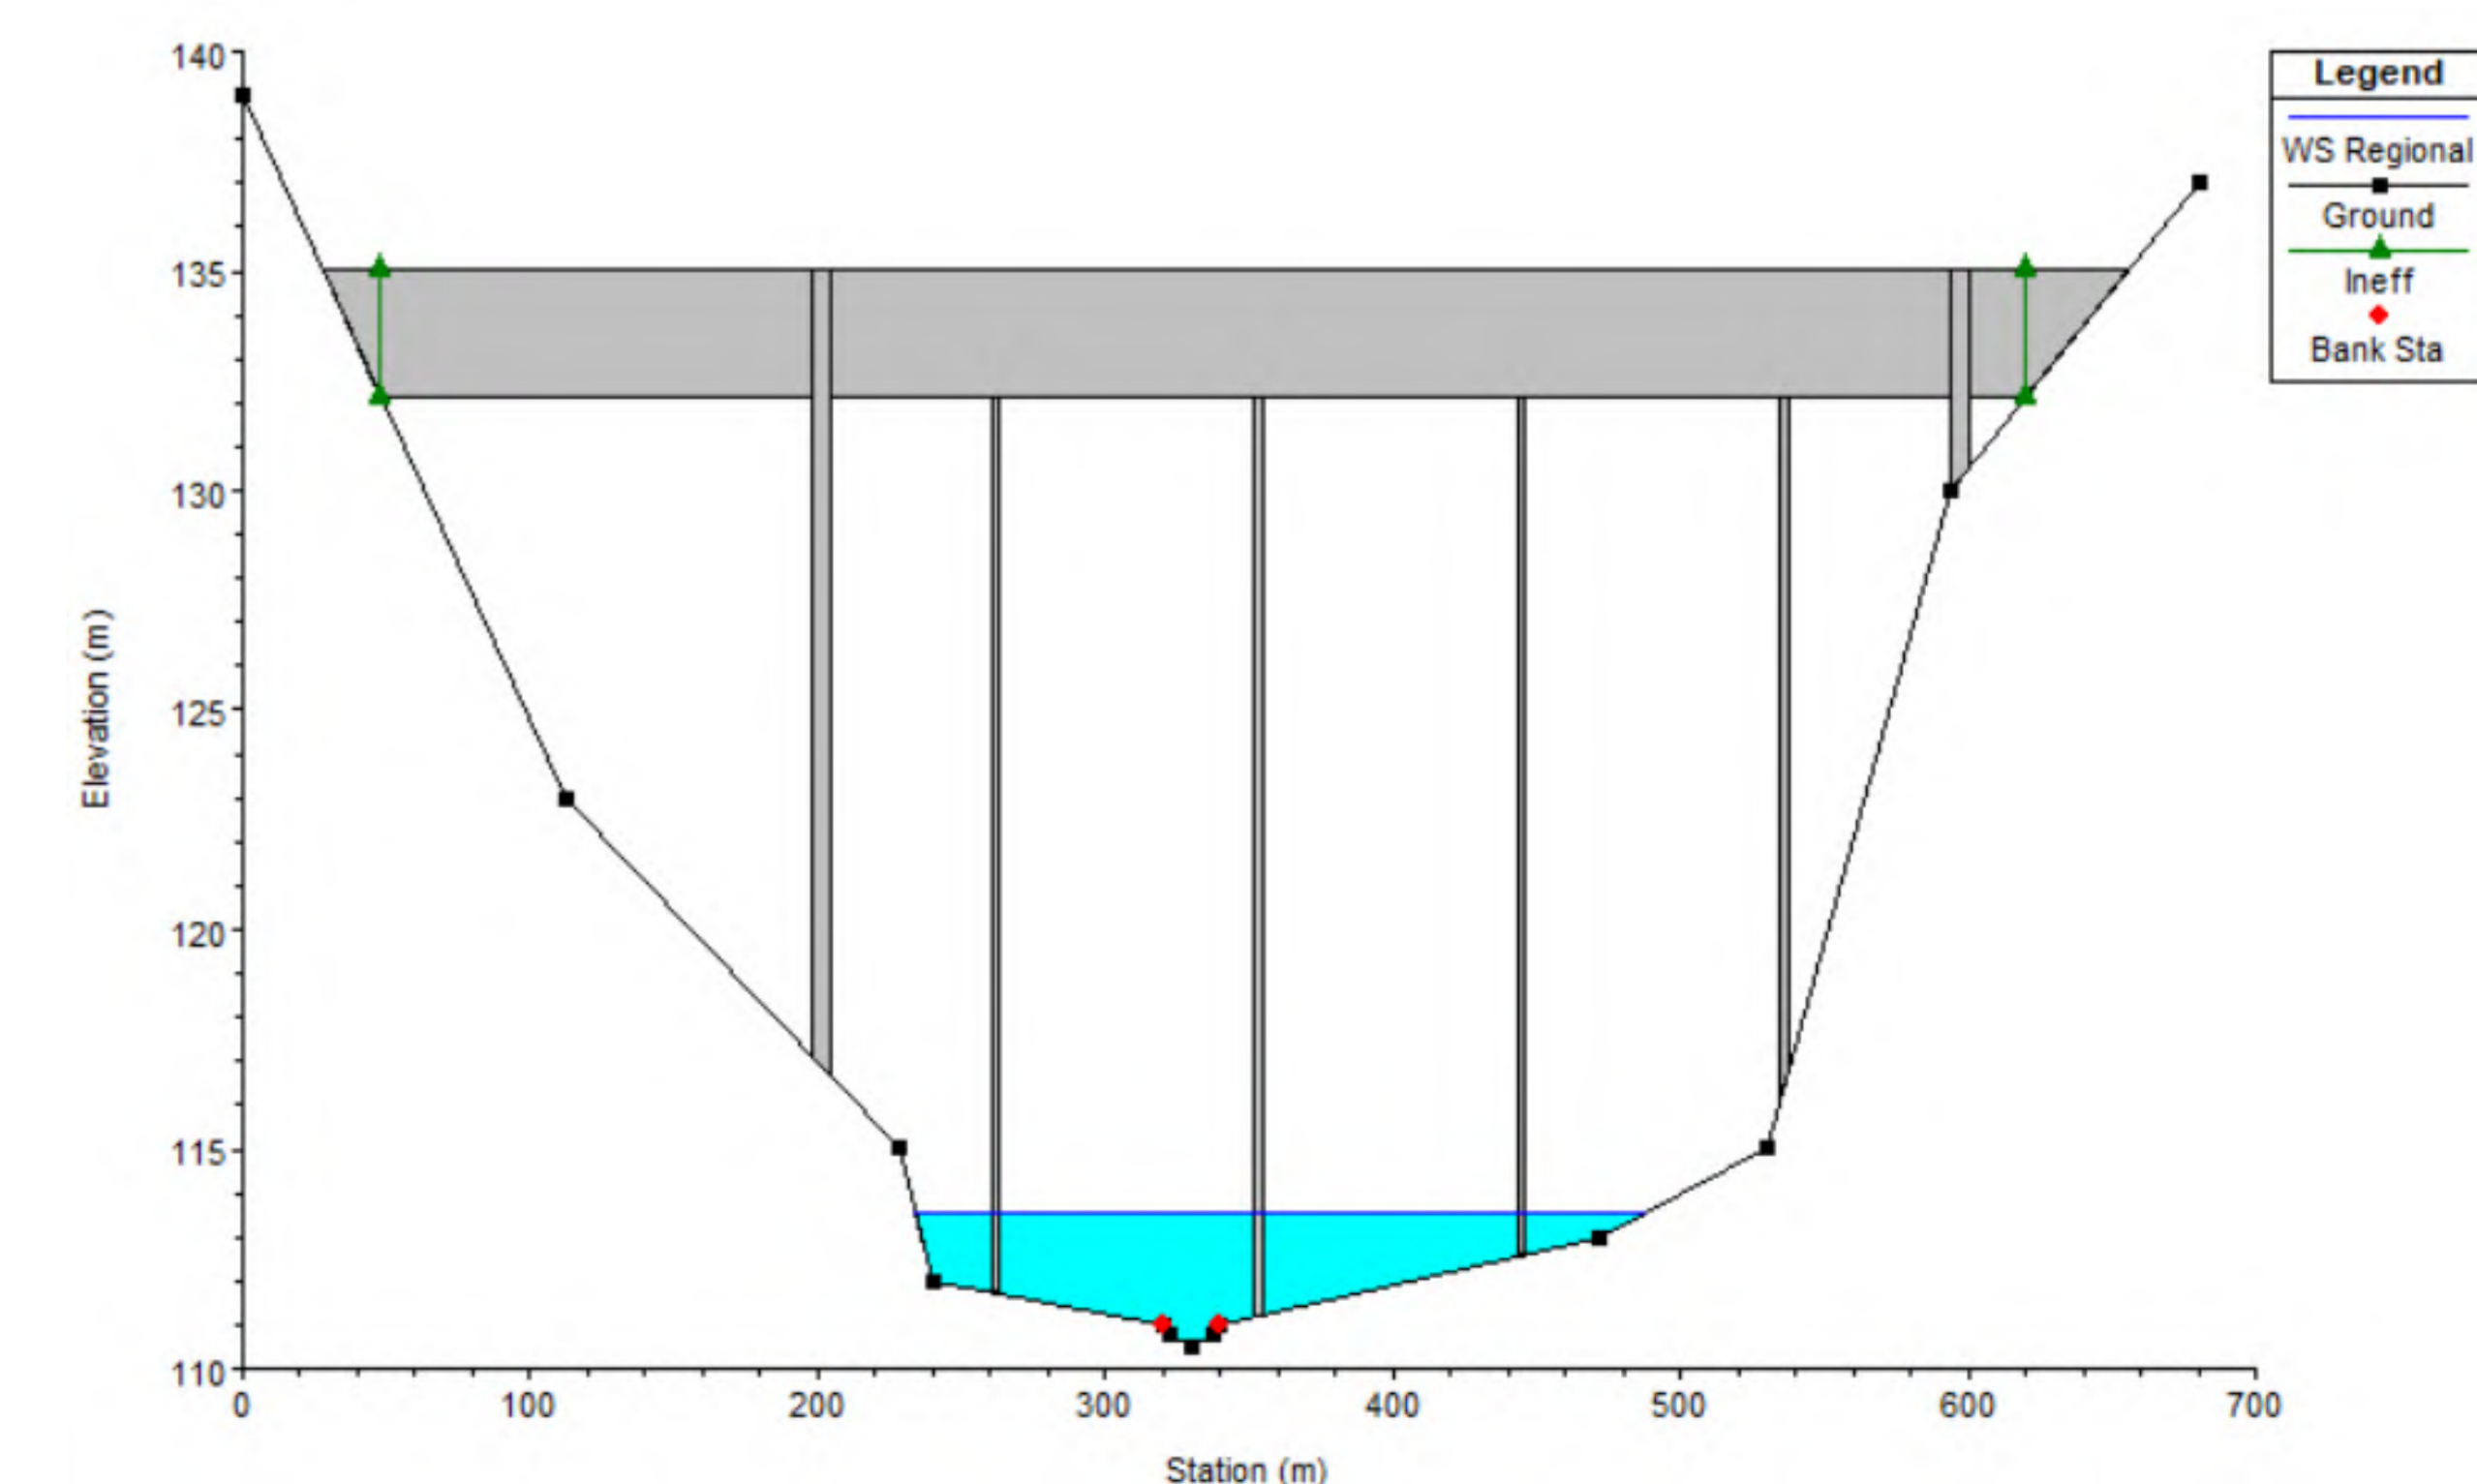
Regional flood elevation at Burnhamthorpe Bridge

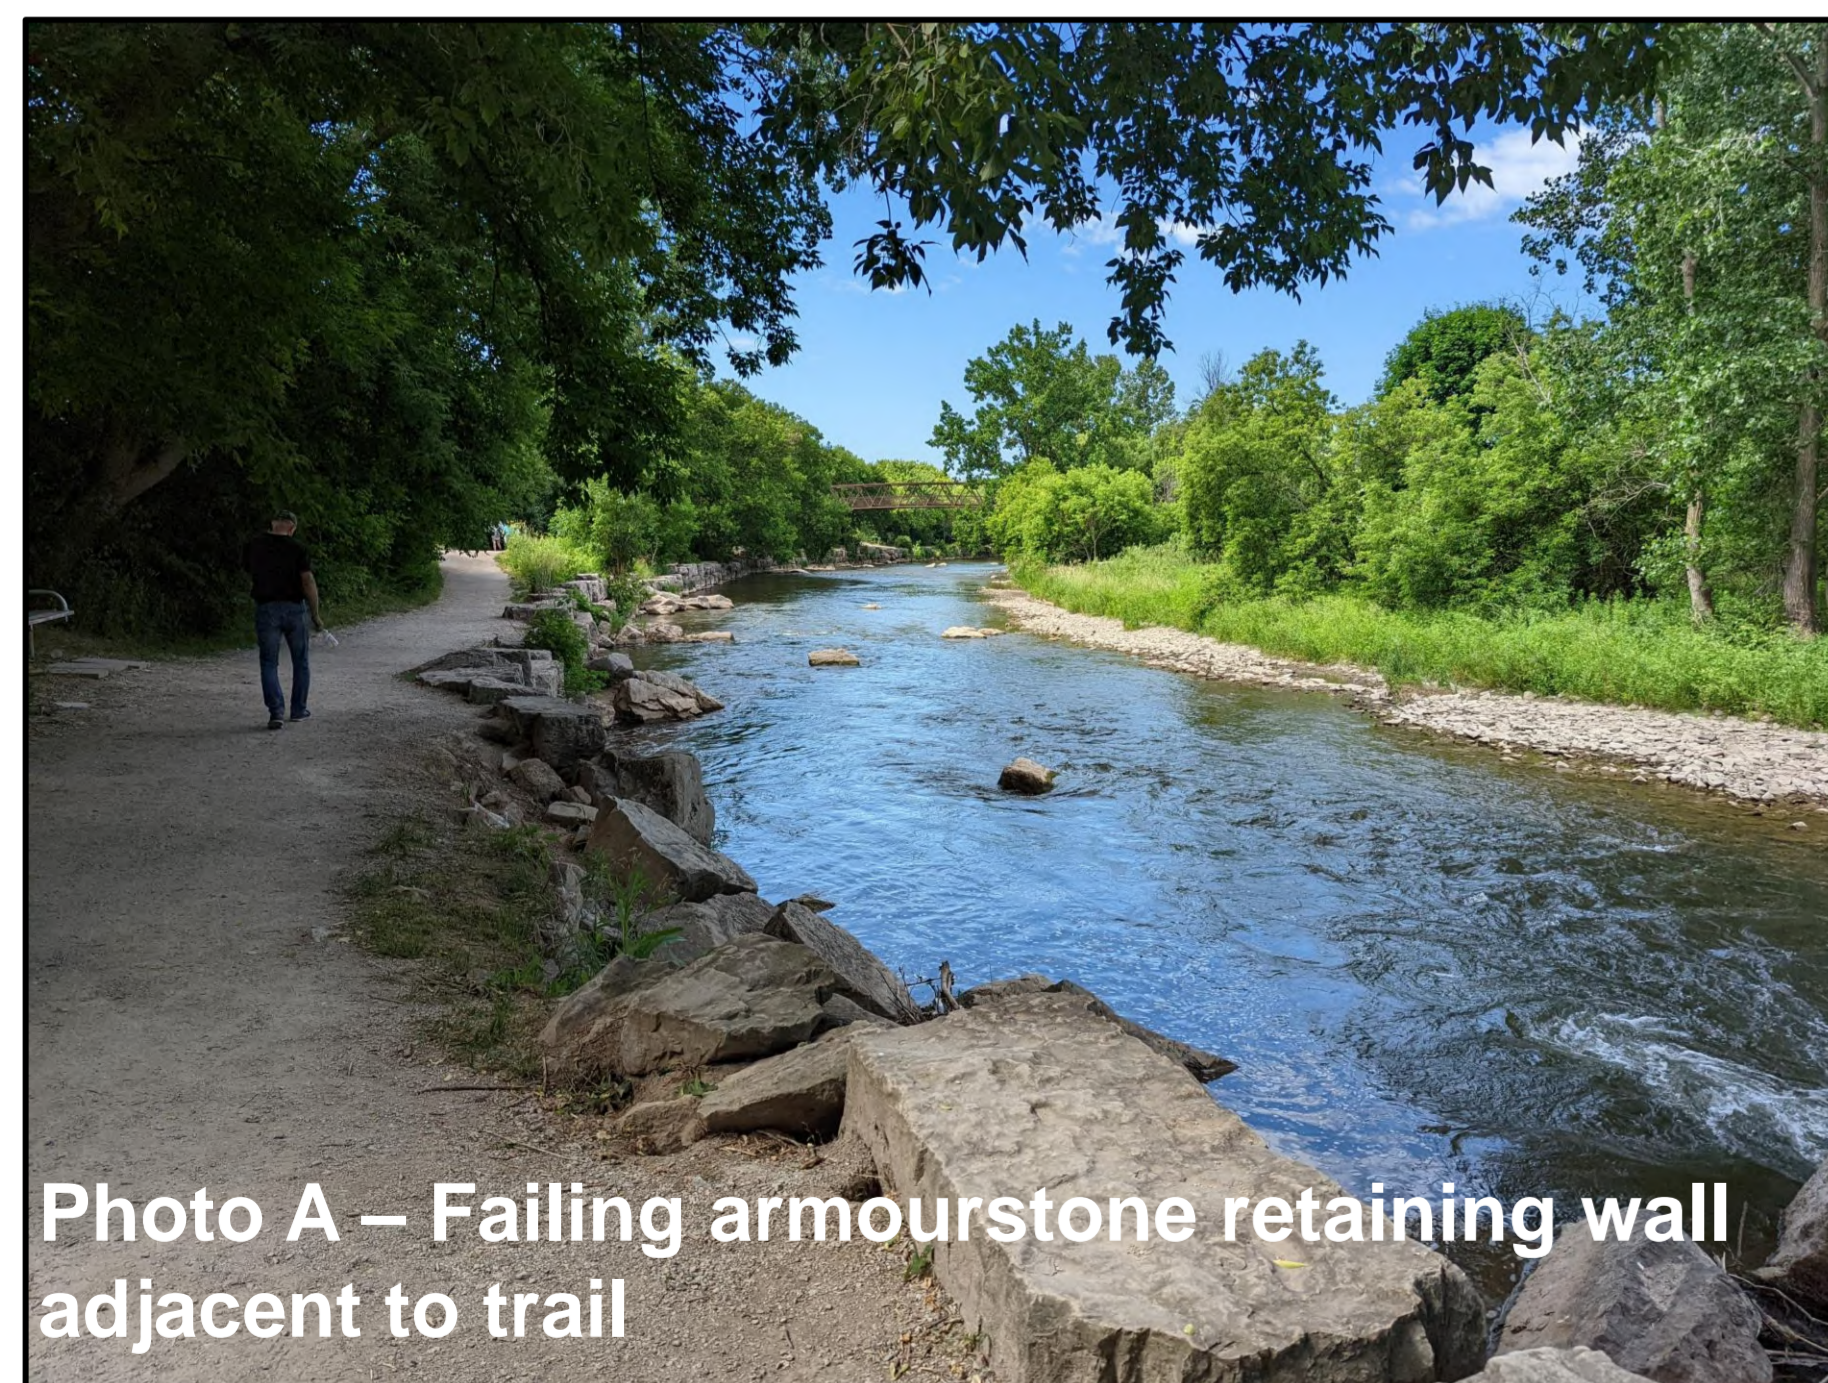
Photo A – Failing armourstone retaining wall adjacent to trail

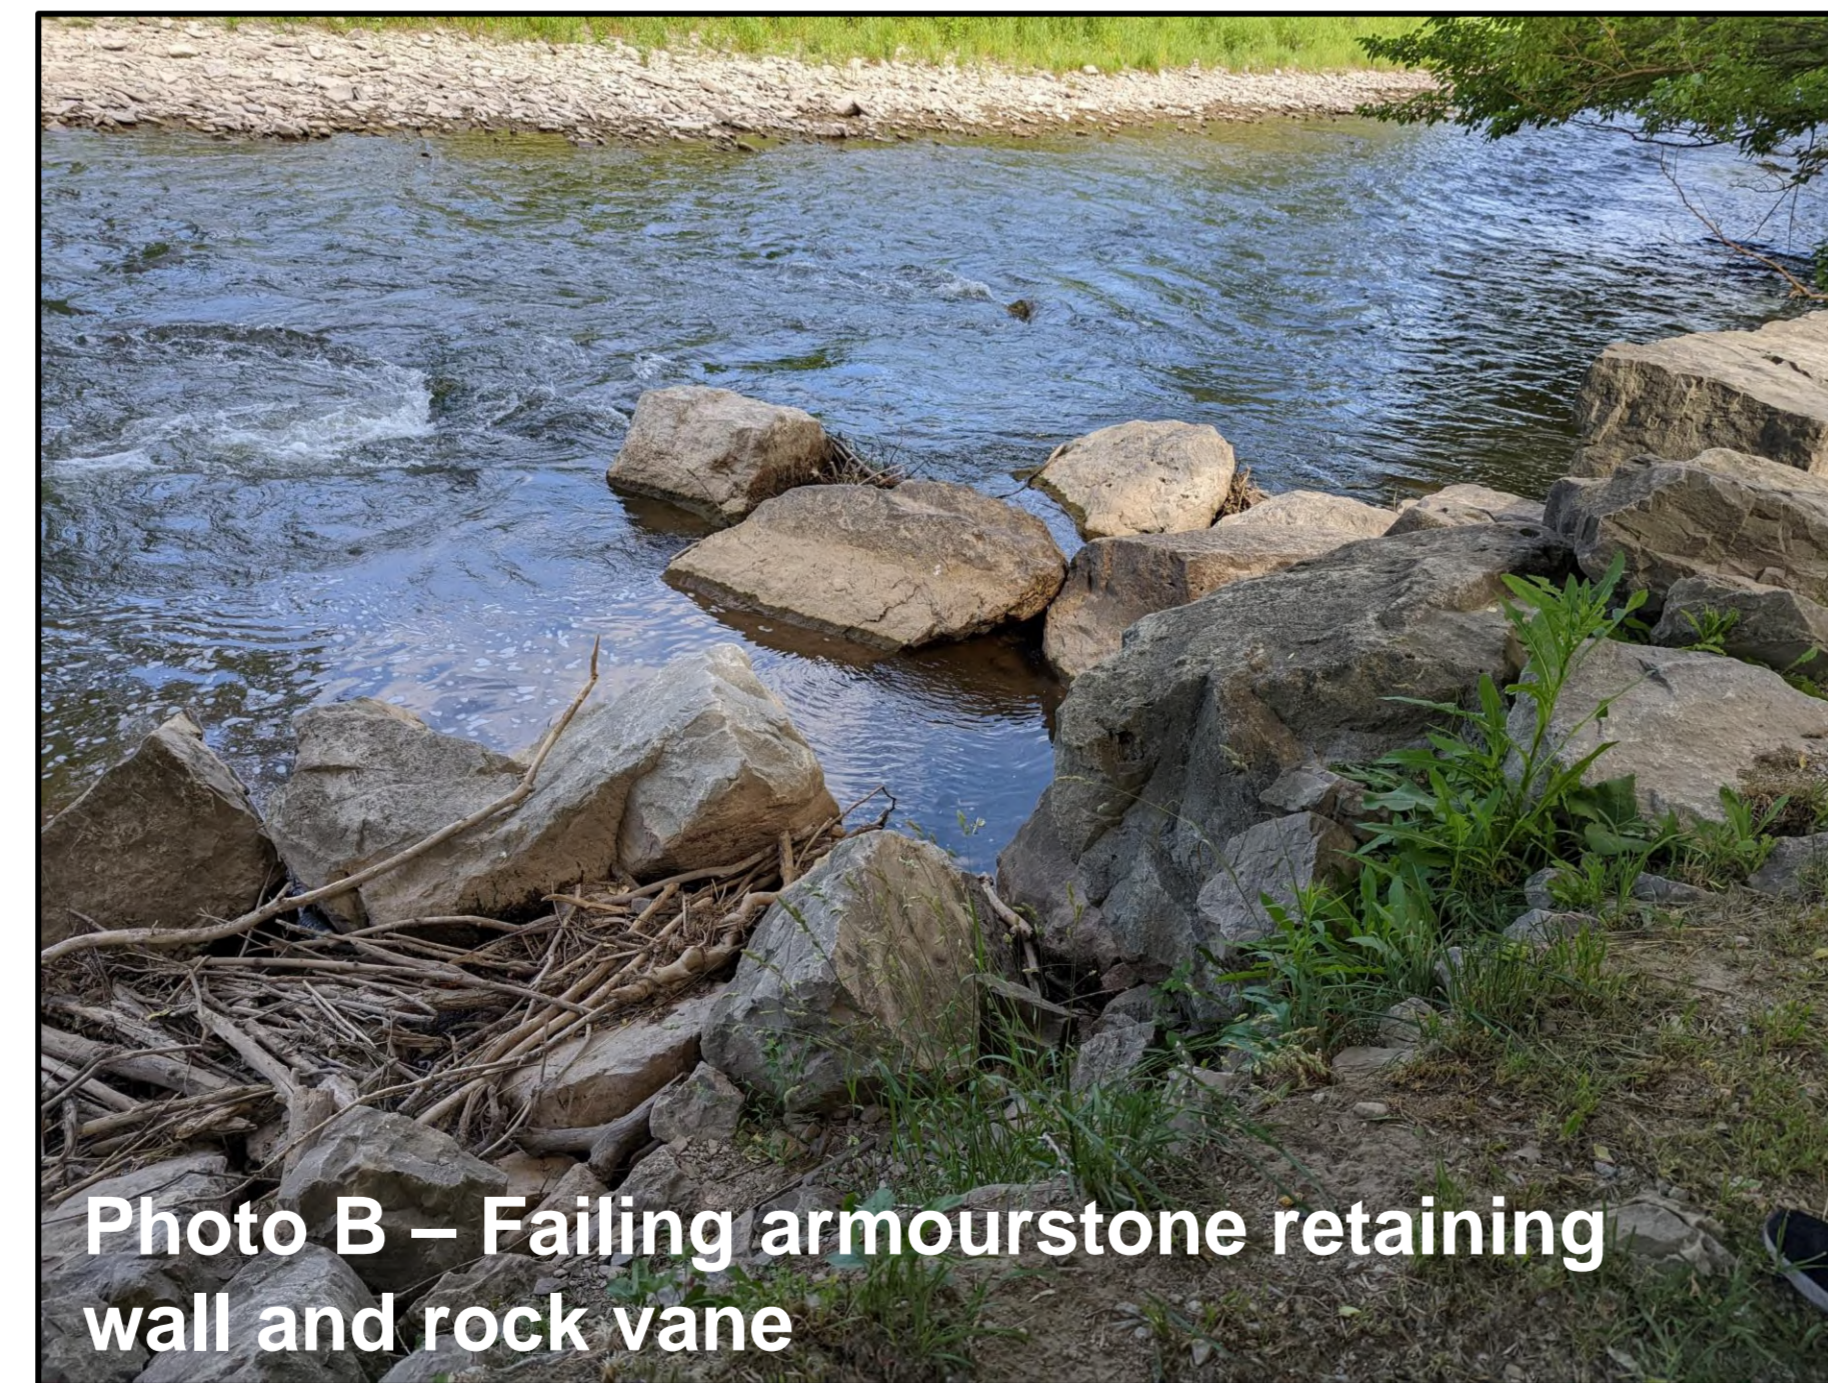
Photo B – Failing armourstone retaining wall and rock vane

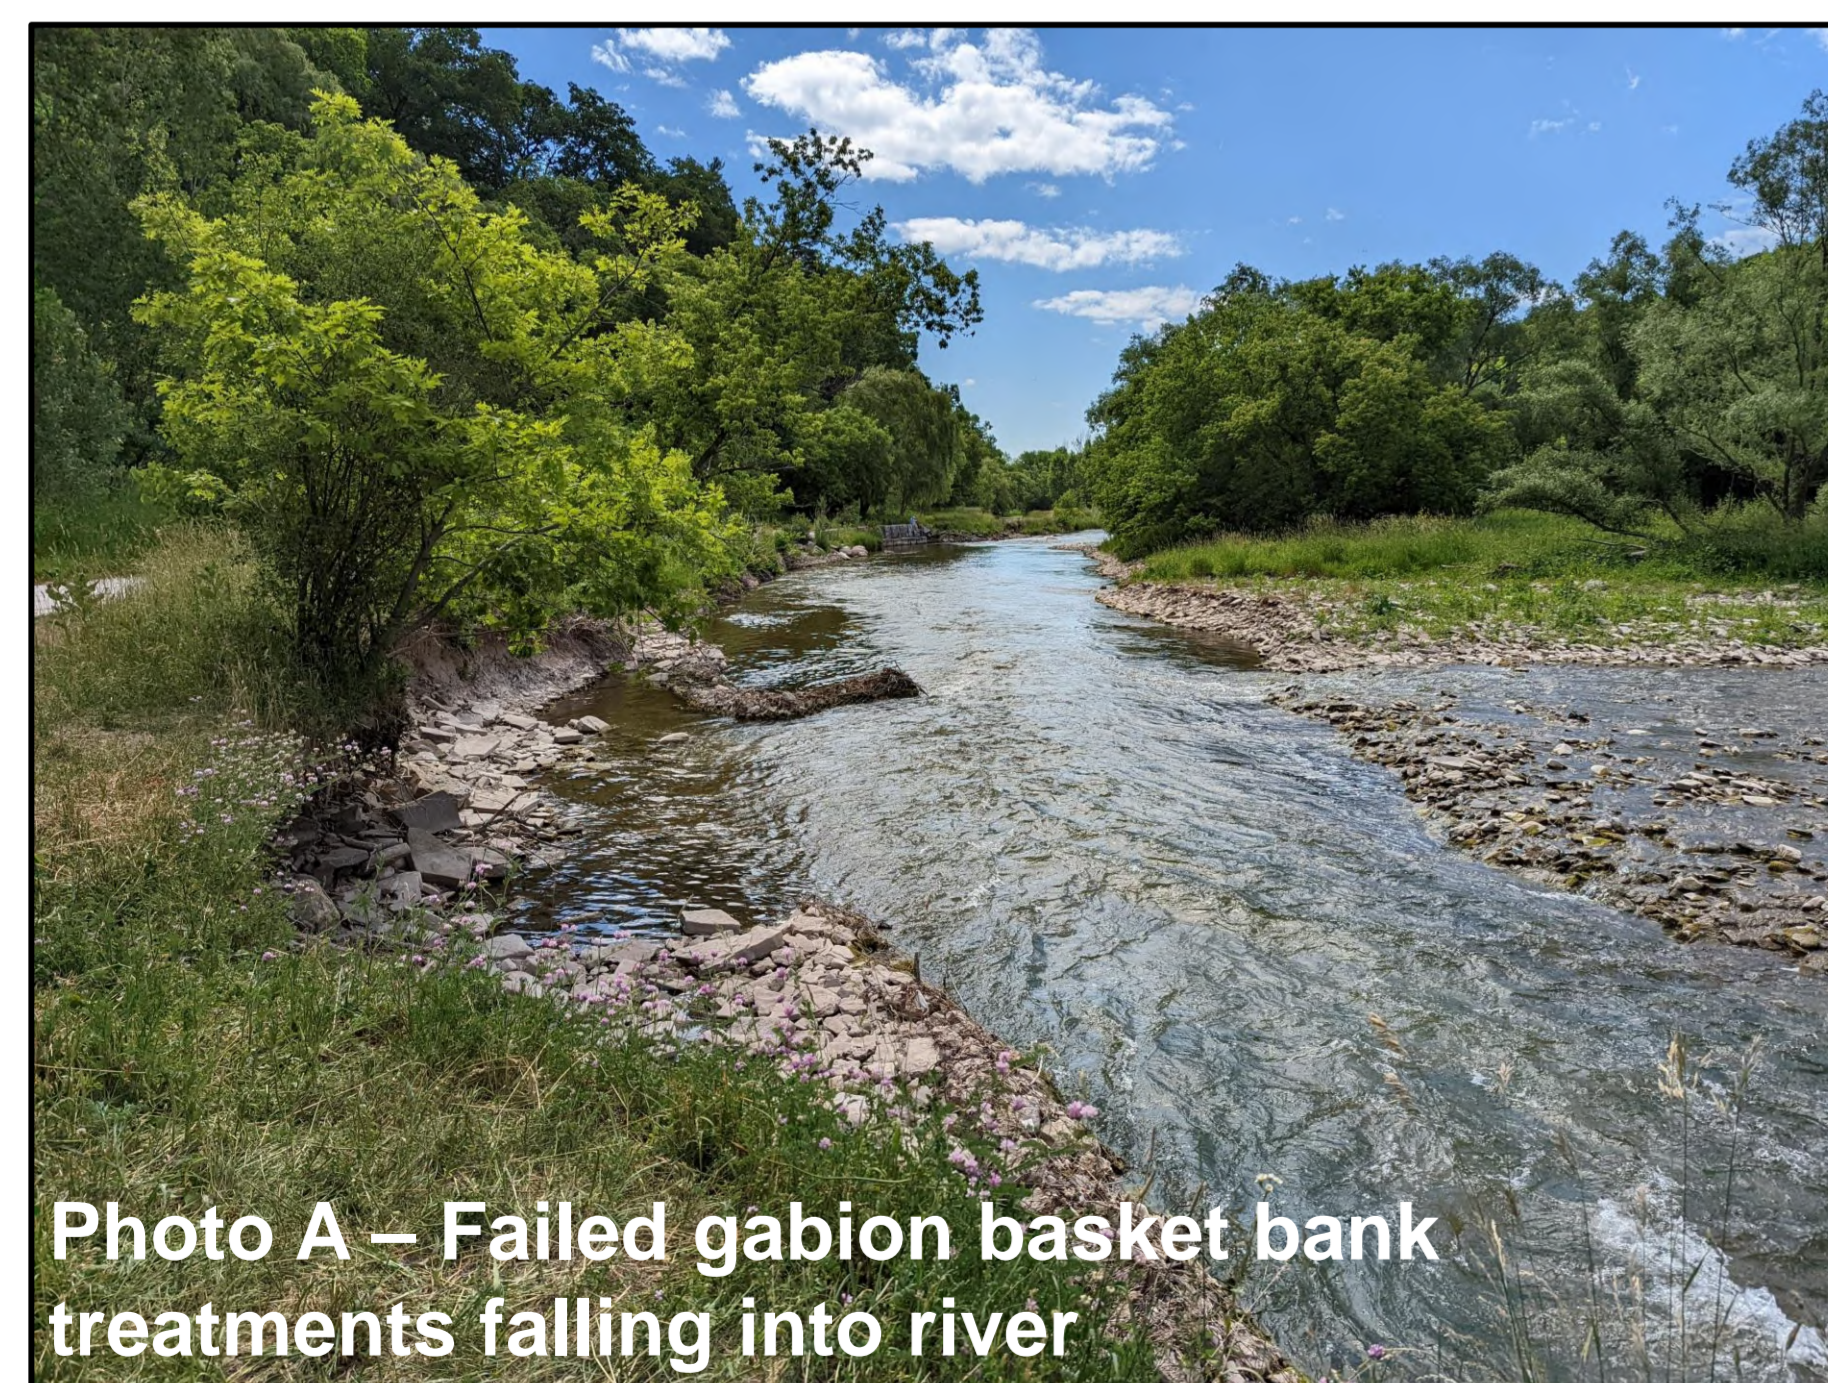
Photo A – Failed gabion basket bank treatments falling into river

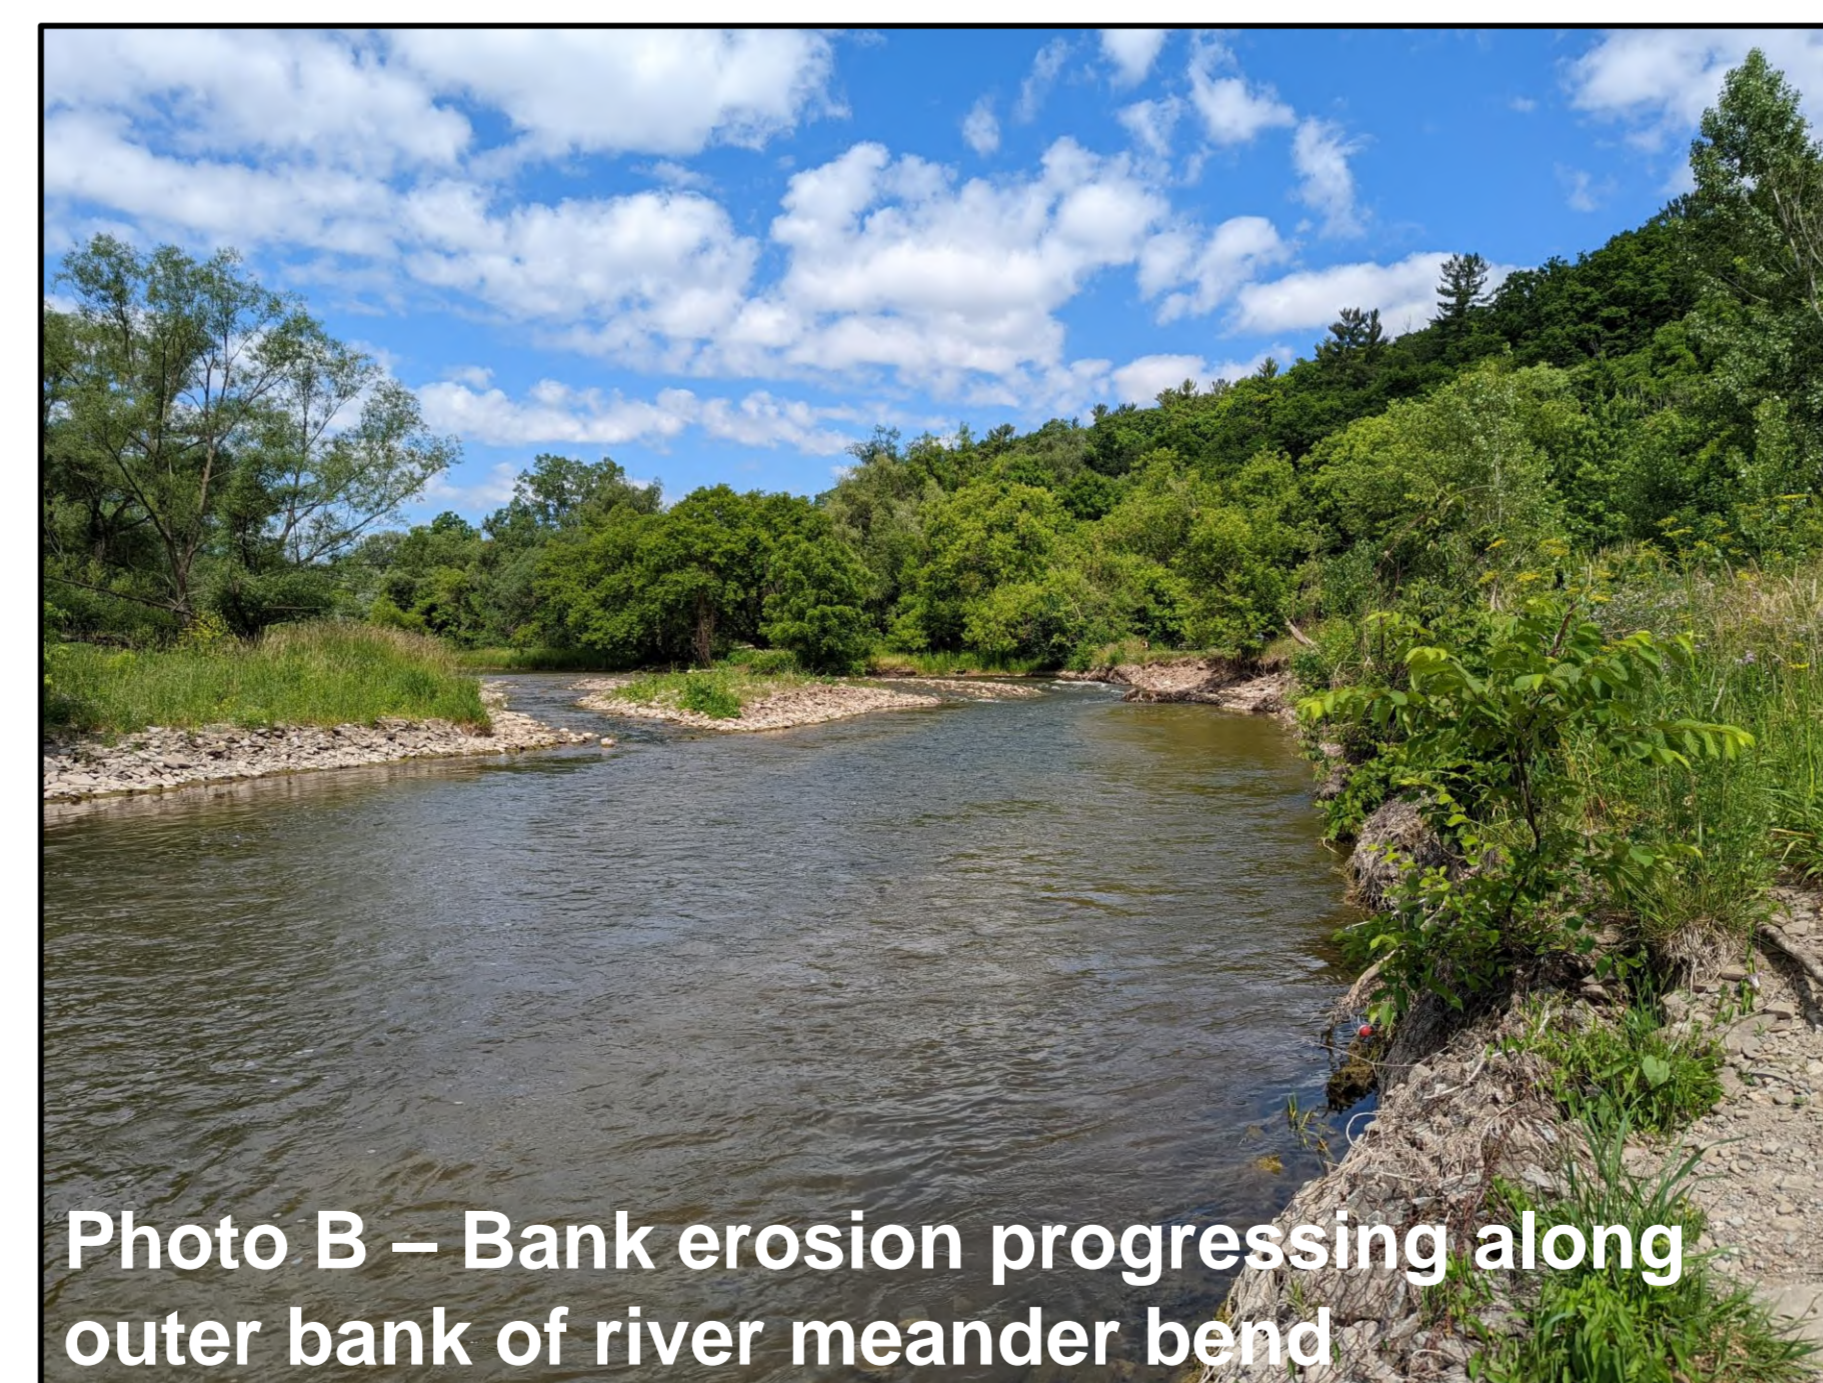
Photo B – Bank erosion progressing along outer bank of river meander bend
