**Credit River Erosion Control Project from
Dundas Street West to Highway 403
ONLINE PUBLIC INFORMATION CENTRE
June 14, 2023**

Credit River Erosion Control EA & Detailed Design
Dundas Street West to Highway 403

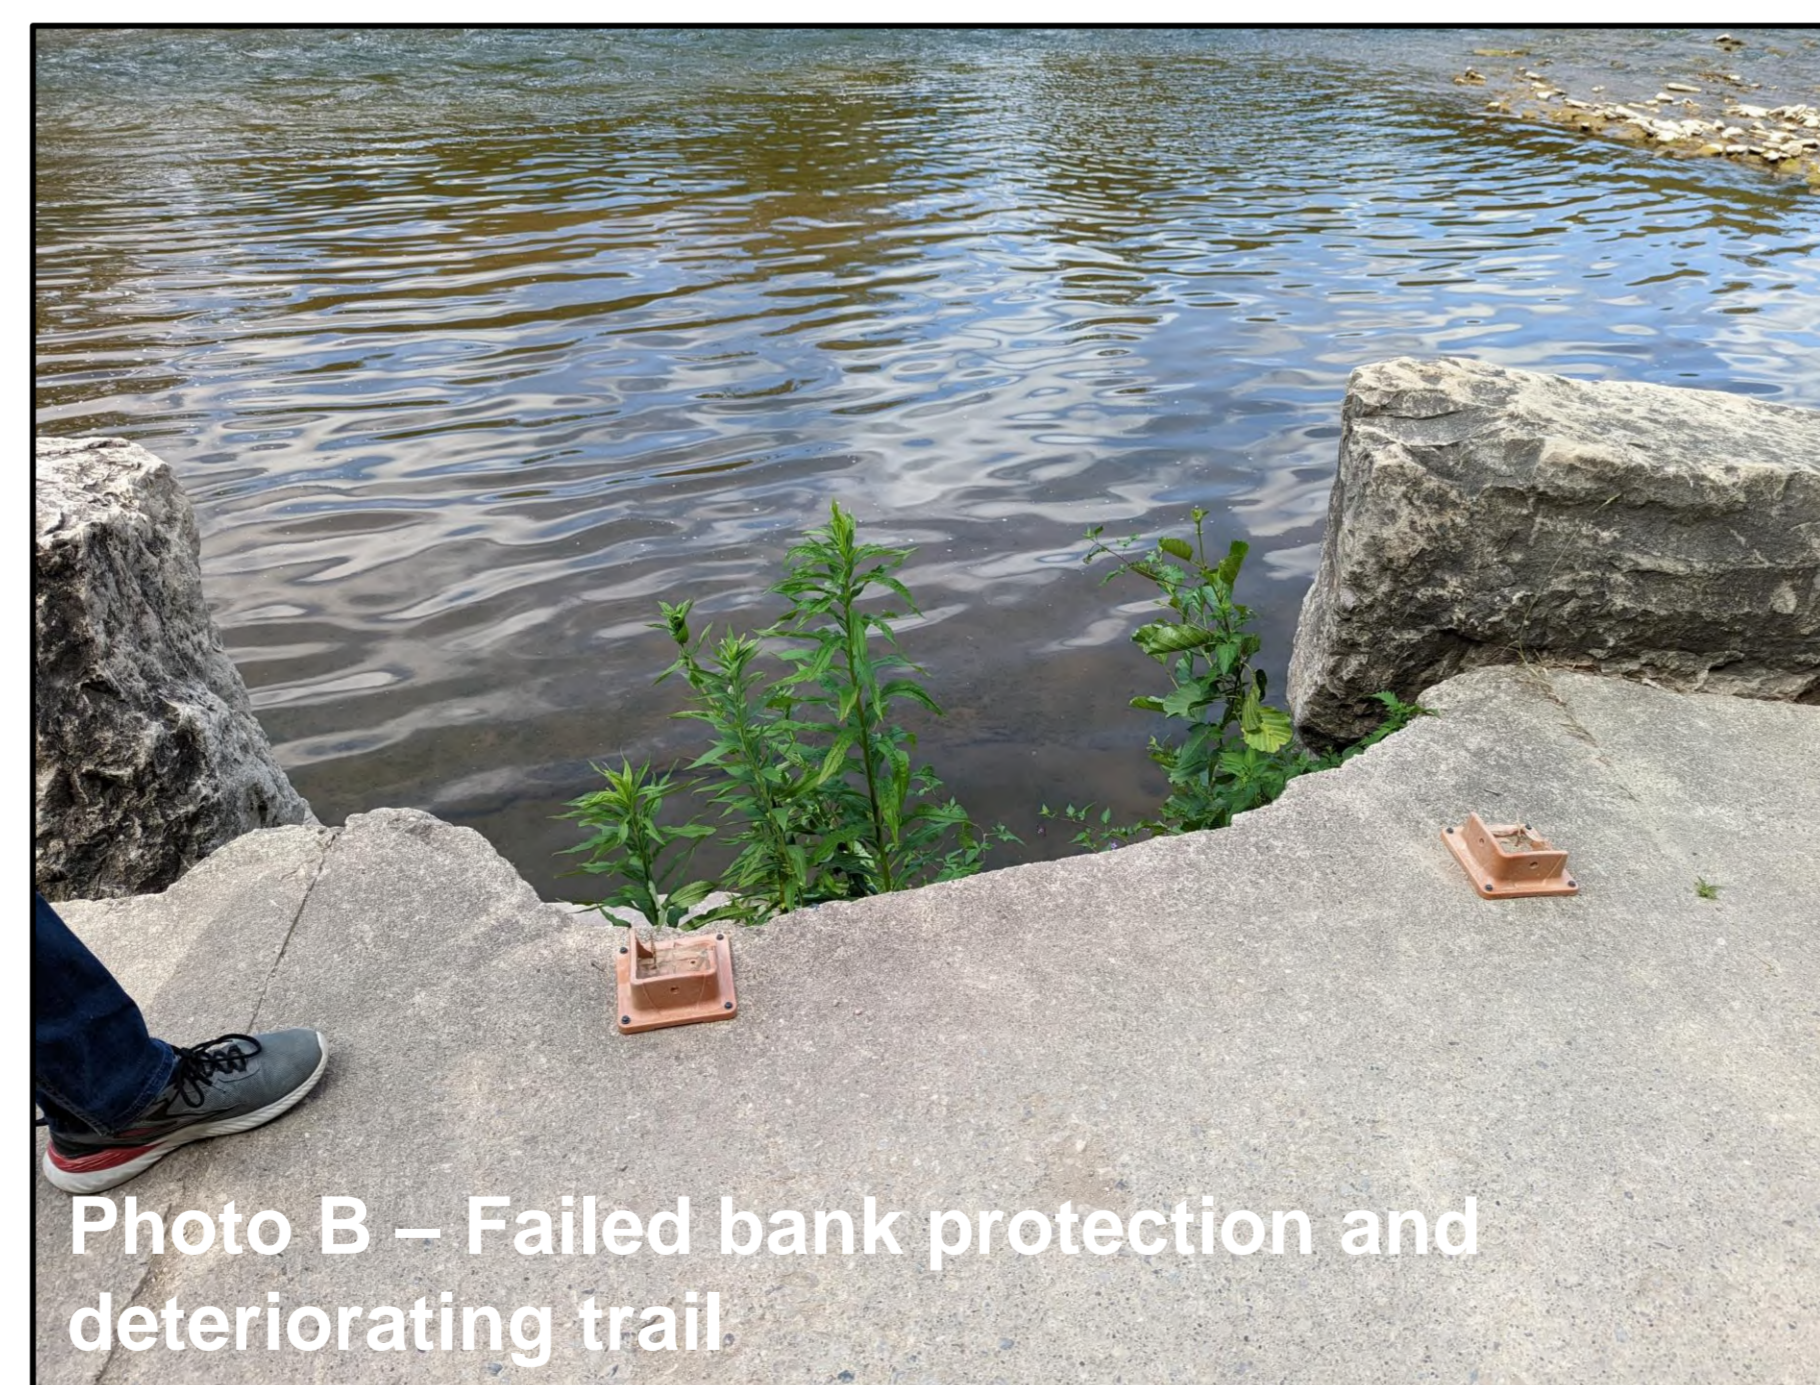
Photo B – Failed bank protection and deteriorating trail

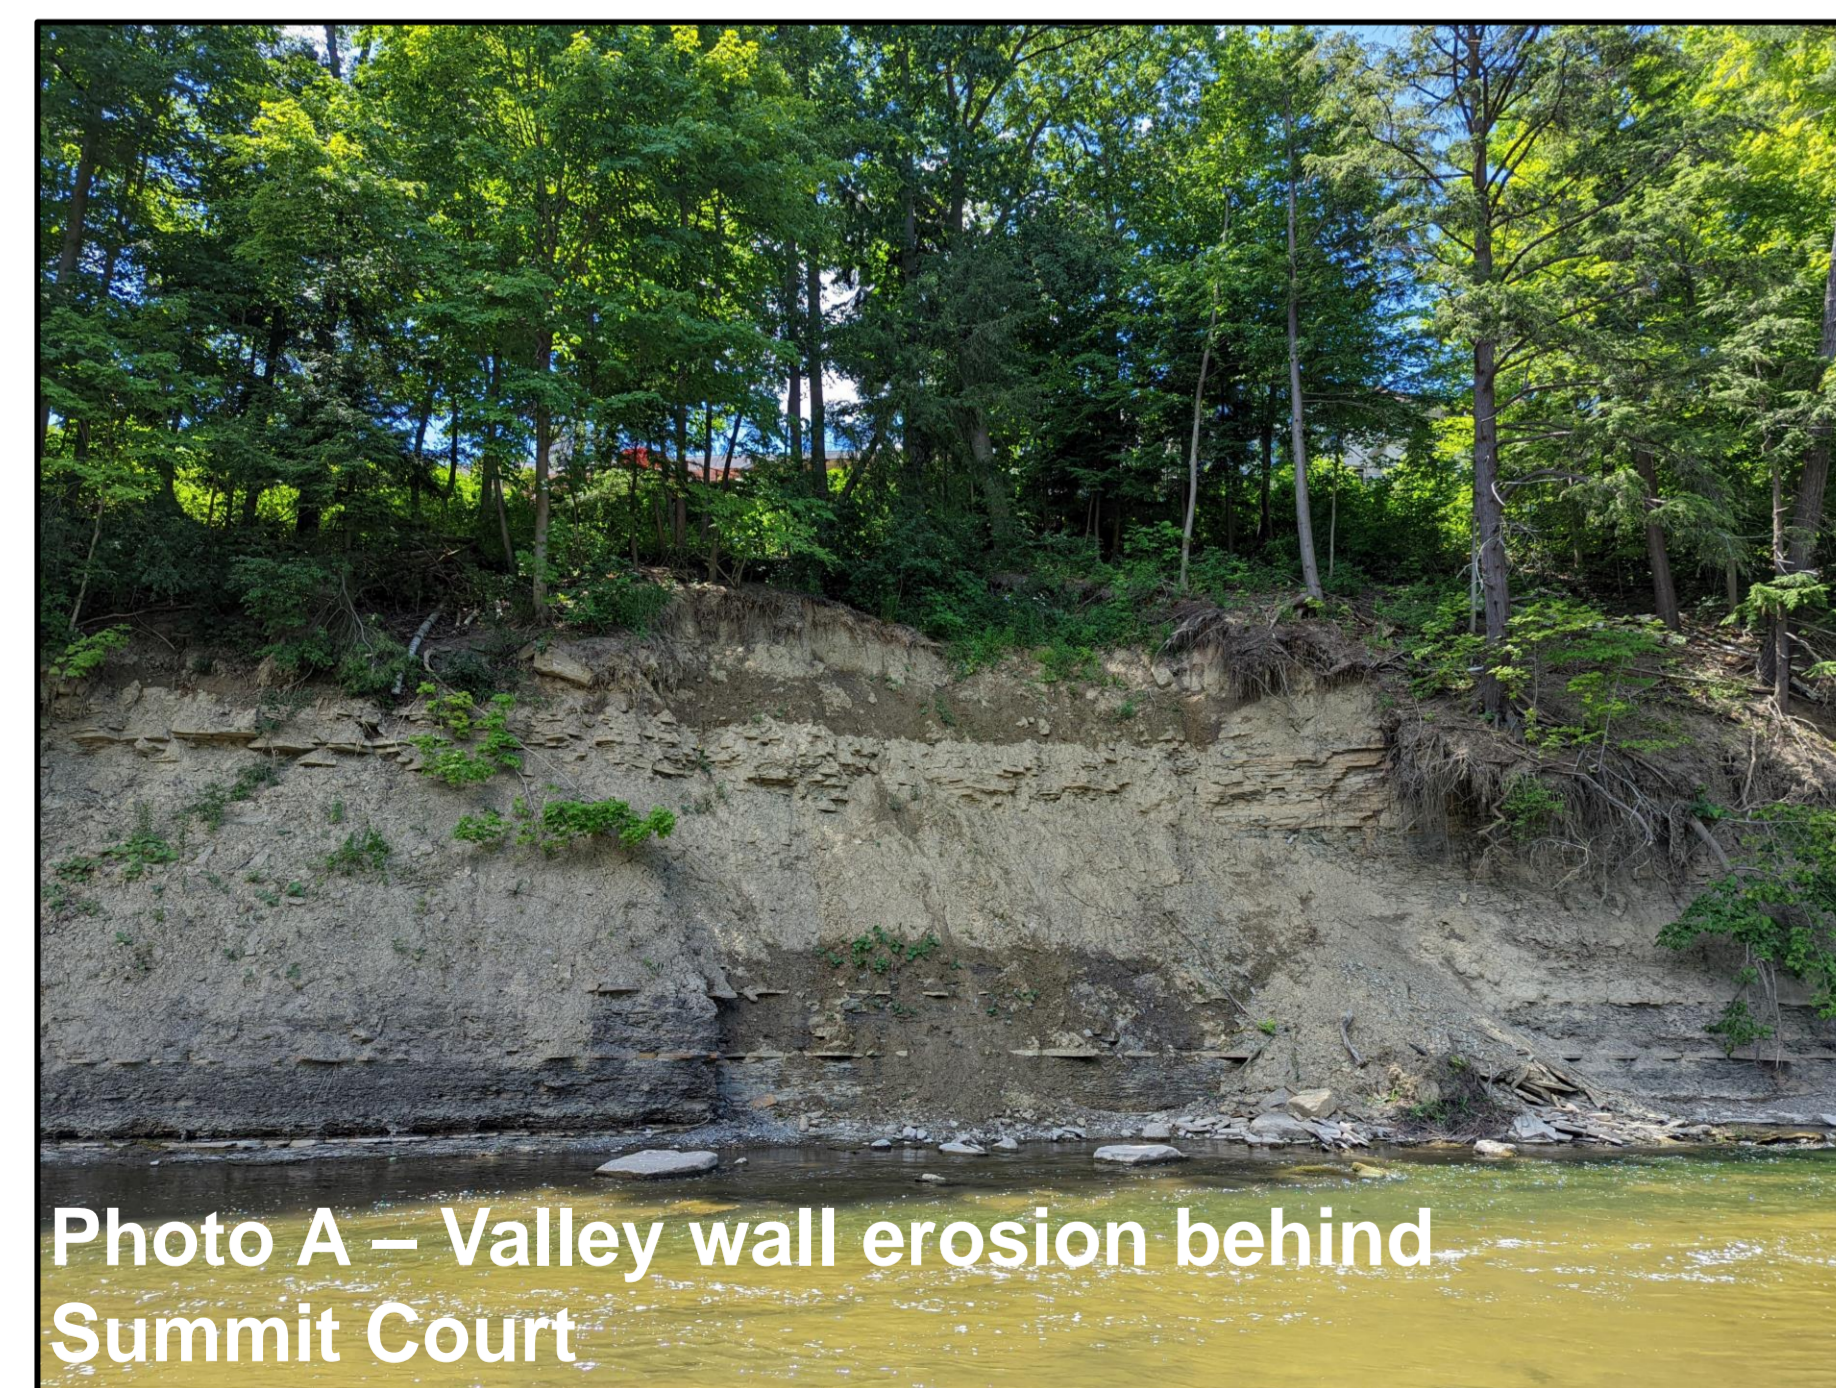
Photo B – River contact points along the toe of slope contribute to erosion

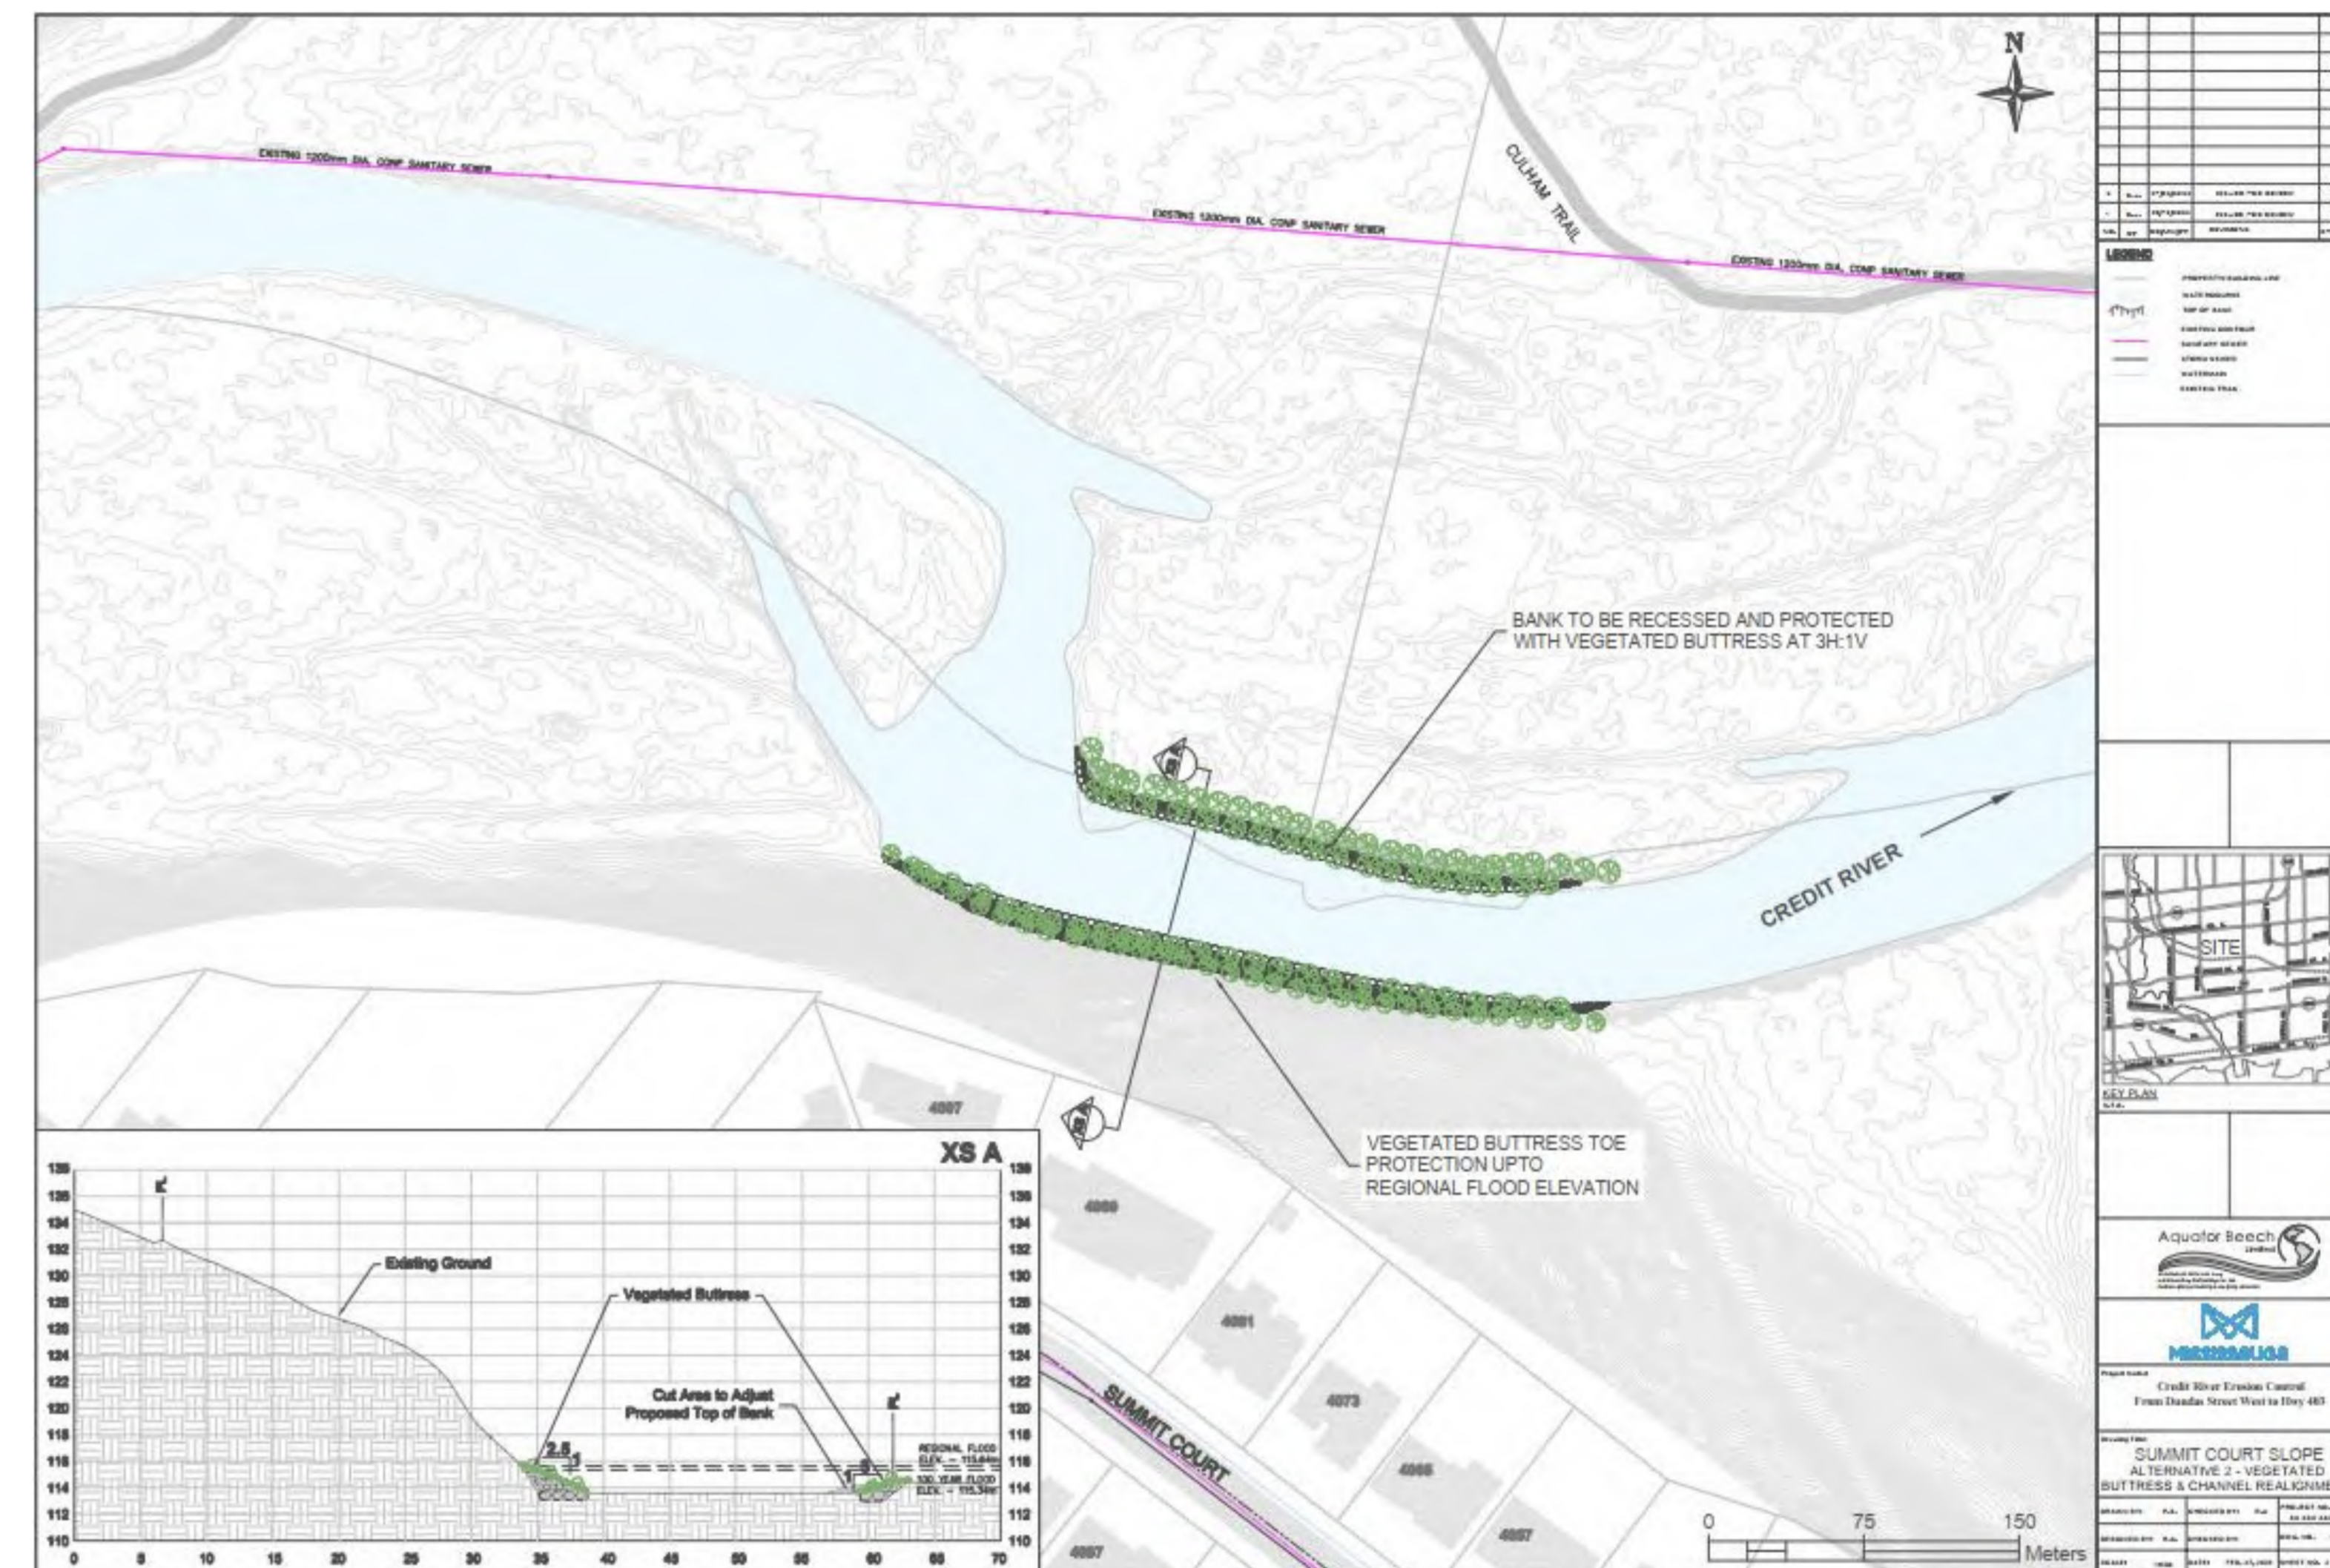
Alternative #2: Vegetated Buttress and Channel Realignment

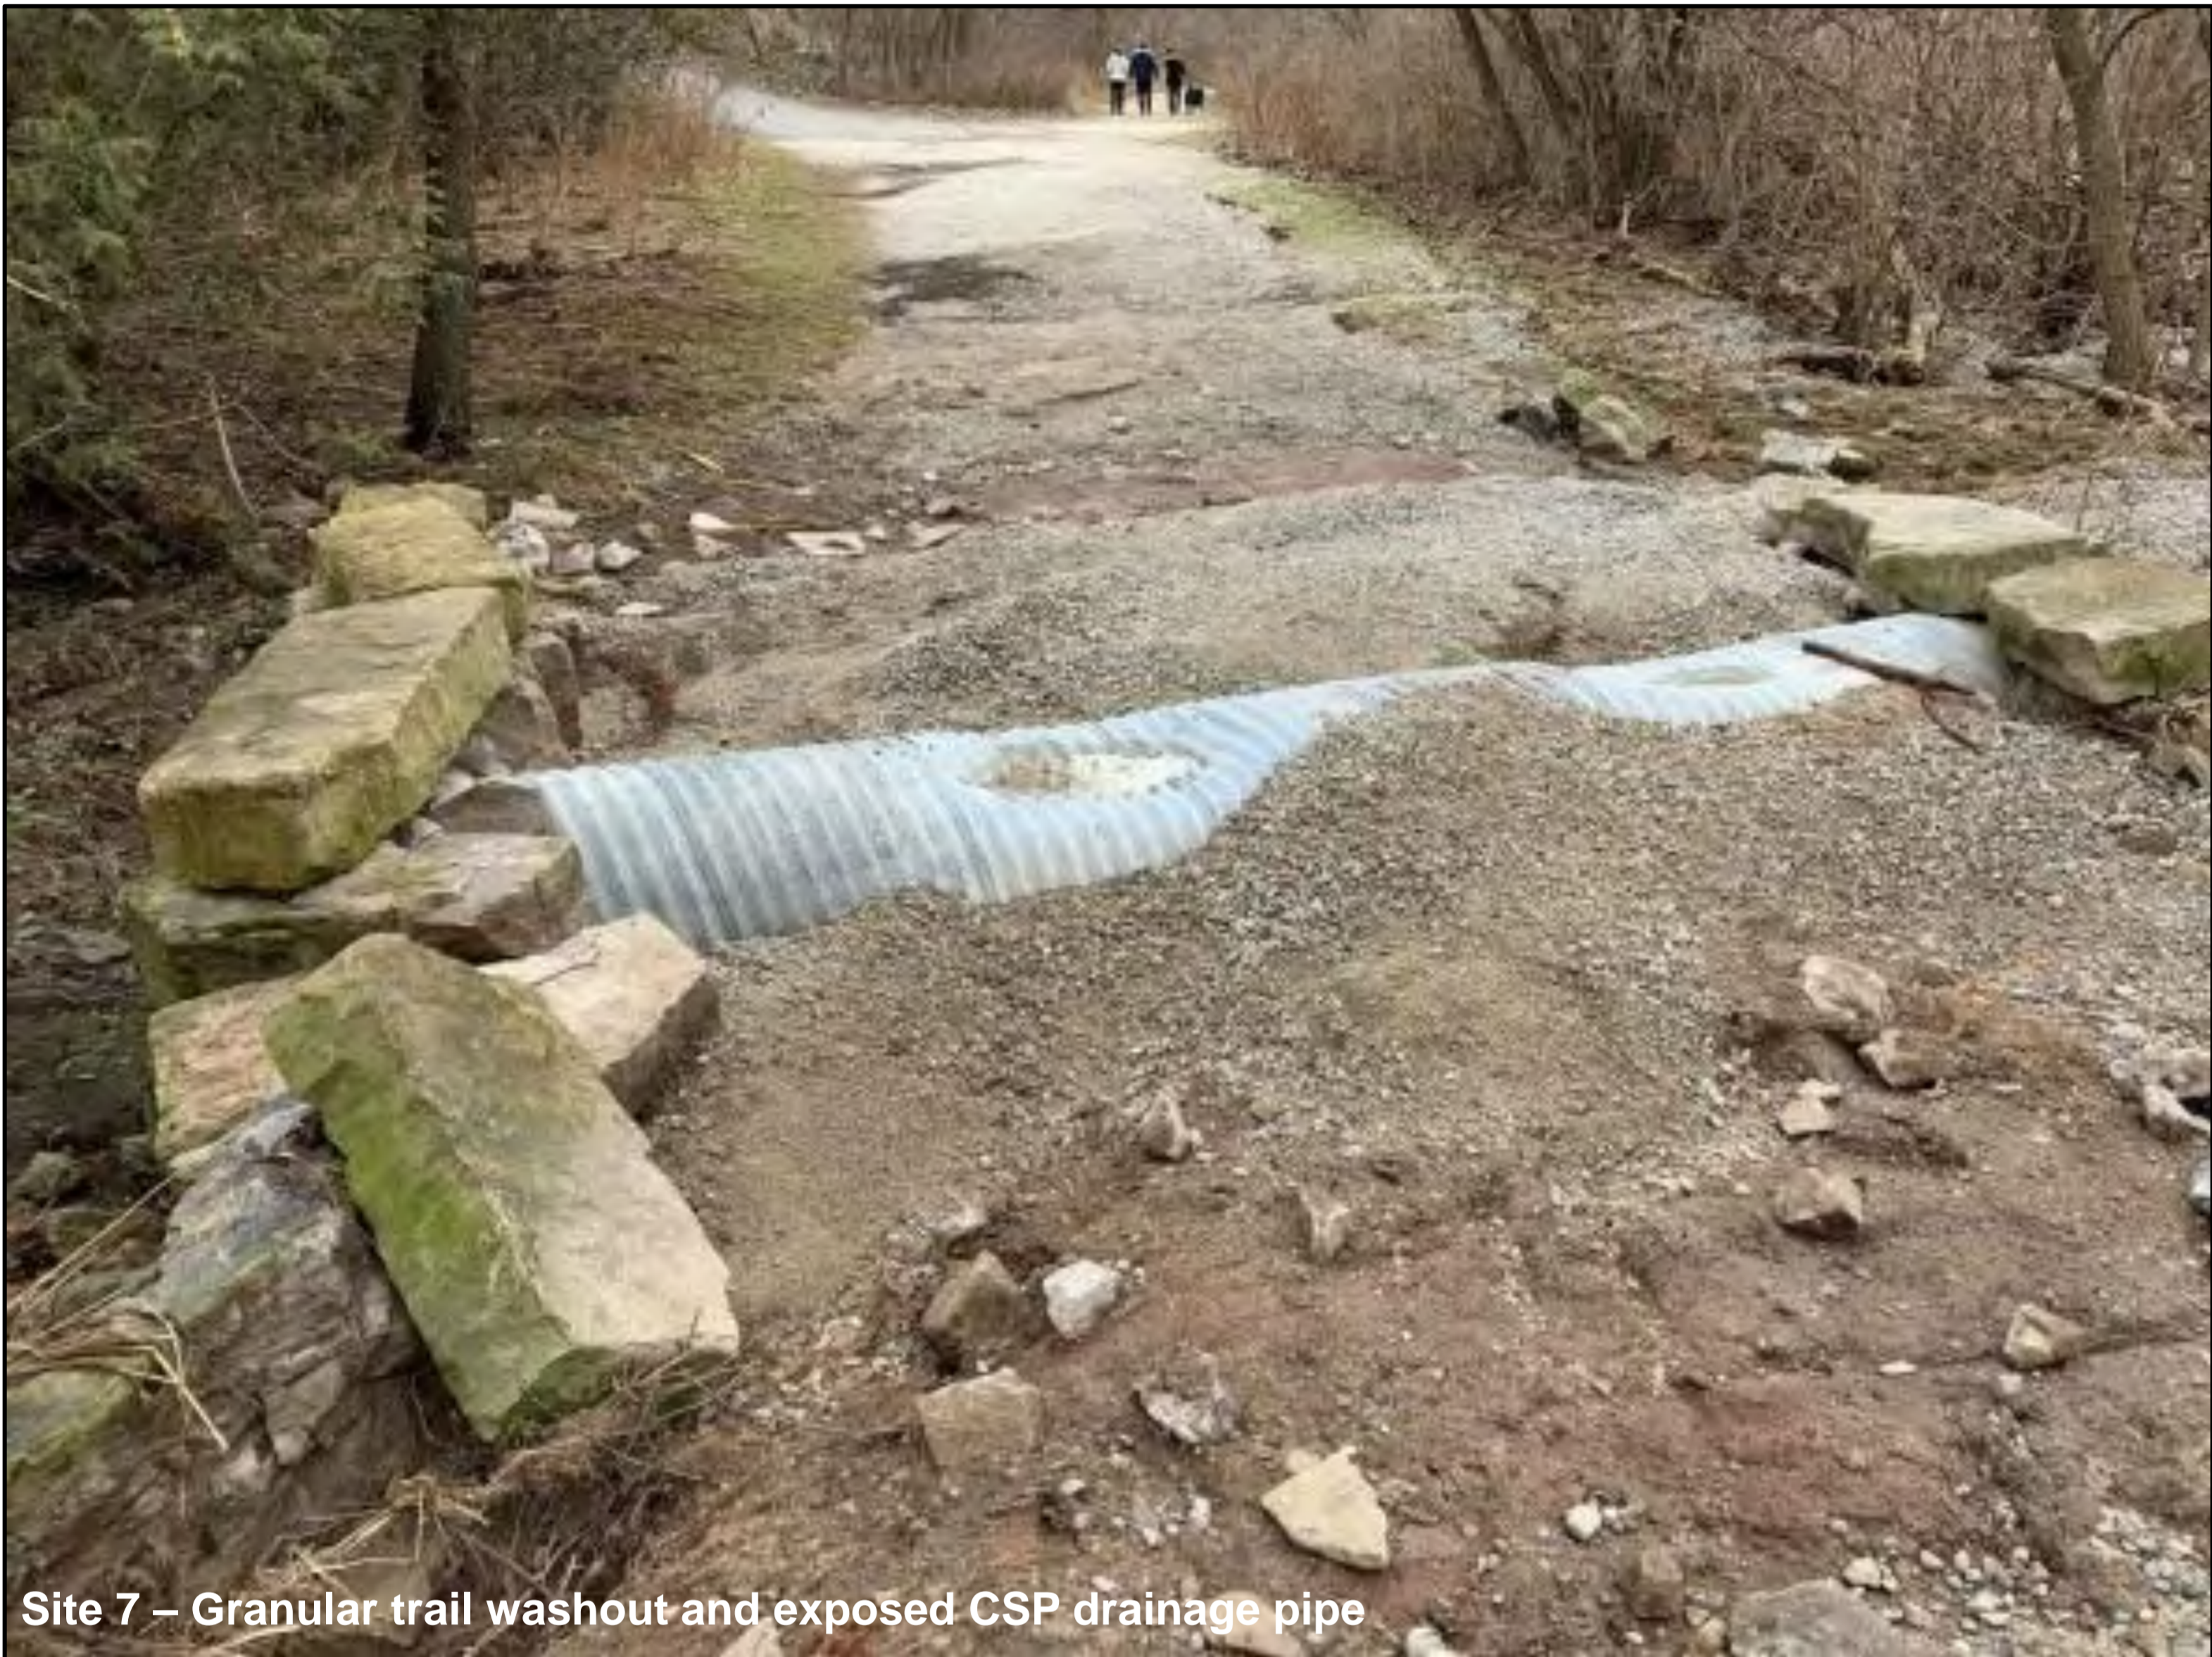
Site 7 – Granular trail washout and exposed CSP drainage pipe

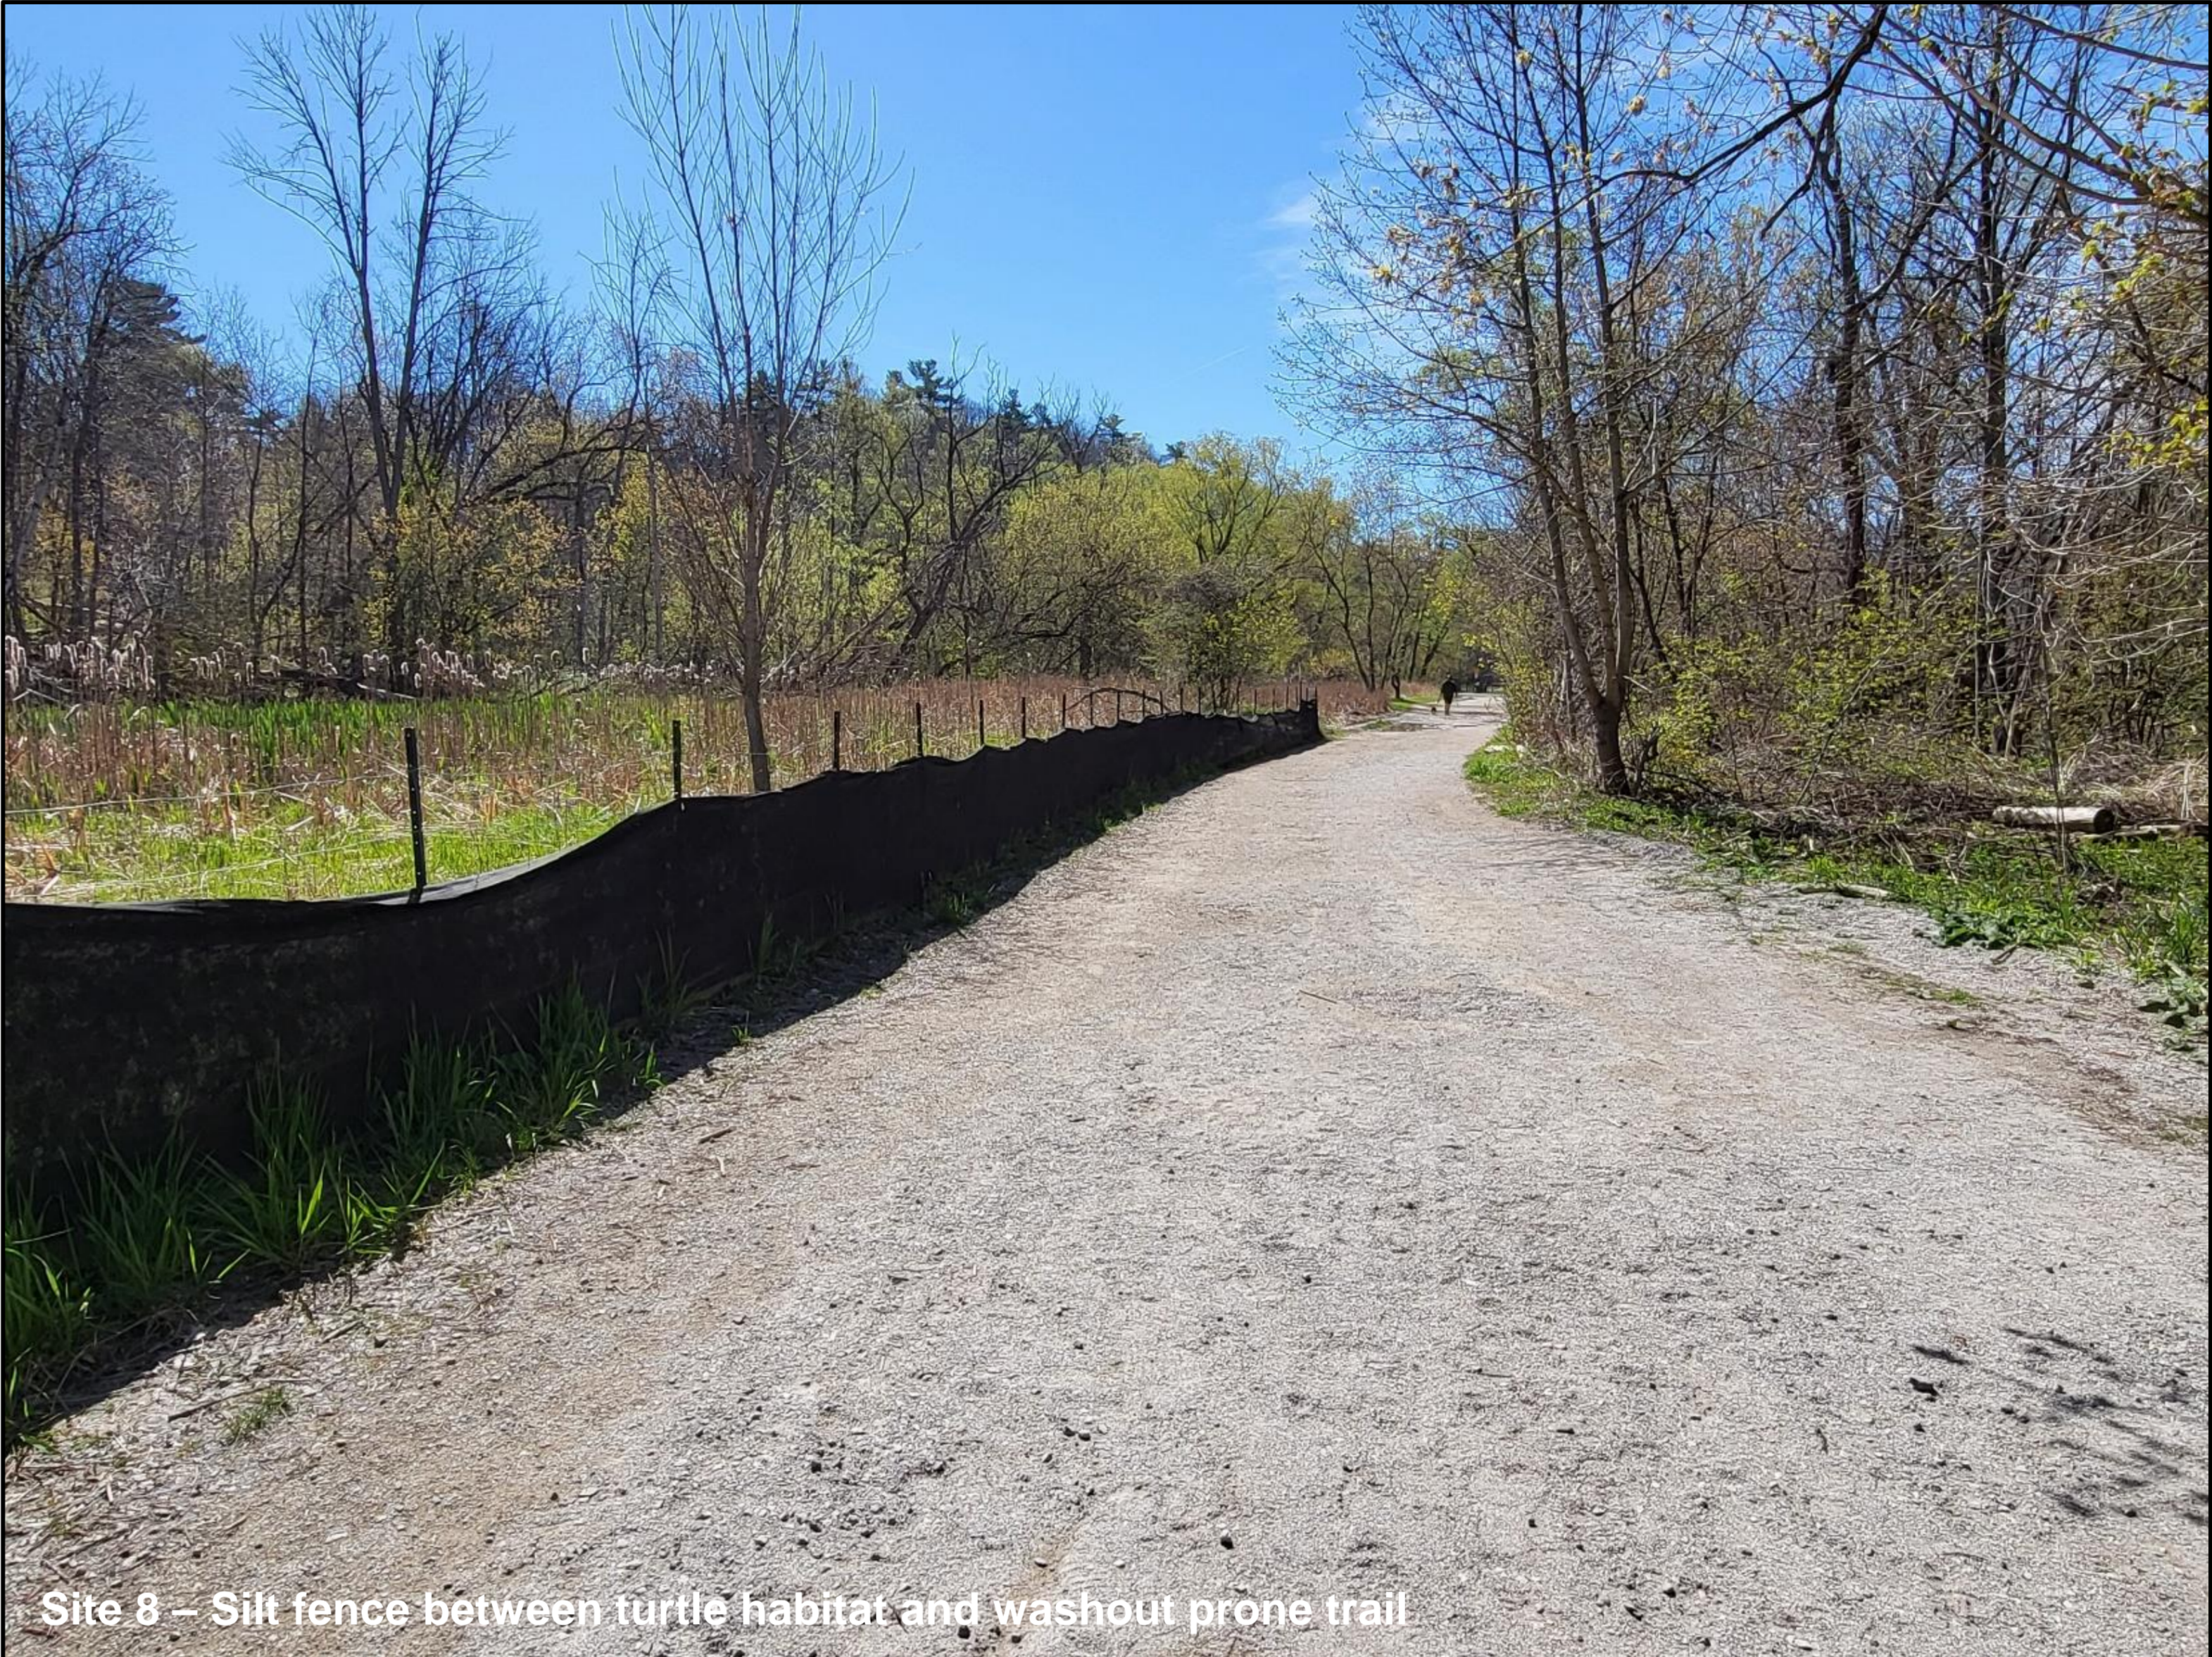
Site 8 – Silt fence between turtle habitat and washout prone trail

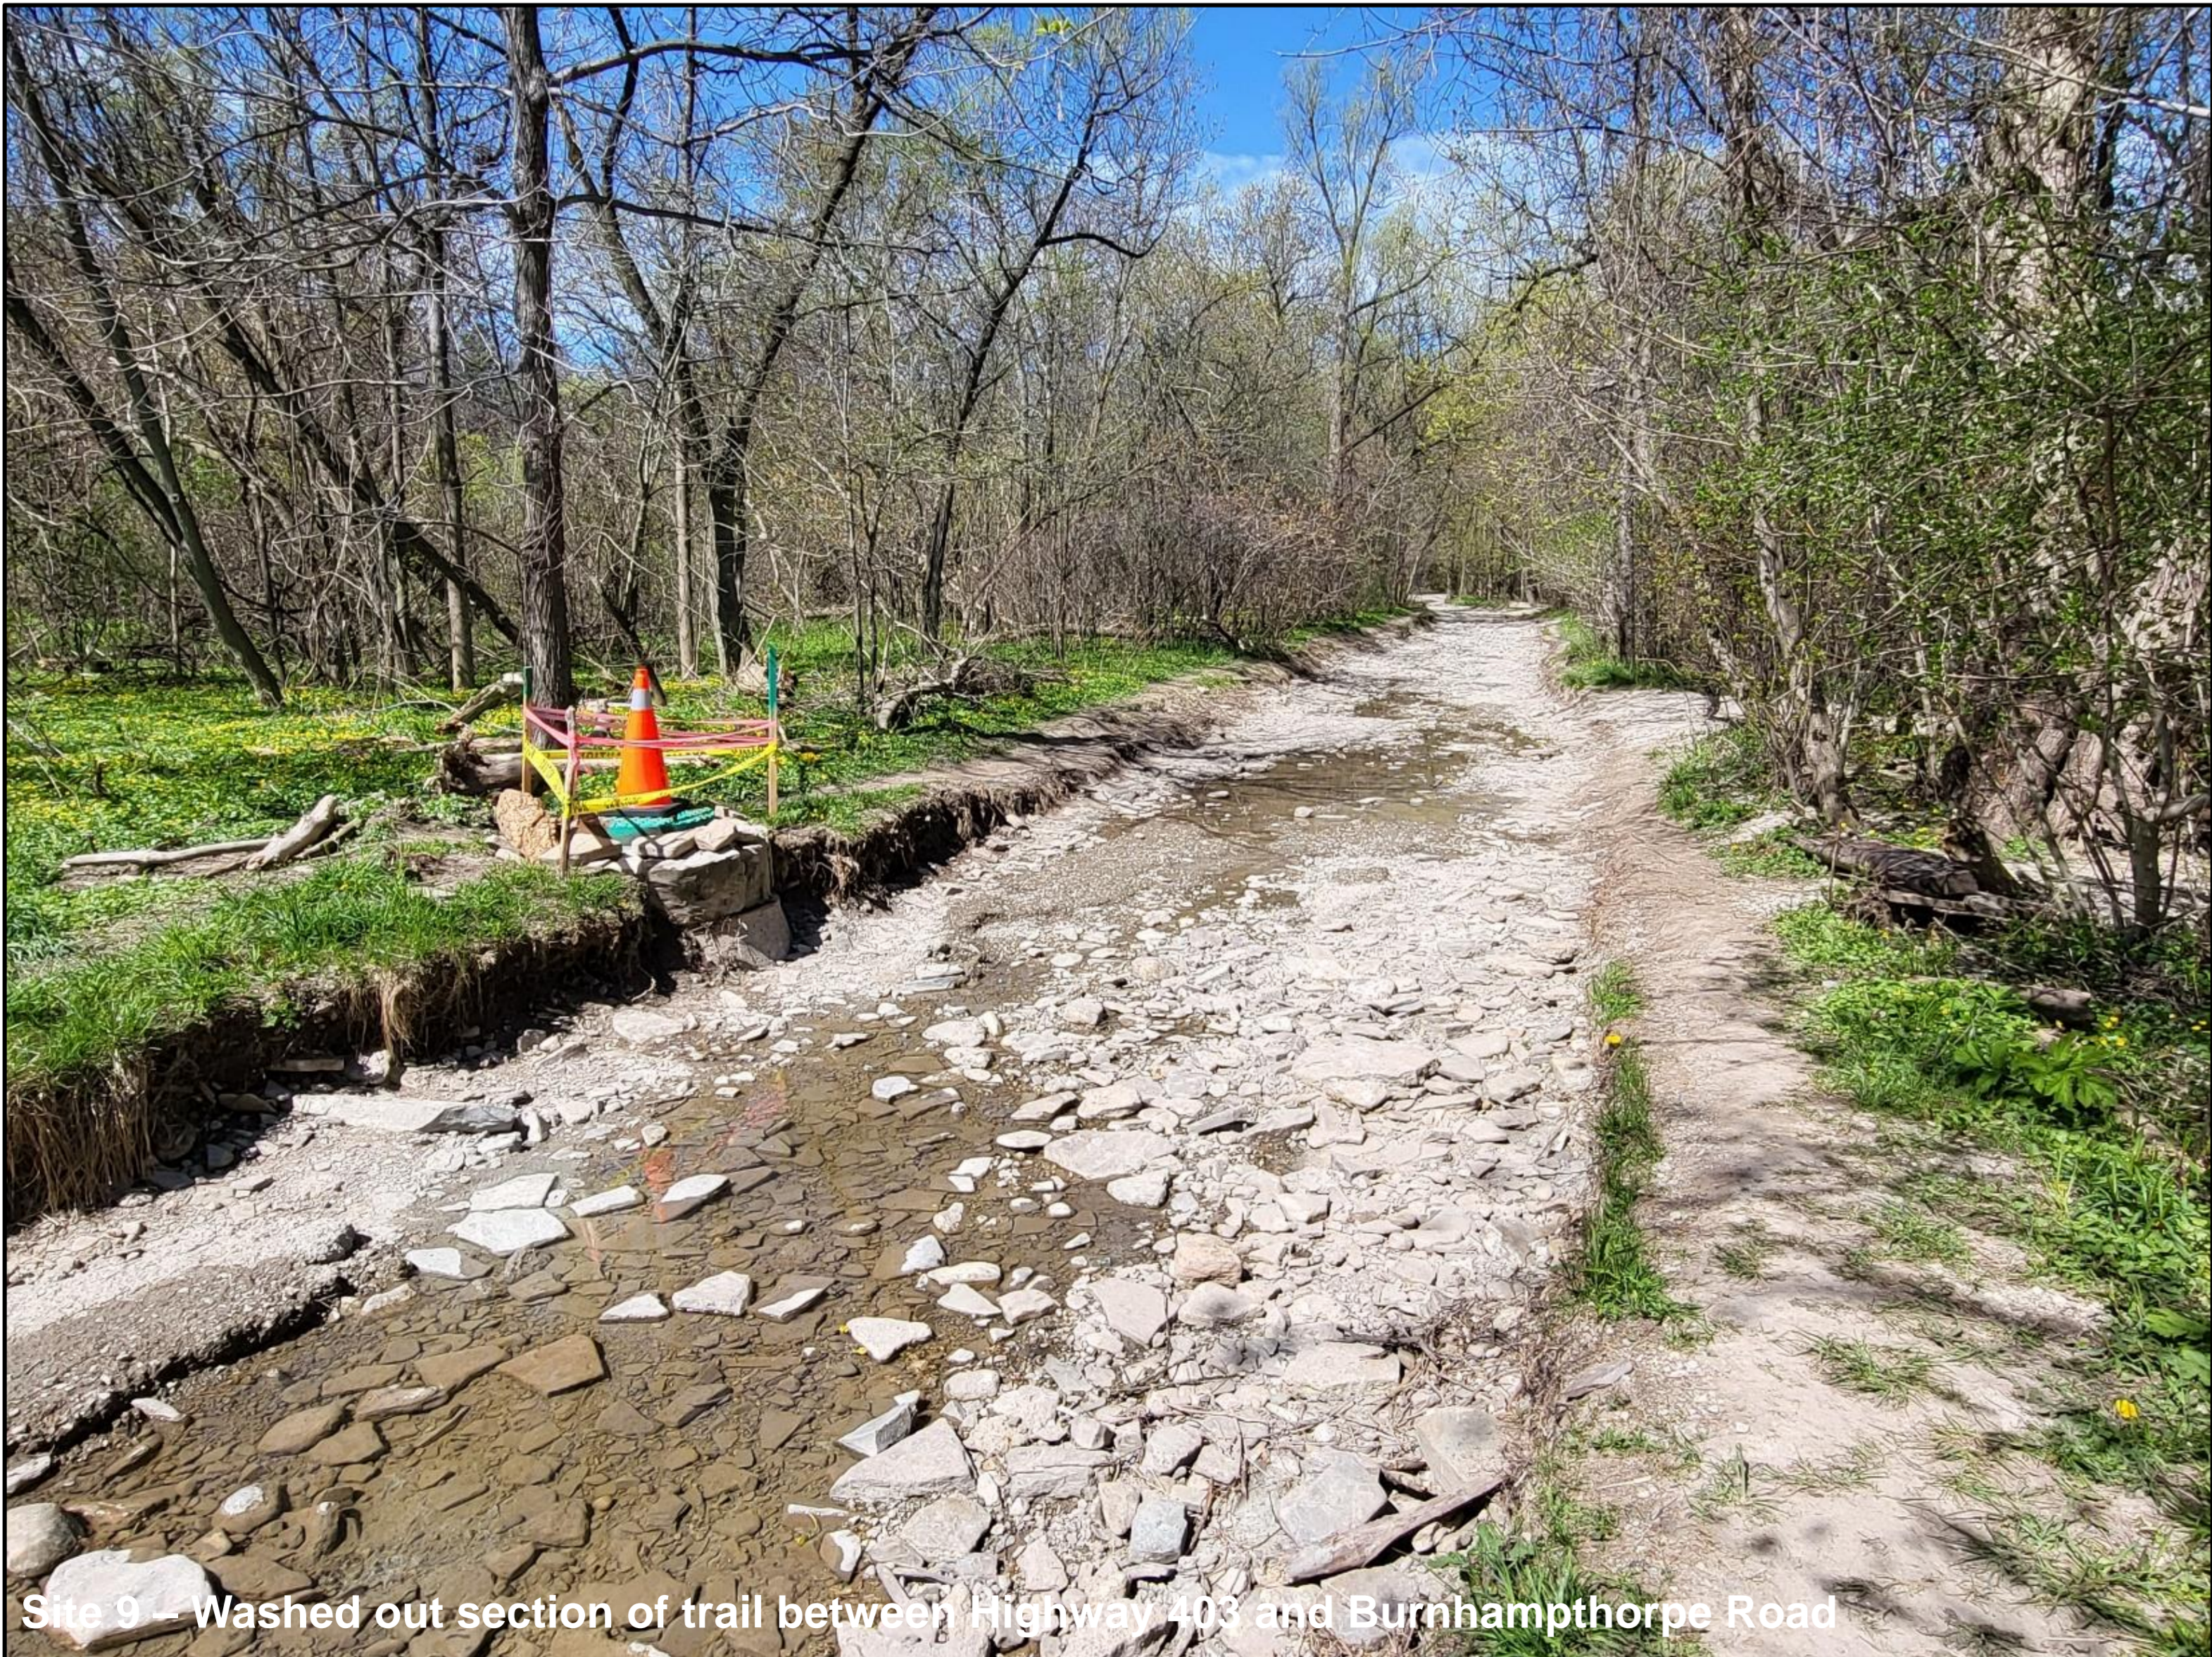
Site 9 – Washed out section of trail between Highway 403 and Burnhamthorpe Road
