**Credit River Erosion Control Project from
Dundas Street West to Highway 403
ONLINE PUBLIC INFORMATION CENTRE
June 14, 2023**

Credit River Erosion Control EA & Detailed Design
Dundas Street West to Highway 403

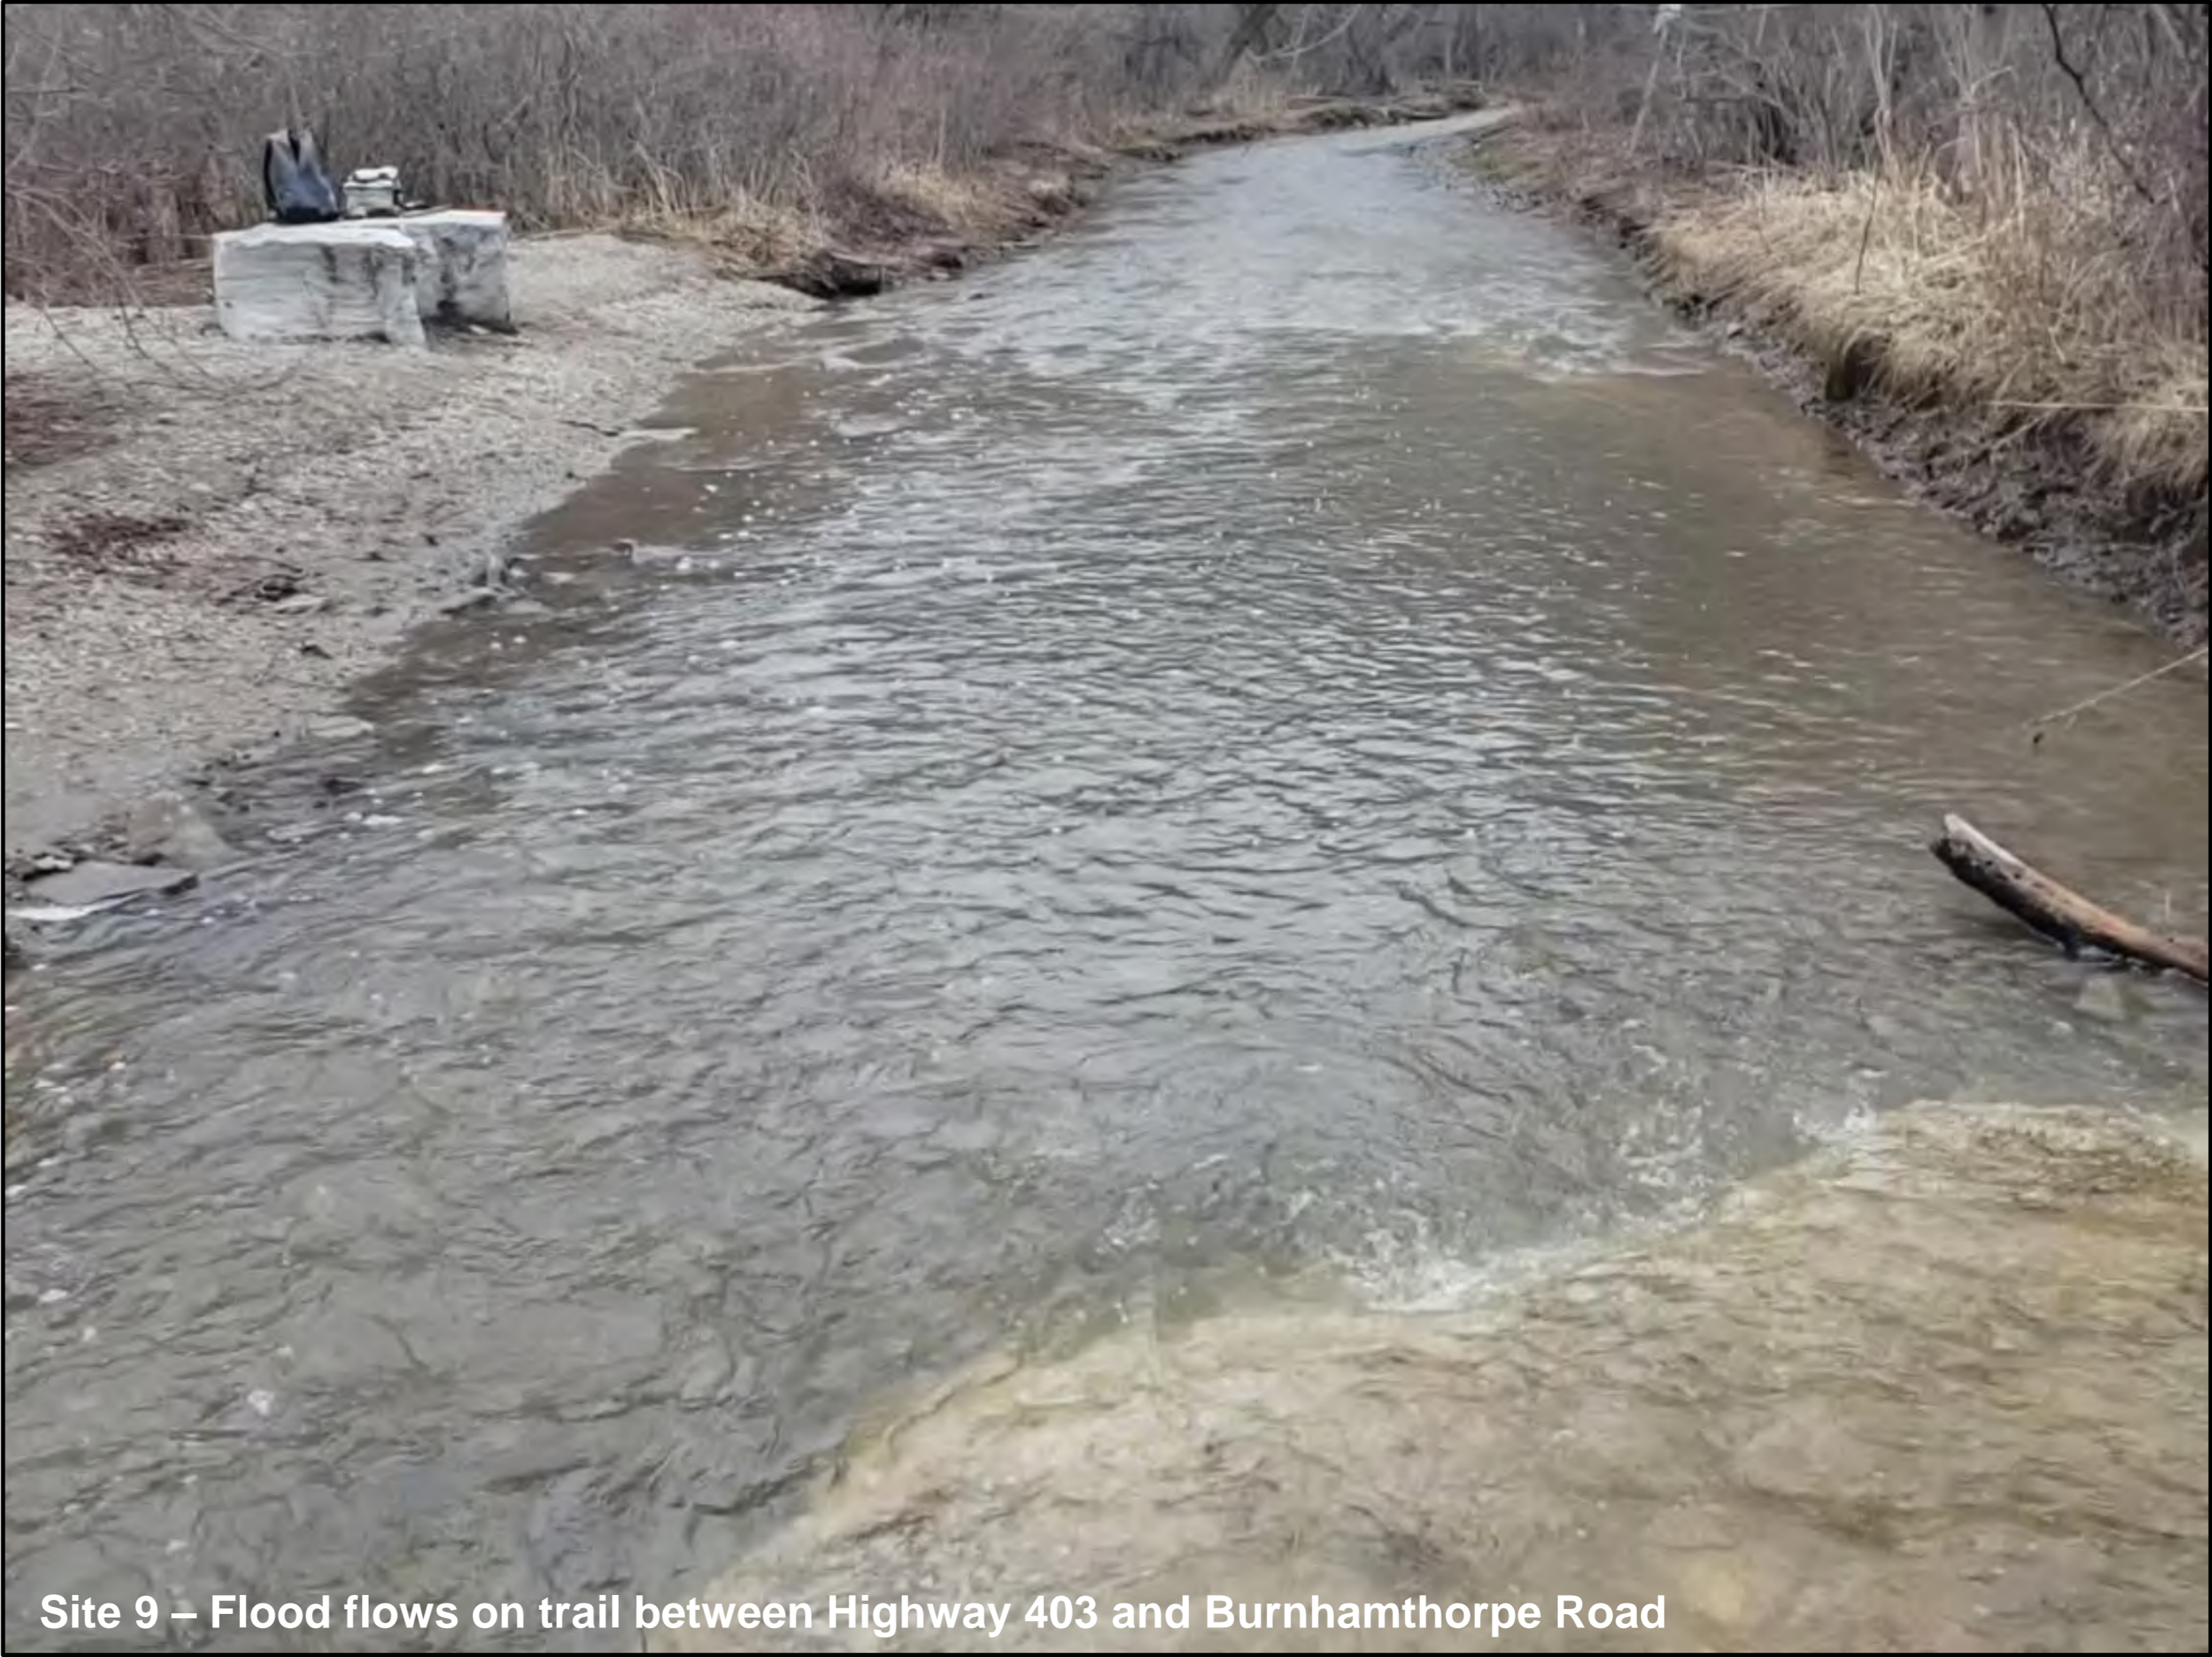
Site 9 – Flood flows on trail between Highway 403 and Burnhamthorpe Road
