Malton Flood Mitigation Study – Etude Drive to Justine Drive

Municipal Class Environmental
Assessment

Public Information Centre

Date: June 16, 2023

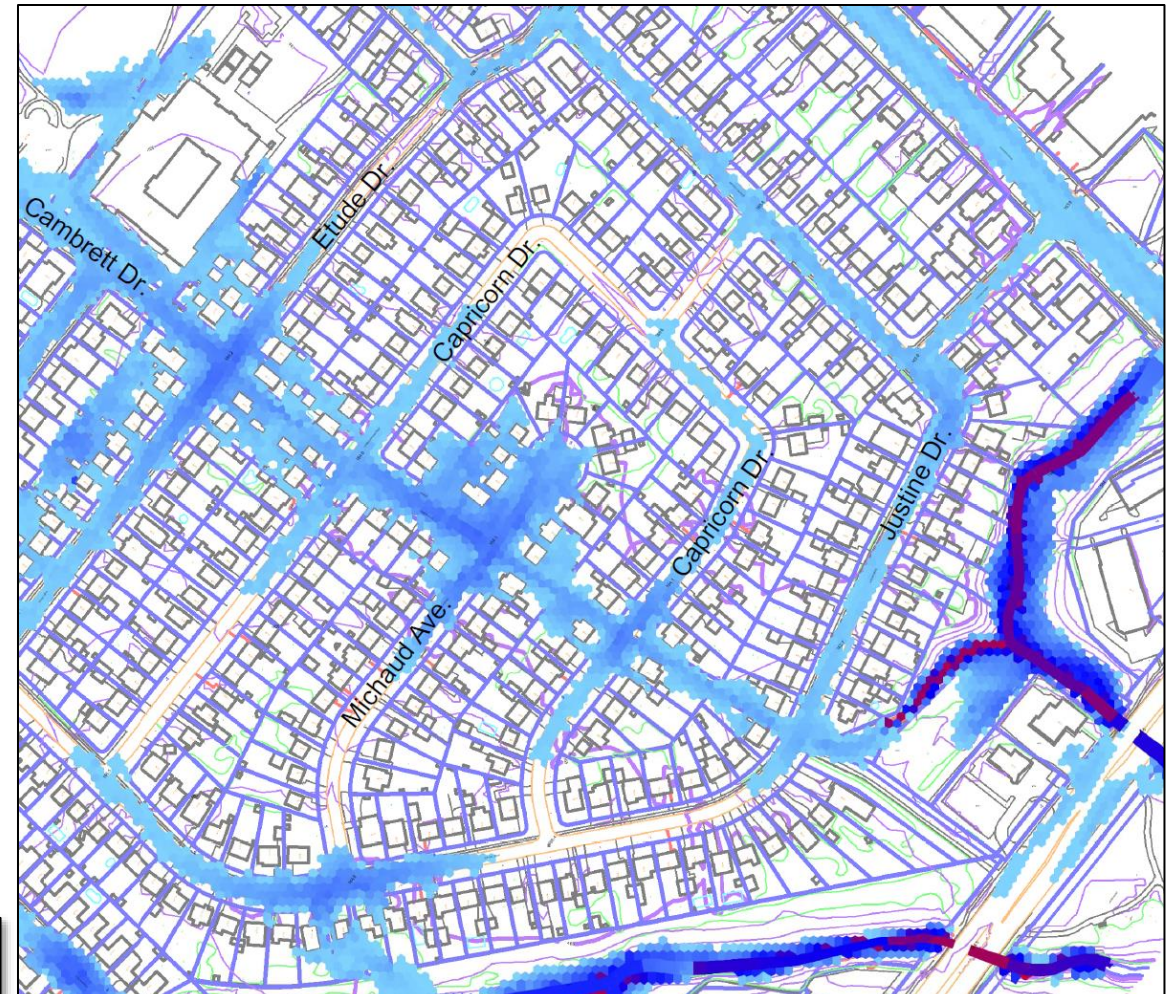
Results of 100-year storm event

- The Flood Mitigation Preliminary Design Report details the modelling steps completed to determine existing flooding conditions
- Results show 37 homes being impacted during the 100-year storm event
- These properties are also being impacted during more frequent storm events, such as 2-year and 5-year storm events

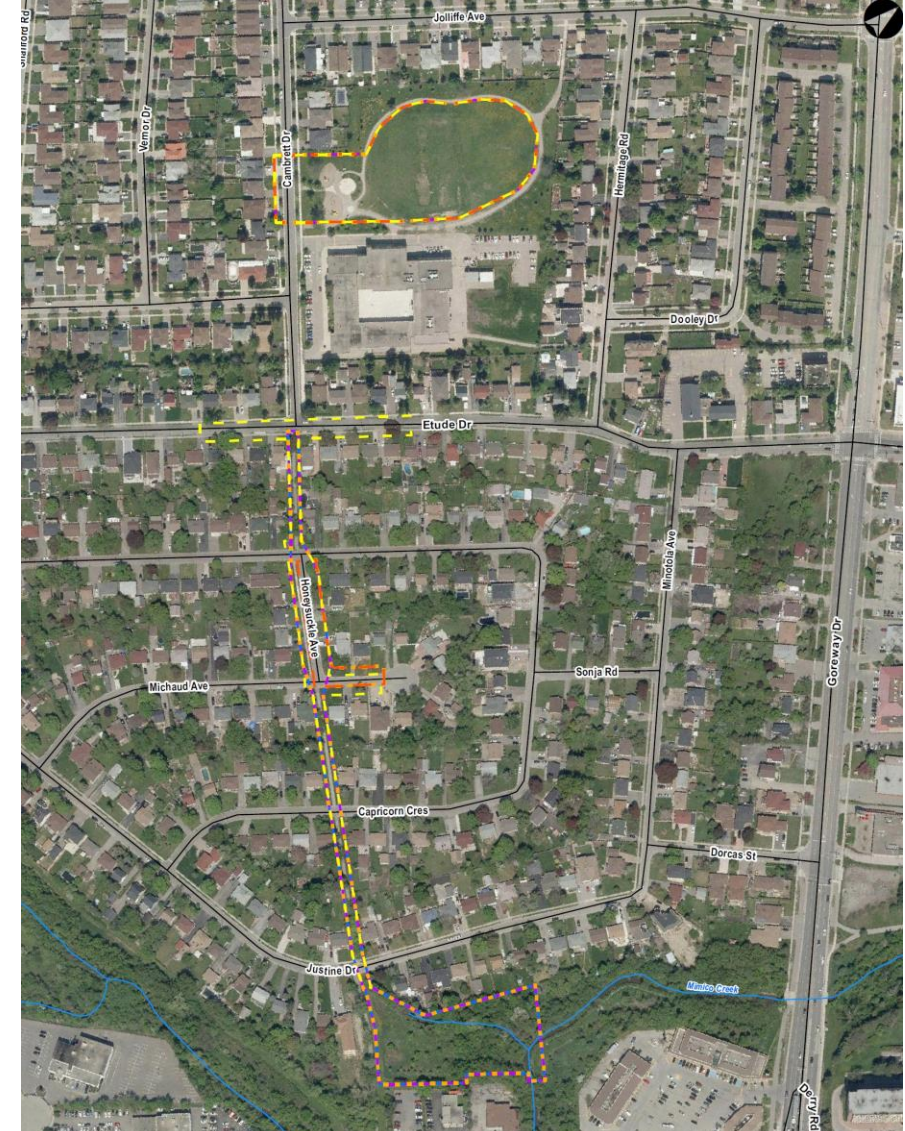
Alternative 1: Replace storm sewer, regrade walkway and outlet upgrades
-

Alternative 2: Construct storage in Ridgewood Park, relief storm sewer, regrade walkway and outlet upgrades
-

Alternative 3: Construct storage in Ridgewood Park, relief storm sewer, bioswales and outlet upgrades
-

Alternative 4: Construct storage in Ridgewood Park and bioswale
-

Alternative 5: Construct storage in Ridgewood Park, additional storage and regrade walkway

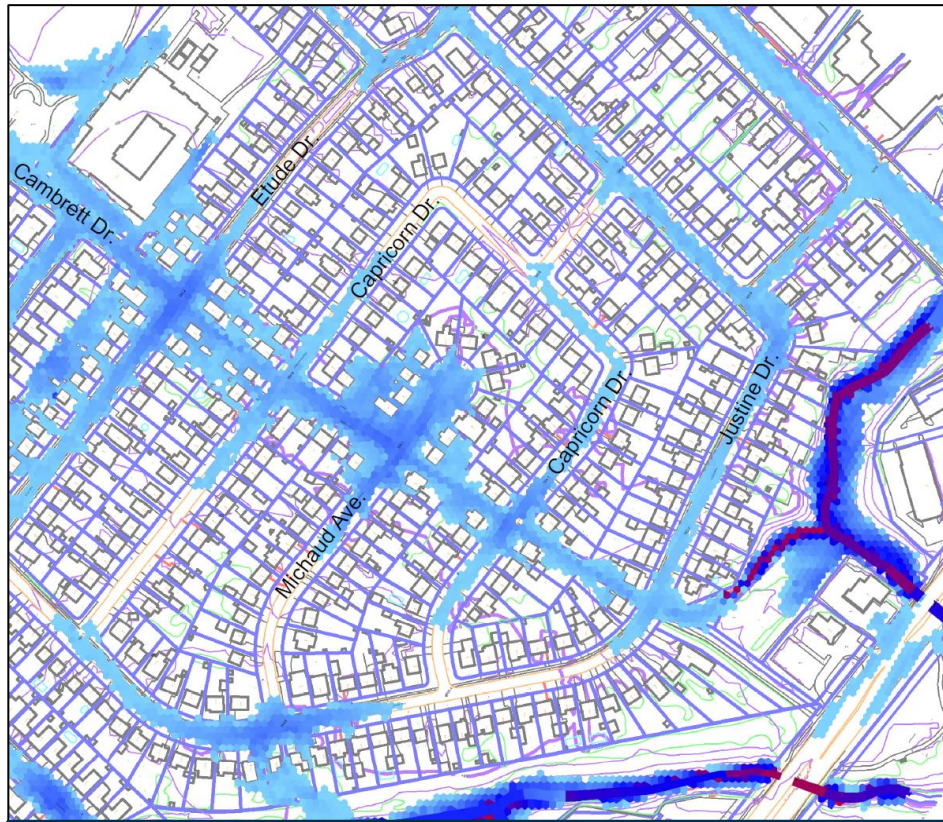
Existing Conditions – 100-year Storm Event

Depths ranging from 0.01 m (light blue) to 2.76 m (red)

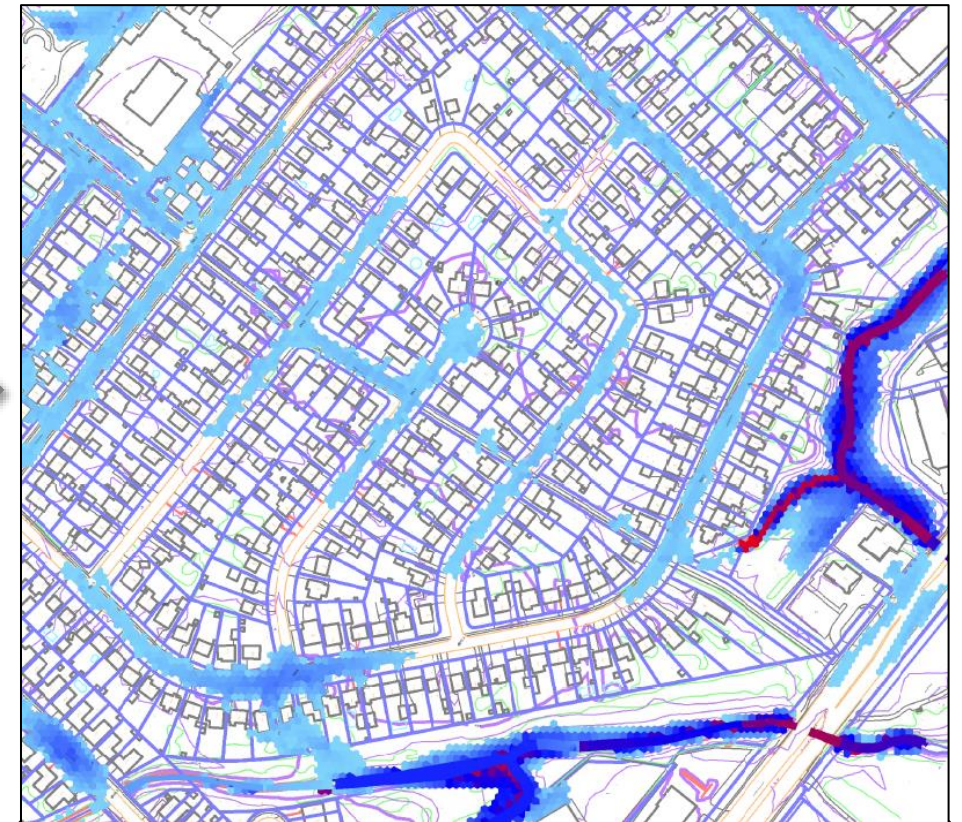
Preferred Solution – 100-year Storm Event

- Based on the modeling results of the 100-year storm event for the preferred solution, there is a significant reduction in flooding when compared to existing conditions. The preferred solution would eliminate all homes along the walkway from being impacted during a 100-year storm event

Alternative 1: Replace storm sewer with 3.0m span and 1.8m rise box culvert, regrade walkway to convey overland flow and outlet upgrades at sewer outfall is preferred:
 - Significantly reduces the potential impacts of flooding
 - Minimizes impacts to public park space
 - Lower construction cost

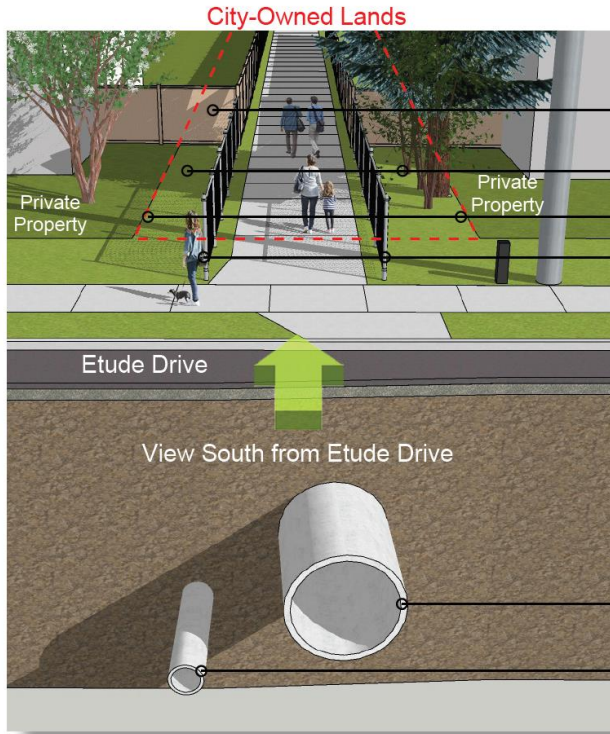
Existing Condition

- Fence and Tree/ Vegetation Encroachments to be Removed
- Zone of Encroachment on City-owned Lands
- Property Line
- Existing Chain Link Fence to be Replaced and Relocated

- Existing Storm Sewer to be Replaced
- Existing Sanitary Sewer

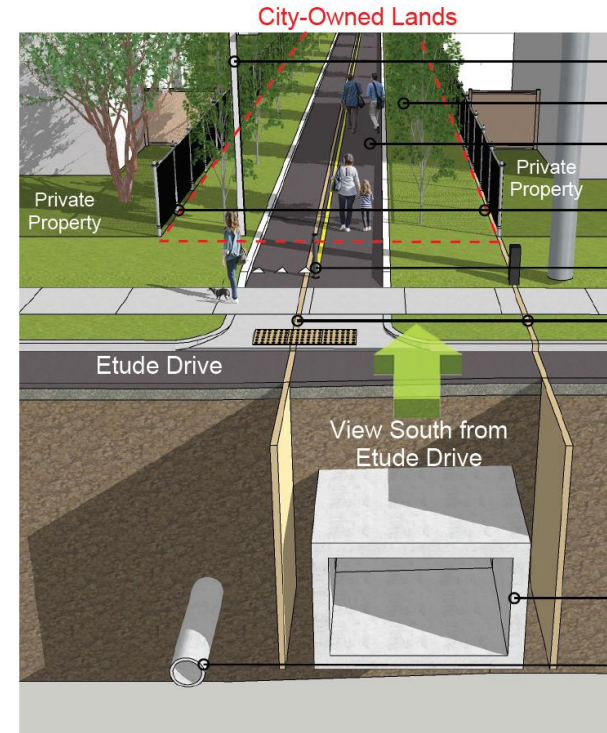
Proposed Condition

- Pathway Light Standard
- New Tree Planting
- Improved Walkway (3.0m Wide Asphalt Path with 150mm Wide Concrete Curbs on Each Side)
- New Chain Link Fence at Property Line
- Relocatable Bollard
- Excavation Limit for New Storm Sewer

- Proposed Storm Box Sewer
- Existing Sanitary Sewer

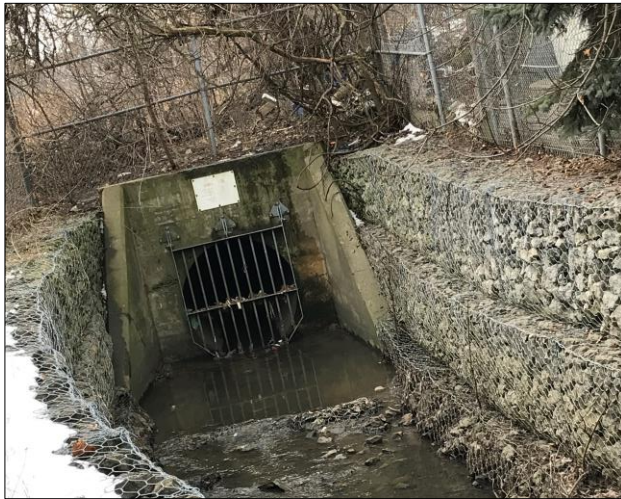
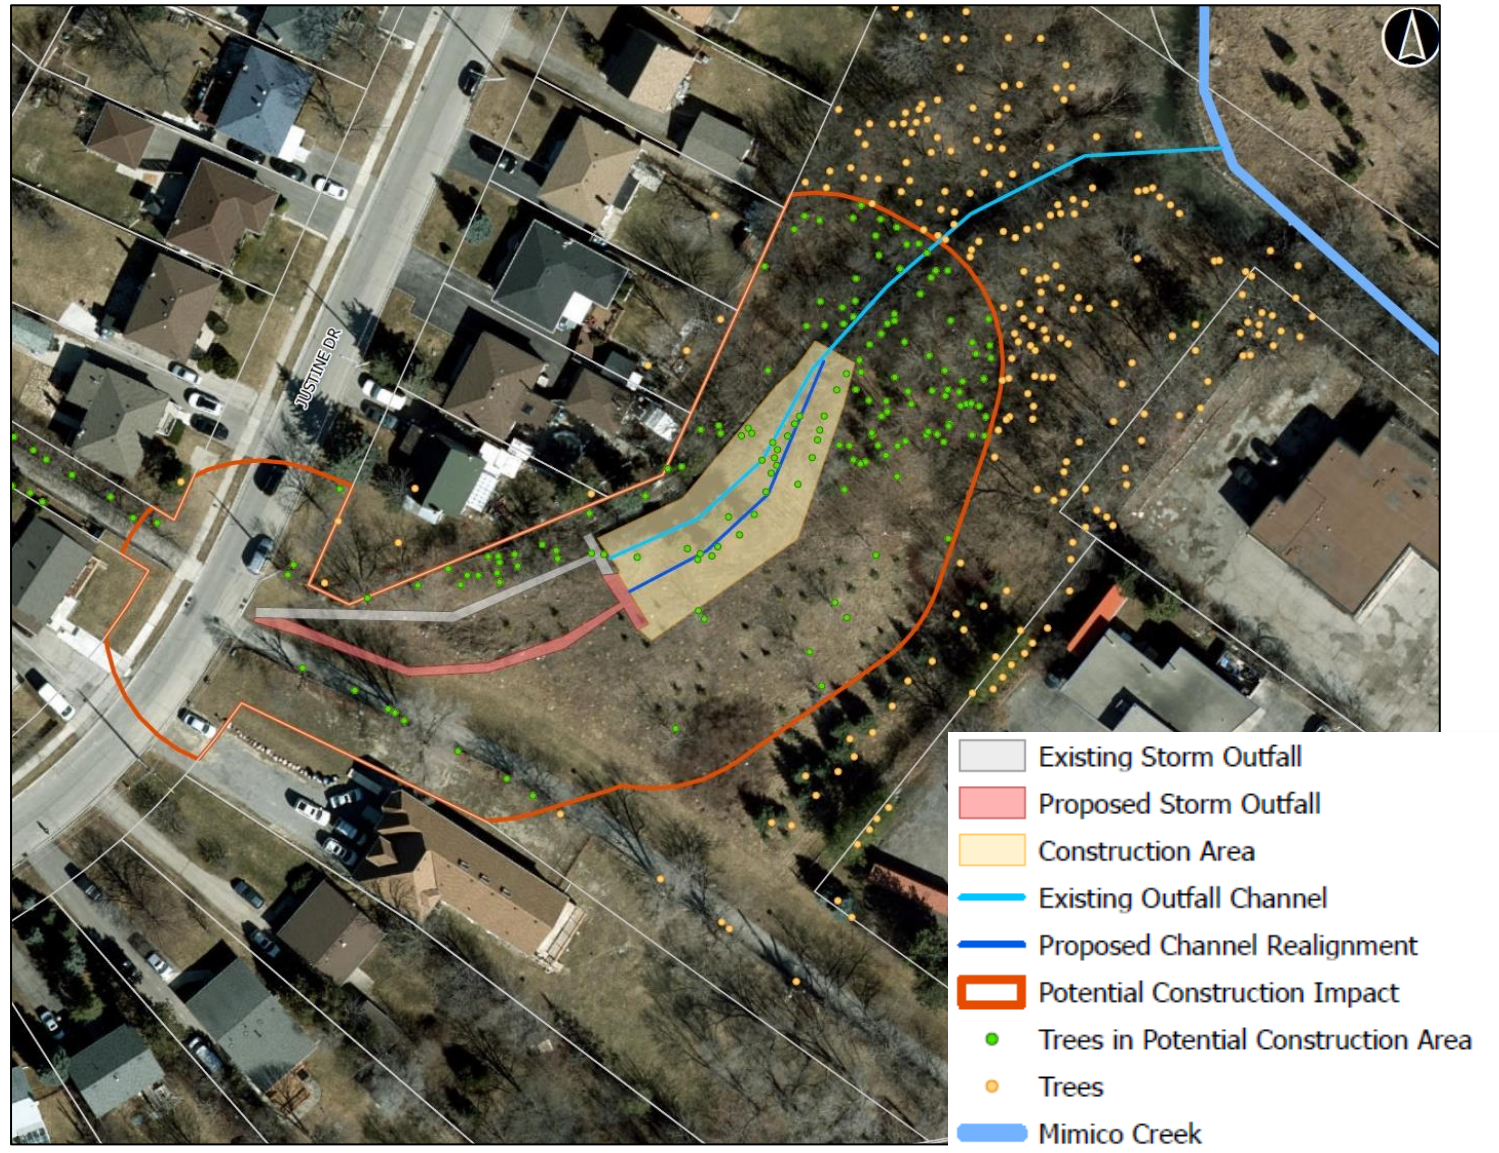
Outlet Upgrades

- Larger outlet structure and channel realignment south of Justine Drive upstream of Mimico Creek
- Future design will minimize impacts to trees and vegetation to fullest extent possible
