AIRSTAR HOLDINGS INC.

# Environmental Impact Study

7211 and 7233 Airport Road, Mississauga, Region of Peel

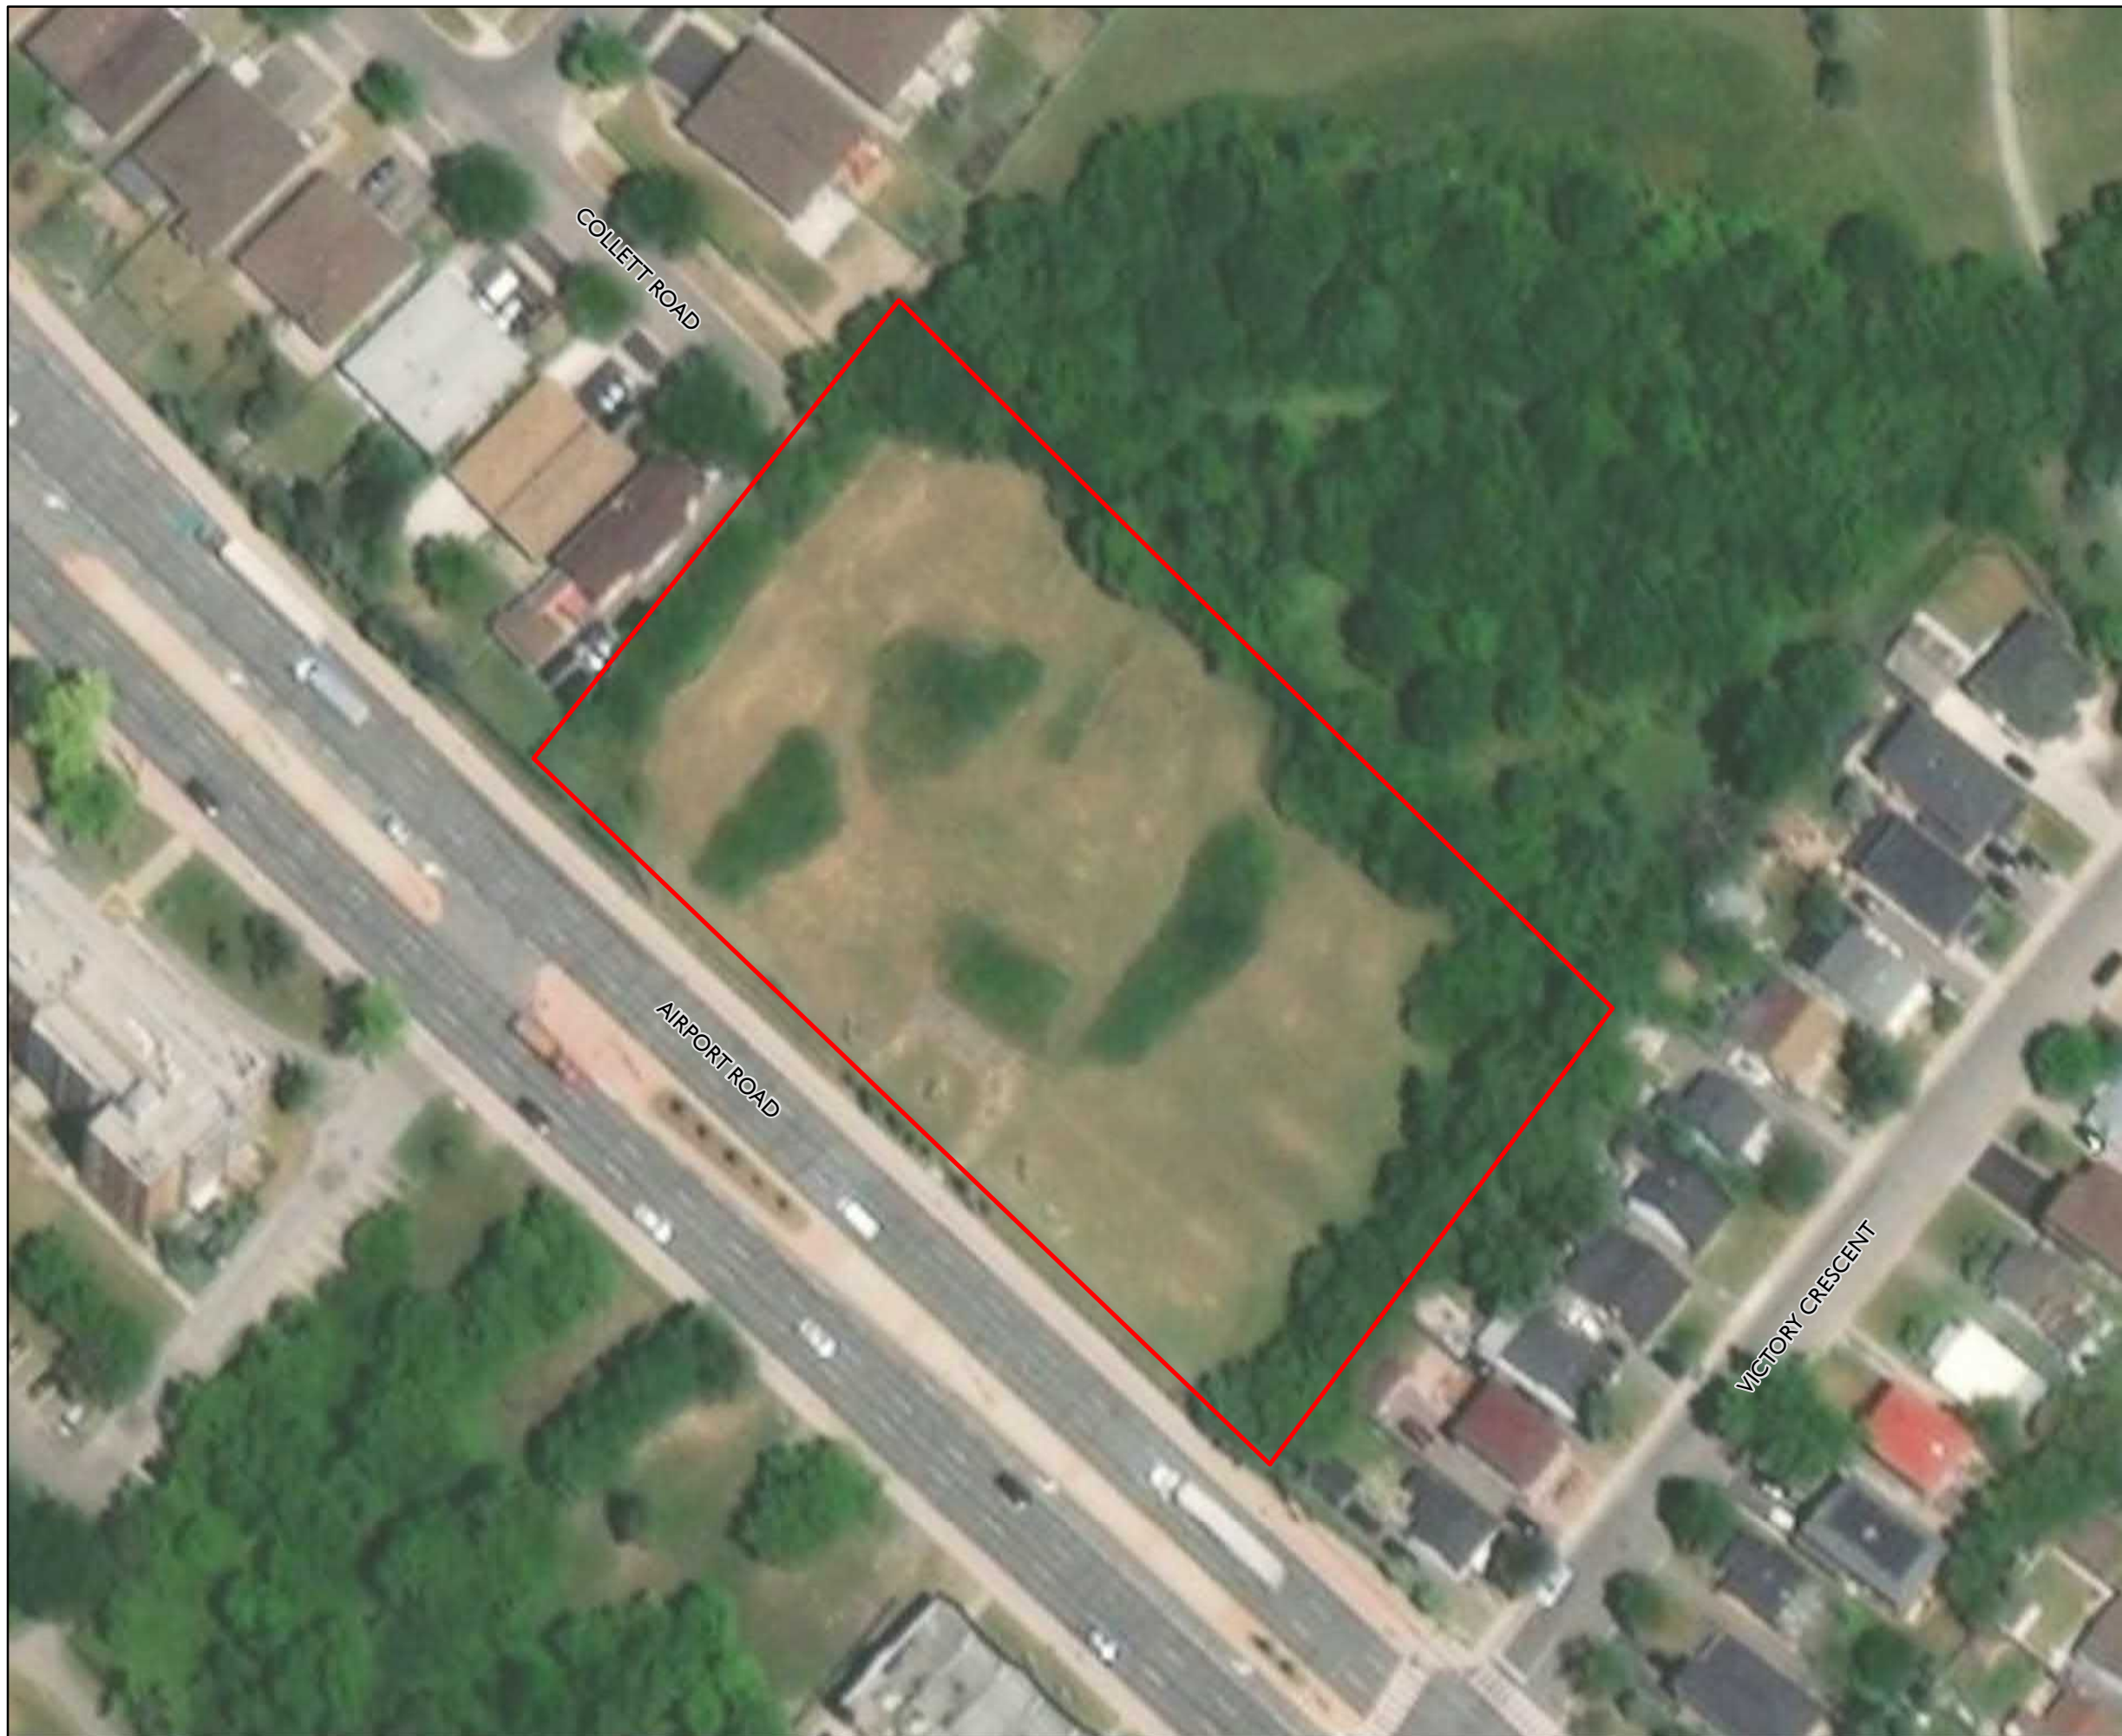
**PROJECT LOCATION**  
FIGURE #1

Property Boundary

The subject property is located on the east side of Airport Road, northwest of Victory Crescent (see Figure 1), and is legally described as Part of Lot 12, Concession 7 (PIN 132720613 and PIN 132720614), in the City of Mississauga (Ward 5).

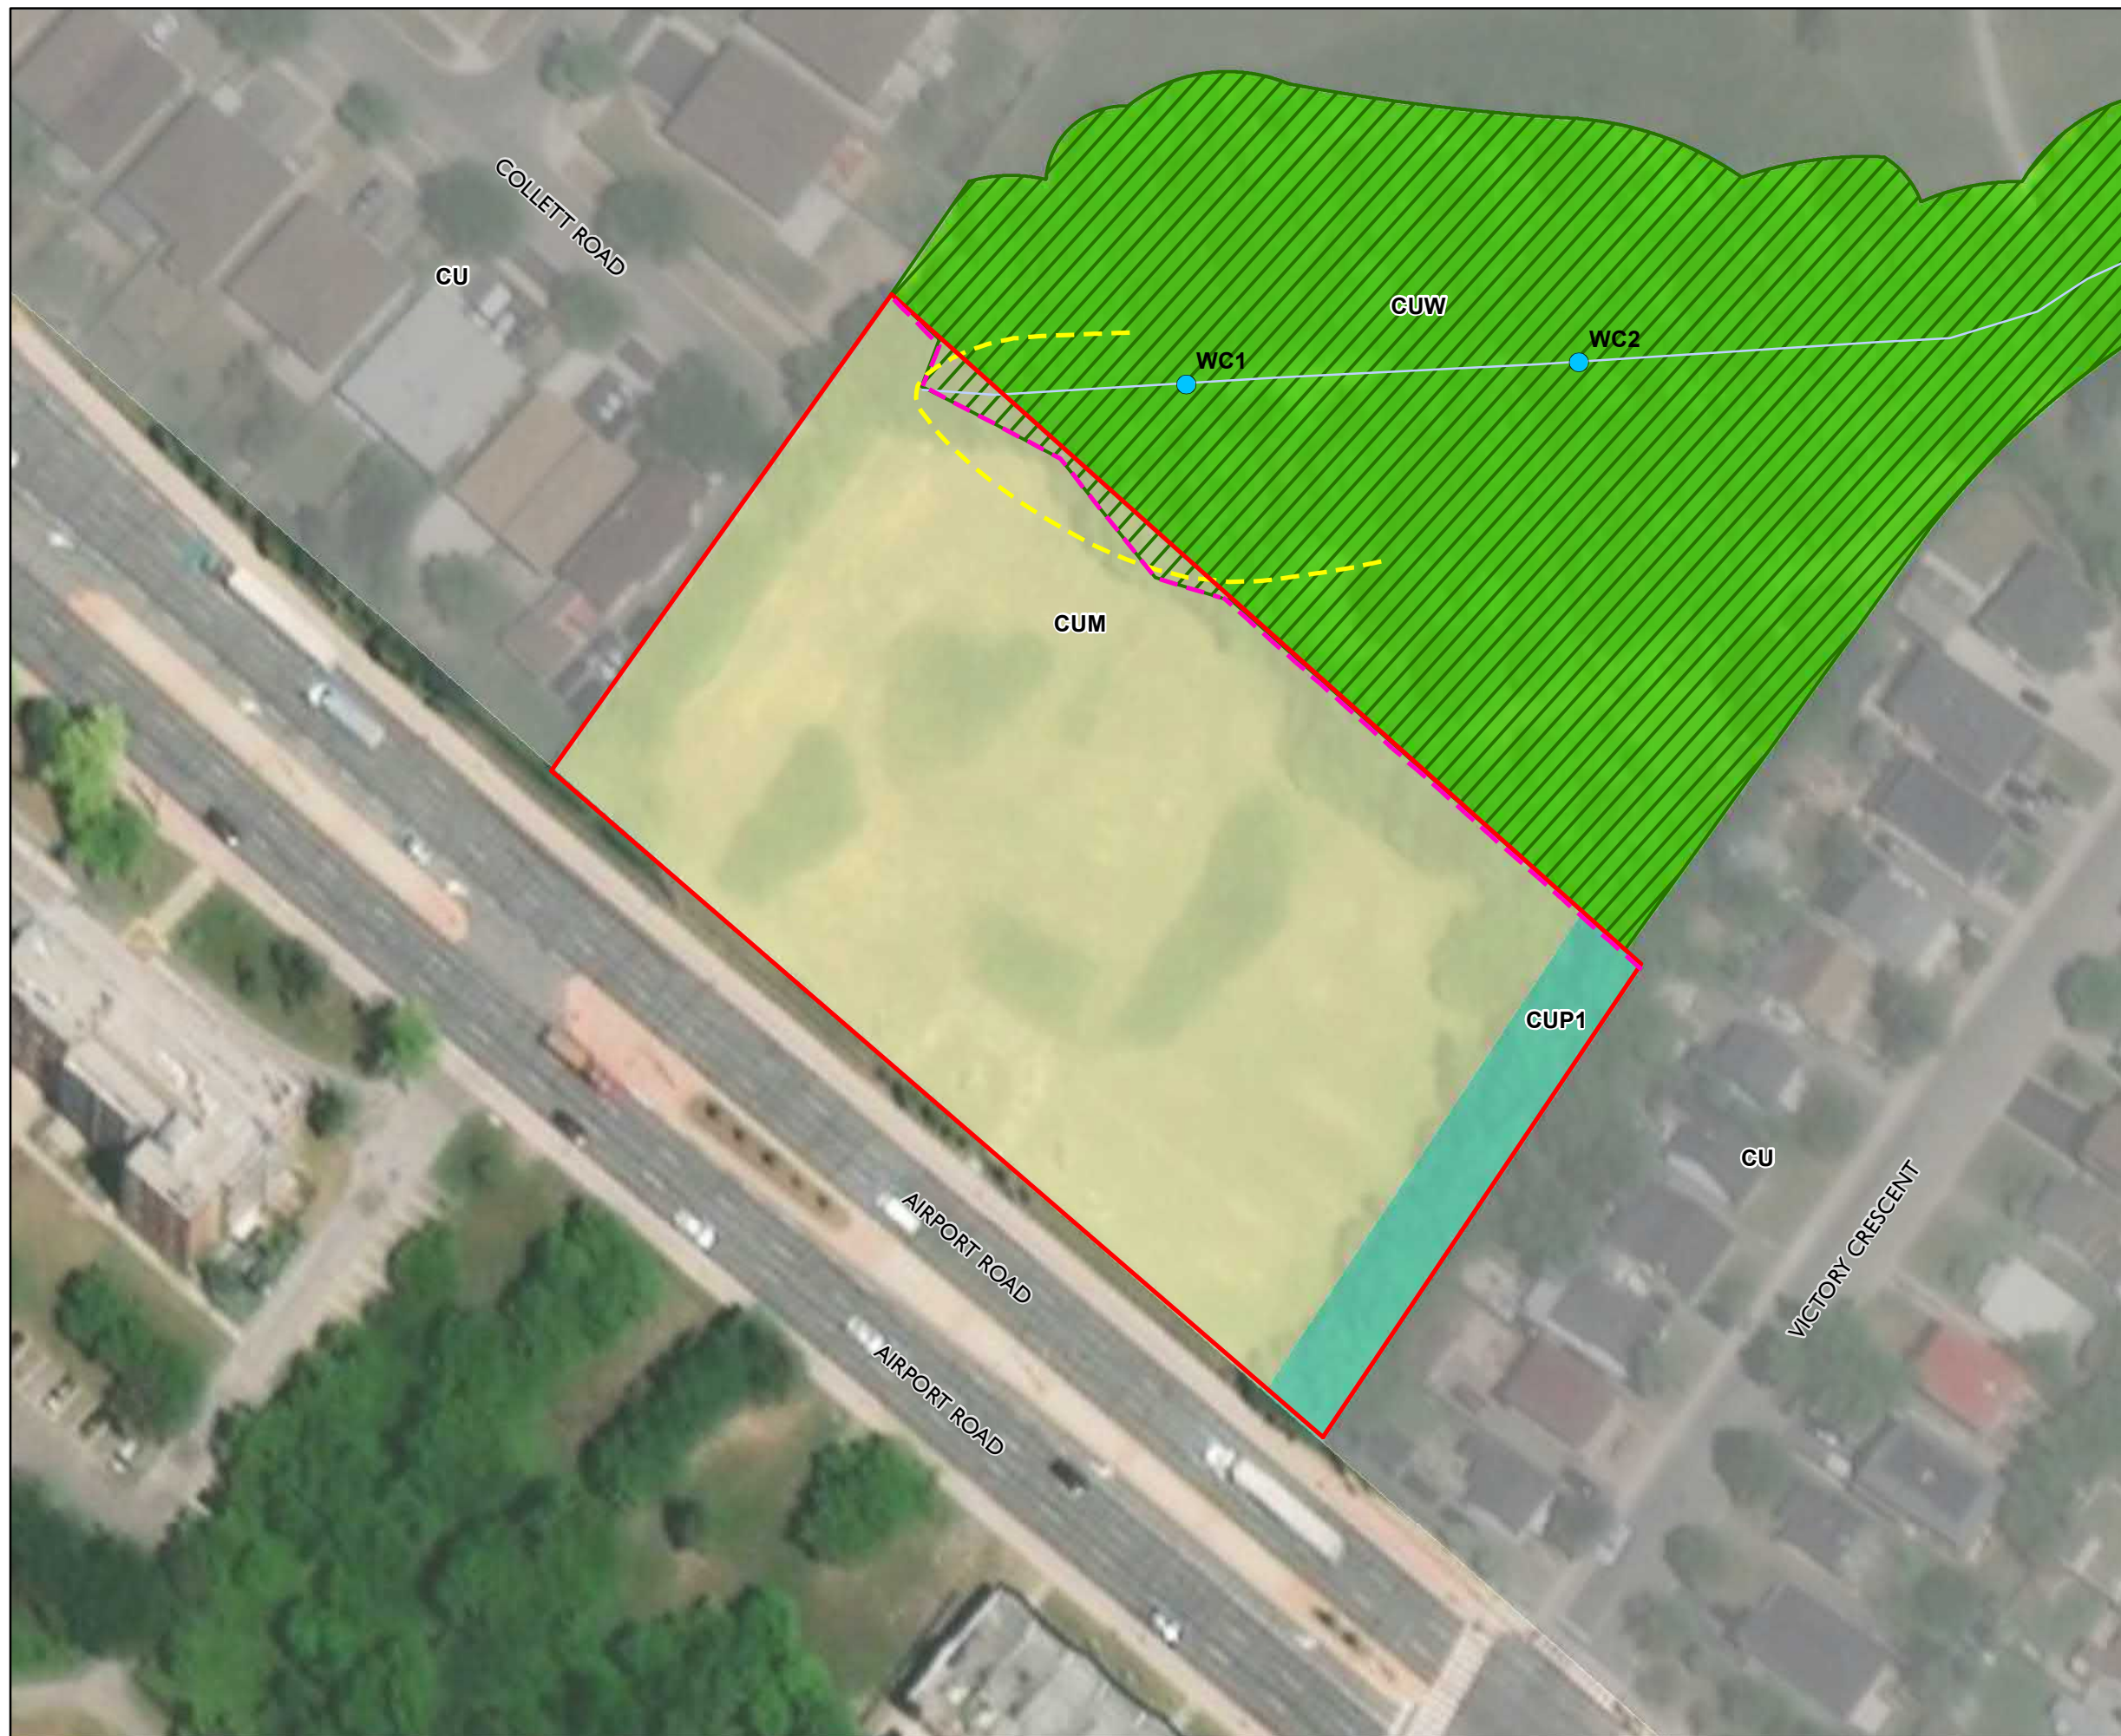
**SITE INVESTIGATION RESULTS**  
 FIGURE #3

ELC Code	Classification	Comments	Photo No. (Appendix C)
CUP1	Deciduous Cultural Plantation	Manitoba Maple ( <i>Acer negundo</i> ) fencerow at the east end of the subject property, backing on to residential units.	4
CUW	Cultural Woodland	Victory Park. Species observed in the canopy and sub-canopy of the deciduous woodland include dominant occurrences of Manitoba Maple, with abundant occurrences Norway Maple ( <i>Acer platanoides</i> ), Trembling Aspen ( <i>Populus tremuloides</i> ), and occasional occurrences of Eastern White Cedar ( <i>Thuja occidentalis</i> ). The understory is dominated by invasive Common Buckthorn ( <i>Rhamnus cathartica</i> ), with occasional occurrences of Dog-strangling Vine ( <i>Vincetoxicum rossicum</i> ), Red-Osier Dogwood ( <i>Cornus sericea</i> ), and Garlic Mustard ( <i>Allaria petiolata</i> ). The limit of the deciduous woodland on the subject property is represented as the Staked Dripline on Figure 3.	5 & 6

On November 10, 2016 a stream assessment was conducted at two locations (identified as WC1 and WC2) in the tributary of Mimico Creek, located north of the subject property (see Figure 3). The tributary at assessment location WC1 and WC2 was observed to be channelized and intermittent, and surrounded by recreational and residential land use.

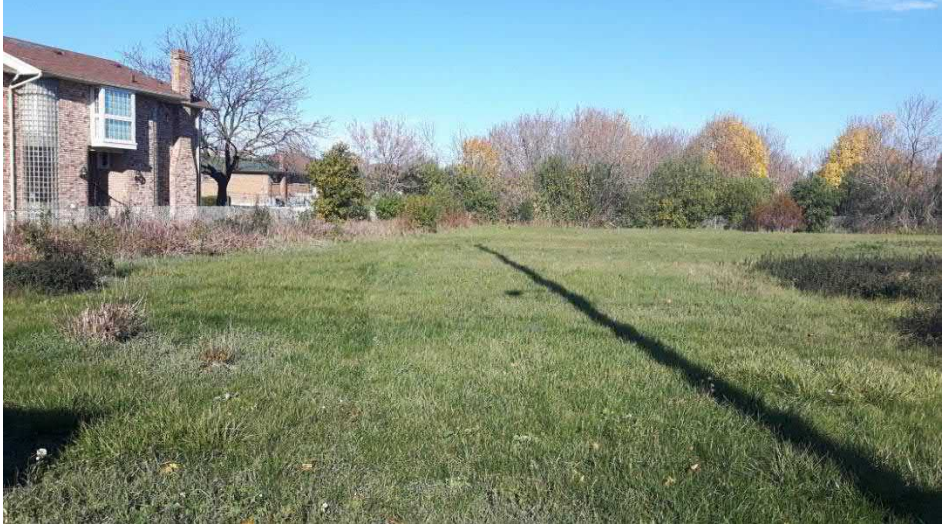
<p>Photograph 8 November 10, 2016</p> <p>Location 1 (WC1) of the watercourse assessment of the tributary of Mimico Creek.</p> <p>Facing west, looking directly at the grated storm sewer inlet of the tributary of Mimico Creek.</p>

At location WC1, there is a storm sewer grated inlet located along the northwestern property boundary, which appeared to accept flow from the tributary. The tributary substrate at WC1 was dominated by of gravel (60%), sand (35%), and silt (5%). At location WC2, the tributary appeared to be a vegetated swale with thick grass throughout. The tributary was dry at both survey locations at the time of observation; however, isolated pools of water were observed. Approximate tributary measurements are summarized below in Table 3.

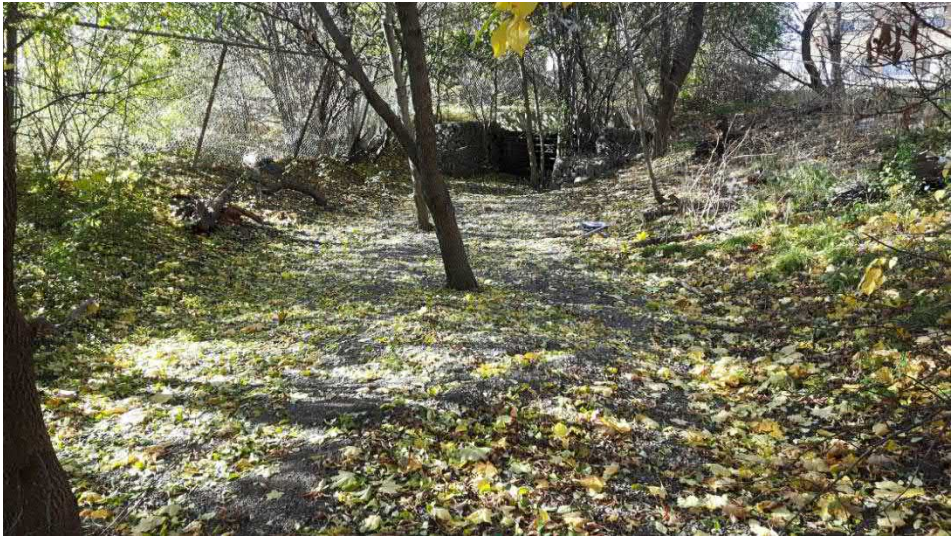
Description	Photo
<p>Photograph 9 November 10, 2016</p> <p>Location 1 (WC1) of the watercourse assessment of the tributary of Mimico Creek.</p> <p>Facing west, looking directly at the grated storm sewer inlet.</p>

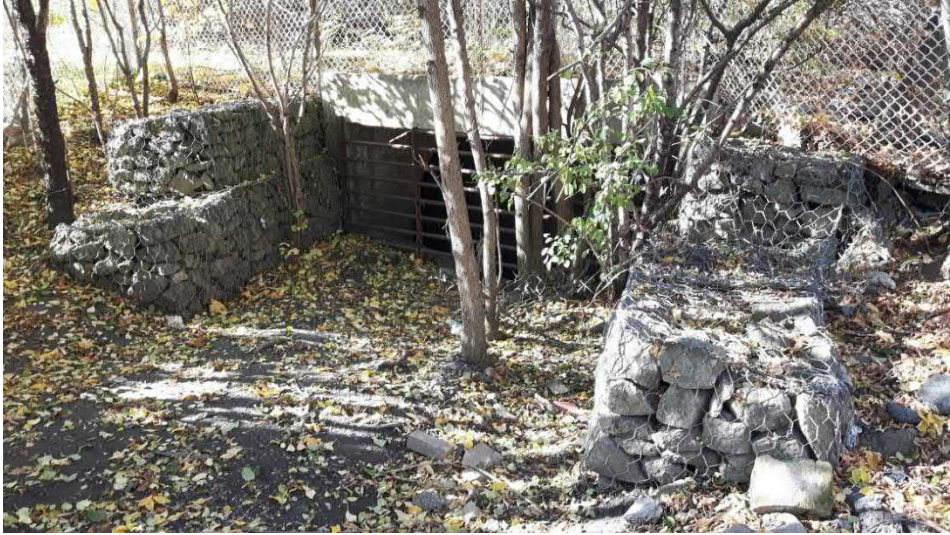
A photograph showing a stone wall on the left and a grated storm sewer inlet in the center. The area is surrounded by trees and fallen leaves, suggesting an outdoor setting in autumn.
<p>Photograph 10 November 10, 2016</p> <p>Location 1 (WC1) of the watercourse assessment of the tributary of Mimico Creek, facing east.</p>

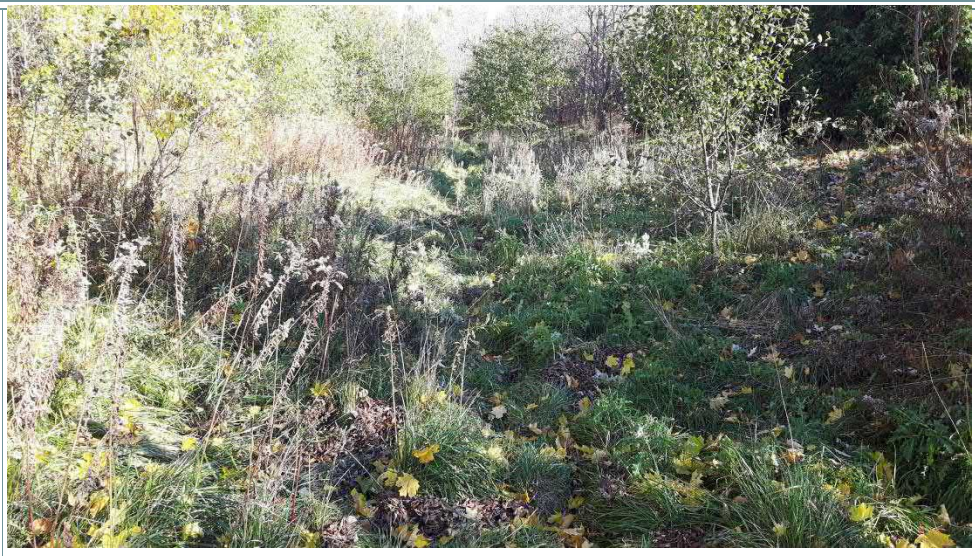
Description	Photo
<p>Photograph 13 November 10, 2016</p> <p>Location 2 (WC2) of the watercourse assessment of the tributary of Mimico Creek, facing west.</p>

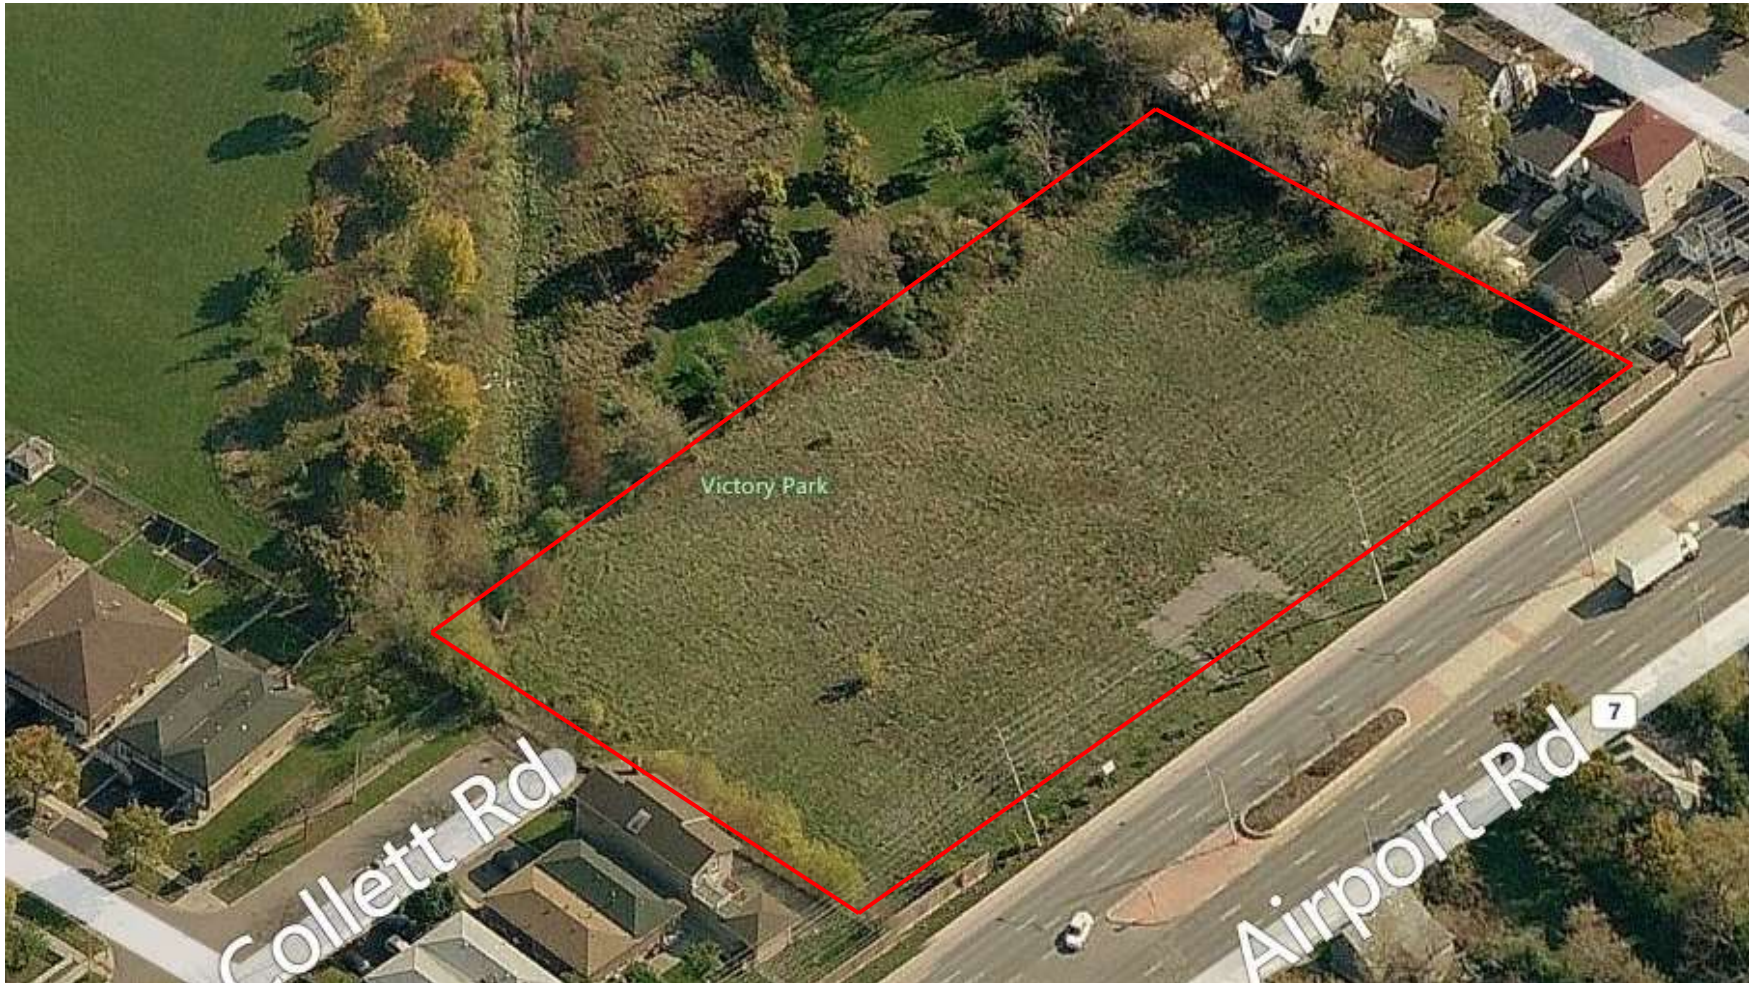
Figure 1. Aerial view of 7211-7233 Airport Road. Boundary lines are approximate.

Refer to Figure 1 on the following page for an aerial view of the subject site.

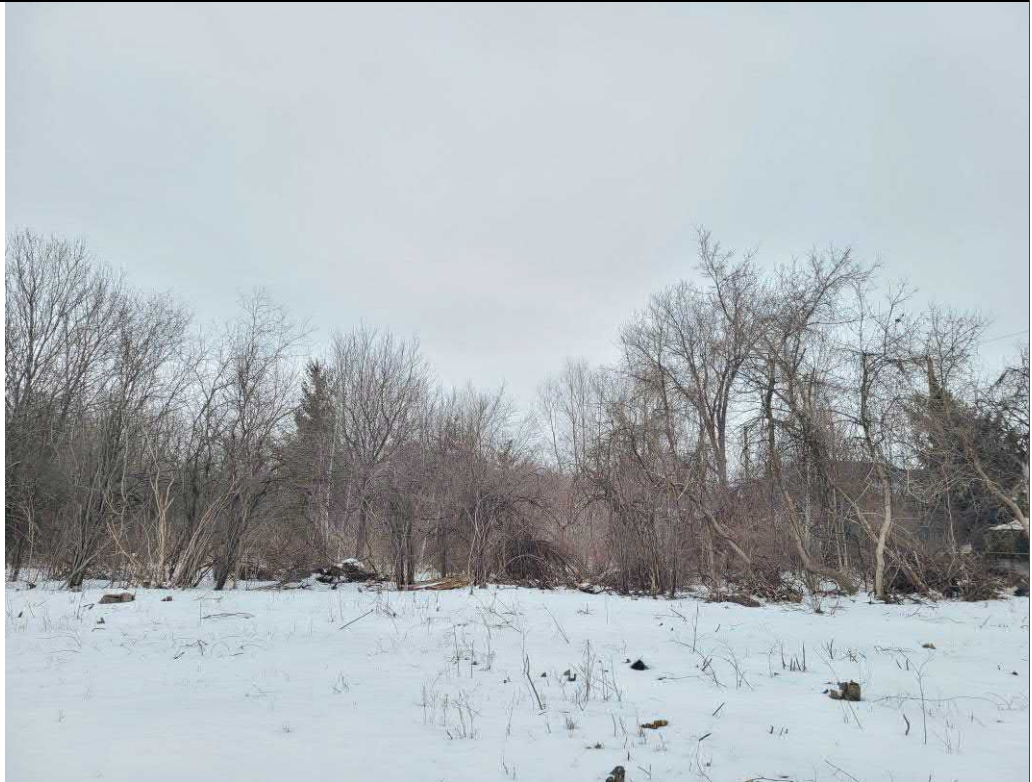
Photo 1: Looking northeast toward new woodland dripline at eastern subject property boundary.

On November 24, 2022 Dillon re-visited the subject property to review and reconfirm the 2013 dripline location based on 2022 existing conditions. As discussed further in **Section 3.2** and **Section 3.9**, succession of the wooded area within Victory Park from parkland to a woodland community has occurred, resulting in an adjustment to the staked dripline for the northeast property boundary.

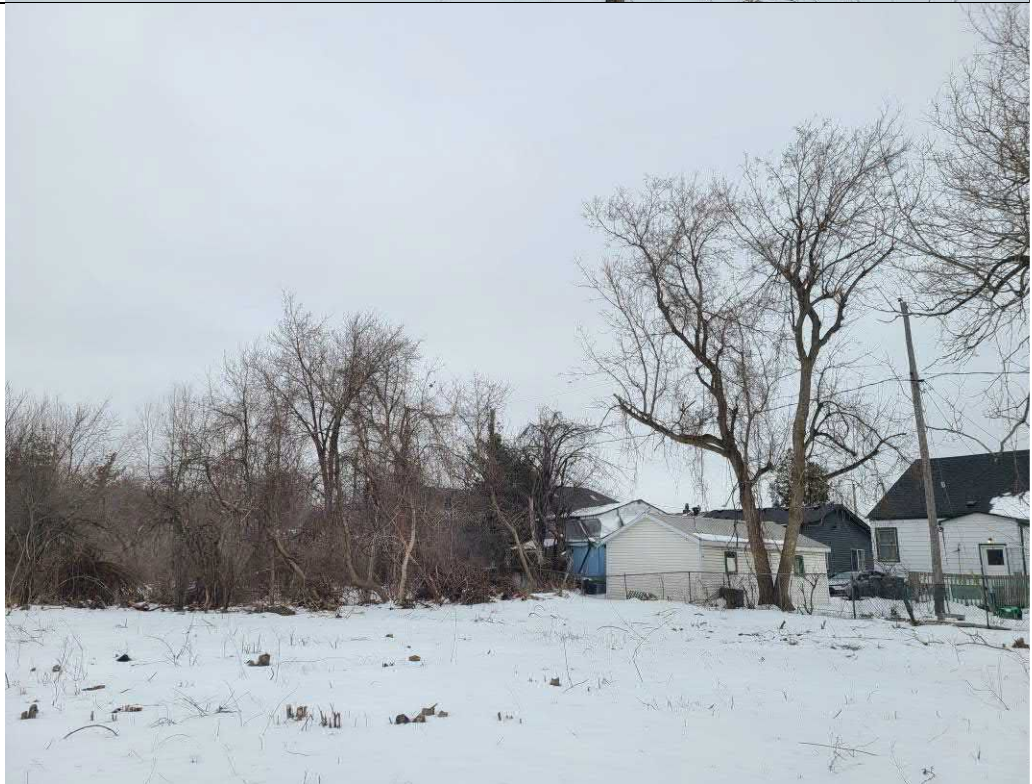
Photo 2: Looking east toward new woodland dripline at the southeastern corner of the subject property.

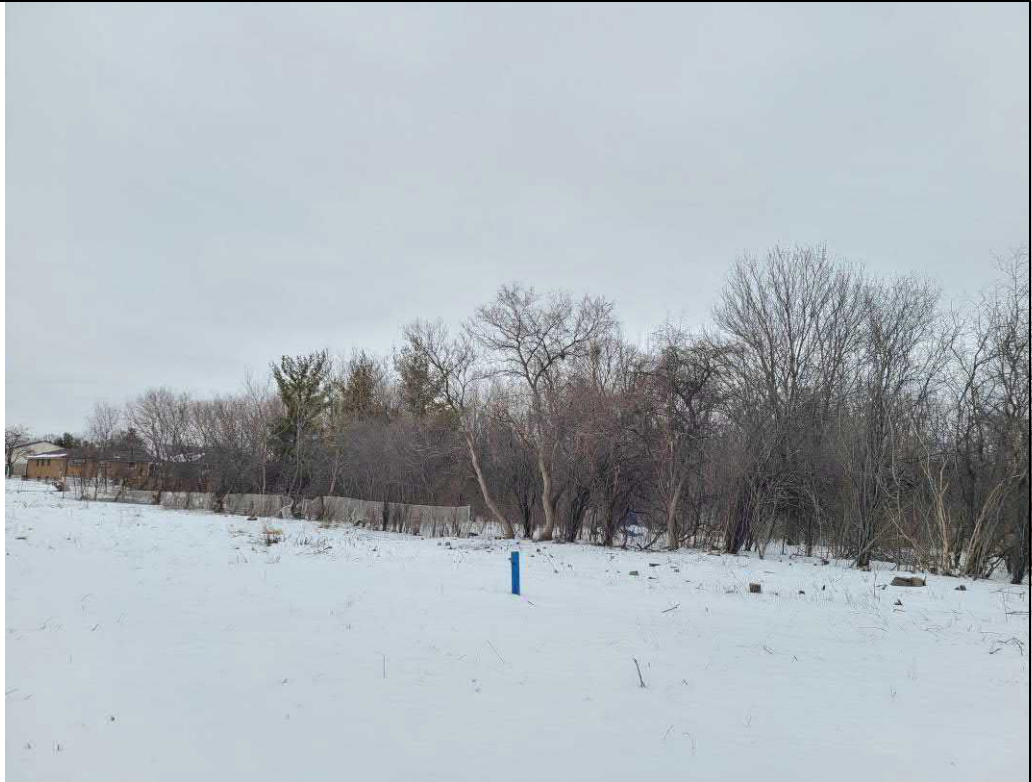
Photo 3: Looking north toward new woodland dripline at eastern subject property boundary.

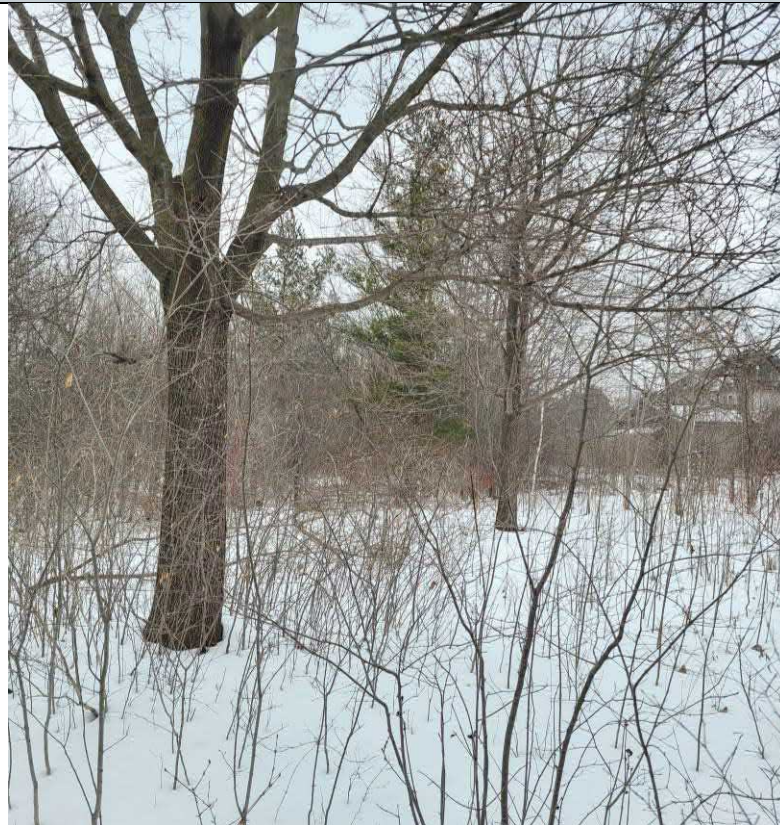
March 3 2023

Photo 5: Looking within Victory Park where woodland succession is occurring. Presence of fast-growing species such as Common Buckthorn.

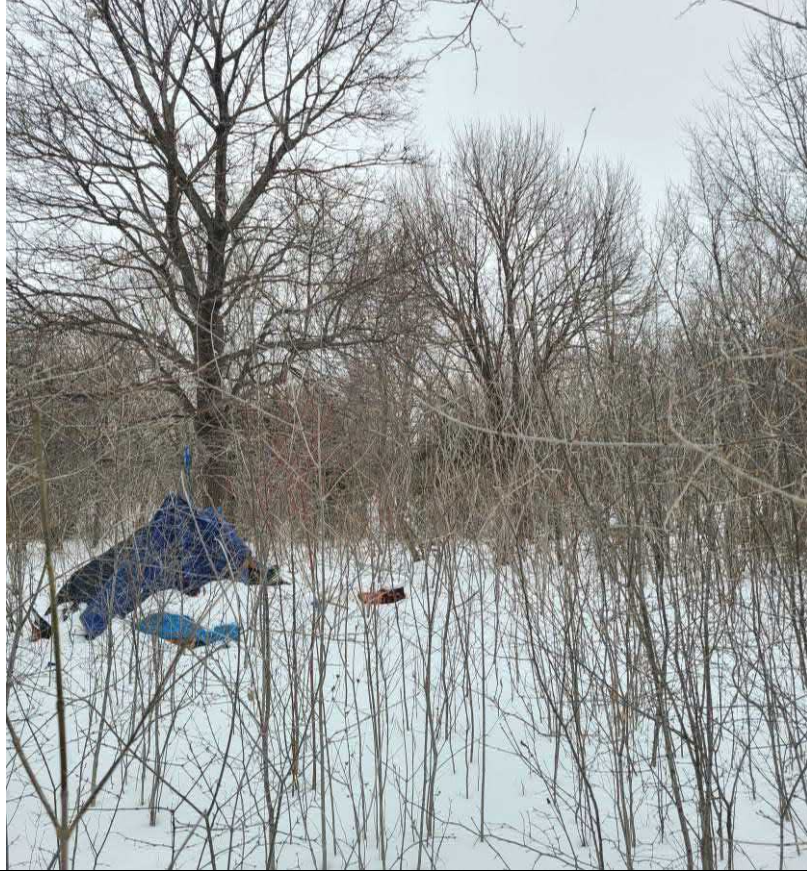
March 3 2023

Photo 6: Looking within Victory Park where woodland succession is occurring.

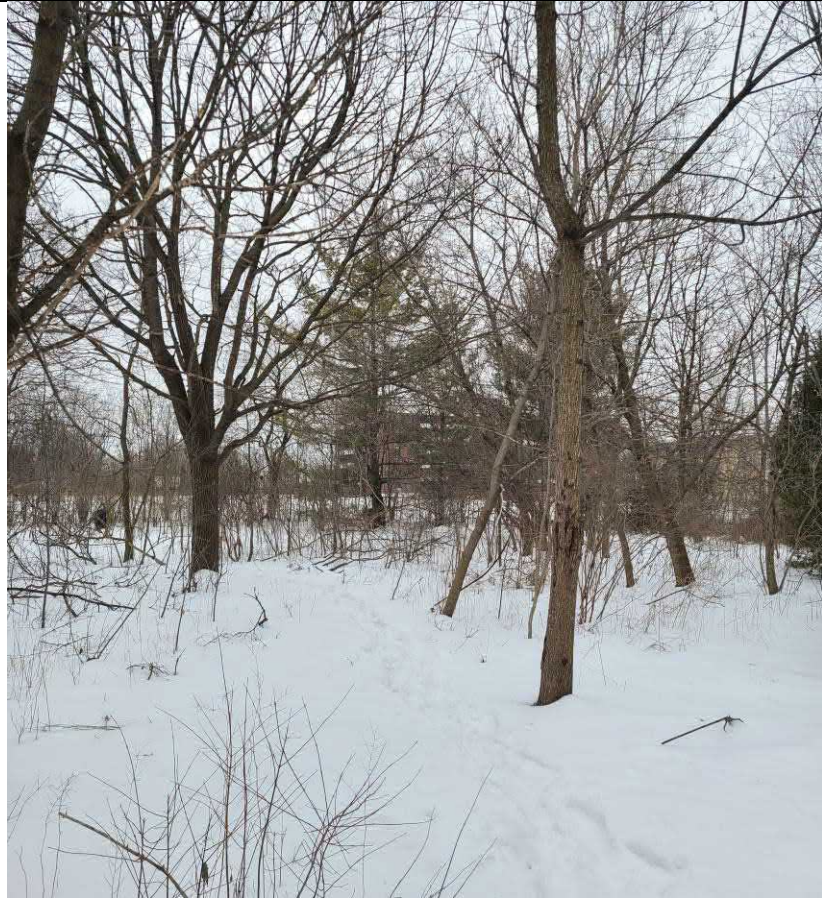
March 3 2023

Photo 8: Looking south within Victory Park where woodland succession is occurring. Presence of fast-growing species such as Common Buckthorn.
