Municipal Class Environmental Assessment Study: Malton Flood Mitigation Study – Etude Drive to Justine Drive

Project File Report

City of Mississauga

February 2024

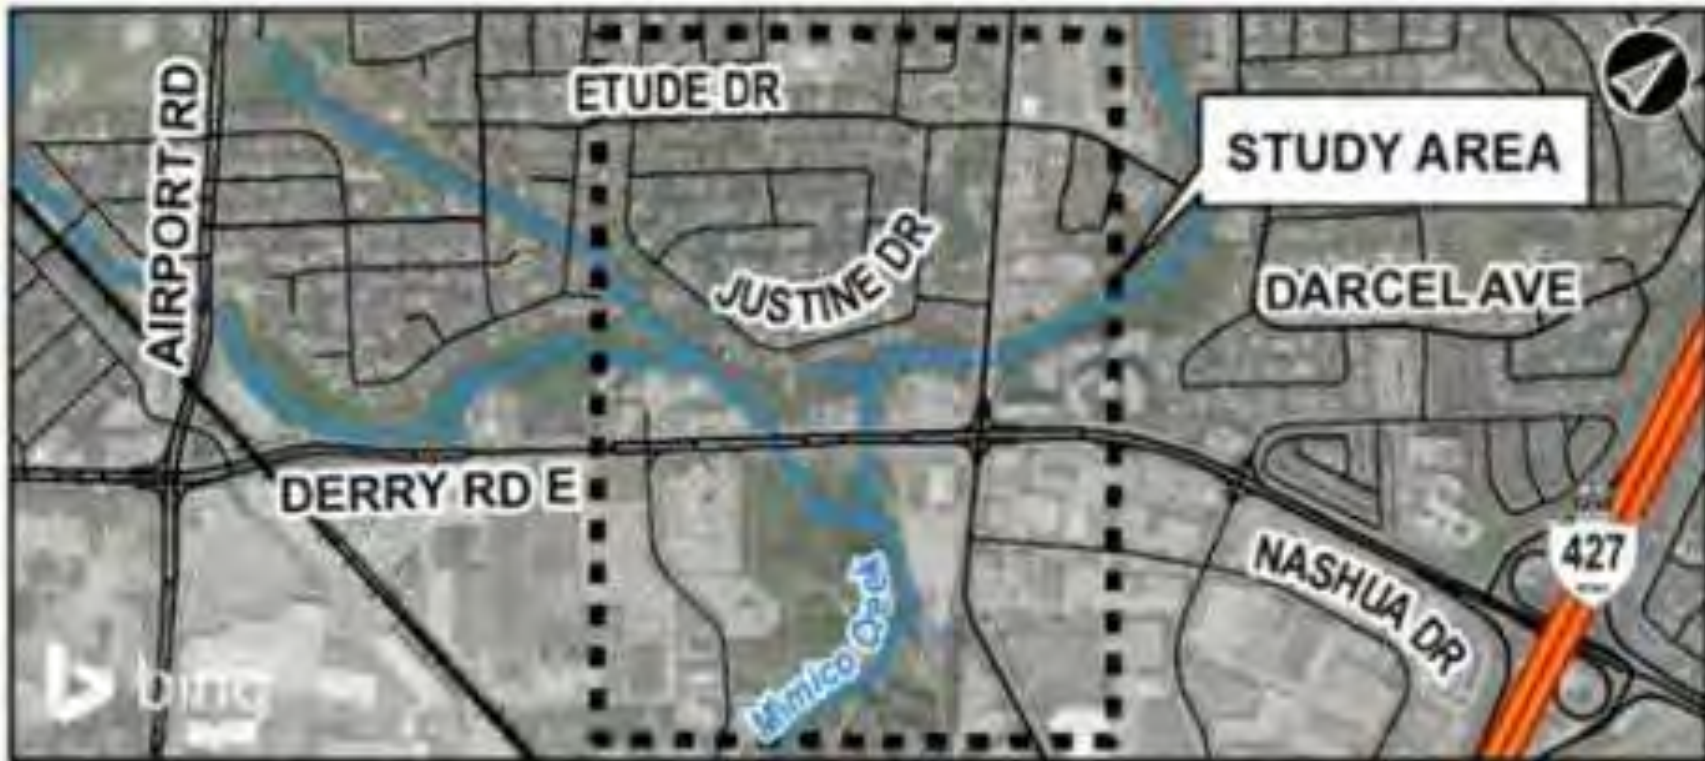
Figure 1-1: Study Area

Refer to **Figure 1-1** for an overview of the larger Study Area and **Figure 1-2** for the general work/project area based on the area identified to be further investigated through the Matrix Solutions Inc. Flood Study. The general work/project area encompasses the pedestrian walkway from Etude Drive to Capricorn Crescent, Honeysuckle Avenue, and the pedestrian pathway from Michaud Avenue to Justine Drive. The general work/project area also includes portions of Derry Greenway Park.

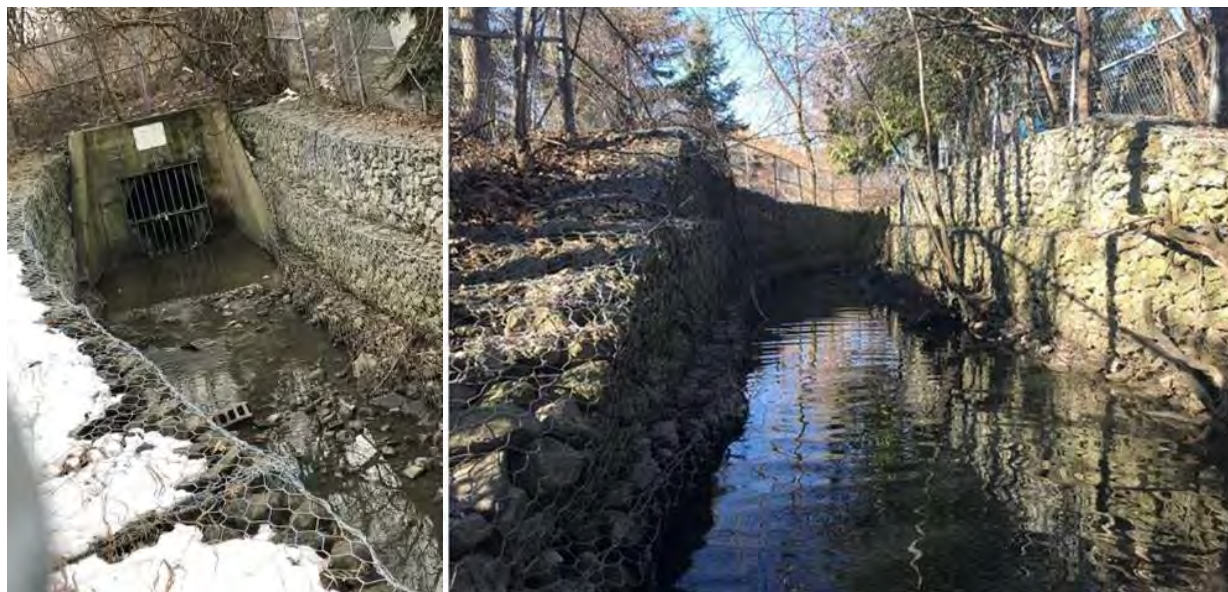
Figure 3-2: Existing Outlet Structure and Channel

The existing outlet structure consists of a concrete headwall with the 1,600 millimetre diameter storm trunk sewer. The trunk sewer discharges into a small channel that conveys runoff from the Malton neighbourhood to Mimico Creek. The channel has vertical gabion basket walls at the outlet structure, and farther downstream the channel transitions to a more natural cross-section. Below are photos of the outlet structure and channel.

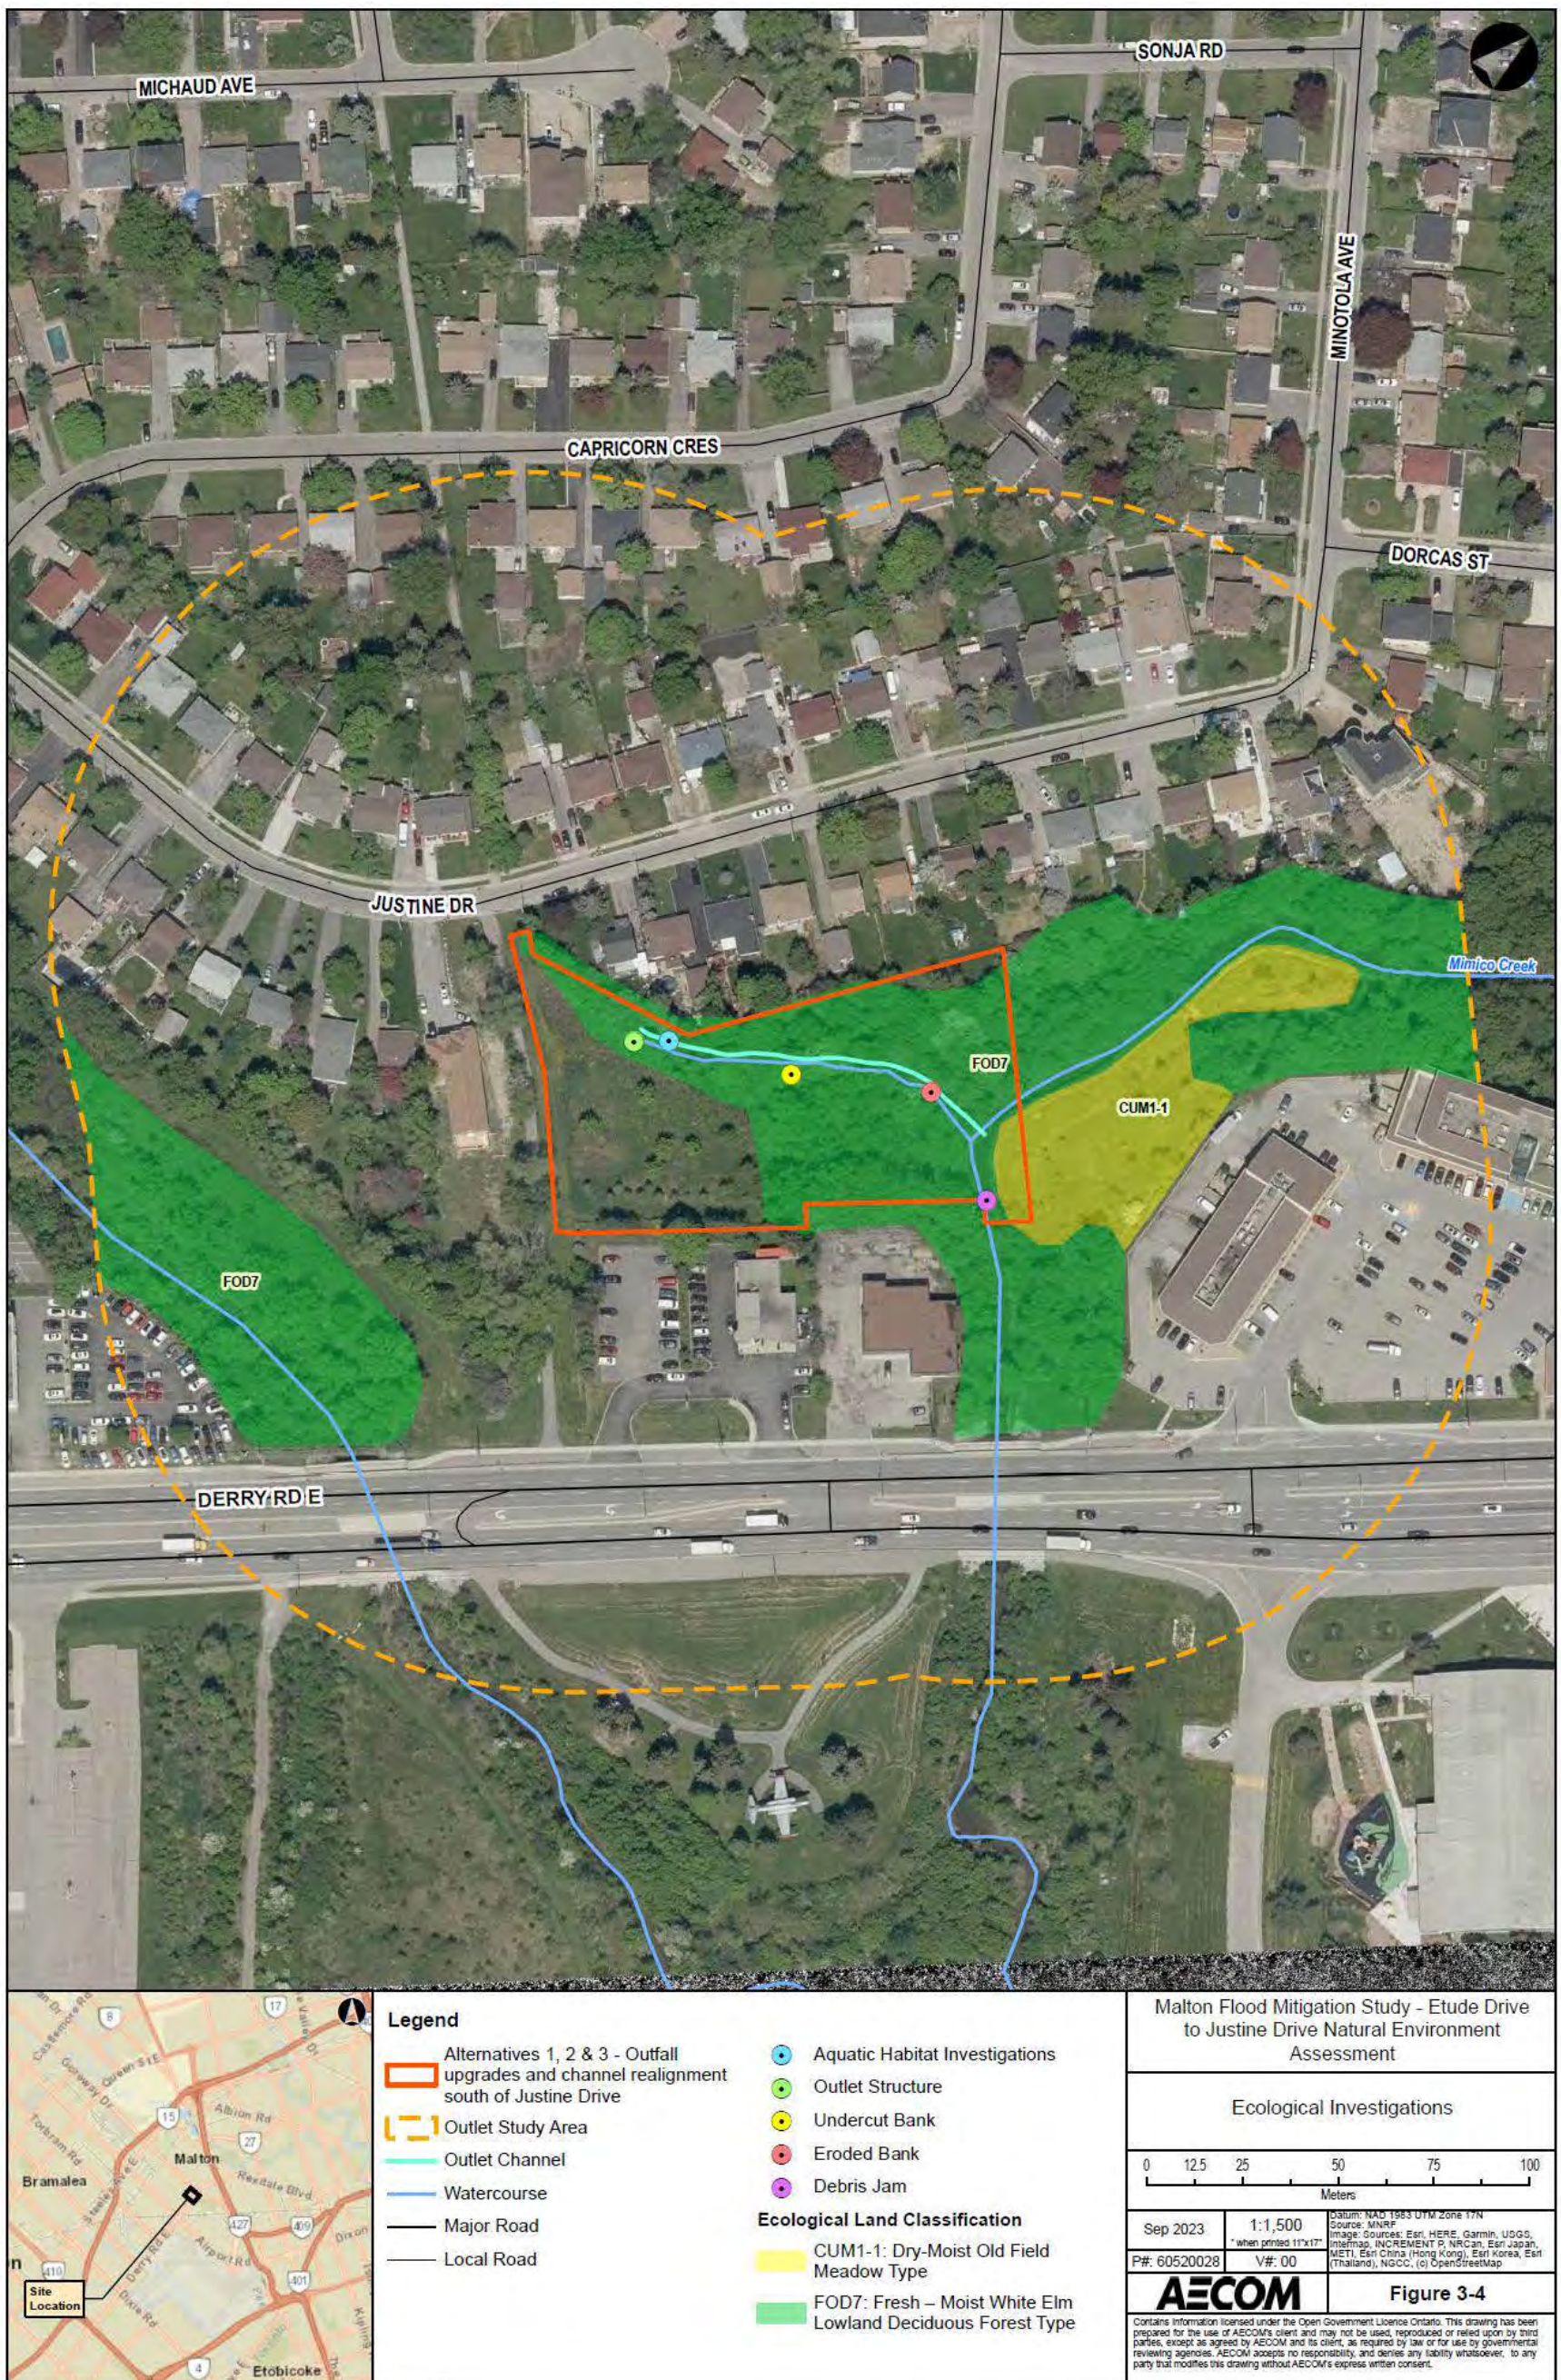
Figure 3-4: Ecological Investigations

The storm drain outlet channel and location of works associated with Alternatives 1, 2 and 3, identified on **Figure 3-4** was assessed from the outlet structure south of Justine Drive to the confluence with Mimico Creek. The storm drain outlet channel was a permanent watercourse channelized for the first approximately 30 metres from the outlet becoming more naturalized for the remaining approximately 70 metres downstream toward the confluence with the main branch of Mimico Creek. The banks and streambed of the outlet channel were armoured by Gabion baskets in the channelized reach. In the unarmoured reach, the substrates consisted of sand, silt, gravel, and clay, in order of abundance. The wetted width of the channel ranged from 3.0 to 4.0 metres with a mean of 3.5 metres and the wetted depth ranged from 0.35 to 0.65 metres with a mean of 0.4 metres. The bankfull width ranged from 4.0 to 4.5 metres and the bankfull depth from 0.5 to 0.9 metres. Both the left and right upstream banks (i.e. facing upstream) were moderately unstable with scouring observed the full length of the assessed reach downstream of the Gabion basket armouring. Substantial undercutting (0.4 to 0.5 metres) of the left upstream bank was observed immediately downstream of the Gabion baskets and substantial slope failure was observed on the right upstream bank at the last meander bend upstream of the confluence with Mimico Creek. Multiple leaning or fallen trees were observed, providing further evidence of bank instability. The channel morphology was predominantly (95%) slow flowing flat with sparse pools (5%) associated with in-water trees and the scour pool at the end of the Gabion baskets. In-stream cover was sparse, limited to woody debris, cobble from the Gabion baskets, and the one undercut bank. No impediments to fish movement were observed within the outlet channel downstream of the outlet structure, which had an open connection to Mimico Creek downstream; however, a large debris jam was observed in Mimico Creek approximately 15 metres downstream of the confluence. No fish were observed in either the outlet channel or Mimico Creek at the time of assessment.

No Species at Risk or Species of Conservation Concern plant species were recorded. Ecological Land Classification community delineations are displayed on **Figure 3-4**. No vegetation communities were present within the footprint for the potential underground storage at Ridgewood Park and are not included in **Figure 3-4**.

Field investigations were completed by an AECOM Ecologist on October 28, 2020. Vegetation communities within the Study Area were assessed and classified into Ecological Land Classification units as per Lee *et al.* (1998) using a combination of aerial photography interpretation and field investigations. This system provides a standard for comparing similar communities across Ontario. This protocol classifies vegetation communities through the completion of a multilayer (canopy, sub-canopy, ground cover) vegetation inventory. A summary of disturbance factors, community conditions, plant species list and representative photographs were also recorded for each vegetation patch (refer to **Appendix C**).
