Cooksville Creek Erosion Control Project at Camilla Road
Municipal Class Environmental Assessment Schedule 'B' Project File
February 2024

Executive Summary

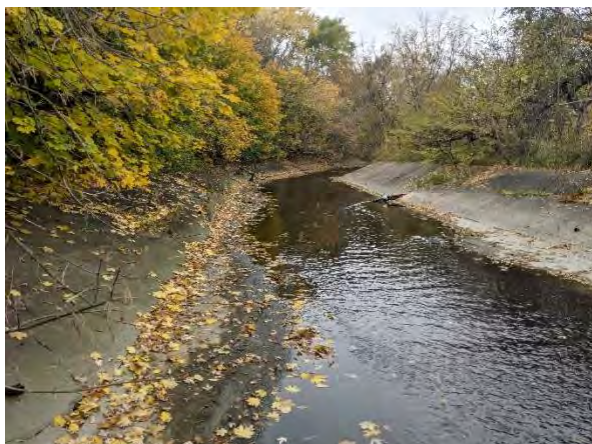
Figure 6. Trapezoidal concrete channel (looking upstream)

West of Camilla Road, the Study Area consists of a trapezoidal concrete channel that is in poor condition, shown in Figure 6. Based on the field survey completed by Resilient in November 2021, the trapezoidal concrete channel has an approximate average base width of approximately 5 m, height of 1.1 m, and a bank slope of 2.5:1. The concrete-lined channel has a fractured bed and banks. The Study Area also includes a three-cell culvert at Camilla Road, as seen in Figure 7, with an overflow cell along the south banks. The culvert appears to be in good condition, but sediment and debris has begun to accumulate within the structure.

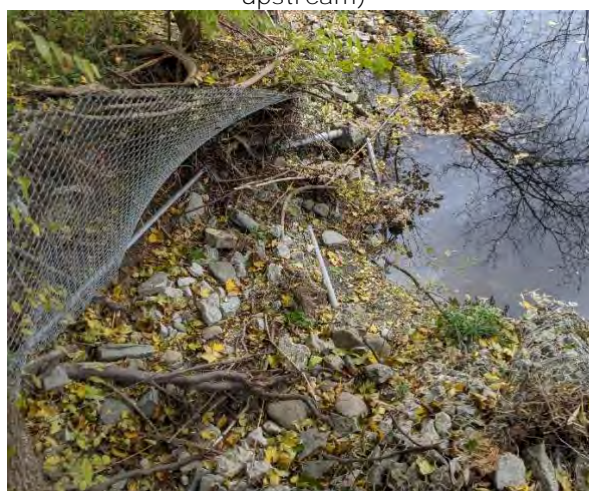
Figure 9. Failed Gabion baskets along creek bank

The Study Area extends approximately 100 m upstream and 100 m downstream of Camilla Road. The study reach consists of an engineered channel constructed approximately 30 to 40 years ago. East of Camilla Road, the Study Area has banks that transition from an approximately 48 m long and 2.1 m high concrete vertical wall to Gabion baskets up to three-tiers high on the north side, and Gabion baskets, leaning interlock retaining wall, and chain link fence on the south side. The channel bed substrate consists of boulders, cobble, gravel, and sand. The concrete wall is in good condition, however the Gabion baskets have either failed or are at risk of failure due to undermining along the bank. The channel downstream (east) of Camilla Road and associated failed gabion baskets are shown in Figure 8 and Figure 9 below.

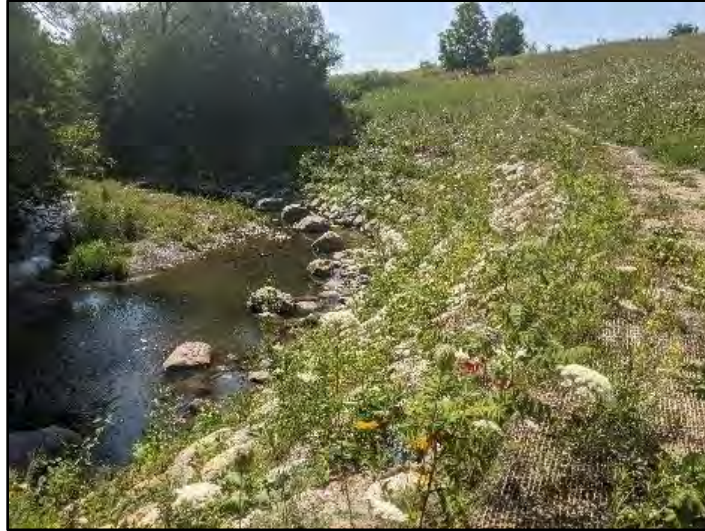
Figure 19. Vegetated Rock Butress

East of Camilla Road, along the south bank, the failed Gabion bank protection and leaning interlocking wall are to be fully replaced with vegetated rock buttress at a 3:1 slope which will require regrading of the existing bank. Native vegetation will be planted throughout the revetment and stone sizes would be designed to withstand watercourse flow velocities to protect the slope against further erosion. The plants to be used for revegetation and their sizes will be determined during detailed design. Excess fill material generated from excavation of the banks is to be characterized and **re-used or disposed of in accordance with Ontario's On-Site and Excess Soil Management Regulation (Ontario Regulation 406/19)**. An example of a vegetated rock buttress design by Resilient is shown in Figure 19 below.

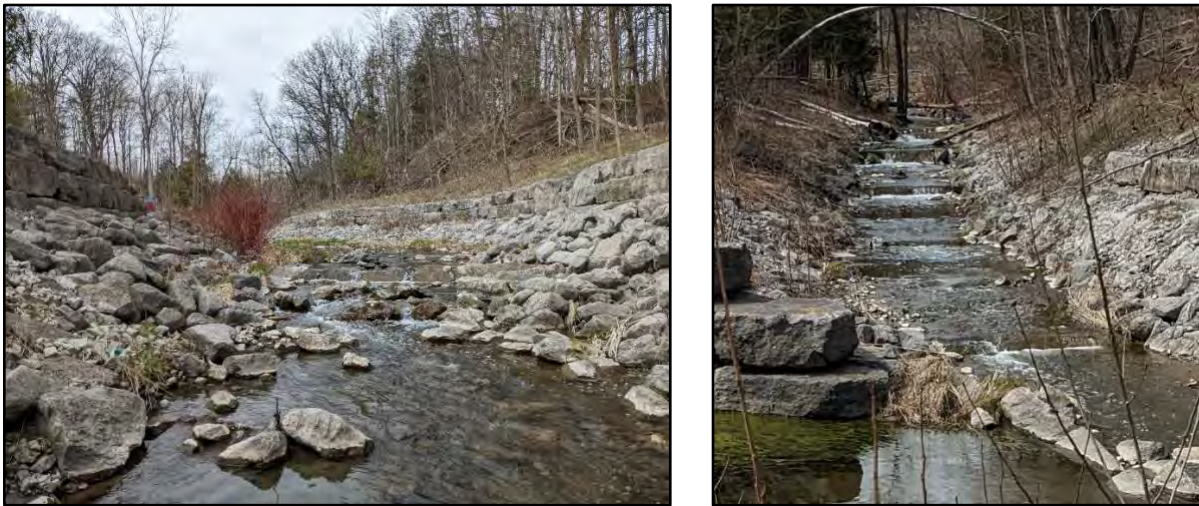
Figure 20. Armourstone Weirs

A series of armourstone weirs will be installed in the channel to create low flow backwater effects upstream of the weir which will provide erosion control and habitat benefits. The placement, spacing, grades and stone sizes will be determined during detailed design. Examples of armourstone weirs are shown in Figure 20 below.

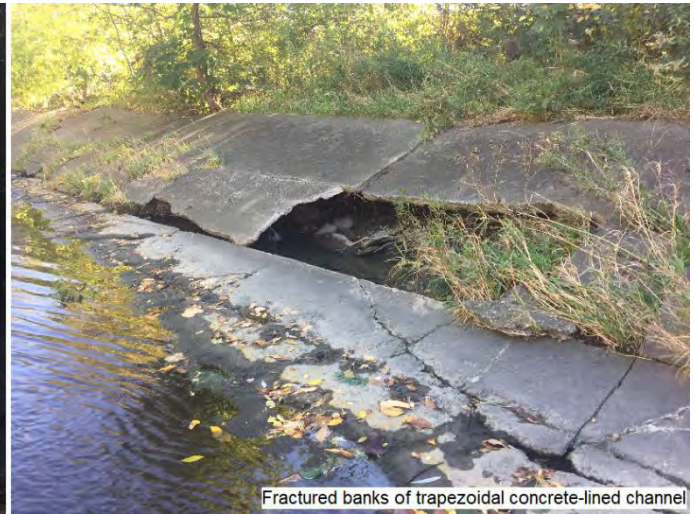
Fractured banks of trapezoidal concrete-lined channel

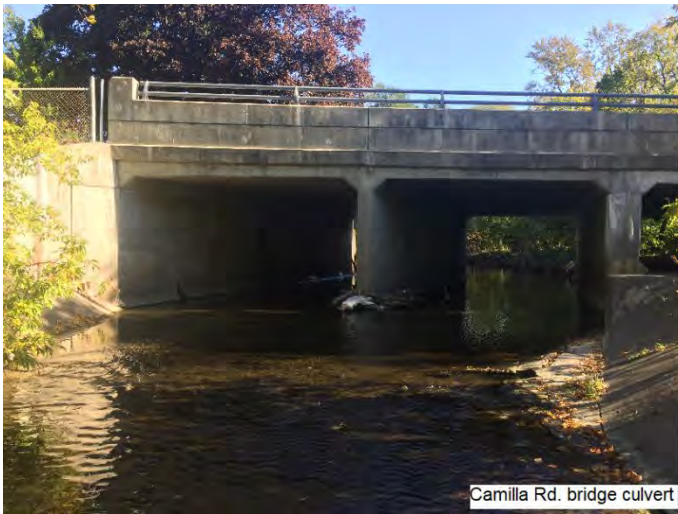
Camilla Rd. bridge culvert

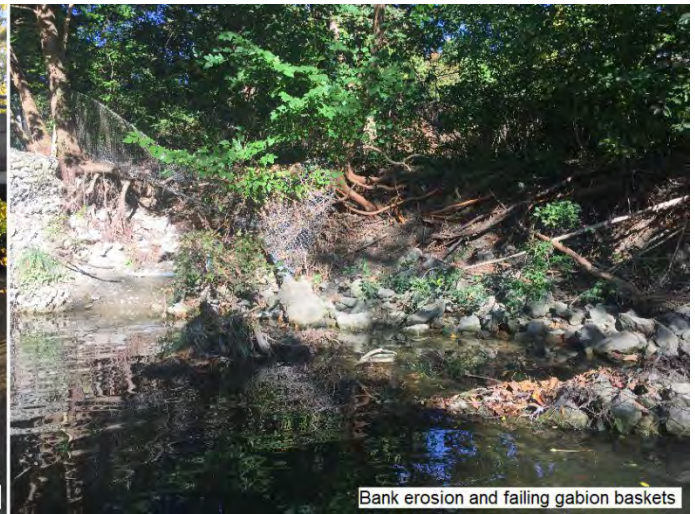
Bank erosion and failing gabion baskets

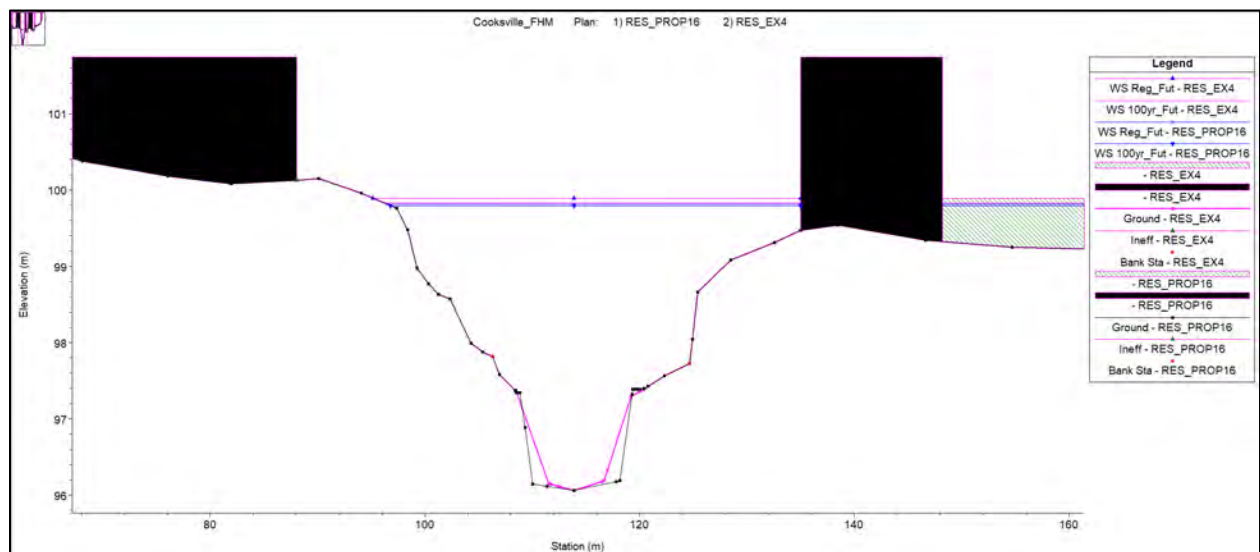
Figure 1. Existing and Proposed Cross Section 13382

Figures 1 to 5 below show a comparison between the existing and proposed cross sections and profile view in the study area, as well as the Future 100-year and Future Regional WSE. At Cross Section 13382, the bottom of the channel will be widened by approximately 3.1 m, and the banks will be reinforced with armourstone. Cross Section 13329 will be repaired and maintained as a hydraulic apron. At Cross Section 13307 the bottom of the channel will be widened by approximately 2.5 meters on the south end, with vegetated rock buttresses implemented along the banks. Similarly, at Cross Section 13253, the channel bottom will be widened by 3.5 meters on the south end, and vegetated rock buttresses along the banks.

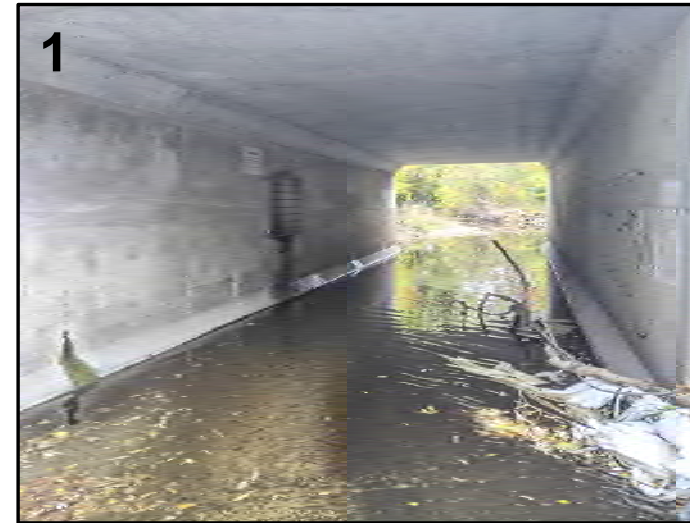
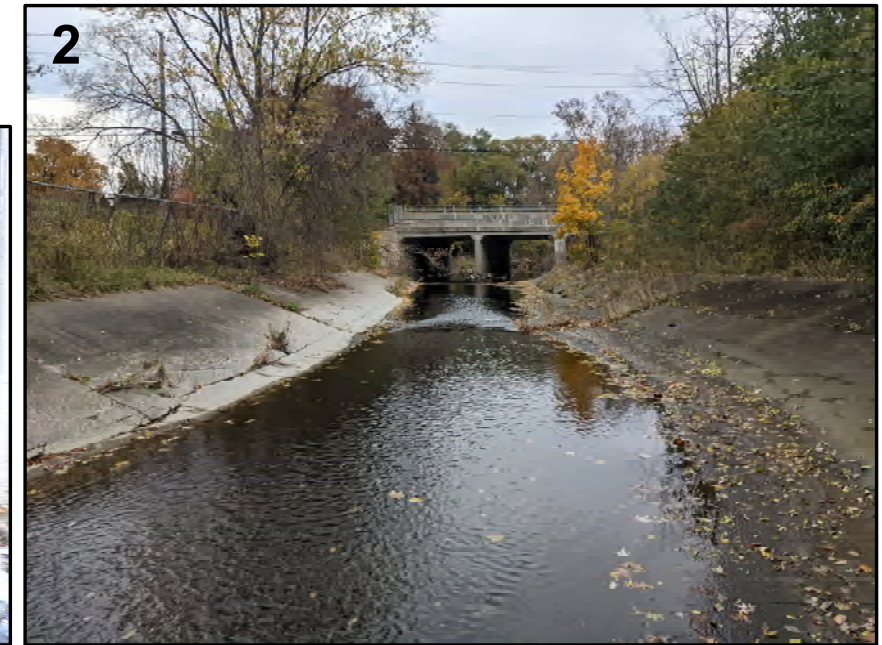
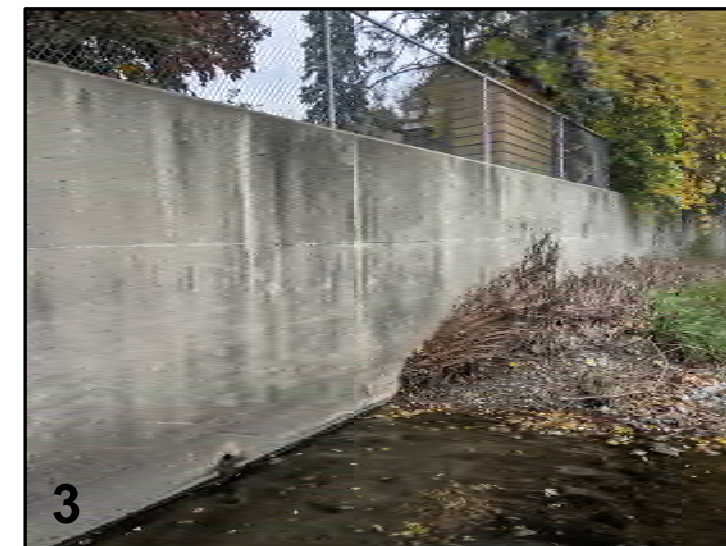
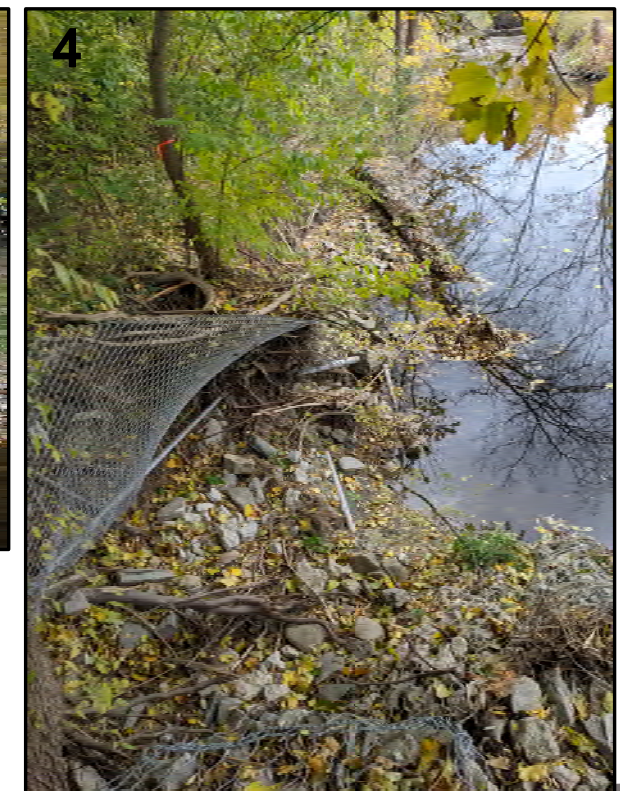
- The channel includes a 3-cell culvert at Camilla Road, with an overflow cell along the south bank. The culvert appears to be in good condition, but sediment and debris has begun to accumulate within the structure.
- Cooksville Creek upstream (west) of Camilla Road consists of a trapezoidal concrete structure in poor condition.
- Downstream (east) of Camilla Road, the creek has banks that transition from a concrete vertical wall to a Gabion basket wall. The Gabion baskets have either failed or are at risk of failure due to undermining along the bank.
- The nearby Hydro One corridor is outside the study area.

1. View inside Camilla Road culvert
2. Trapezoidal concrete channel (looking downstream)
3. Concrete wall along creek bank
4. Failed Gabion baskets along creek bank

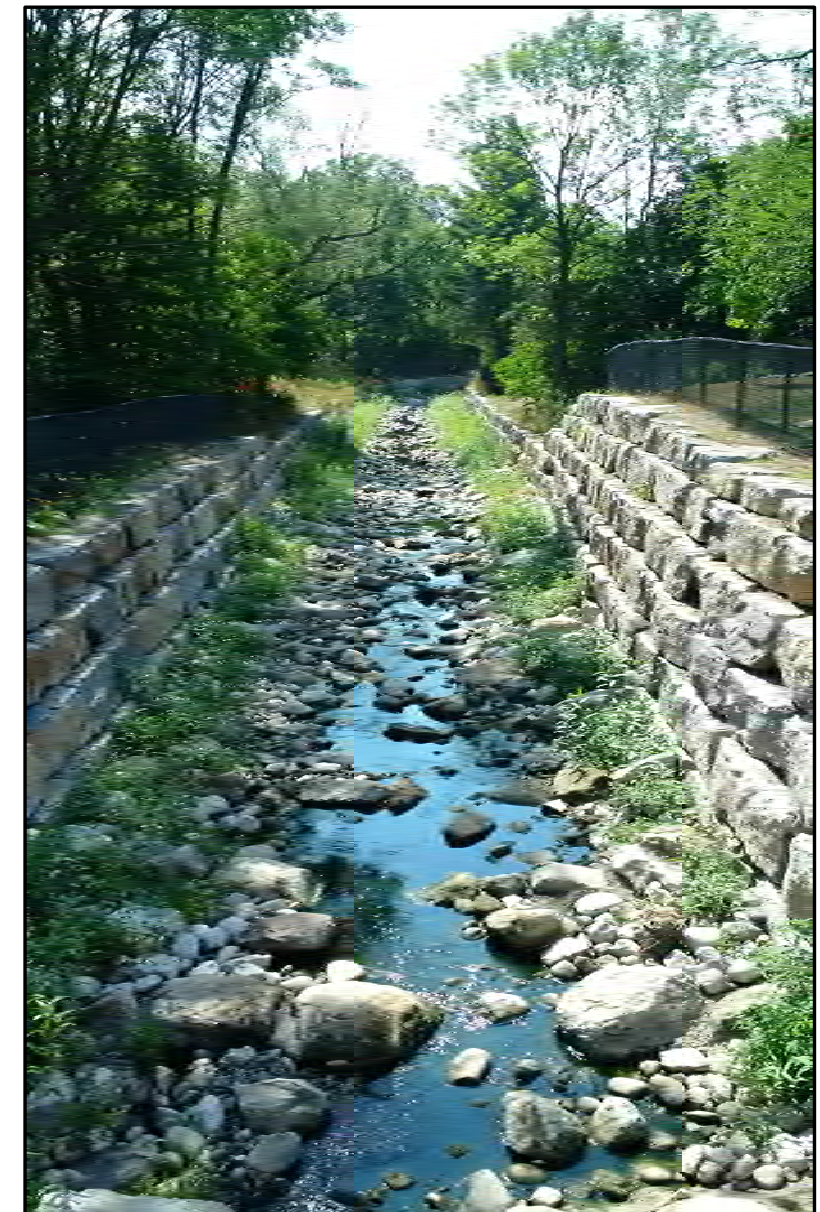
Channel with Armourstone Example

- Provides a moderately natural and “green” solution
- Minimizes disturbance area and vegetation removal
- Reduces erosion risks
- Promotes removal of debris in the channel
- Improves fish habitat and passage through the watercourse
- No loss to private property table land
- Moderate capital costs and low future maintenance costs
- Blends with existing erosion protection surrounding the site
