**COOKSVILLE CREEK EROSION CONTROL PROJECT
UPSTREAM OF MISSISSAUGA VALLEY BOULEVARD
TO THE CANADIAN PACIFIC RAILWAY RAIL CROSSING
MISSISSAUGA, ONTARIO
PROJECT REPORT**

Prepared for:
CITY OF MISSISSAUGA

Prepared by:
MATRIX SOLUTIONS INC., A MONTROSE ENVIRONMENTAL COMPANY

Version 1.0
April 2024
Guelph, Ontario

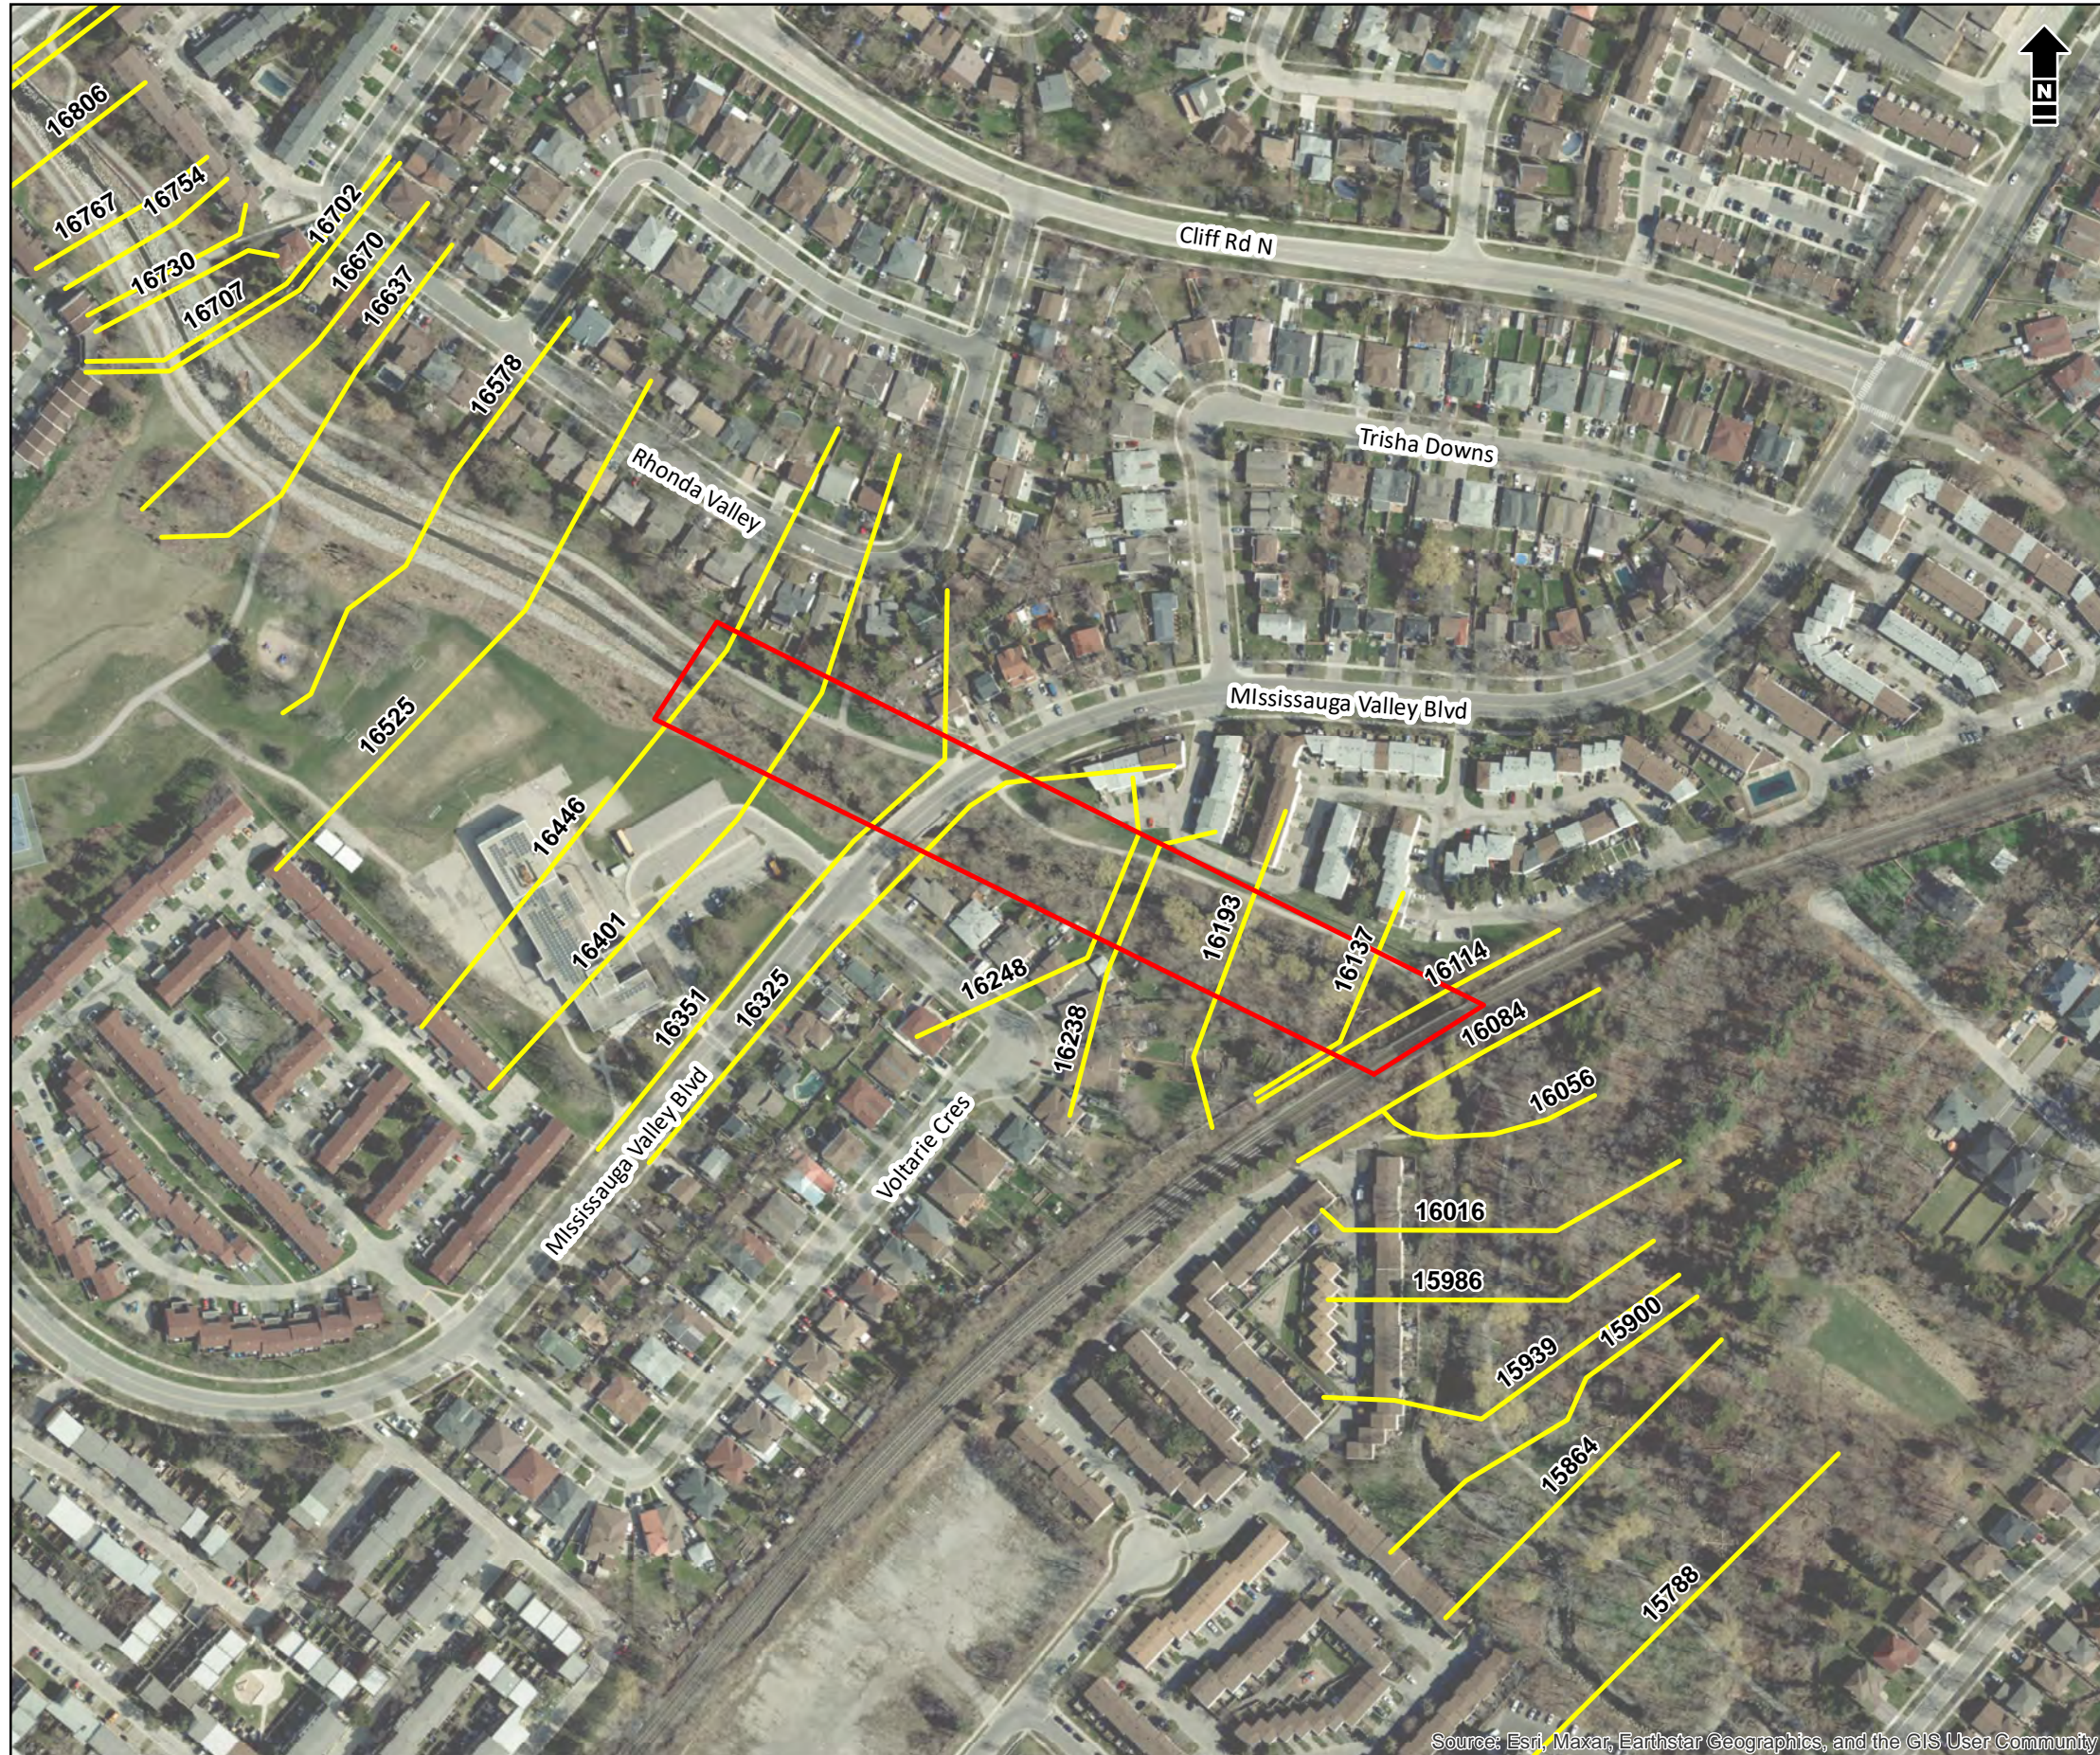
Each of the hydraulic models were updated by Matrix with the 2022 topographic survey data of the study area; this included updates to the cross-section geometries and crossings from cross-section 16114 to 16446 (see Figure 3 for section locations in the 1D model). The basis of comparison (BOC) model includes lower bed elevations ranging from 0.05 to 0.39 m lower than the existing model bed elevations, with reductions. The updated HEC-RAS models provide a BOC for changes to modelled water surface elevations and channel velocities under existing conditions.

- Hec-Ras Cross-Sections
- Study Area

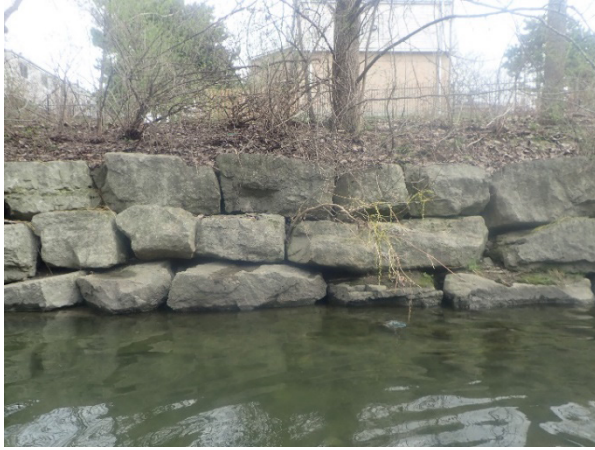
The predominant engineered erosion control measure in the study area was armourstone along the channel banks. A total for 280 m (~39%) of banks were protected by armourstone through the study area. Armourstone protection ranged from single to three-tiered armourstone walls. In general, the armourstone erosion protection along the Cooksville Creek banks was considered to be in good condition with little evidence of undermining, failure and undercutting/outflanking.

PHOTOGRAPH 1 Three-tier Armourstone Protection on the North Bank of Cooksville Creek, Armourstone Intact, Vegetation Establishment on Top of Armourstone Wall

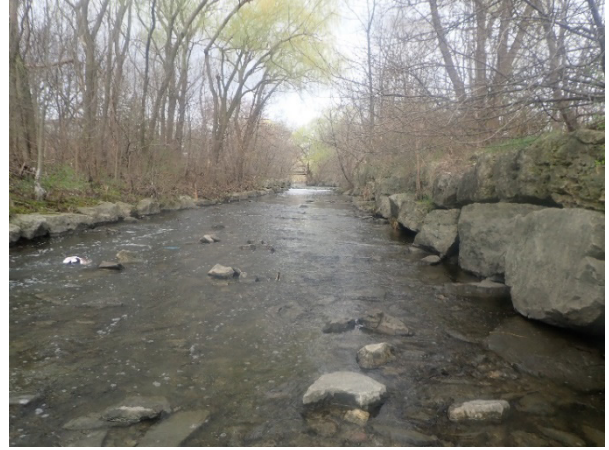
PHOTOGRAPH 2 Upstream View of Channel Cross-section, North Bank (right) Protected by Three-tiered Armourstone Wall, South Bank (left) Protected by Single-tier Armourstone Wall

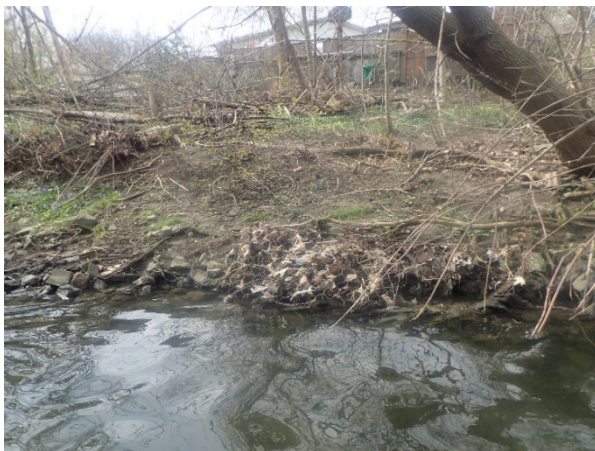
Gabion baskets (single tiered) accounted for approximately 26% of the total length of channel banks in the study area. The condition of the gabions was generally degraded (sagging, corroded) or failed (empty, fallen). Gabion stone was observed on the channel bed in proximity to failed gabion bank protection; however, gabion baskets were not observed on the channel bed.

PHOTOGRAPH 3 Emptied Gabion Cage Remains Intact with Channel Bank; Gabion Stone has been Disbursed from the Erosion Protection

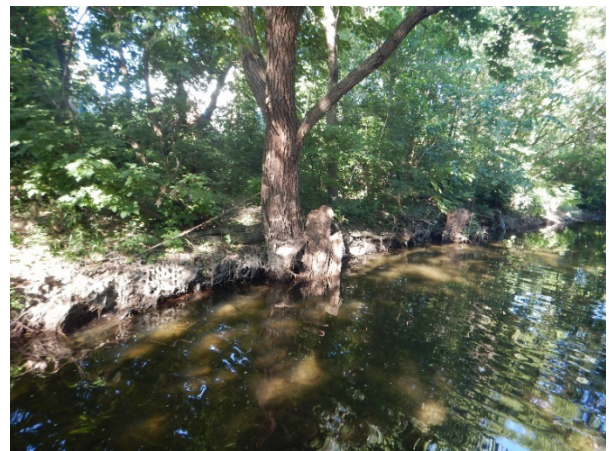
PHOTOGRAPH 4 Degraded Gabion Cage; Slumping and Deformation of the Erosion Control Measure, Some Gabion Stone has Washed into Channel

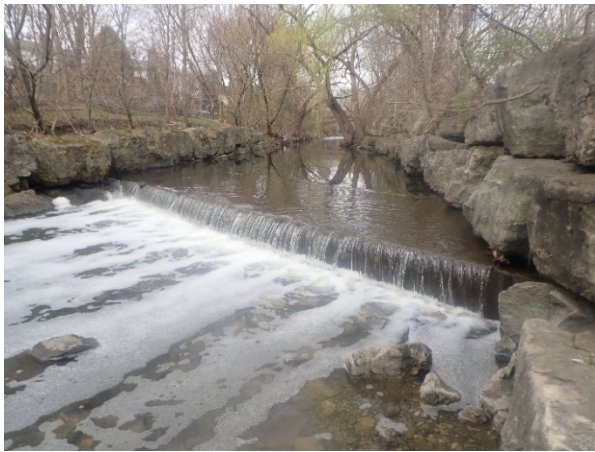
- A concrete sanitary sewer encasement (grade control structure) was located between the CP rail crossing and Mississauga Valley Boulevard (St. 0+240 m; Photograph 5). The concrete cap extends approximately 2.5 m in length along the channel profile. The maximum drop in bed elevation was measured at 0.64 m from the top of the concrete encasement to the channel bed. The concrete encasement was intact.
- A concrete weir grade control structure was located at the upstream limit of the CP rail crossing (Photograph 6). The weir appears to be intact and directs flow through the CP rail crossing.

PHOTOGRAPH 5 Concrete Sanitary Sewer Encasement at Sewer Crossing 0+240 ; Sanitary Sewer Encasement Creates a Maximum Drop in Bed Elevation of 0.64 m

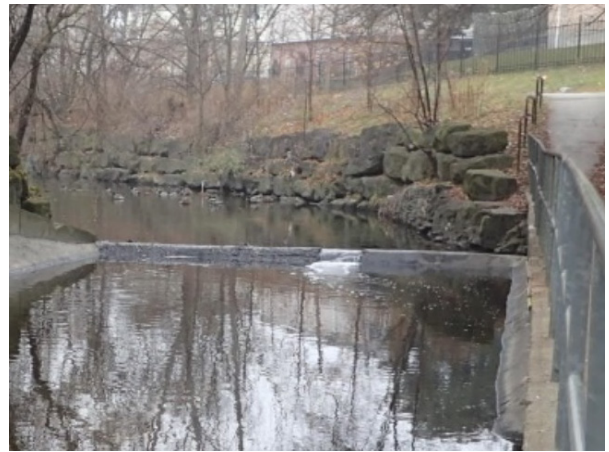
PHOTOGRAPH 6 Concrete Weir at Upstream Limit of Canadian Pacific Railway Rail Crossing

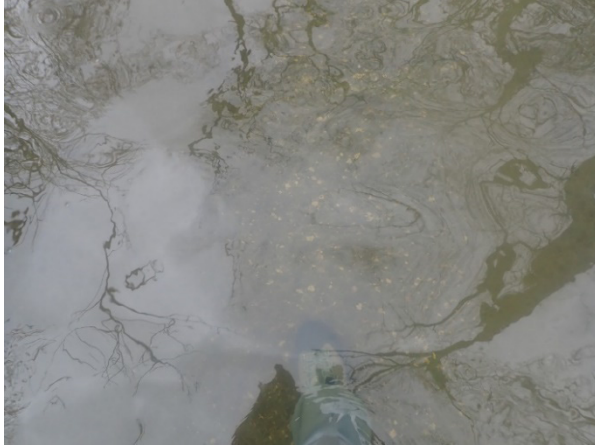
A small portion (approx. 15 m) of the channel bed profile is lined with concrete immediately downstream of the upstream study area limit. The concrete was considered to be intact, with little evidence of cracking or undermining. The concrete lining extended along the profile of Cooksville Creek, upstream of the study reach.

PHOTOGRAPH 7 Concrete-lined Channel Bed Through the Upstream Lengths of the Study Reach

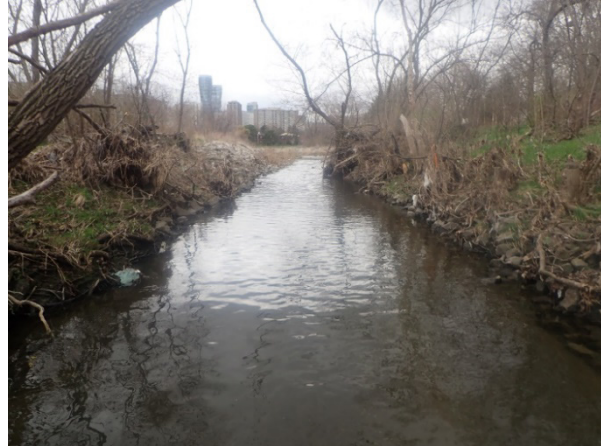
PHOTOGRAPH 8 Upstream View of Approximately 15 m of Channel Bed Profile Protected by Concrete lining in Upstream Lengths of Study Reach

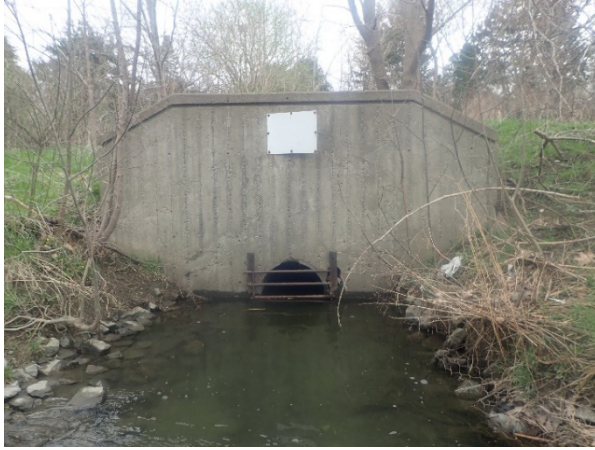
Throughout the study area, two stormwater outfalls discharge into Cooksville Creek. Two concrete outfall headwalls were observed (See Photographs 9 and 10). The outfall structures were observed to be in relatively good condition (i.e., no undercutting of outfall structure, no substantial deterioration of concrete headwalls).

PHOTOGRAPH 9 A 750 mm diameter Stormwater Outfall Enters the Channel on the North Bank of Cooksville Creek Upstream of the Mississauga Valley Boulevard Crossing; the Concrete Outfall was Grated and had a Concrete Headwall Structure

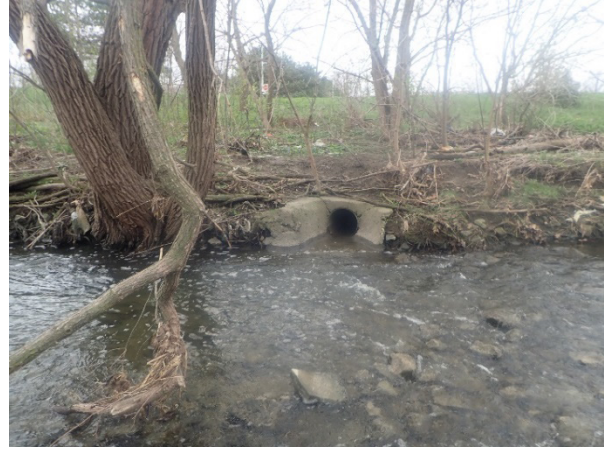
PHOTOGRAPH 10 A 400 mm diameter Storm Outfall on the South Bank of Cooksville Creek Upstream of the Mississauga Valley Boulevard Crossing

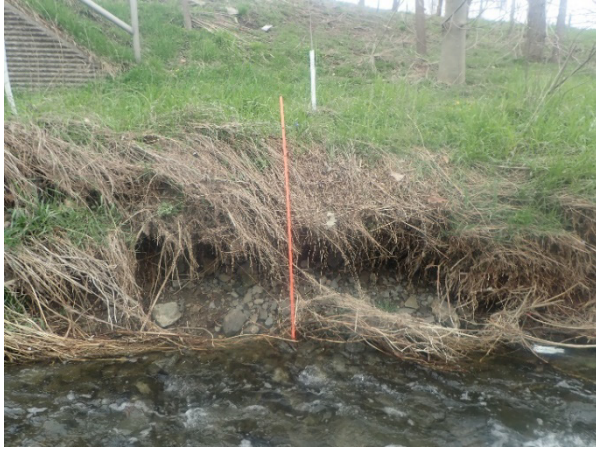
Where no erosion control measures were in place, some evidence of ongoing channel bank erosion was exhibited. Areas of bank erosion were concentrated directly downstream of Mississauga Valley Boulevard on the north channel bank, and upstream of Mississauga Valley Boulevard on the north bank near the upstream limit of the study area.

PHOTOGRAPH 11 Vertical Eroded Bank with Exposed Roots and Gravel and Sand Material within the Bank; Located Directly Downstream of Mississauga Valley Boulevard (North Bank)

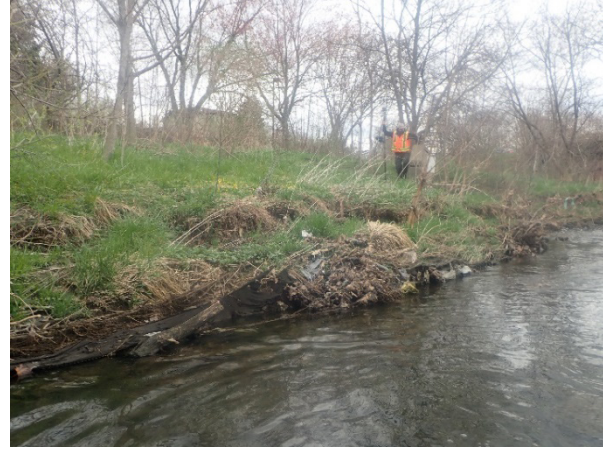
PHOTOGRAPH 12 Slumping Bank Material Directly Upstream of the 750 mm Concrete Stormwater Outfall (North Bank); Located Near Upstream Limit of Study Area

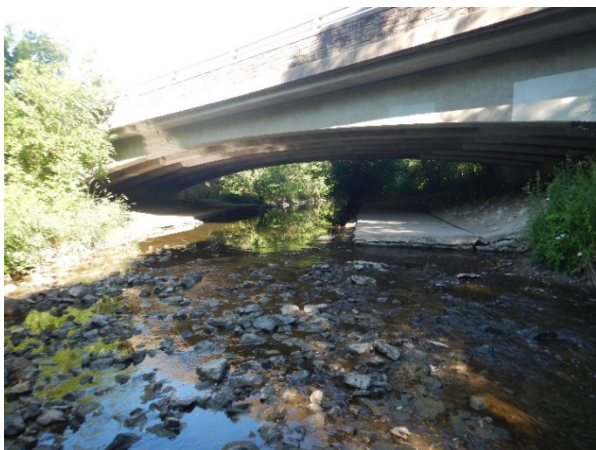
Underneath Mississauga Valley Boulevard, the cross-section was trapezoidal; concrete slabs with embedded cobble were on the slopes. These slabs were generally in-tact. At the toe of the slope, the concrete slabs created a defined low flow channel; these gabions were placed on top of a foundation of gabions. These gabions were corroded and emptied of gabion stone. On the upstream south side of the bridge, scour has occurred along the banks and the slope toe slabs now interfere with a continuity of flow in the channel.

PHOTOGRAPH 13 Scour of Channel Banks has Occurred on the Upstream South Side of the Bridge Inlet

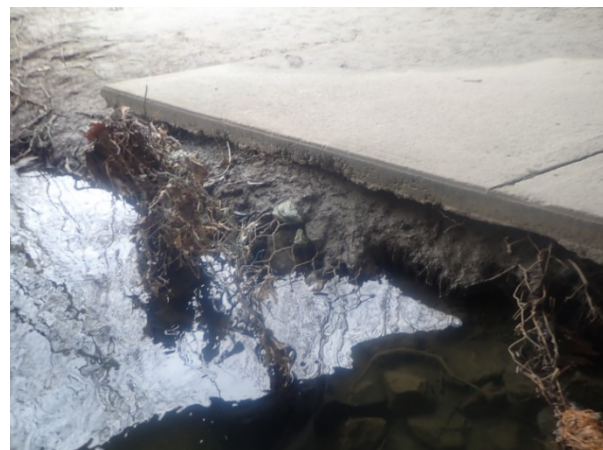
PHOTOGRAPH 14 Corrosion of Gabions Underneath the Concrete Slabs

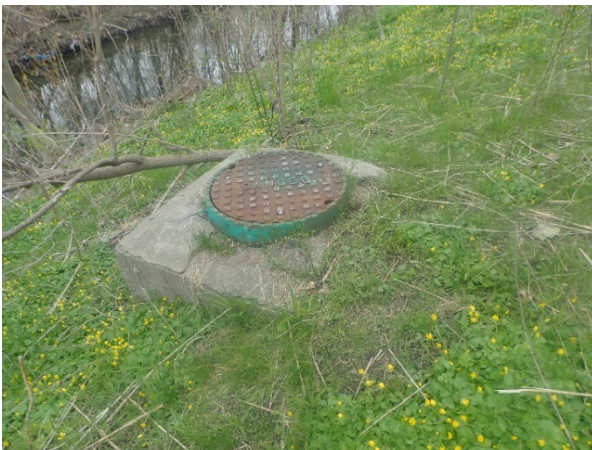
Within the study area, there are five manholes. Four manholes were in proximity to the pedestrian trail on the north channel bank and are associated with the sanitary sewer that runs parallel to the Cooksville Creek bank. One manhole was located on the south bank associated with the sanitary sewer crossing at 0+240 m. None of the manholes were directly exposed to the creek; the nearest manhole to the channel bank was located ~5 m from the south bank.

PHOTOGRAPH 15 Manhole within the Cooksville Creek Corridor Associated with a Sanitary Sewer Crossing

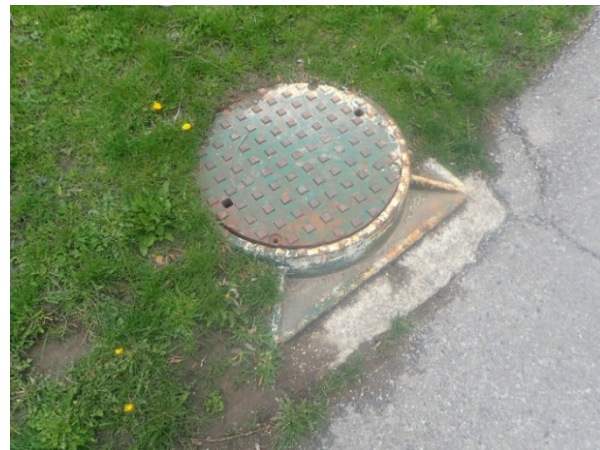
PHOTOGRAPH 16 Manholes Exist Along the Pedestrian Pathway and are Generally Associated with the Sanitary Sewer which Runs Parallel to Cooksville Creek

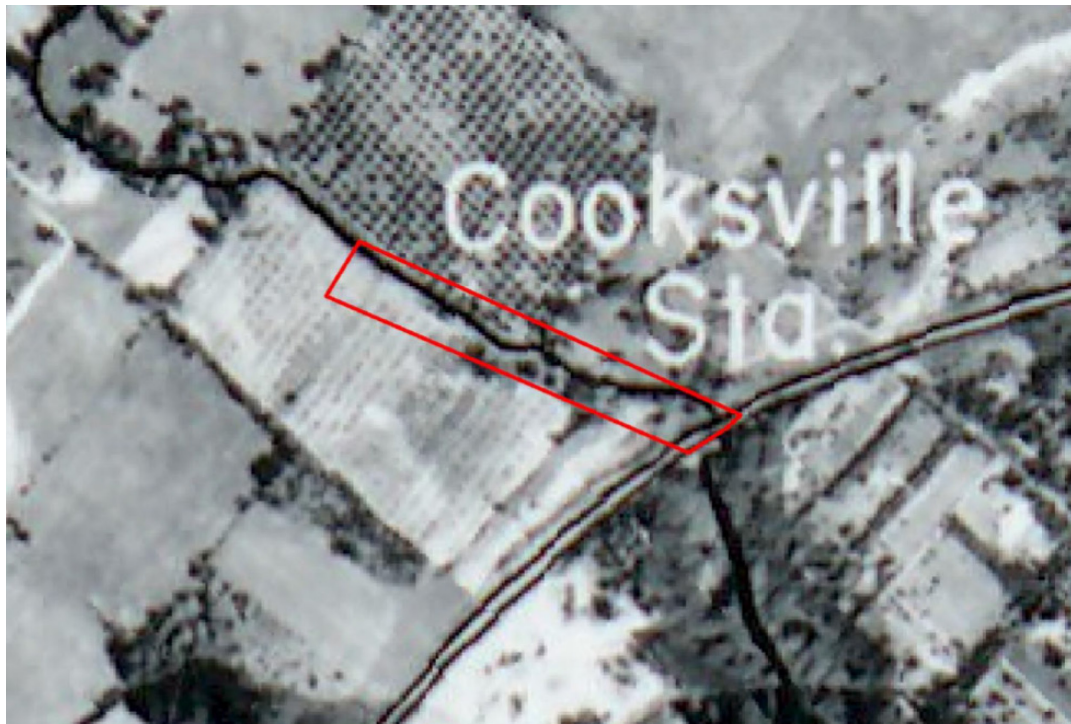
Historical maps and aerial imagery of the Cooksville Creek area in the Stage 1 archaeological assessment for this study show that the creek has moved in spatial position over the past approximately 150 years, only nearing its current alignment in 1954 (Figure 6) as opposed to crossing the current study area as shown in the 1859 and 1877 maps. This migrating channel moved laterally to the southward or underwent a realignment during the works shown in the 1966 (Figure 7) likely coinciding with placement of sanitary infrastructure.

FIGURE 6 1954 Aerial Image of the Cooksville Creek Study Area (Screen Capture from Stage 1 Archaeological Report)

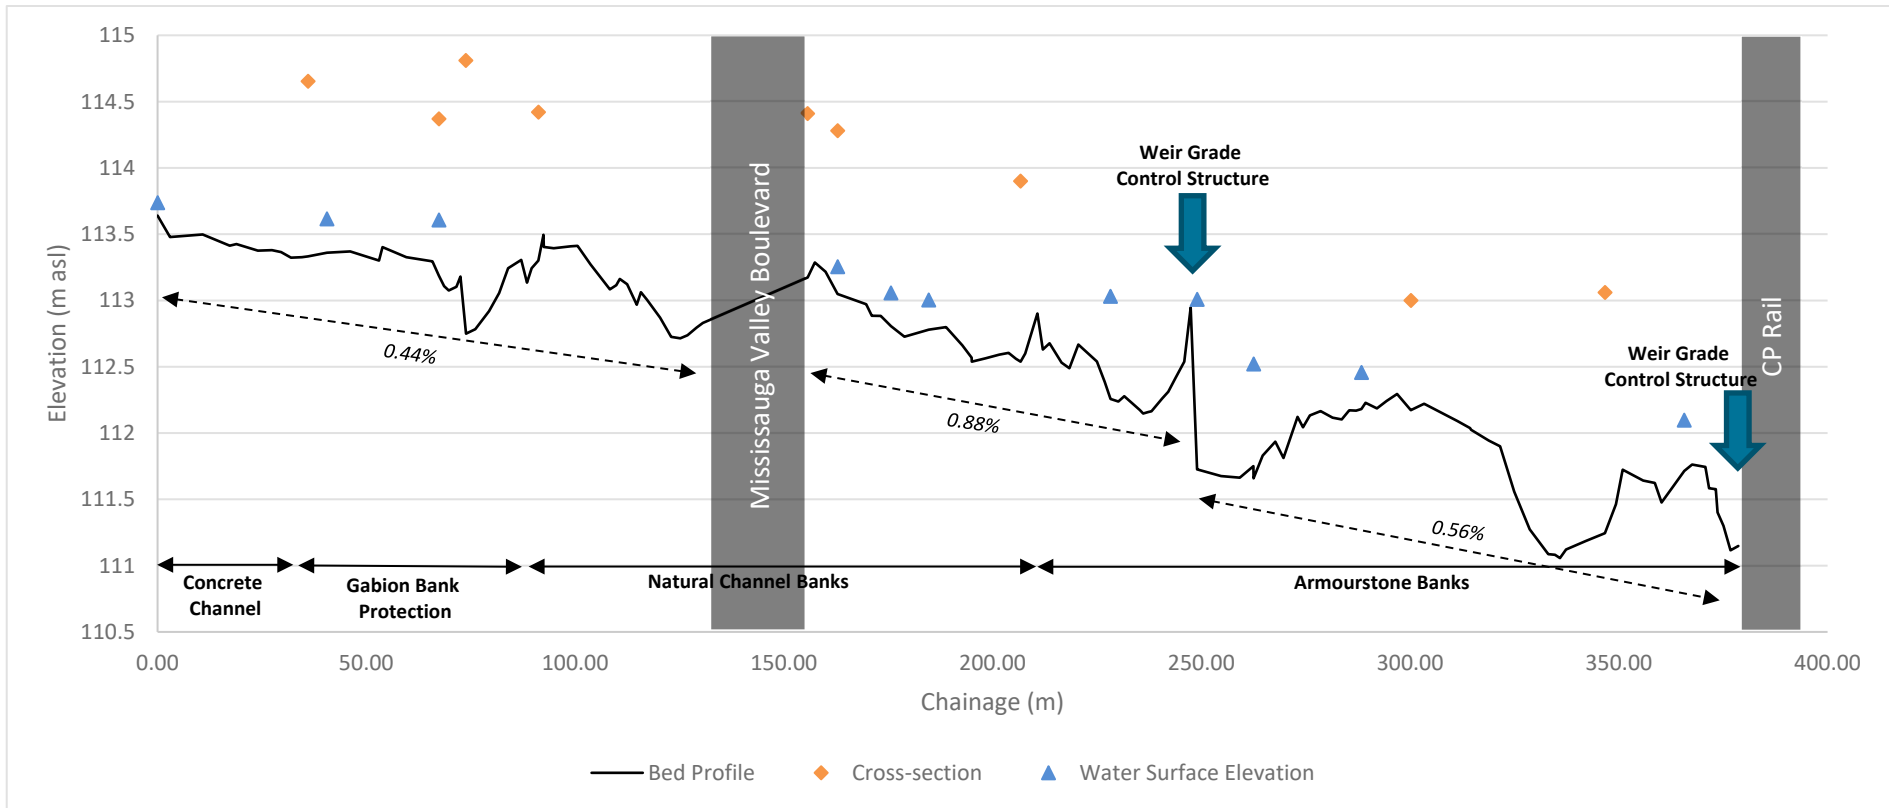
FIGURE 2 Channel bed profile with cross-section locations and average bed gradients.

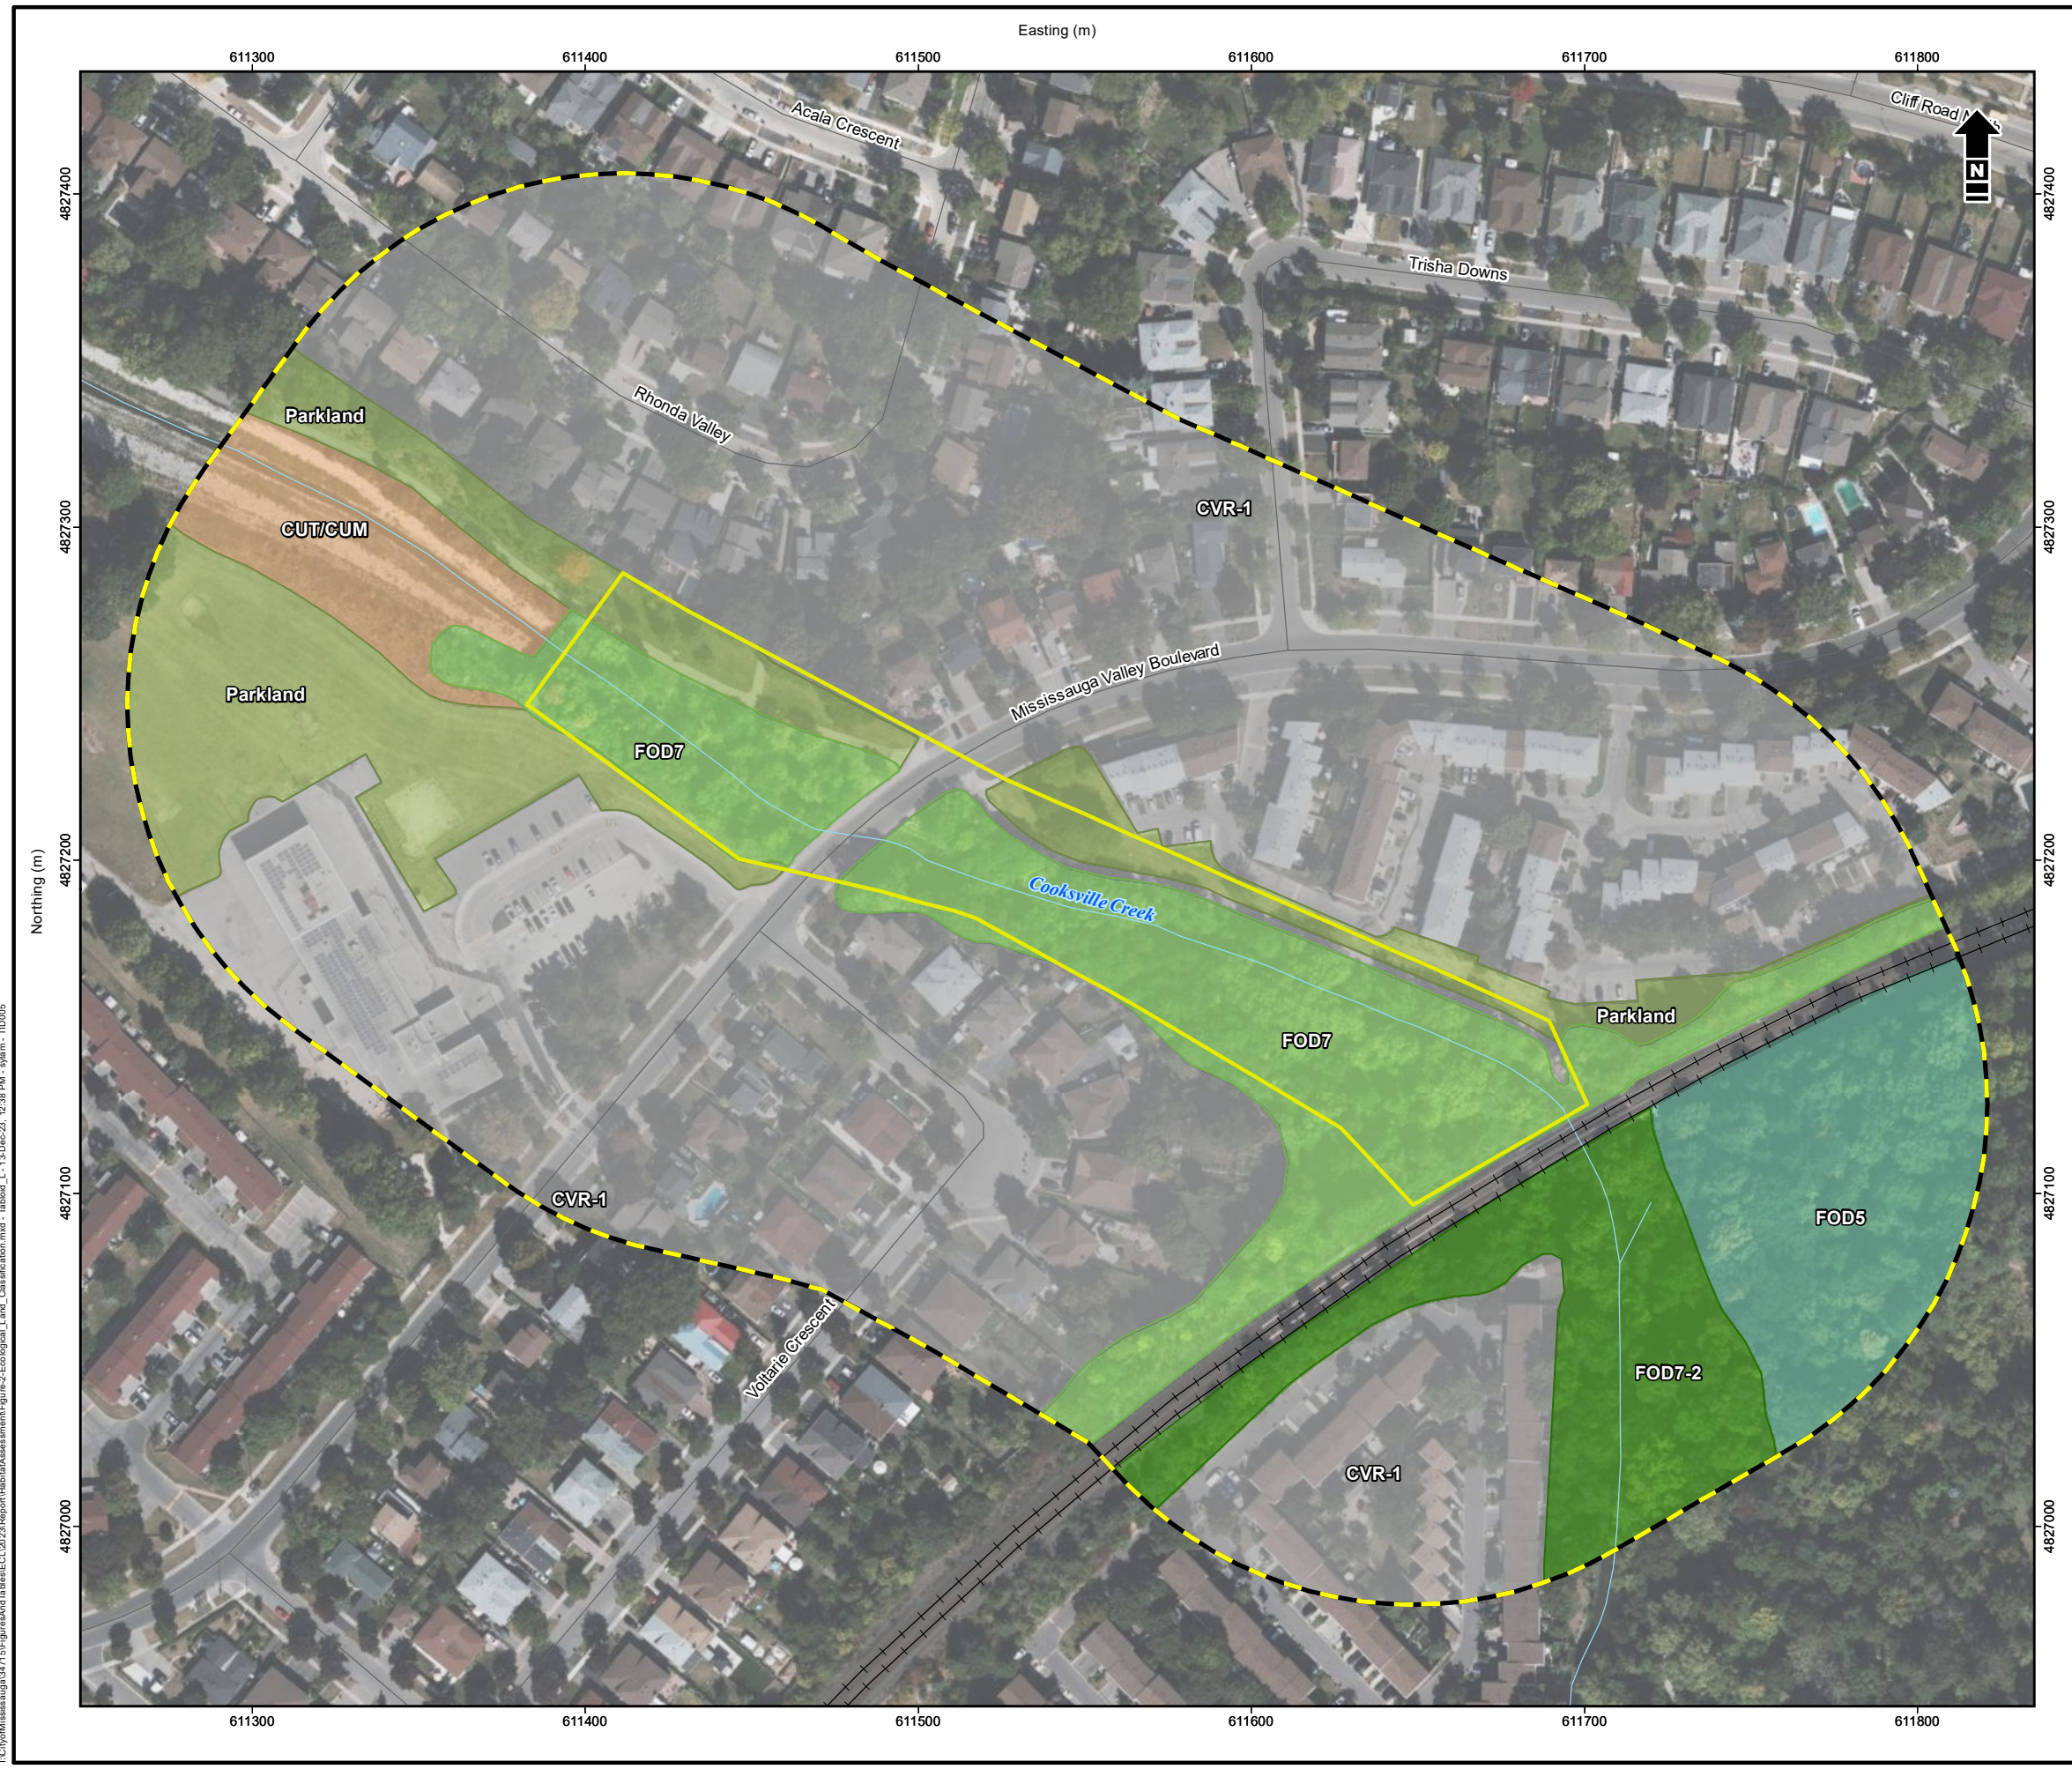
Vegetation communities were characterized and mapped using the Ecological Land Classification (ELC) systems for southern Ontario (Lee 2008, 1998) during two site visits on June 3 and July 1, 2022. Existing ELC data for Sites MY3 and CV12 from the NAS (City of Mississauga 2021a, City of Mississauga 2021b) data was confirmed and updated. Details of the vegetation communities were recorded including species composition, dominance, and uncommon species or features. The vegetation inventory was compiled and refined by incidental observations recorded throughout all site visits. ELC communities are shown on Figure 3.

- Study Area (Center: 611542 E, 4827191 N)
 - Study Area (120m Buffer)
 - Watercourse (Credit Valley Conservation)
 - Road
 - Railway
- Ecological Land Classification**
- CUT/CUM: Cultural Thicket/Cultural Meadow
 - CVR-1: Residential Low Density
 - FOD5: Dry-Fresh Sugar Maple Deciduous Forest
 - FOD7: Fresh-Moist Lowland Deciduous Forest
 - FOD7-2: Fresh-Moist Ash Lowland Deciduous Forest
 - Parkland

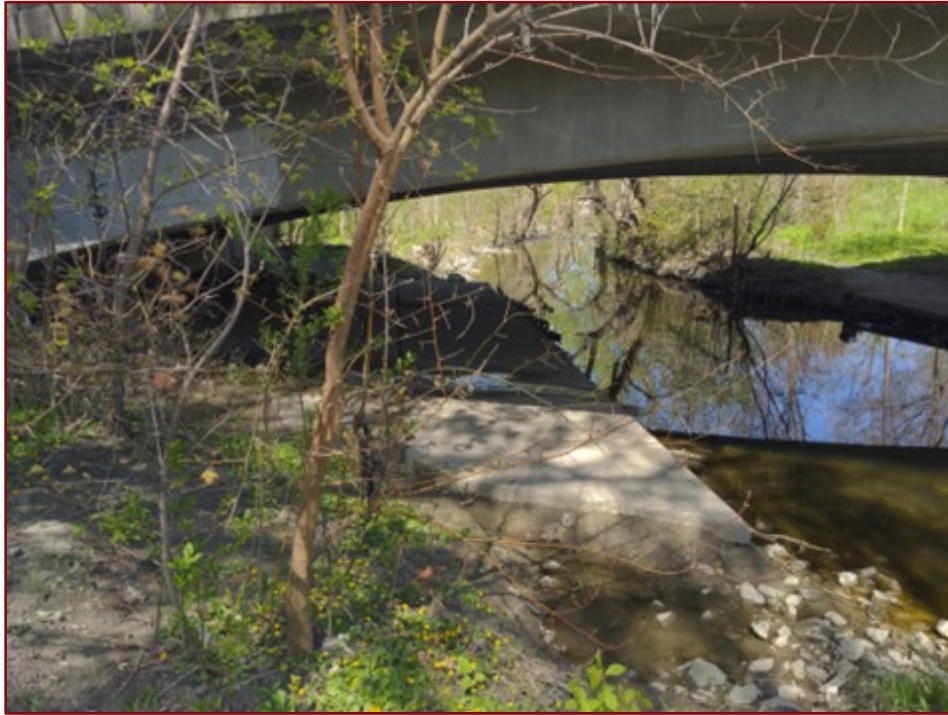
Image 5: Disturbance Under Mississauga Valley Boulevard Bridge

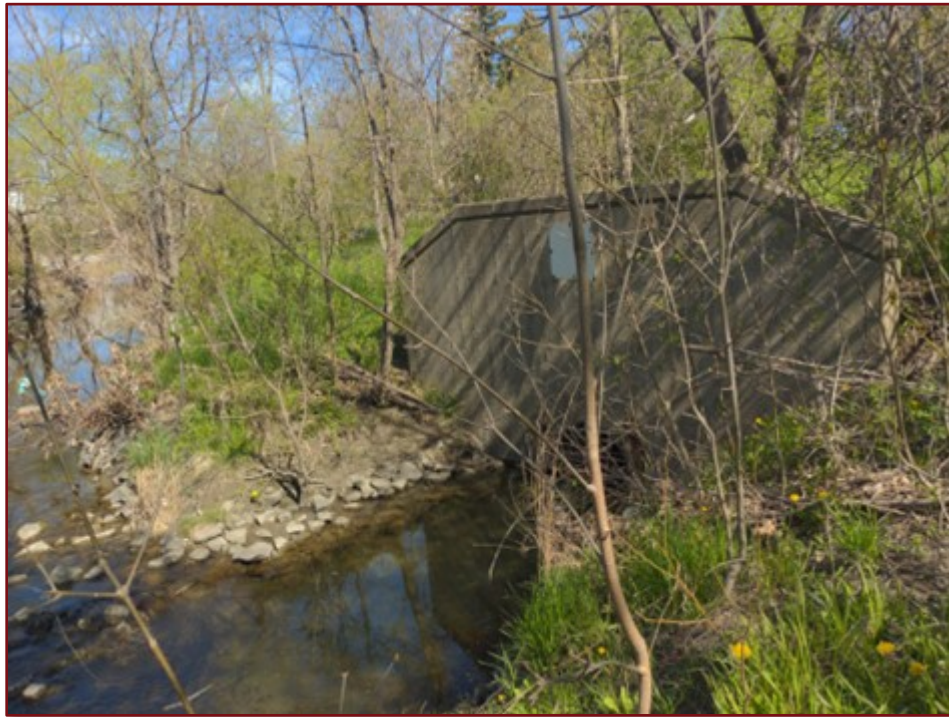
Image 9: Concrete Drain Disturbance
