**Report on  
Geotechnical Investigation and  
Slope Stability Assessment  
Proposed Buildings  
1720 Sherwood Forrest Circle  
Mississauga, Ontario**

**Prepared For:  
Sherwood Forrest Limited  
Partnership**

**Project No:** 23-162-102

**Date:** July 24, 2023

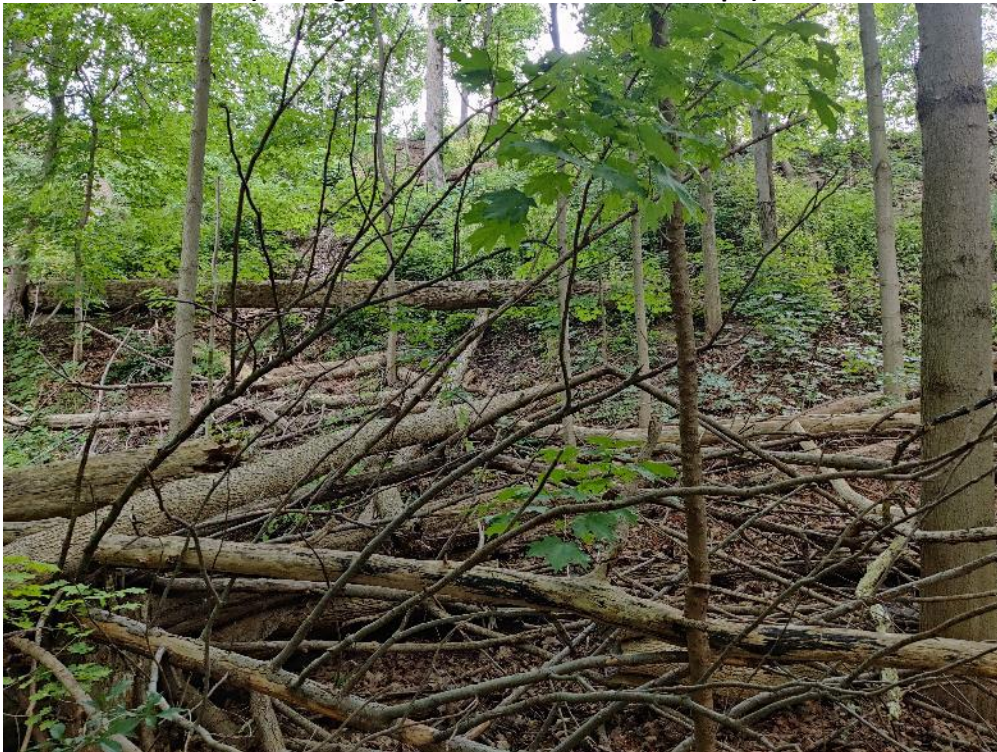
**Photo B14: Steep slope conditions in area of Cross-Section X7-X7  
(looking west – upward from toe of slope)**

- The steepness of the slopes ranged from 1.4H:1V (at Cross-Section X7-X7) to flatter than 2.0H:1V.
- The slopes were covered with trees, grasses and other vegetation (see Photos in **Appendix B**), and were generally well protected from surface erosion. No seepage from the slope surface was found during the site visit. No evidence of slope failures was observed during our site visit.
