# PHASE ONE ENVIRONMENTAL SITE ASSESSMENT

**2555 Erin Centre Boulevard,  
Mississauga, Ontario**

**Grounded Engineering Inc.**  
**File No.** 24-095  
**Issued** 2024-07-29

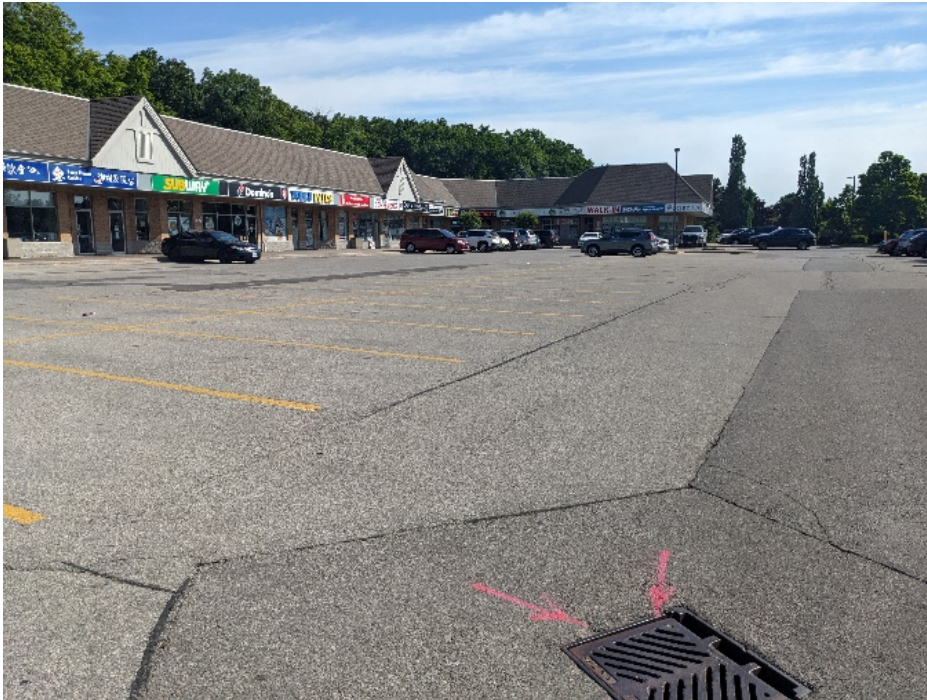
**Photograph 1**

Location: Phase One Property

Direction: Southeast corner of the Property facing Northeast

Description: L-shaped commercial plaza with central parking lot.

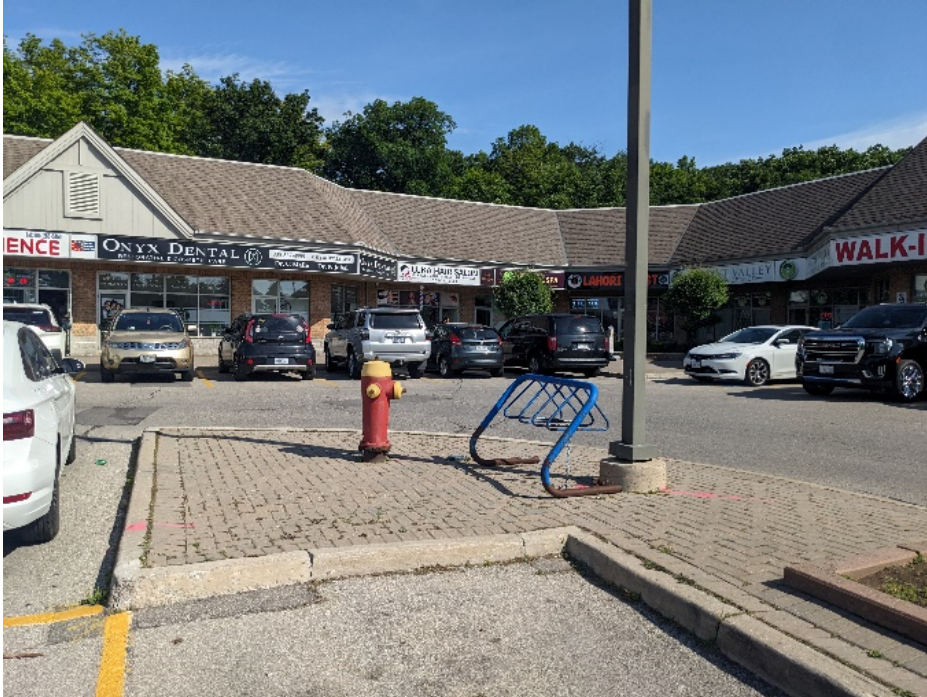
**Photograph 2**

Location: Phase One Property

Direction: North side of the Property facing North

Description: Showing various tenants of the commercial plaza including medical clinics, salon services, restaurants.

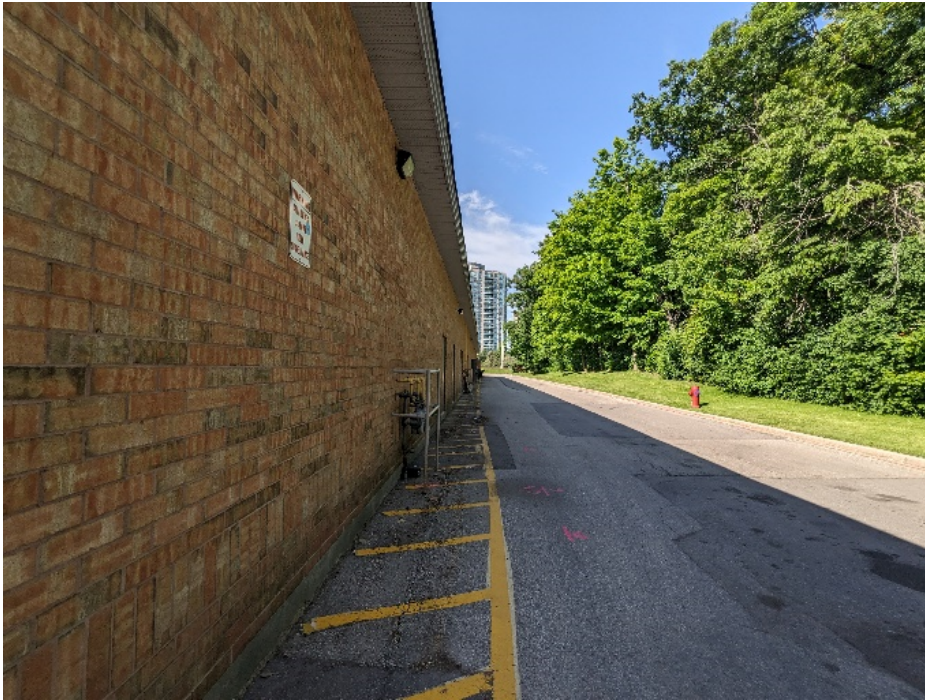
**Photograph 3**

Location: Phase One Property

Direction: West side of the Property facing Southwest

Description: Laneway behind the commercial plaza (west side of the building). Multiple gas meters (utilities) are observed.

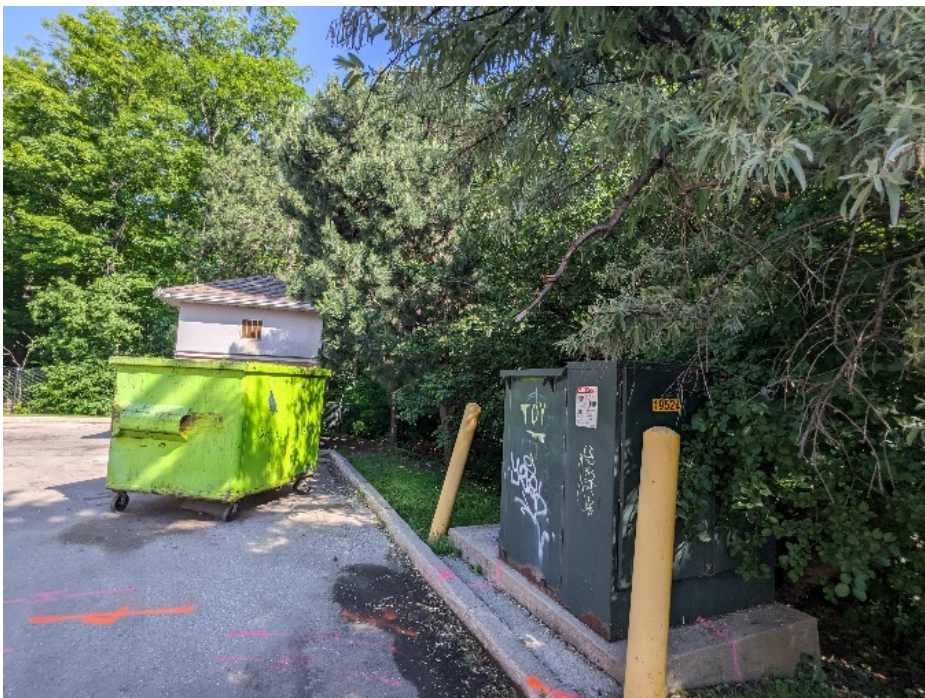
**Photograph 4**

Transformers were observed on the Phase One Property and adjacent to the northeast. These are considered to be potentially contaminating activities on site.
--	--

Location: Phase One Property

Direction: North corner of the Property facing North

Description: Garbage storage area and pad-mounted transformer (Alectra Utilities transformer TX19524, confirmed to be non-PCB containing).

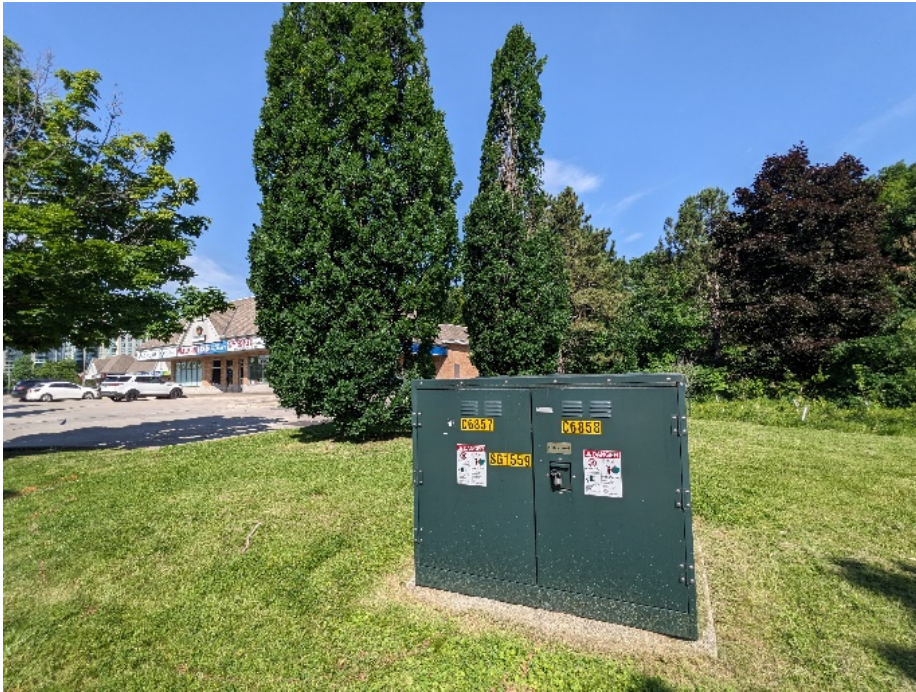
**Photograph 5**

5303 Erin Mills Parkway Adjacent East	55 B	55 - Transformer Manufacturing, Processing and Use	Yes (APEC 4)	Based on a previous Phase I ESA (Soil-Eng Ltd., 1995), a transformer was observed to the northeast of the Property on an adjacent property. A ground-mounted transformer was also observed in this off-site location during the site visit on June 13, 2024. Based on its proximity and upgradient location to the Property, it is considered to lead to an APEC on the Property.

Location: Study Area (East adjacent property)

Direction: Directly Northeast of the Property, facing Southwest

Description: Off-site transformer located directly Northeast of the Property (Alectra Utilities switchgear SG1559, confirmed to be non-PCB containing).

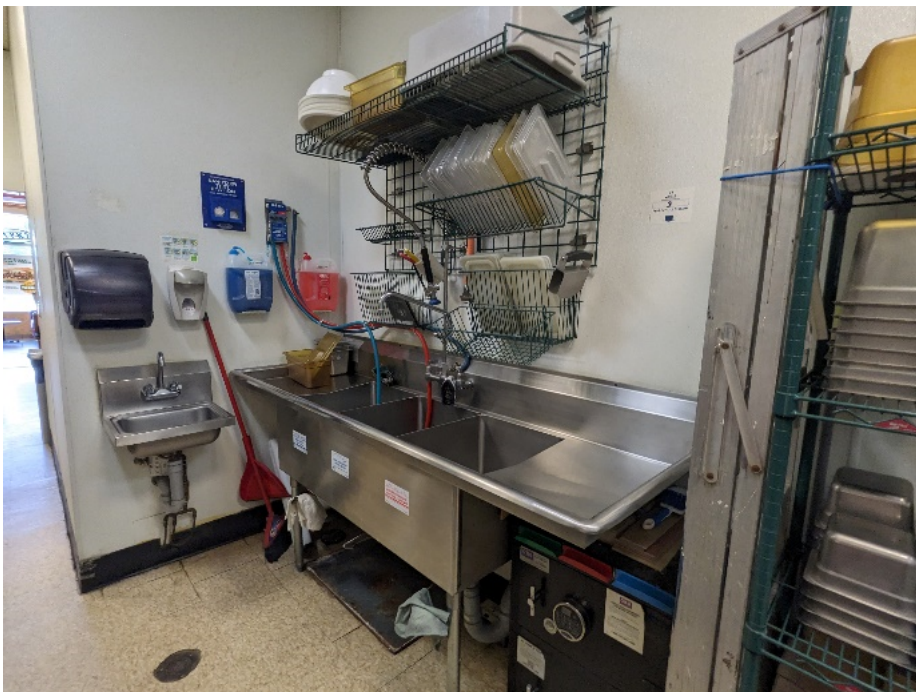
**Photograph 6**

Location: Phase One Property

Direction: Inside Subway sandwich shop (South side of the commercial plaza)

Description: Grease trap observed underneath the sink at the back of the unit.

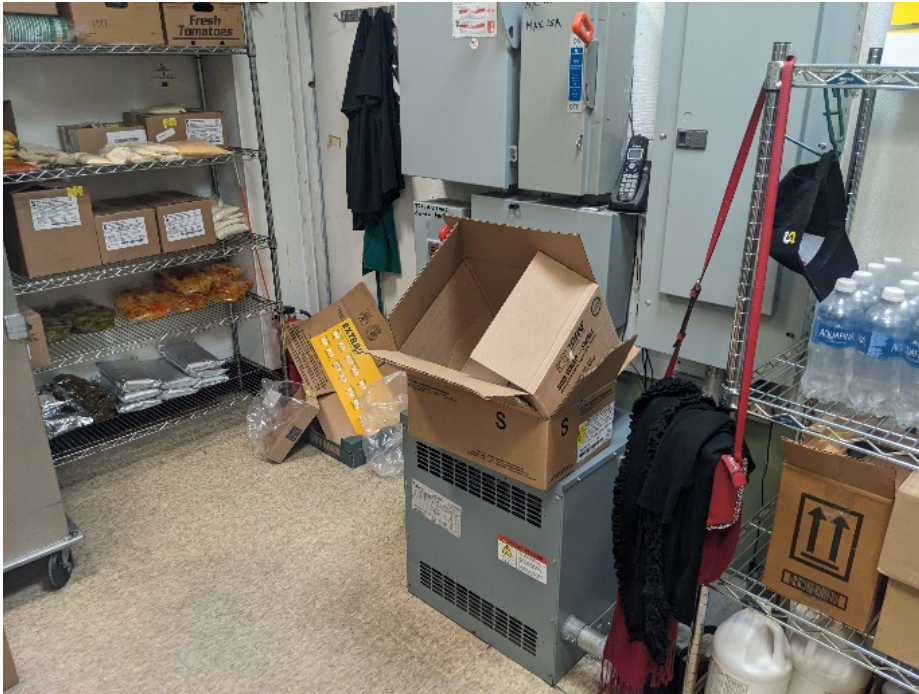
**Photograph 7**

Location: Phase One Property

Direction: Inside Subway sandwich shop (South side of the commercial plaza)

Description: A dry-type transformer observed at the back of the unit (as indicated on the label).

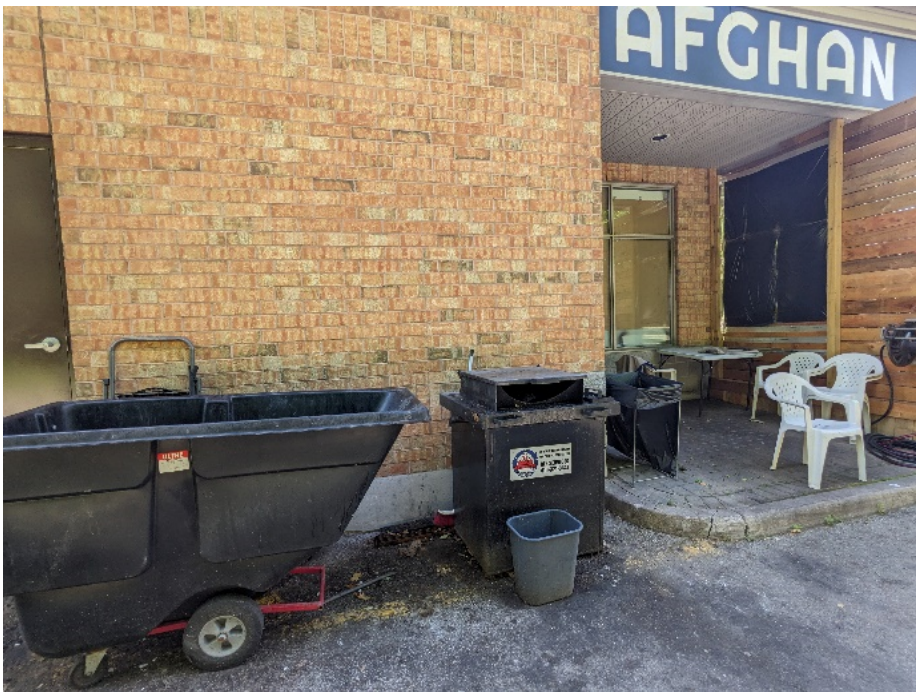
**Photograph 8**

<b>Above Ground Storage Tanks (AST)</b>	An eighty (80) gallon waste cooking oil storage bin was observed to the southwest side of the building, outside of the restaurant. The waste cooking oil storage bin is picked up and drop off by REX Service.
<b>Underground Storage Tanks (UST)</b>	None
<b>Potable and Non-potable Water Sources</b>	There were no water wells observed on the Site.
<b>Hydro</b>	Buried hydro enters the Property at the transformer located adjacent to the northeast corner of the Property via Erin Centre Blvd.
<b>Gas</b>	Gas line enters the Property from the southeast/east via Erin Centre Blvd.
<b>Communication</b>	Buried communication line enters the Property from the southeast/east via Erin Centre Blvd.
<b>Electrical/Outdoor Lighting</b>	Electrical line enters the Property from the southeast/east via Erin Centre Blvd.
<b>Storm Sewer</b>	Catch basins are observed throughout the Property within the at-grade parking lot and along the Property boundary on Erin Centre Blvd.

Location: Phase One Property

Direction: On the west side of the building (behind the plaza, Afghan Flame restaurant)

Description: A waste cooking oil storage bin observed behind Afghan Flame restaurant.

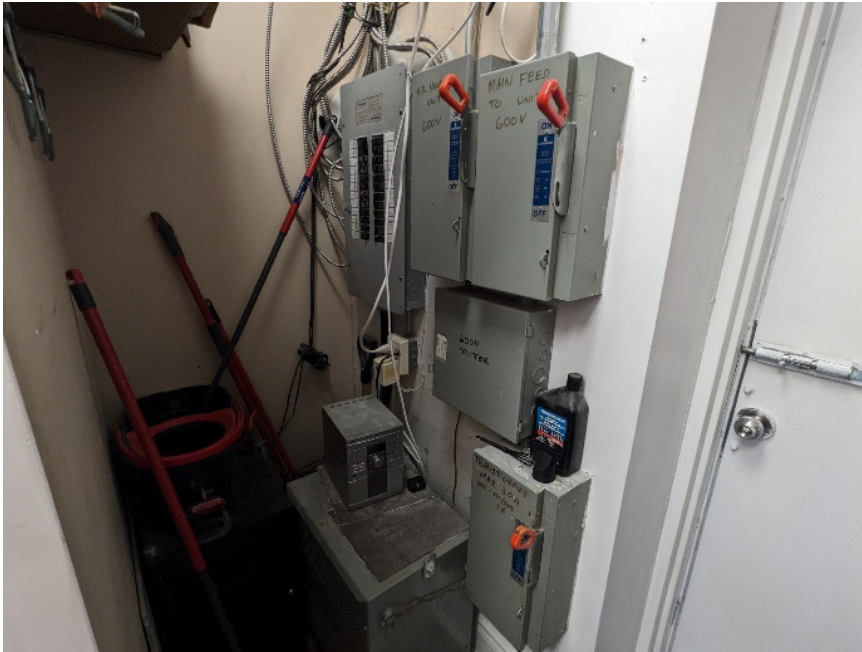
**Photograph 9**

Location: Phase One Property

Direction: Inside Luka Hair Salon  
(North side of the plaza)

Description: A dry-type transformer observed at the back of the unit (as indicated on the label).

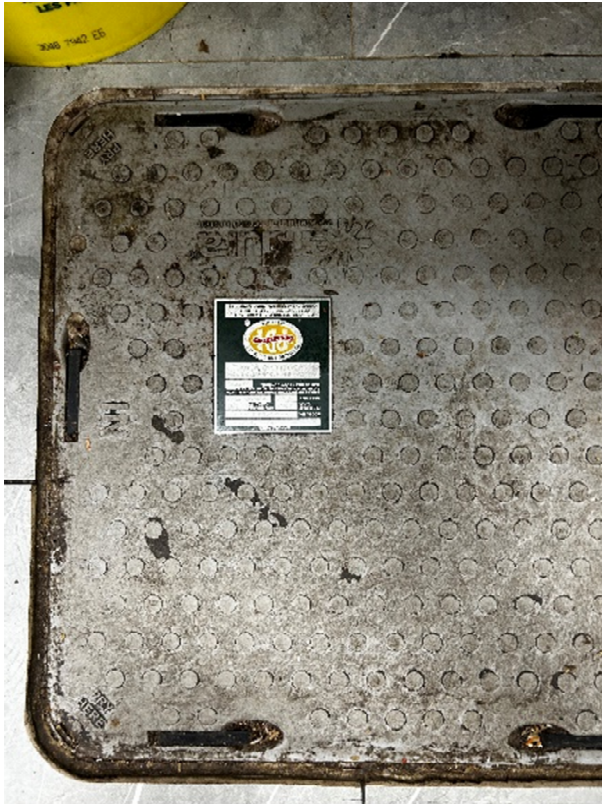
**Photograph 11**

Location: Phase One Property

Direction: Inside Lahor Twist  
(North corner of the plaza,  
formerly Top Hat Cleaners)

Description: An oil grease trap  
observed on the kitchen floor.

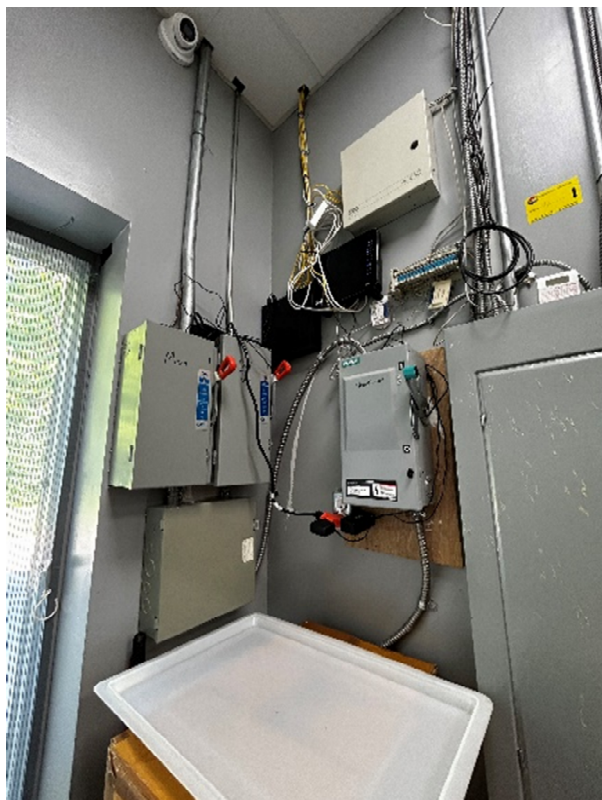
**Photograph 12**

Location: Phase One Property

Direction: Inside Lahor Twist  
(North corner of the plaza,  
formerly Top Hat Cleaners)

Description: A dry-type  
transformer observed at the back  
of the unit (as indicated on the  
label).

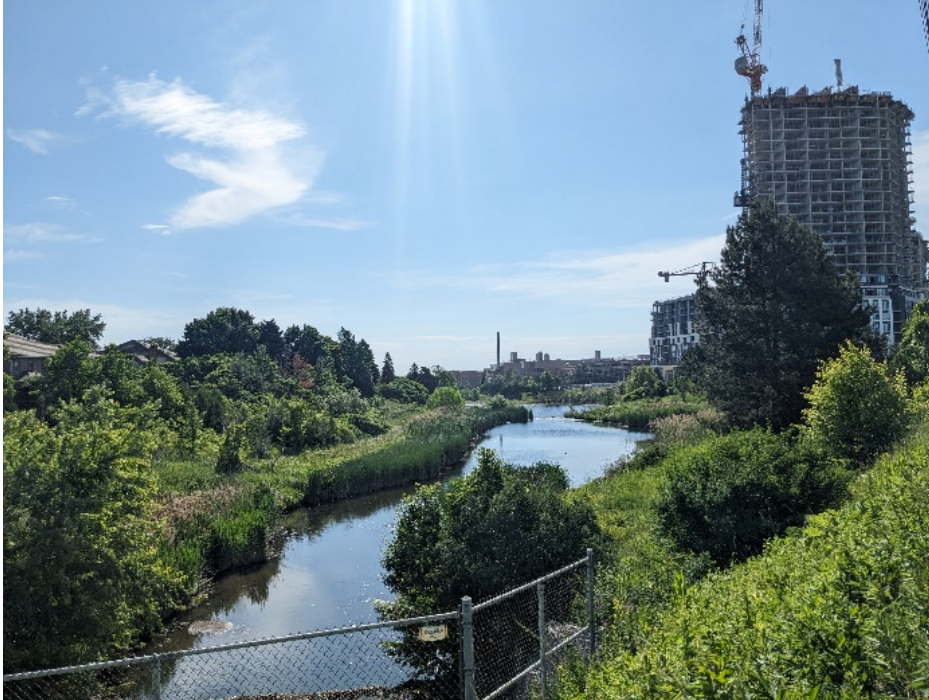
**Photograph 13**

Location: Study Area

Direction: South of the Property

Description: Large stormwater management pond observed approximately 60 m South of the Property, on the opposite side of Erin Centre Blvd.

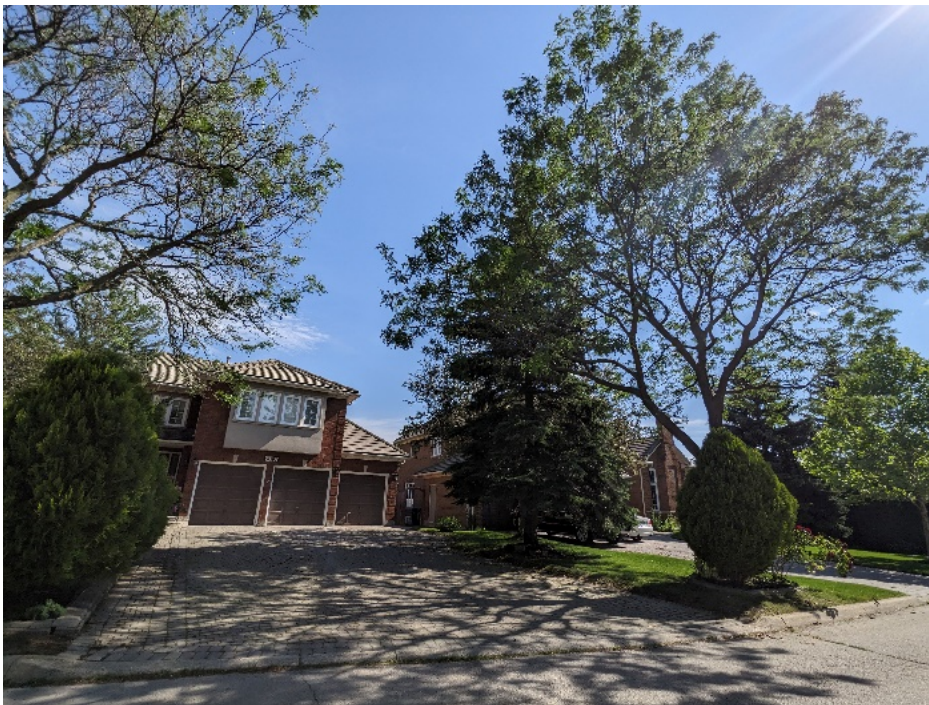
**Photograph 14**

Location: Study Area

Direction: Southeast of the Property

Description: Residential homes observed to the South/Southeast of the Property.

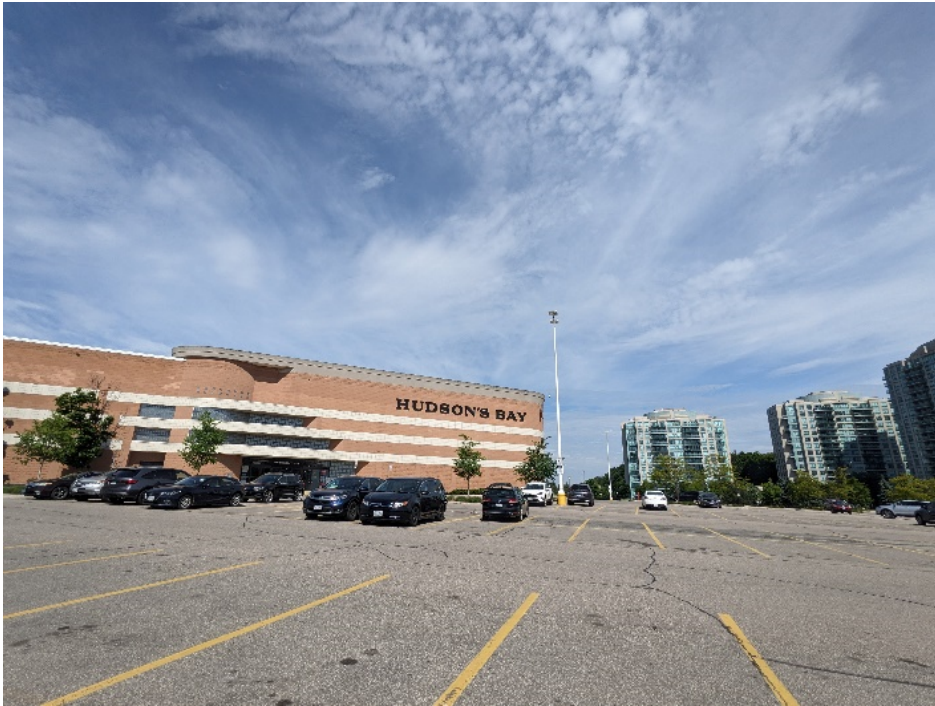
### Photograph 15

Location: Study Area
