PHASE TWO ENVIRONMENTAL SITE ASSESSMENT

**2555 Erin Centre Boulevard. |
Mississauga, Ontario**

Grounded Engineering Inc.

File No. 24-095

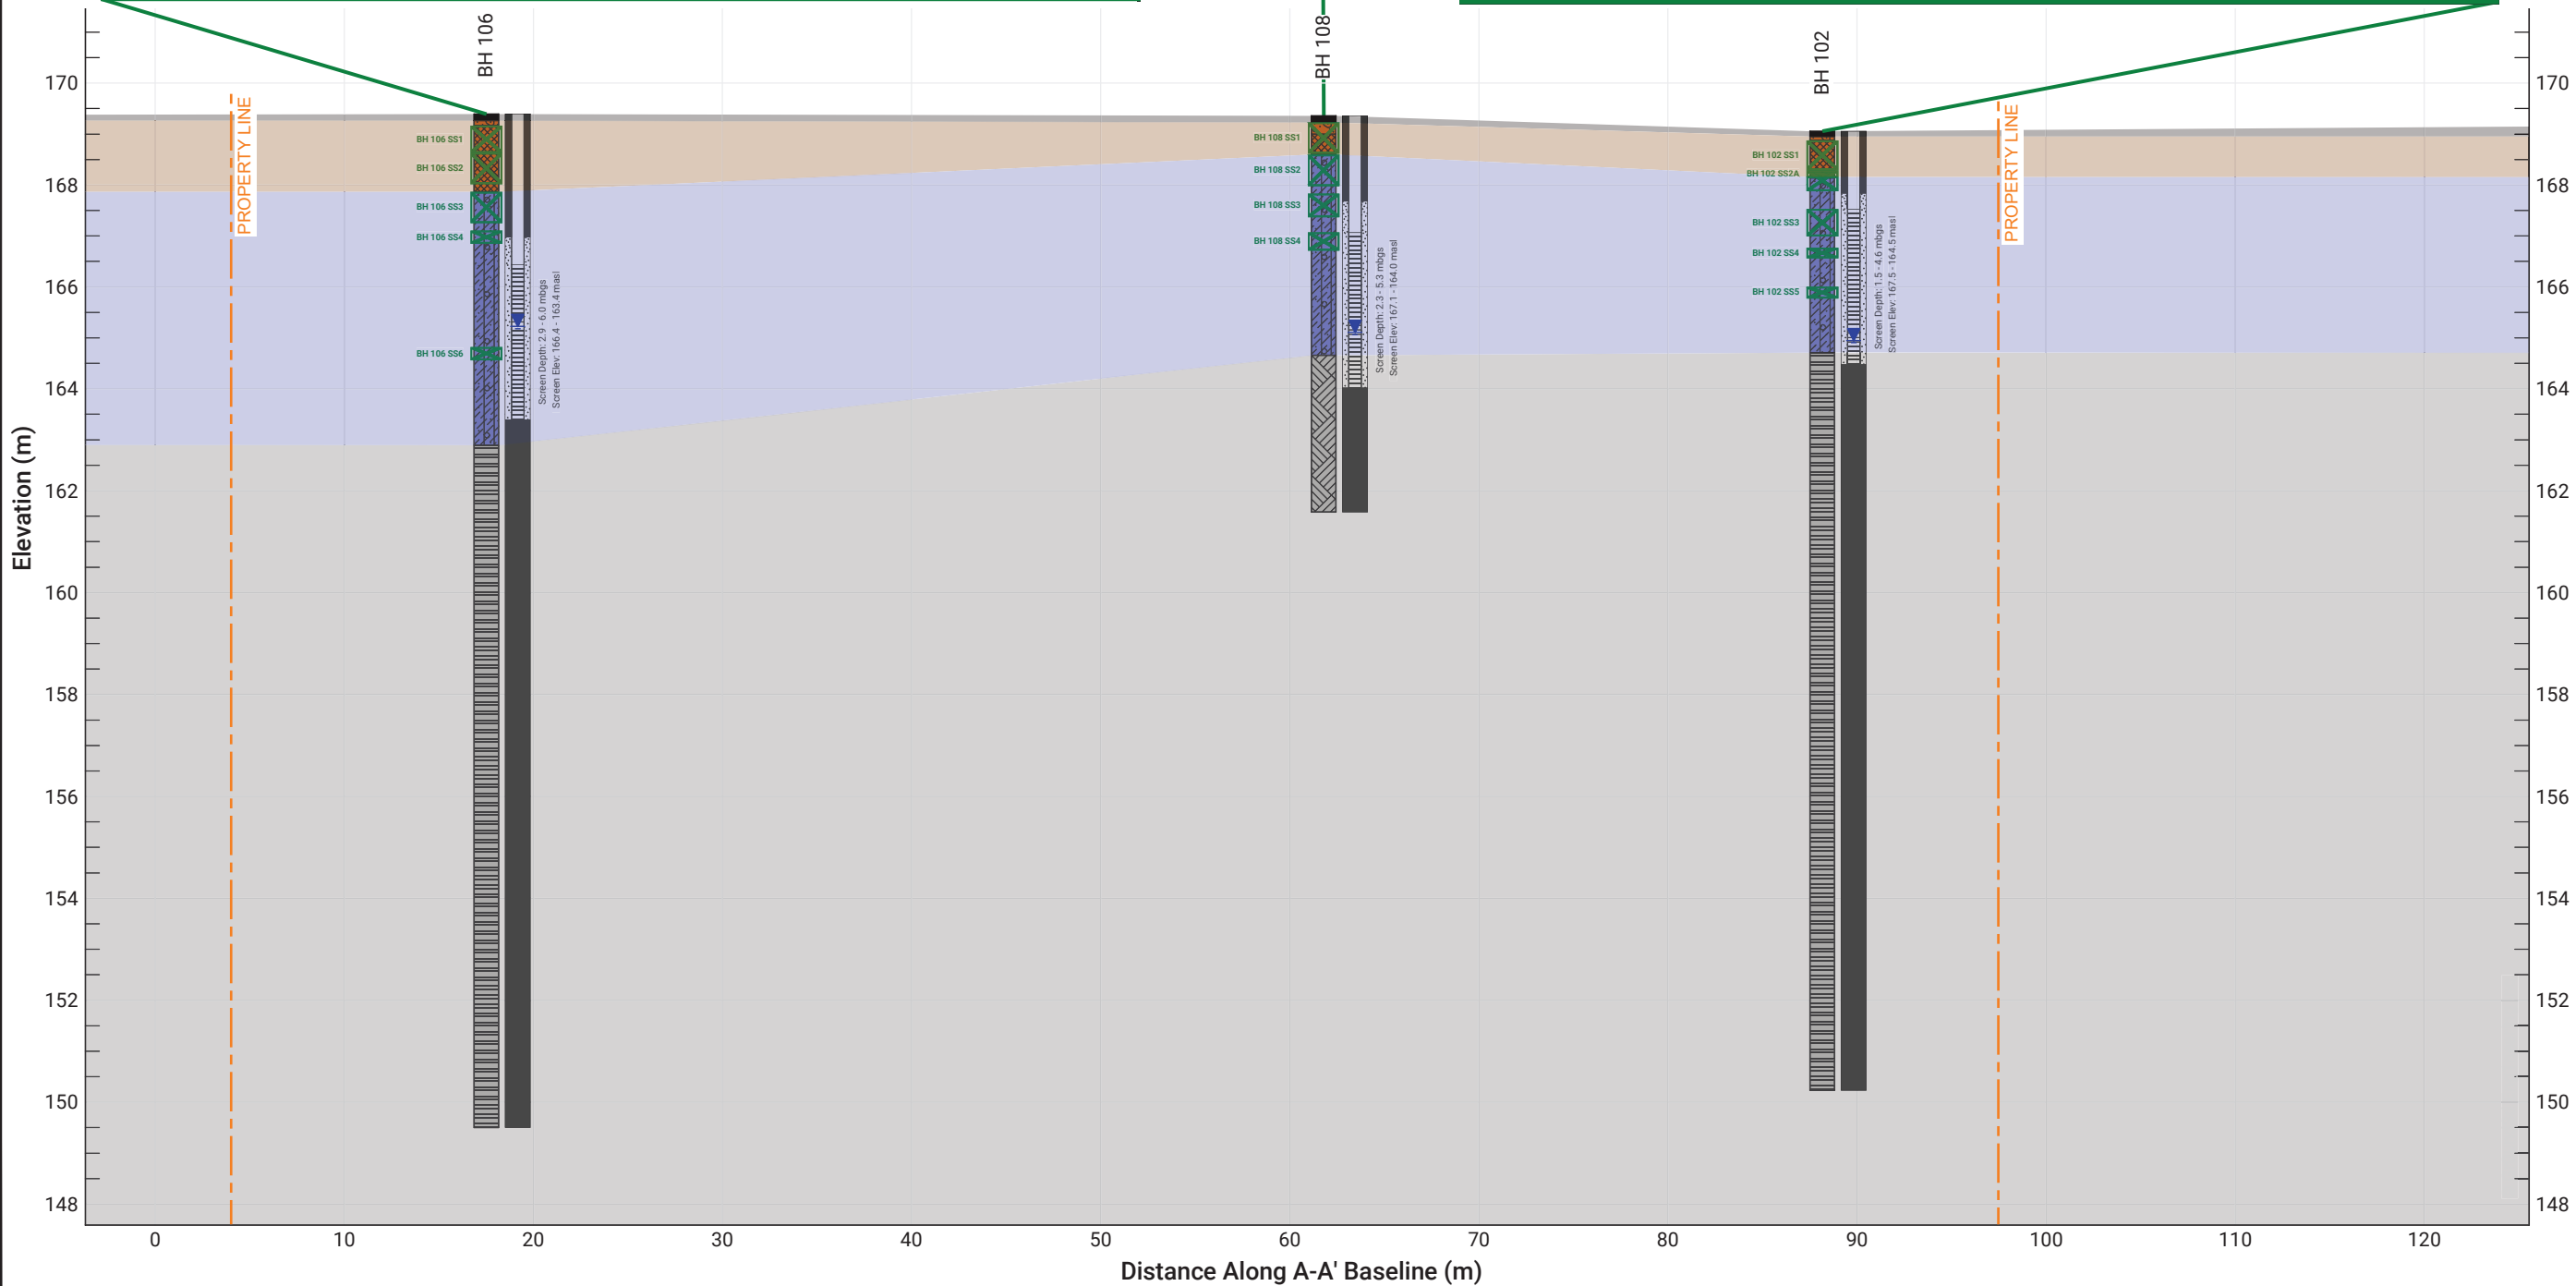
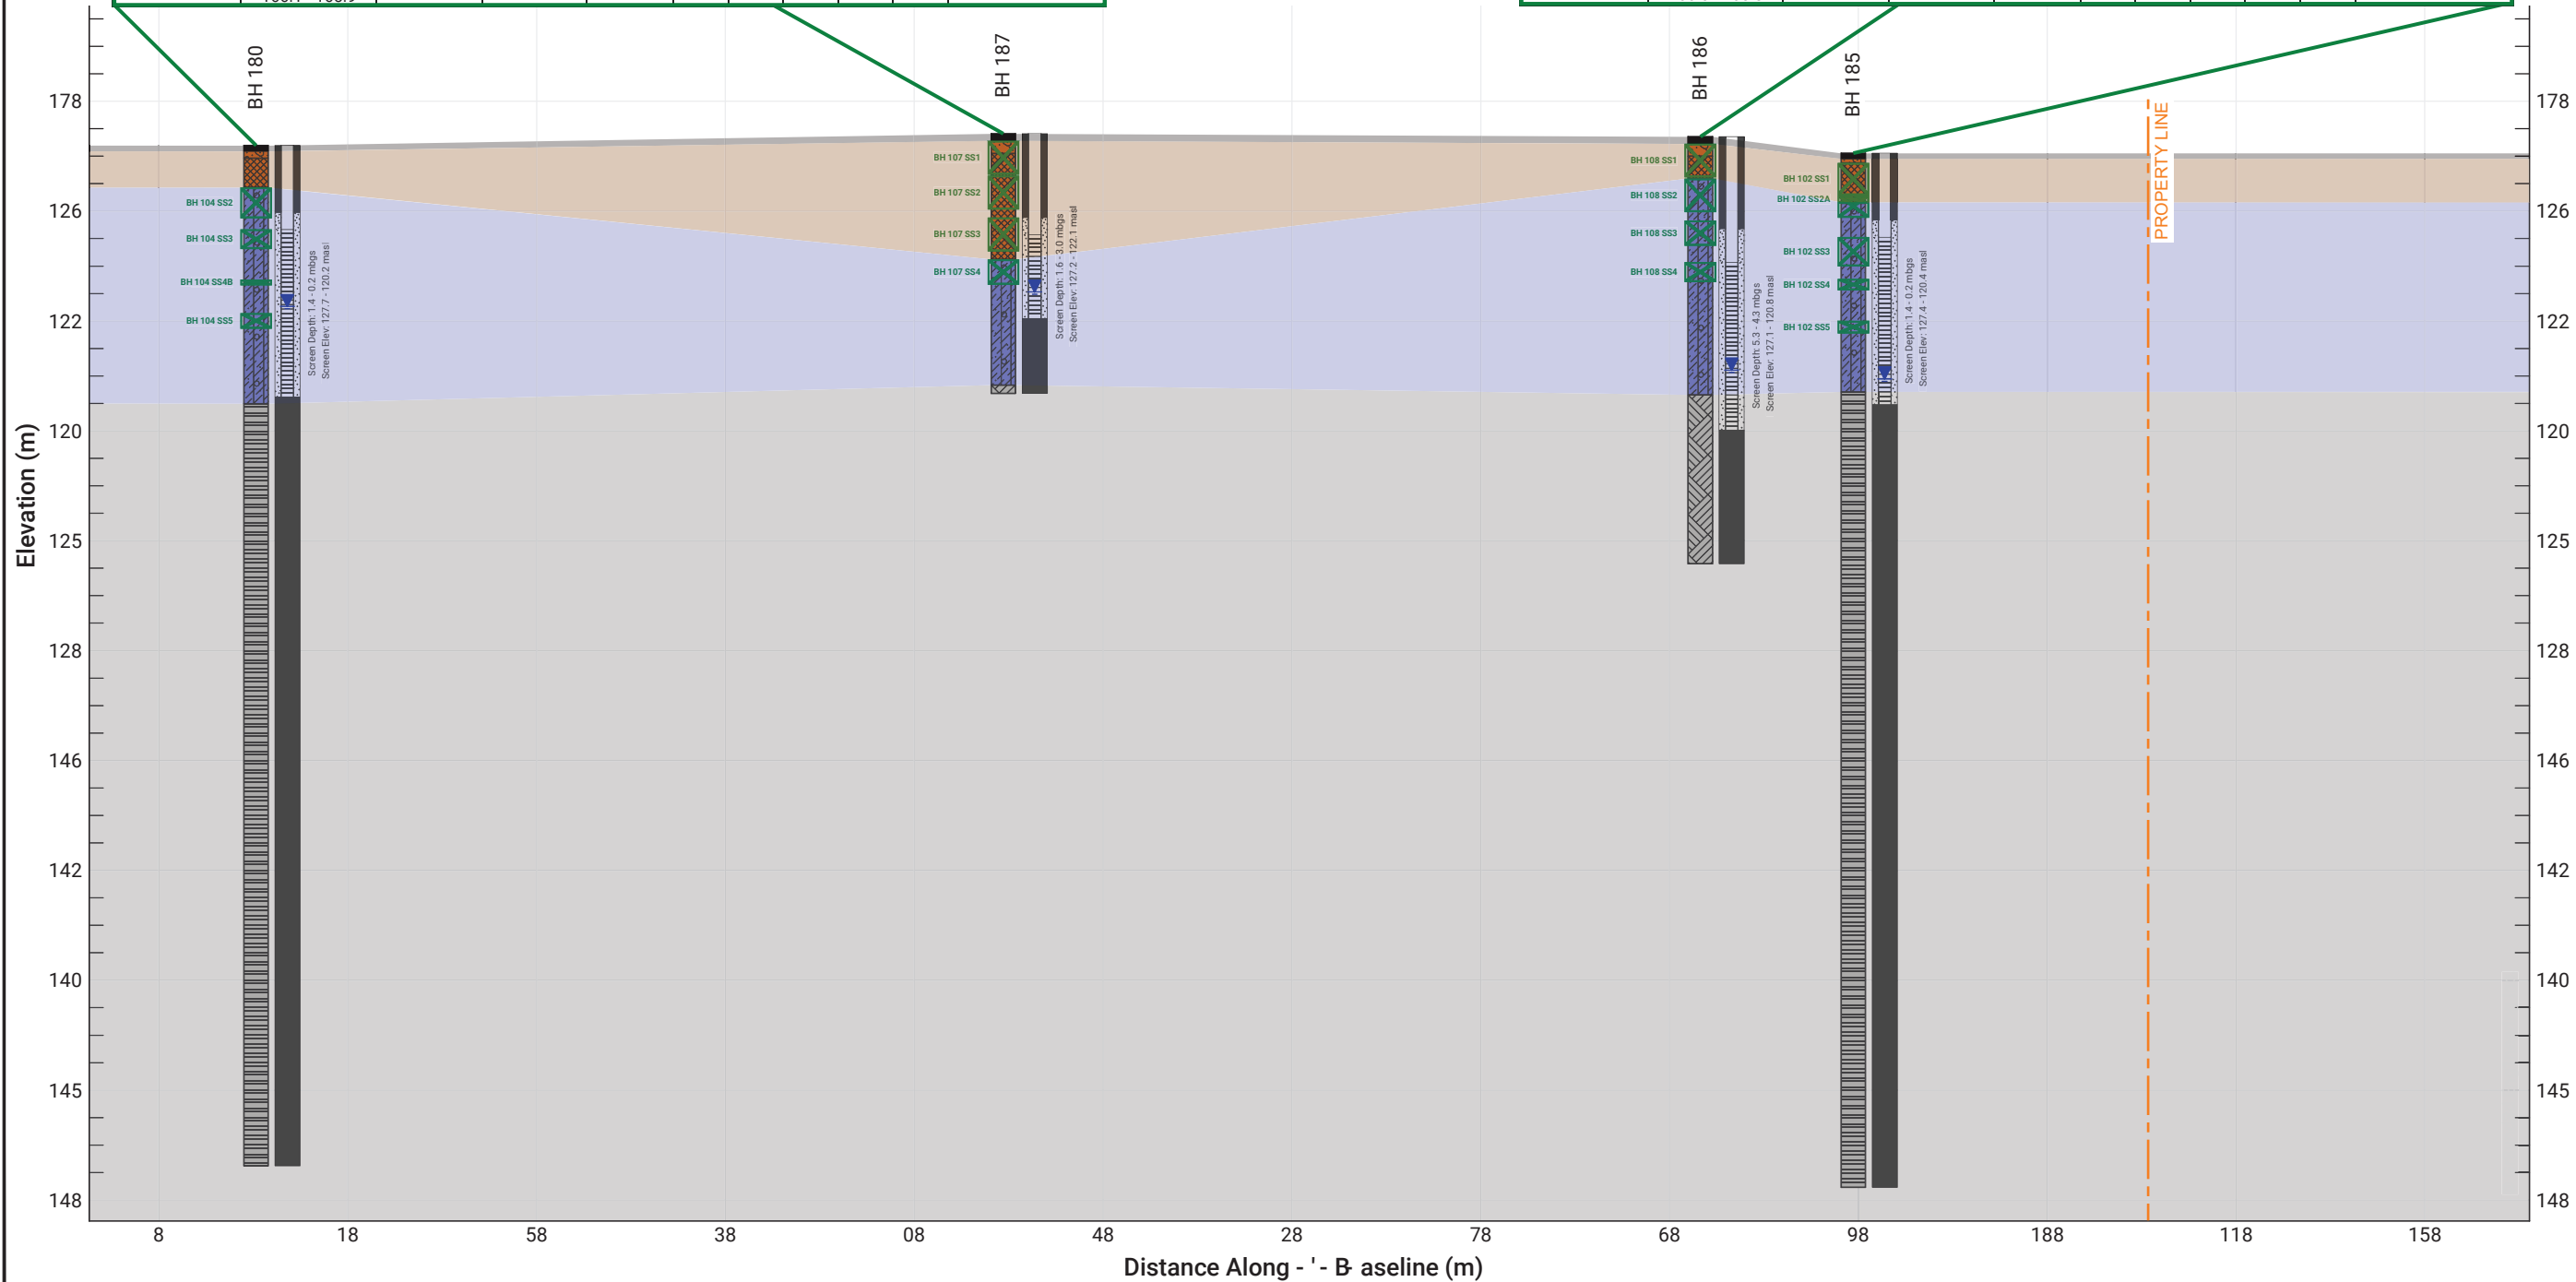
Note
The soil/rock stratigraphy shown on the cross section between borehole locations is interpreted. The actual soil/rock conditions may vary.
All sampled parameters meet Table 3 RPI Standards.
HYDRIDE-FORMING METALS (As, Sb, Se), OTHER REGULATED PARAMETERS (ORPs) (B-HWS, Cr(VI), CN, EC, Hg, SAR)

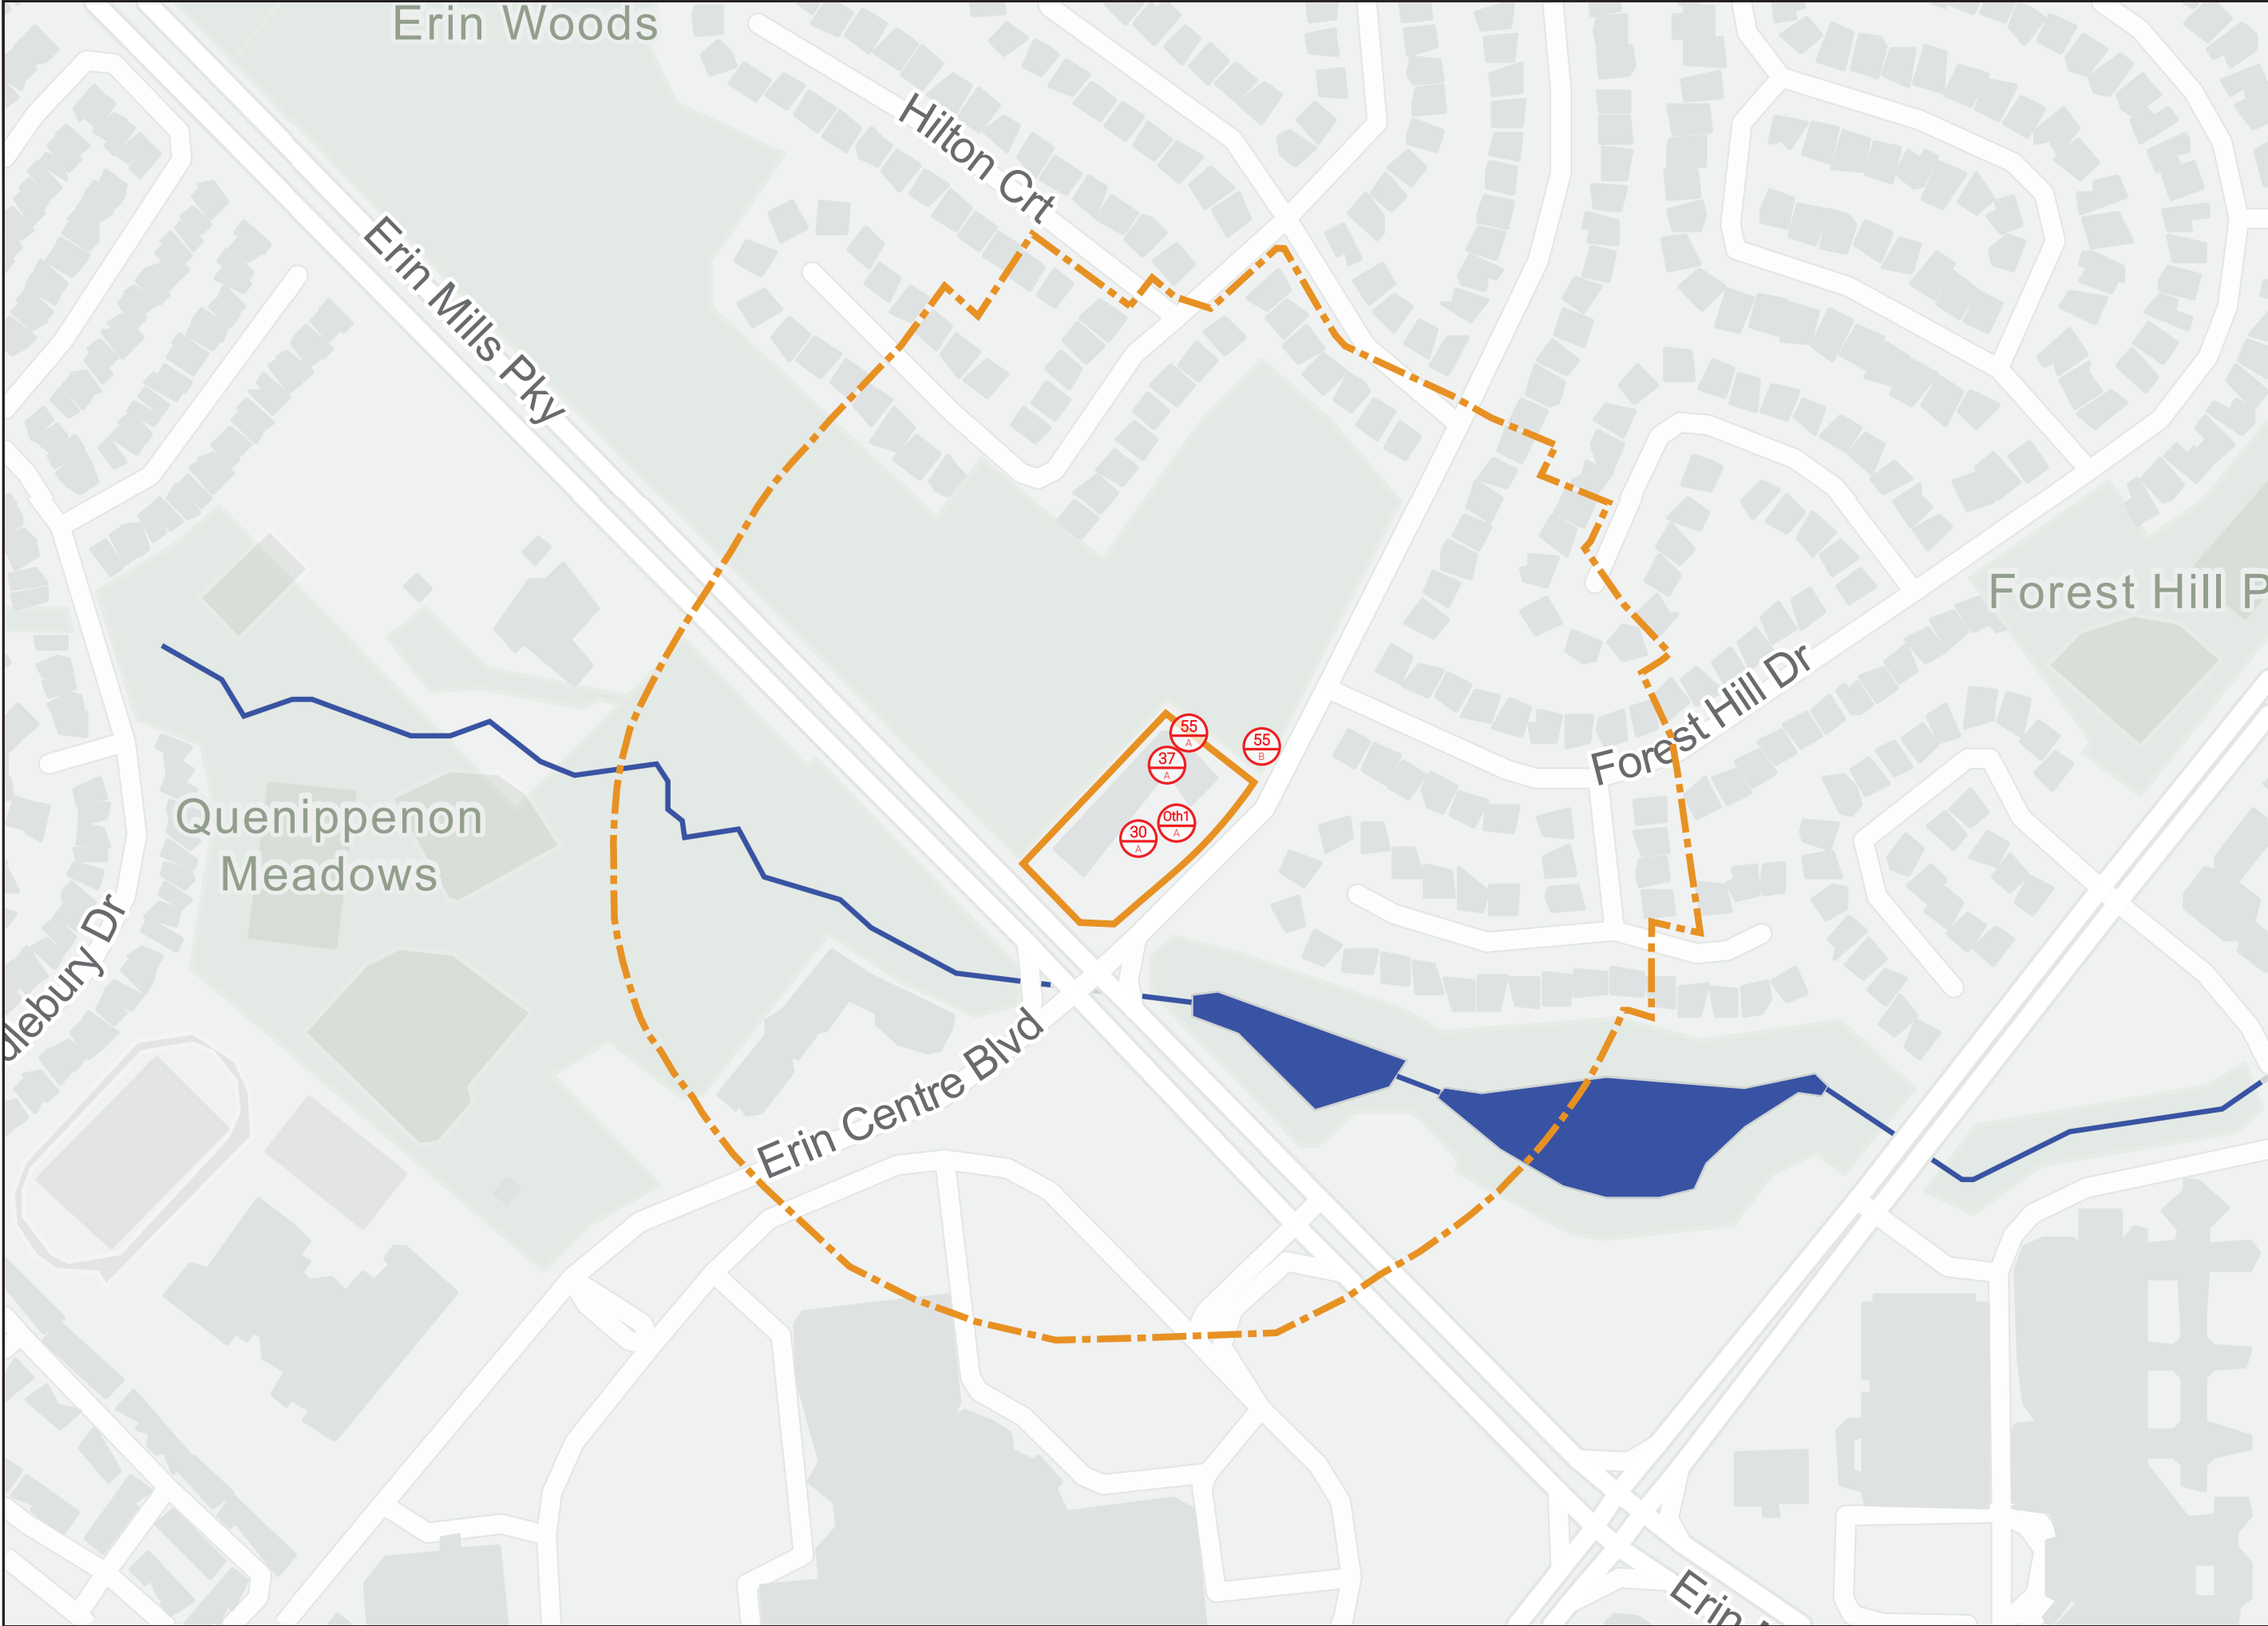
FIGURE 3

Figure 3 – Phase One Study Area

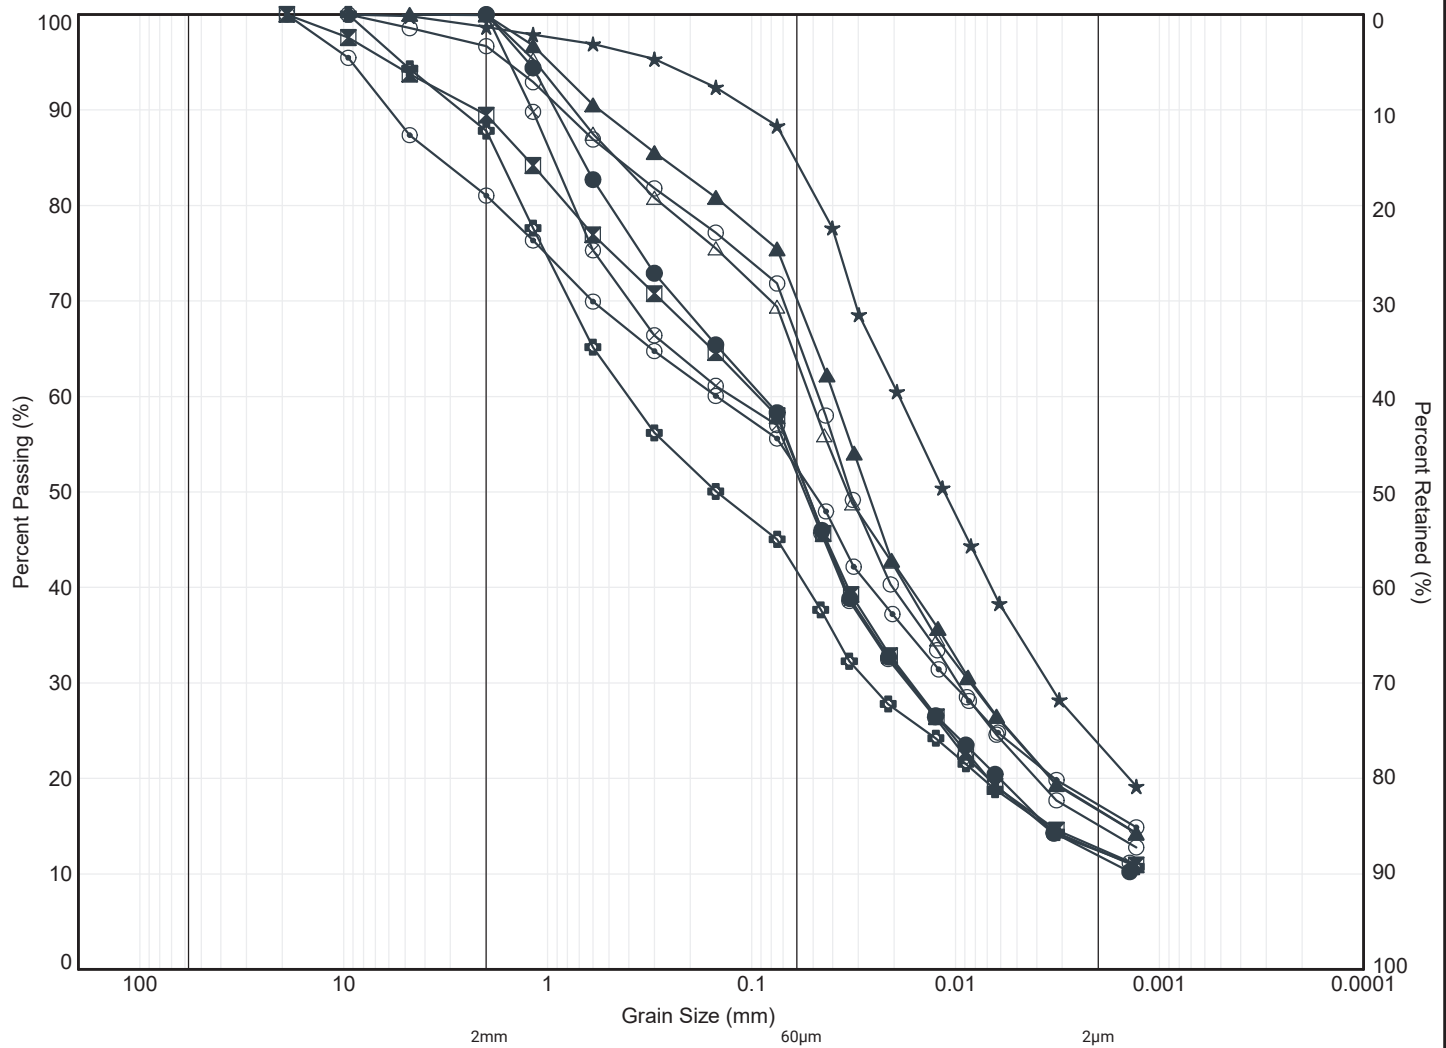
MIT SYSTEM	COBBLES	GRAVEL			SAND			SILT	CLAY
		COARSE	MEDIUM	FINE	COARSE	MEDIUM	FINE
