# PHASE TWO ENVIRONMENTAL SITE ASSESSMENT

**23 Elizabeth St. N., 42, 44 & 46 Park  
St. E. | Mississauga, Ontario**

**Grounded Engineering Inc.**

**File No.** 20-088 (Rev.1)

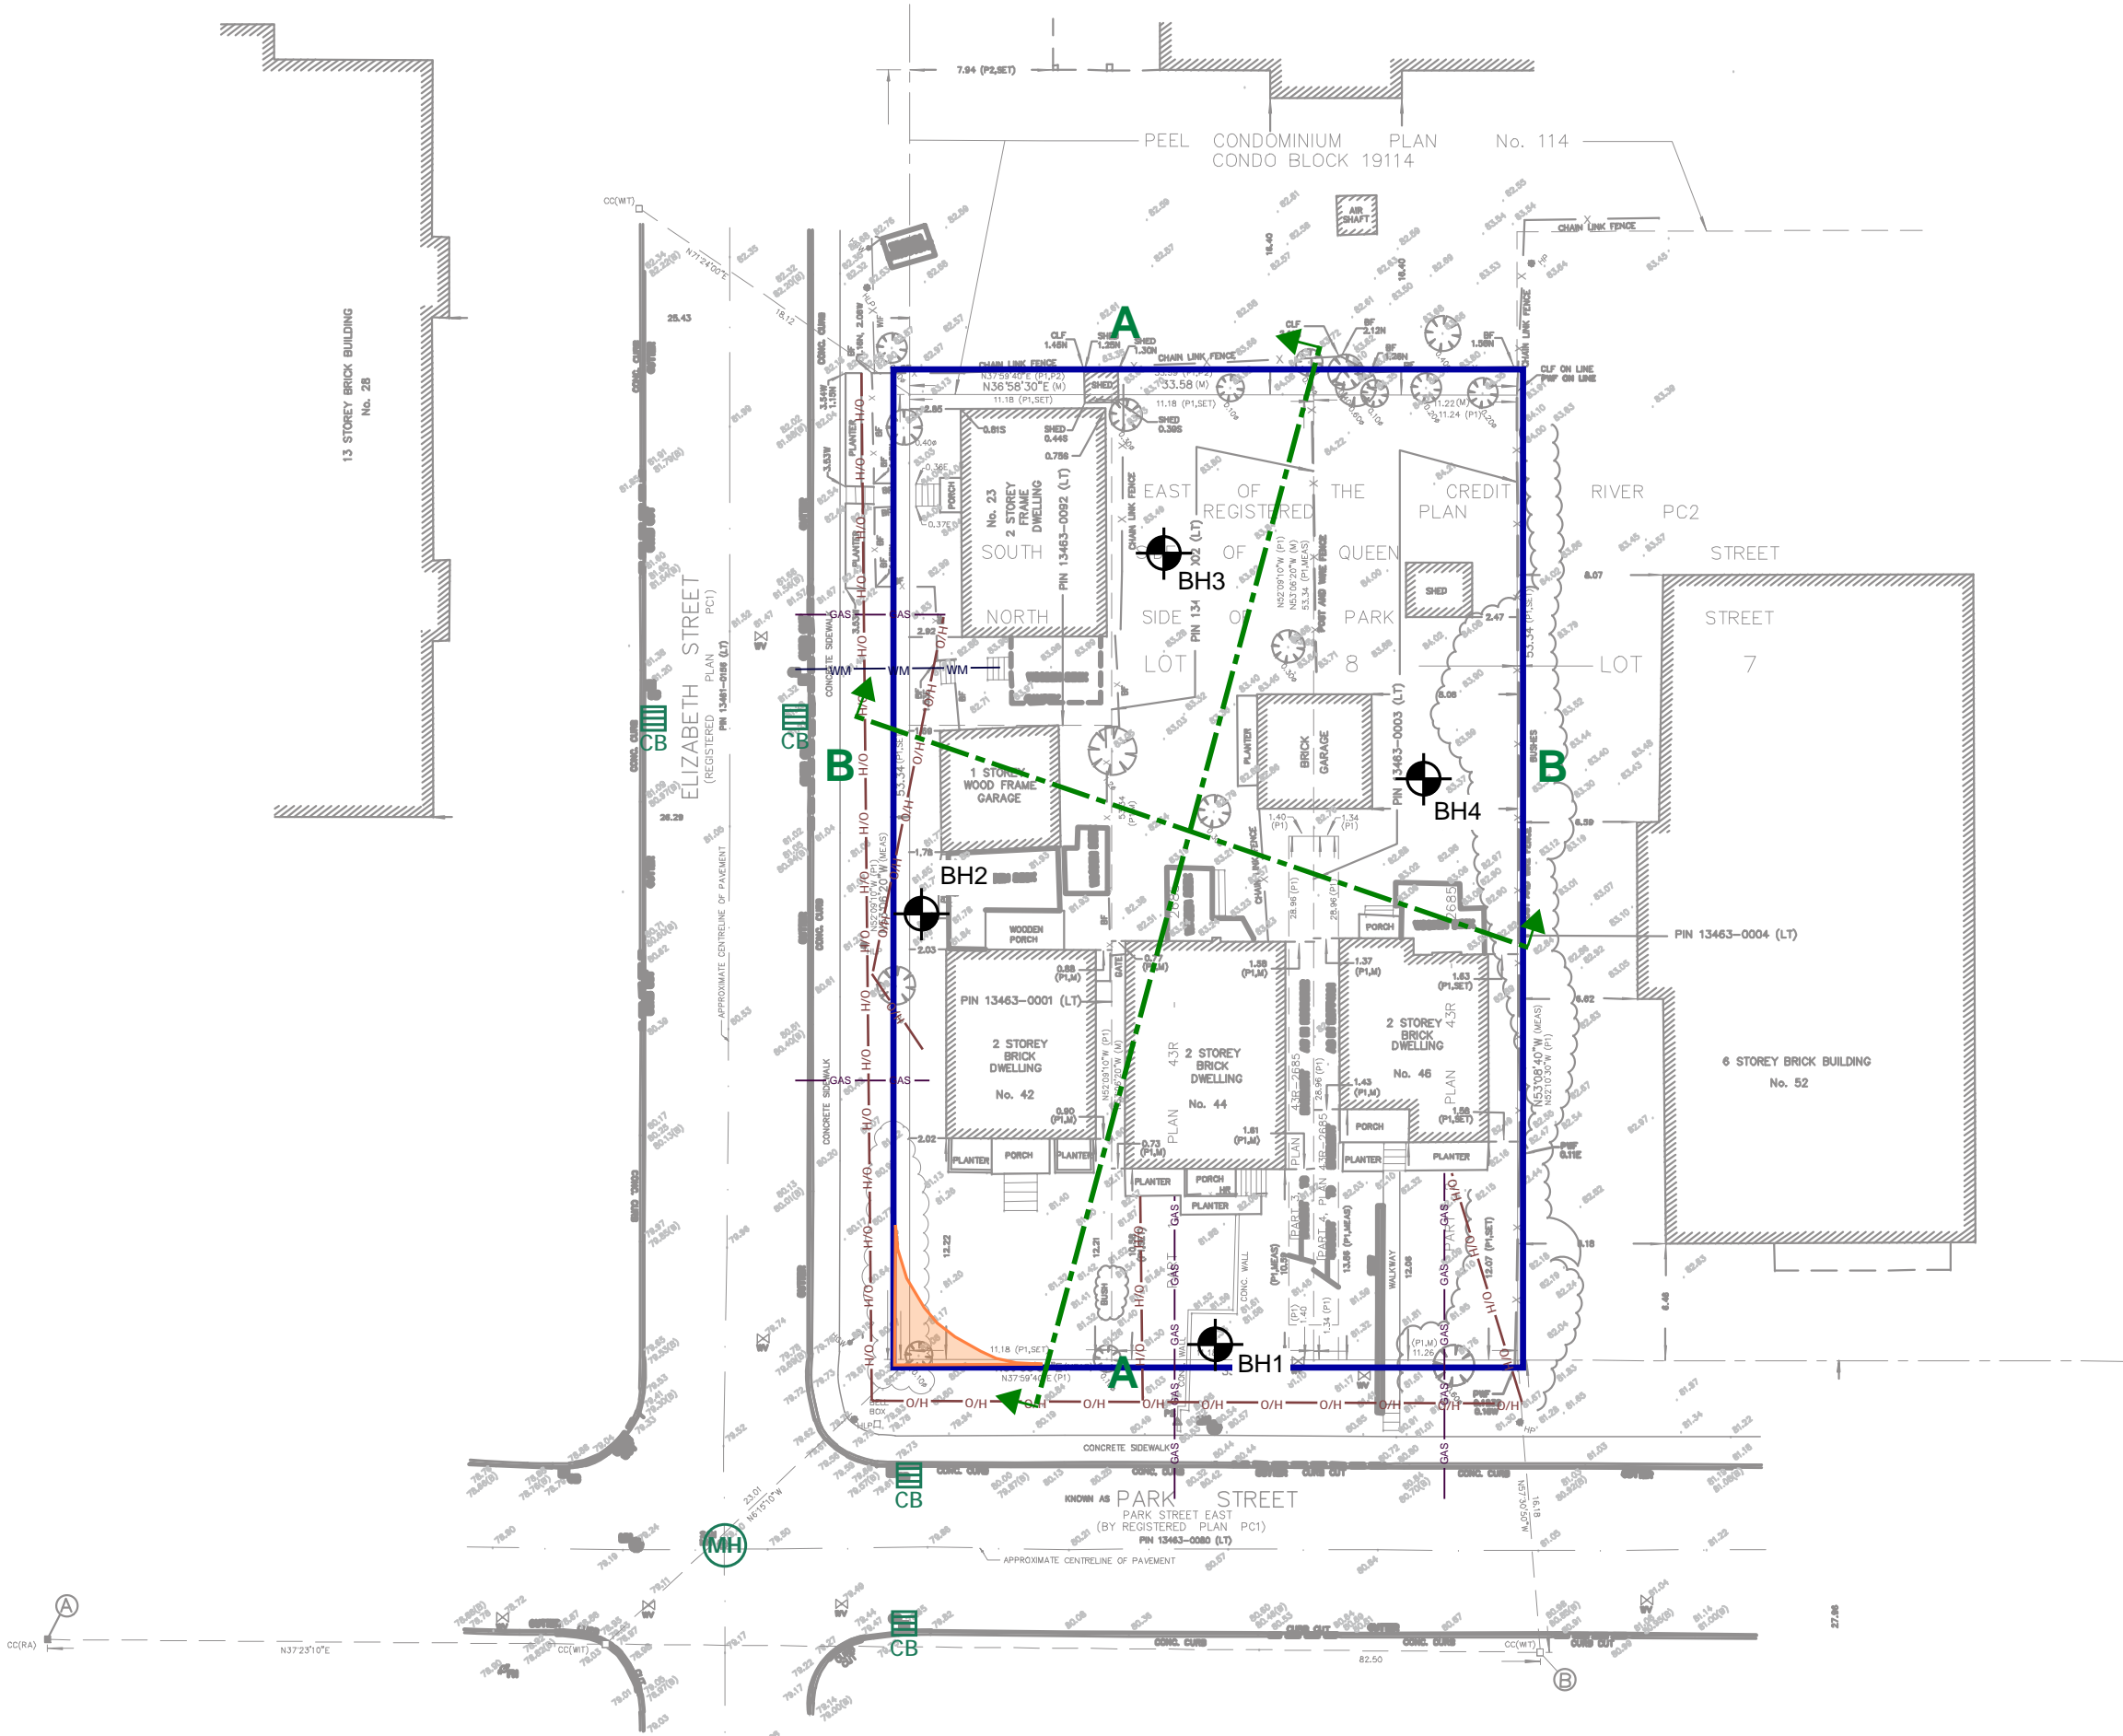
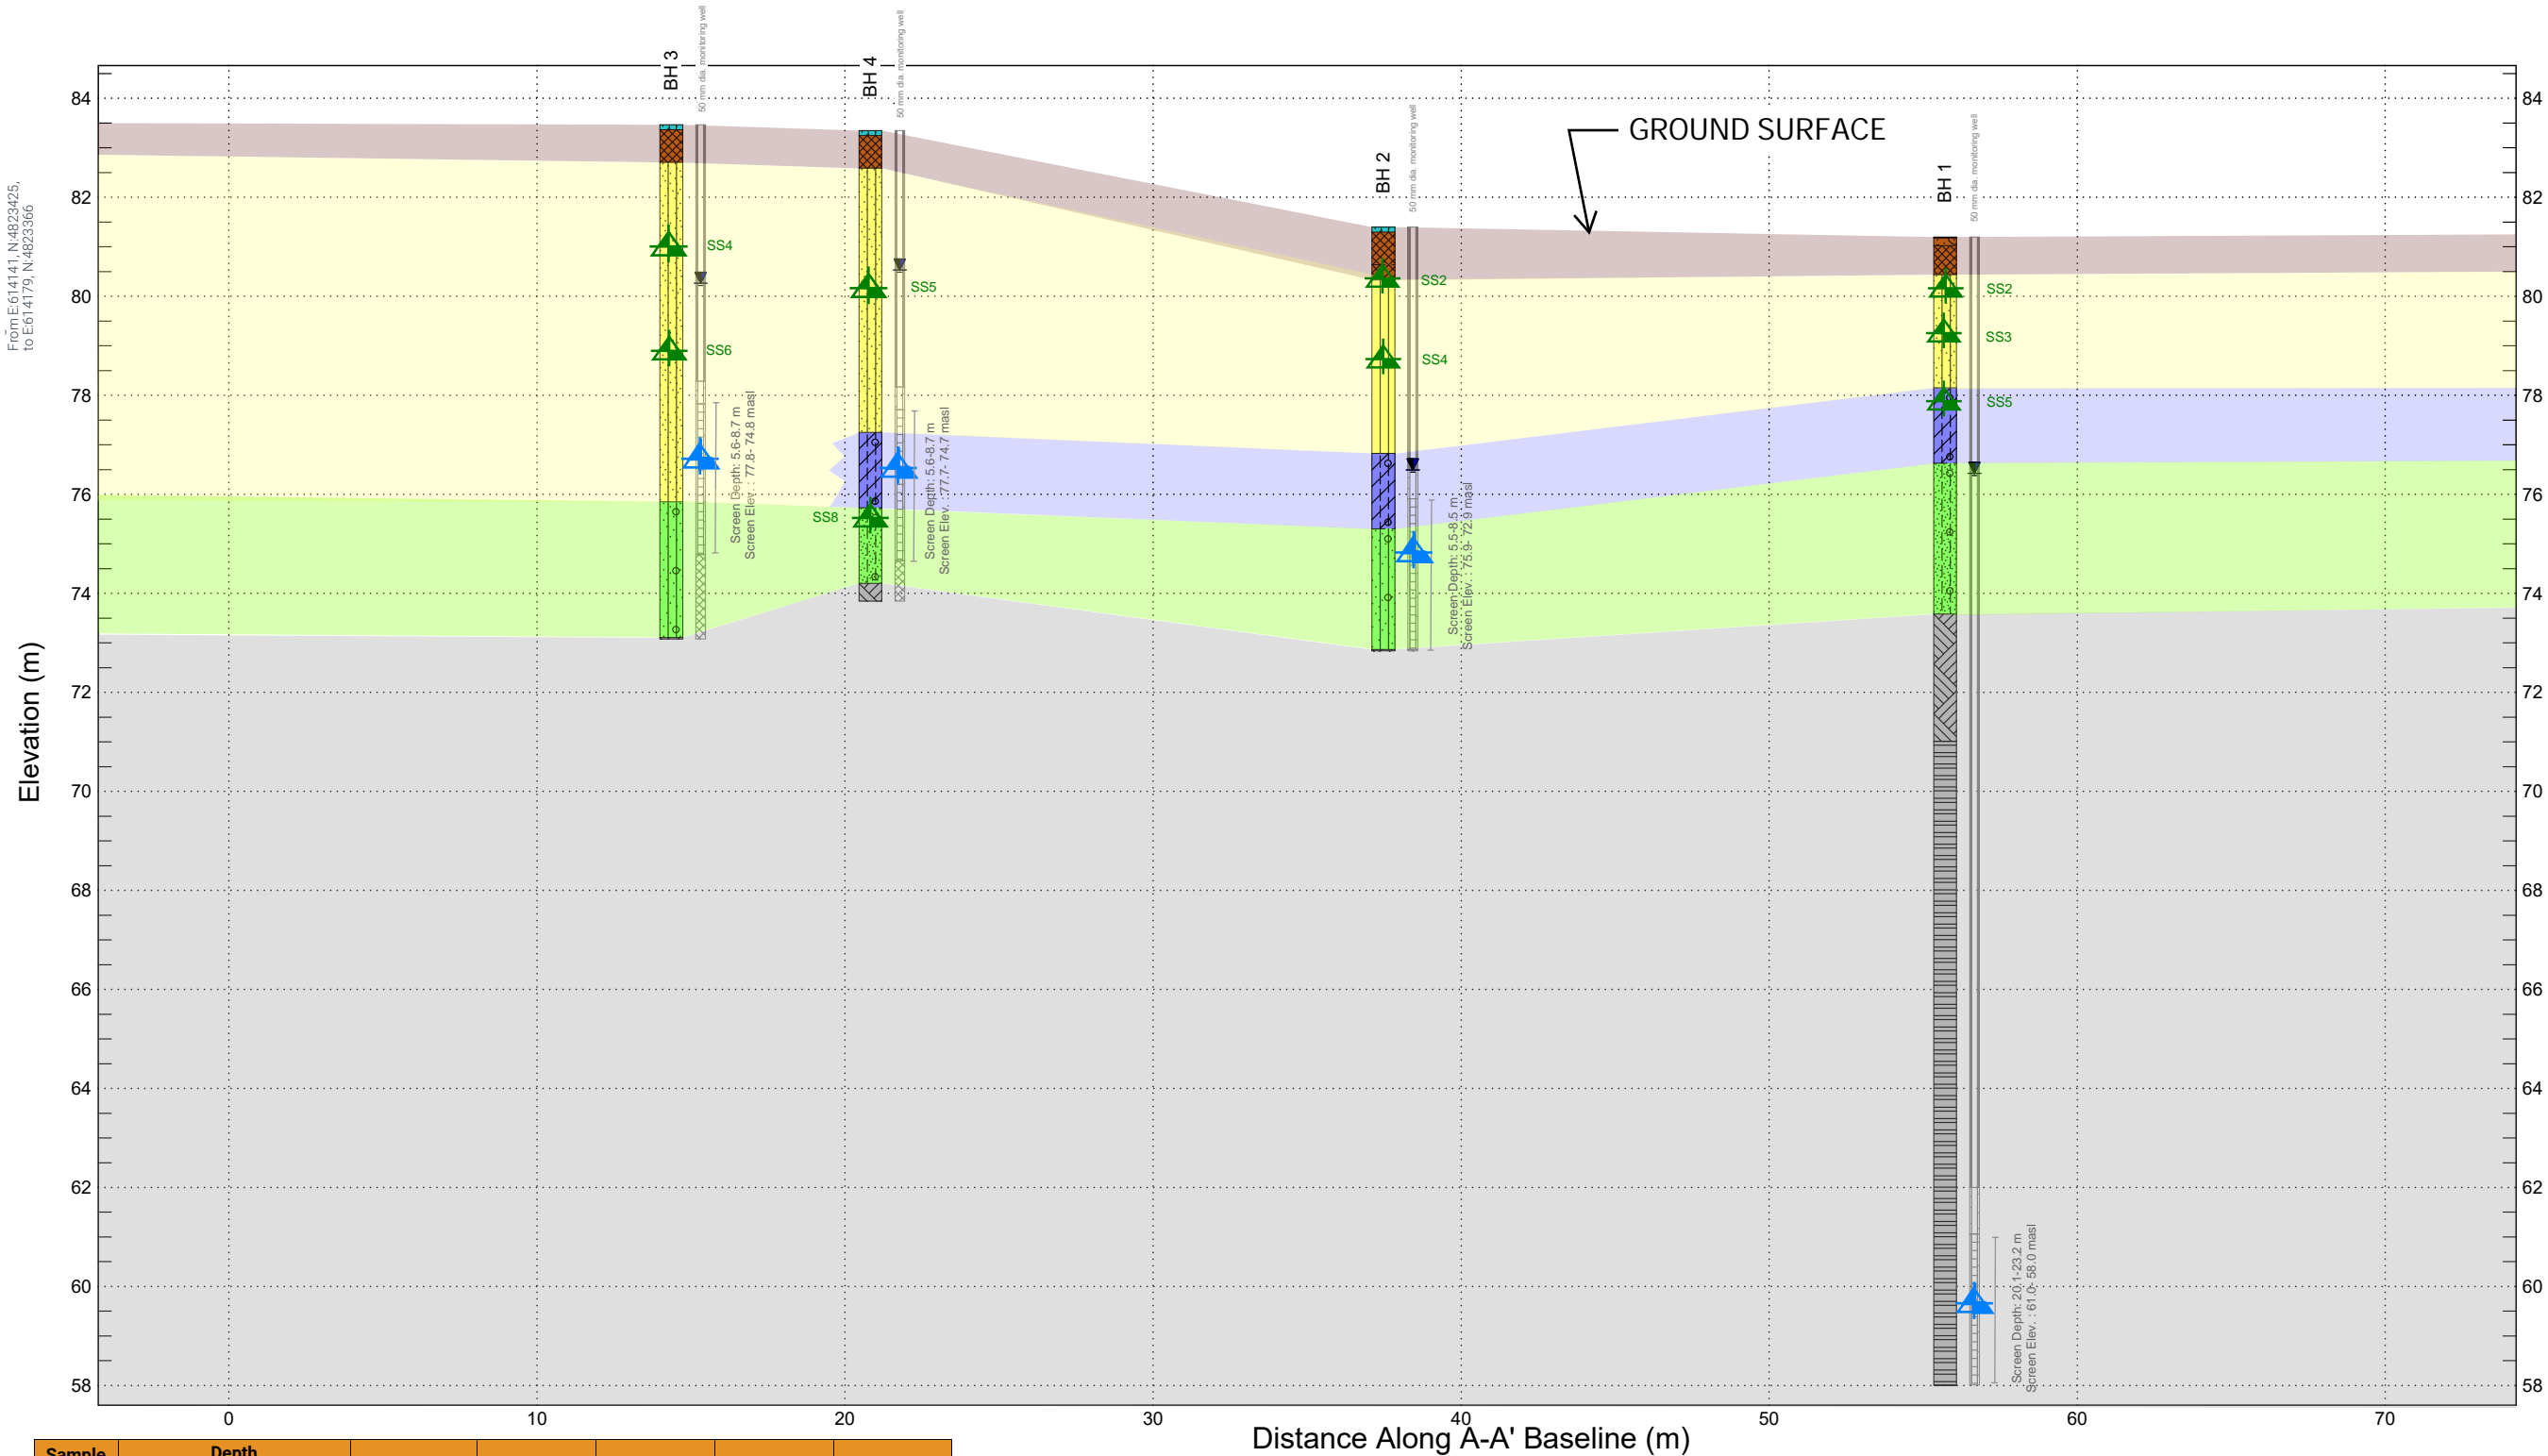
From E614141, N4823425,  
to E614179, N4823366

Sample ID	Depth		Strata	Metals	H-Metals	ORPs	PHCs/BTEX
	mbgs	masl					
BH1 SS2	0.8 - 1.4	80.4-79.8	Silt and Sand	✓	✓	✓	✓
BH1 SS3	1.5 - 2.1	79.7-79.1	Silt and Sand	✓	✓	✓	
BH1 SS5	3.0 - 3.7	78.1-77.5	Glacial Till				✓
BH2 SS2	0.8 - 1.2	80.6-80.2	Fill	✓	✓	✓	✓
BH2 SS4	2.3 - 2.9	79.1-78.5	Silt and Sand	✓	✓	✓	✓
BH3 SS4	2.3 - 2.6	81.2-80.9	Silt and Sand	✓	✓	✓	✓
BH3 SS6	4.6 - 4.8	78.9-78.7	Silt and Sand	✓	✓	✓	✓
BH4 SS5	3.0 - 3.5	80.3-79.8	Silt and Sand	✓	✓	✓	✓
BH4 SS8	7.6 - 8.1	75.7-75.3	Glacial Till	✓	✓	✓	✓

Sample ID	Screen Depth		Screen Strata	Metals	H-Metals	ORPs	PHCs/BTEX
	mbgs	masl					
BH1	20.1-23.2	61.0-58.0	Bedrock	✓	✓	✓	✓
BH2	5.5-8.5	75.9-72.9	Glacial Till	✓	✓	✓	✓
BH3	5.6-8.7	77.8-74.8	Silt and Sand to Glacial Till	✓	✓	✓	✓
BH4	5.6-8.7	77.7-74.7	Silty Sand to Glacial Till	✓	✓	✓	✓

Note  
The soil stratigraphy shown on the cross section between borehole locations is interpreted. The actual soil condition may vary

The results of the analysis were compared to the applicable Site Condition Standard for the Phase Two Property (Table 3 RPI). The laboratory certificates of analysis are provided in Appendix E, and the results of the soil chemical analysis are provided in Tables 2 to 12 and presented on Figures 6 and 7.

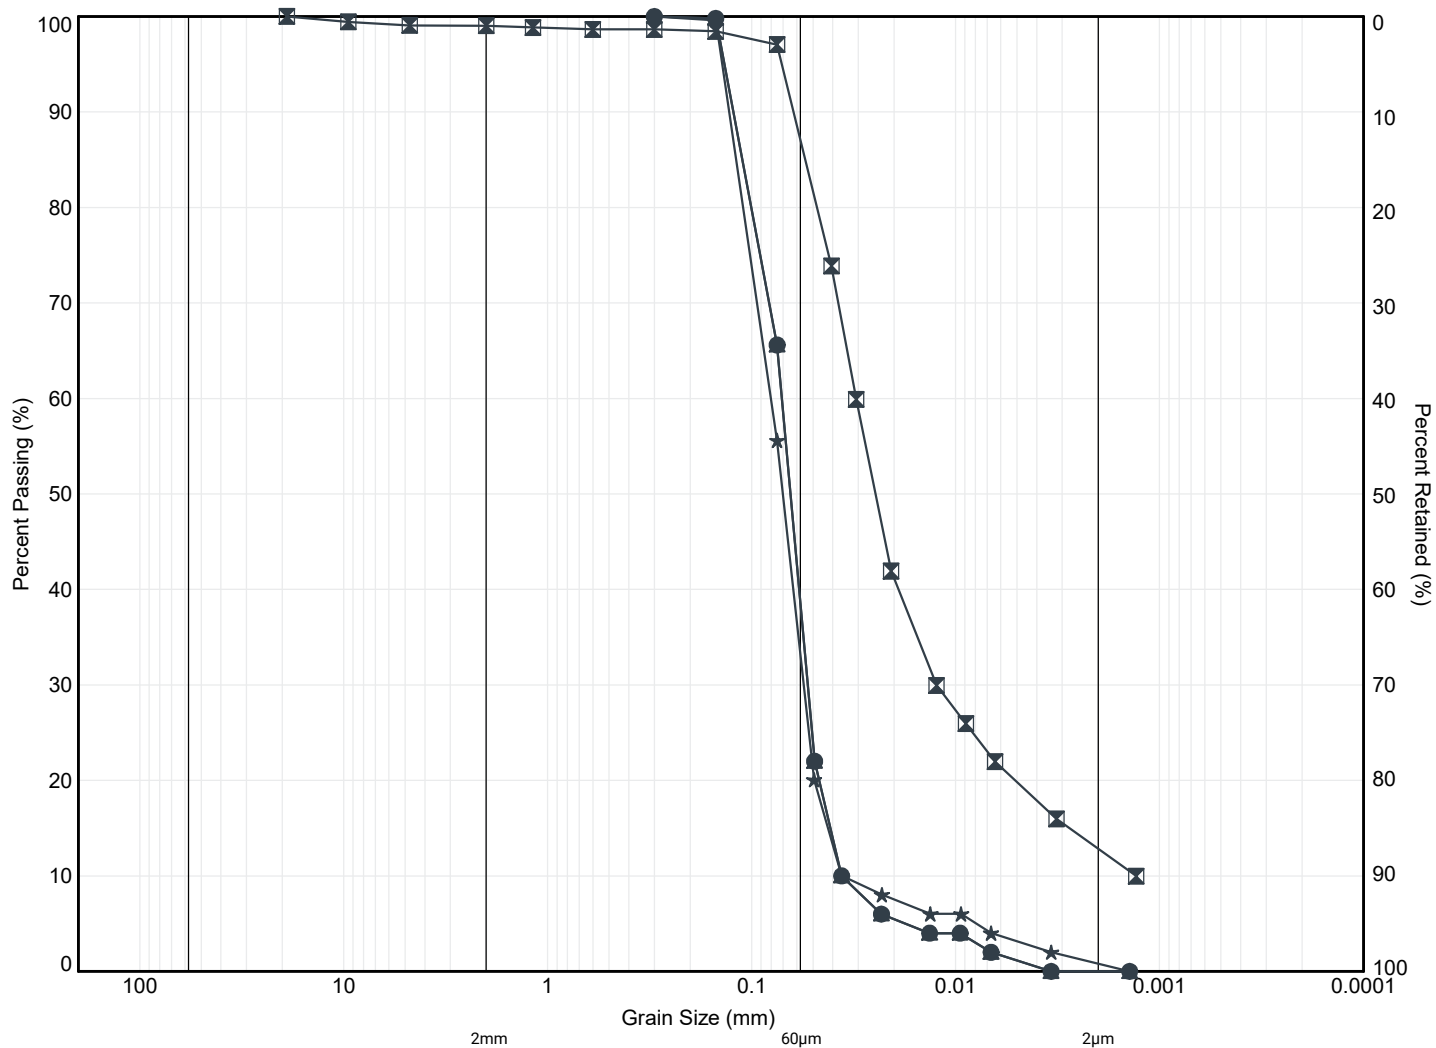
Borehole	Sample	Depth (m)	Elev. (m)	Gravel (%)	Sand (%)	Silt (%)	Clay (%)
● 1	SS4	2.6	78.6	0	57	43	0
⊠ 2	SS5	3.4	78.0	1	10	76	13
▲ 3	SS5	3.2	80.2	0	57	43	0
★ 4	SS5	3.3	80.1	0	63	36	1

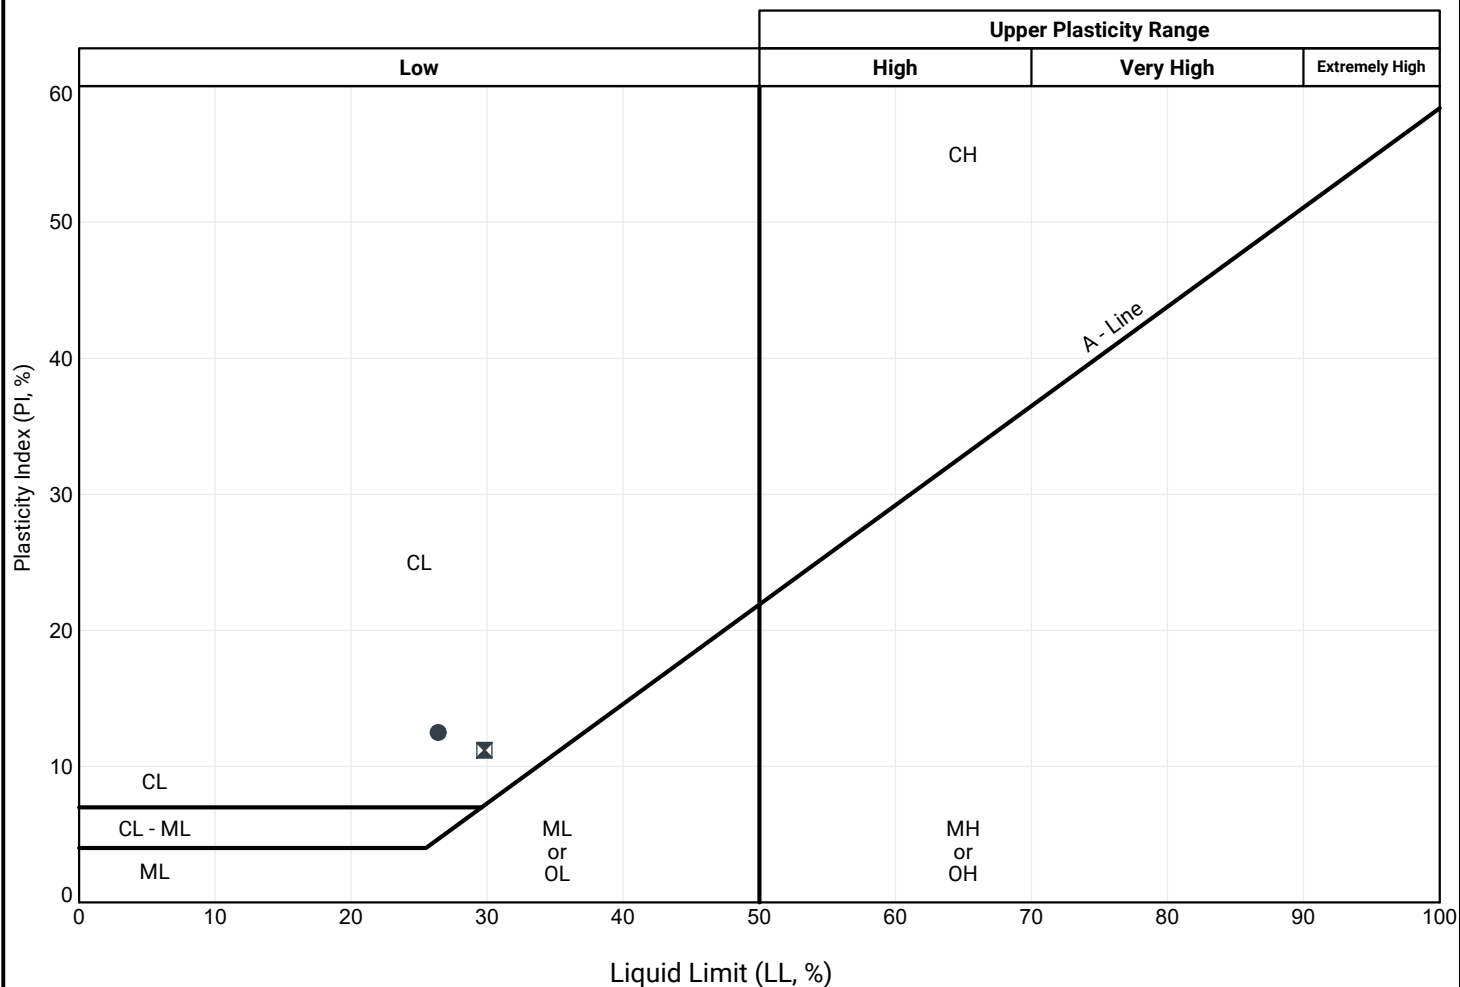
Borehole	Sample	Depth (m)	Elev. (m)	LL (%)	PL (%)	PI (%)
● 1	SS6	4.9	76.3	26	14	12
⊠ 4	SS8	7.8	75.5	30	19	11

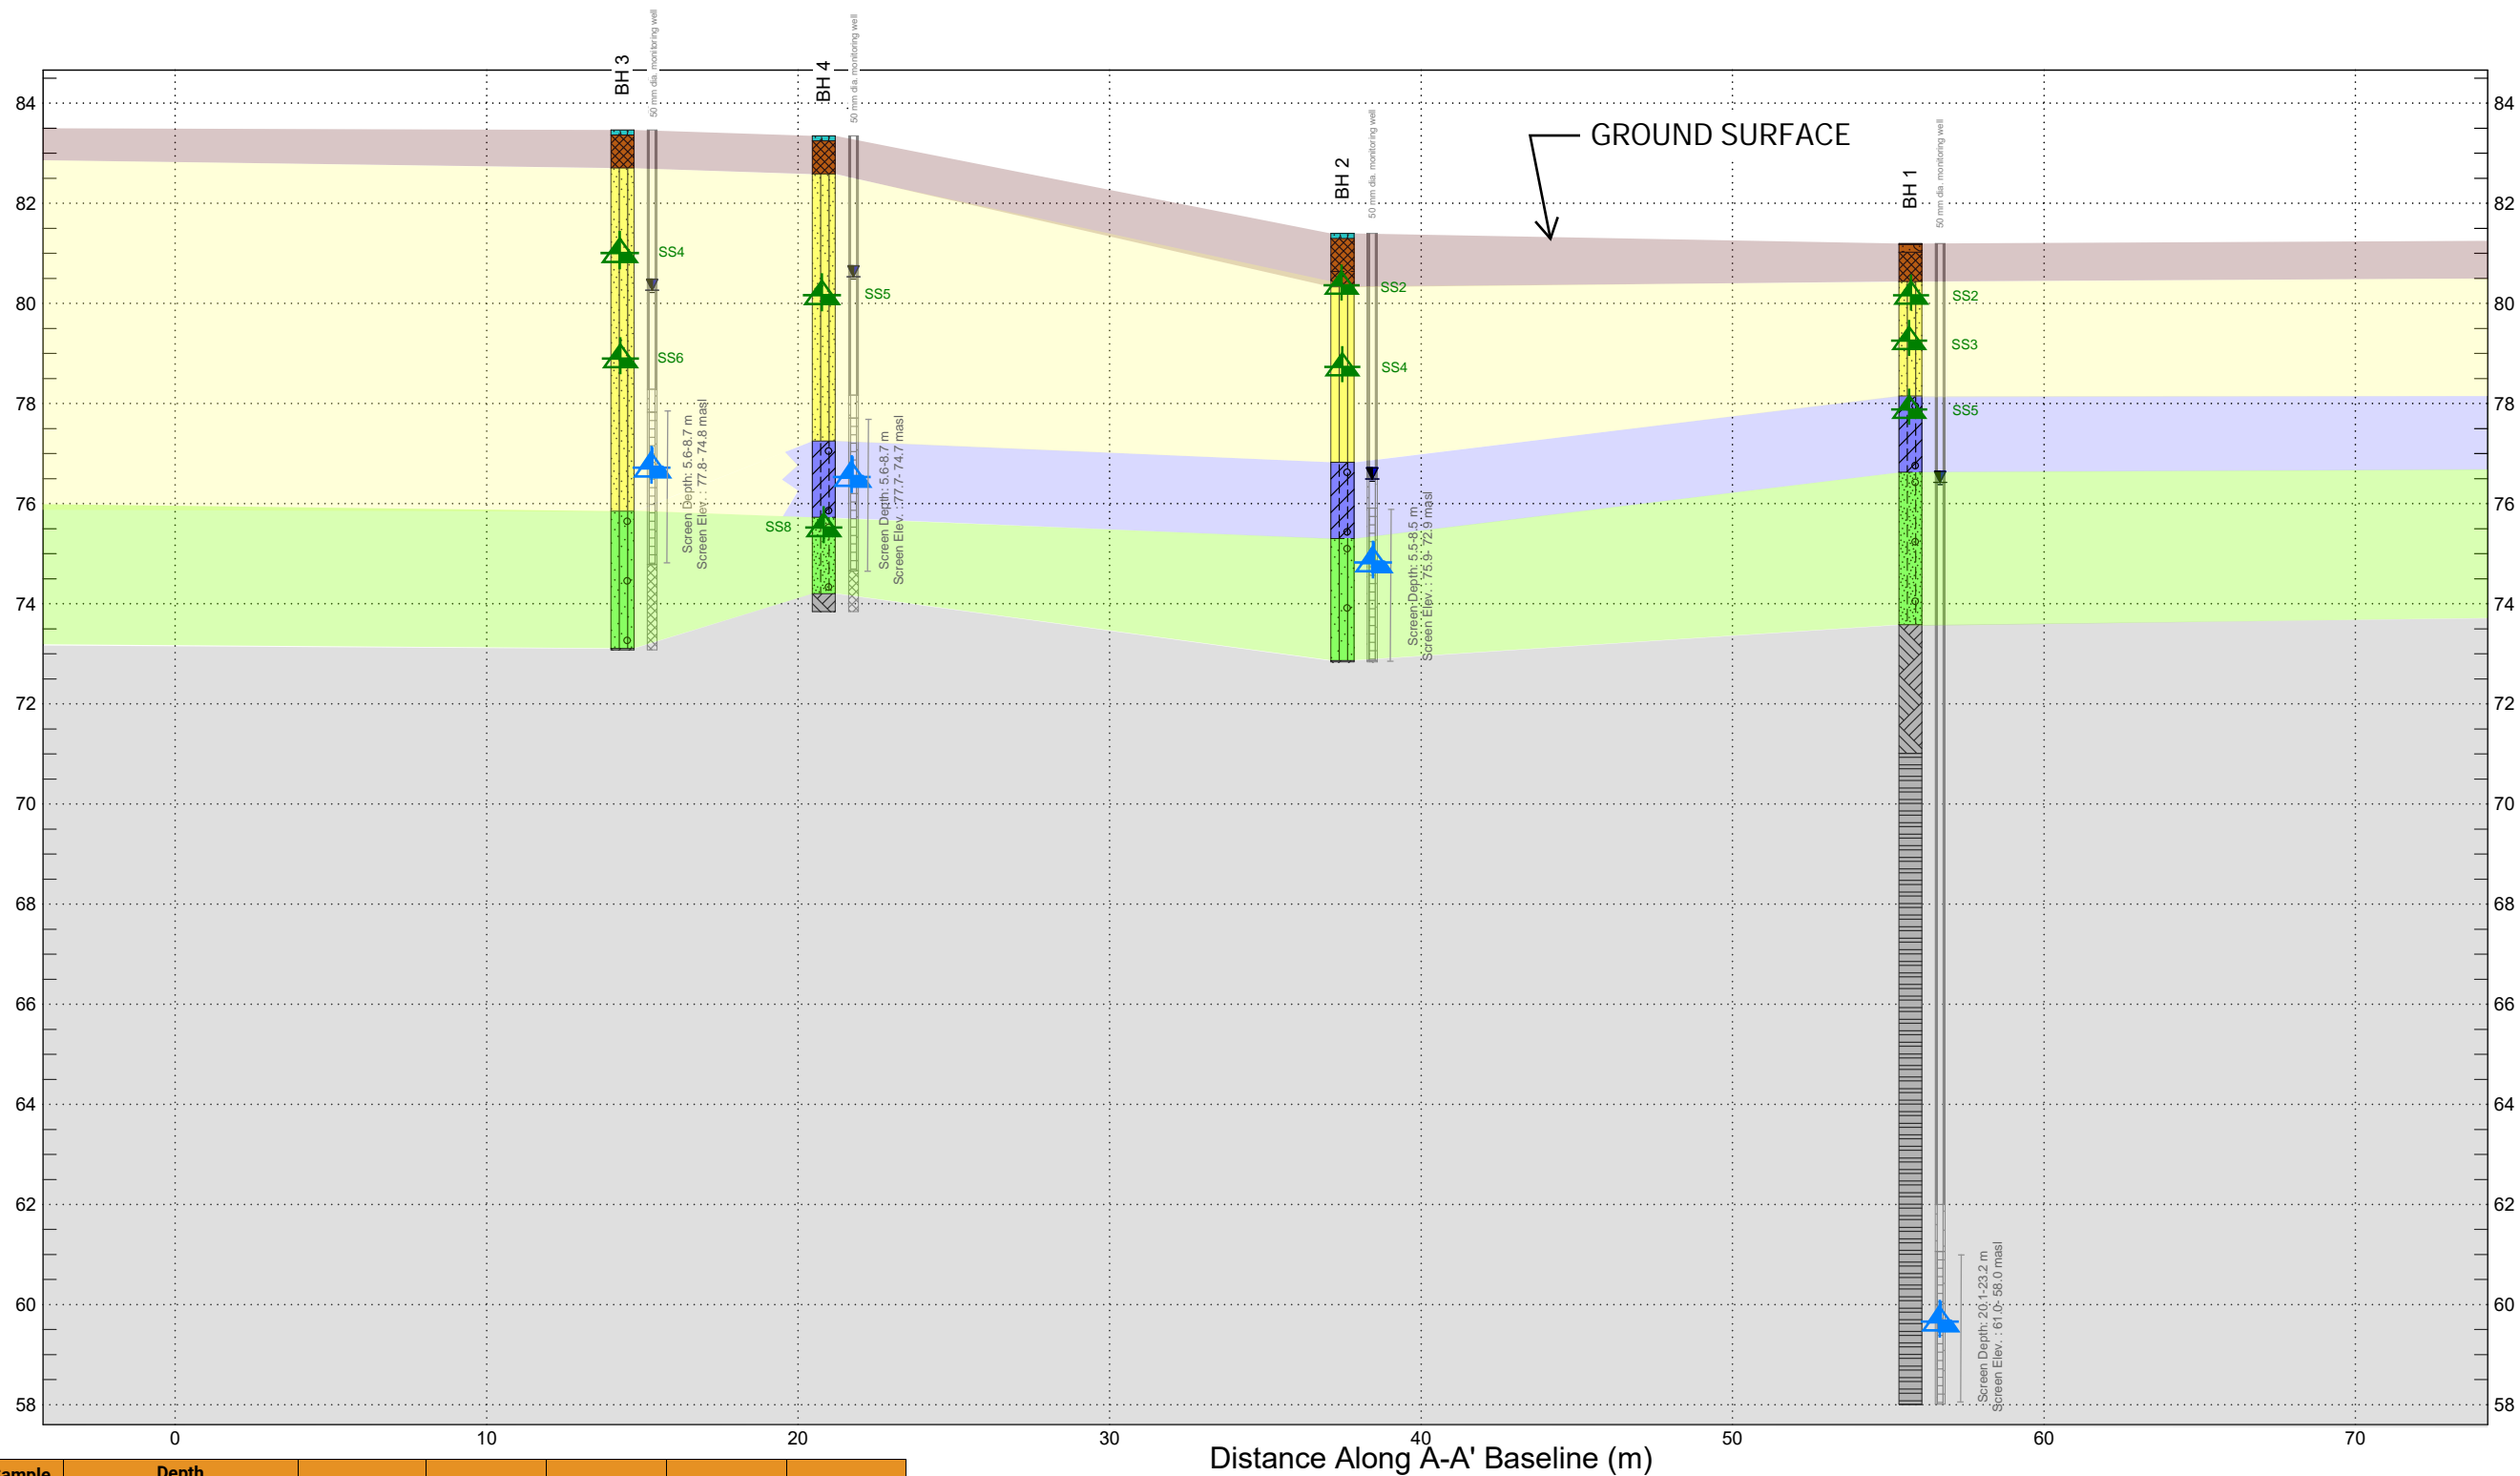
From E614141, N4823425,  
to E614179, N4823366

Sample ID	Depth		Strata	Metals	H-Metals	ORPs	PHCs/BTEX
	mbgs	masl					
BH1 SS2	0.8 - 1.4	80.4-79.8	Silt and Sand	✓	✓	✓	✓
BH1 SS3	1.5 - 2.1	79.7-79.1	Silt and Sand	✓	✓	✓	
BH1 SS5	3.0 - 3.7	78.1-77.5	Glacial Till				✓
BH2 SS2	0.8 - 1.2	80.6-80.2	Fill	✓	✓	✓	✓
BH2 SS4	2.3 - 2.9	79.1-78.5	Silt and Sand	✓	✓	✓	✓
BH3 SS4	2.3 - 2.6	81.2-80.9	Silt and Sand	✓	✓	✓	✓
BH3 SS6	4.6 - 4.8	78.9-78.7	Silt and Sand	✓	✓	✓	✓
BH4 SS5	3.0 - 3.5	80.3-79.8	Silt and Sand	✓	✓	✓	✓
BH4 SS8	7.6 - 8.1	75.7-75.3	Glacial Till	✓	✓	✓	✓

Sample ID	Screen Depth		Screen Strata	Metals	H-Metals	ORPs	PHCs/BTEX
	mbgs	masl					
BH1	20.1-23.2	61.0-58.0	Bedrock	✓	✓	✓	✓
BH2	5.5-8.5	75.9-72.9	Glacial Till	✓	✓	✓	✓
BH3	5.6-8.7	77.8-74.8	Silt and Sand to Glacial Till	✓	✓	✓	✓
BH4	5.6-8.7	77.7-74.7	Silty Sand to Glacial Till	✓	✓	✓	✓

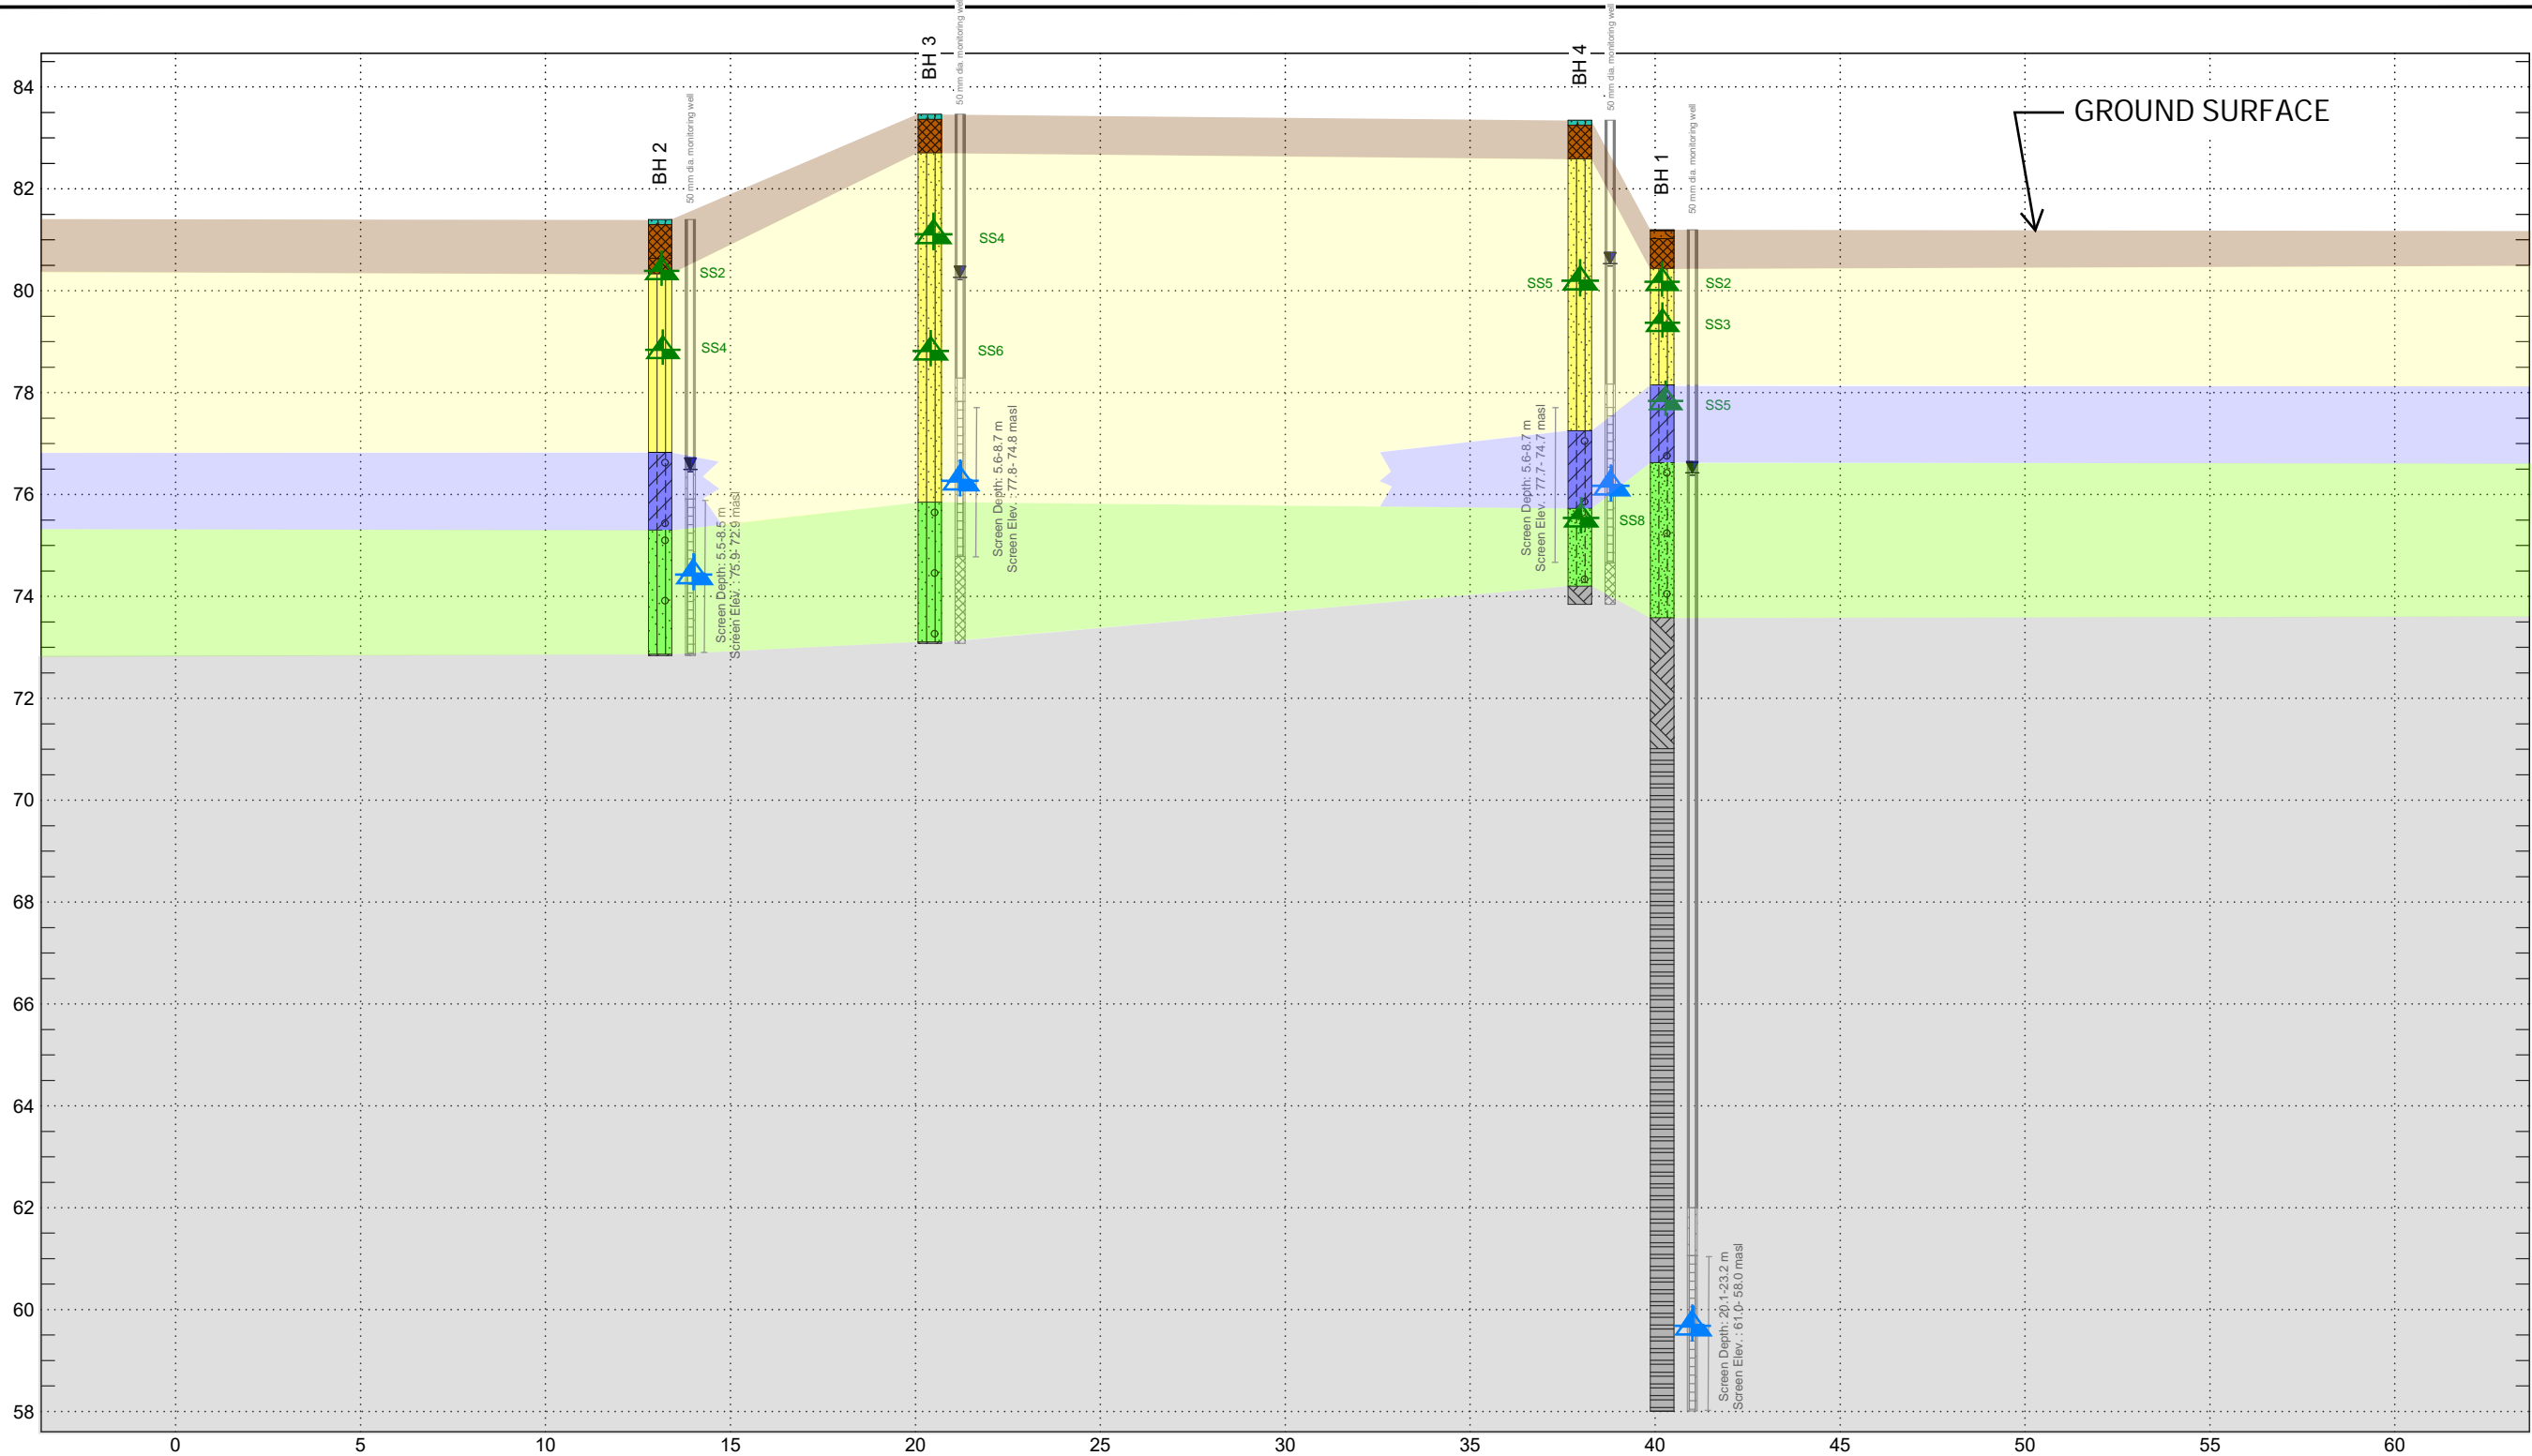
Figure No  
FIGURE 7

Alignment: B-B'  
From E614132, N4823384,  
to E614184, N4823414
