**HERITAGE IMPACT STATEMENT**

**3650 Eglinton Avenue West, Mississauga, ON**

**Part of Lot 4, Concession 2 NDS, Trafalgar Township  
Plan 1542 Part of Lots 1, 2, 43R25632 Part 2**

Revised November 2023

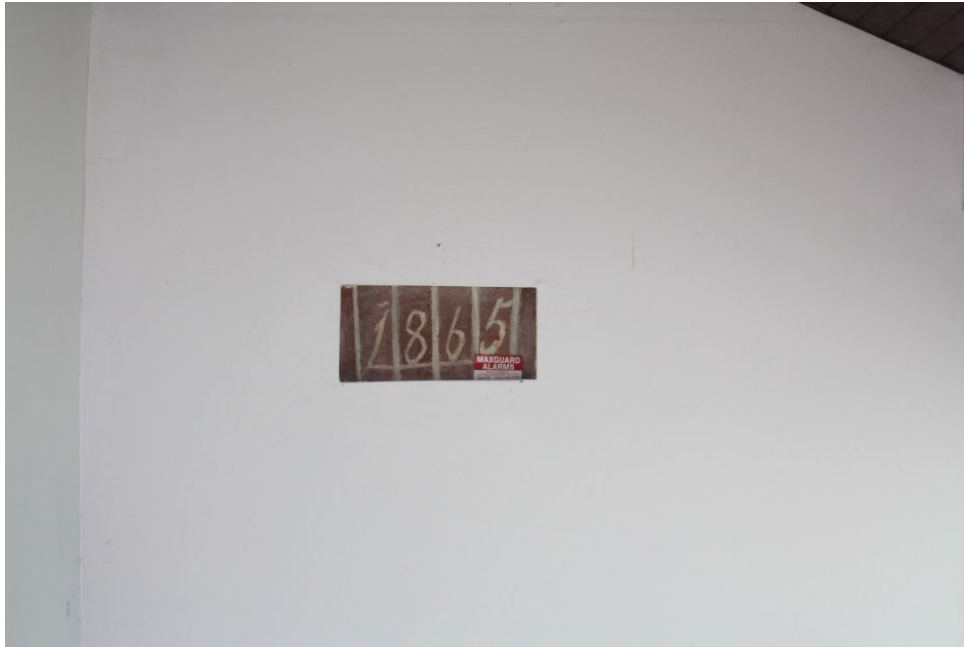
identified above as being in place in 1861. The date “1865” has been chiselled into the original dwelling’s south façade, now an interior wall for the second, one storey addition. Assessment

*Figure 10 The interior north wall of the one storey addition, 2013. The wall board has been cut away to display a portion of the south exterior wall of the original dwelling. The vertical fan shape of the bricks here suggests that the date was placed on a window arch now hidden by the modern addition (Photo by author.)*

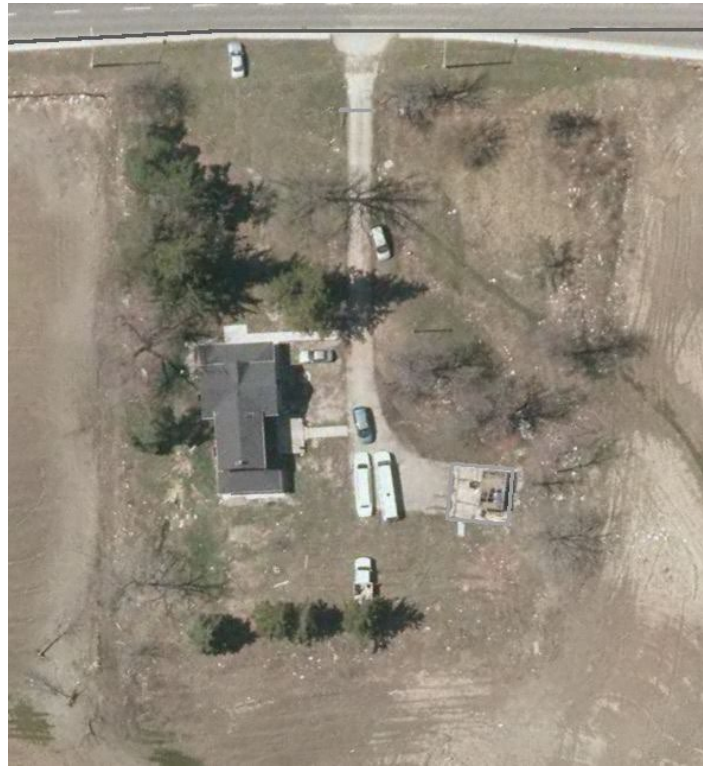
The subject property consists of an approximately one acre rectangle of land fronting on Eglinton Avenue West and contains the remnants of a nineteenth century farm complex. The only extant structures are the farm house itself which has an addition on its south façade, and a plywood shed recently erected on the concrete slab foundation of an earlier garage. An asphalt and gravel drive runs from Eglinton Avenue, east of the house and ends at the garage location. Concrete walkways connect the driveway to the front and side entrances. Some mature trees, remnants of an earlier windrow that sheltered the house and drive, remain on the property. The aerial photo below provides an overview of the current state of the property. The photo also shows the

*Figure 20 Detail of a 2013 aerial photo of 3650 Eglinton Avenue West. The long white objects are stretch limousines (Mississauga emaps.)*

outline of a small stream running from northwest to southeast on the eastern side of the lot. The property is bounded on the west by a wood post and wire fence, now completely collapsed and overgrown with vegetation.

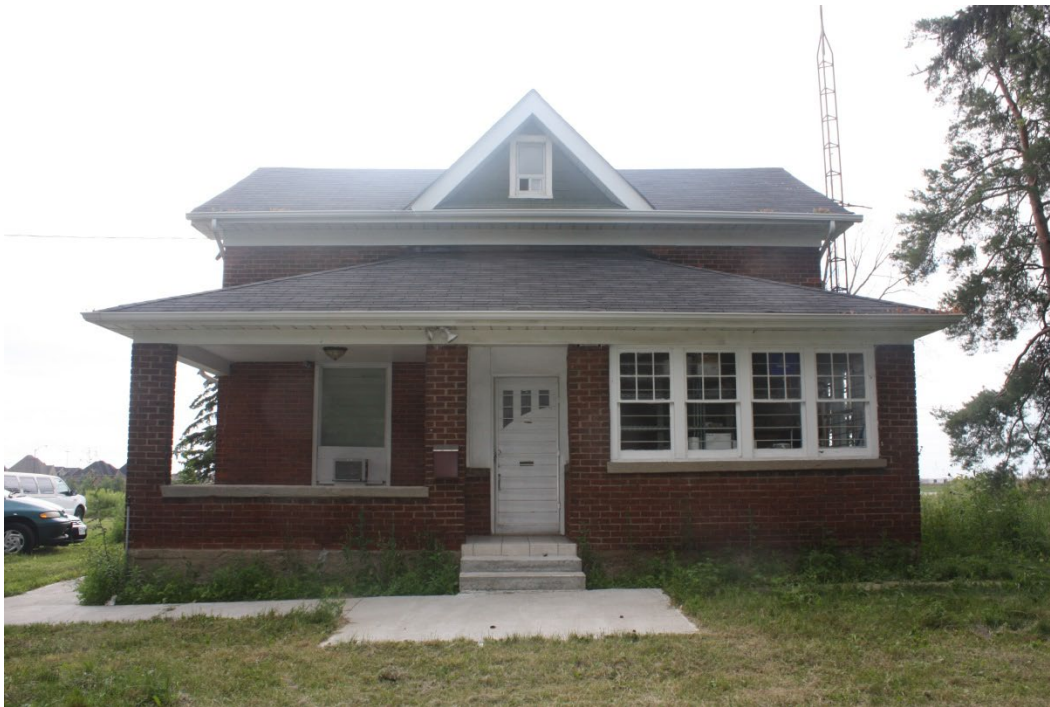
*Figure 21 The front or north façade of 3650 Eglinton Avenue West, 2013 (Photo by author.)*

The farmhouse is a one and a half storey red brick structure of vernacular design seated upon a fieldstone foundation. The brickwork is a simple stretcher bond. The original window placement on the front façade is hidden by the newer brick veranda. A central gable, simple in design and execution, accents the sloping roof and encloses a two over one vertically aligned window. The fascia is unadorned but the structure has returned eaves on the east and west elevations. The fabric appears to be replacement material. The east and west façades have two bays of windows providing light to each floor. The windows are vertical, two over one paned in design. They rest upon stone lintels, though those on the eastern elevation have been replaced or covered. The windows are crowned by simple vertically placed brick arches. All of the exterior windows appear to be replacements. Grey asphalt shingles cover all roofs. The rear or south

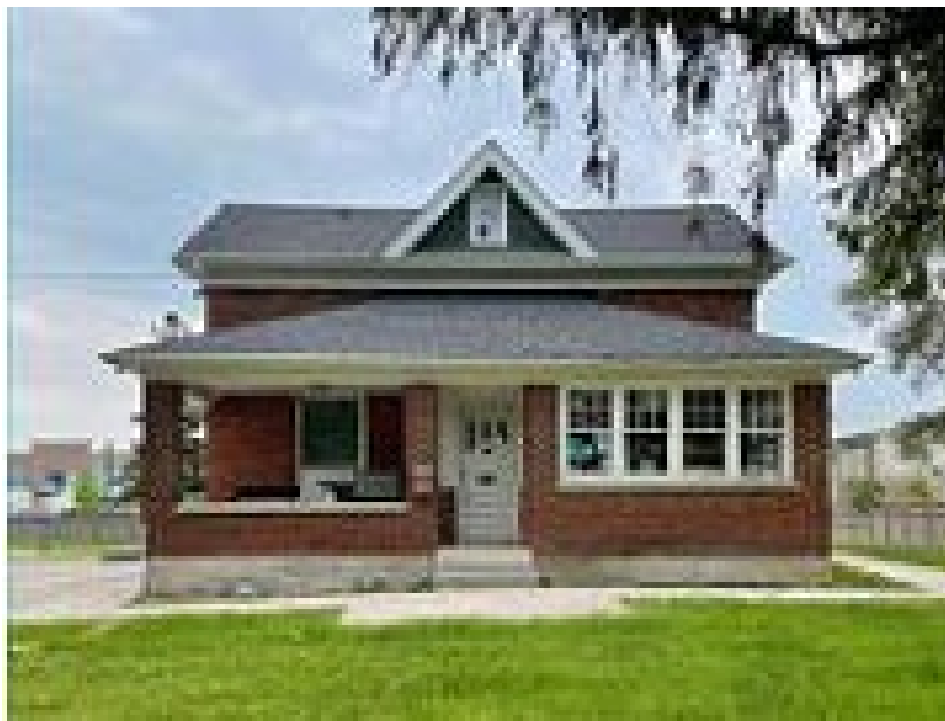
*Figure 22 The front or north façade of 3650 Eglinton Avenue West, 2023 (Photo by owner.)*

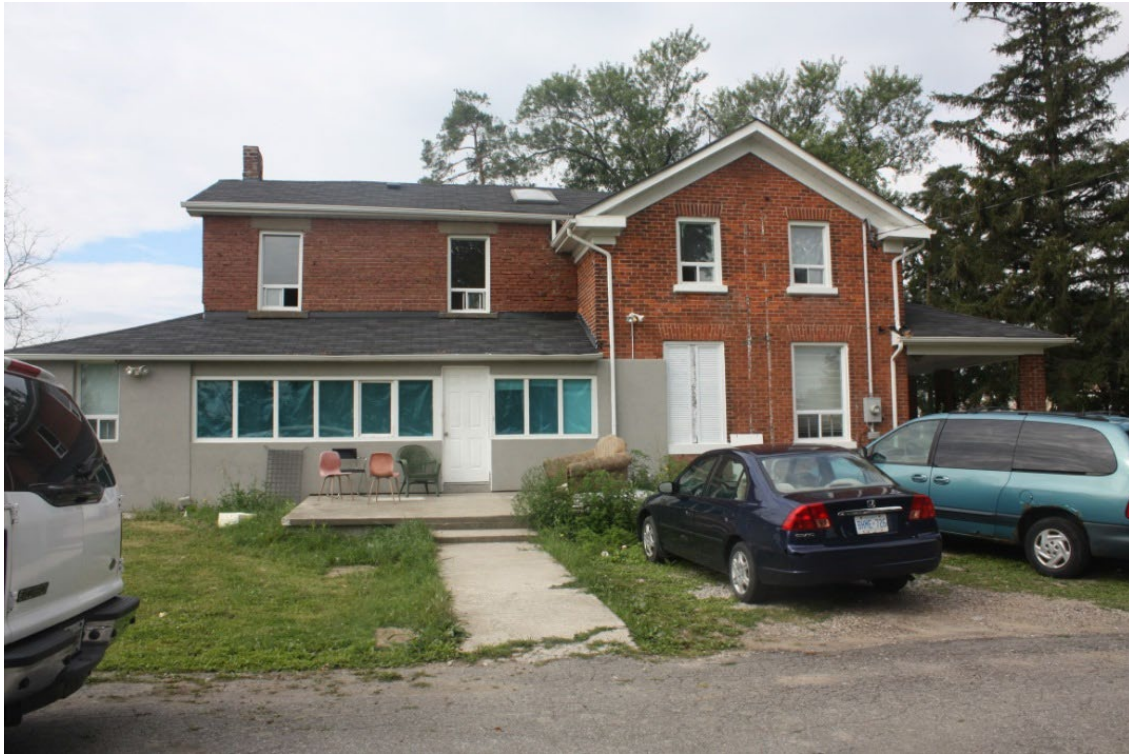
*Figure 23 The east façade of 3650 Eglinton avenue West, showing the original farmhouse and its southern extension, 2013 (Photo by author.)*

elevation of the original house (figures 23 and 24) is almost entirely hidden by the later additions. The original symmetry of the front façade has been altered by the partially closed in front veranda composed of corrugated brick in a simple stretcher bond pattern. The front door is also a replacement and the entrance is now protected by an iron gate. The original brickwork at the southwest corner of the building has suffered serious deterioration in recent years (figure 37).

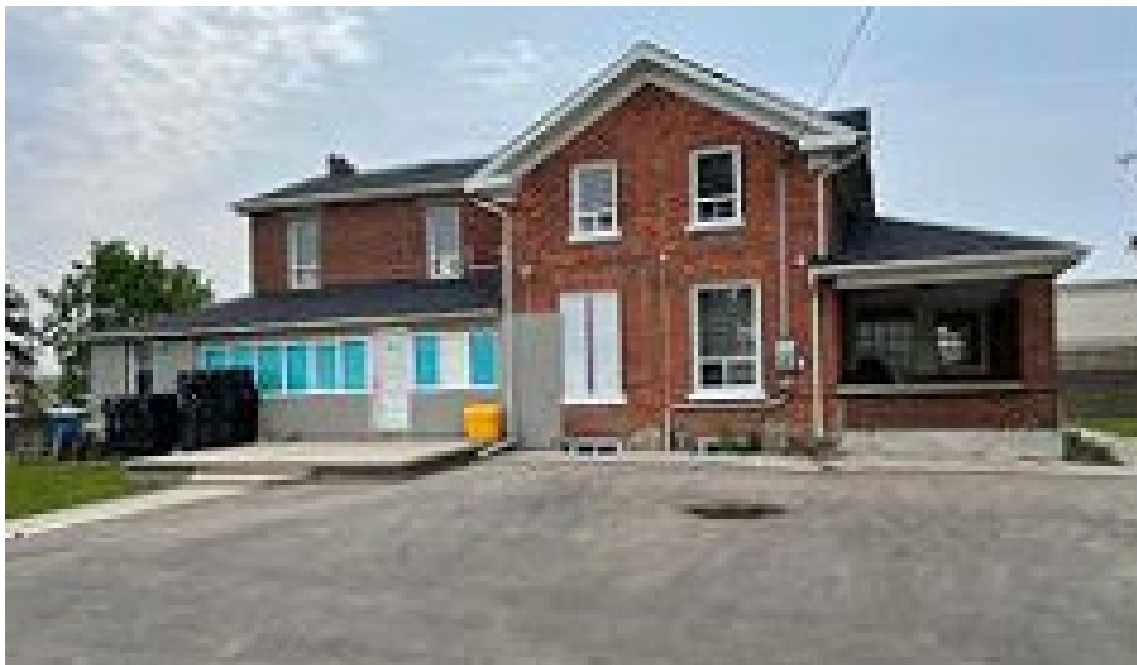
*Figure 24 The east façade of 3650 Eglinton avenue West, showing the original farmhouse and its southern extension, 2023 (Photo by owner.)*

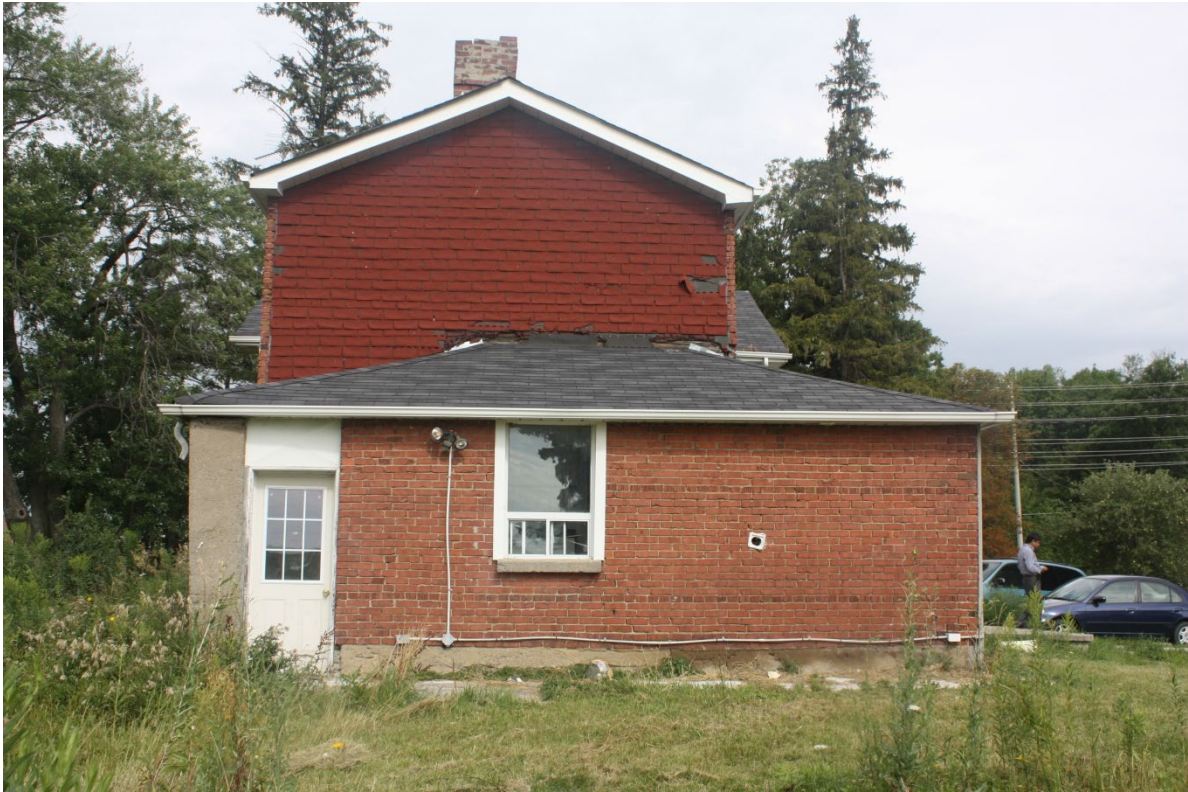
*Figure 25 The south façade of 3650 Eglinton Avenue West, 2013 (Photo by author.)*

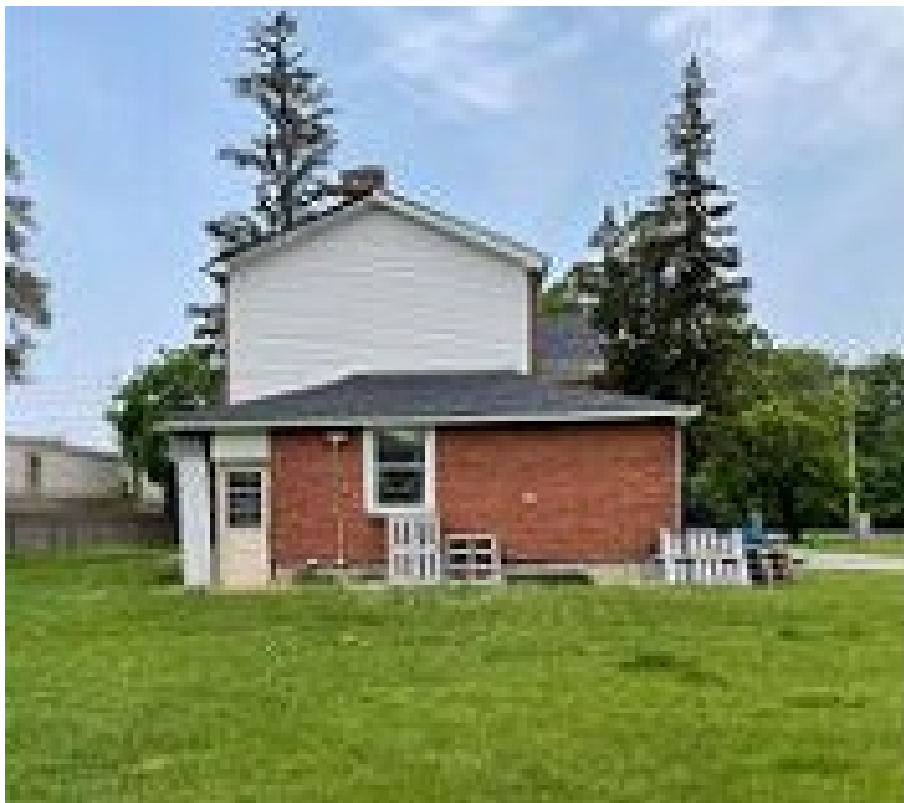
*Figure 26 The south façade of 3650 Eglinton Avenue West, 2023 (Photo by owner.)*

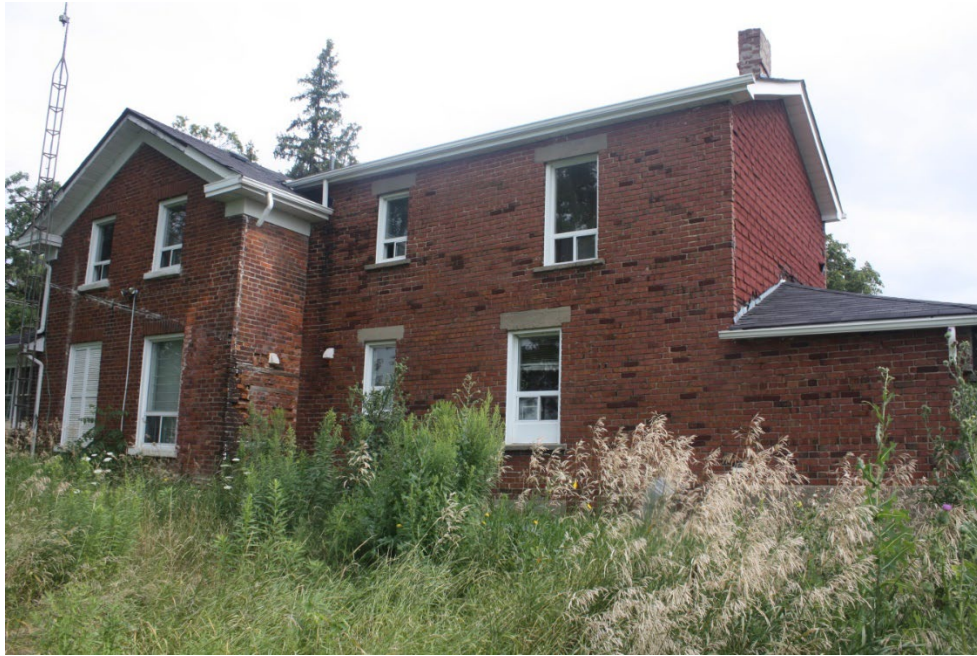
*Figure 27 The west façade of 3650 Eglinton Avenue West, 2013 (Photo by author.)*

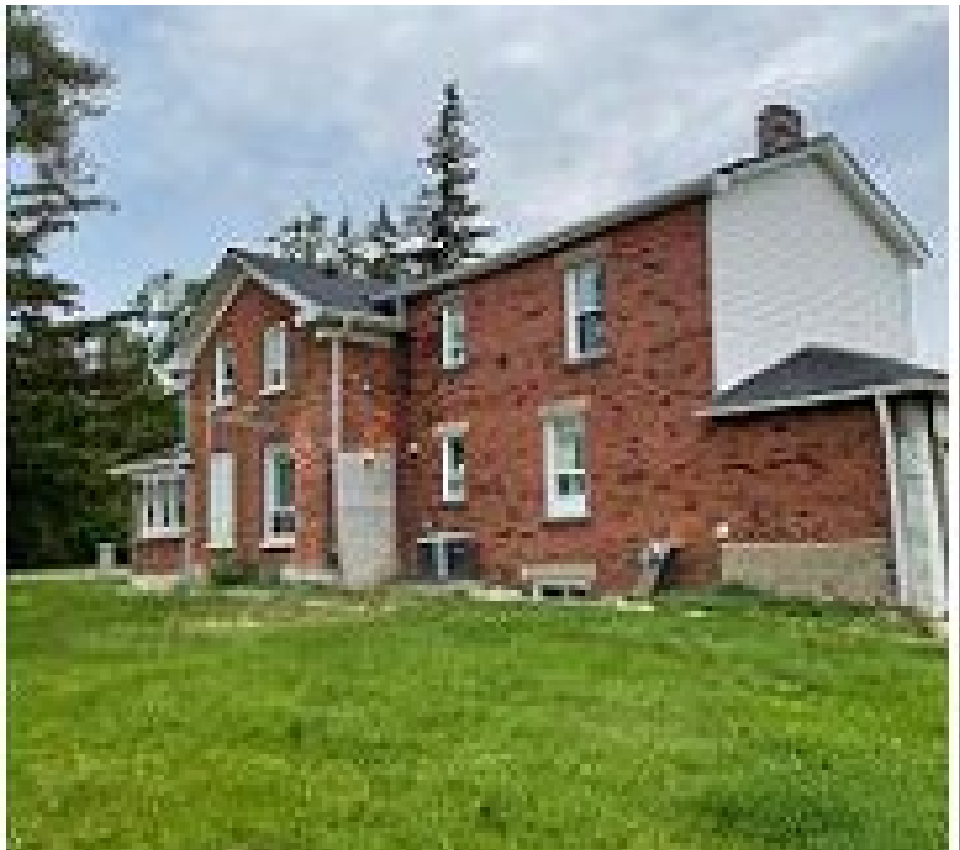
*Figure 28 The west façade of 3650 Eglinton Avenue West, 2023 (Photo by owner.)*

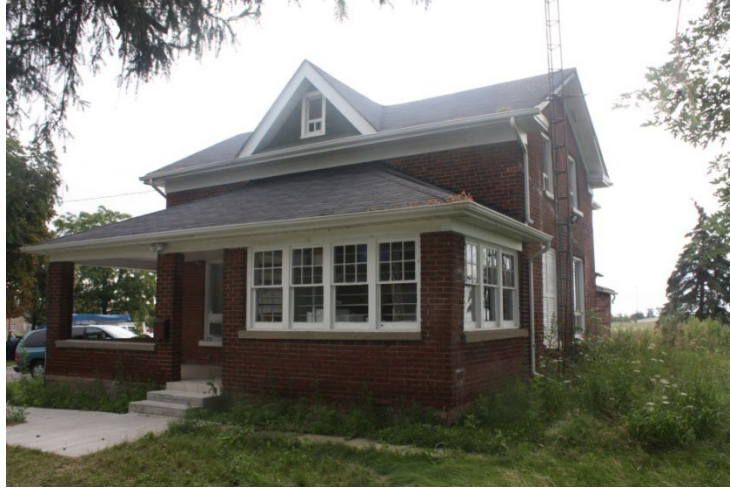
*Figure 29 The north and west façades of 3650 Eglinton Avenue West, 2013 (Photo by author.)*

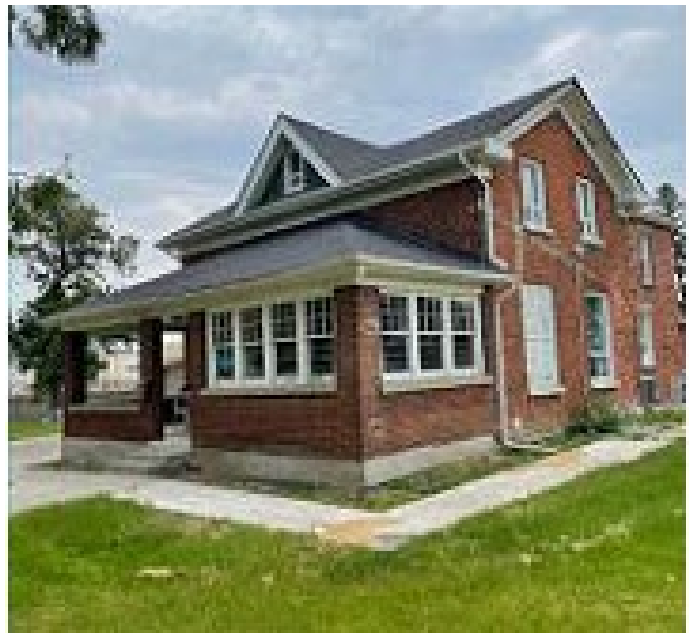
*Figure 30 The north and west façades of 3650 Eglinton Avenue West, 2023 (Photo by owner.)*

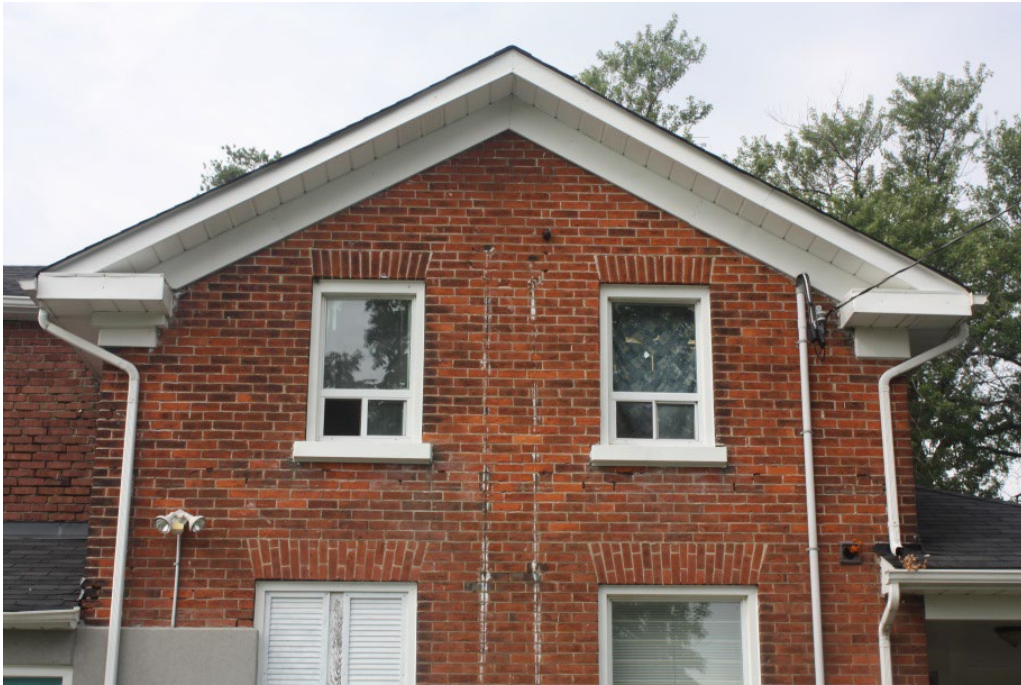
*Figure 31 Detail of the east façade, 3650 Eglinton Avenue West, showing the returned eaves and window treatment, 2013 (Photo by author.)*

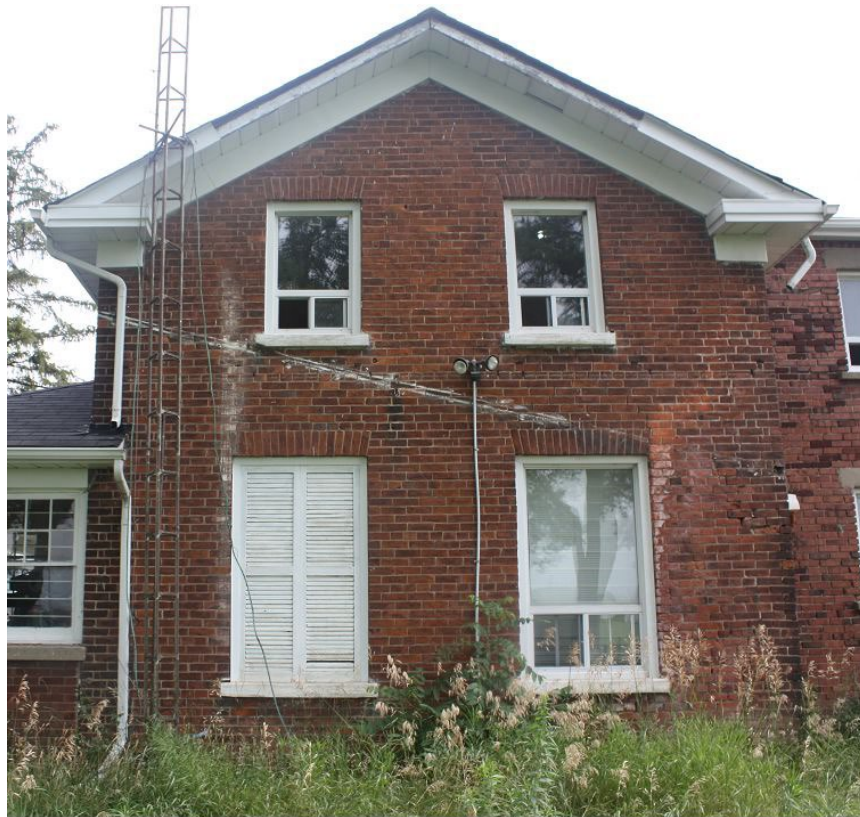
*Figure 32 Detail of the west façade, 3650 Eglinton Avenue West, showing the returned eaves and window treatment, 2013 (Photo by author.)*

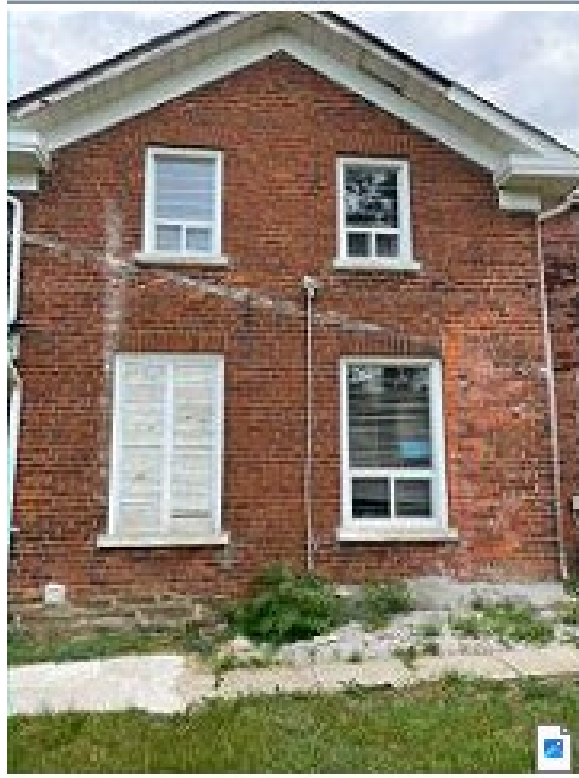
*Figure 33 Detail of the west façade, 3650 Eglinton Avenue West, showing the returned eaves and window treatment, 2023 (Photo by owner.)*

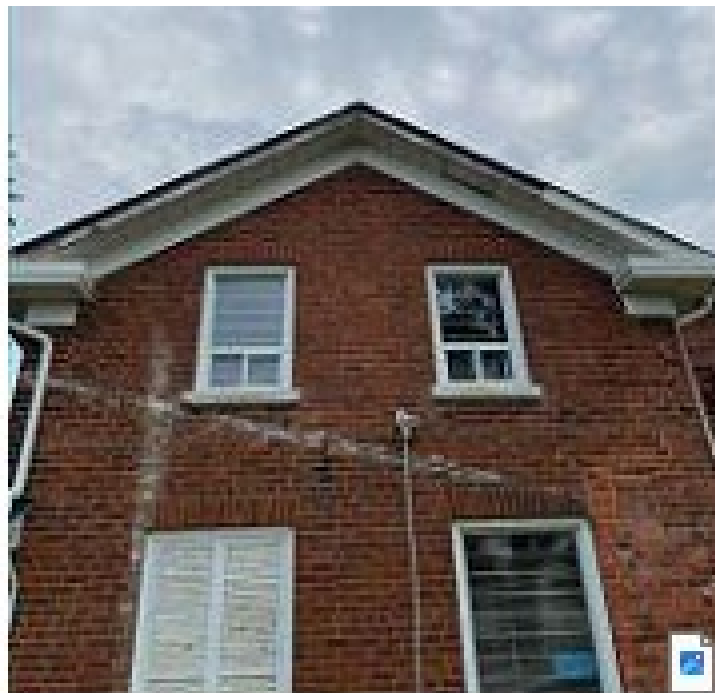
*Figure 34 Detail of the west façade, 3650 Eglinton Avenue West, showing the returned eaves and window treatment, 2023 (Photo by owner.)*

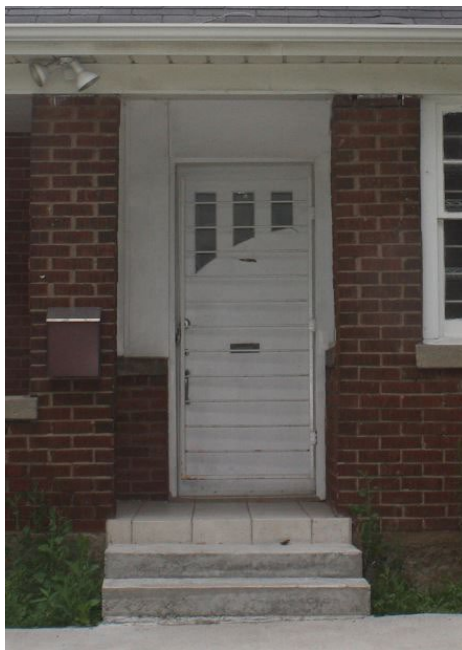
*Figure 35 The front door of 3650 Eglinton Avenue West, 2013 (Photo by author.)*

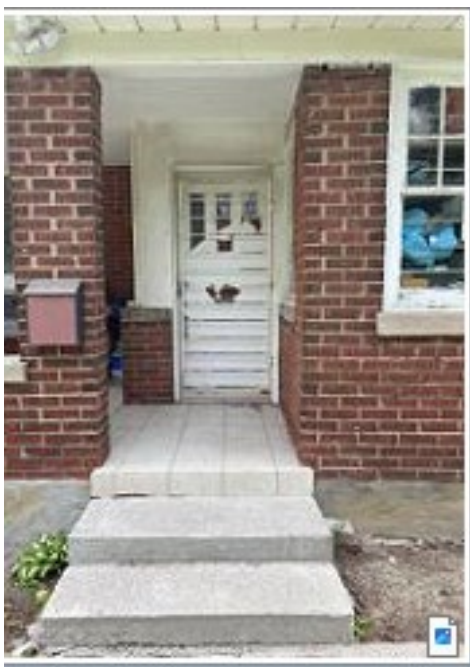
*Figure 36 The front door of 3650 Eglinton Avenue West, 2023 (Photo by owner.)*

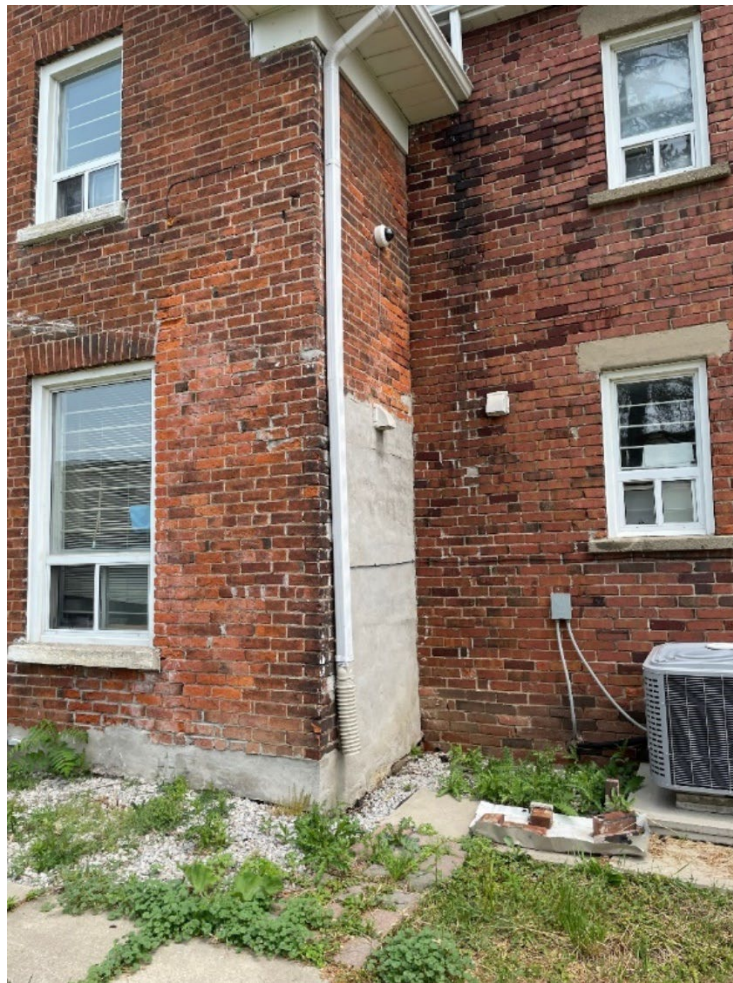
*Figure 37 Deteriorating brickwork at the southwest corner of the original farmhouse, 2023  
(Photo by owner.)*

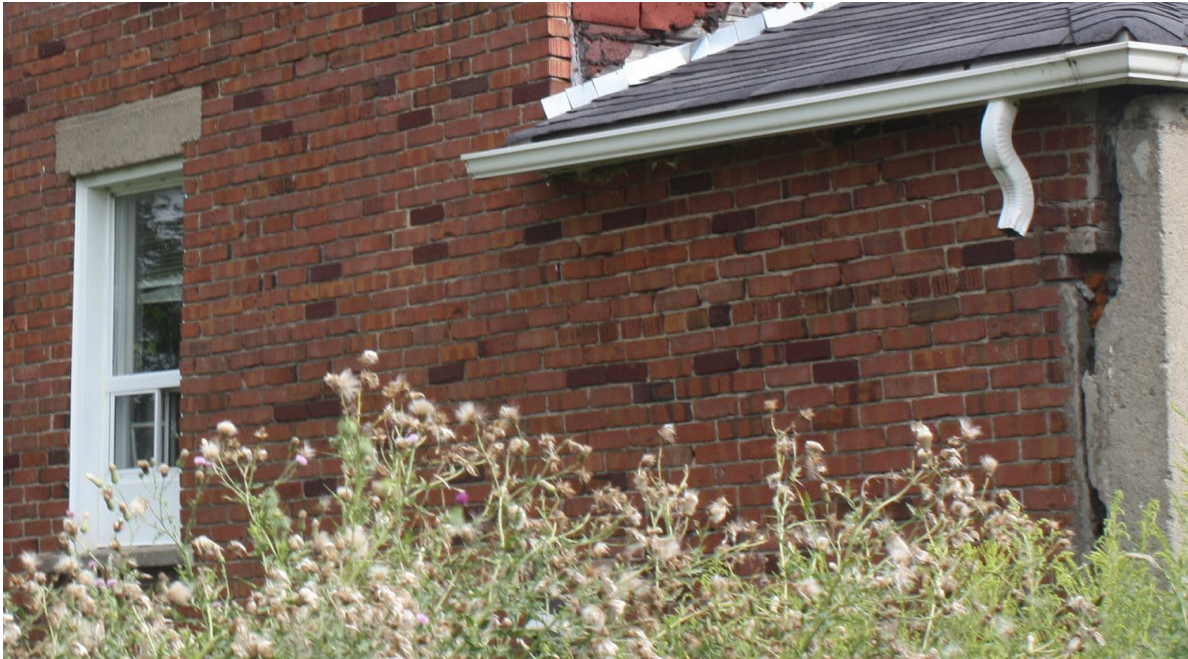
An addition has been added to the original farmhouse consisting of a rectangular one and a half story extension on its south façade which in turn is surrounded on its east and south sides by a single storey extension. While the east façade of the one storey portion is covered in parching, giving the appearance of a separate addition, the brickwork on its south and west elevations match that of the two storey brick structure. This supposition is supported by the continuation of the brickwork on the west façade from the two storey addition on to the one storey portion. The addition was likely erected in the late nineteenth or early twentieth century. Its brickwork is

*Figure 38 Continuity of brickwork on the west façade of the addition, 2013 (Photo by author.)*

somewhat coarser than that of the original house and its workmanship has not, in general, weathered as well as that of the original farmhouse. An effort was however made to match the window treatment of this addition with that of the original structure, as can be seen in the following images. The south façade of the two storey addition was surfaced with asphalt

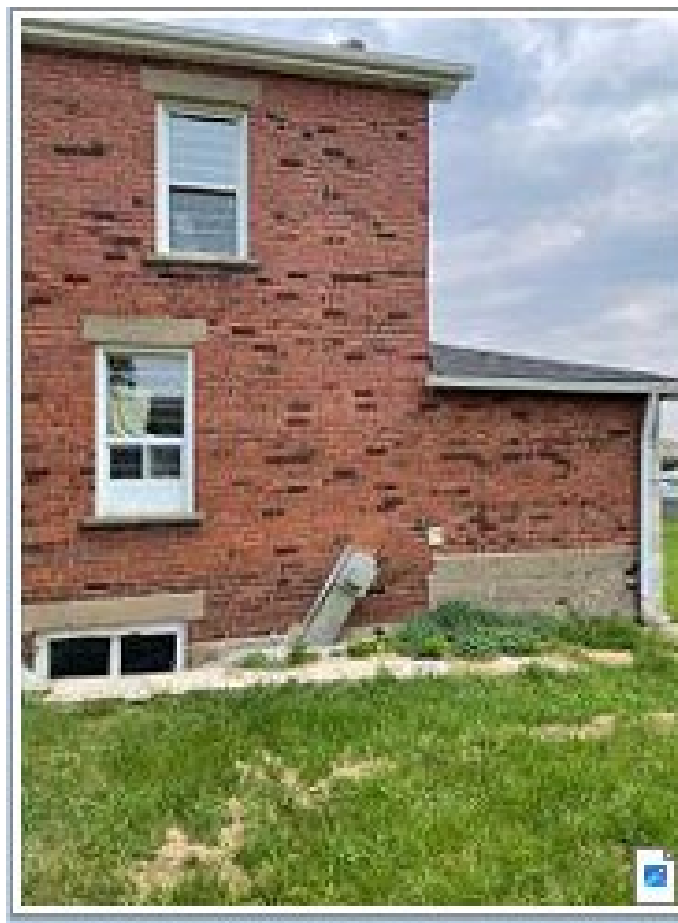
*Figure 39 Continuity of brickwork on the west façade of the addition, 2023 (Photo by owner.)*

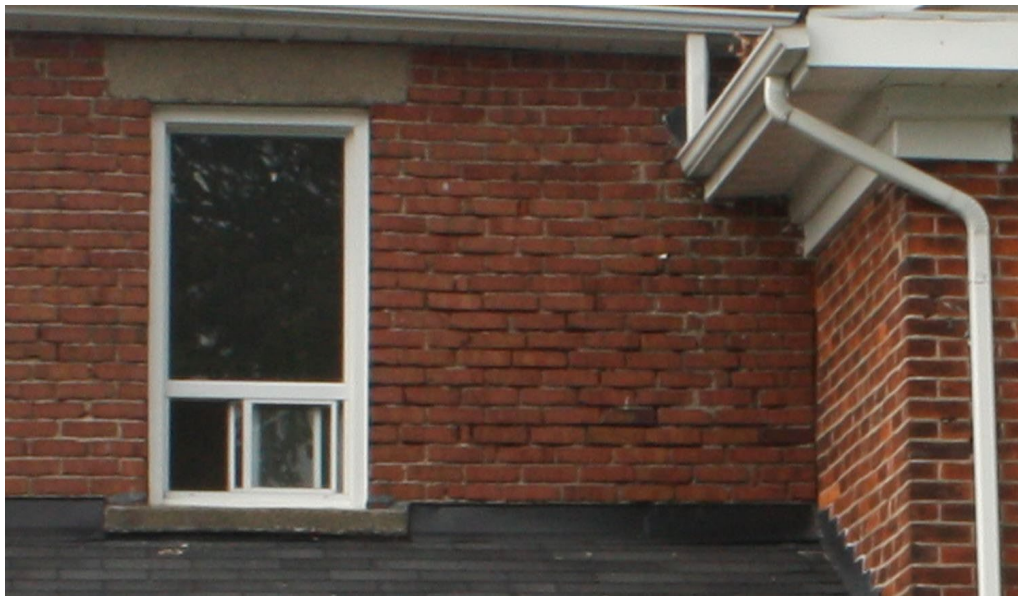
*Figure 40 Detail of the brick and window treatment of the first addition to 3650 Eglinton Avenue West, 2013 (Photo by author.)*

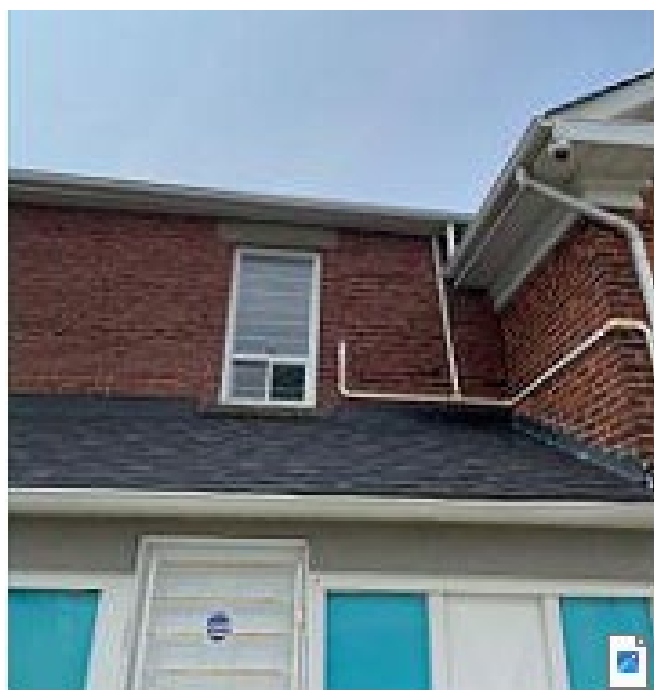
*Figure 41 Detail of the brick and window treatment of the first addition to 3650 Eglinton Avenue West, 2023 (Photo by owner.)*

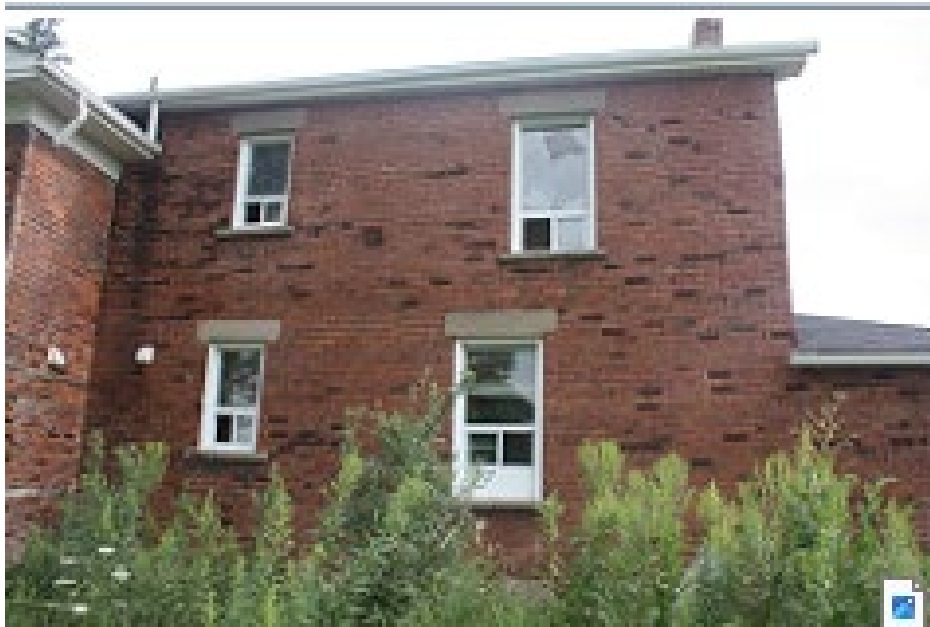
*Figure 42 Window treatment and detailing on the west elevation of the addition, 2013. (Photo by author.)*

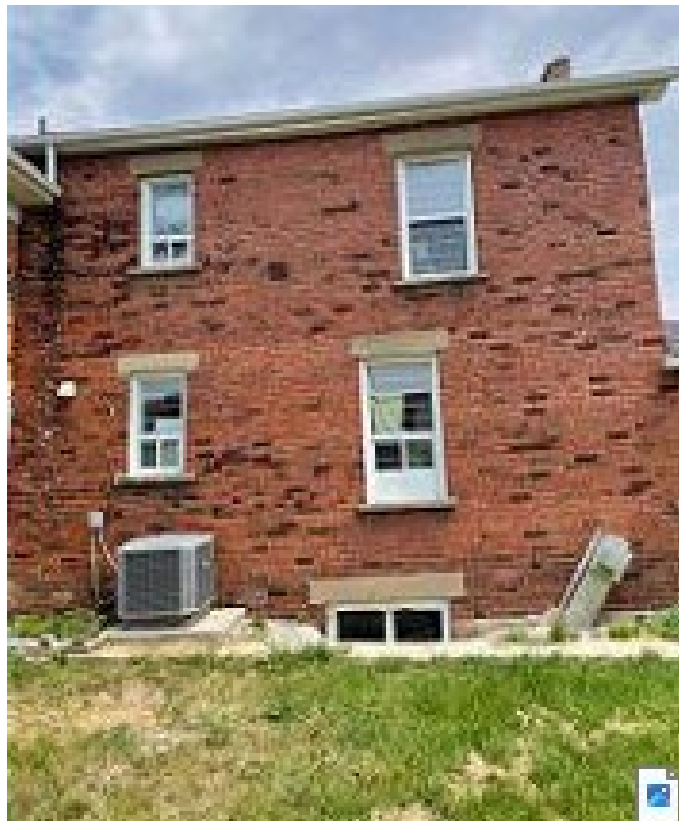
*Figure 43. Window treatment and detailing on the west elevation of the addition, 2023. (Photo by owner.)*

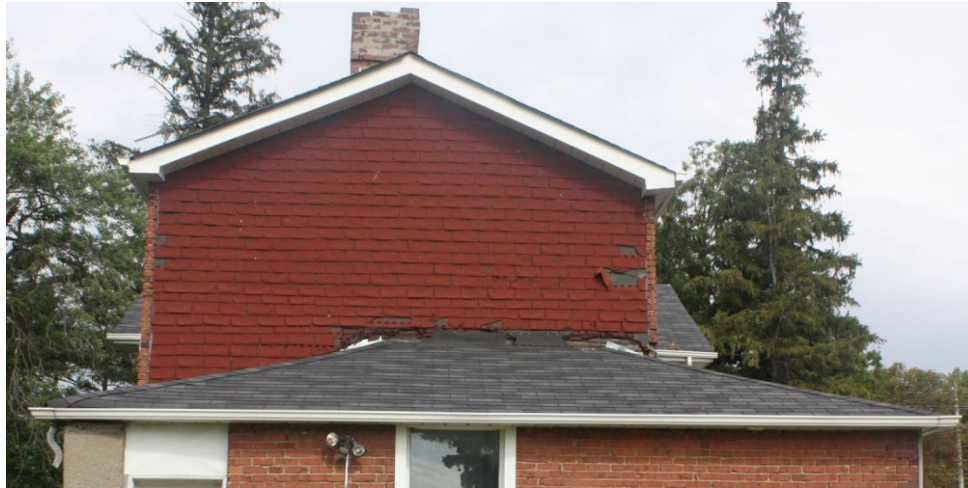
shingling which suffered substantial deterioration (figure 44) but the asphalt shingling has been replaced by aluminum siding (figures 45). The brick chimney servicing the addition also shows signs of deterioration.

*Figure 44 The south elevation of the two storey extension, 2013 (Photo by author.)*

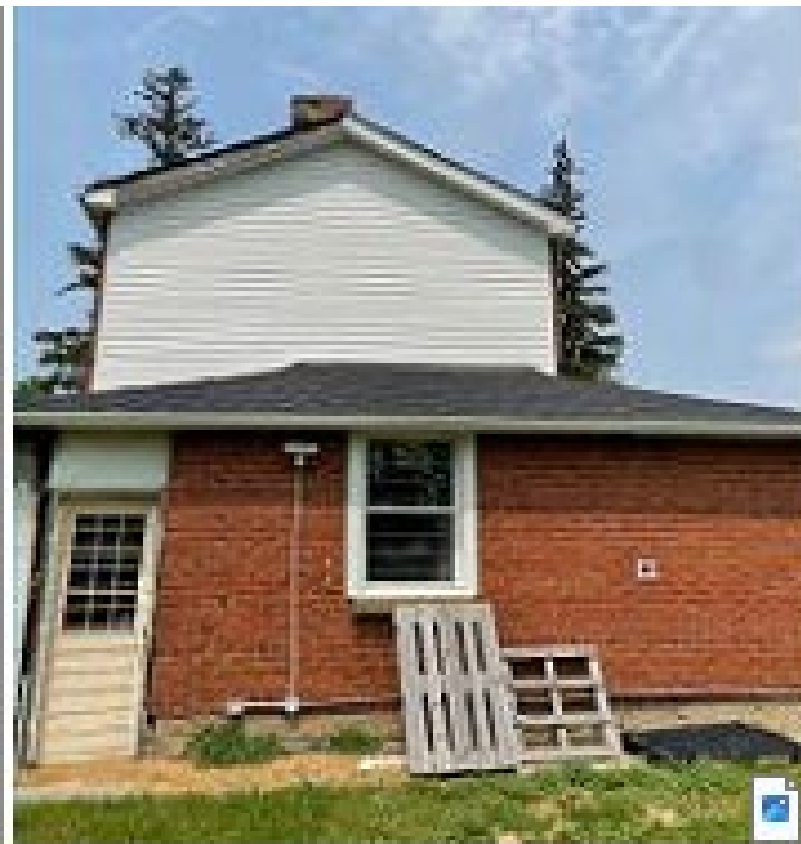
*Figure 45 The south elevation of the two storey extension, 2023 (Photo by owner.)*

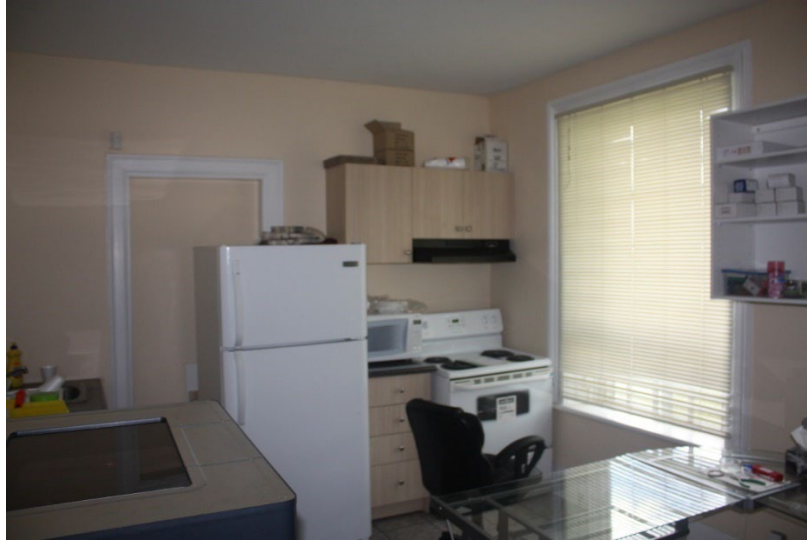
The interior of the original farmhouse has undergone massive change, particularly on the main floor where virtually none of the original fabric remains. The main floor now serves as an office

Figure 46 The northwest room on the main floor of 3650 Eglinton Avenue West is now an office and break room, 2013 (Photo by author.)

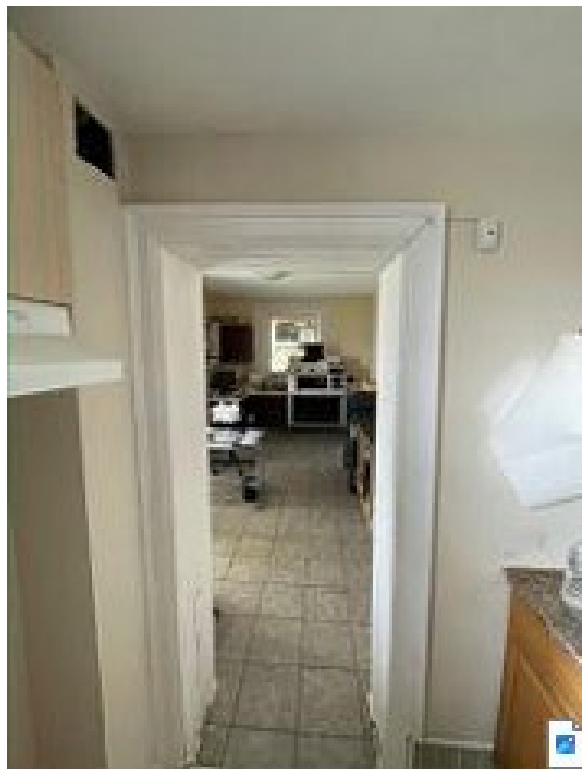
Figure 47 Looking into the northwest room on the main floor of 3650 Eglinton Avenue West, now an office and break room, 2023 (Photo by owner.)

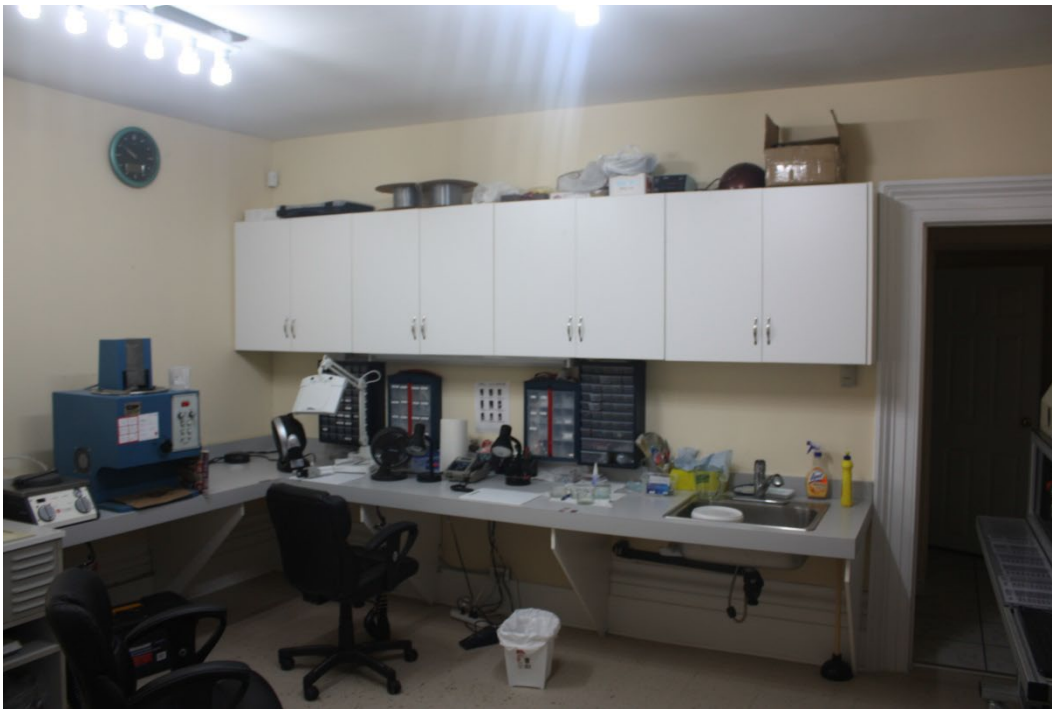
*Figure 48 The northeast room on the main floor of 3650 Eglinton Avenue West is now a small fabricating area, 2013 (Photo by author.)*

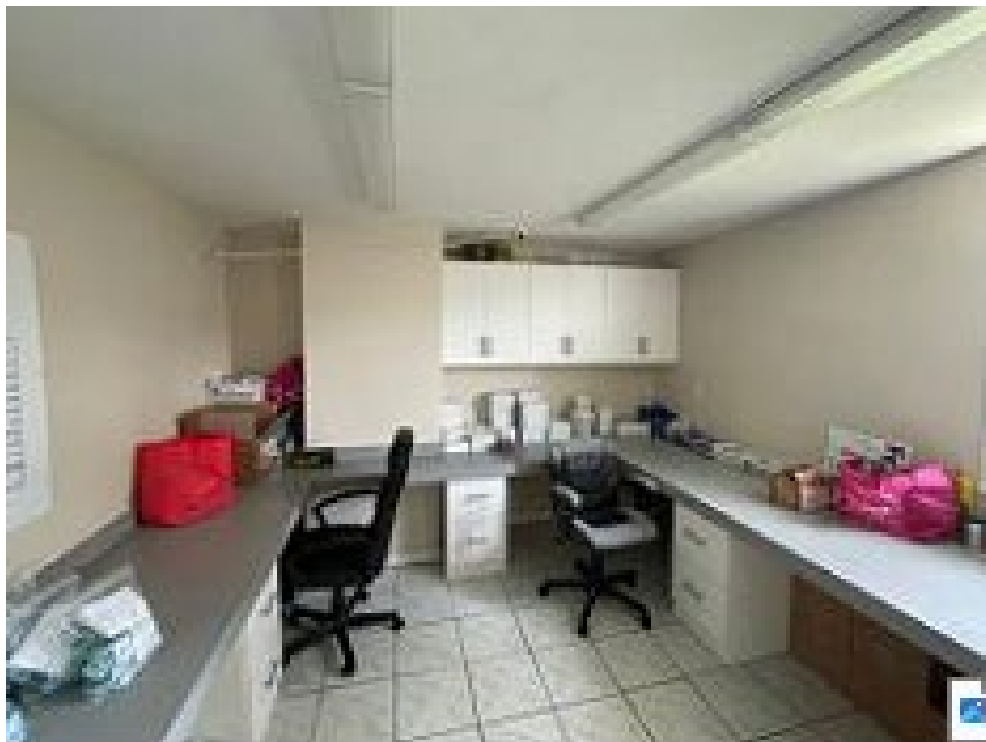
*Figure 49 The northeast room on the main floor of 3650 Eglinton Avenue West is now a small fabricating area, 2023 (Photo by owner.)*

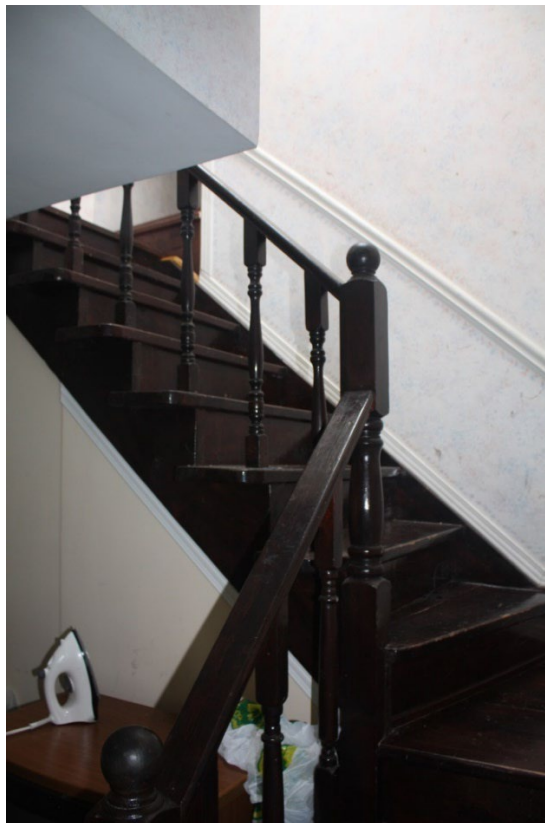
*Figure 51 the staircase in the addition leading to the second floor of both portions of the house, 2013 (Photo by author.)*

level is now via the side entrance to the rear addition and a staircase which serves both portions of the structure. The building is now effectively divided into two separate areas consisting of the first floor office and fabricating area of the original farmhouse, and bedrooms for students on both levels of the addition and on the second floor of the original farmhouse.

With the exception of the staircase shown above, (figures 51, 52, 53 and 54), the interior of the addition is strictly utilitarian in nature and little of the original fabric has been retained. The first floor of the addition consists of a narrow room on the east side, a central corridor and a small living area to the west. At the rear is a modern kitchen and the entrance to the basement. A bathroom and the bedrooms on the second floor of the addition are similarly functional in nature and show little of the structure's original fabric.

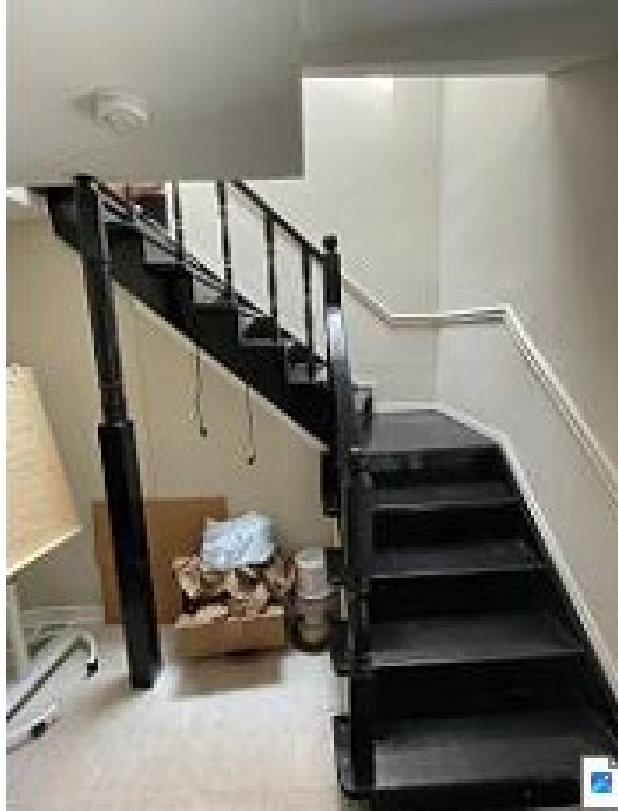
*Figure 52 the staircase in the addition leading to the second floor of both portions of the house, 2023 (Photo by owner.)*

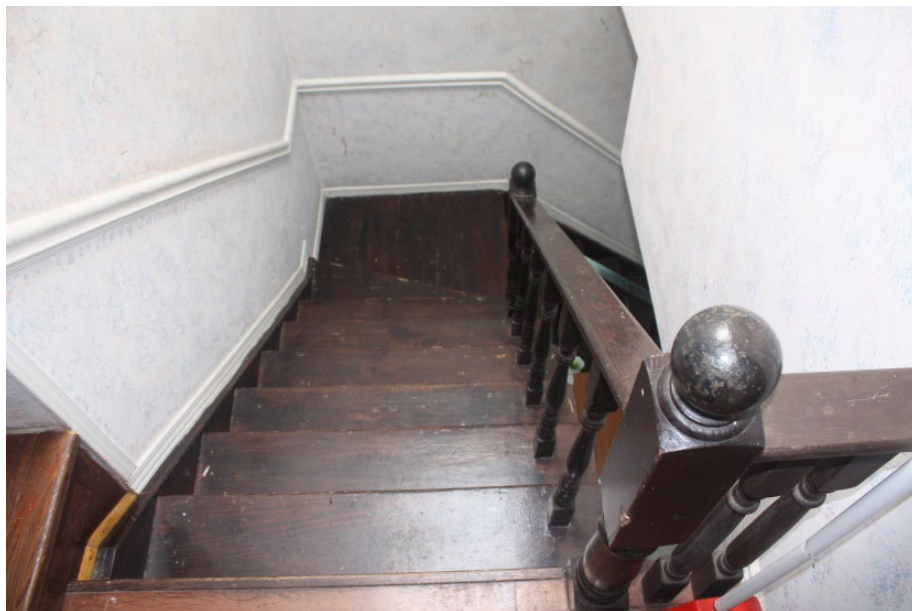
*Figure 53 Looking down the staircase from the second level of the addition. The original building is on the left in this image, 2013 (Photo by author.)*
