**HERITAGE IMPACT STATEMENT**

**3650 Eglinton Avenue West, Mississauga, ON**

**Part of Lot 4, Concession 2 NDS, Trafalgar Township  
Plan 1542 Part of Lots 1, 2, 43R25632 Part 2**

Revised November 2023

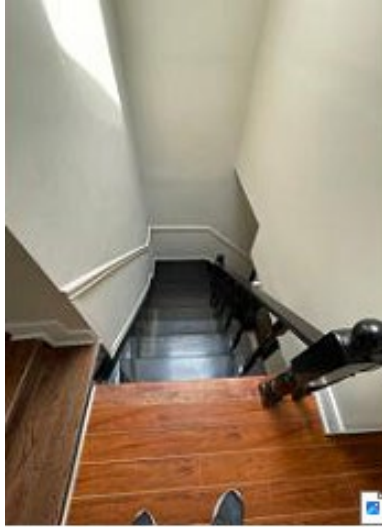
*Figure 54 Looking down the staircase from the second level of the addition. The original building is on the left in this image, 2023 (Photo by owner.)*

With the exception of the staircase shown above, (figures 51, 52, 53 and 54), the interior of the addition is strictly utilitarian in nature and little of the original fabric has been retained. The first floor of the addition consists of a narrow room on the east side, a central corridor and a small living area to the west. At the rear is a modern kitchen and the entrance to the basement. A bathroom and the bedrooms on the second floor of the addition are similarly functional in nature and show little of the structure's original fabric.

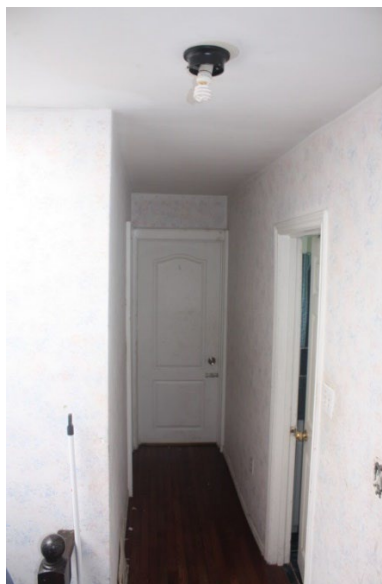
The central hall configuration remains intact on the second floor of the original farmhouse and there are four rooms now used as bedrooms. The woodwork surrounding the windows and doors appears to be original fabric but the windows and the doors are all replacements.

*Figure 55 The upper level hallway of the original farmhouse, 3650 Eglinton Avenue West, 2013 (Photo by author.)*

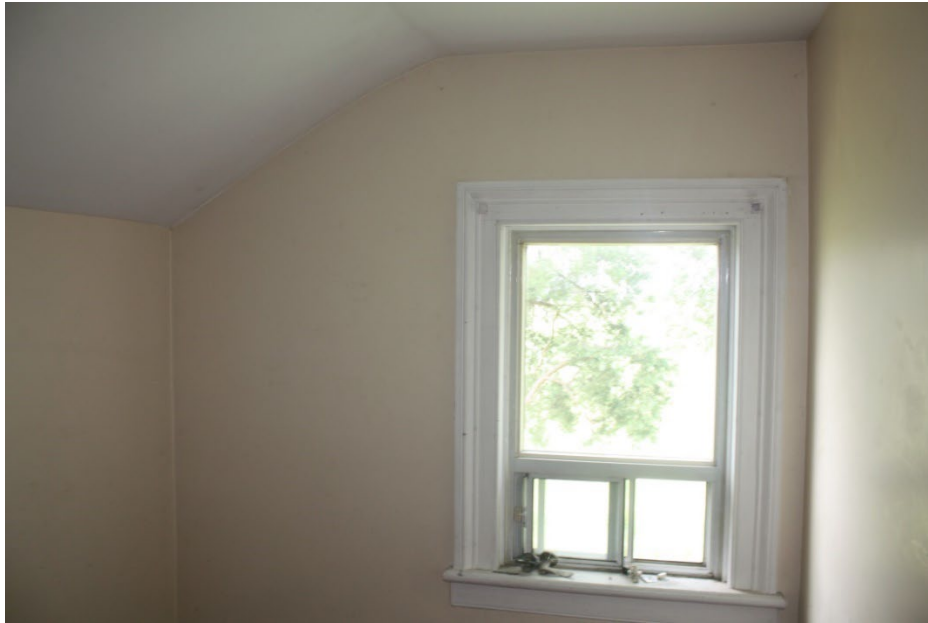
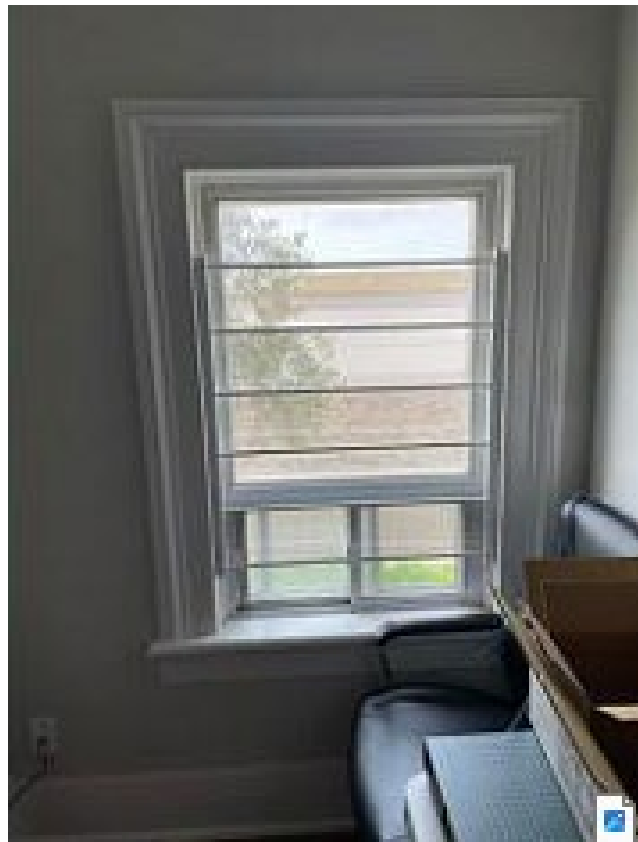
*Figure 56 the southwest bedroom, upper level of the original farmhouse, 3650 Eglinton Avenue West, 2013 (Photo by author.)*

*Figure 57 the southwest bedroom, upper level of the original farmhouse, 3650 Eglinton Avenue West, 2023 (Photo by owner.)*

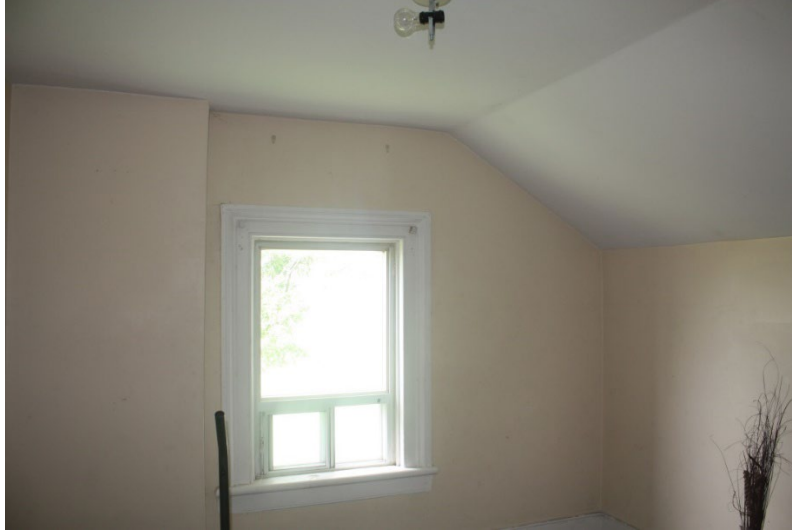
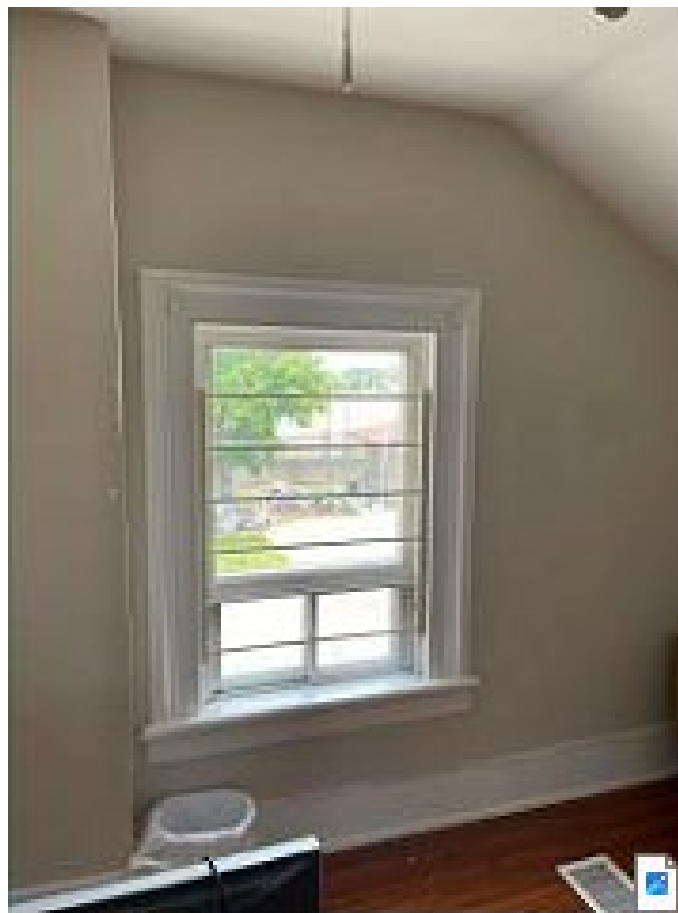
*Figure 58 the southeast bedroom, upper level of the original farmhouse, 3650 Eglinton Avenue West, 2013 (Photo by author.)*

*Figure 59 the southeast bedroom, upper level of the original farmhouse, 3650 Eglinton Avenue West, 2023 (Photo by owner.)*

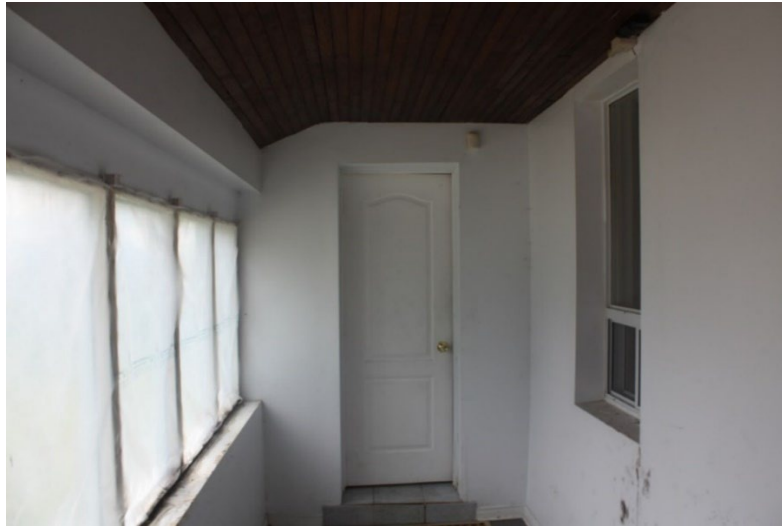
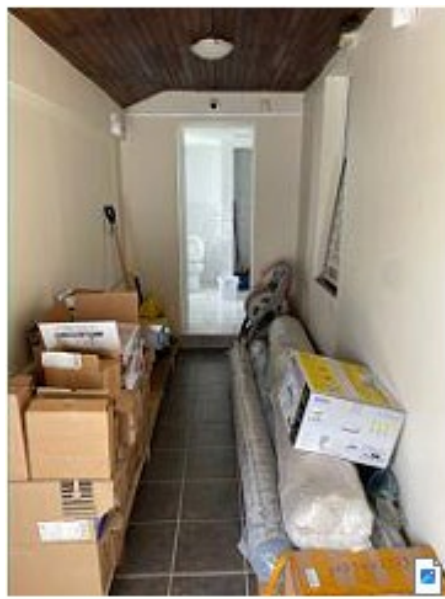
*Figure 60 The empty room on the eastern side of the addition's main floor, 2013 (Photo by author.)*

*Figure 61 The empty room on the eastern side of the addition's main floor, 2023 (Photo by owner.)*

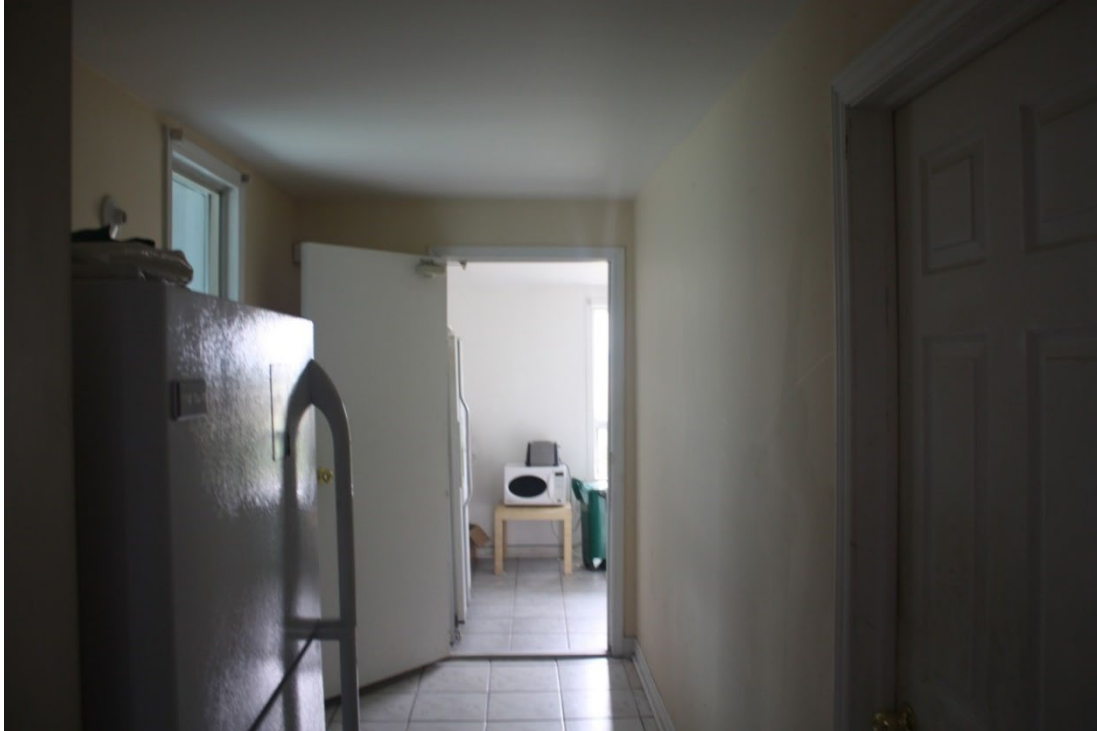
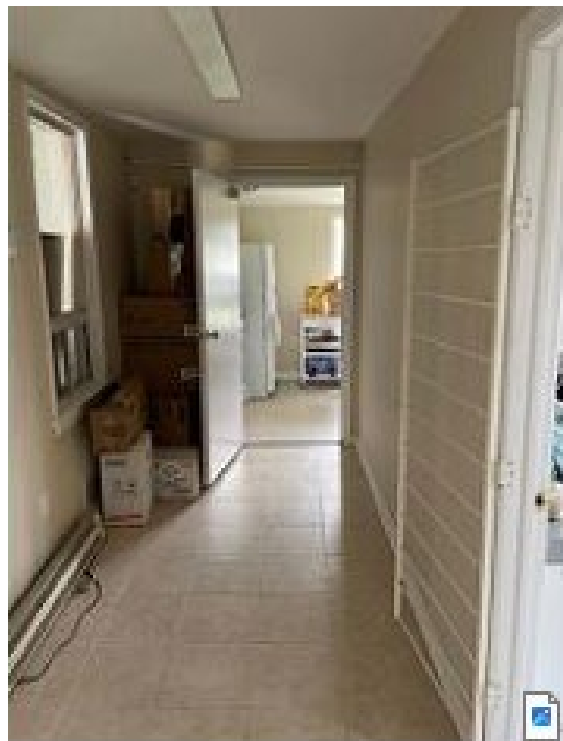
*Figure 62 The main level central hallway of the addition leading to the kitchen in the rear, 2013  
(Photo by author.)*

*Figure 63 The main level central hallway of the addition leading to the kitchen in the rear, 2023  
(Photo by owner.)*

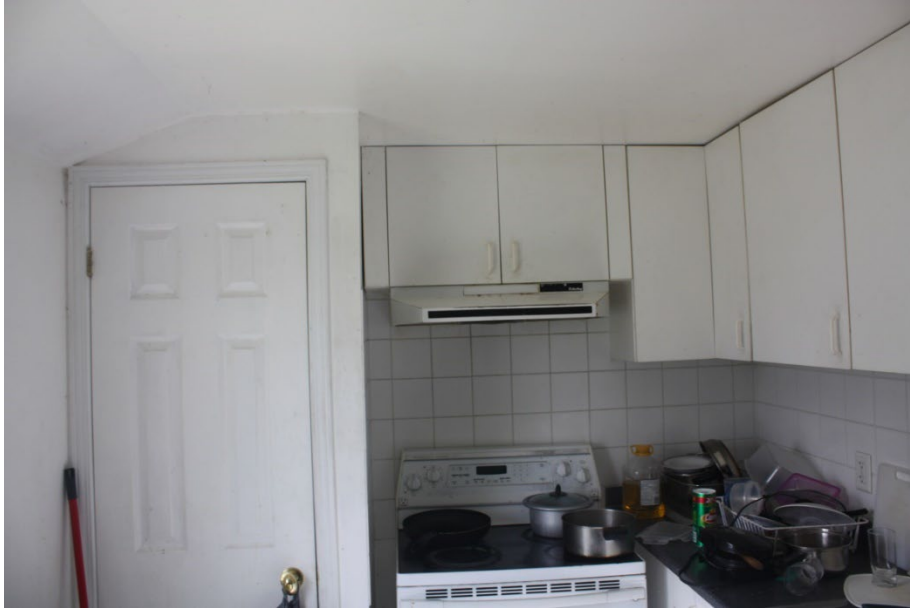
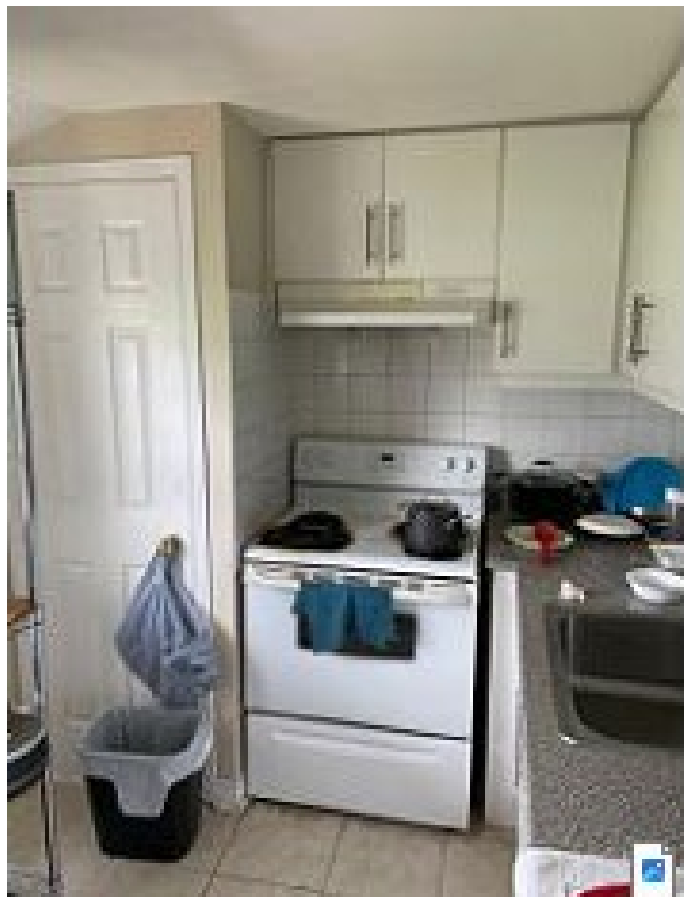
*Figure 66 The kitchen at the rear of the addition's main floor. The doorway leads to the basement, 2013 (Photo by author.)*

*Figure 67 The kitchen at the rear of the addition's main floor. The doorway leads to the basement, 2023 (Photo by owner.)*

The basement of both the original farmhouse and its addition is accessed from the rear kitchen. The foundation walls of the original structure are of fieldstone, while those of the addition are of concrete blocks. The floor is cement in both portions of the structure.

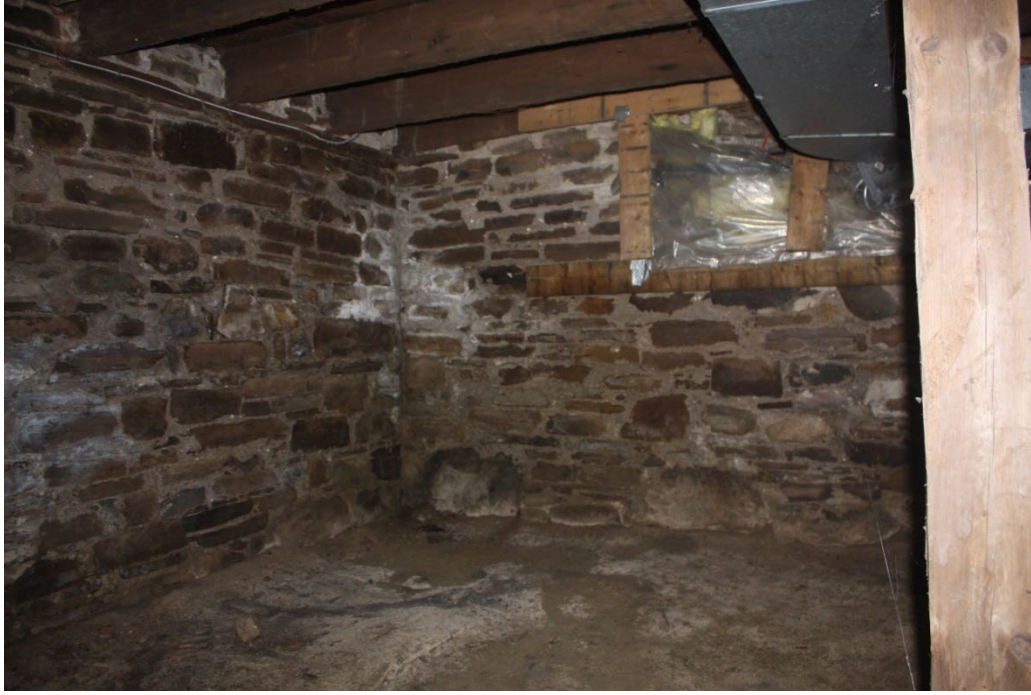
*Figure 72 The basement of the original farmhouse, 2013 (Photo by author.)*

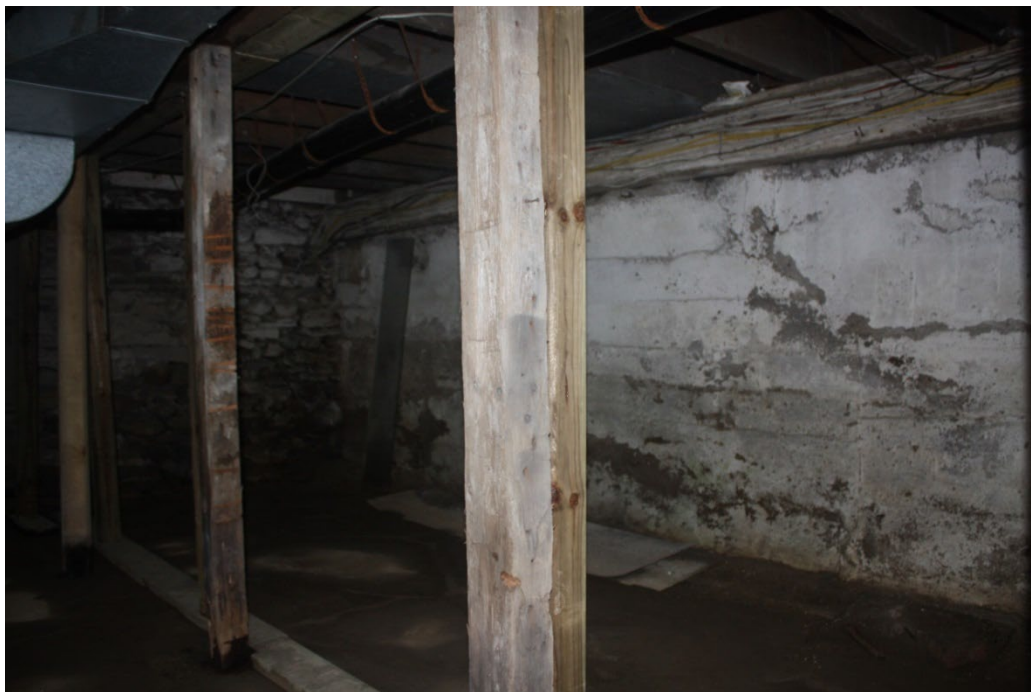
*Figure 73 The basement of the addition, 2013. Timber had been inserted to support the structure (Photo by author.)*

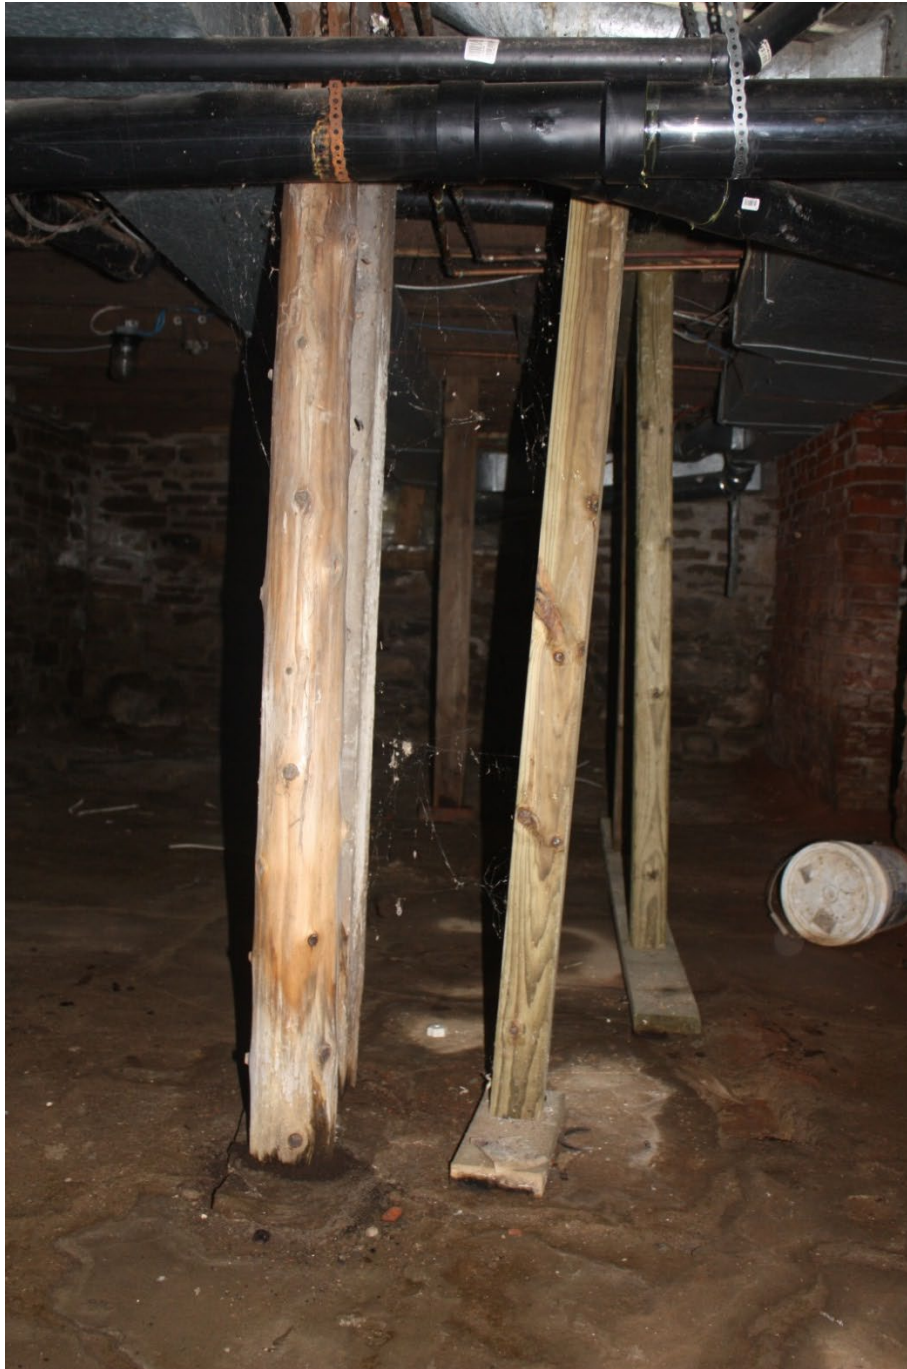
*Figure 74 timber supports in the basement of the original farmhouse, 2013 (Photo by author.)*

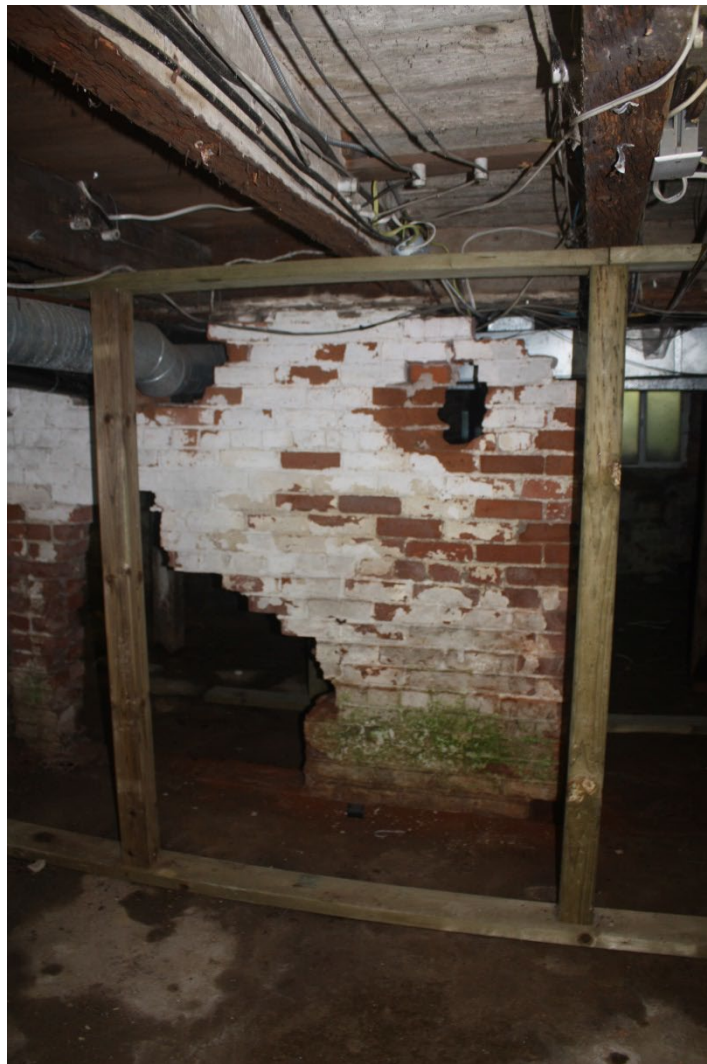
Figure 75 A gap in the interior basement wall of the original farmhouse and supporting timbers, 2013 (Photo by author.)

farmhouse and its addition may have been compromised by this water damage, but an engineering study would be required to determine this. There is visual evidence, shown above, of recent stabilizing efforts.

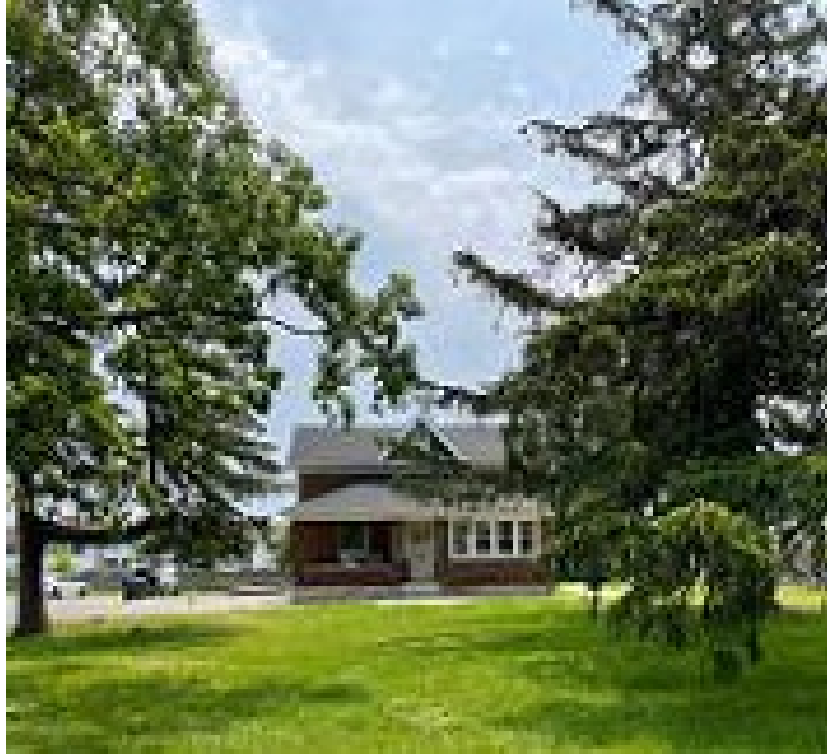
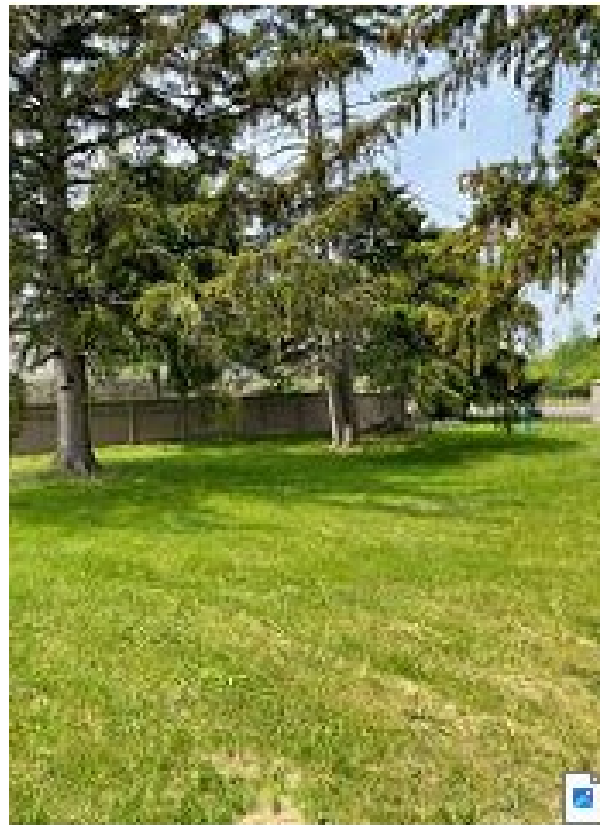
The grounds are no longer being maintained as they were in the pre-2000 period. The images below depict the condition of the property and identify a number of mature and maturing chestnut and spruce trees that form a remnant of the windrow which once protected the farmhouse and lined the drive.

*Figure 78 Mature trees at the front of the farmhouse, 2023 (Photo by owner.)*

*Figure 79 Mature trees at the front of the farmhouse, 2023 (Photo by owner.)*

comparative purposes. It may also be appropriate to dismantle the original structure in a manner which allows for the preservation of brickwork and foundation fieldstone as a source of material for repair and alteration projects in the region. Where possible existing trees should be integrated into the new development.

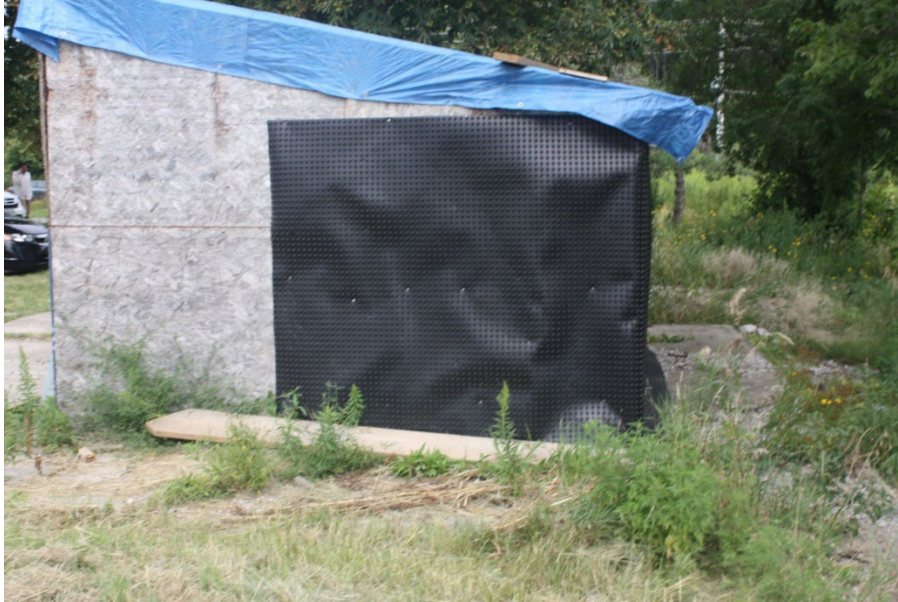
*Figure 82 A plywood shed now sits on the concrete slab that formed the foundation of the demolished garage, 2013 (Photo by author.)*

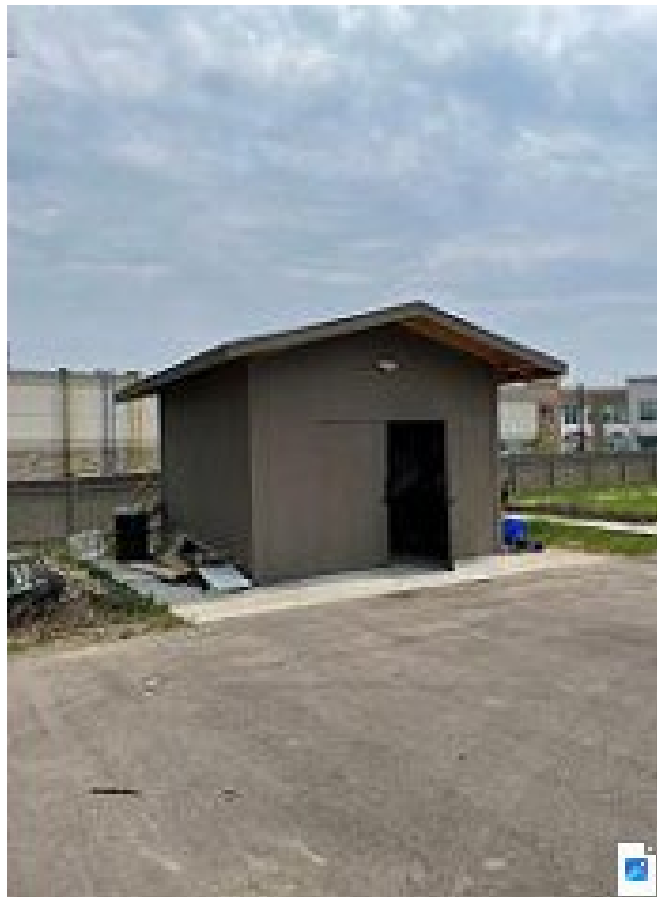
*Figure 83 A replacement shed now sits on the concrete slab that formed the foundation of the demolished garage, 2023 (Photo by owner.)*
