Updated Phase One Environmental Site Assessment

2935 & 2955 Mississauga Road
Mississauga, Ontario

December 3, 2025

File No: 02409377.002

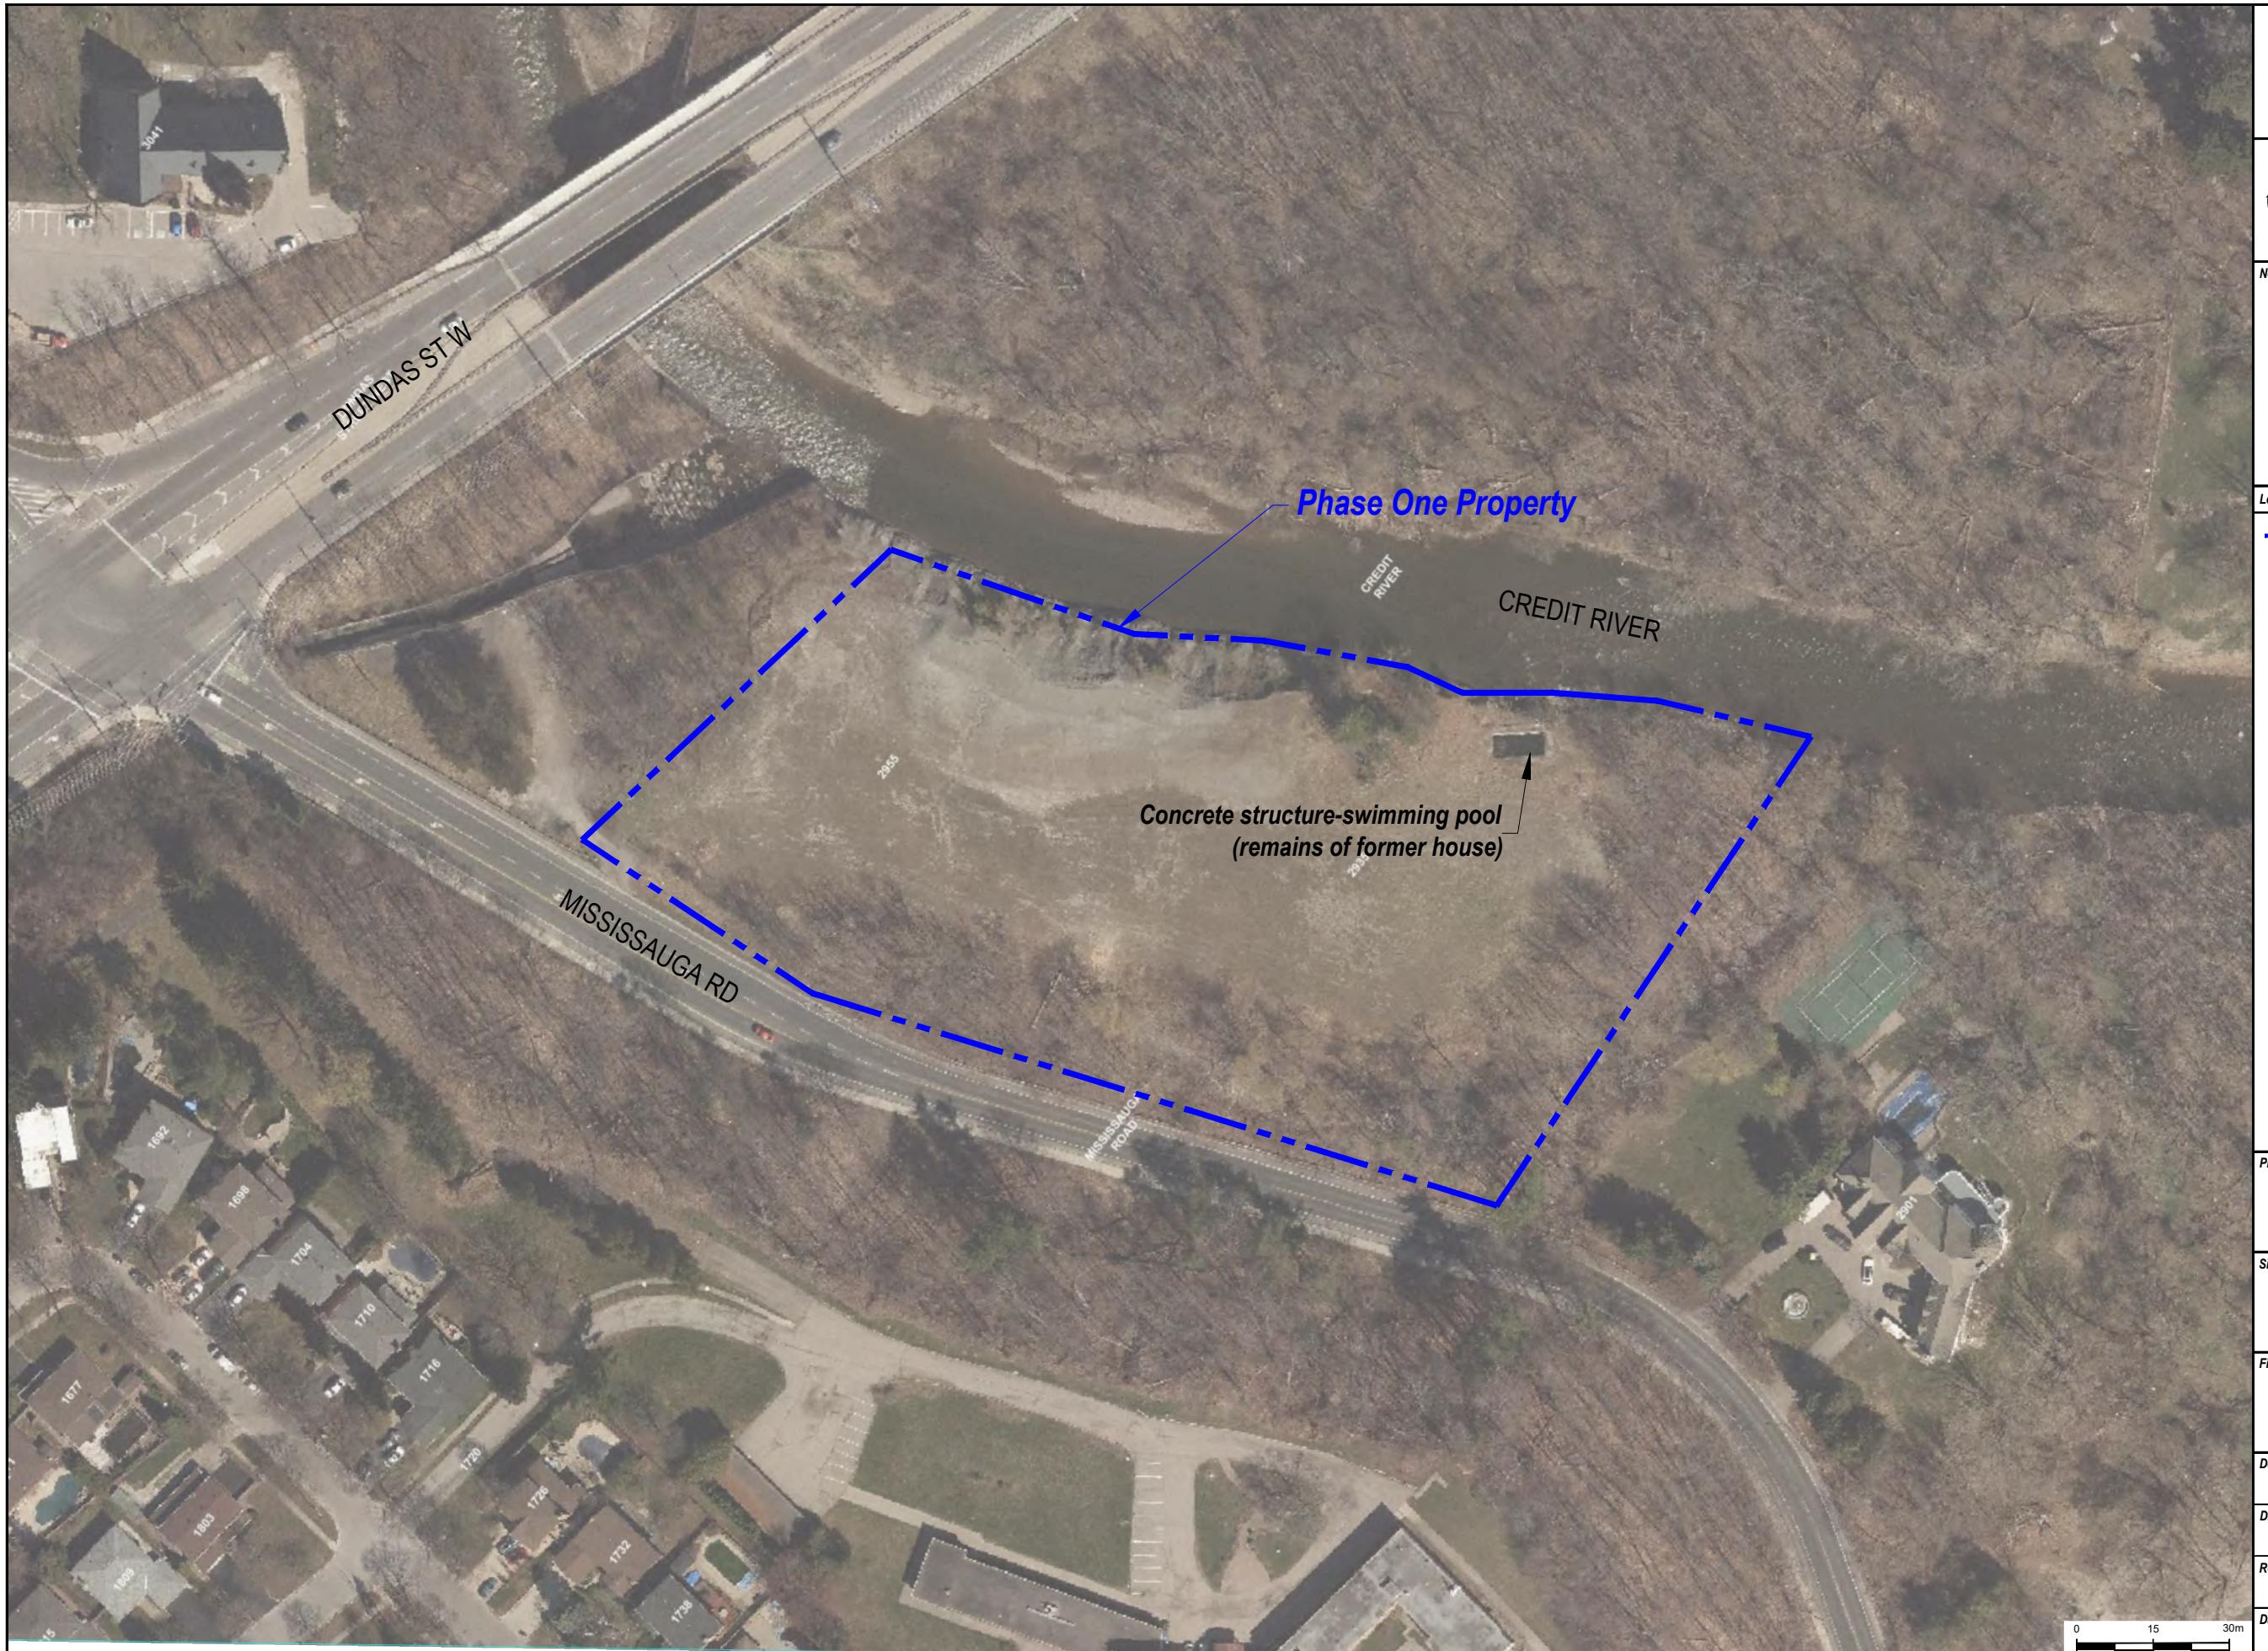
Phase One Property Boundary
Project Title: Updated Phase One Environmental Site Assessment	
Site Location: 2935 & 2955 Mississauga Road, Mississauga, Ontario	
Figure Title: PHASE ONE PROPERTY	
Designed By: SA	File No.: 02409377.001
Drawn By: AA	Scale: As Shown
Reviewed By: MS	Figure No.: 2
Date: Oct 2024	2

The Property is situated at the east quadrant of Mississauga Road and Dundas Street West, in Mississauga, Ontario. The Property is identified with the municipal address of 2935 & 2955 Mississauga Road, Mississauga, Ontario. The Phase One Property is irregular in shape, with a total area of approximately 2.14 hectares (5.28 acres). The Property is currently vacant with remains of a fire damaged dwelling, in the northeast portion of 2935 Mississauga Road. The Property is largely consisting of open land with trees bordering the east, south and west sides of the Property. The north side of the Property slopes down sharply to the bank of the Credit River that flows adjacent to the northern portion of the Property. The surrounding area is largely protected as a green land, conservation lands and parks, the remainder of the study area is predominantly residential, community, and commercial in land use. The location of and extent of the Property is indicated in Figures 1 and 2.

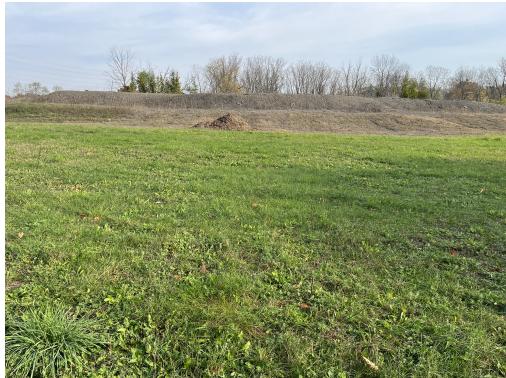
Photograph 1

Location: 2935 & 2955 Mississauga Road

Viewing: Phase One Property

Description: Open land with trees, adjacent

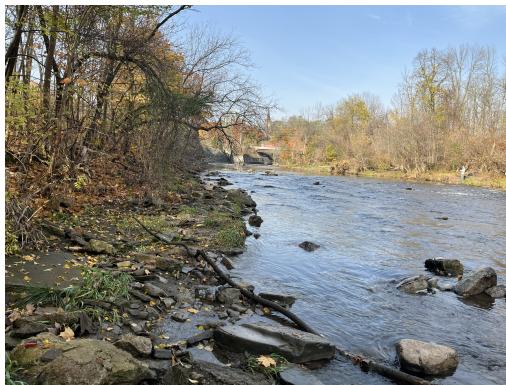
Photograph 2

Location: 2935 & 2955 Mississauga Road

Viewing: Adjacent Property to the North

Description: Credit River

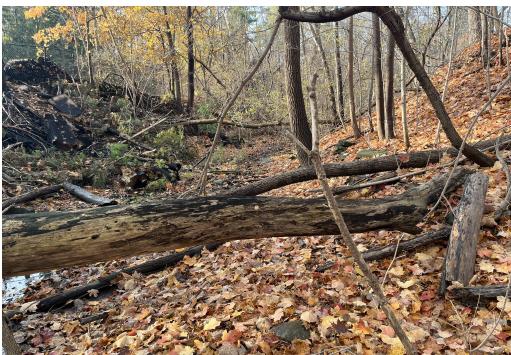
Photograph 3

Location: 2935 & 2955 Mississauga Road

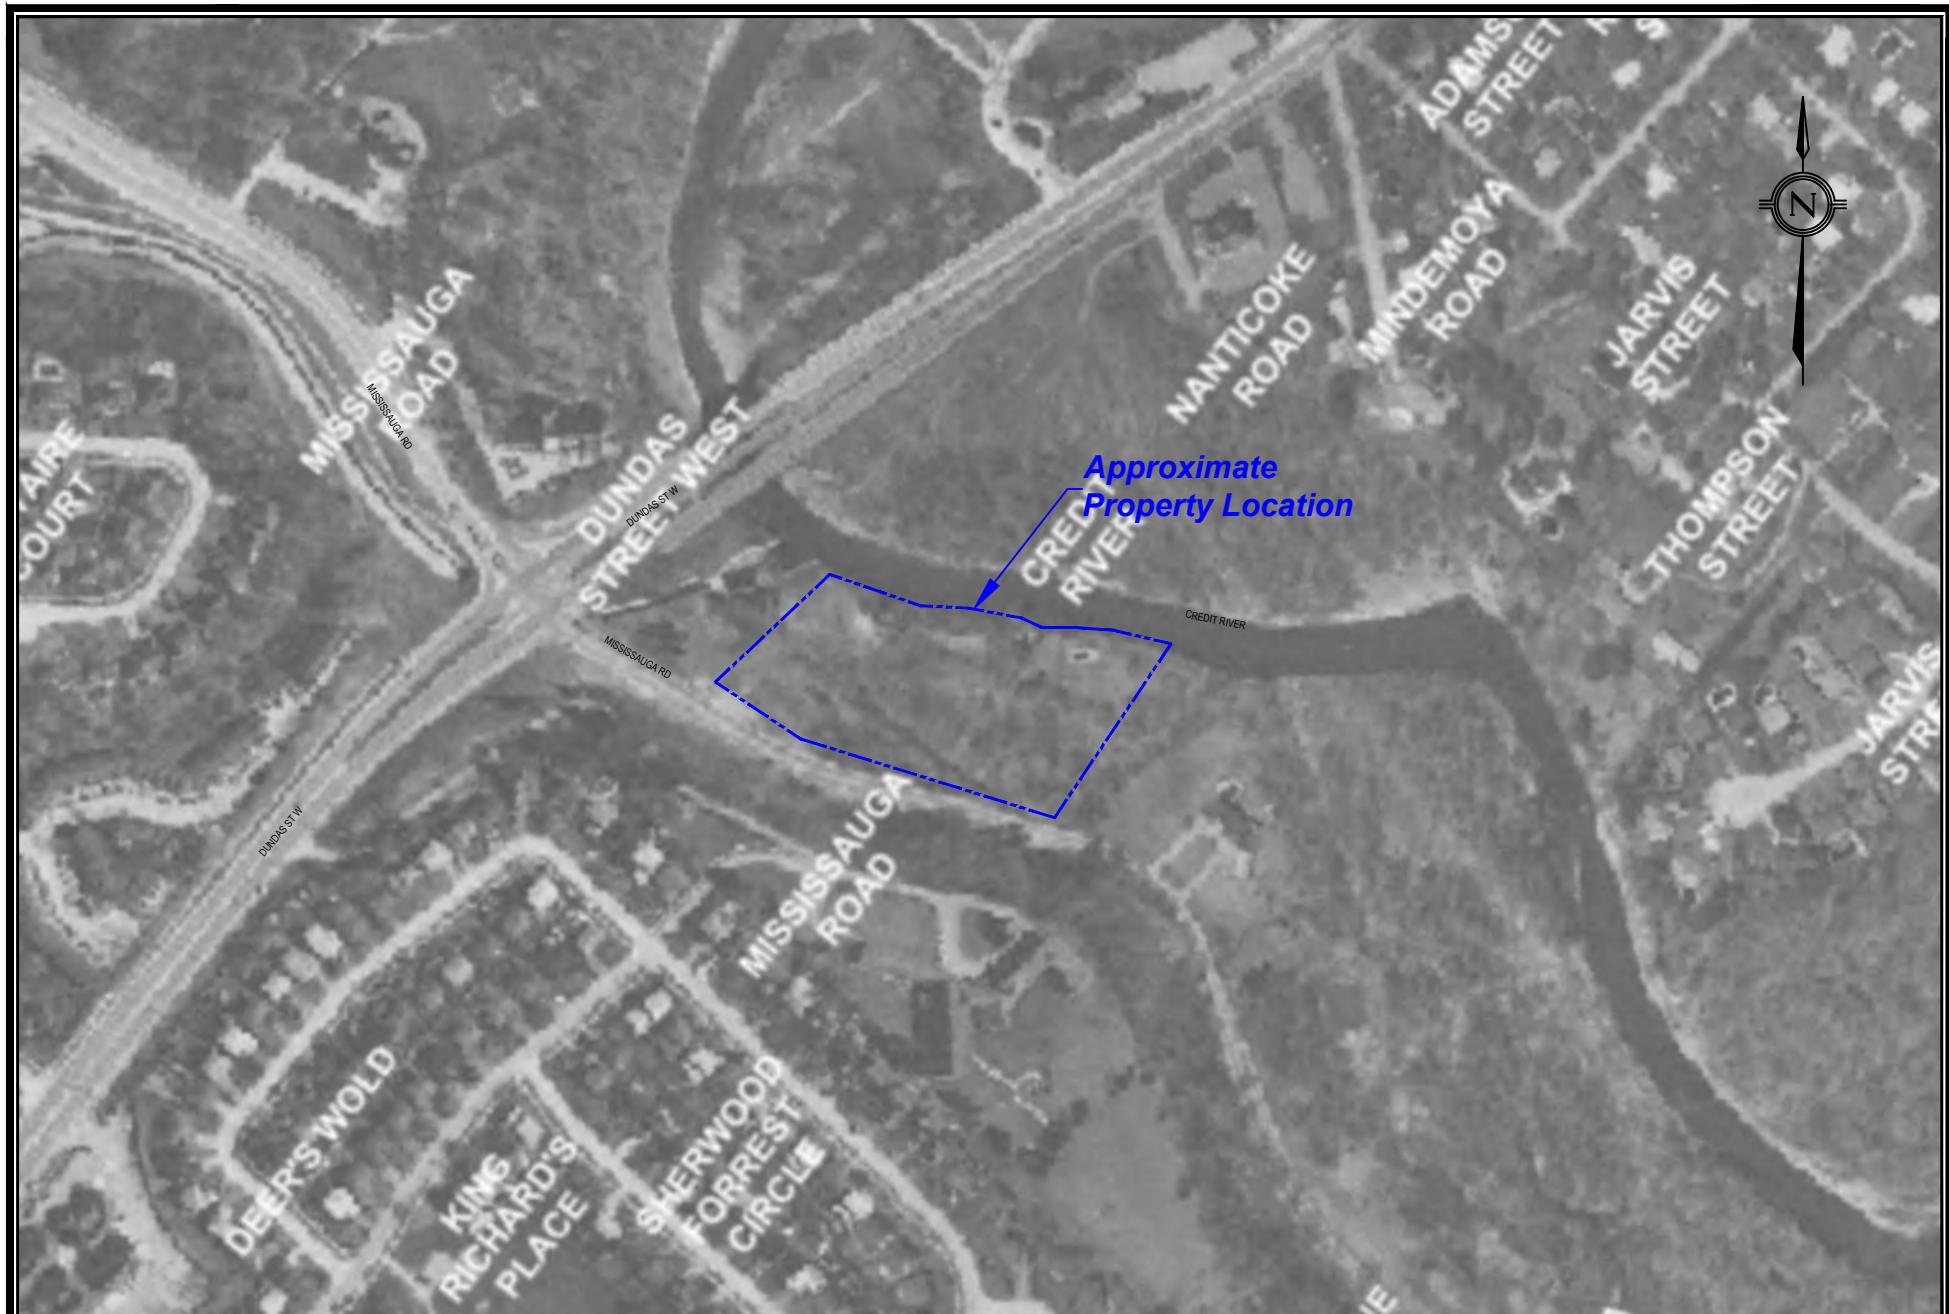
YEAR :
1989

Title: AERIAL PHOTOGRAPH
