51-55 DUNDAS STREET WEST & 60-78 AGNES STREET
MISSISSAUGA, ONTARIO

AUGUST 6, 2025

HERITAGE IMPACT ASSESSMENT

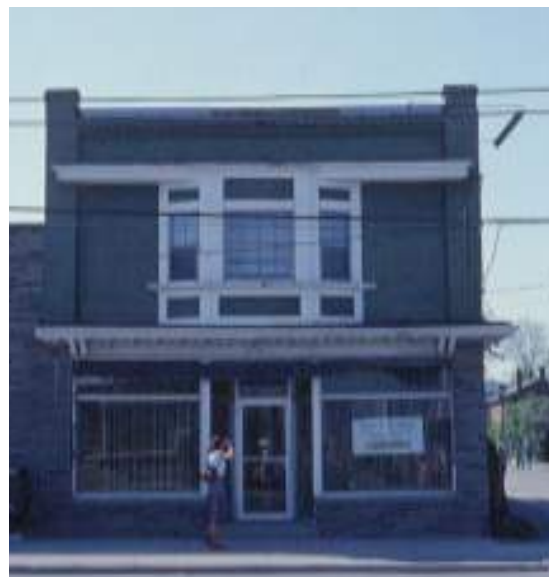
Figure 5. 1978 photo of 51 Dundas Street West. Note: original image was inverted and manually modified above (Mississauga Library, Photo Identifier: A571).

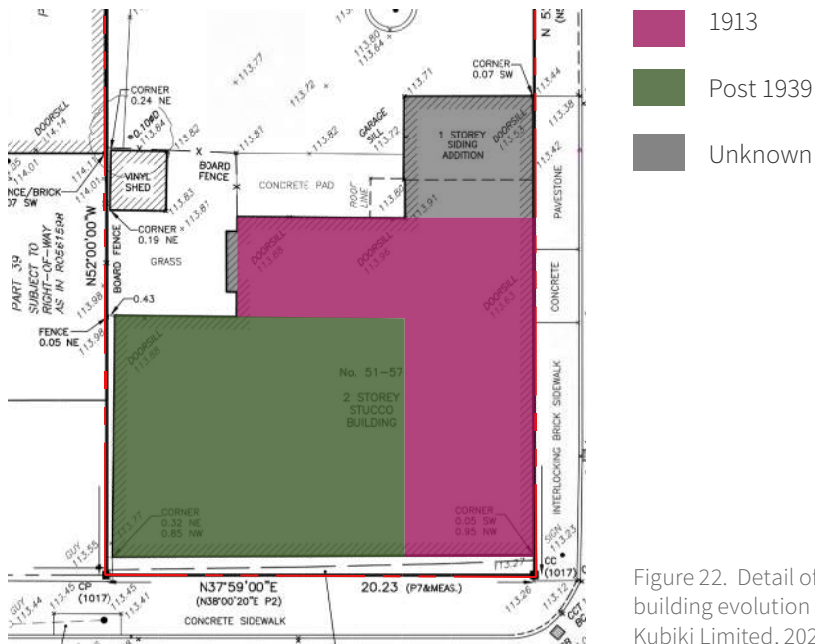
Figure 22. Detail of survey of the Site with the approximate building evolution of 51, 55-57 indicated (Tarasick McMillan Kubiki Limited, 2024; annotated by ERA).

- The two-storey portion of the building was originally clad in rough red brick. Portions of the east, west, and north elevations have since been clad in stucco. All exterior walls, including the attached houseform portion have been painted. Other alterations include: the addition of signage and stone cladding on the south and east elevations, metal over-cladding on the cornice on the south elevation, modifying the height and composition of the brick parapet on the south elevation, and altering the storefront entrance. Windows have been replaced. The one-storey commercial portion to the west is a later addition.

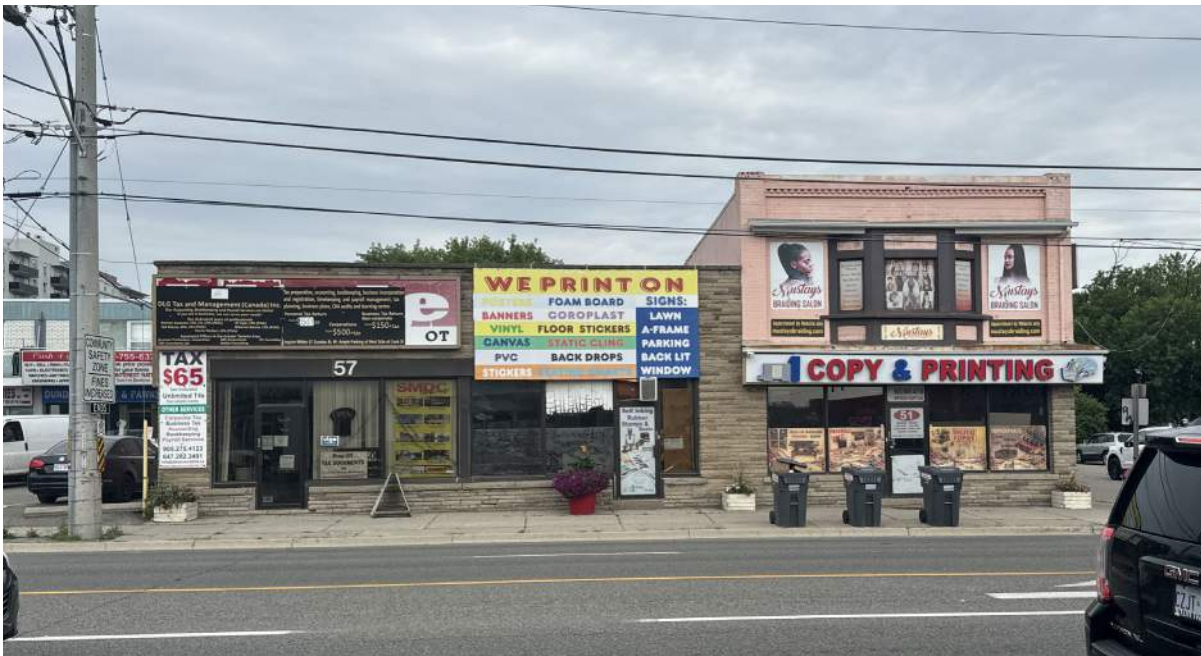
Figure 28. Photo of south elevation of 51, 55-57 Dundas Street West (ERA, 2025).

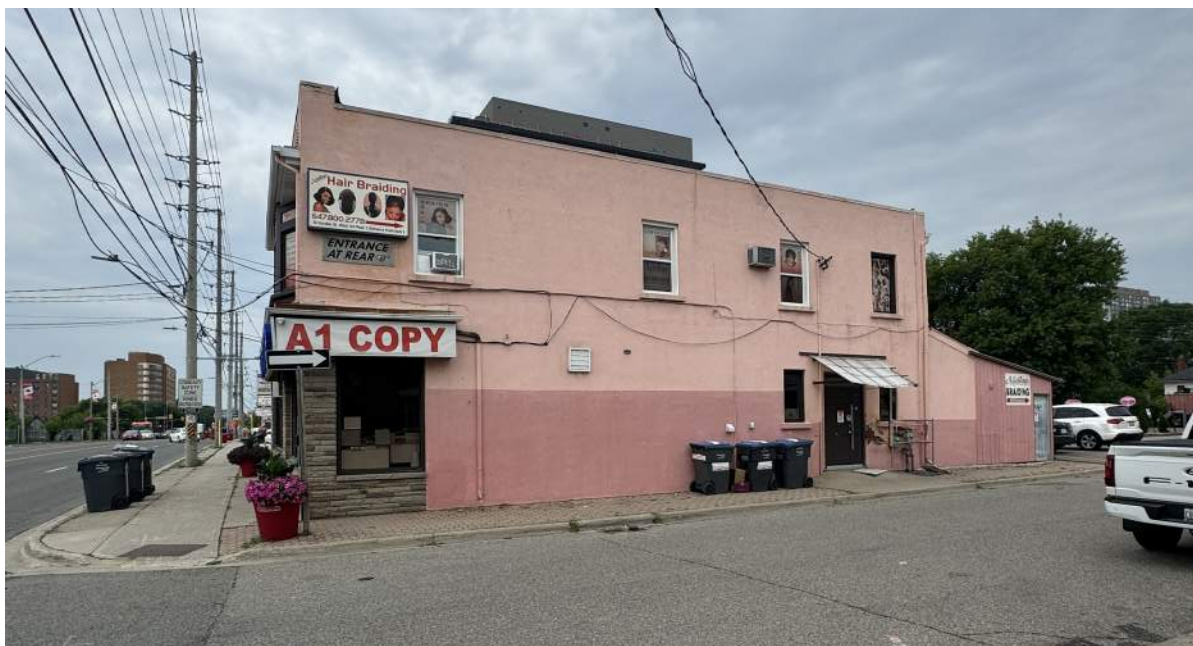
Figure 29. Photo of east elevation of 51, 55-57 Dundas Street West (ERA, 2025).

- At the east elevation, the brick is overclad with stucco. Areas of investigation indicate the stucco is firmly bonded, and it was not possible to remove the stucco without damaging the underlying brick, rendering the brick in defective condition. Brick exposed at the parapet level of the east elevation, beneath the flashing, was in poor condition, showing erosion of the mortar joints.

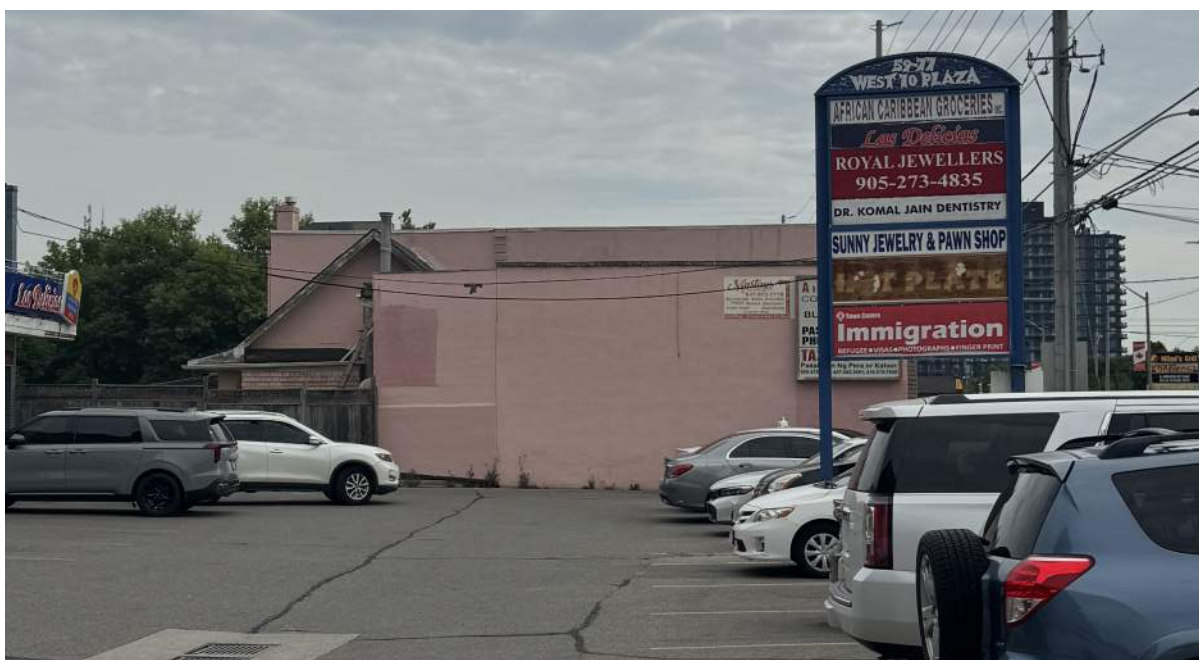
Figure 30. Photo of west elevation of 51, 55-57 Dundas Street West (ERA, 2025).

- The condition of the stuccoed wall at the west elevation, exposed to the exterior above the roof of the adjacent building, is assumed to be similar to the east. At the interior, there is a large opening in the west wall to allow passage between the southern portion and the attached one-storey commercial space, which are combined under one tenancy.

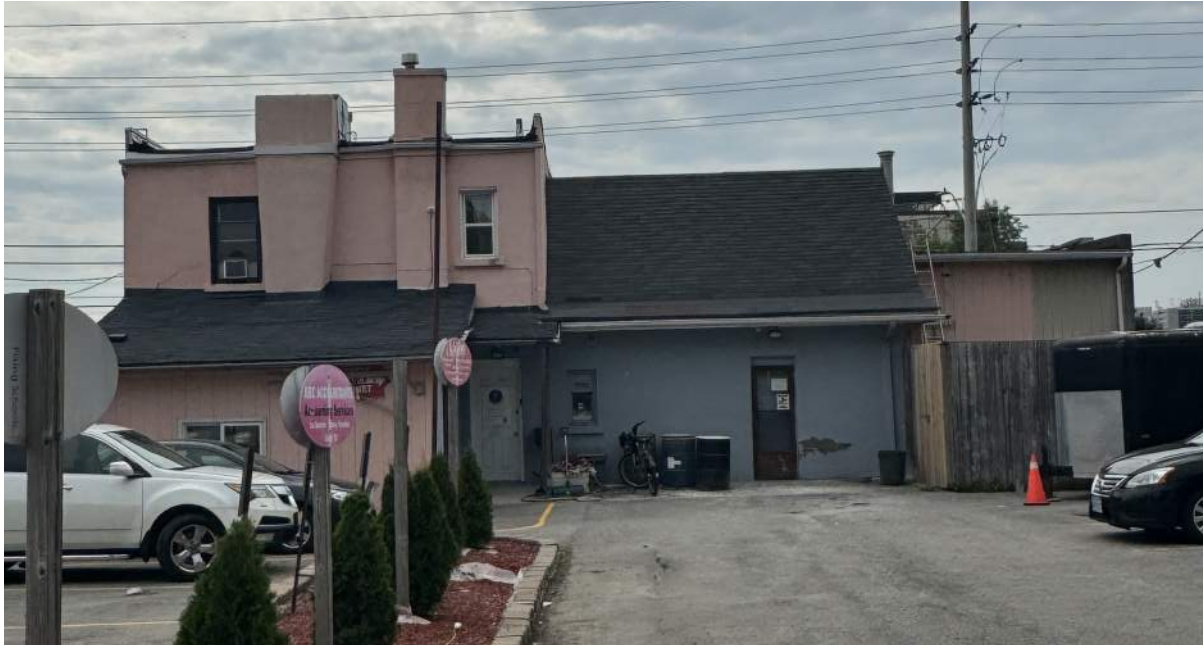
Figure 31. Photo of north elevation of 51, 55-57 Dundas Street West (ERA, 2025).

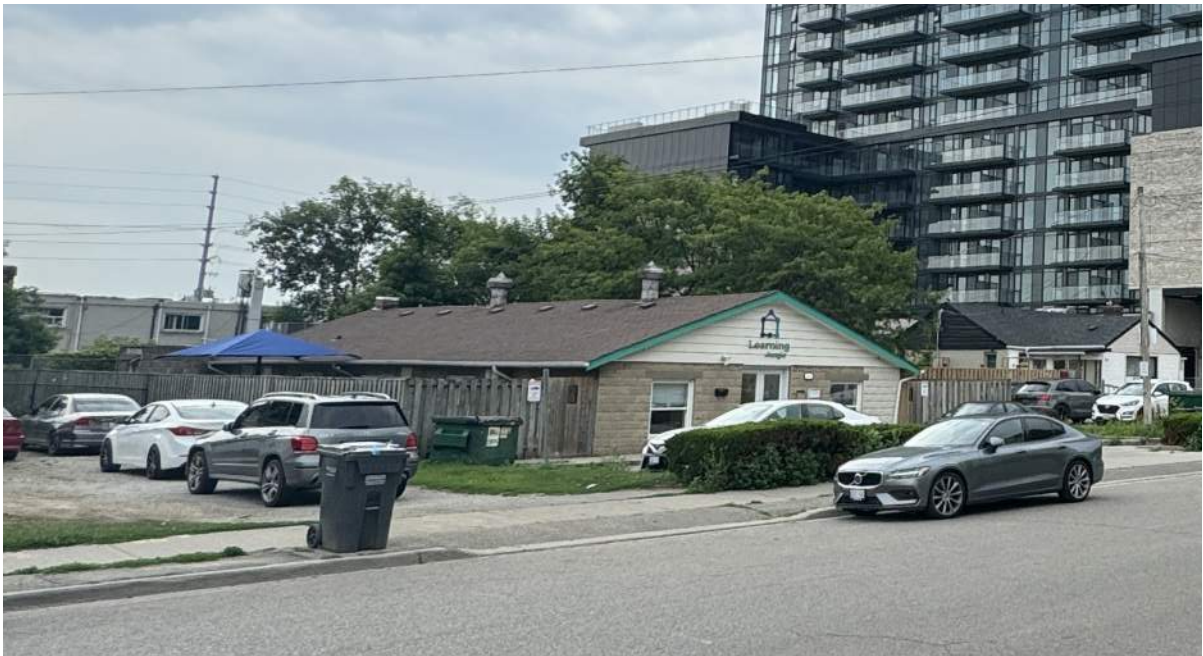
Figure 34. Photo of north and east elevations of 78 Agnes Street (ERA, 2025).

- The concrete block is generally in fair condition, although areas of poor and defective condition are visible towards the south of the building, where significant step cracking and loss of mortar is present.
- The east and west exterior walls have monolithic concrete buttresses along the concrete block walls. The buttresses are of crude construction and are in poor or defective condition, with spalling and severe cracking visible.
- Brick masonry at chimneys on the south and west elevations is in poor condition, exhibiting severe loss of mortar and incompatible repairs.
- Exterior woodwork is generally in poor condition, with loss of finish and water damage visible.
- The retrofit vinyl windows are in fair condition. The retrofit vinyl or metal clad doors are in fair condition.
- The asphalt shingle roof is in fair condition.

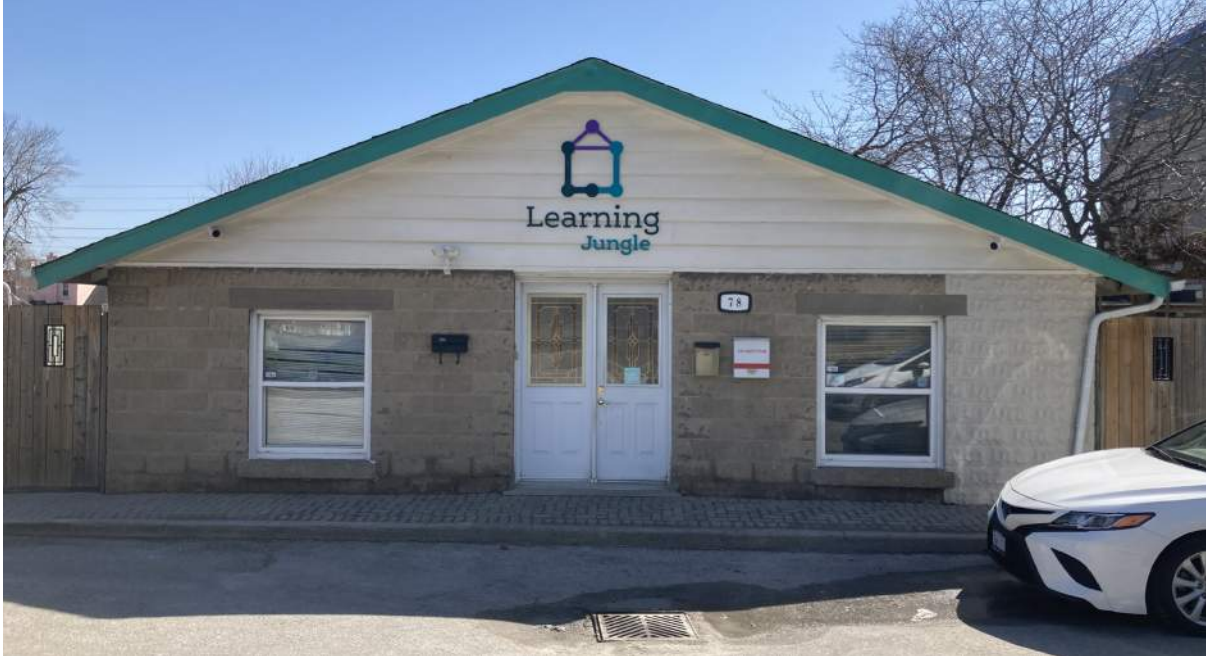
Figure 35. Photo of north elevation of 78 Agnes Street (ERA, 2025).

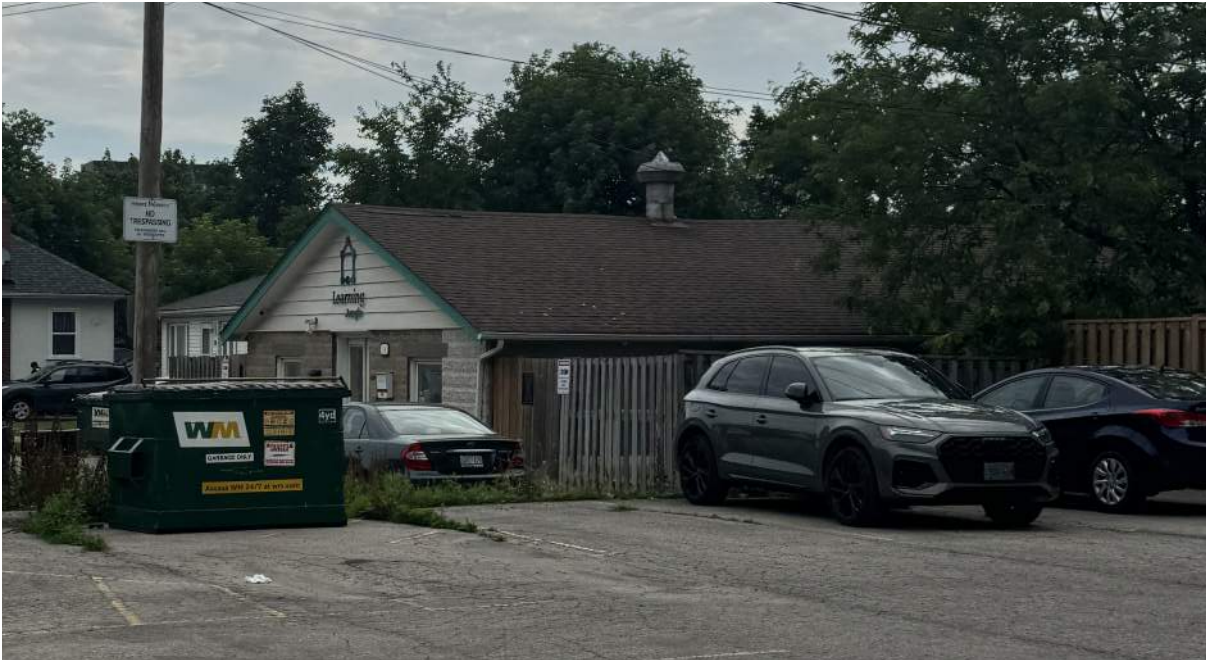
Figure 36. Photo of north and west elevations of 78 Agnes Street (ERA, 2025).

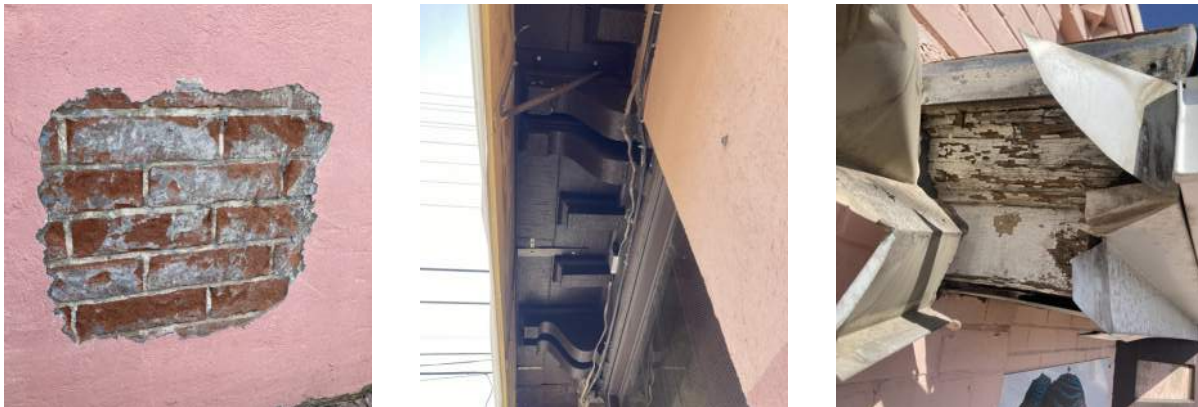
Figure 37. Left to right: 51 Dundas Street West detail photos of brick found beneath stucco of east elevation; underside of the lower storefront cornice woodwork at south elevation; and the woodwork found beneath the metal cladding of the upper cornice at south elevation (ERA, 2025).

The building at 51, 55-57 Dundas Street East is generally in fair condition, with areas in poor or defective condition.

- Brick cladding on the south elevation is painted, concealing the underlying condition. At the parapet level on the south elevation, the brick is in poor condition, exhibiting step cracking.

- Woodwork at the parapet level cornice on the south elevation was exposed by Arcana, removing prefinished metal overcladding. The cornice woodwork is in poor condition, with loss of finish, separation of components, and water damage visible.

- Wood brackets and soffit were visible without any destructive investigation. The woodwork is exposed beneath the signage band located above the storefront on the south and east elevations. The wood soffit and brackets are painted, concealing their underlying condition.

- The retrofit vinyl or metal windows are in fair condition. The retrofit vinyl or metal doors are in poor condition. The metal storefront assembly at south elevation in poor condition. The framing of the bay window at the south elevation is clad in prefinished metal and in fair condition. The exposed wood panels are in poor condition, where loss of paint finish and potential water damage is visible.

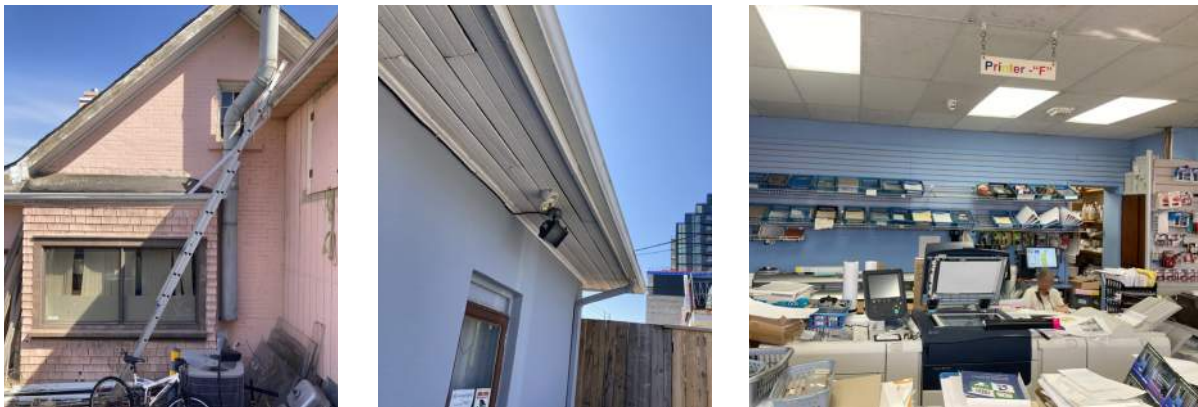
Figure 38. Left to right: 55-55 Dundas Street West detail photos of west elevation; wood soffit at north elevation; interior view looking north at the junction between the houseform building and the addition to the south (ERA, 2025).

- Exterior brick masonry on the houseform building visible at the west gable appears intact although it is painted, thereby concealing the underlying condition. All other exterior walls are either overlaid with stucco or concealed by abutting construction.

- Woodwork at the houseform building, including gable fascia, soffit and wood cladding, is in poor or defective condition.
- The retrofit metal windows are in fair condition, and the wood window at west gable is in poor condition. The retrofit metal door at north elevation is in poor condition. The metal storefront assembly at south elevation of the one-storey commercial addition is in poor condition.

- The asphalt shingle roof of the houseform building is in fair condition. The roof of the one-storey commercial addition was not accessed for this assessment.

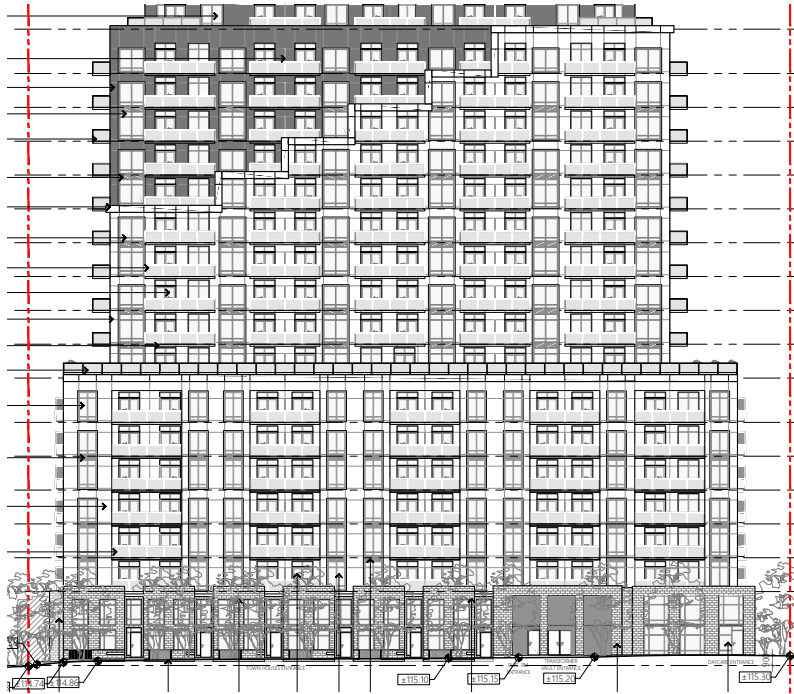
Figure 46. Excerpt of proposed west elevation (RA Lumbao Architects, 2025).

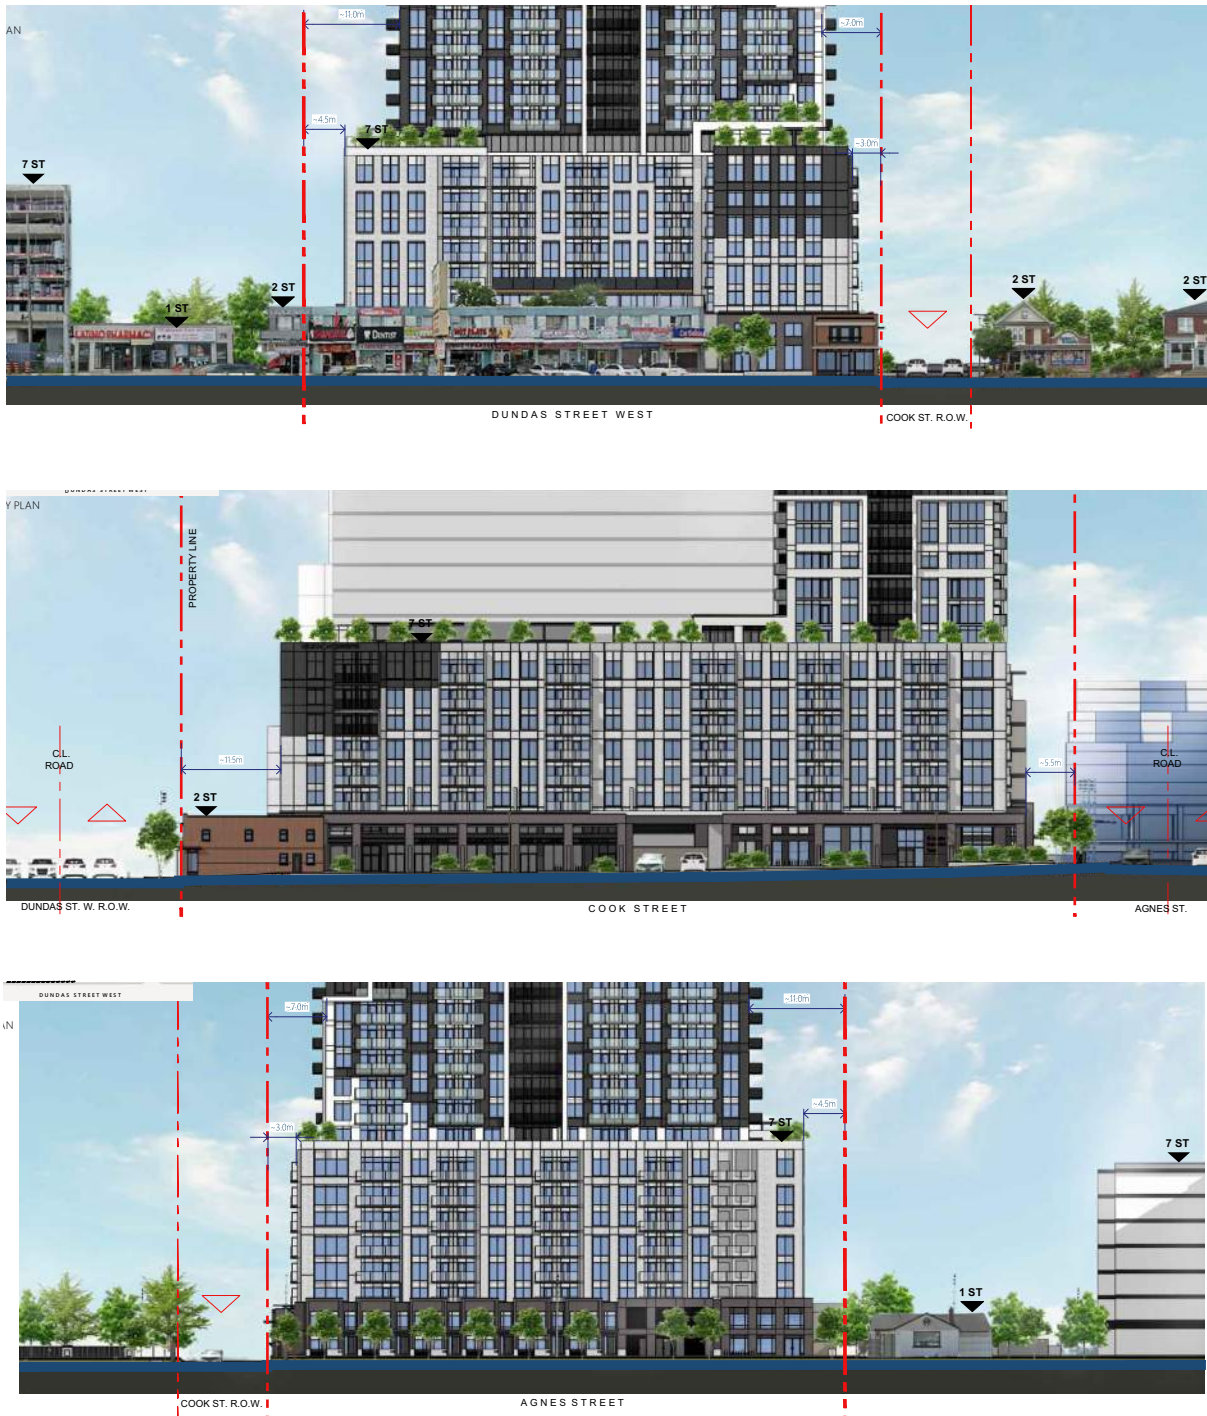
Figure 49. Elevations of the proposed development within the streetscape as shown along (top to bottom) Dundas Street West, Cook Street, and Agnes Street (RA Lumbao Architects, 2025).

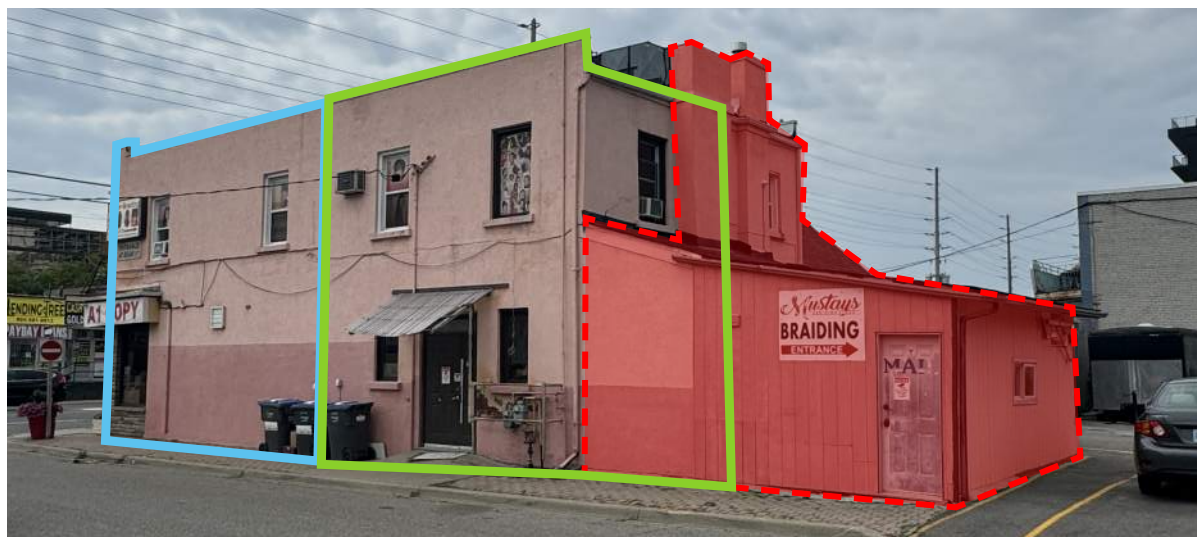
☐ Retained

Dismantled and reconstructed

Removed

Figure 50. Photo of the west and partial north elevations with approximate overlays showing the general conservation approach for 51, 55-57 Dundas Street West (ERA, 2025).

The dismantling of the northern portion of the original two-storey building will be mitigated by the in-situ retention and conservation of the southern portion of the building to a depth of approximately 8 metres, which will maintain the presence of the building in the streetscape. The ERA-identified heritage attributes of the Site are found on the south elevation and will be retained in situ.

The north portion of the east elevation, as well as a portion of the north return wall will be reconstructed to contribute to the three-dimensional legibility of the resource and help reinstate the original appearance of the building. Existing material from the northern portion will be salvaged for use in the conservation of the southern portion. Conservation work across the retained elements will extend the longevity of the resource. Refer to the conservation strategy summary for more detail.

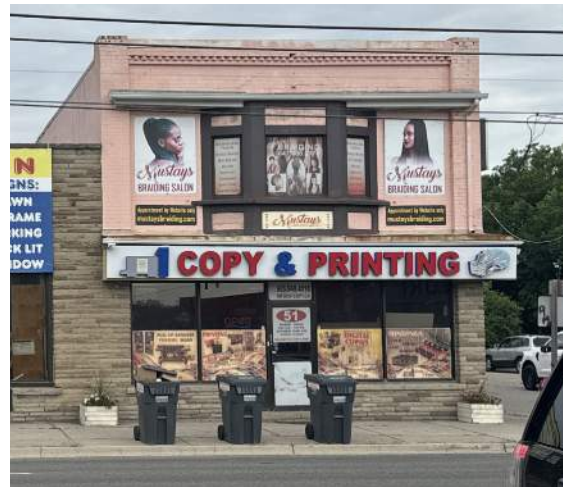
Figure 53. Photo of south elevation of 1913 portion of 51, 55-57 Dundas Street West (ERA, 2025).

Impact: Demolish existing storefront and stone cladding at the ground floor level on the south elevation of the original two-storey building

Rationale and Mitigation: The storefront at the ground floor of the south elevation will be replaced by a new historically-appropriate storefront configuration. The angel stone will be removed from the exterior masonry walls, exposing the original brick walls.

- New storefront assembly with recessed entrance, based on archival documentation; and
- Conservation work to the retained portion of the building will be implemented in order to address existing conditions and bring the retained building into a state of good repair. Work includes:

- General masonry repair and cleaning;
 - Selective masonry replacement using salvaged material in sound condition or new to match existing;
 - Repair or replace woodwork where needed; and

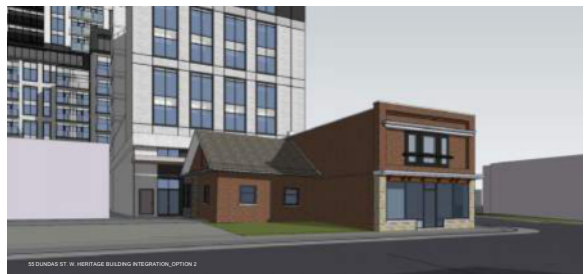
Figure 55. Rendering of proposed development option with houseform attachment (RA Lumbao Architects, 2025).

Another option considered the retention of the one-storey houseform structure located at the northern portion of the building. This option was not pursued due to the structure's poor condition and lack of integrity, and due to the lack of archival information available to understand the original appearance and form of the one-storey houseform structure, thereby limiting the ability to reconstruct the structure based on historical documentation.

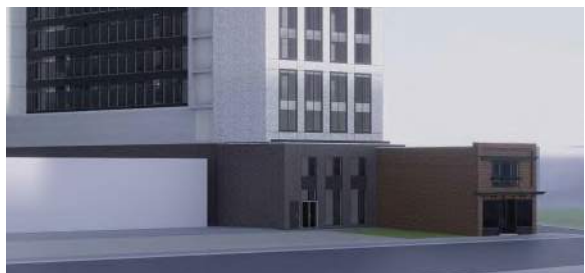
Figure 57. Rendering of the preferred strategy (RA Lumbao Architects, 2025).

The preferred and selected option as presented in this report includes the retention of the two-storey portion of the building with abutting new construction that does not include a projecting canopy. In addition to providing three dimensional legibility of the heritage building within the proposed development, the selected strategy provides a conservation strategy informed by available historic documentation.
