## Phase One Environmental Site Assessment

580 Hazelhurst Road, Mississauga, Ontario  
G2S19650

2715623 Ontario Inc.

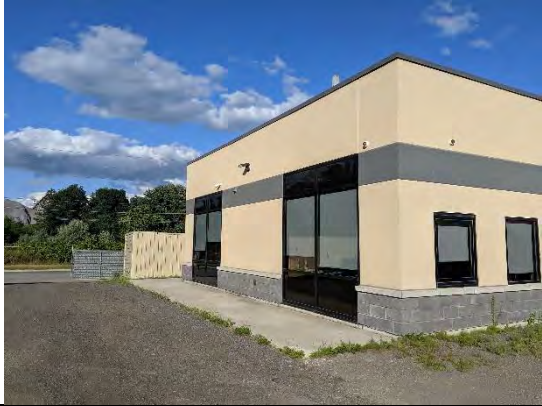
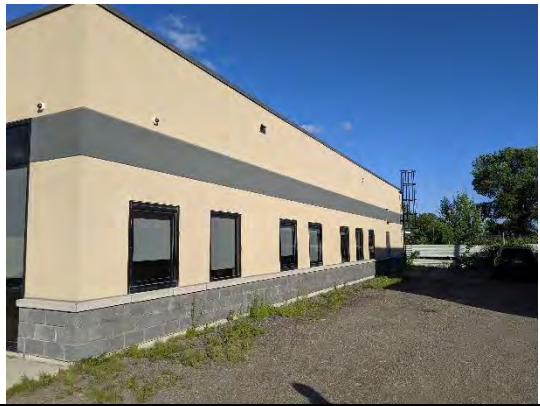
<b>Photo #1:</b> North exterior of office Site building, facing east.	<b>Photo #2:</b> Southwest exterior of office Site building, facing east.

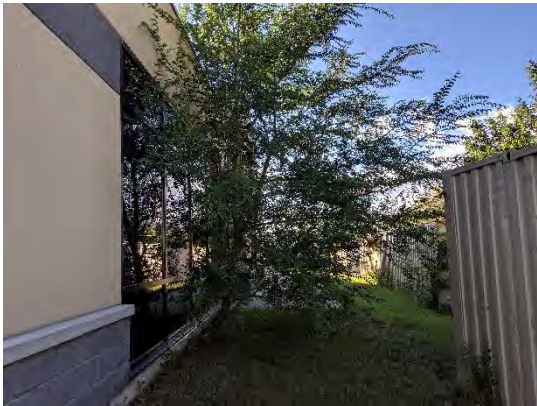
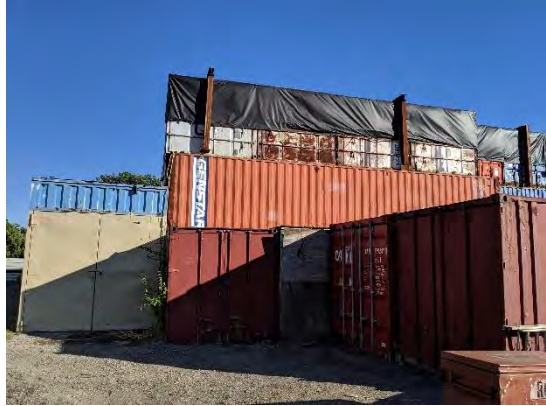
<b>Photo #5:</b> Northeast exterior of office building, facing north.	<b>Photo #6:</b> North exterior of seacan building, facing southeast.
