## Phase One Environmental Site Assessment

**Commercial Property**  
2155 Leanne Boulevard  
Mississauga, Ontario  
L5K 1K8

**April 14, 2026**

**OHE Project No.: 31865**

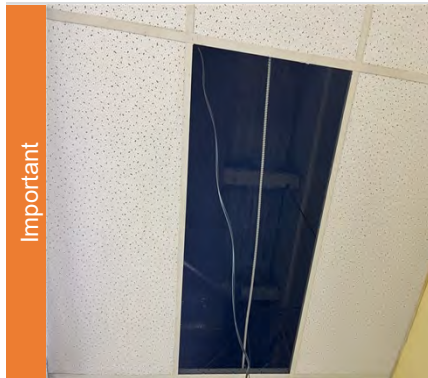
### COM-BUILDING CONSTRUCTION - Missing ceiling tiles

Missing ceiling tiles were noted in multiple areas. Missing ceiling tiles could lead to fire spreading into a combustible space that is inaccessible to firefighters. Additionally, missing ceiling tiles may lead to compromised structural steel, which could be weakened by heat leading to a possible building collapse. To prevent the spread of smoke and fire, we recommend that all missing ceiling tiles be installed.

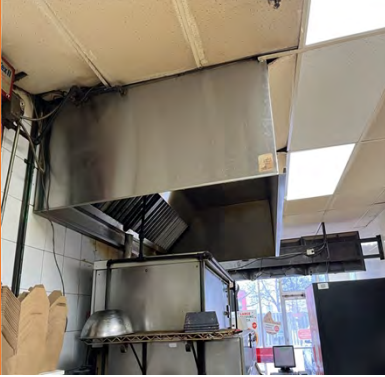
#### COM-COMMERCIAL COOKING - No exhaust system tag

There is no tag on the exhaust system indicating when the last professional cleaning was performed. Accumulation of residues in and around cooking equipment is a fire hazard which may lead to significant losses. The entire exhaust system, including grease extractors, should be inspected at intervals of not greater than 7 days to determine if grease or other residues have been deposited within. When grease or other residues are evident as deposits within the hood, grease removal devices, or ducts, the system should be cleaned. Exhaust systems should be professionally cleaned at intervals not greater than 12 months. However, in cases of deep fat cooking, char broiling, or similar cooking operations, the systems should be cleaned at intervals not greater than 6 months. Records of tests and a schedule of future testing should be maintained in the kitchen office.

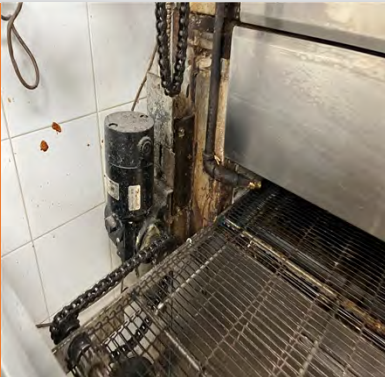
#### COM-COMMERCIAL COOKING - Cooking appliances grease accumulation

The pizza oven were showing signs of significant grease build-up. Accumulations of grease deposits may increase the risk of a fire. Grease removal devices, fume hoods, fans, ducts and other appurtenances should be cleaned to bare metal at frequent intervals prior to surfaces becoming heavily contaminated with grease or oily sludge. To reduce grease accumulation and the potential for a fire and allow the fire system to function properly, we recommend that improvements be made to the cleaning schedule.

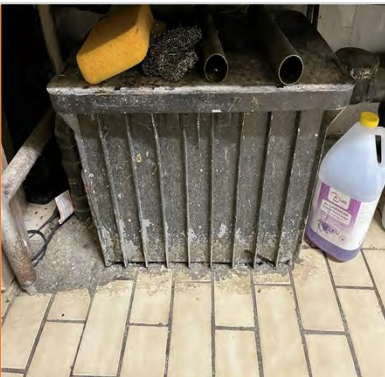
#### COM-COMMERCIAL COOKING - Staff cleaning grease trap

At the time of inspection, it appeared that the staff was cleaning the grease trap. A grease trap/interceptor must be examined and cleaned at least once every 90 consecutive days; or when the total thickness of fats, oils and grease, and solids in the grease interceptor is equal to 25% or more of the wastewater depth. Due to the complexity of cleaning, examination, and inspection of the trap/interceptor, expertise or repair of replacement of parts, and the requirements for maintaining the requisite maintenance log, we strongly recommend that a professional be contracted to provide the service.

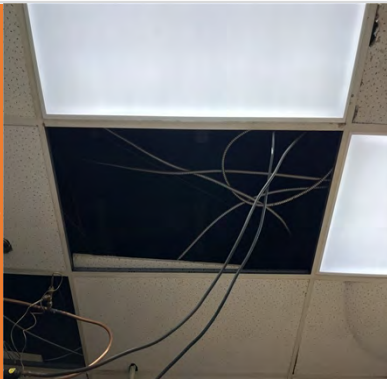
#### COM-ELECTRICAL - Loose wiring

Branch wiring were not properly secured in above the ceiling and in overall electrical wiring. Loose wires can cause connections to work loose, create a short circuit and possibly cause a fire. In order to ensure that the installed system is adequate and free of any potential electrical hazards, we recommend that a licensed electrician be retained to inspect and review the electrical system and electrical equipment. The system should be inspected to ensure that there are no major faults, weak points or loose connections and any necessary replacements/upgrades be made by a certified electrician to meet the safety requirements of the Code.

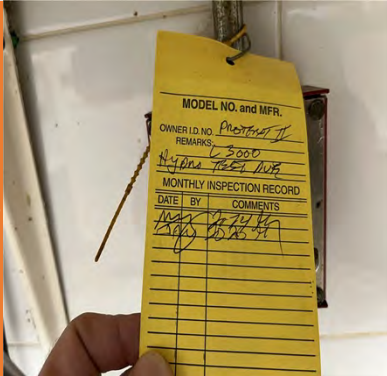
#### COM-PORTABLE FIRE EXTINGUISHERS - No hydrostatic testing

The fixed fire suppression system lacked adequate hydrostatic testing. The lack of hydrostatic testing may result in the system not adequately operating in the event of a fire. In order to ensure that the system will operate as designed, we recommend that hydrostatic testing be completed. All hydrostatic tests should be completed by certified professionals under strict guidelines with inspections occurring (at minimum) every 5 years.

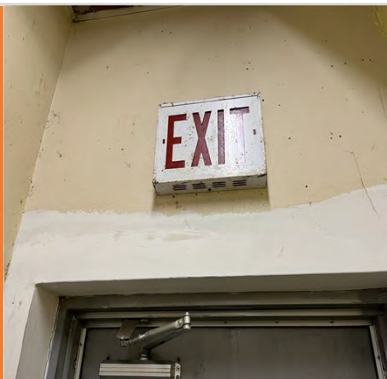
#### COM-LIFE SAFETY - Exit signs are not lit

Rear emergency exit sign was not lit which could lead to occupants being unable to locate an exit in an emergency. Emergency exit signage is especially important when smoky conditions exist and visibility is limited (ex. in a fire) as they will direct persons towards determined emergency routes. To ensure life safety and safe egress, we recommend that all emergency exit signs be continuously illuminated and inspected on a regular basis to ensure operation.

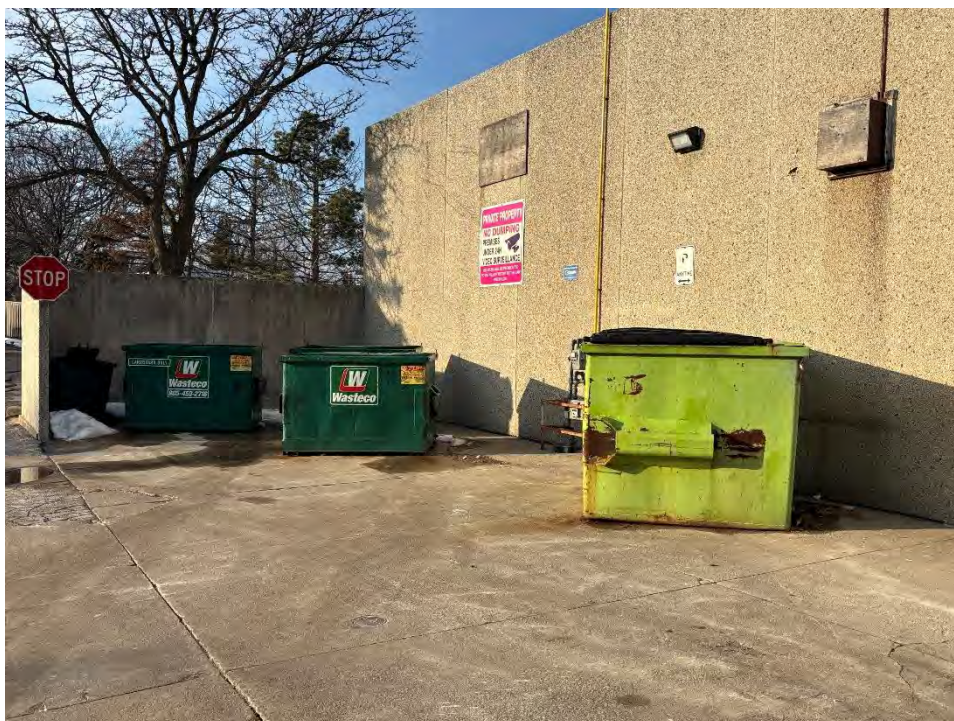
**Photograph 8:** View of the recycling and garbage dumpsters located to the northwest of Building B at the Property.

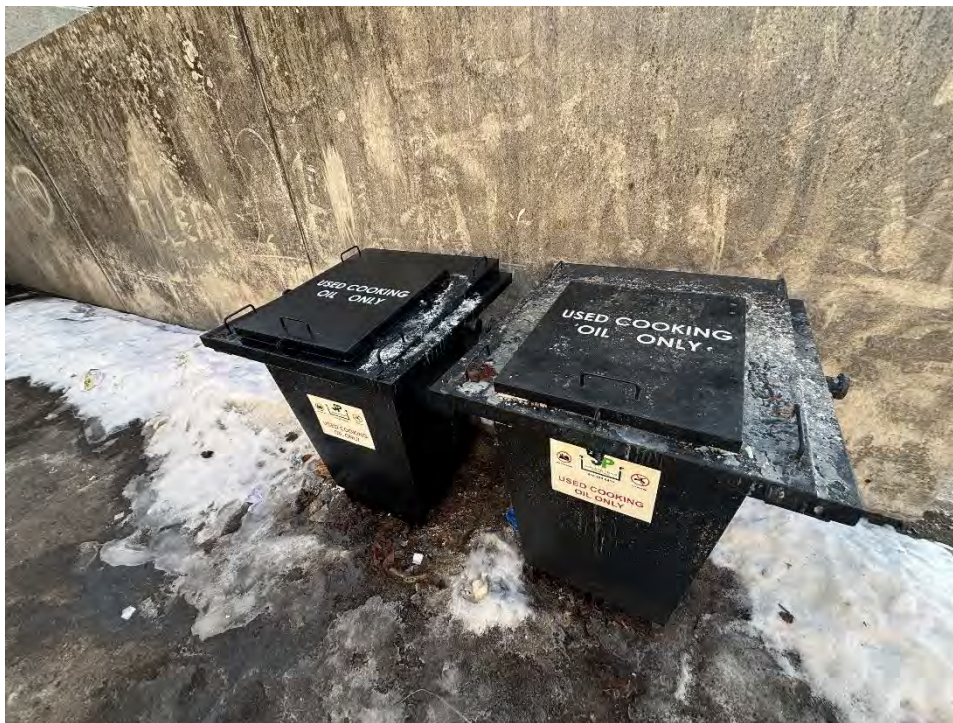
**Photograph 9:** View of the used cooking oil bins located to the northwest of Building B at the Property.

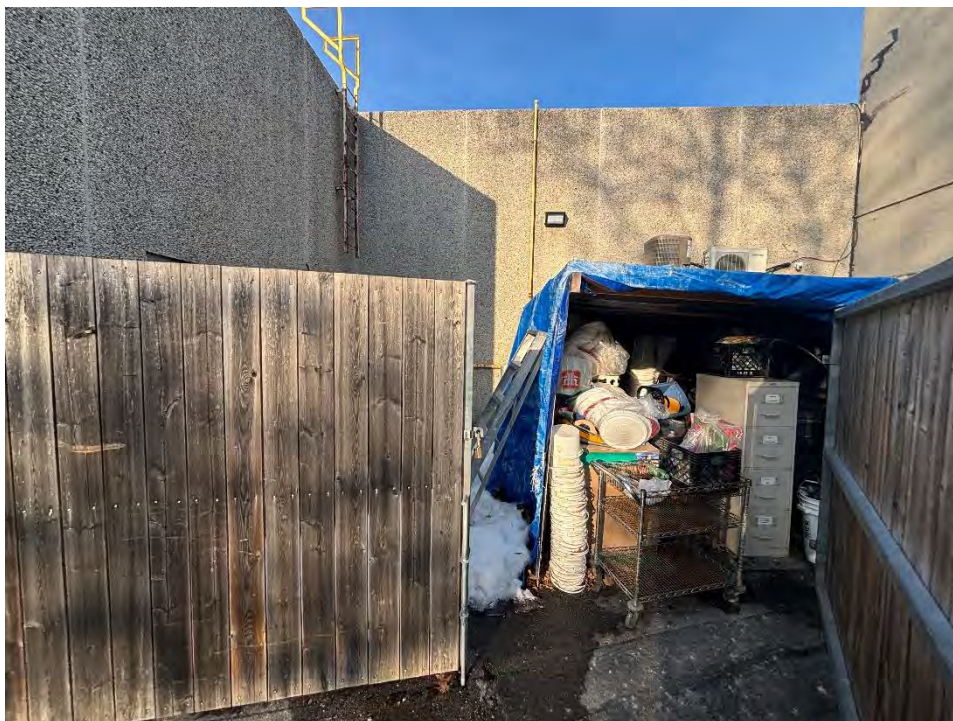
**Photograph 10:** View of makeshift storage located to the southwest of Building A at the Property.

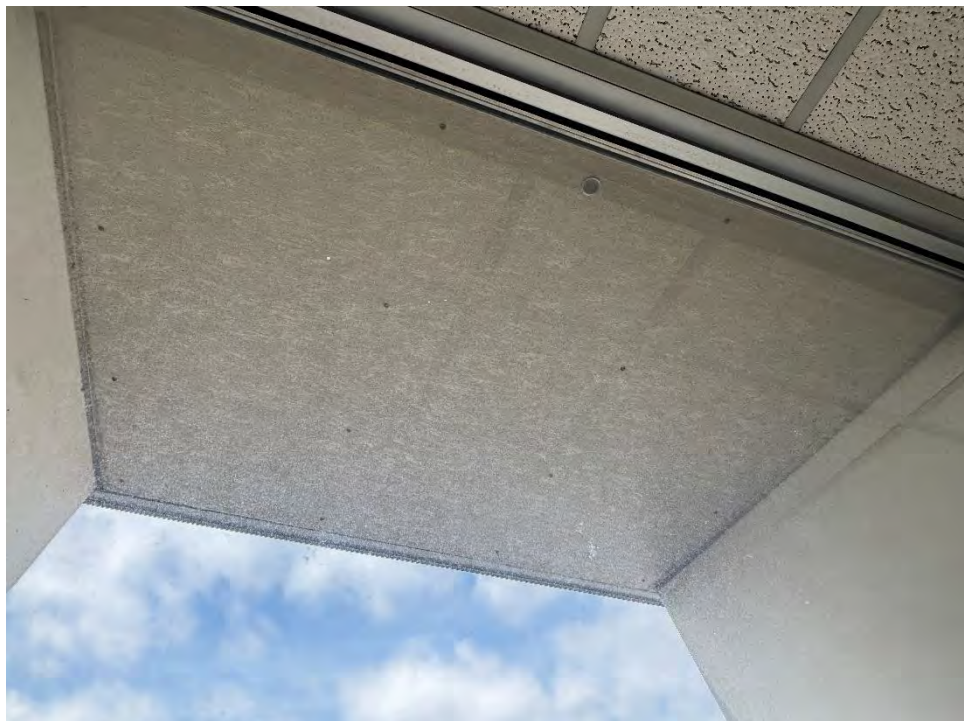
**Photograph 19:** View of potential non-friable asbestos-containing Transite cement panels on the exterior canopies of Building B at the Property.

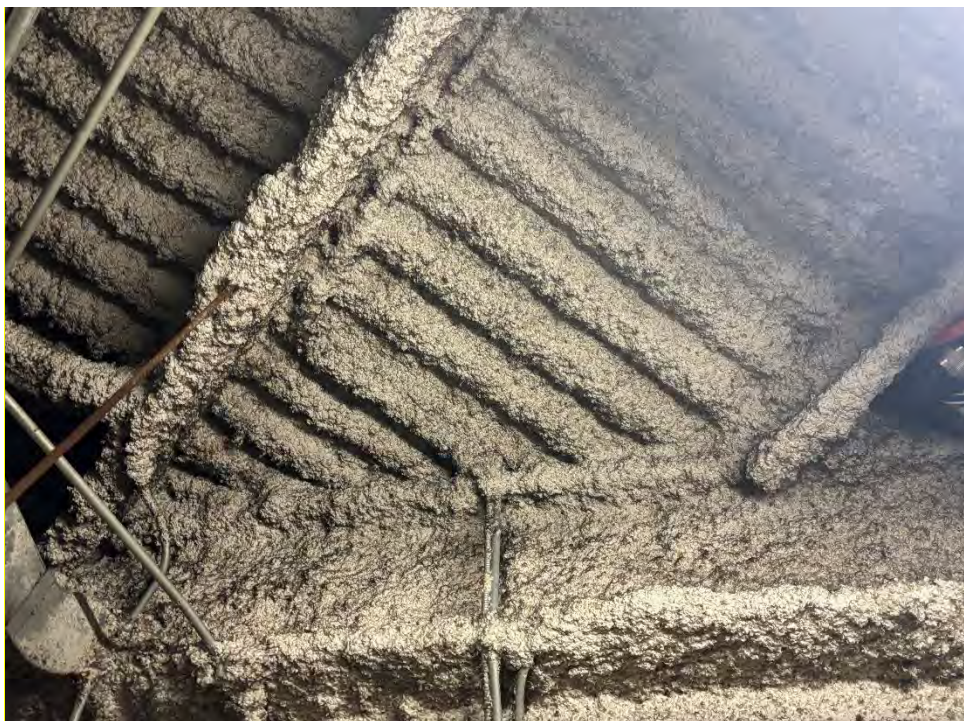
**Photograph 20:** View of potential friable asbestos-containing sprayed fireproofing located on the ceiling deck of Building B at the Property.

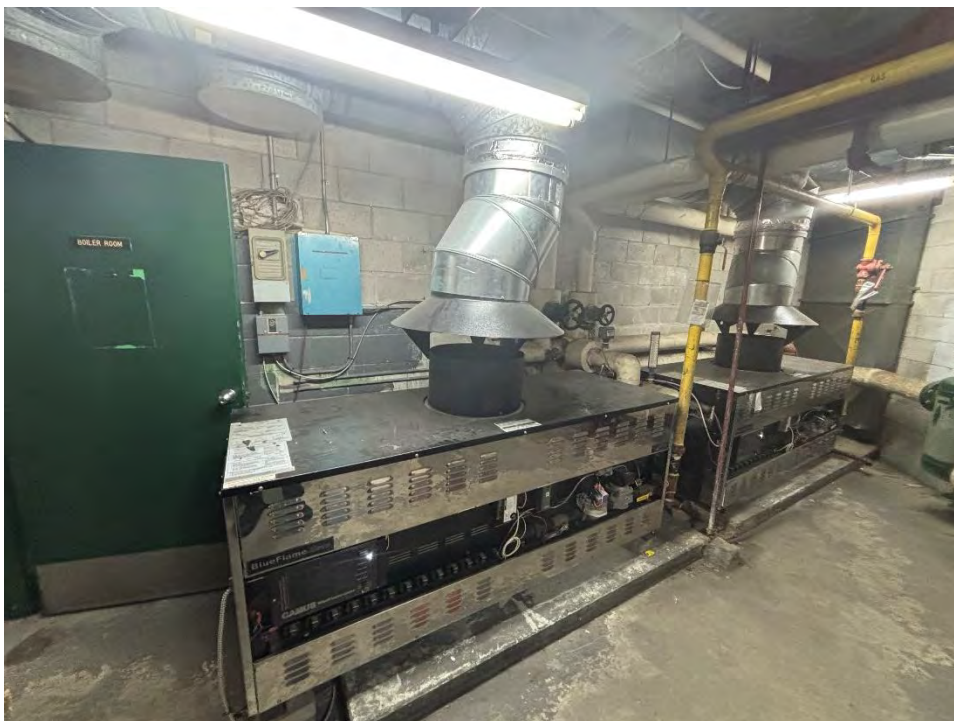
**Photograph 24:** View of the boiler room of Building B at the Property.

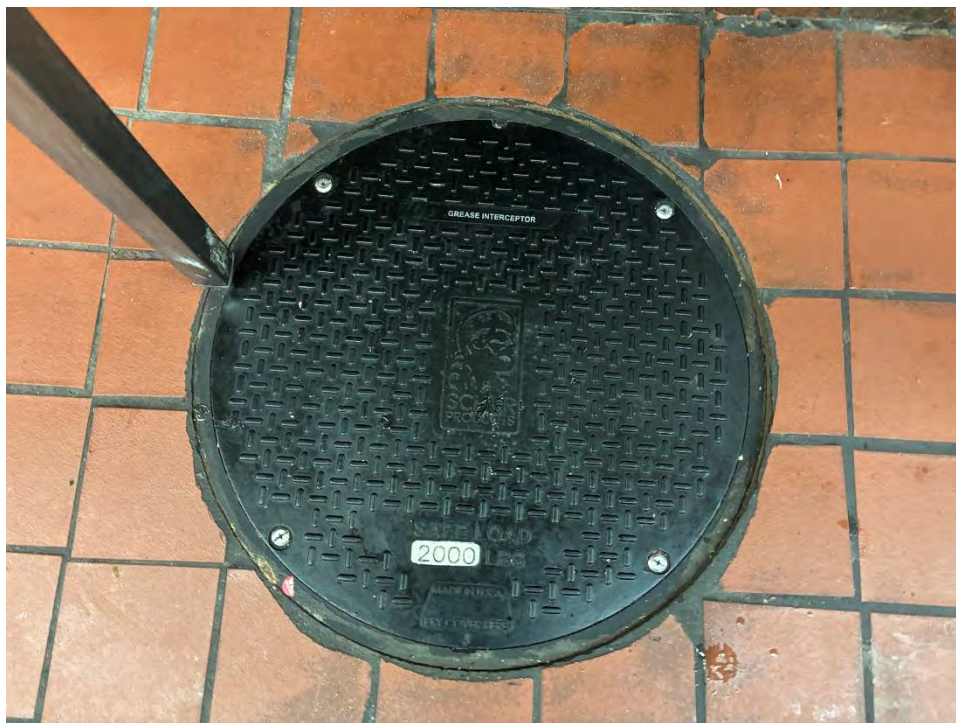
**Photograph 26:** View of the grease interceptor located in Unit 106 (Swiss Chalet) in Building A at the Property.
