2233 & 2235 Hurontario Ltd.  
1400-3280 Bloor St. W., Centre Tower  
Toronto, ON M8X 2X3

File No. 24-099  
April 15, 2026

**Subject: Slope Opinion Letter**  
**2233 & 2235 Hurontario Street, Mississauga, Ontario**

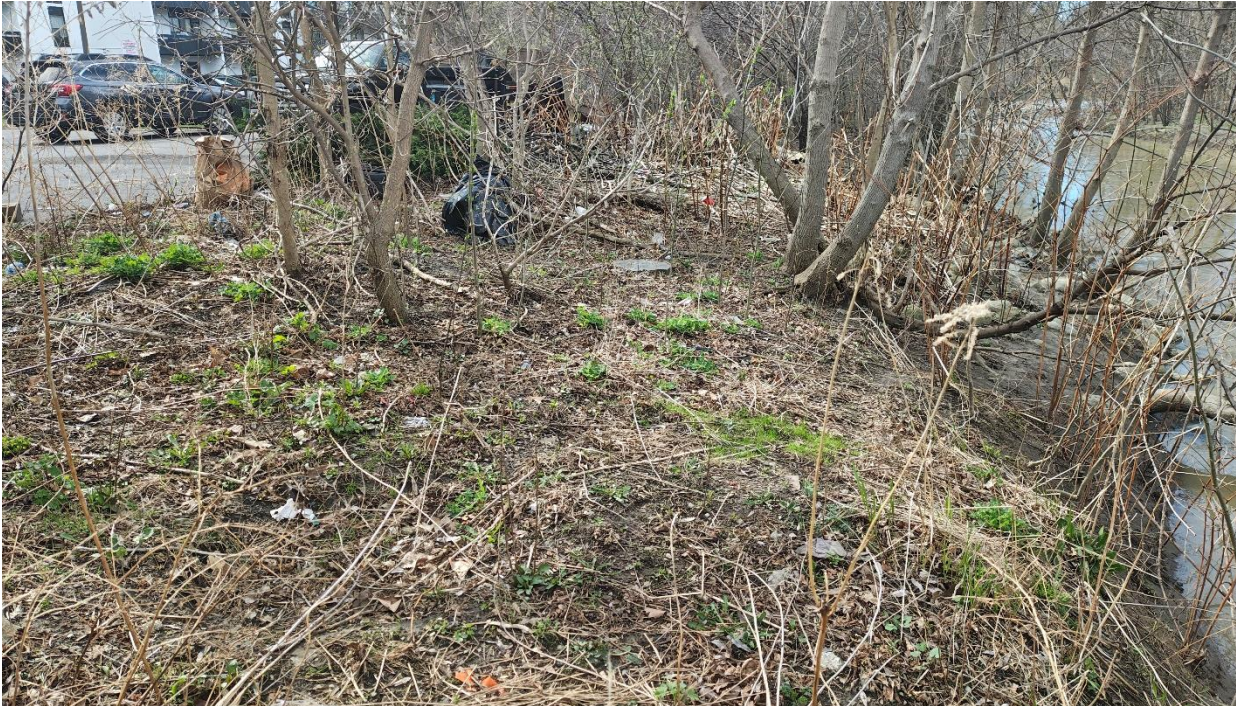
**Photo 1**

**Looking northwest along bank of Cooksville Creek**

The bank of Cooksville Creek grades gently up towards the parking lot.

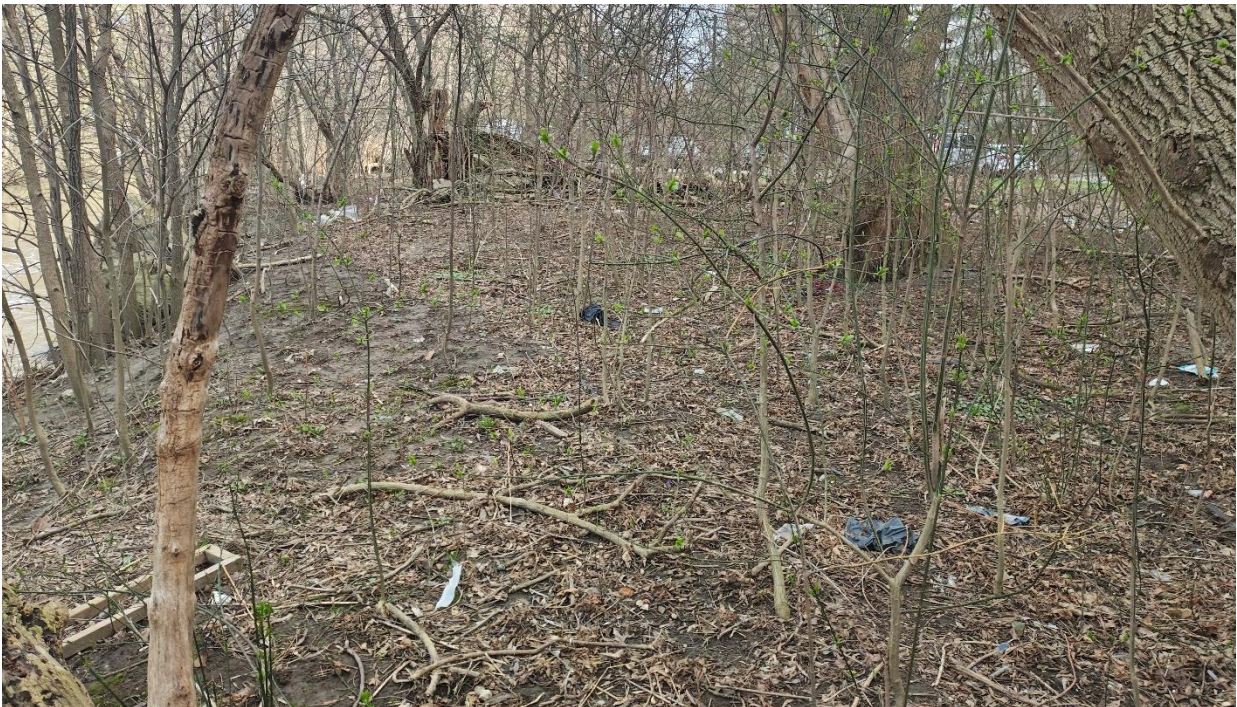
**Photo 2**

**Looking southeast along bank of Cooksville Creek**

The bank of Cooksville Creek appears relatively flat.

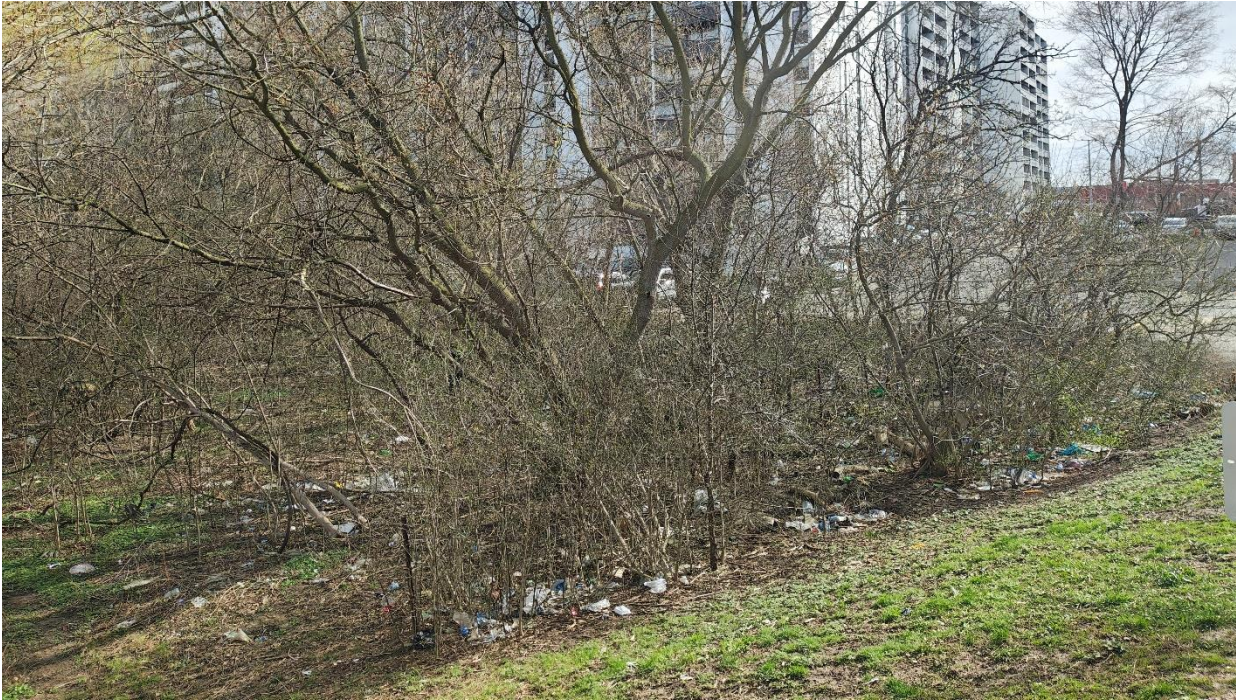
**Photograph 3**

**Looking southwest towards existing buildings and parking lot**  
The ground grades gently up towards the parking lot.

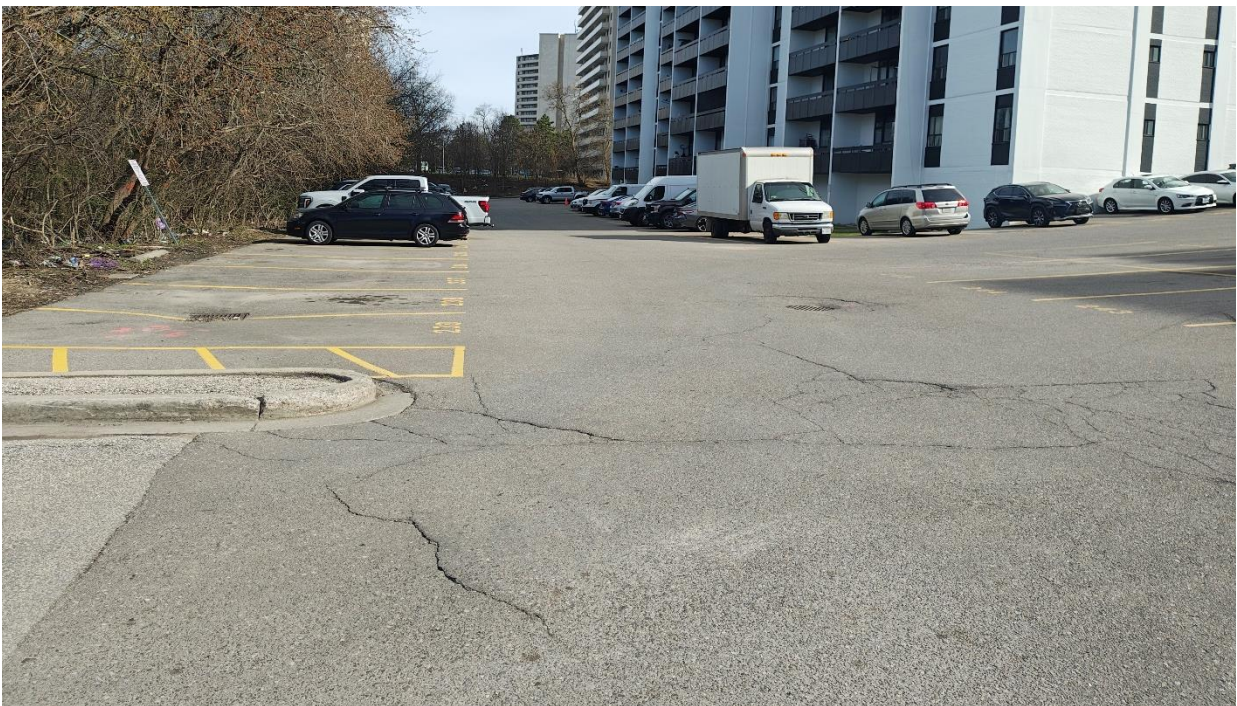
**Photograph 4**

**Looking southeast across the parking lot**  
The parking lot grades gently up towards Hurontario Street.
