Phase One Environmental Site Assessment

5150 Ninth Line

Mississauga, Ontario

DS Project No: 18-748-100
Date: 2019-02-11

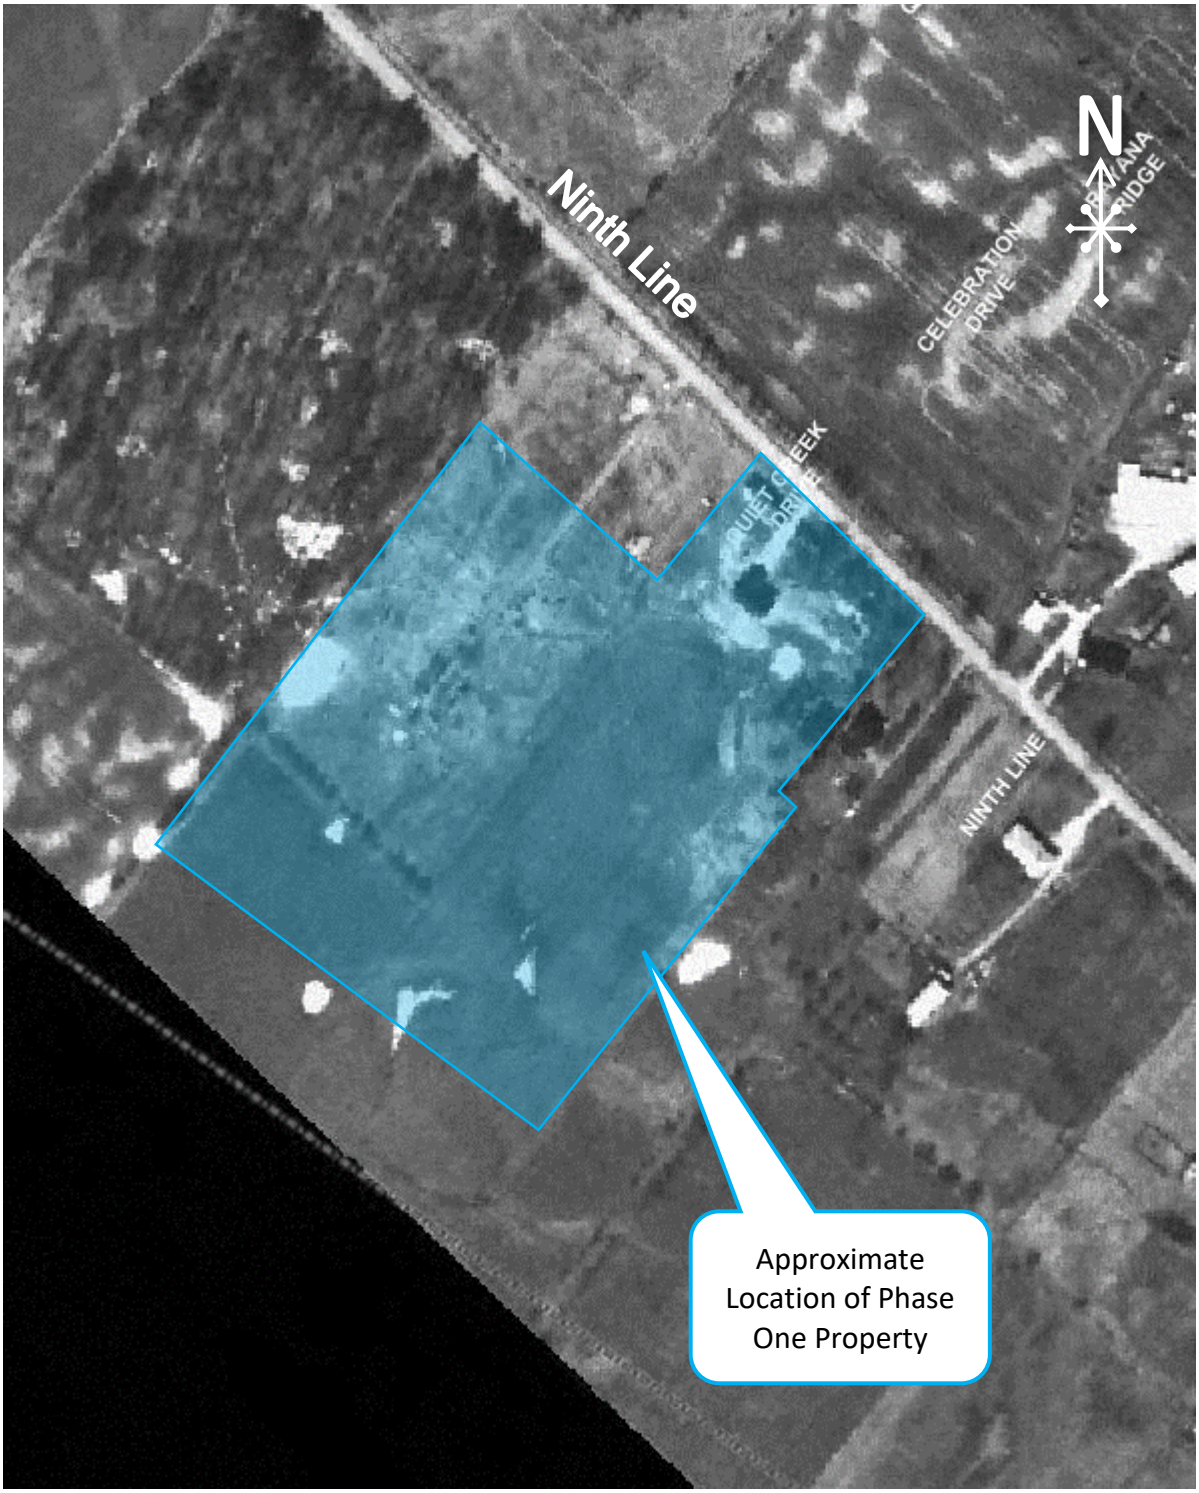
AERIAL PHOTOGRAPH: 1975

1975	A residential structure (Site Building A) appears to have been constructed where previous land disturbance was observed in the 1966 aerial photograph.	North: No significant changes. West: No significant changes. East: No significant changes. South: No significant changes.
1985	Several smaller shed-like structures appear to have been constructed to the north of and west of the residential building.	North: The residential structure to the north of the Phase One Property appears to have been constructed. West: No significant changes. East: No significant changes. South: No significant changes.
1992	The property resembles in present day configuration.	North: No significant changes. West: No significant changes. East: The large structure mentioned in the 1966 aerial appears to have been demolished. South: No significant changes.
2004		North: The veterinary clinic to the north of the Phase One Property appears to have been developed.
