GEOTECHNICAL INVESTIGATION
SLOPE STABILITY
AND
STREAMBANK EROSION ANALYSIS
2935 & 2955 MISSISSAUGA ROAD
MISSISSAUGA, ONTARIO

File No. 1-08-3220
September 4, 2008
© **Terraprobe Limited**

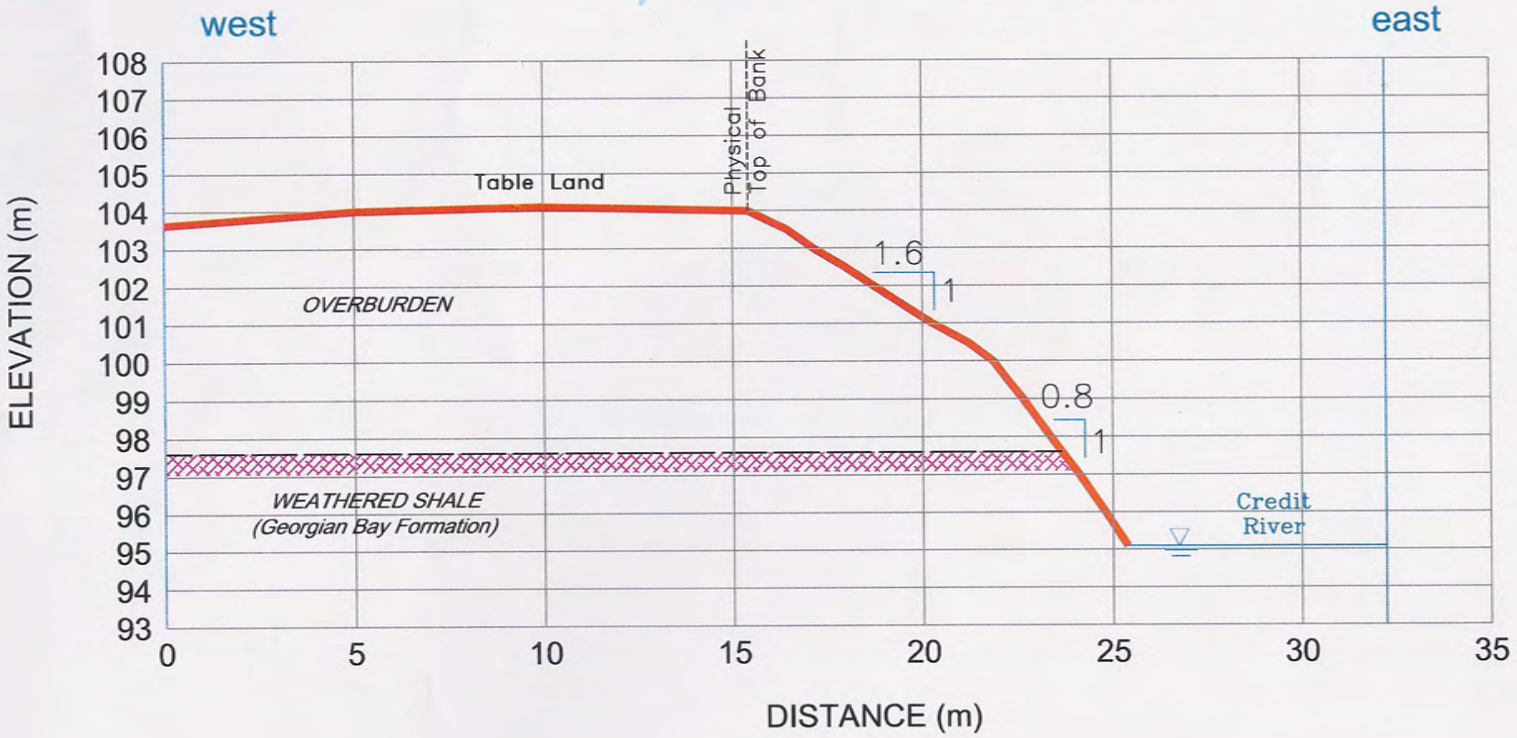
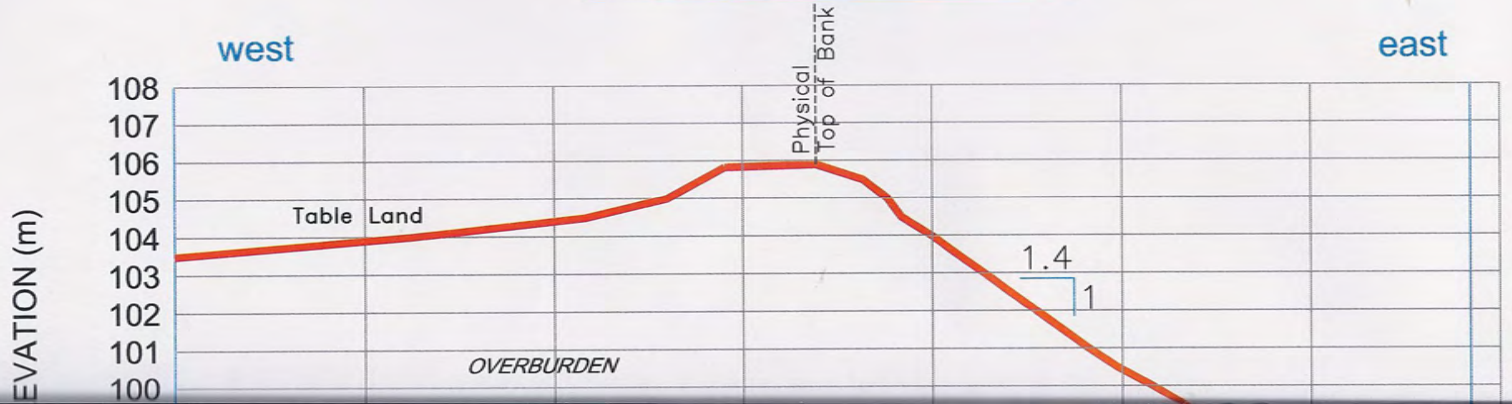
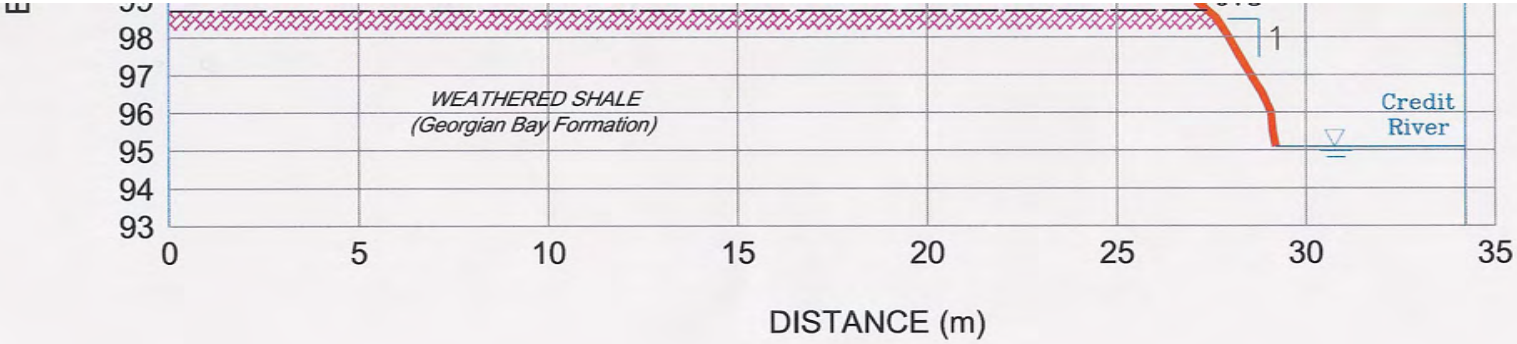
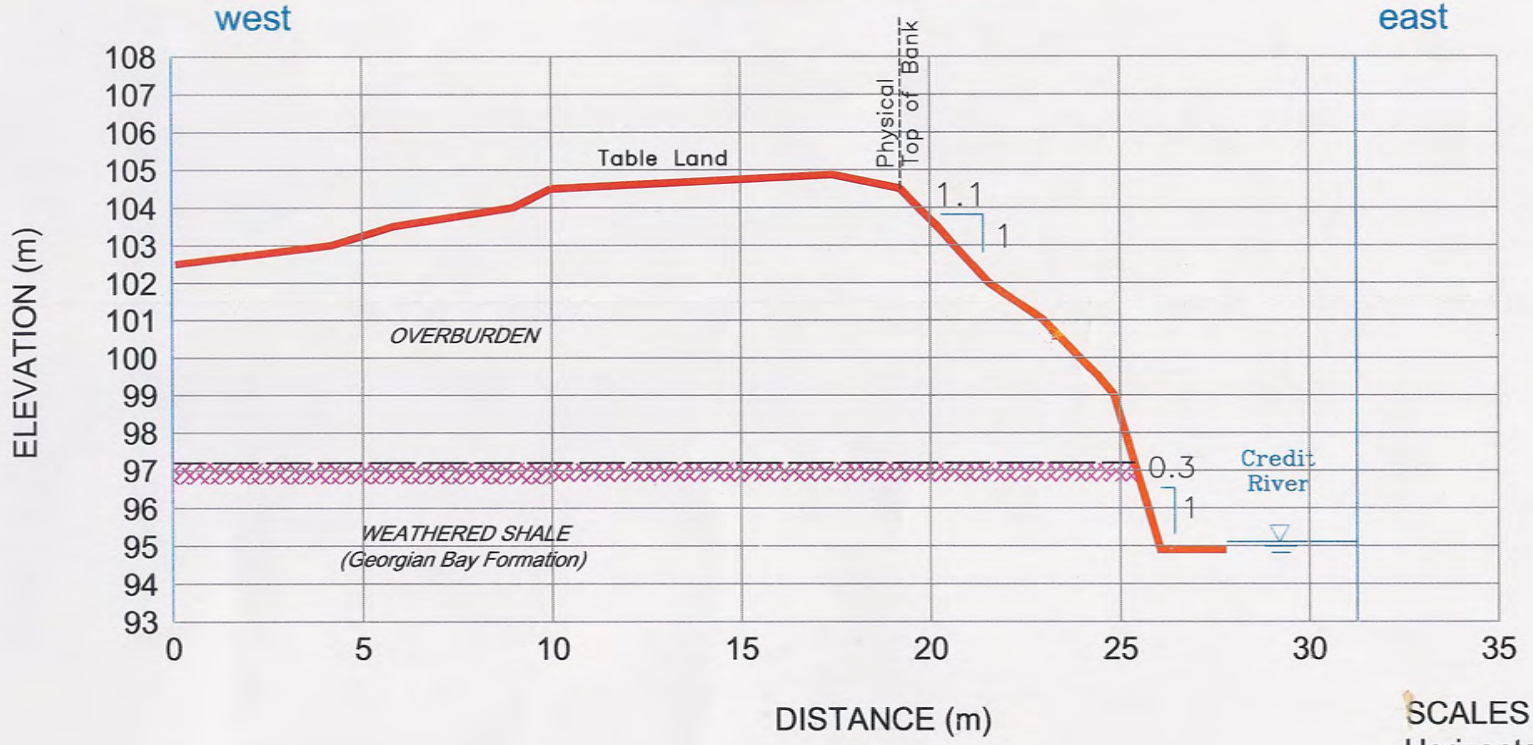
FIGURE 4A

The valley slope located along the east property boundary (Credit River) is among the steepest and highest within the study area. The lower portion of the slope comprises shale bedrock which underlies the overburden. The inclination of the lower shale portion of the slope is relatively steep and near vertical at locations. It generally varies from about 0.3 to 0.8 (horz.) to 1 (vert.) or locally steeper. The upper (overburden) potion of the slope is relatively less steep compared to the lower shale portion. The overall average inclinations of the overburden portion of the slope vary from about 1.1 (horz.) to 1 (vert.) at Section 3 to about 1.6 (horz.) to 1 (vert.) at Section 1. The overburden slope, close to Borehole 3, is also at locally near vertical inclination and appeared to be unstable. Please refer to enclosed sections (Figures 3, 4A and 4B) and photographs for details.

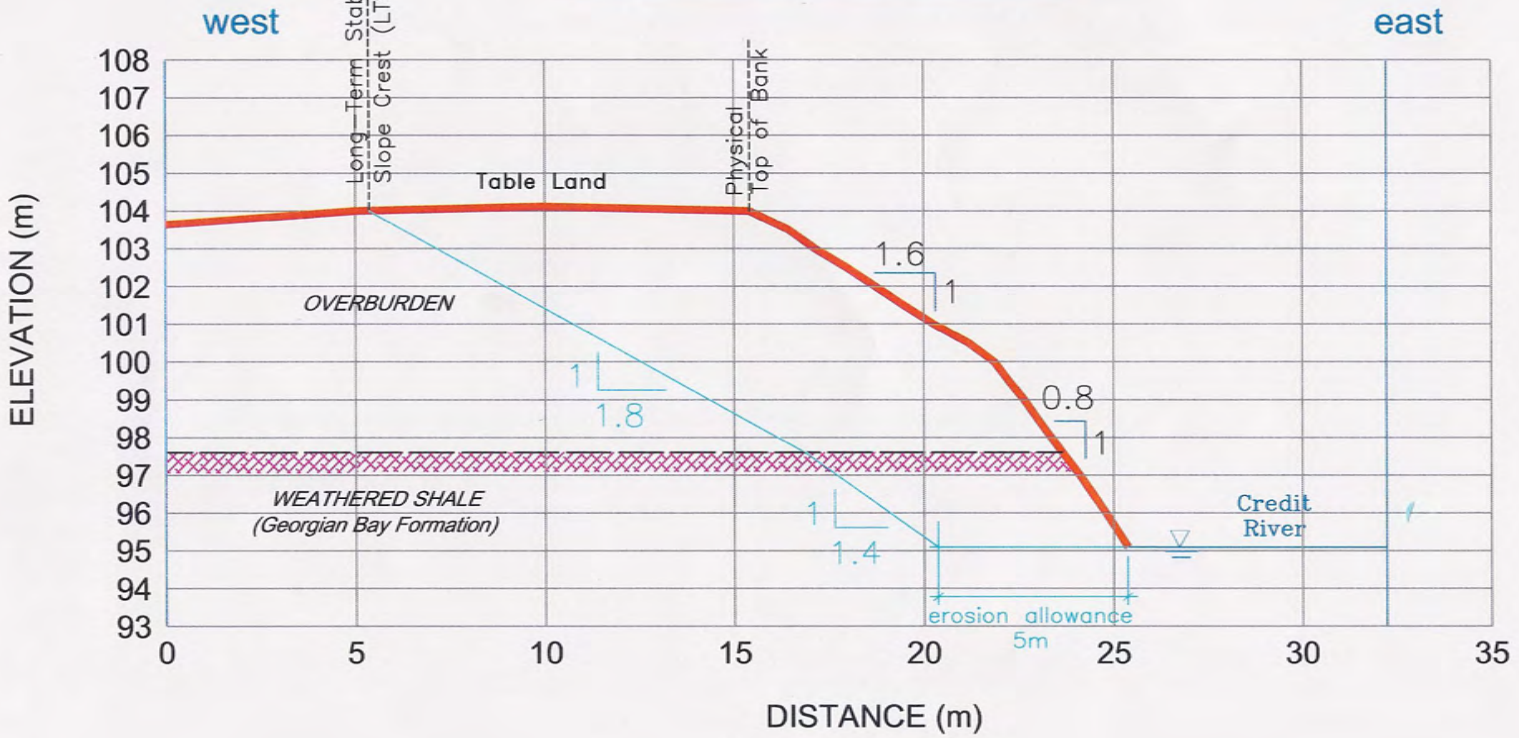
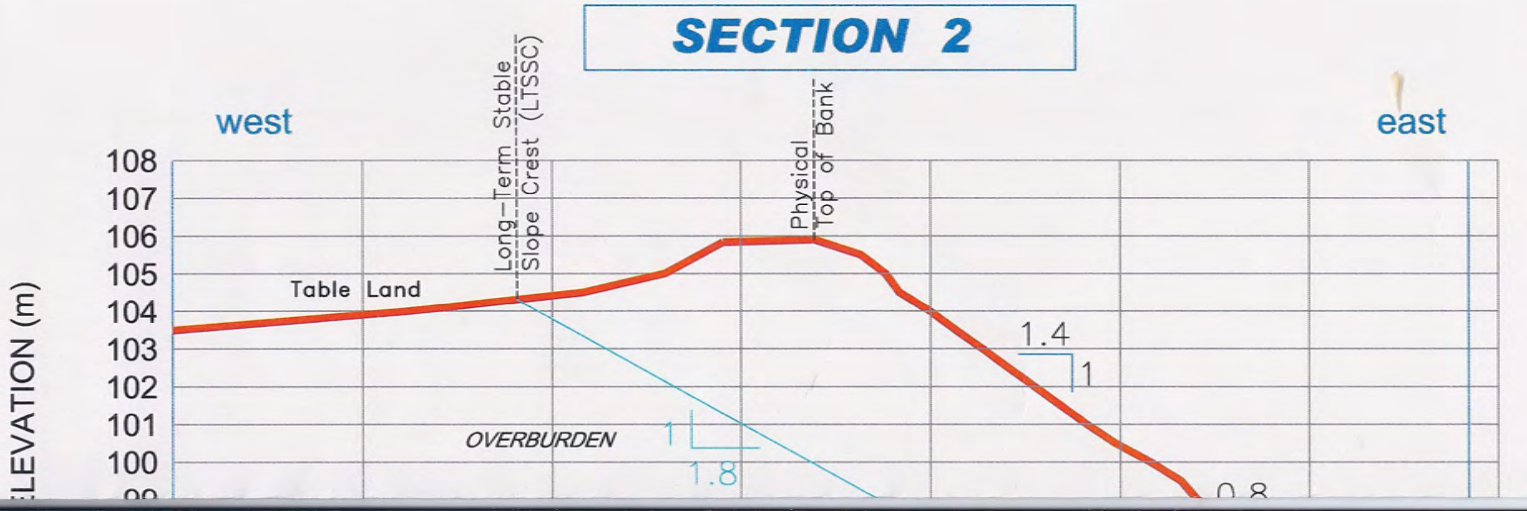
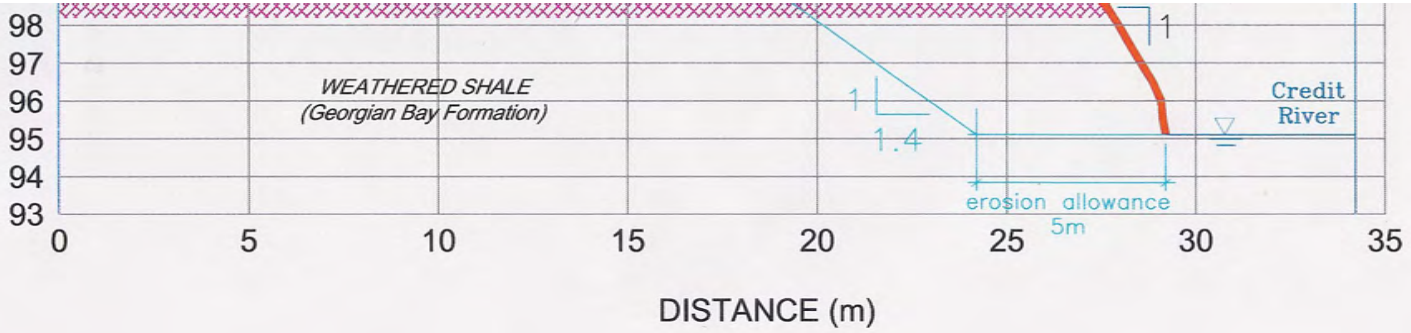
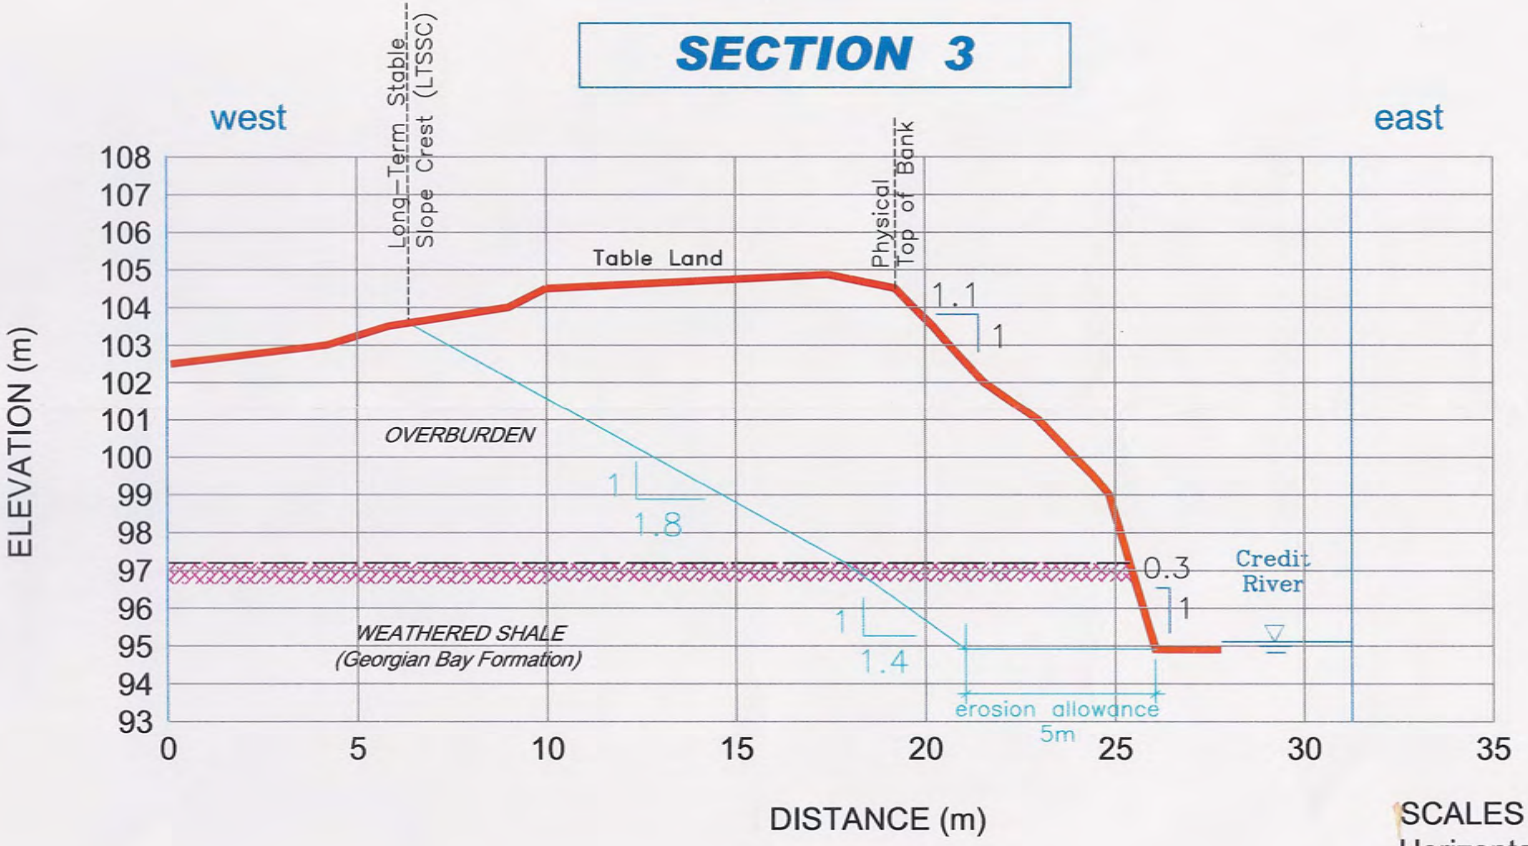
FIGURE 5A

to CVC Policy Guidelines, a long term stable slope inclination of 1.4 horz. to 1 vert. is recommended for the slope portion comprising shale bedrock. Figure 3 and Figures 5A and 5B present the estimated location of the Long-term Stable Slope Crest in plan and sections. These figures delineate the location of the Long-term Stable Slope Crest where it is located behind the Physical Top of Bank (inland, towards the tableland) including both east and south slopes. In other areas, existing slope is considered to be stable in the long-term. Figure 6 presents the stable slope crest model to determine the long-term stable slope crest location based on applicable setbacks.

Figure 3 and Figures 5A and 5B present the estimated location of the Long-term Stable Slope Crest in plan and sections. These figures delineate the location of the Long-term Stable Slope Crest where it is located behind the Physical Top of Bank (inland, towards the tableland), including both east and south slopes. In other areas, existing slope is considered to be stable in the long-term.

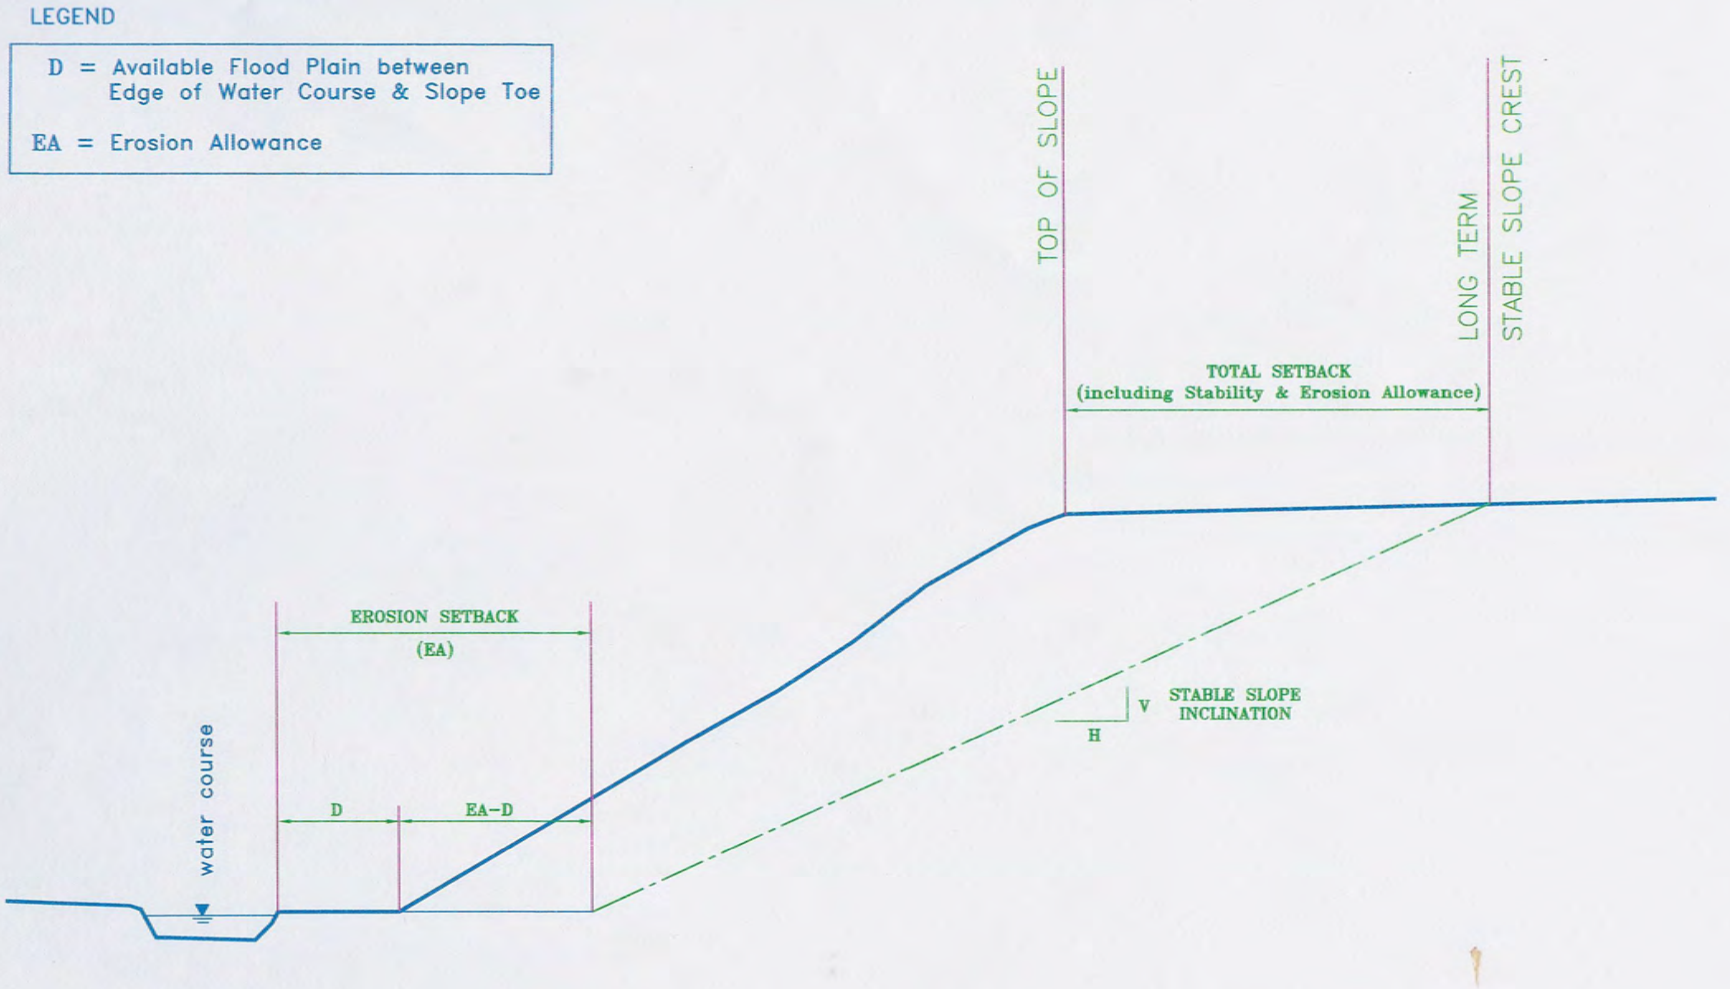
LONG TERM STABLE SLOPE CREST MODEL

The Long-term Stable Slope Crest location was calculated based on the applicable erosion and stability setbacks (stable slope inclination) in accordance with the CVC guidelines, as shown on the enclosed Long-Term Stable Slope Crest Model (Figure 6). As noted before, Figure 3 and Figures 5A and 5B present the estimated location of the Long-term Stable Slope Crest in plan and sections. These figures delineate the location of the Long-term Stable Slope Crest where it is located behind the Physical Top of Bank (inland, towards the tableland), including both east and south slopes. In other areas, existing slope is considered to be stable in the long-term. For planning purposes the long-term refers to a 100 year planning horizon.

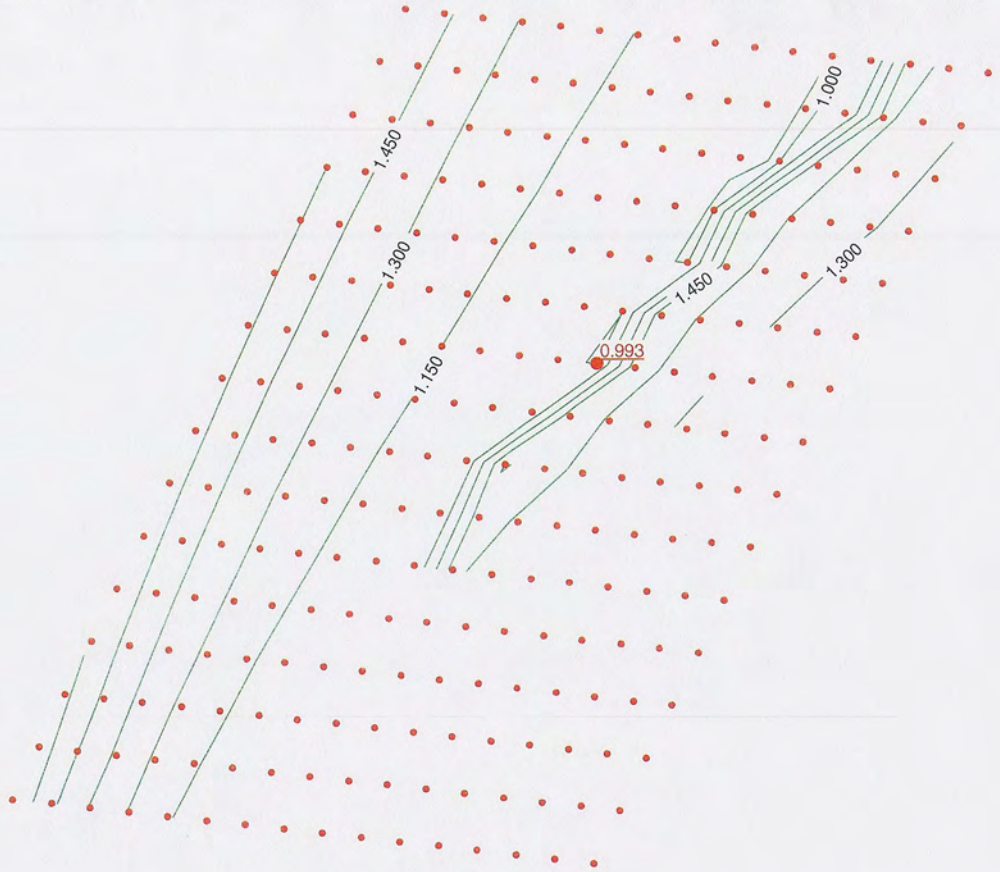
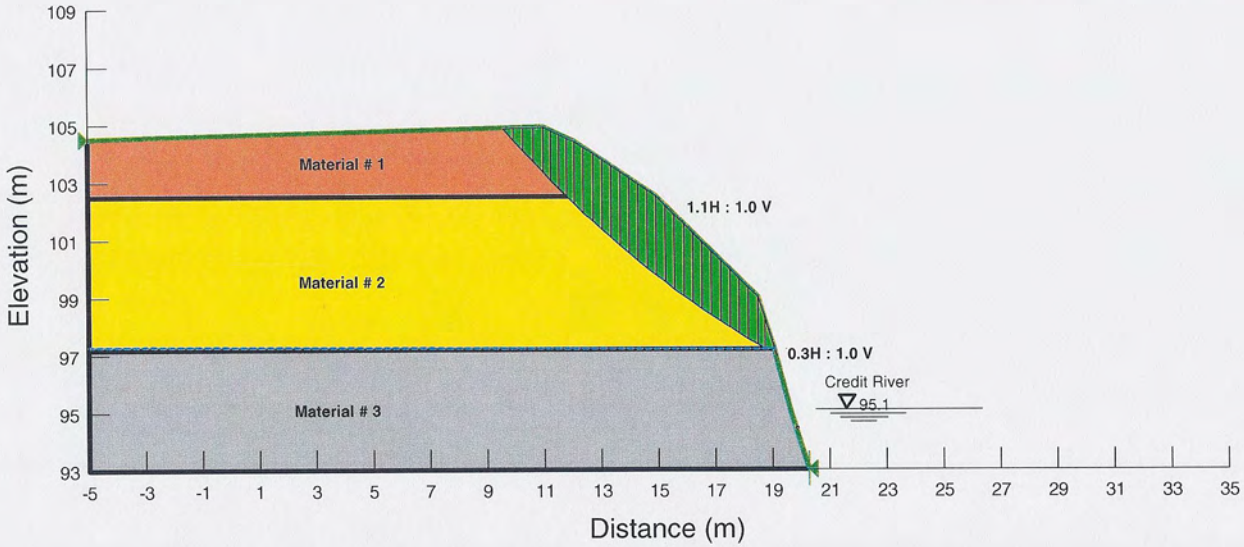
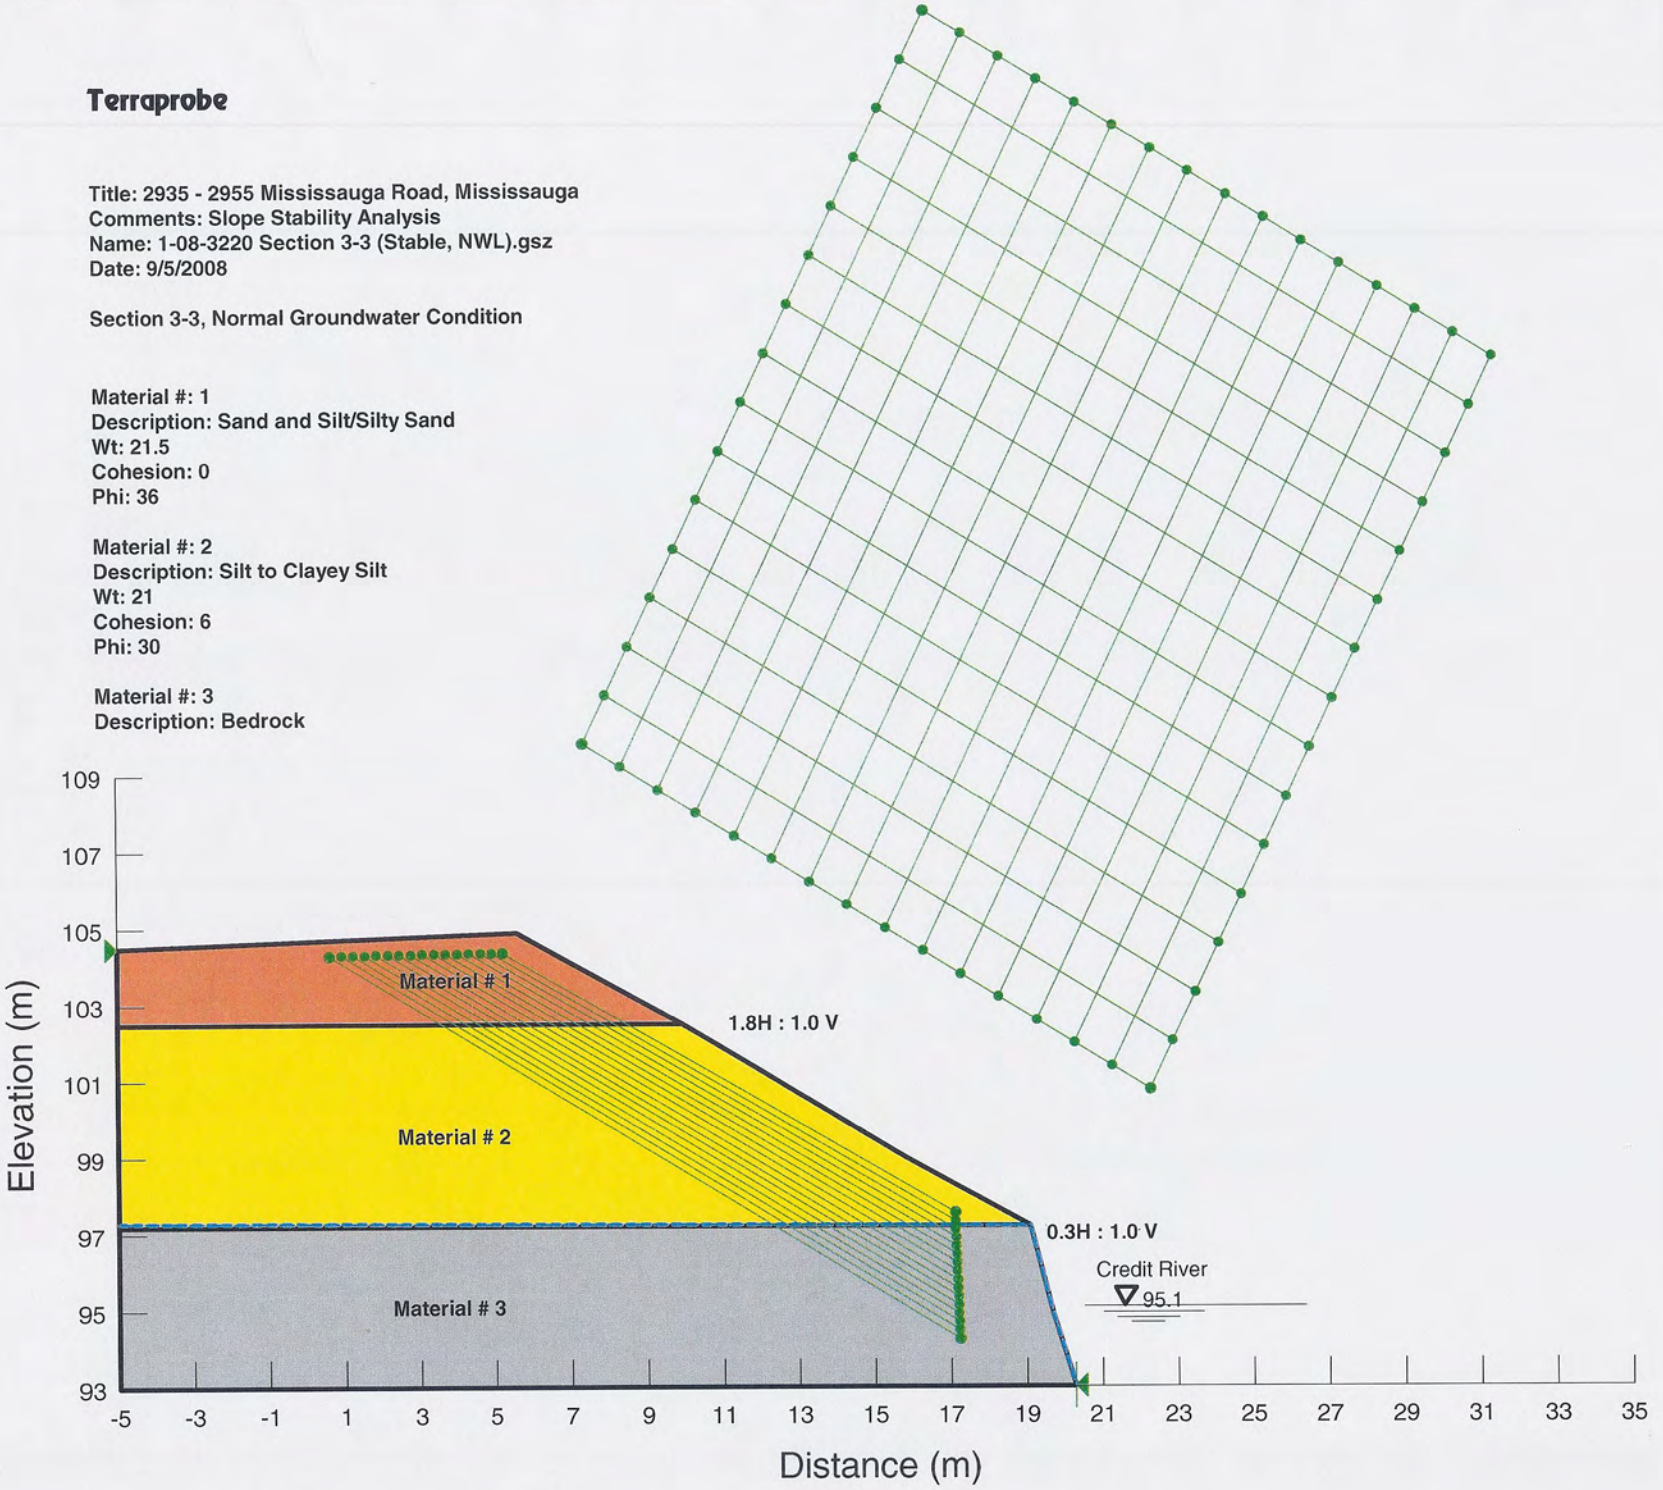
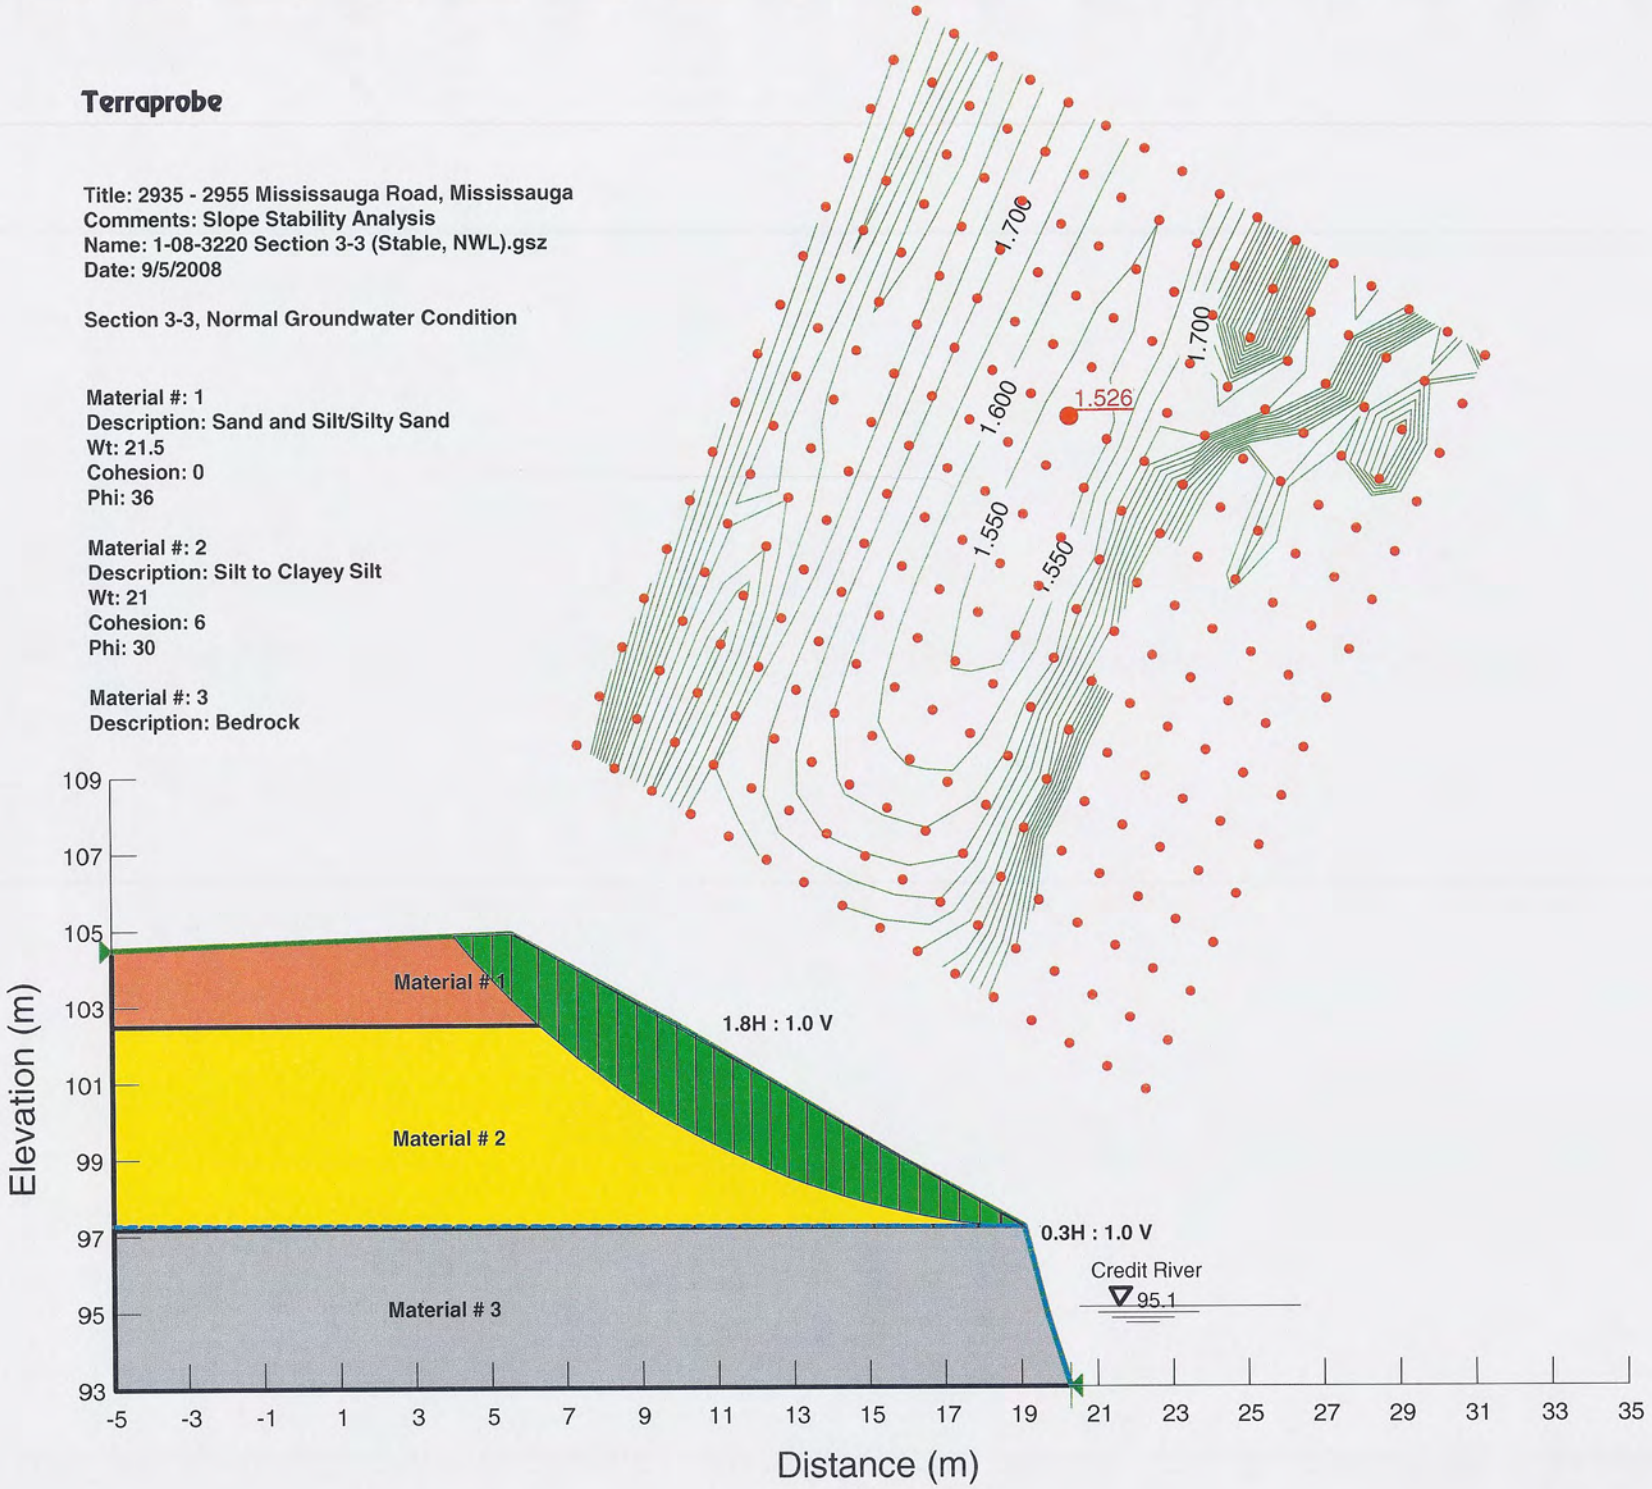
The results of the slope stability analysis conducted for a hypothetical slope profile with a flatter inclination of 1.8 horizontal to 1 vertical for the overburden soil with similar sub-surface conditions as that of Section 3, for both normal and elevated ground water conditions, are presented on the enclosed figures, and are summarized below:

Section	Assumed Overburden Slope Inclination	Minimum Factor of Safety for Potential Slope Slides		Type of Slope Slide
		Normal Ground Water (Normal Condition)	Elevated Ground Water (Temporary Condition)	
Section 3	1.8 H : 1V	1.53	1.31	Overburden Slope Slide

The above minimum computed factors of safety of 1.53 for the long-term (normal groundwater condition) and 1.31 for the short-term, temporary and infrequent condition (elevated groundwater level) are considered satisfactory and adequate. The remaining sections (Sections 1 and 2) were also re-analyzed with this flatter slope inclination of 1.8 to 1 (horizontal to vertical) to determine factors of safety against potential slope slides. The minimum factors of safety obtained for Sections 1 and 2 with a flatter inclination of 1.8 horizontal to 1 vertical for the overburden soil and with similar sub-surface conditions as that of the individual sections, were 1.67 and 1.71, which are considered to be satisfactory and adequate (refer to enclosed Slope Stability Analysis Figures).

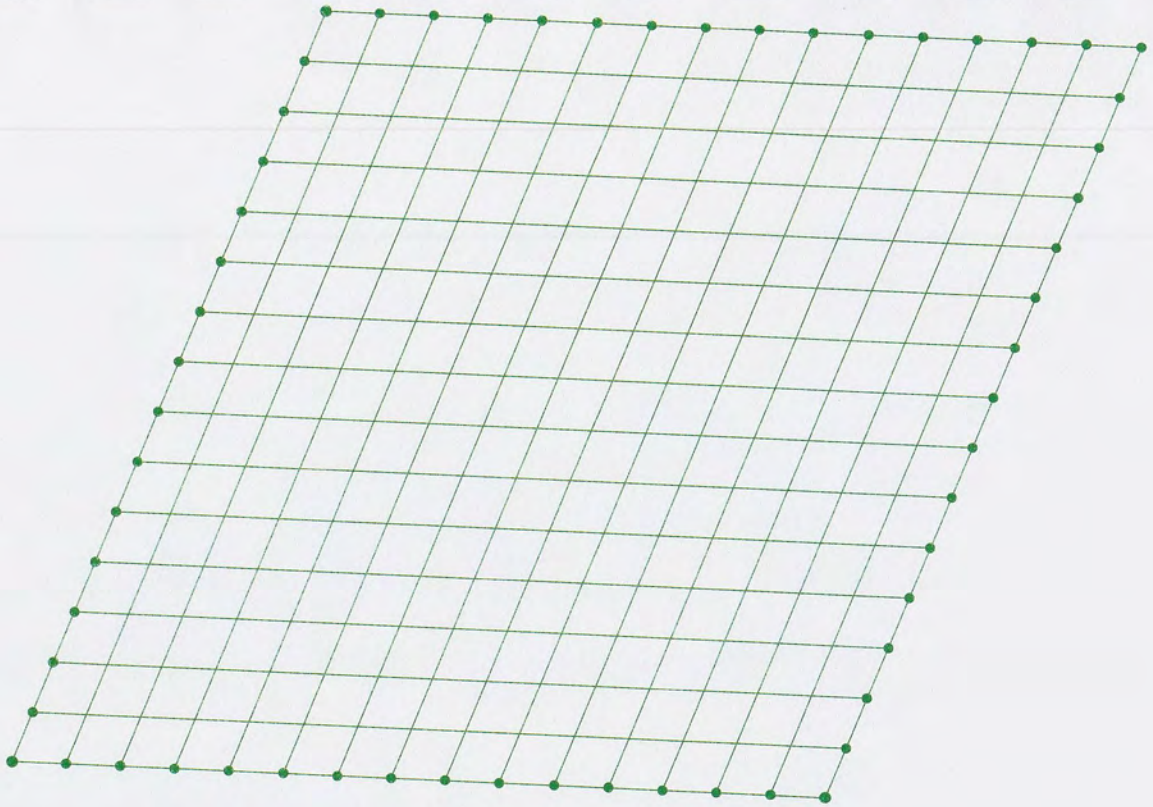
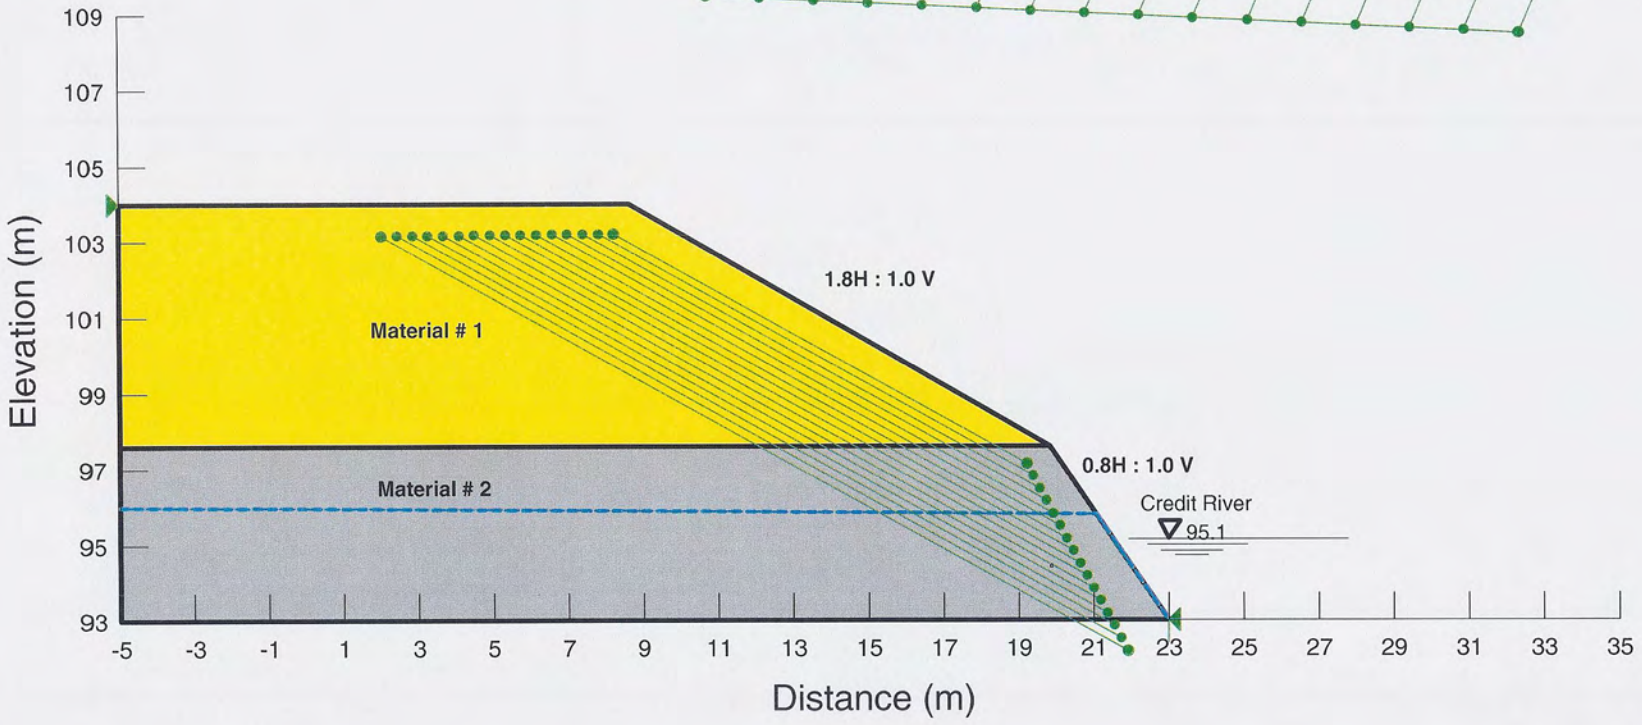
Section 1-1, Normal Groundwater Condition

Material #: 1
Description: Silt to Clayey Silt
Wt: 21
Cohesion: 6
Phi: 30

Material #: 2
Description: Bedrock

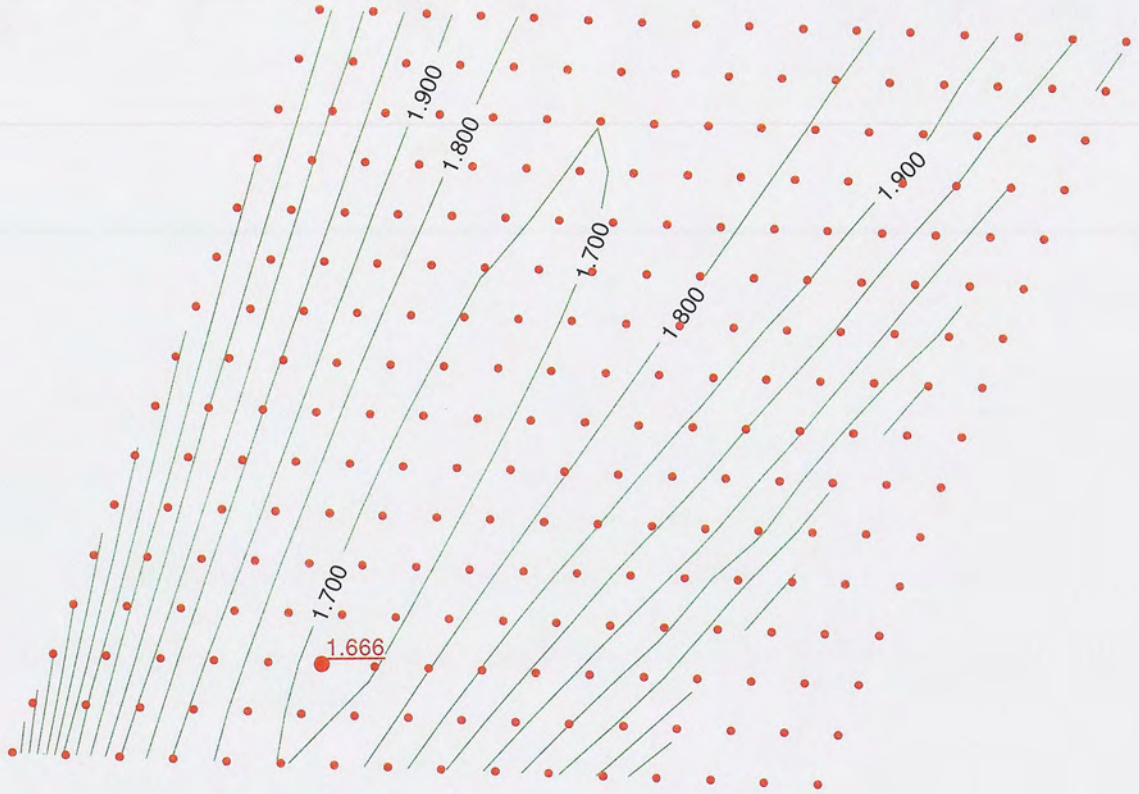
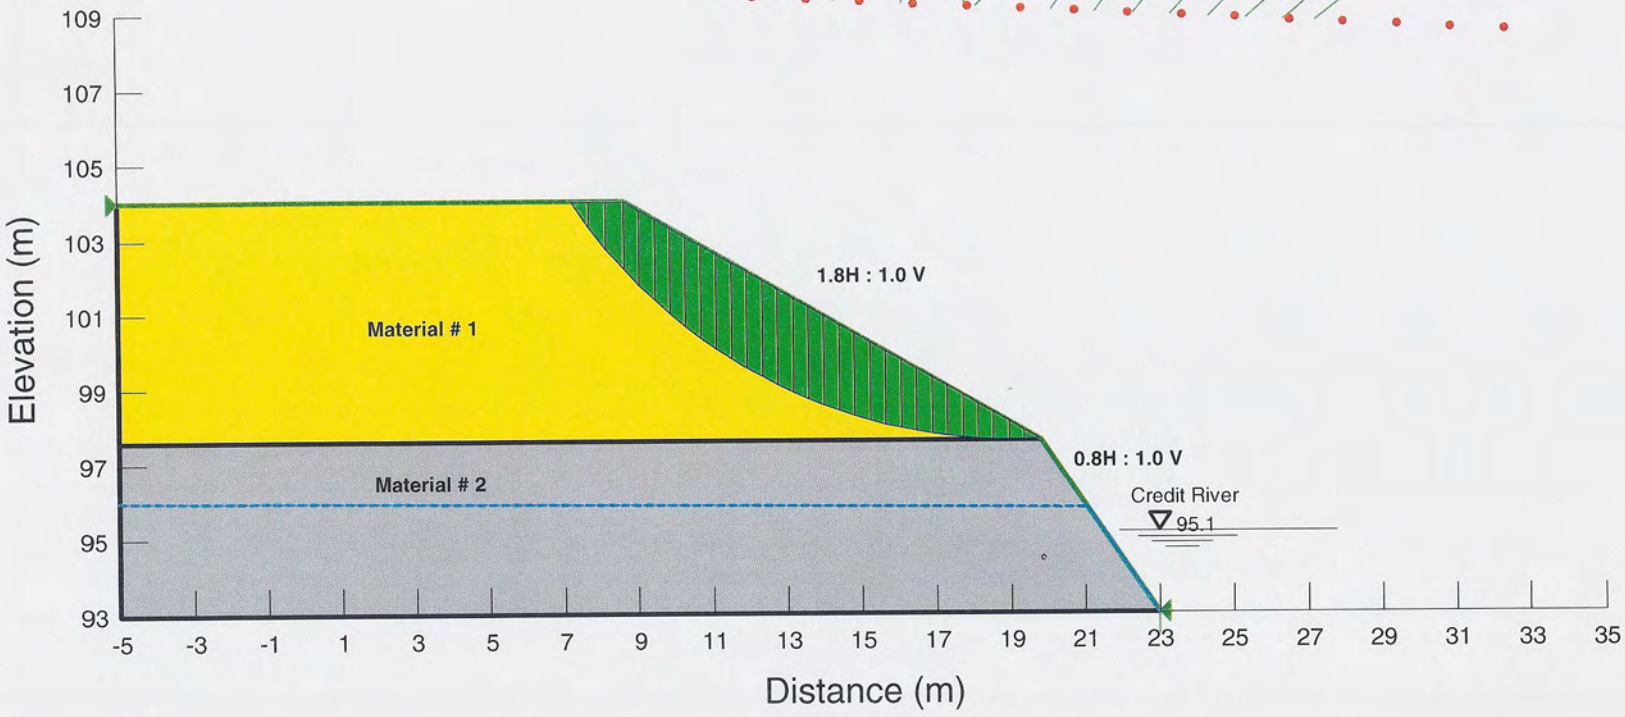
Section 1-1, Normal Groundwater Condition

Material #: 1
Description: Silt to Clayey Silt
Wt: 21
Cohesion: 6
Phi: 30

Material #: 2
Description: Bedrock

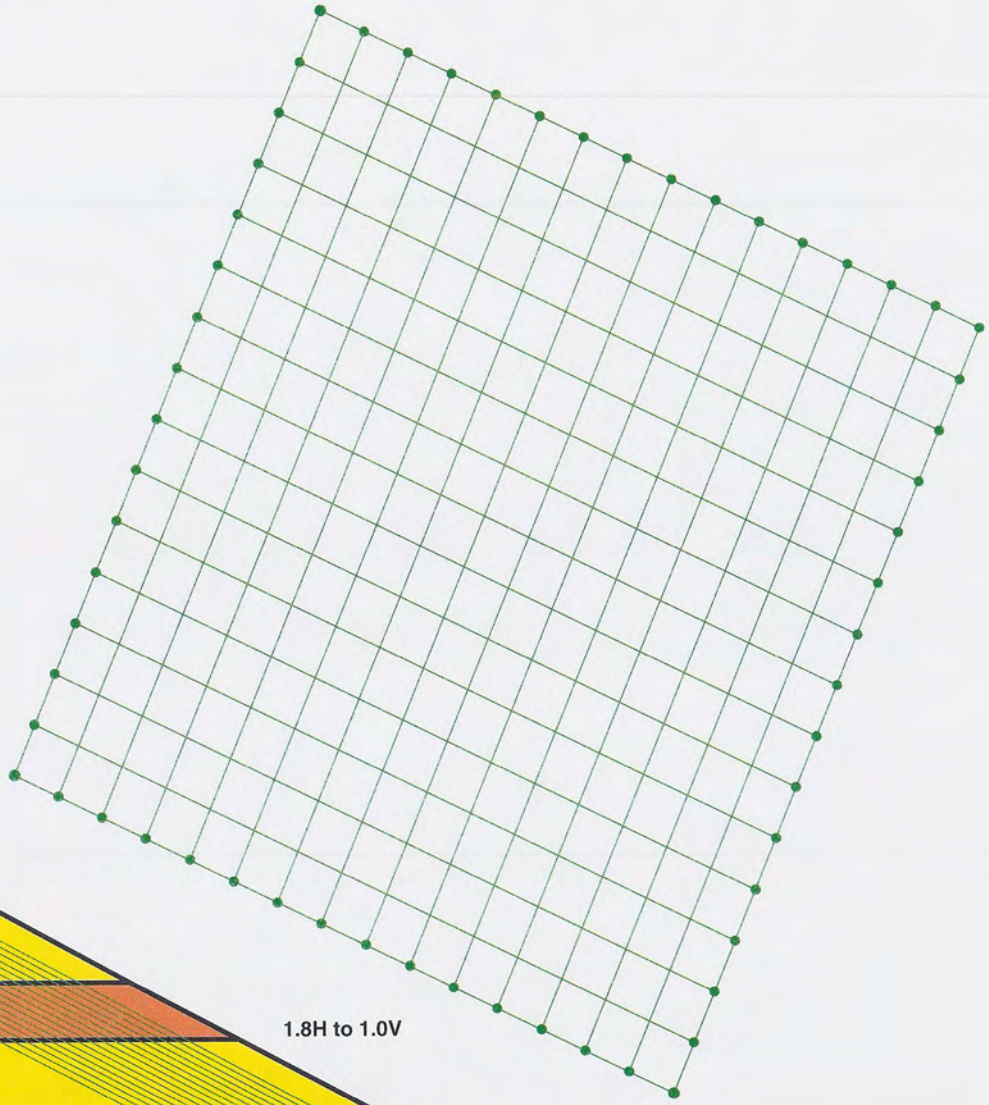
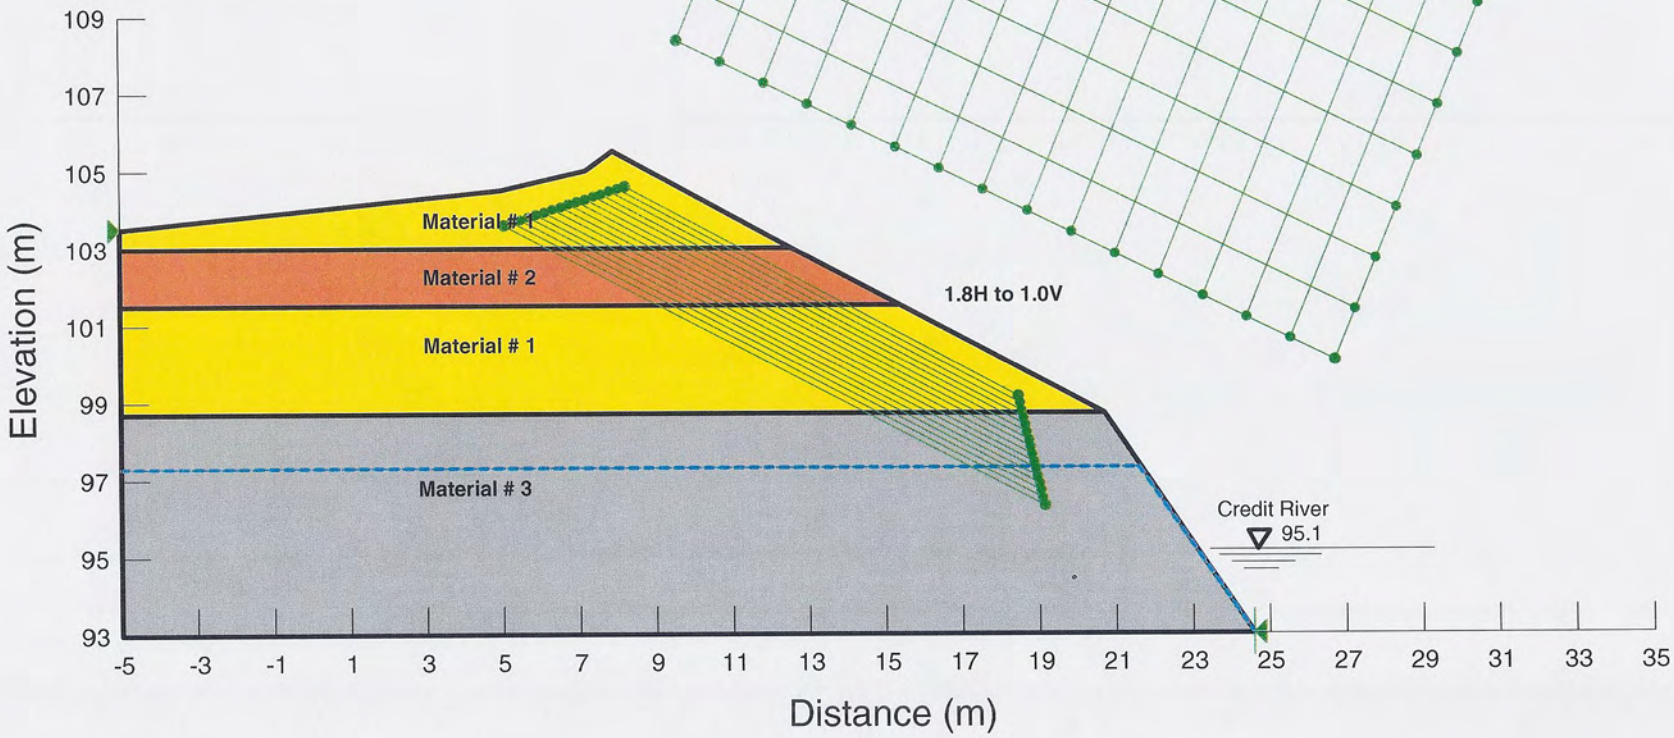
Section 2-2, Normal Groundwater Condition

Material #: 2
Description: Silt and Sand
Wt: 21.5
Cohesion: 0
Phi: 36

Material #: 3
Description: Bedrock
