GEOTECHNICAL INVESTIGATION
SLOPE STABILITY
AND
STREAMBANK EROSION ANALYSIS
2935 & 2955 MISSISSAUGA ROAD
MISSISSAUGA, ONTARIO

File No. 1-08-3220
September 4, 2008
© **Terraprobe Limited**

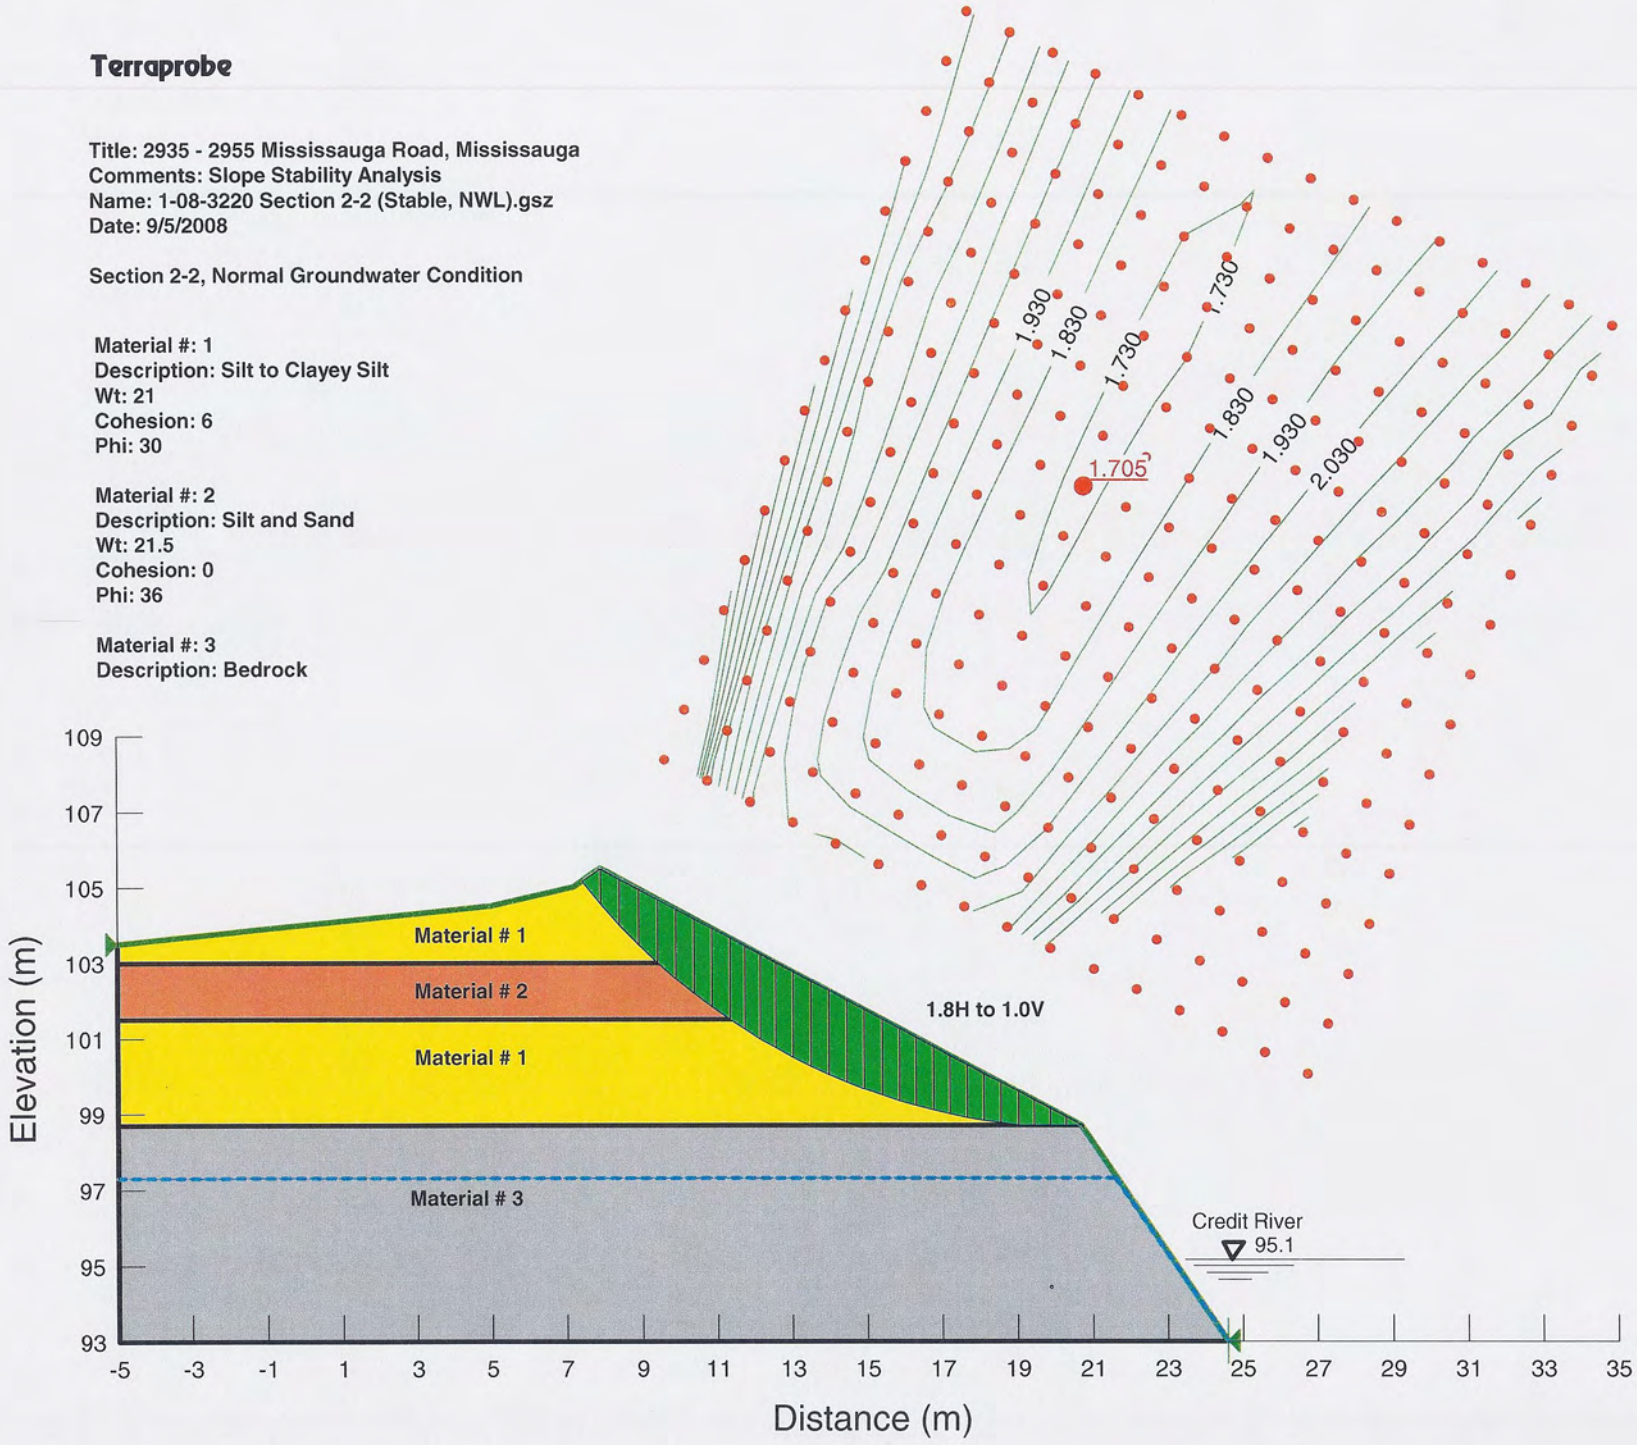
Section 2-2, Normal Groundwater Condition

Material #: 2
Description: Silt and Sand
Wt: 21.5
Cohesion: 0
Phi: 36

Material #: 3
Description: Bedrock

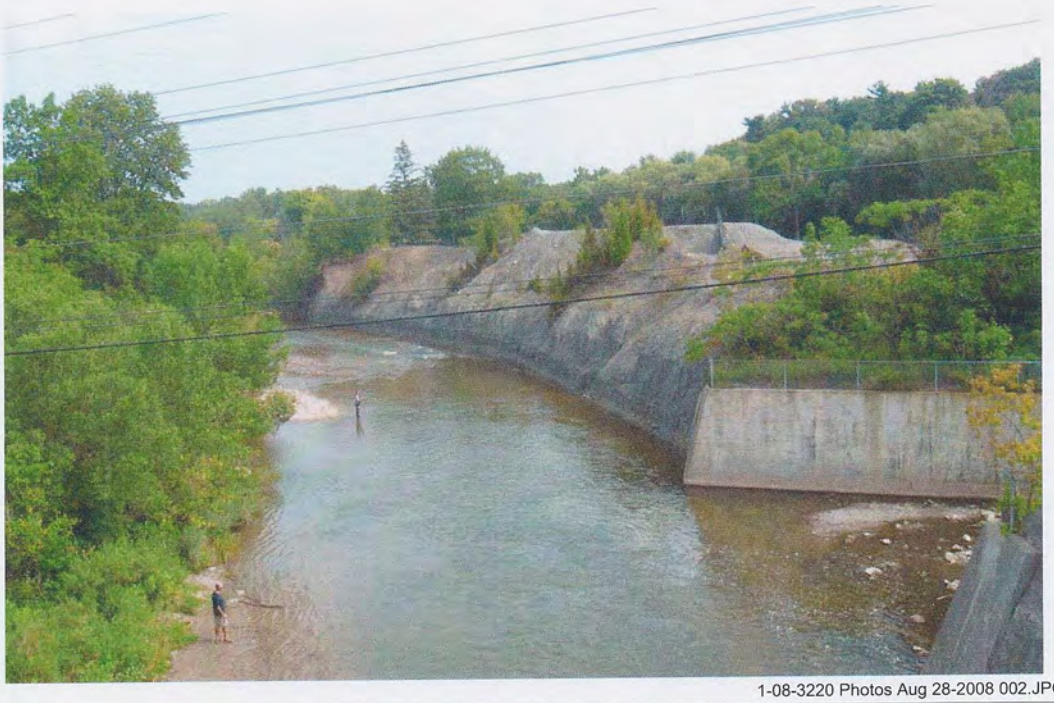
1-08-3220 Photos Aug 28-2008 002.JPG

PHOTOGRAPH #1 - Looking south along the river alignment from Dundas Street West Bridge. An overall view of the valley slope located along the east property boundary.

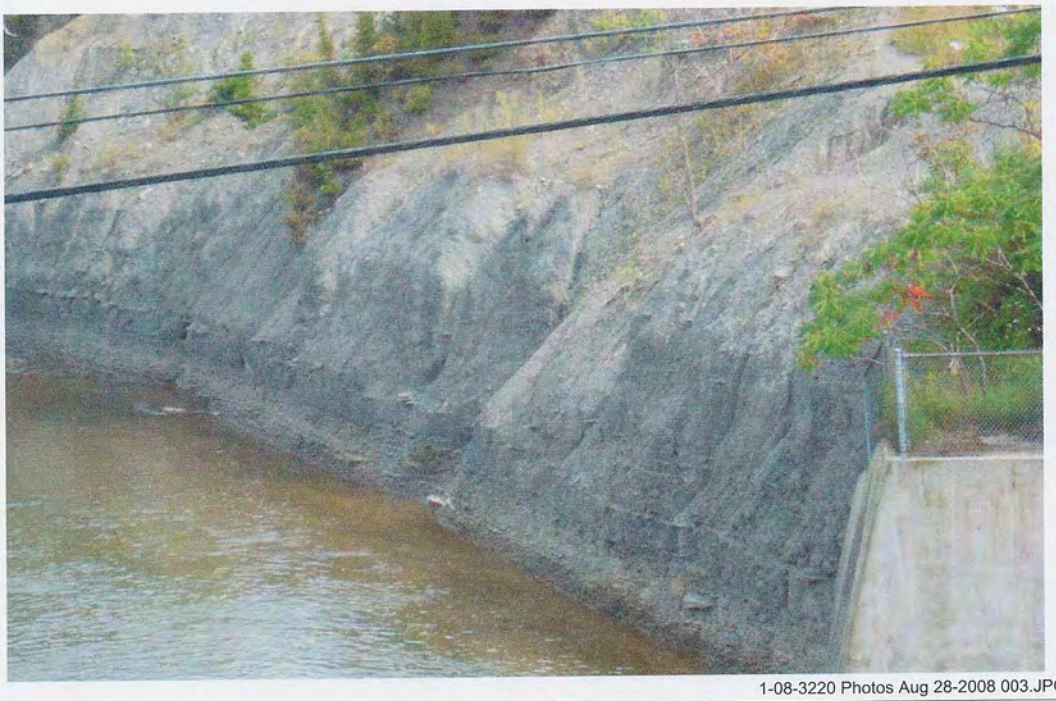
1-08-3220 Photos Aug 28-2008 003.JPG

PHOTOGRAPH #2 - A close-up view of the northerly portion of the slope. Lower portion of the slope is near vertical and consists of shale. River at the slope toe. Active toe erosion evident.

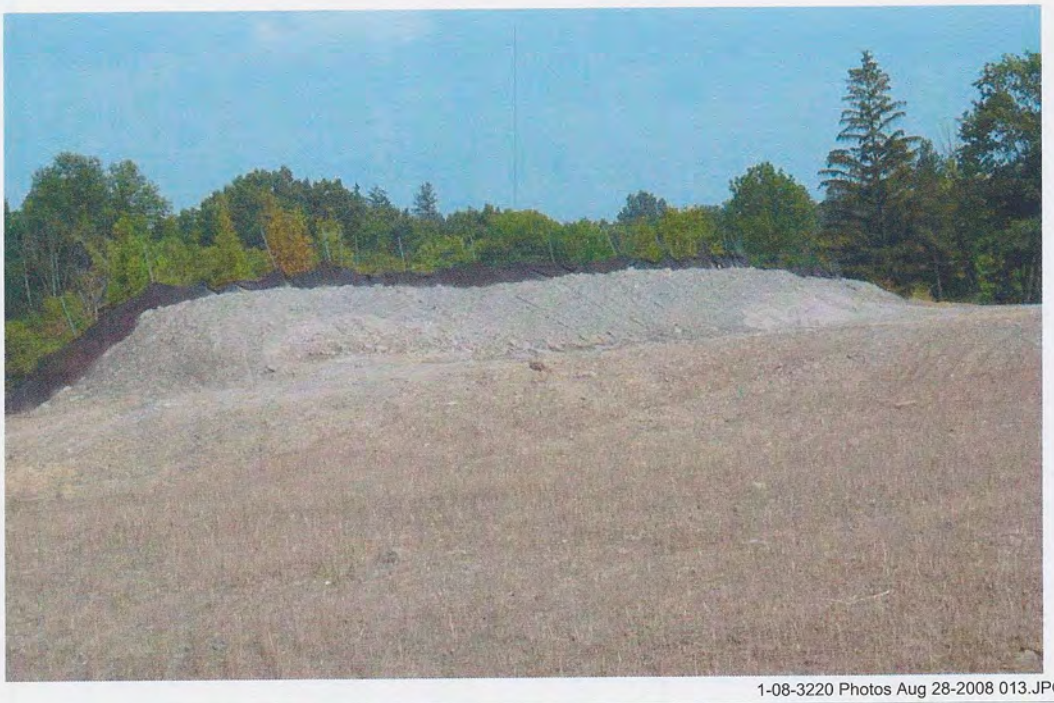
1-08-3220 Photos Aug 28-2008 013.JPG

It is noted that the rear (west) portion of the high (middle) slope area, behind the top of bank, extending from about Section 1 to approximately to the middle of Sections 2 and 3, has been disturbed and re-graded. The area to the rear (west) of the top of bank currently consists of a relatively narrow and level plateau (about 1 m to 3 m) wide, followed by a drop of about 2 m to 3 m. It appears that the ground behind the top of bank in this area has been lowered and re-graded.

PHOTOGRAPH #7 - Looking southeast towards the backside of the valley slope located at the river (along east property boundary). The rear portion of the slope has been disturbed and regraded.

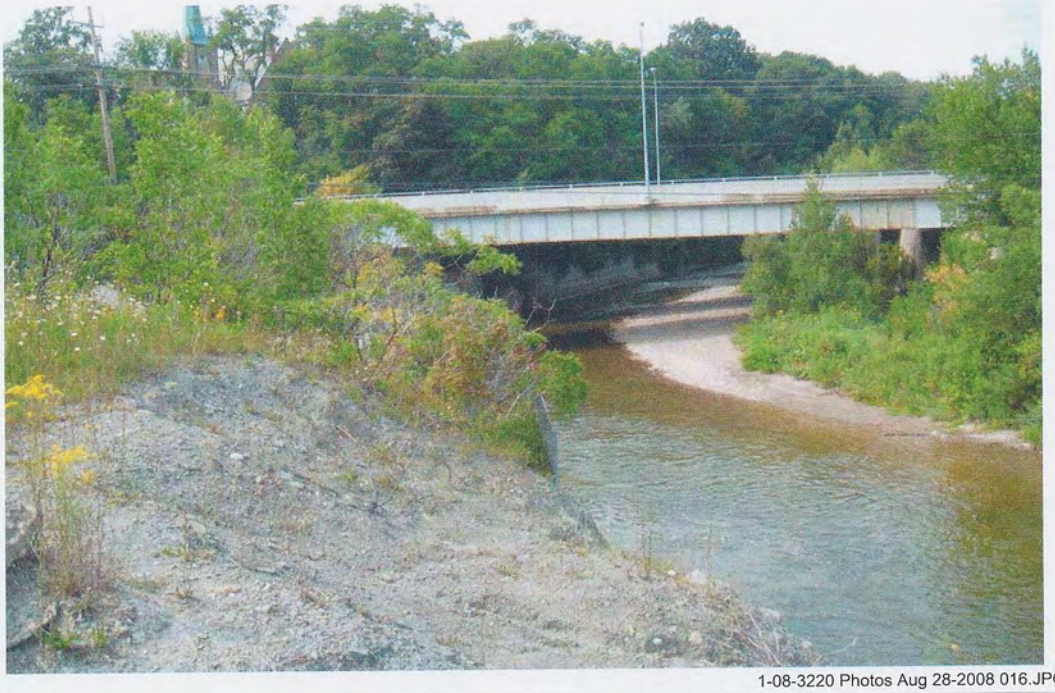
1-08-3220 Photos Aug 28-2008 016.JPG

PHOTOGRAPH #8 - Looking north along the north portion of the east slope. The slope surface is generally bare.

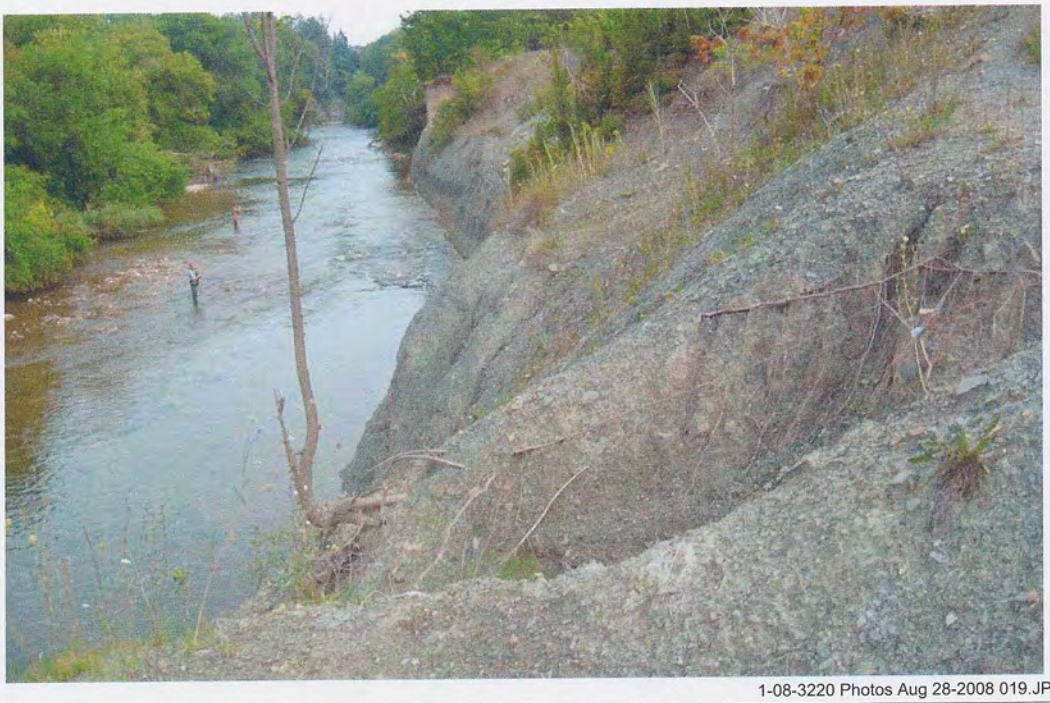
1-08-3220 Photos Aug 28-2008 019.JPG

PHOTOGRAPH #9 -Looking south along the south portion of the east slope. The lower portion of the slope (shale) is steep. Overburden slope is generally bare and includes deep rills at locations due to surface drainage.

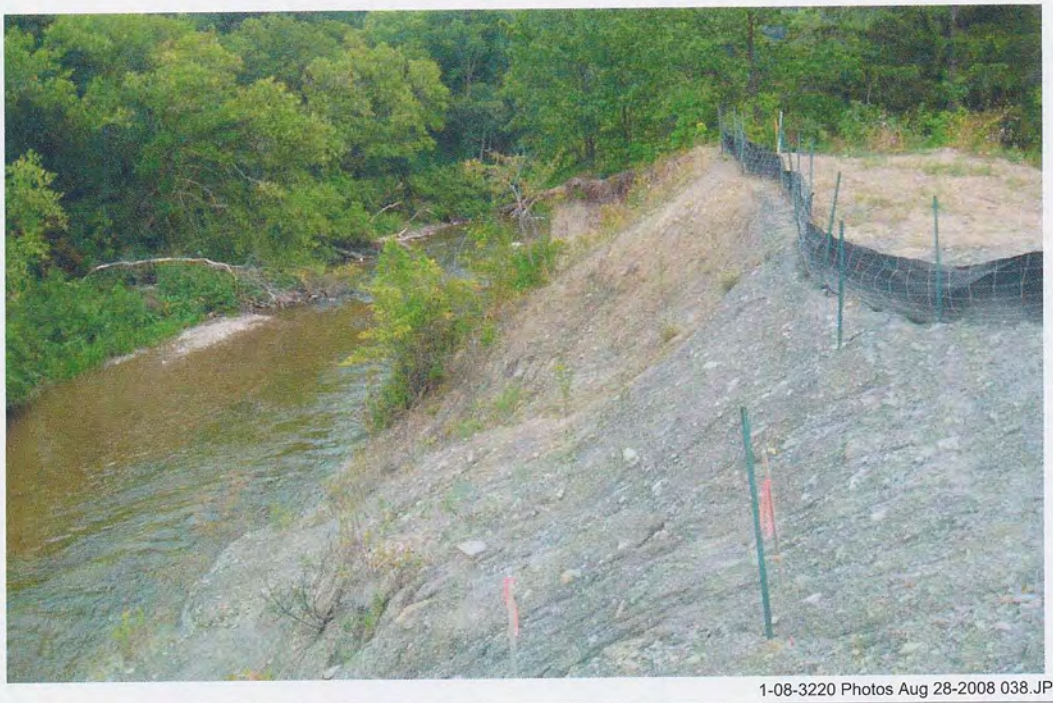
1-08-3220 Photos Aug 28-2008 038.JPG

PHOTOGRAPH #17 - A view of the south half portion of the east slope.

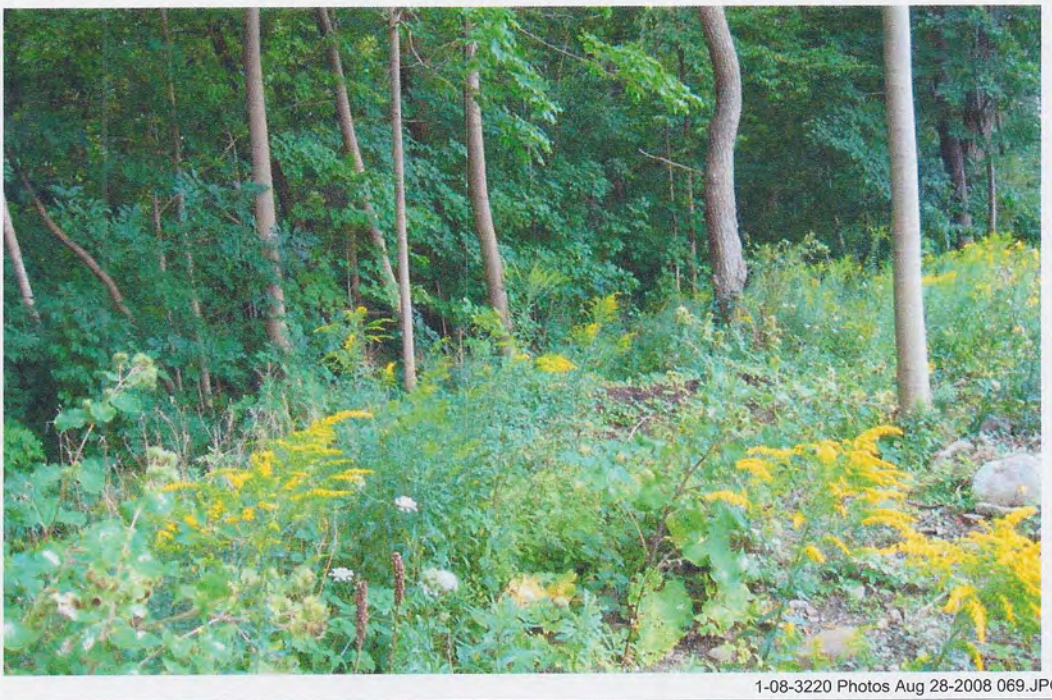
1-08-3220 Photos Aug 28-2008 069.JPG

PHOTOGRAPH #26 - Another view of west vegetated/forested area. The area is densely vegetated and the slope is very gentle.
