# PHASE I ENVIRONMENTAL SITE ASSESSMENT
# 1055 BLOOR STREET, MISSISSAUGA, ON

***FINAL***

**Prepared for:** CAPREIT Limited Partnership
**Prepared by:** Premier Environmental Services Inc.
**Premier Project Number:** 625004.OT Task 1

March 13, 2026

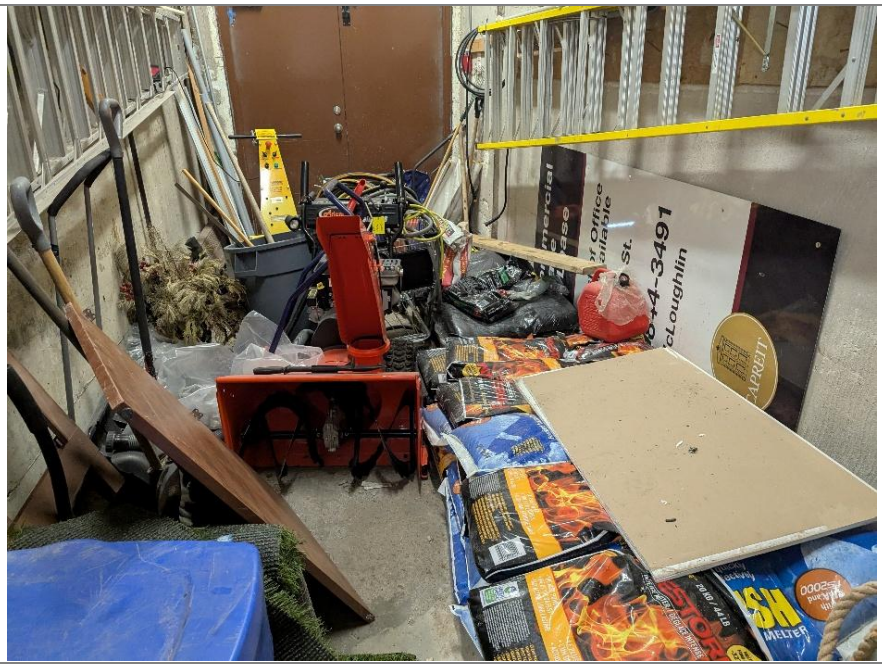
| Photo No. | Date: |

A view of a basement maintenance room including two gas powered snow blowers and two jerry cans of fuel.

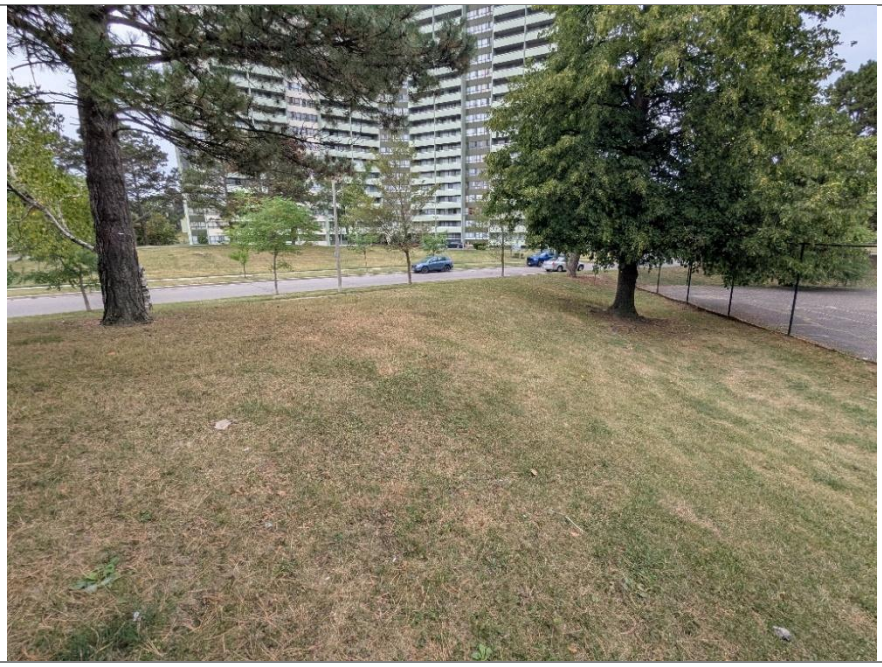
| Photo No. | Date: |

An alternate view of the northern easement property.
