→ **Sheridan Creek Erosion Control
Study – Lushes Avenue to Clarkson
Road South**

Purpose of the Virtual Public Information Centre

Introduction to the Study

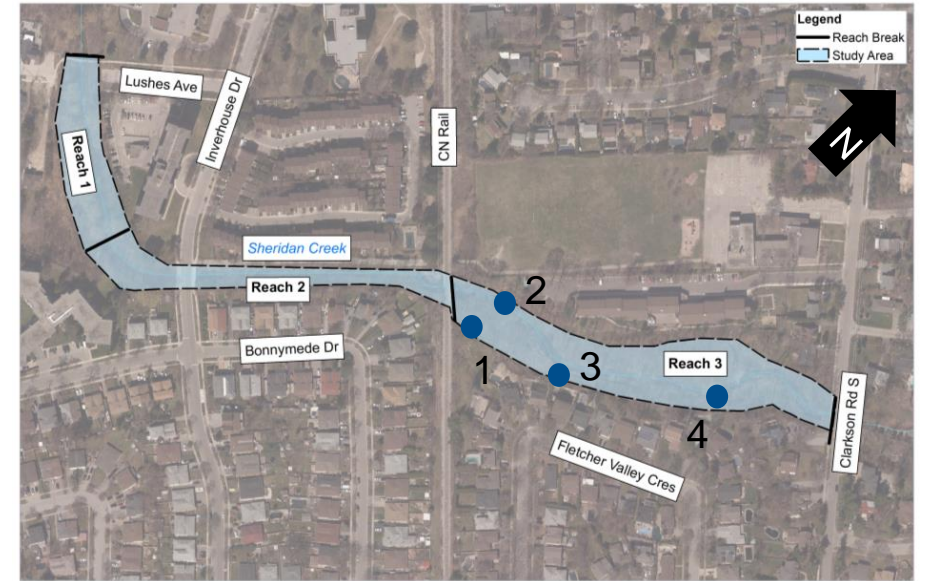
1
Scour of bed and damaged gabion baskets

- Remove failing bank protection and debris and stabilize banks with alternative treatments to protect stormwater infrastructure and private property from erosion and reduce hazard to public safety
- Restore fish passage through removal of barriers and grade control
- Enhance geomorphic stability and aquatic habitat of the channel through establishment of natural watercourse features
