Our ref: 11227231

20 May 2021

Slope Stability Evaluation 904 Mississauga Heights Drive, Mississauga, Ontario

MR. POLLA 904 MISSISSAUGA HEIGHTS DRIVE, MISSISSAUGA, ON SLOPE STABILITY ANALYSES

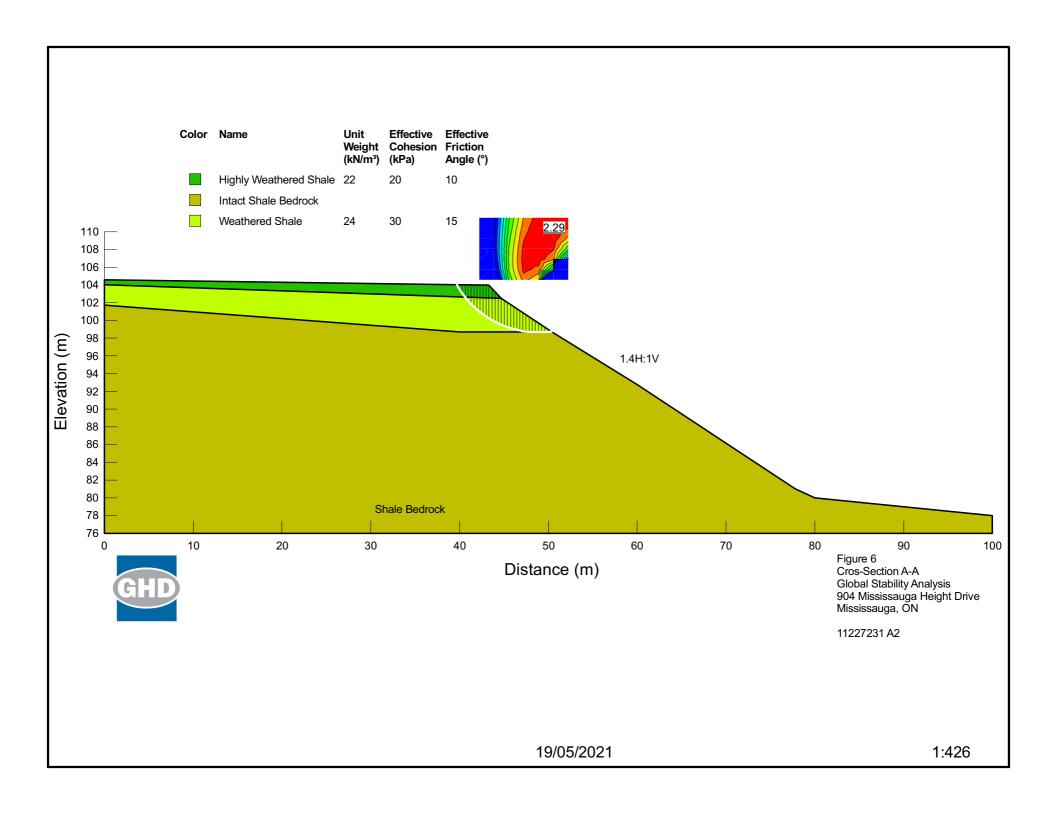
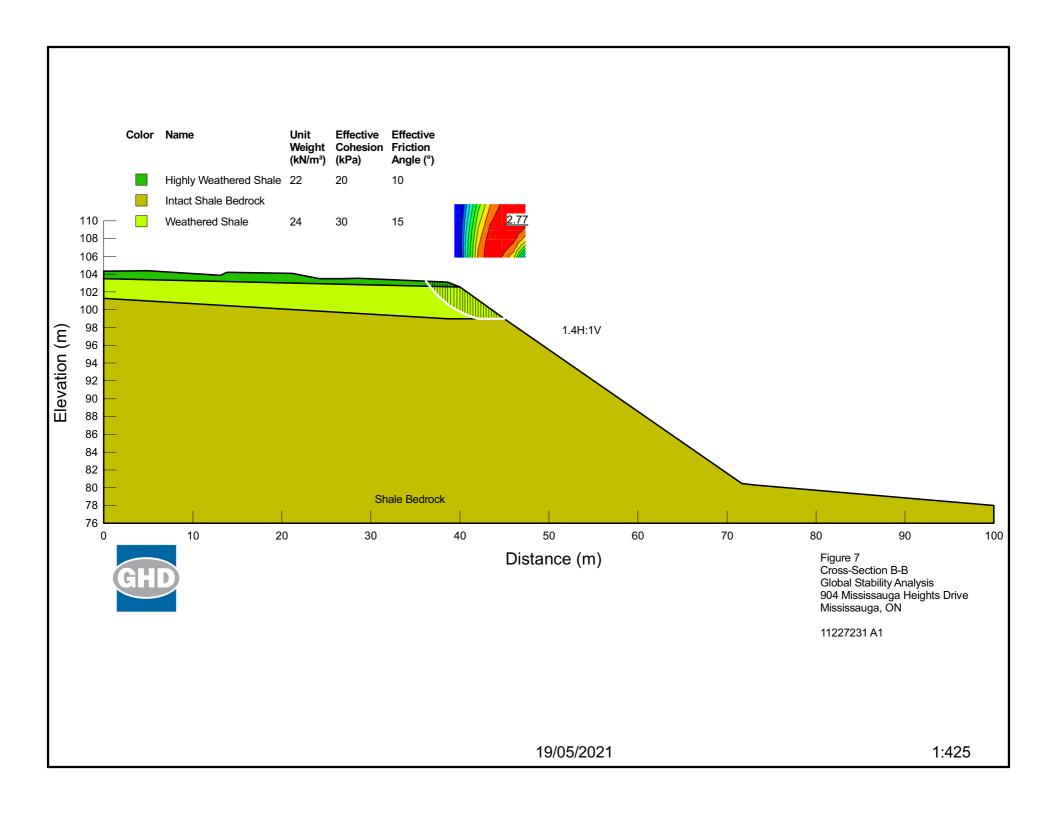
CROSS-SECTIONS A-A' AND B-B'

Cross-Section	Factor of Safety	Figure	Remarks
Cross-Section A-A	2.29	Figure 6	
Cross-Section B-B	2.77	Figure 7

A review of Figure 6 and Figure 7 and Table 4 shows that the factors of safety for both cross-sections A-A and B-B exceeded the targeted factor of safety of 1.5.
