# SLOPE STABILITY AND EROSION RISK ASSESSMENT

60 Dundas Street East  
Mississauga, Ontario

**File No.** 21-067

**Issued** August 2, 2022

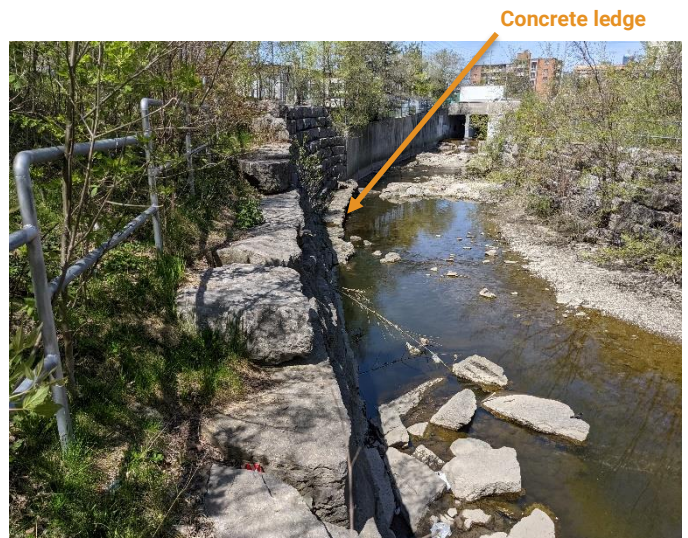
### Photograph 3

**Direction/Object:** North, along toe

**Description:** At the south end of site there is a block retaining wall that decreases in height. The retaining walls appear to be in a good state of maintenance. There is a concrete ledge beneath the tallest portion of the armourstone wall. The concrete ledge appears to be undermined.

Active erosion observed on the east side of the creek only, where the shoreline protection consists of gabion stone walls. On the west side of the creek (subject site) there is a concrete ledge beneath the tallest part of the armourstone wall. The concrete ledge appears to be undermined.
