ARBORIST REPORT & TREE PROTECTION PLAN

DIXIE MALL

1250 South Service Road
Mississauga L5E 1V4

Date: October 21, 2020

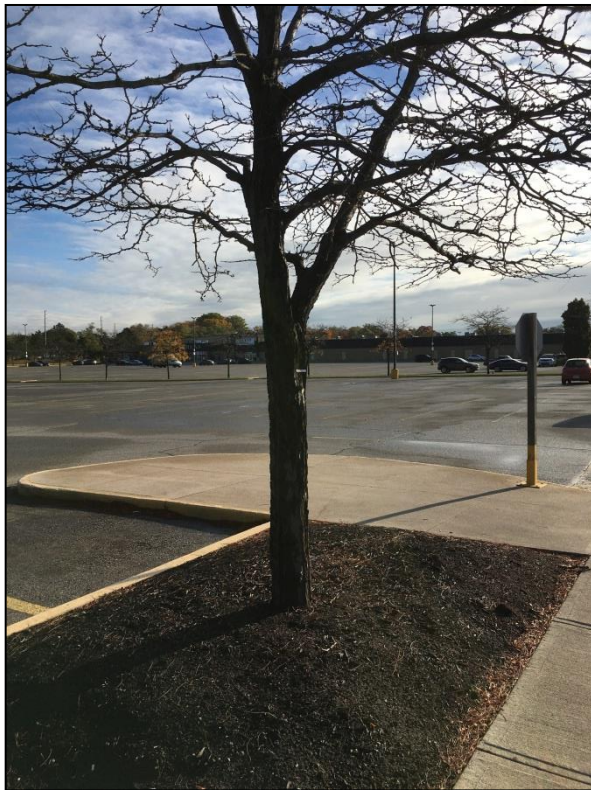
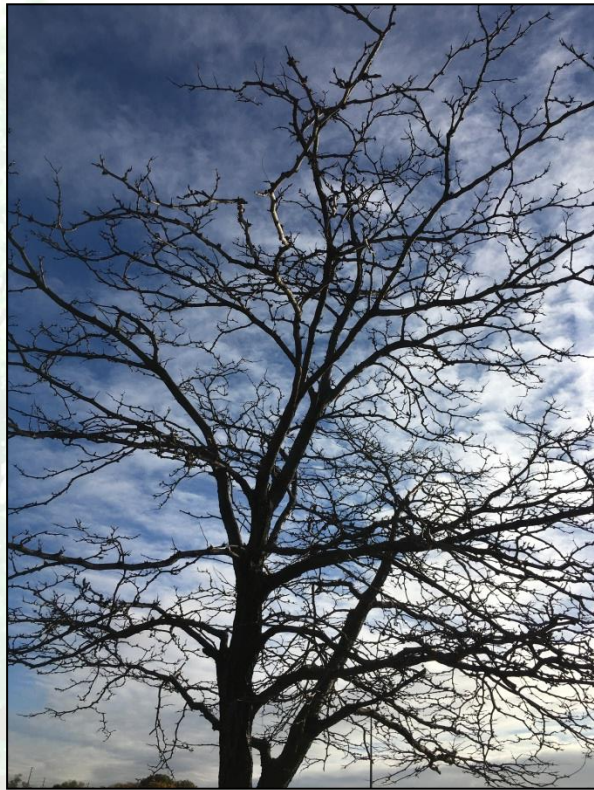
The tree has a buried root flare, is co-dominant at 2m with included bark, unhealed trunk wounds, dieback, deadwood, gypsy moth egg masses and requires pruning.

Due to the condition of this tree and the proposed construction, my client will require permission to remove this tree. As a result of the removal of this tree, my client is required to plant one (1) deciduous trees of 6cm diameter or greater, or one (1) evergreen tree that is 1.8m tall or larger, as compensation. The species and planting location will be determined during the landscape design phase of the project. An application to remove this tree will have to be submitted to Mississauga Urban Forestry.

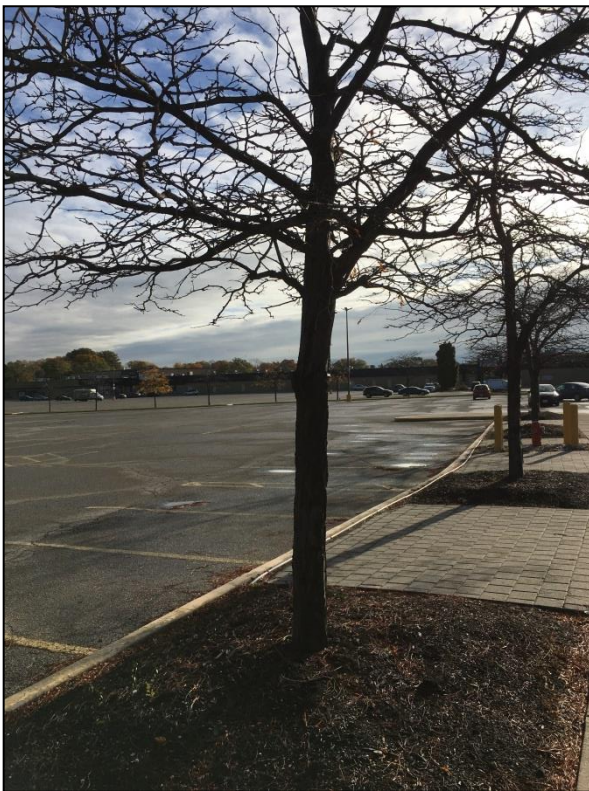
The tree has a buried root flare, included bark, unhealed trunk wounds, dieback, deadwood, gypsy moth egg masses and requires pruning.

Due to the condition of this tree and the proposed construction, my client will require permission to remove this tree. As a result of the removal of this tree, my client is required to plant one (1) deciduous trees of 6cm diameter or greater, or one (1) evergreen tree that is 1.8m tall or larger, as compensation. The species and planting location will be determined during the landscape design phase of the project. An application to remove this tree will have to be submitted to Mississauga Urban Forestry.

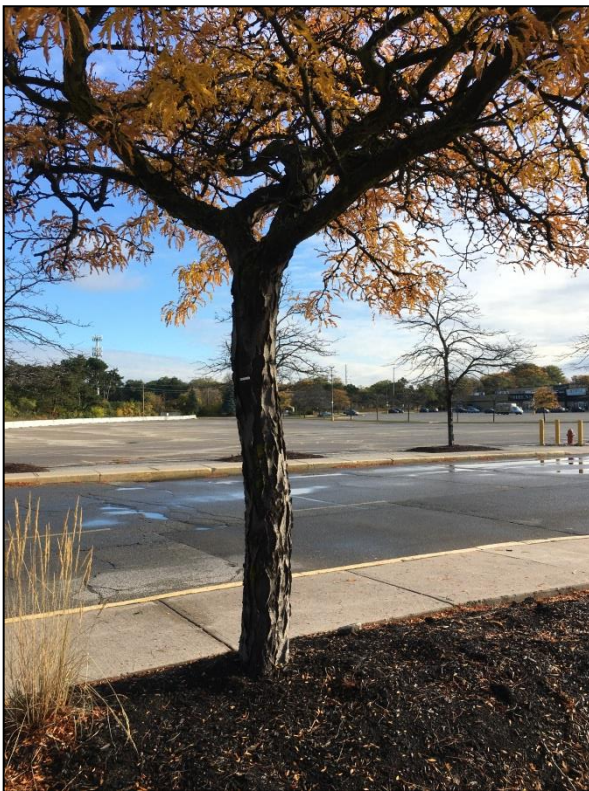
The tree has exposed and girdled roots, is co-dominant at 2m with included bark, unhealed trunk wounds, dieback, deadwood, gypsy moth egg masses and requires pruning.

Due to the condition of this tree and the proposed construction, my client will require permission to remove this tree. As a result of the removal of this tree, my client is required to plant one (1) deciduous trees of 6cm diameter or greater, or one (1) evergreen tree that is 1.8m tall or larger, as compensation. The species and planting location will be determined during the landscape design phase of the project. An application to remove this tree will have to be submitted to Mississauga Urban Forestry.

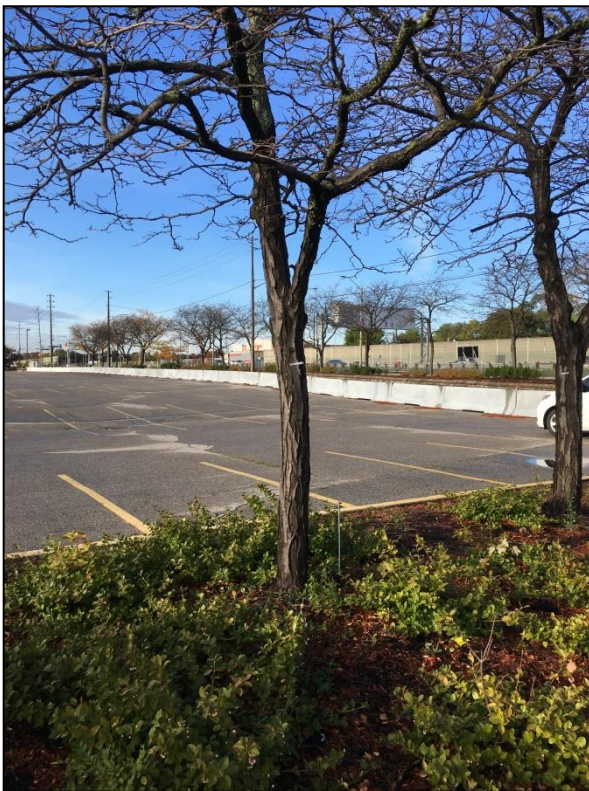
The tree has exposed and girdled roots, unhealed trunk wounds, dieback, deadwood, gypsy moth egg masses and requires pruning.

Due to the condition of this tree and the proposed construction, my client will require permission to remove this tree. As a result of the removal of this tree, my client is required to plant one (1) deciduous trees of 6cm diameter or greater, or one (1) evergreen tree that is 1.8m tall or larger, as compensation. The species and planting location will be determined during the landscape design phase of the project. An application to remove this tree will have to be submitted to Mississauga Urban Forestry.

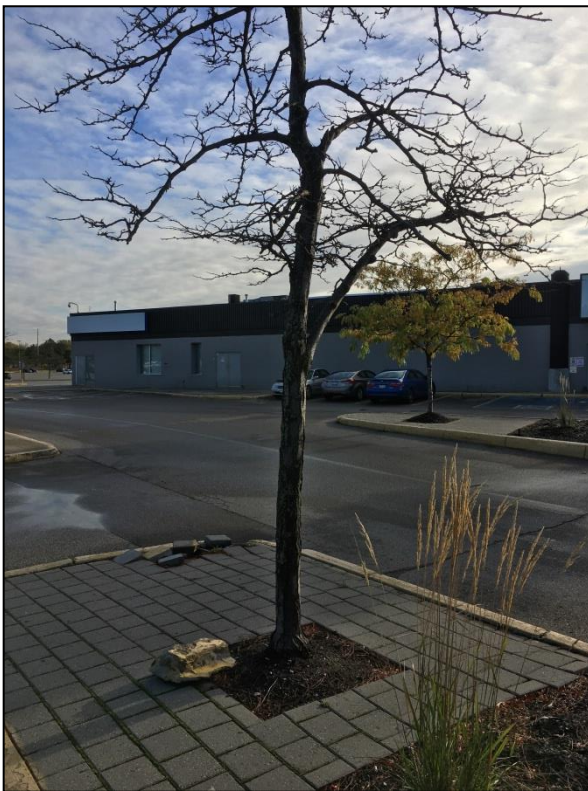
The tree has exposed and girdled roots, unhealed trunk wounds, sun scalding, dieback, deadwood, gypsy moth egg masses and requires pruning.

Due to the condition of this tree and the proposed construction, my client will require permission to remove this tree. As a result of the removal of this tree, my client is required to plant one (1) deciduous trees of 6cm diameter or greater, or one (1) evergreen tree that is 1.8m tall or larger, as compensation. The species and planting location will be determined during the landscape design phase of the project. An application to remove this tree will have to be submitted to Mississauga Urban Forestry.

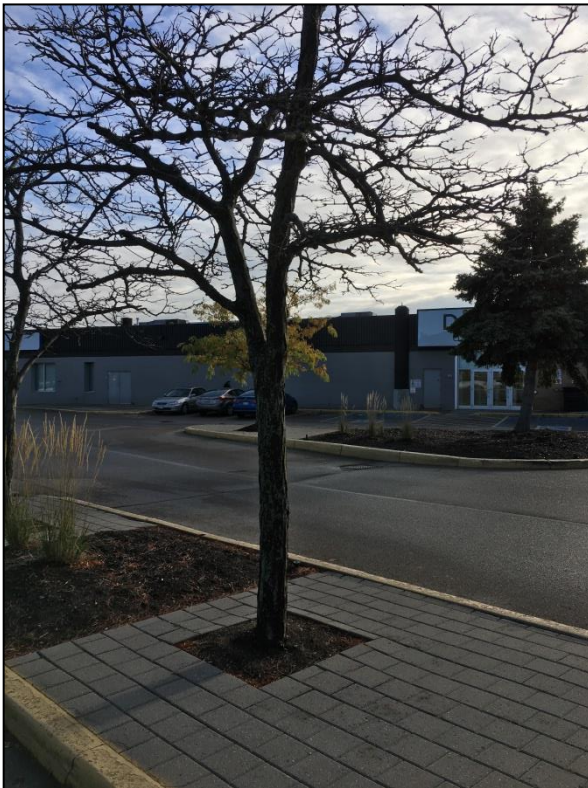
The tree has exposed roots and girdled roots, is co-dominant at 1.8m with included bark, unhealed trunk wounds, sun scalding, dieback, deadwood, gypsy moth egg masses and requires pruning.

Due to the condition of this tree and the proposed construction, my client will require permission to remove this tree. As a result of the removal of this tree, my client is required to plant one (1) deciduous trees of 6cm diameter or greater, or one (1) evergreen tree that is 1.8m tall or larger, as compensation. The species and planting location will be determined during the landscape design phase of the project. An application to remove this tree will have to be submitted to Mississauga Urban Forestry.

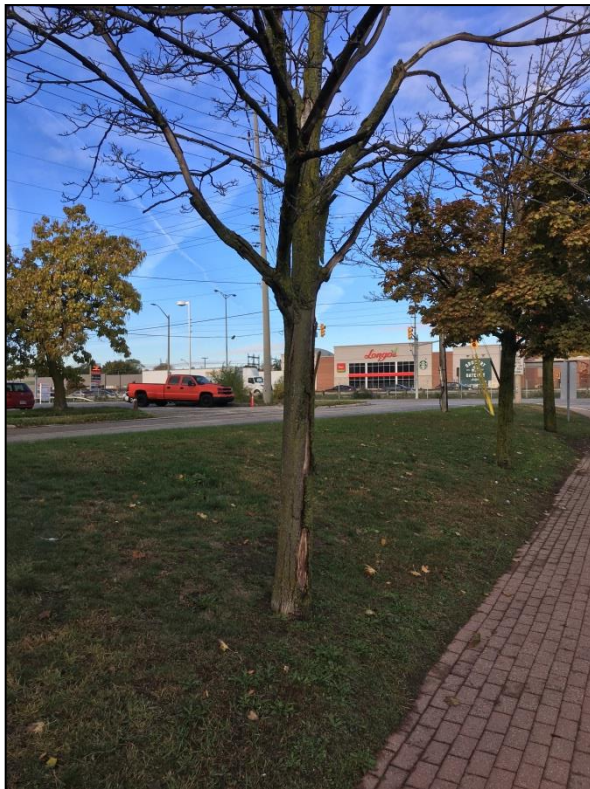
This tree is 100% dead.

Due to the condition of this tree and the proposed construction, my client will require permission to remove this tree. As a result of the removal of this tree, my client is required to plant one (1) deciduous trees of 6cm diameter or greater, or one (1) evergreen tree that is 1.8m tall or larger, as compensation. The species and planting location will be determined during the landscape design phase of the project. An application to remove this tree will have to be submitted to Mississauga Urban Forestry.

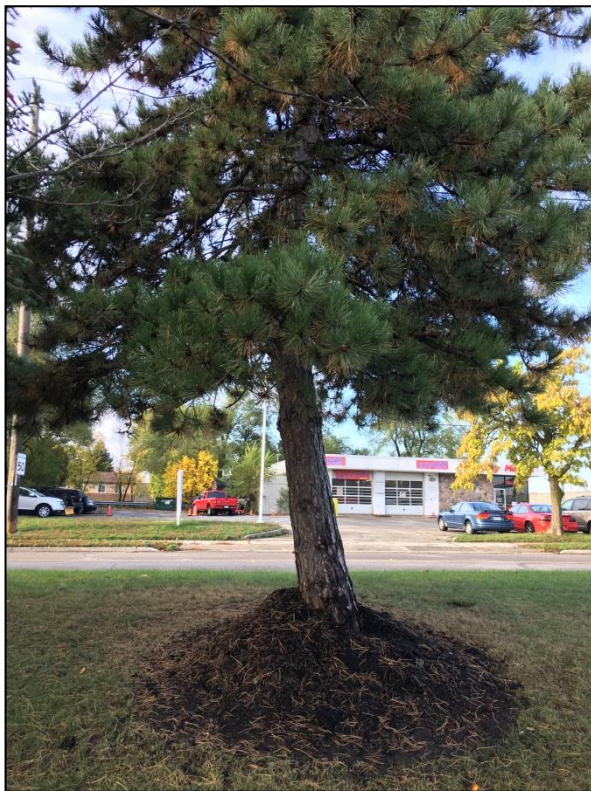
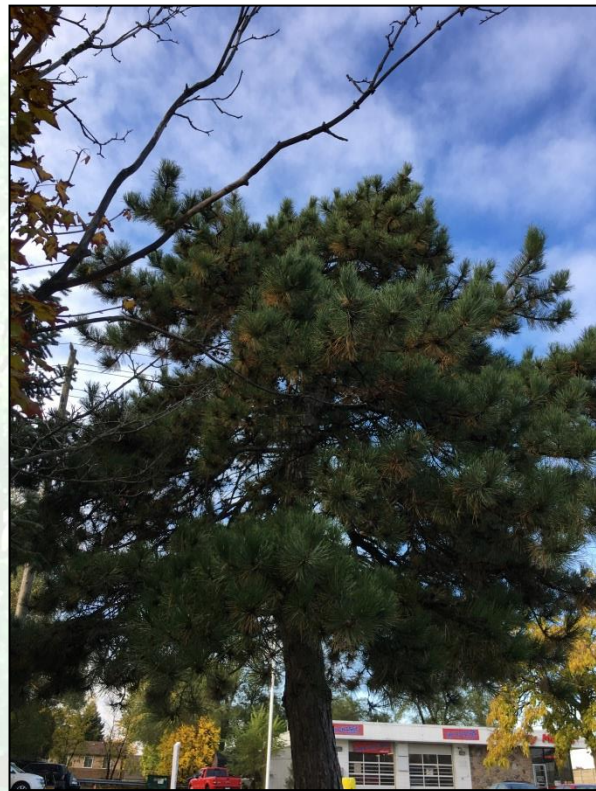
Tree #173 – Austrian Pine (30 dia. DBH) – REMOVAL PERMIT REQUIRED

The tree is growing on a lean, has a buried root flare, unhealed trunk wounds, and requires pruning.

Due to the proposed construction, my client will require permission to remove this tree. As a result of the removal of this tree, my client is required to plant one (1) deciduous trees of 6cm diameter or greater, or one (1) evergreen tree that is 1.8m tall or larger, as compensation. The species and planting location will be determined during the landscape design phase of the project. An application to remove this tree will have to be submitted to Mississauga Urban Forestry.

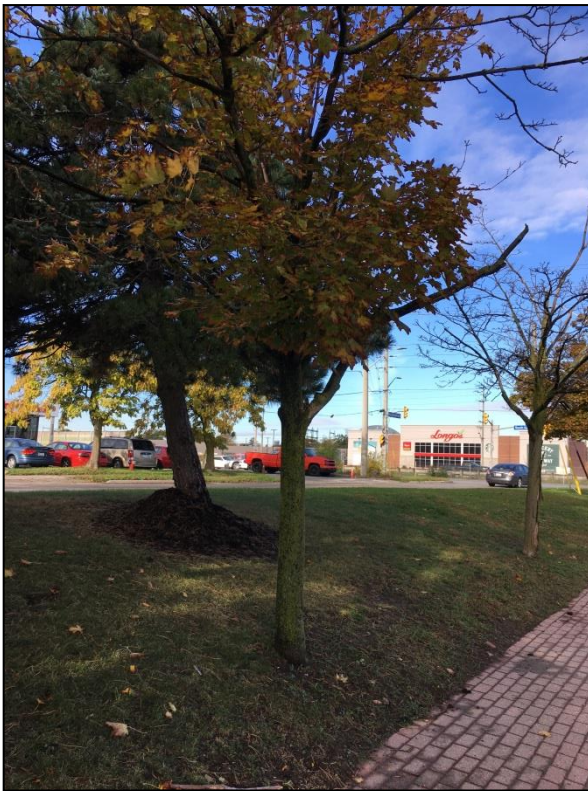
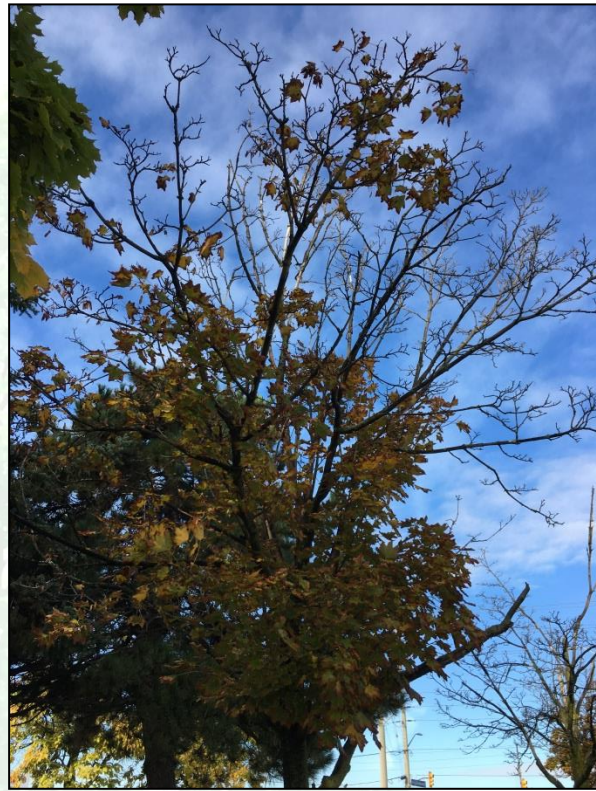
Tree #174 – Norway Maple (16cm dia. DBH) – REMOVED

This tree is almost dead and has significant canopy dieback.

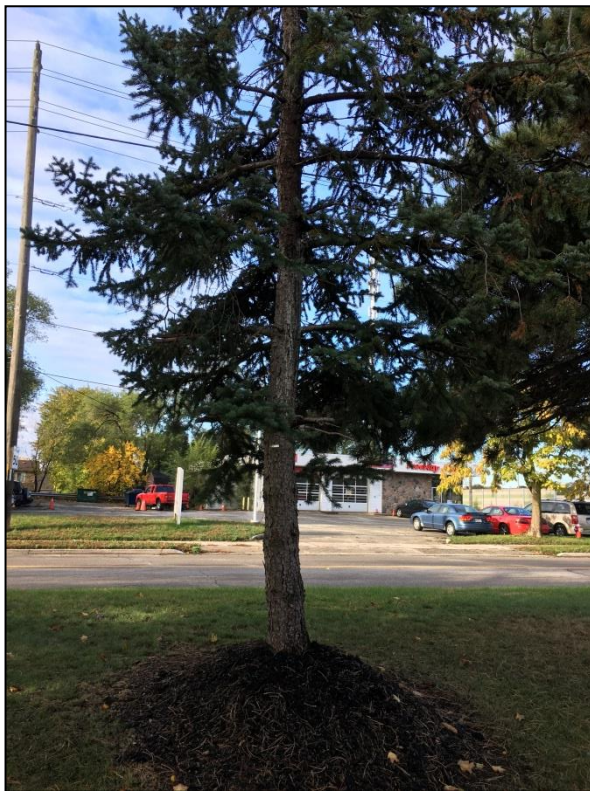
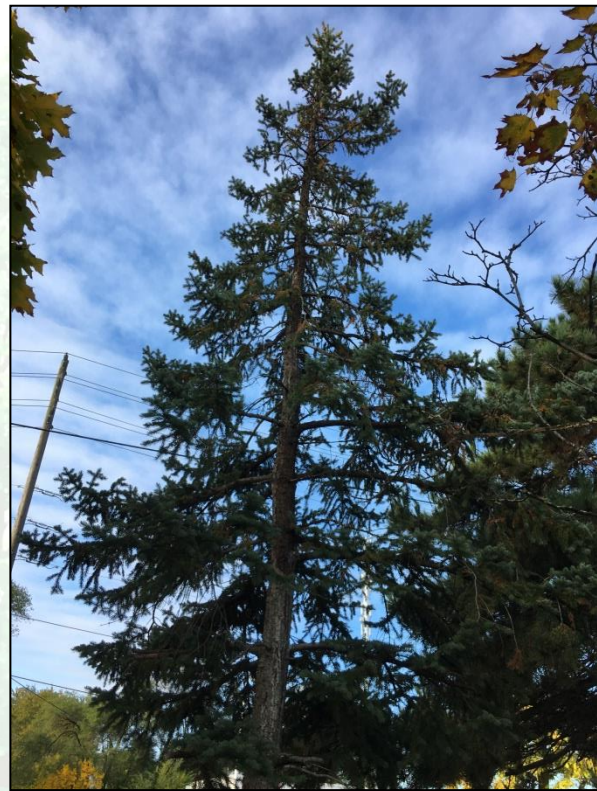
Tree #175 – Blue Spruce (19 dia. DBH) – REMOVAL PERMIT REQUIRED

The tree has a buried root flare, unhealed trunk wounds, uneven canopy, dieback, deadwood, and requires pruning.

Due to the proposed construction, my client will require permission to remove this tree. As a result of the removal of this tree, my client is required to plant one (1) deciduous trees of 6cm diameter or greater, or one (1) evergreen tree that is 1.8m tall or larger, as compensation. The species and planting location will be determined during the landscape design phase of the project. An application to remove this tree will have to be submitted to Mississauga Urban Forestry.

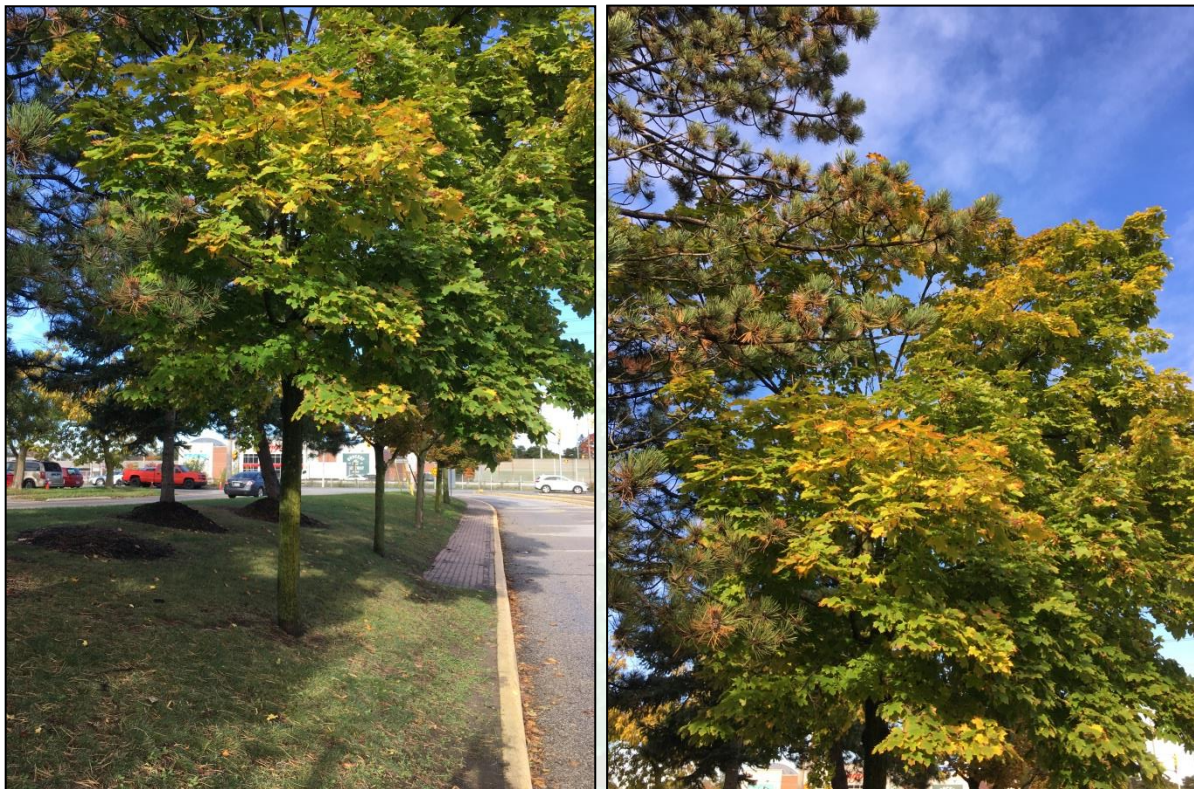
Tree #176 – Norway Maple (20cm dia. DBH) – REMOVAL PERMIT REQUIRED

The tree has a buried root flare, unhealed trunk wounds, uneven canopy, tar spot, dieback, deadwood, and requires pruning

Due to the condition of this tree and the proposed construction, my client will require permission to remove this tree. As a result of the removal of this tree, my client is required to plant one (1) deciduous trees of 6cm diameter or greater, or one (1) evergreen tree that is 1.8m tall or larger, as compensation. The species and planting location will be determined during the landscape design phase of the project. An application to remove this tree will have to be submitted to Mississauga Urban Forestry.

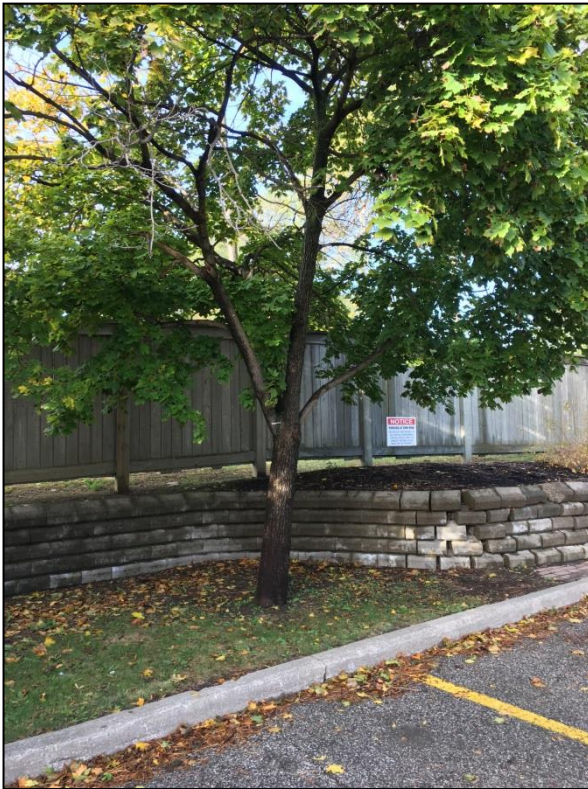
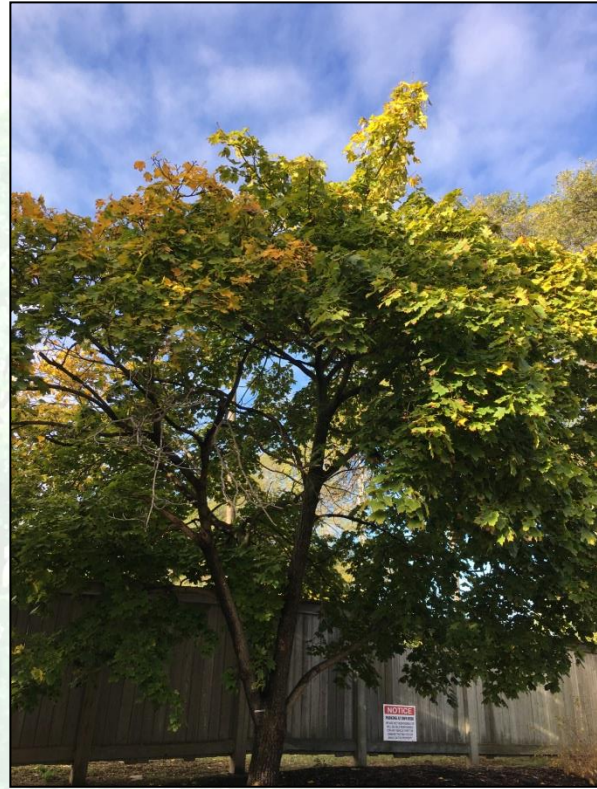
Tree #182 – Norway Maple (17cm dia. DBH) – REMOVAL PERMIT REQUIRED

The tree has a buried root flare, unhealed trunk wounds, dieback, deadwood, and is 50% dead.

Due to the condition of this tree and the proposed construction, my client will require permission to remove this tree. As a result of the removal of this tree, my client is required to plant one (1) deciduous trees of 6cm diameter or greater, or one (1) evergreen tree that is 1.8m tall or larger, as compensation. The species and planting location will be determined during the landscape design phase of the project. An application to remove this tree will have to be submitted to Mississauga Urban Forestry.

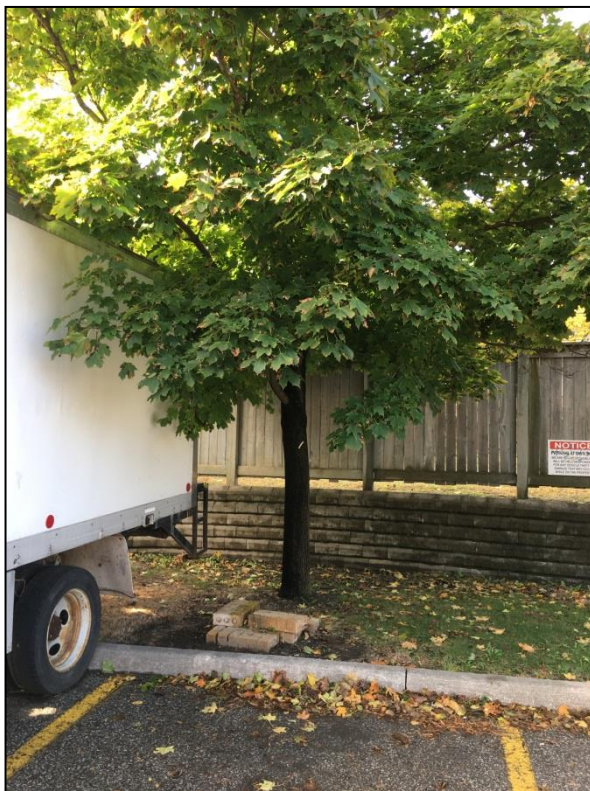
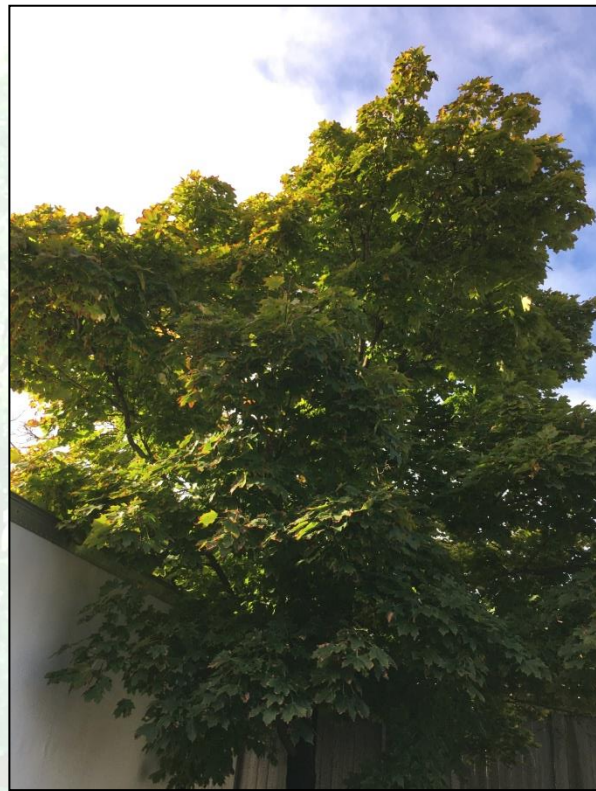
Tree #183 – Norway Maple (24cm dia. DBH) – REMOVAL PERMIT REQUIRED

The tree has exposed and girdled roots, unhealed trunk wounds, exposed cambium, tar spot, dieback, deadwood, and requires pruning.

Due to the condition of this tree and the proposed construction, my client will require permission to remove this tree. As a result of the removal of this tree, my client is required to plant one (1) deciduous trees of 6cm diameter or greater, or one (1) evergreen tree that is 1.8m tall or larger, as compensation. The species and planting location will be determined during the landscape design phase of the project. An application to remove this tree will have to be submitted to Mississauga Urban Forestry.

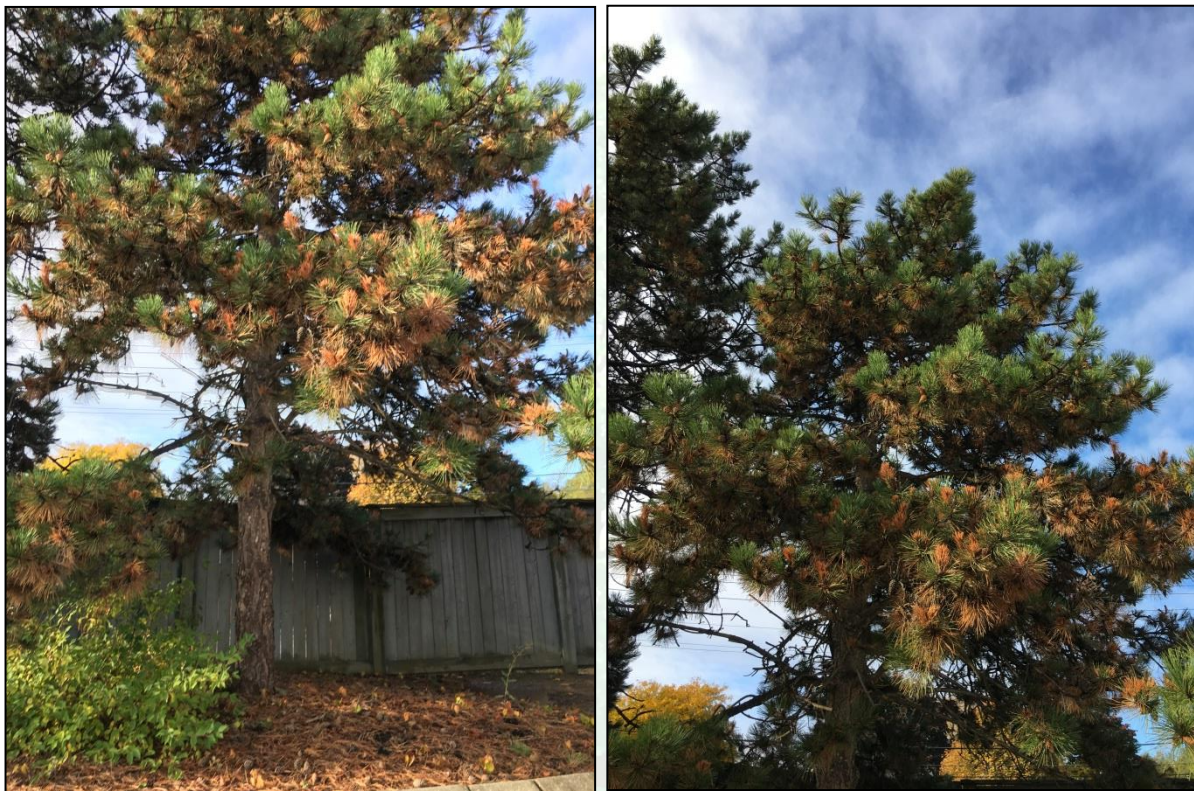
Tree #184 – Austrian Pine (24 dia. DBH) – REMOVAL PERMIT REQUIRED

The tree has exposed and girdled roots, unhealed trunk wounds, dieback, deadwood, and requires pruning.

Due to the condition of this tree and the proposed construction, my client will require permission to remove this tree. As a result of the removal of this tree, my client is required to plant one (1) deciduous trees of 6cm diameter or greater, or one (1) evergreen tree that is 1.8m tall or larger, as compensation. The species and planting location will be determined during the landscape design phase of the project. An application to remove this tree will have to be submitted to Mississauga Urban Forestry.

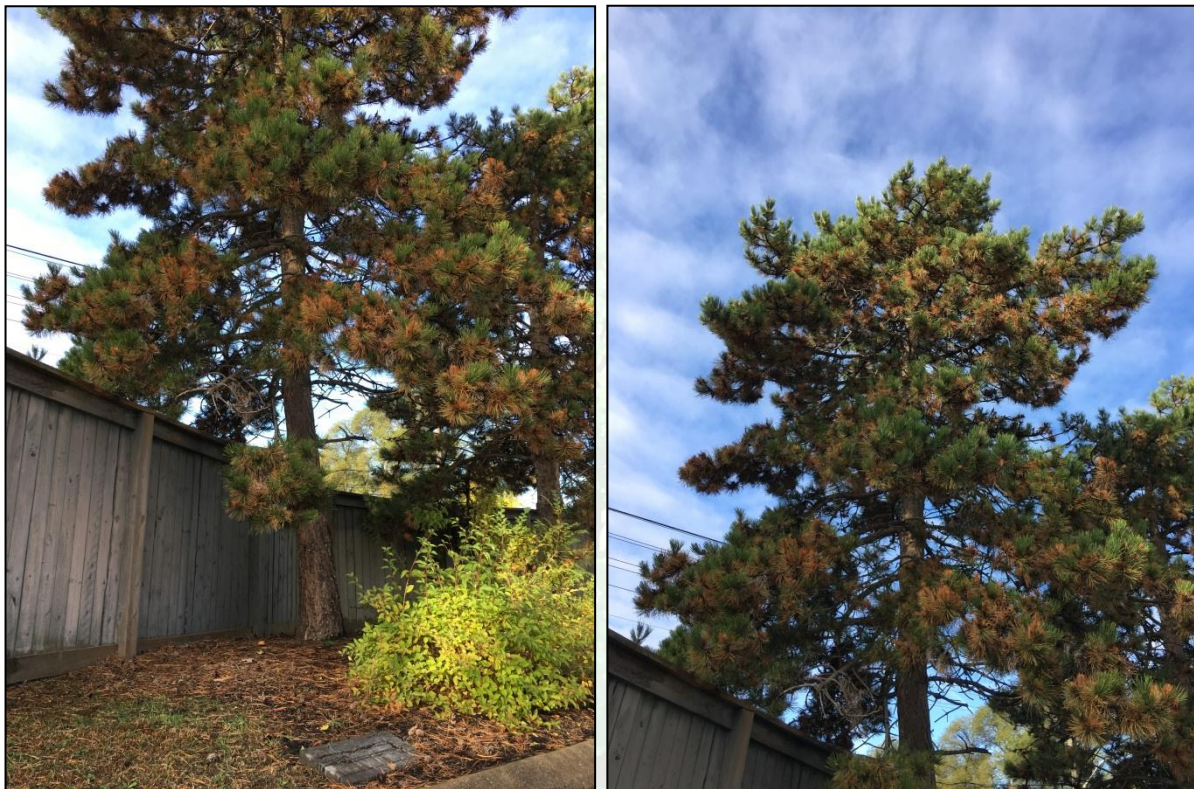
Tree #185 – Austrian Pine (24 dia. DBH) – REMOVAL PERMIT REQUIRED

The tree has a buried root flare, unhealed trunk wounds, dieback, deadwood, and requires pruning.

Due to the proposed construction, my client will require permission to remove this tree. As a result of the removal of this tree, my client is required to plant one (1) deciduous trees of 6cm diameter or greater, or one (1) evergreen tree that is 1.8m tall or larger, as compensation. The species and planting location will be determined during the landscape design phase of the project. An application to remove this tree will have to be submitted to Mississauga Urban Forestry.

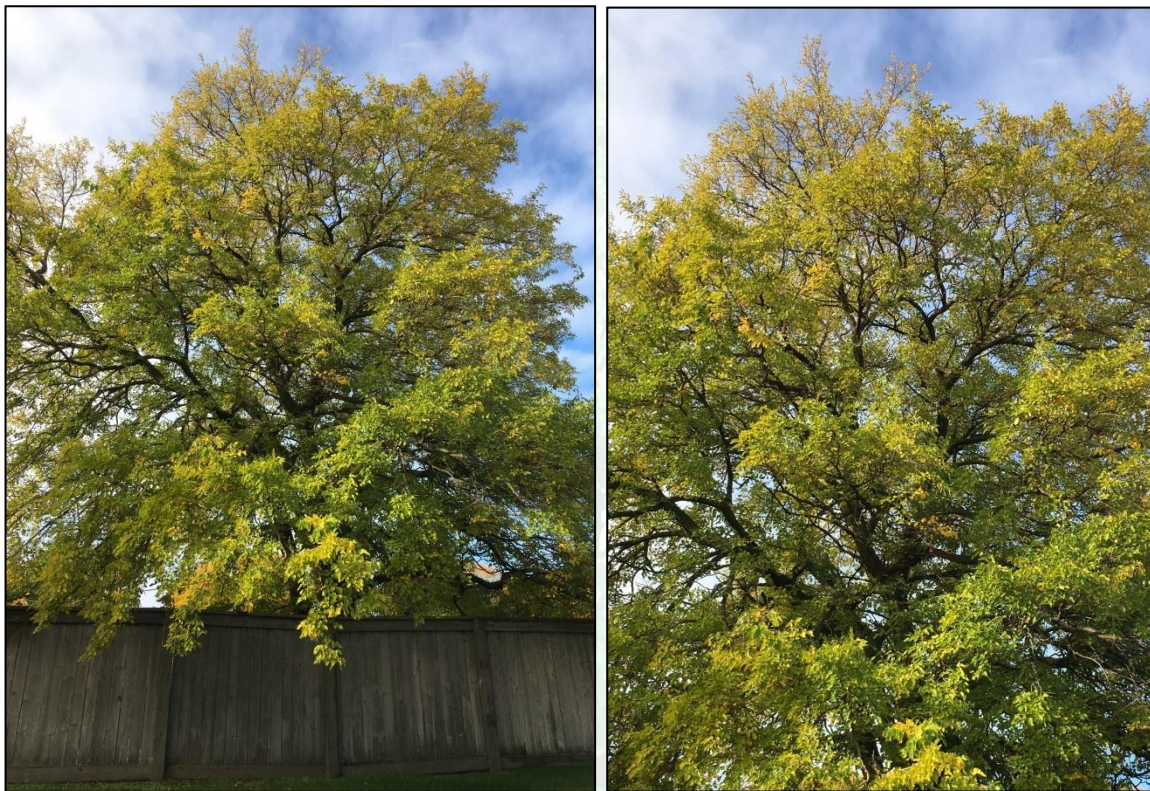
Tree #186 – American Elm (72 dia. DBH) – REMOVAL PERMIT REQUIRED

The tree has exposed and girdled roots, unhealed trunk wounds, minor dieback, deadwood, and requires pruning.

Due to the proposed construction, my client will require permission to remove this tree. As a result of the removal of this tree, my client is required to plant one (2) deciduous trees of 6cm diameter or greater, or one (2) evergreen tree that is 1.8m tall or larger, as compensation. The species and planting location will be determined during the landscape design phase of the project. An application to remove this tree will have to be submitted to Mississauga Urban Forestry.

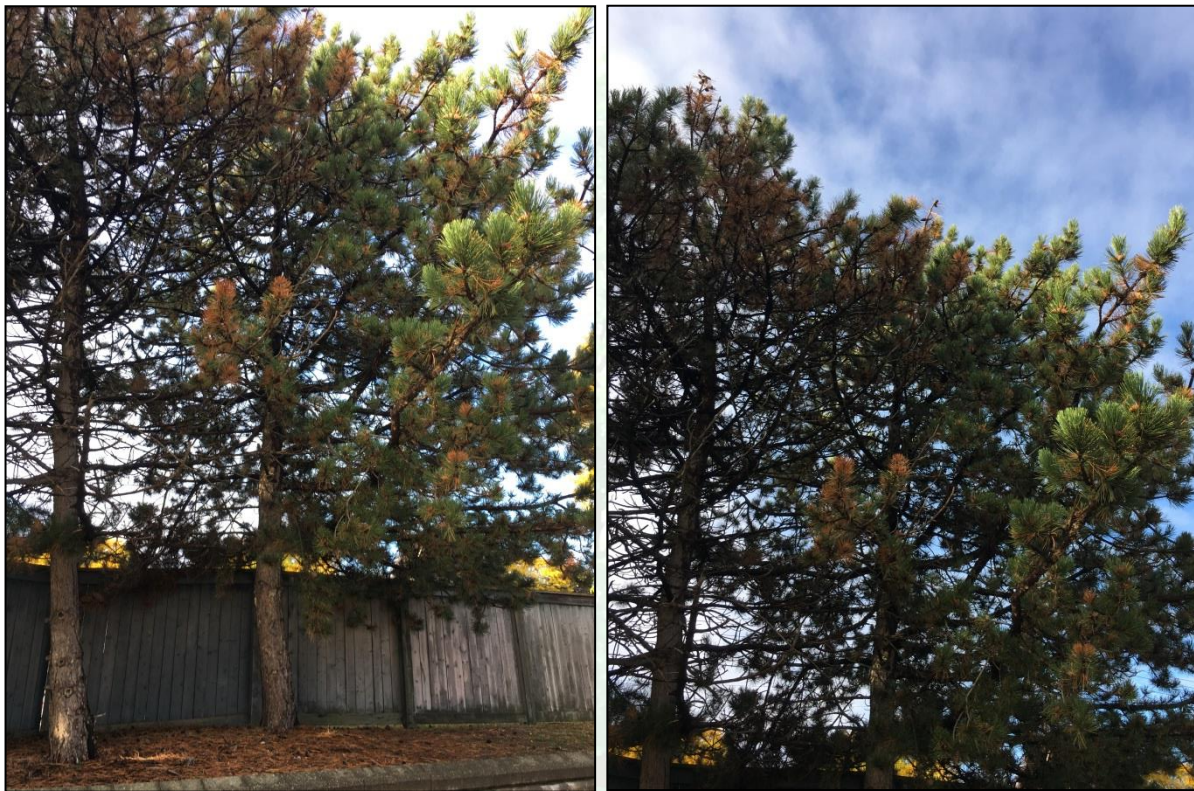
Tree #187 – Austrian Pine (32 dia. DBH) – REMOVAL PERMIT REQUIRED

The tree has exposed and girdled roots, unhealed trunk wounds, dieback, deadwood, and requires pruning.

Due to the proposed construction, my client will require permission to remove this tree. As a result of the removal of this tree, my client is required to plant one (1) deciduous trees of 6cm diameter or greater, or one (1) evergreen tree that is 1.8m tall or larger, as compensation. The species and planting location will be determined during the landscape design phase of the project. An application to remove this tree will have to be submitted to Mississauga Urban Forestry.

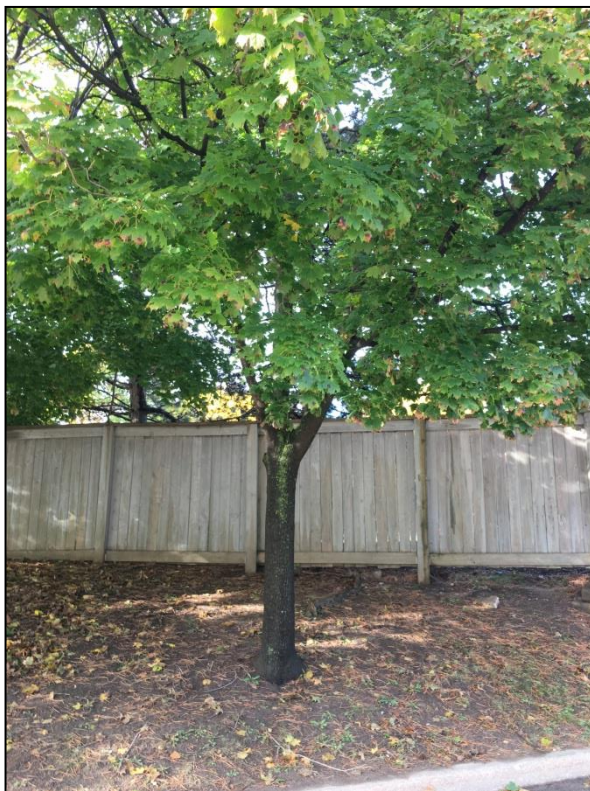
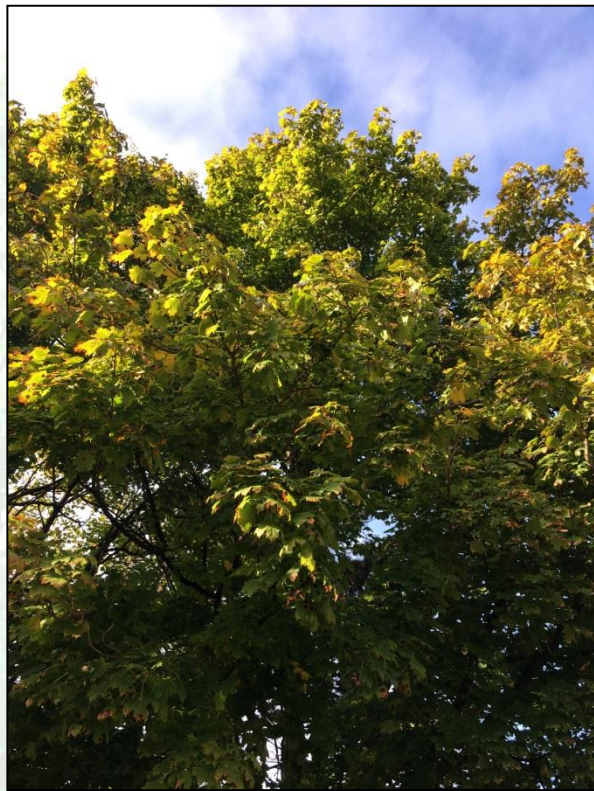
Tree #190 – Norway Maple (29cm dia. DBH) – REMOVAL PERMIT REQUIRED

Tree #190, a 29cm dia. Norway Maple (*Acer platanoides*) is a privately-owned deciduous tree growing on the west portion of the subject site.

The tree has exposed and girdled roots, unhealed trunk wounds, tar spot, dieback, deadwood, and requires pruning.

Due to the condition of this tree and the proposed construction, my client will require permission to remove this tree. As a result of the removal of this tree, my client is required to plant one (1) deciduous trees of 6cm diameter or greater, or one (1) evergreen tree that is 1.8m tall or larger, as compensation. The species and planting location will be determined during the landscape design phase of the project. An application to remove this tree will have to be submitted to Mississauga Urban Forestry.

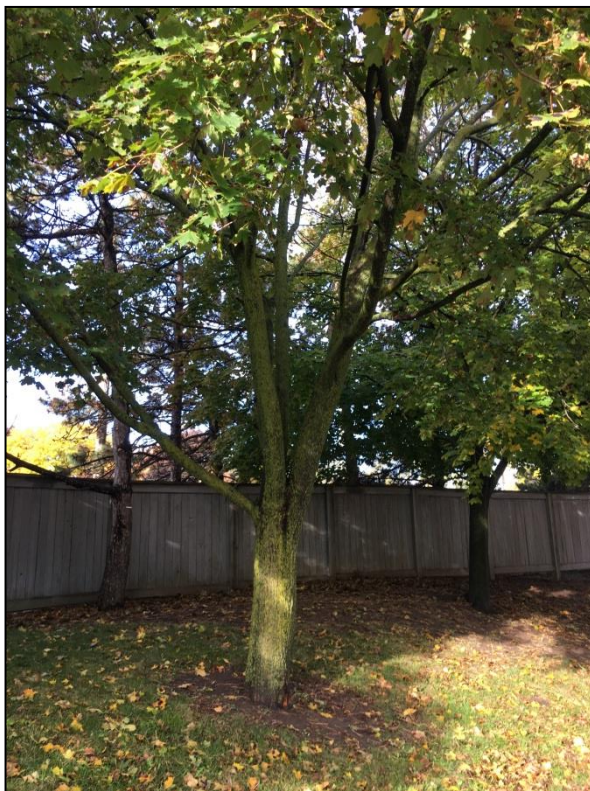
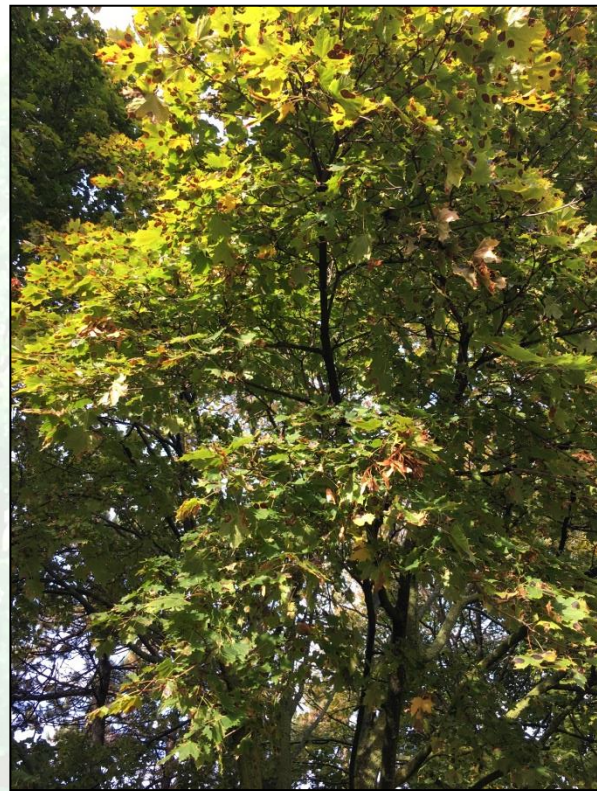
Tree #193 – Norway Maple (44cm dia. DBH) – REMOVAL PERMIT REQUIRED

Tree #193, a 44cm dia. Norway Maple (*Acer platanoides*) is a privately-owned deciduous tree growing on the west portion of the subject site.

The tree has exposed and girdled roots, unhealed trunk wounds, tar spot, dieback, deadwood, and requires pruning.

Due to the condition of this tree and the proposed construction, my client will require permission to remove this tree. As a result of the removal of this tree, my client is required to plant one (1) deciduous trees of 6cm diameter or greater, or one (1) evergreen tree that is 1.8m tall or larger, as compensation. The species and planting location will be determined during the landscape design phase of the project. An application to remove this tree will have to be submitted to Mississauga Urban Forestry.

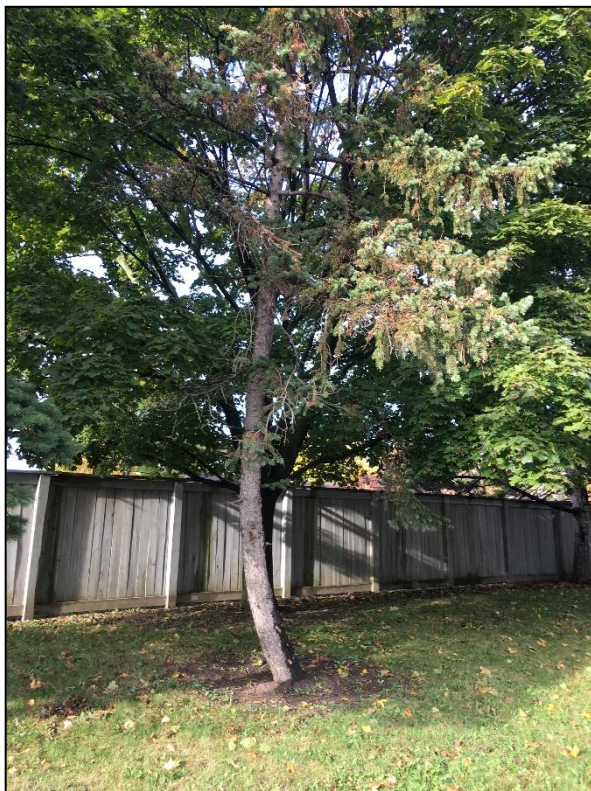
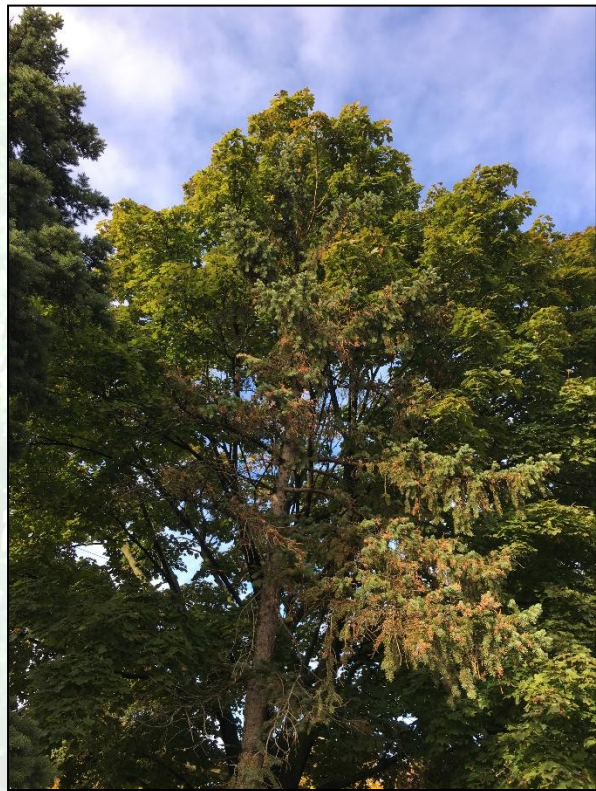
Tree #195 – Blue Spruce (20cm dia. DBH) – REMOVAL PERMIT REQUIRED

Tree #195, a 20cm dia. Blue Spruce (*Picea pungens*) is a privately-owned evergreen tree growing on the west portion of the subject site.

The tree is growing on a lean, unhealed trunk wounds, uneven canopy, dieback, deadwood, and requires pruning.

Due to the condition of this tree and the proposed construction, my client will require permission to remove this tree. As a result of the removal of this tree, my client is required to plant one (1) deciduous trees of 6cm diameter or greater, or one (1) evergreen tree that is 1.8m tall or larger, as compensation. The species and planting location will be determined during the landscape design phase of the project. An application to remove this tree will have to be submitted to Mississauga Urban Forestry.

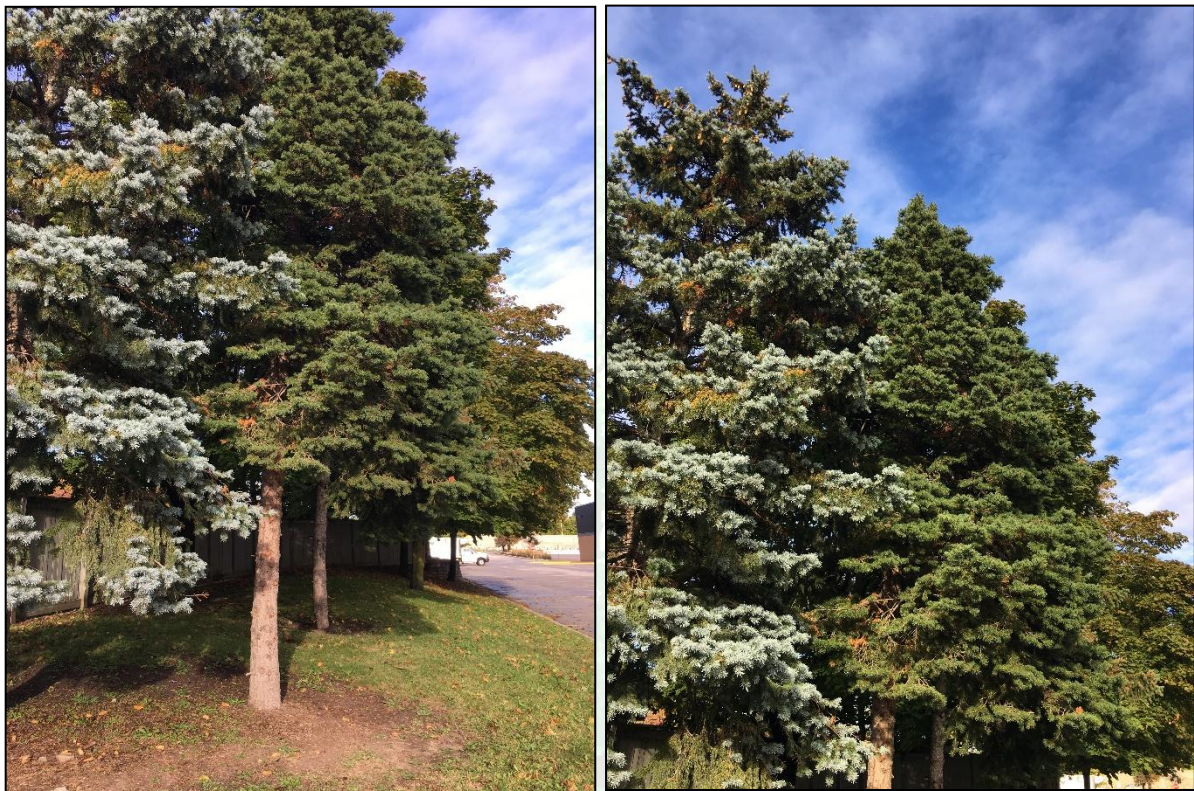
Tree #196 – Blue Spruce (26cm dia. DBH) – REMOVAL PERMIT REQUIRED

Tree #196, a 26cm dia. Blue Spruce (*Picea pungens*) is a privately-owned evergreen tree growing on the west portion of the subject site.

The tree is growing on a lean, unhealed trunk wounds, uneven canopy, dieback, deadwood, and requires pruning.

Due to the condition of this tree and the proposed construction, my client will require permission to remove this tree. As a result of the removal of this tree, my client is required to plant one (1) deciduous trees of 6cm diameter or greater, or one (1) evergreen tree that is 1.8m tall or larger, as compensation. The species and planting location will be determined during the landscape design phase of the project. An application to remove this tree will have to be submitted to Mississauga Urban Forestry.

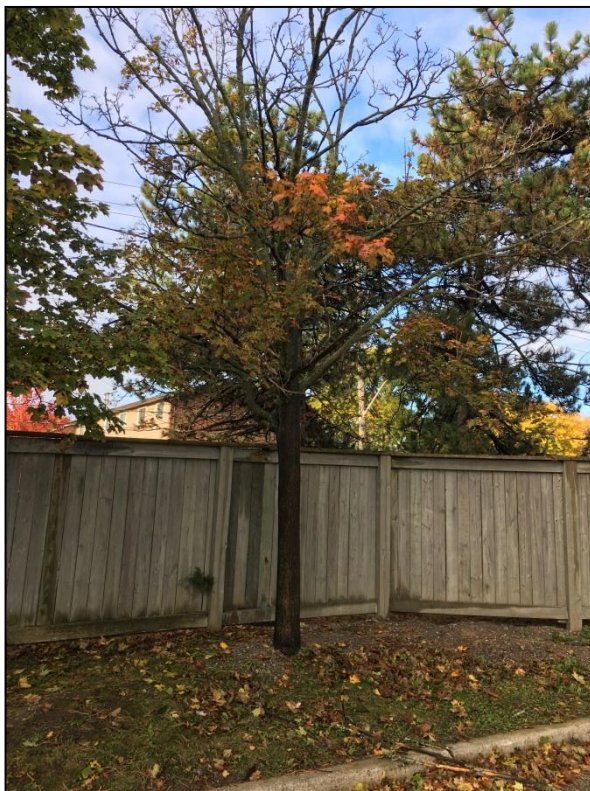
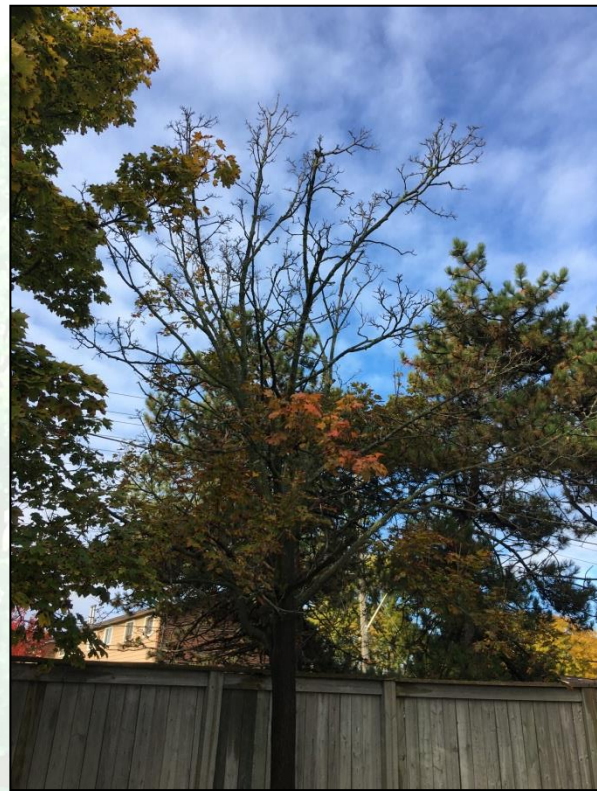
Tree #198 – Norway Maple (25cm dia. DBH) – REMOVAL PERMIT REQUIRED

Tree #198, a 25cm dia. Norway Maple (*Acer platanoides*) is a privately-owned deciduous tree growing on the west portion of the subject site.

The tree has a buried root flare, unhealed trunk wounds, tar spot, dieback, deadwood, and requires pruning.

Due to the condition of this tree and the proposed construction, my client will require permission to remove this tree. As a result of the removal of this tree, my client is required to plant one (1) deciduous trees of 6cm diameter or greater, or one (1) evergreen tree that is 1.8m tall or larger, as compensation. The species and planting location will be determined during the landscape design phase of the project. An application to remove this tree will have to be submitted to Mississauga Urban Forestry.
