ARBORIST REPORT & TREE PROTECTION PLAN

DIXIE MALL

1250 South Service Road
Mississauga L5E 1V4

Date: October 21, 2020

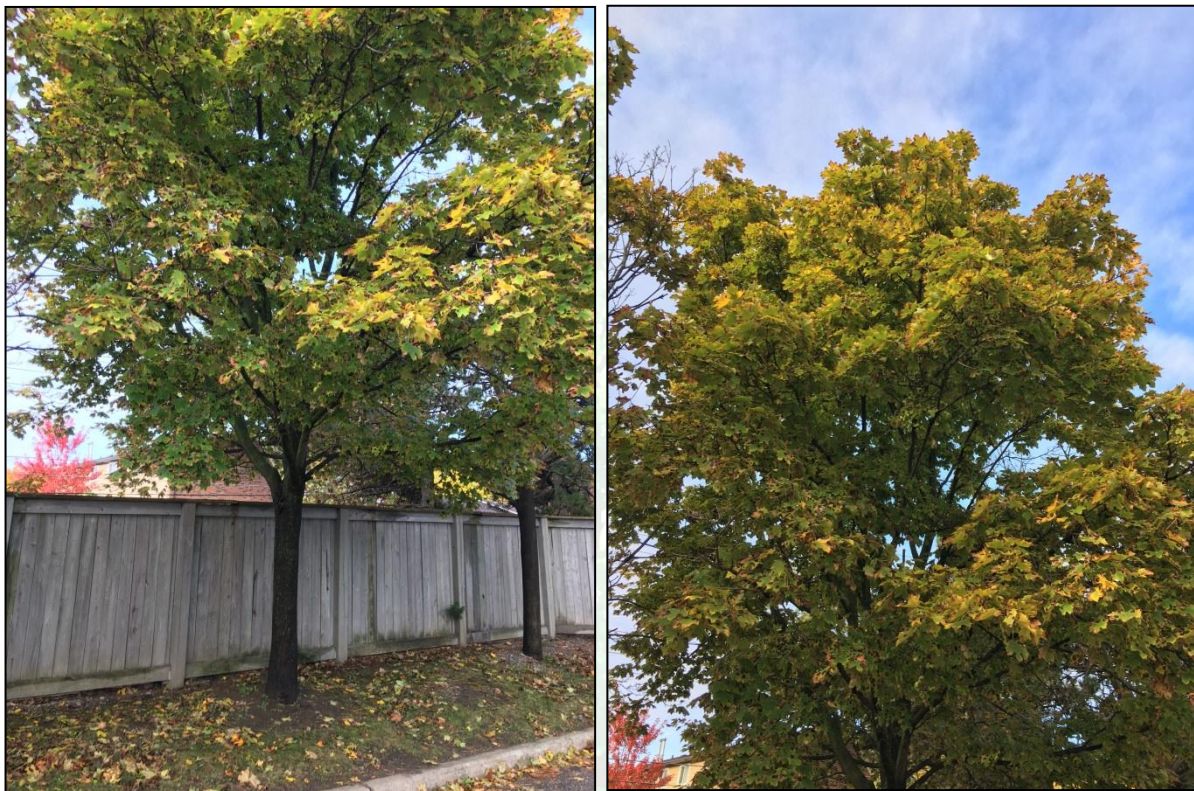
Tree #199 – Norway Maple (27cm dia. DBH) – REMOVAL PERMIT REQUIRED

Tree #199, a 27cm dia. Norway Maple (*Acer platanoides*) is a privately-owned deciduous tree growing on the west portion of the subject site.

The tree has exposed and girdled roots, unhealed trunk wounds, exposed cambium, tar spot, dieback, deadwood, and requires pruning.

Due to the condition of this tree and the proposed construction, my client will require permission to remove this tree. As a result of the removal of this tree, my client is required to plant one (1) deciduous trees of 6cm diameter or greater, or one (1) evergreen tree that is 1.8m tall or larger, as compensation. The species and planting location will be determined during the landscape design phase of the project. An application to remove this tree will have to be submitted to Mississauga Urban Forestry.

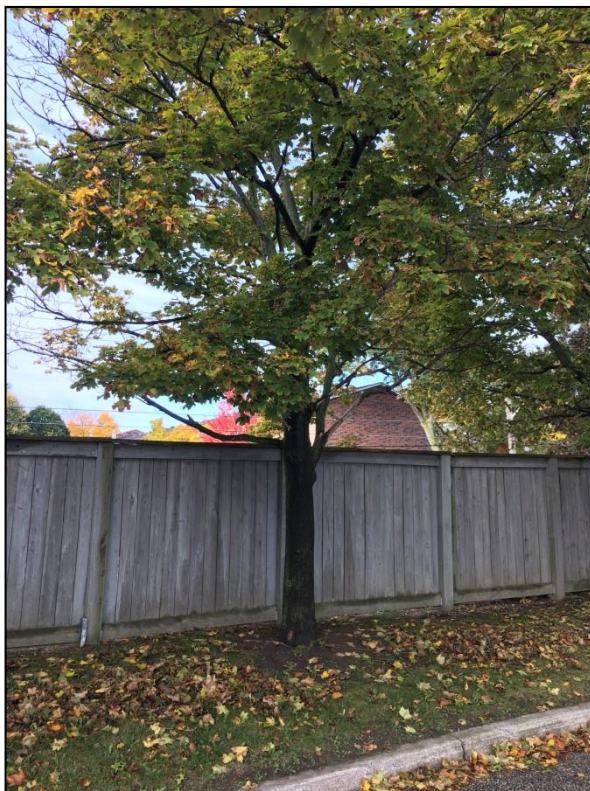
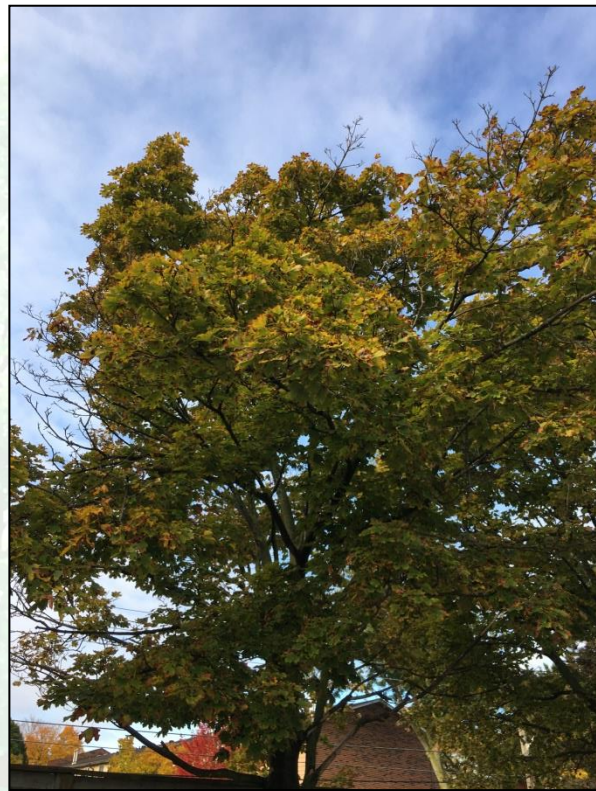
Tree #200 – Norway Maple (27cm dia. DBH) – REMOVAL PERMIT REQUIRED

Tree #200, a 27cm dia. Norway Maple (*Acer platanoides*) is a privately-owned deciduous tree growing on the west portion of the subject site.

The tree has exposed and girdled roots, unhealed trunk wounds, tar spot, dieback, deadwood, and requires pruning.

Due to the condition of this tree and the proposed construction, my client will require permission to remove this tree. As a result of the removal of this tree, my client is required to plant one (1) deciduous trees of 6cm diameter or greater, or one (1) evergreen tree that is 1.8m tall or larger, as compensation. The species and planting location will be determined during the landscape design phase of the project. An application to remove this tree will have to be submitted to Mississauga Urban Forestry.

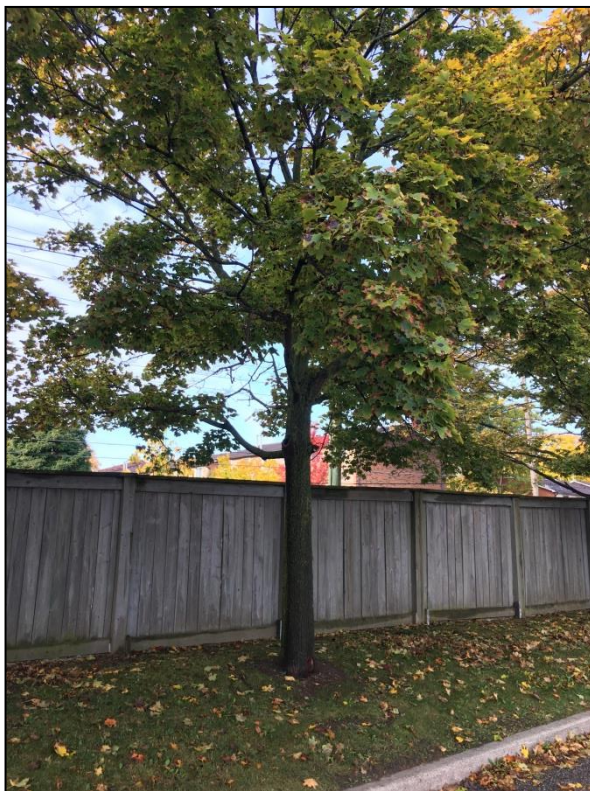
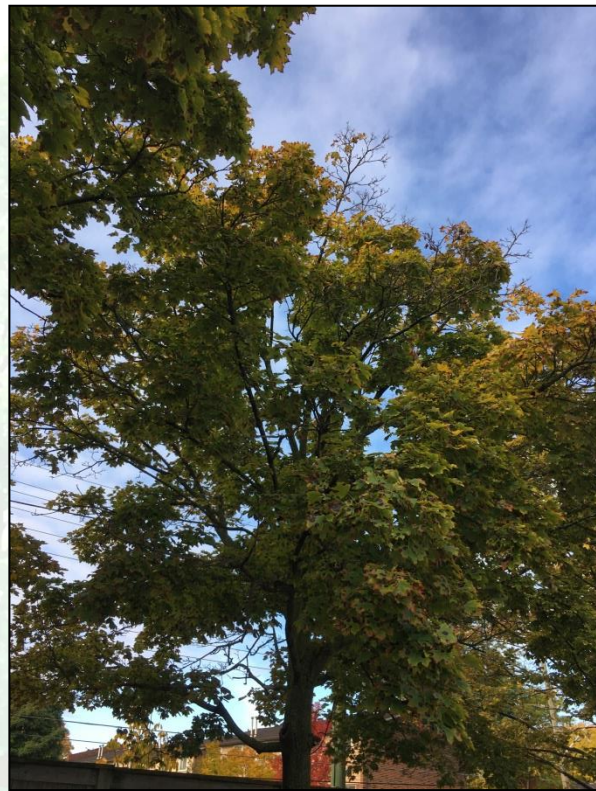
Tree #201 – Norway Maple (28cm dia. DBH) – REMOVAL PERMIT REQUIRED

Tree #201, a 28cm dia. Norway Maple (*Acer platanoides*) is a privately-owned deciduous tree growing on the west portion of the subject site.

The tree has exposed and girdled roots, unhealed trunk wounds, tar spot, dieback, deadwood, and requires pruning.

Due to the condition of this tree and the proposed construction, my client will require permission to remove this tree. As a result of the removal of this tree, my client is required to plant one (1) deciduous trees of 6cm diameter or greater, or one (1) evergreen tree that is 1.8m tall or larger, as compensation. The species and planting location will be determined during the landscape design phase of the project. An application to remove this tree will have to be submitted to Mississauga Urban Forestry.

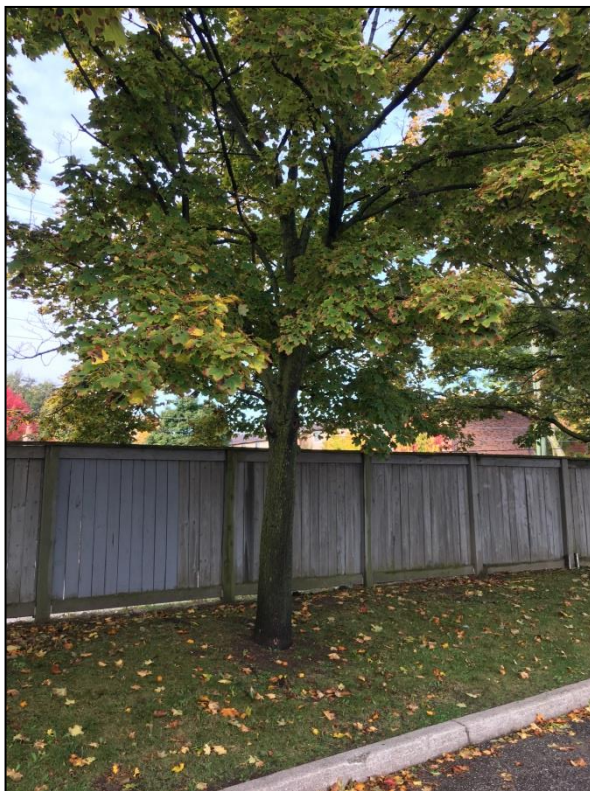
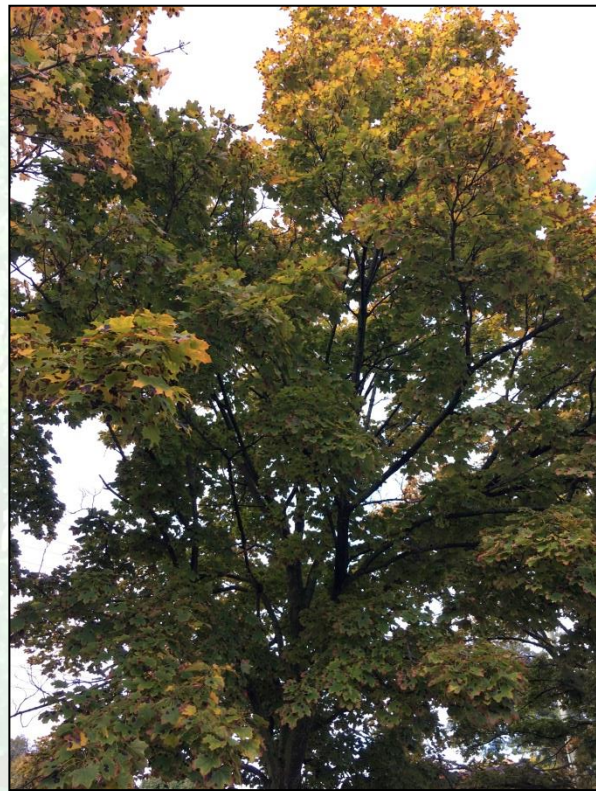
Tree #202 – Norway Maple (34cm dia. DBH) – REMOVAL PERMIT REQUIRED

Tree #202, a 34cm dia. Norway Maple (*Acer platanoides*) is a privately-owned deciduous tree growing on the west portion of the subject site.

The tree has exposed and girdled roots, unhealed trunk wounds, tar spot, dieback, deadwood, and requires pruning.

Due to the condition of this tree and the proposed construction, my client will require permission to remove this tree. As a result of the removal of this tree, my client is required to plant one (1) deciduous trees of 6cm diameter or greater, or one (1) evergreen tree that is 1.8m tall or larger, as compensation. The species and planting location will be determined during the landscape design phase of the project. An application to remove this tree will have to be submitted to Mississauga Urban Forestry.

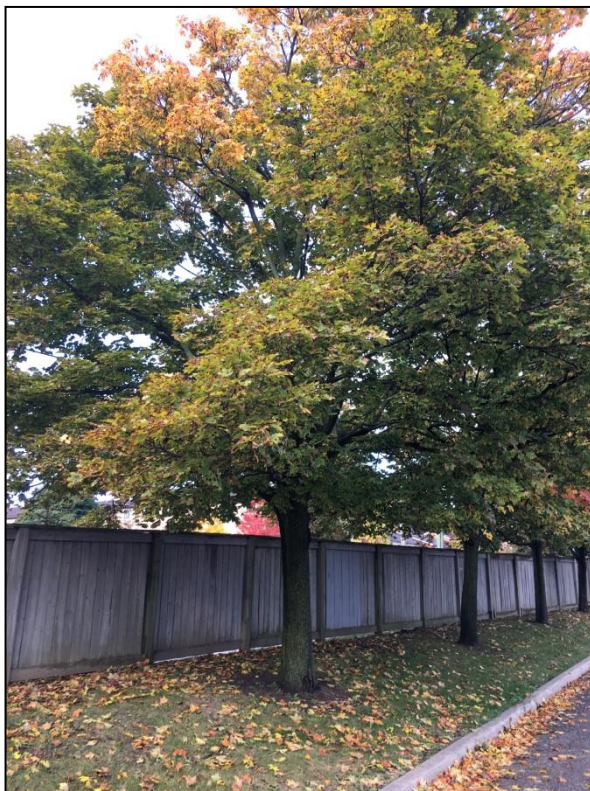
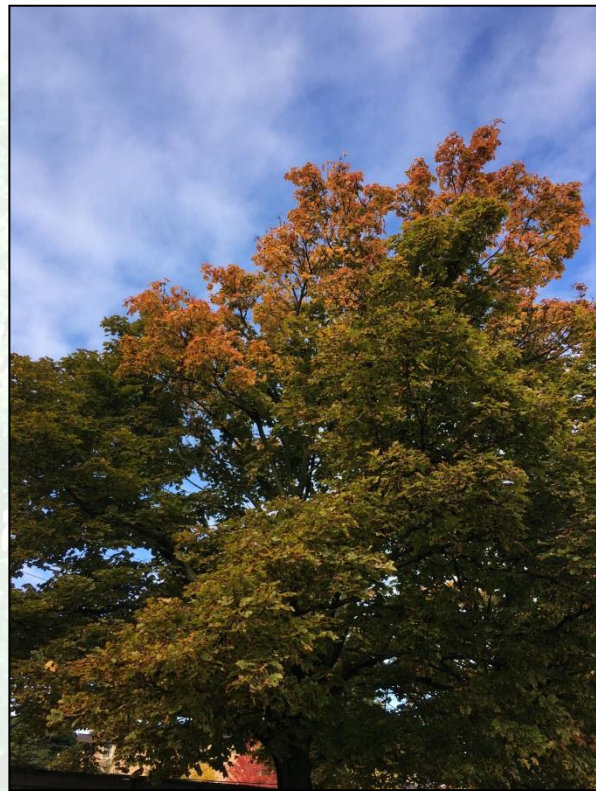
Tree #203 – Norway Maple (9,11cm dia. DBH) – REMOVAL PERMIT REQUIRED

Tree #203, a 9,11cm dia. Norway Maple (*Acer platanoides*) is a privately-owned deciduous tree growing on the west portion of the subject site.

The tree is co-dominant at base with included bark, deformed trunk, unhealed trunk wounds, deadwood, and requires pruning.

Due to the condition of this tree and the proposed construction, my client will require permission to remove this tree. As a result of the removal of this tree, my client is required to plant one (1) deciduous trees of 6cm diameter or greater, or one (1) evergreen tree that is 1.8m tall or larger, as compensation. The species and planting location will be determined during the landscape design phase of the project. An application to remove this tree will have to be submitted to Mississauga Urban Forestry.

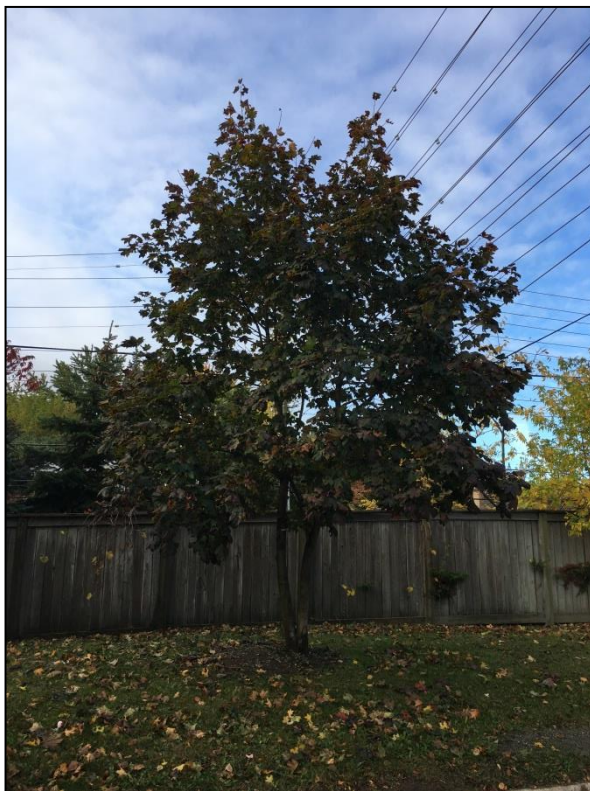
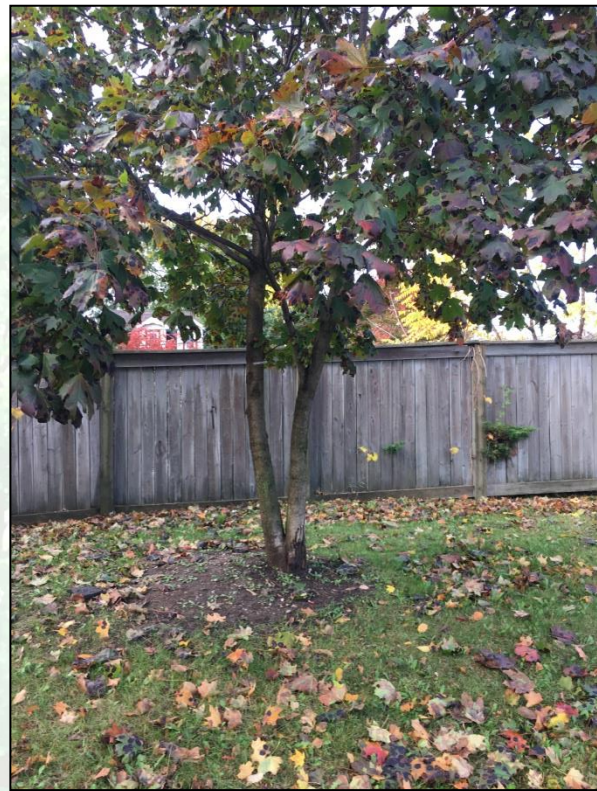
Tree #211 – Norway Maple (27cm dia. DBH) – REMOVAL PERMIT REQUIRED

Tree #211, a 27cm dia. Norway Maple (*Acer platanoides*) is a privately-owned deciduous tree growing on the west portion of the subject site.

The tree is growing adjacent to retaining wall/fence, has exposed and girdled roots, unhealed trunk wounds, tar spot, dieback, deadwood, and requires pruning.

Due to the condition of this tree and the proposed construction, my client will require permission to remove this tree. As a result of the removal of this tree, my client is required to plant one (1) deciduous trees of 6cm diameter or greater, or one (1) evergreen tree that is 1.8m tall or larger, as compensation. The species and planting location will be determined during the landscape design phase of the project. An application to remove this tree will have to be submitted to Mississauga Urban Forestry.

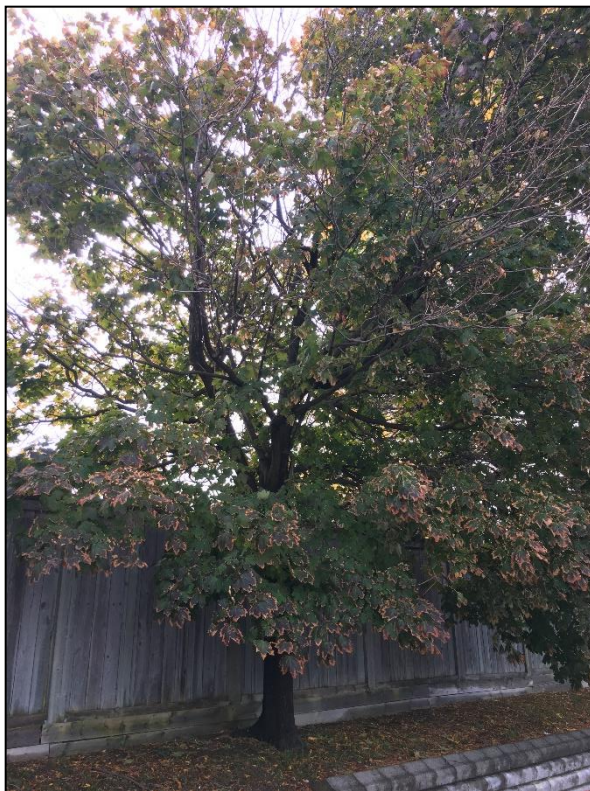
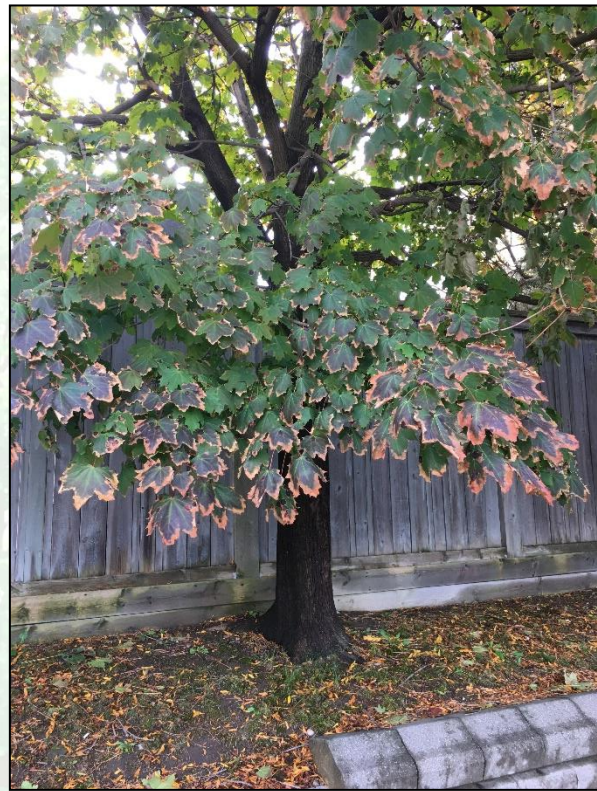
Tree #212 – Honey Locust (45cm dia. DBH) – REMOVAL PERMIT REQUIRED

Tree #212, a 45cm dia. Honey Locust (*Gleditsia triacanthos*) is a privately-owned deciduous tree growing on the west portion of the subject site.

The tree is growing adjacent to retaining wall/fence, has an elevated root plate, exposed roots, girdled roots, unhealed trunk wounds, dieback, deadwood, gypsy moth, and requires pruning.

Due to the condition of this tree and the proposed construction, my client will require permission to remove this tree. As a result of the removal of this tree, my client is required to plant one (1) deciduous trees of 6cm diameter or greater, or one (1) evergreen tree that is 1.8m tall or larger, as compensation. The species and planting location will be determined during the landscape design phase of the project. An application to remove this tree will have to be submitted to Mississauga Urban Forestry.

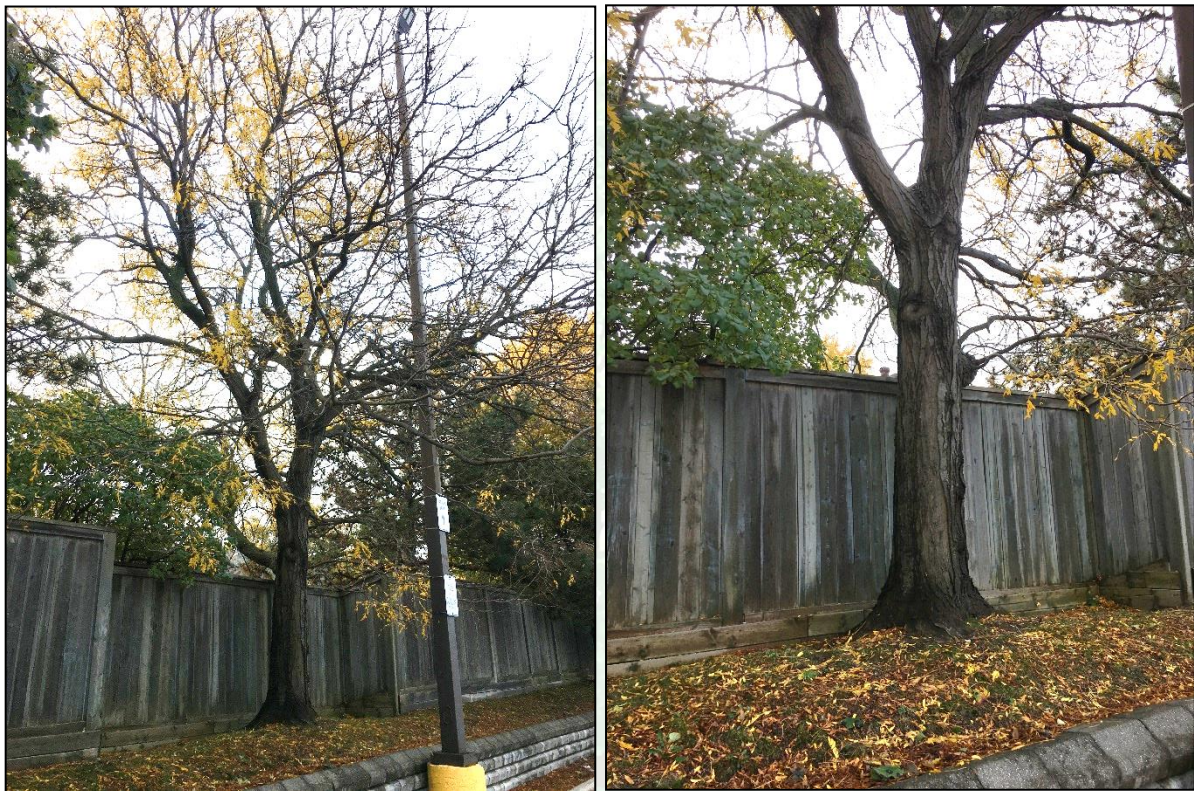
Tree #213 – Norway Maple (37cm dia. DBH) – REMOVAL PERMIT REQUIRED

Tree #213, a 37cm dia. Norway Maple (*Acer platanoides*) is a privately-owned deciduous tree growing on the west portion of the subject site.

Due to the condition of this tree and the proposed construction, my client will require permission to remove this tree. As a result of the removal of this tree, my client is required to plant one (1) deciduous trees of 6cm diameter or greater, or one (1) evergreen tree that is 1.8m tall or larger, as compensation. The species and planting location will be determined during the landscape design phase of the project. An application to remove this tree will have to be submitted to Mississauga Urban Forestry.

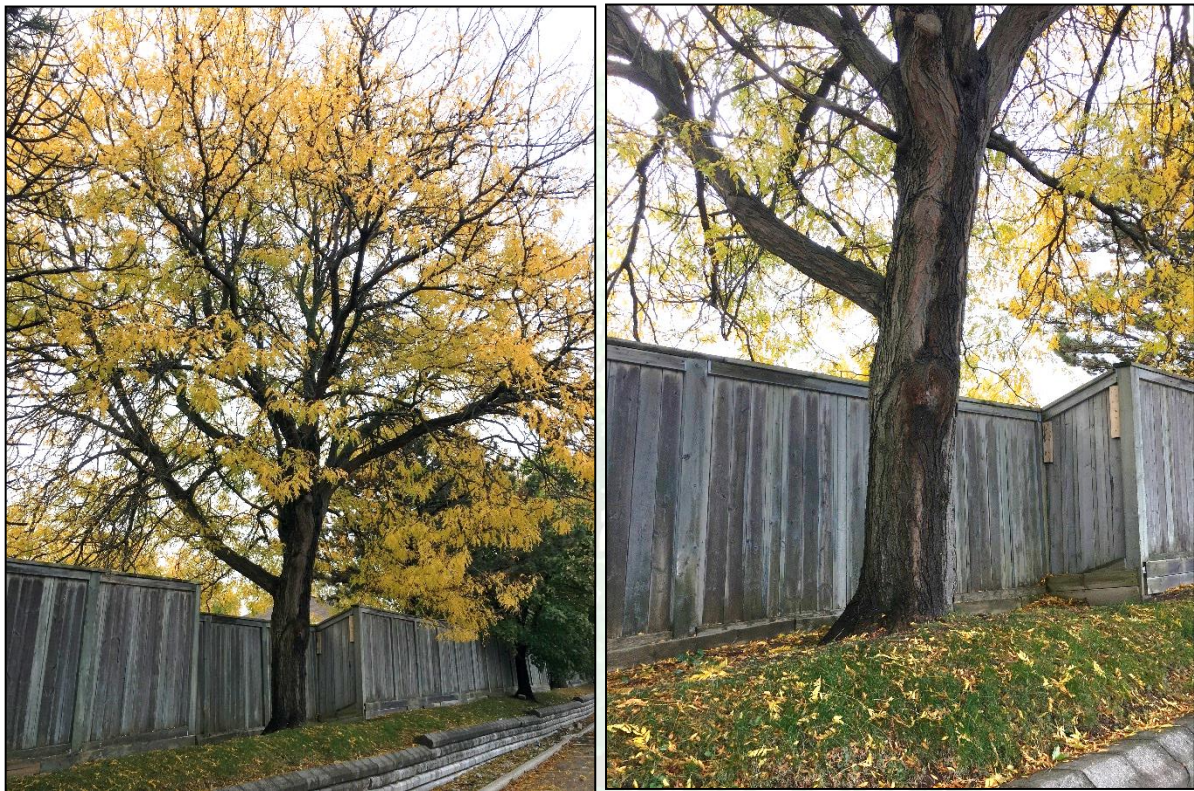
Tree #214 – Honey Locust (62cm dia. DBH) – REMOVAL PERMIT REQUIRED

Tree #214, a 62cm dia. Honey Locust (*Gleditsia triacanthos*) is a privately-owned deciduous tree growing on the west portion of the subject site.

The tree is growing adjacent to retaining wall/fence, has an elevated root plate, exposed roots, girdled roots, unhealed trunk wounds, dieback, deadwood, gypsy moth, and requires pruning.

Due to the condition of this tree and the proposed construction, my client will require permission to remove this tree. As a result of the removal of this tree, my client is required to plant one (1) deciduous trees of 6cm diameter or greater, or one (1) evergreen tree that is 1.8m tall or larger, as compensation. The species and planting location will be determined during the landscape design phase of the project. An application to remove this tree will have to be submitted to Mississauga Urban Forestry.

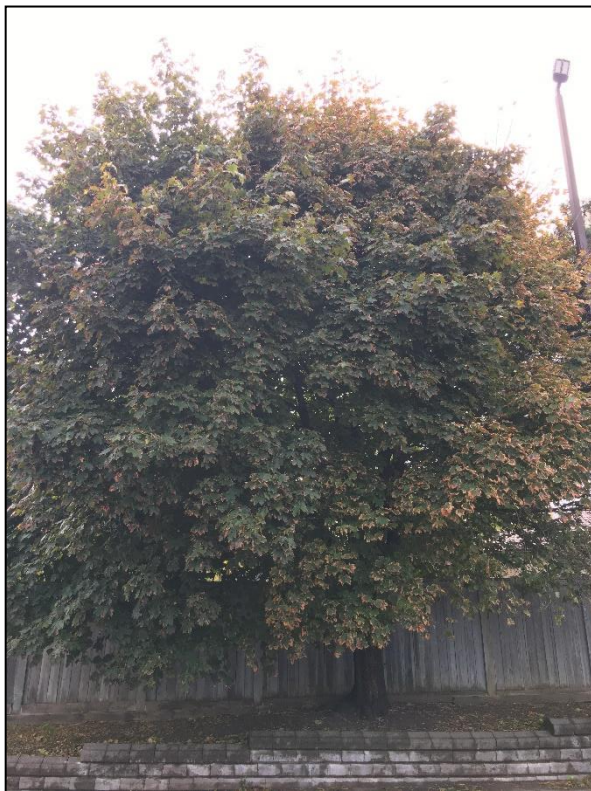
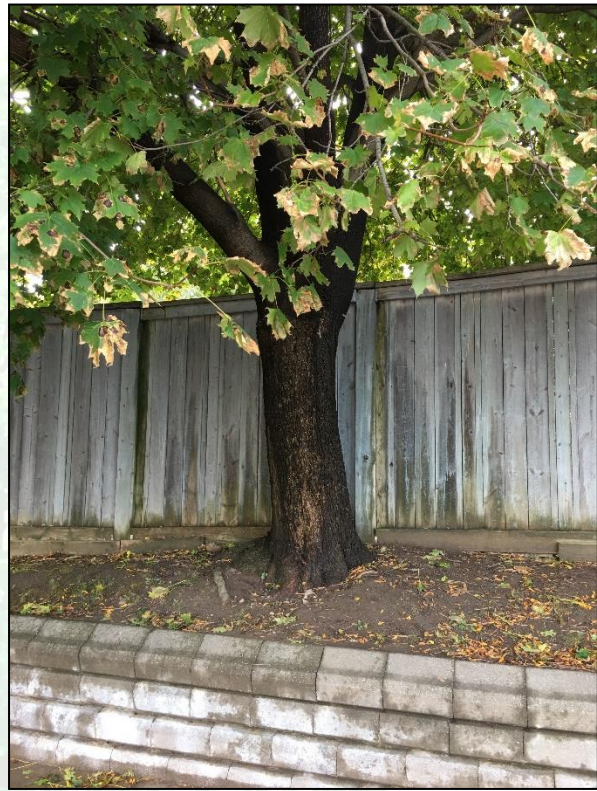
Tree #215 – Norway Maple (45cm dia. DBH) – REMOVAL PERMIT REQUIRED

Tree #215, a 45cm dia. Norway Maple (*Acer platanoides*) is a privately-owned deciduous tree growing on the west portion of the subject site.

The tree is growing adjacent to retaining wall/fence, has a wire basket intact, exposed roots, girdled roots, unhealed trunk wounds, tar spot, dieback, deadwood, and requires pruning.

Due to the condition of this tree and the proposed construction, my client will require permission to remove this tree. As a result of the removal of this tree, my client is required to plant one (1) deciduous trees of 6cm diameter or greater, or one (1) evergreen tree that is 1.8m tall or larger, as compensation. The species and planting location will be determined during the landscape design phase of the project. An application to remove this tree will have to be submitted to Mississauga Urban Forestry.
