**GEOTECHNICAL INVESTIGATION  
SLOPE STABILITY & STREAMBANK EROSION STUDY  
900 MISSISSAUGA HEIGHTS DRIVE  
MISSISSAUGA, ONTARIO**

File No. 1-18-0001-01

June 14, 2018

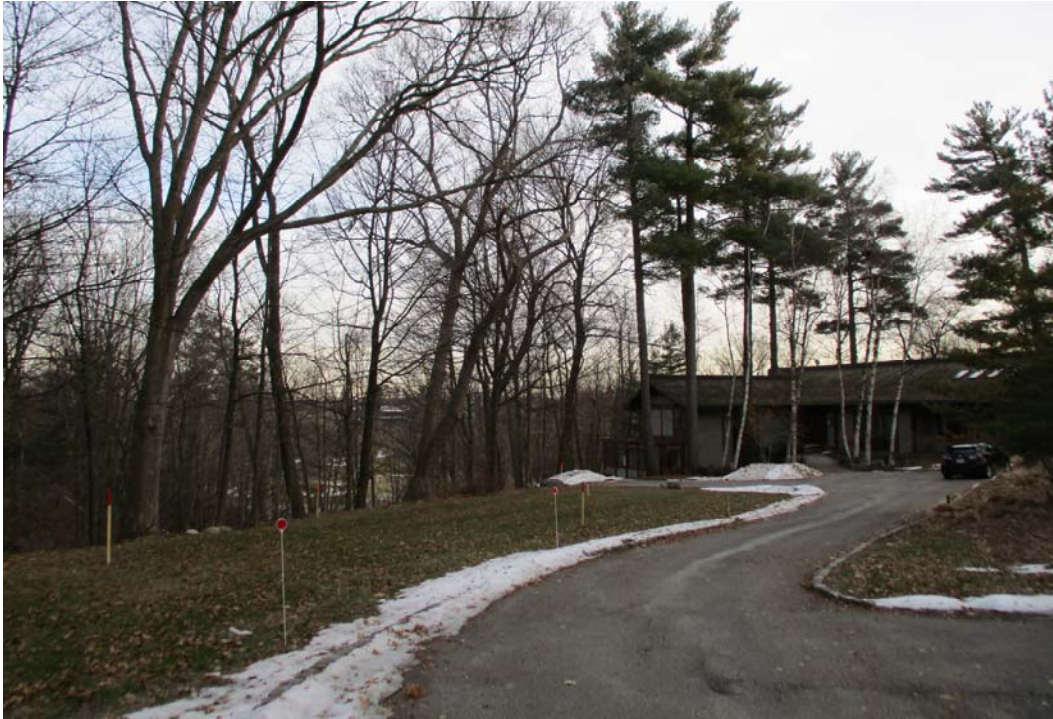
PHOTOGRAPH 1. Looking southeast, a view of the front yard tableland. The tableland is relatively flat and consists of landscaped areas and asphalt paved driveway. A residential dwelling situated on the tableland is visible in background.

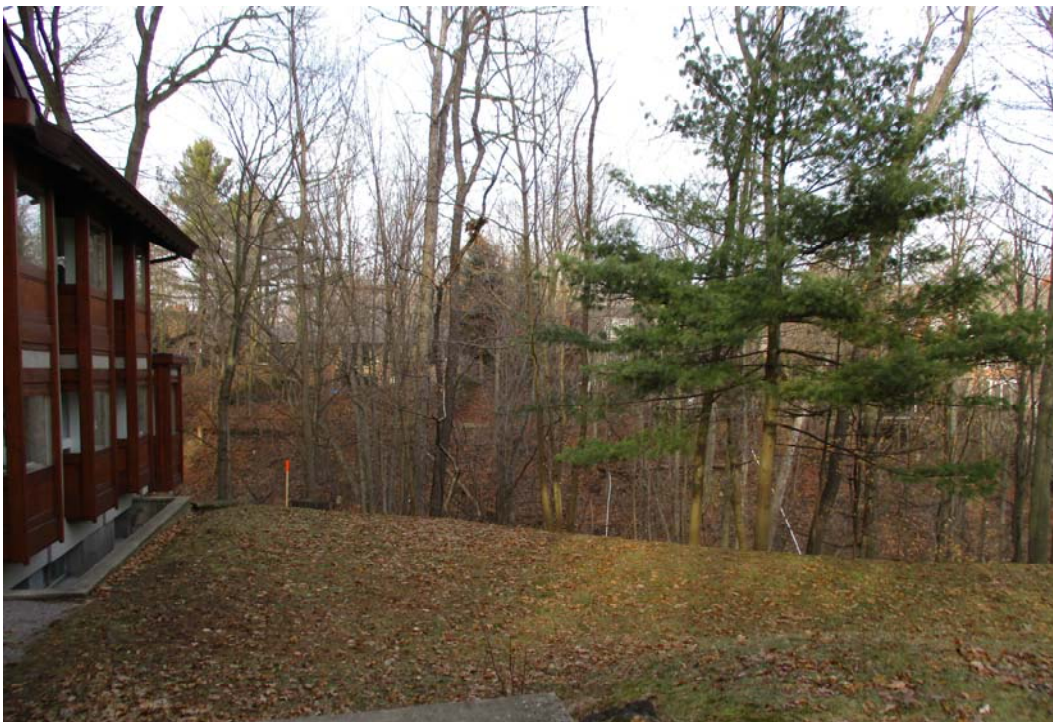
PHOTOGRAPH 2. Looking north, a view of backyard tableland. A gently grassed sloping ground backyard is located between the house and the slope crest.

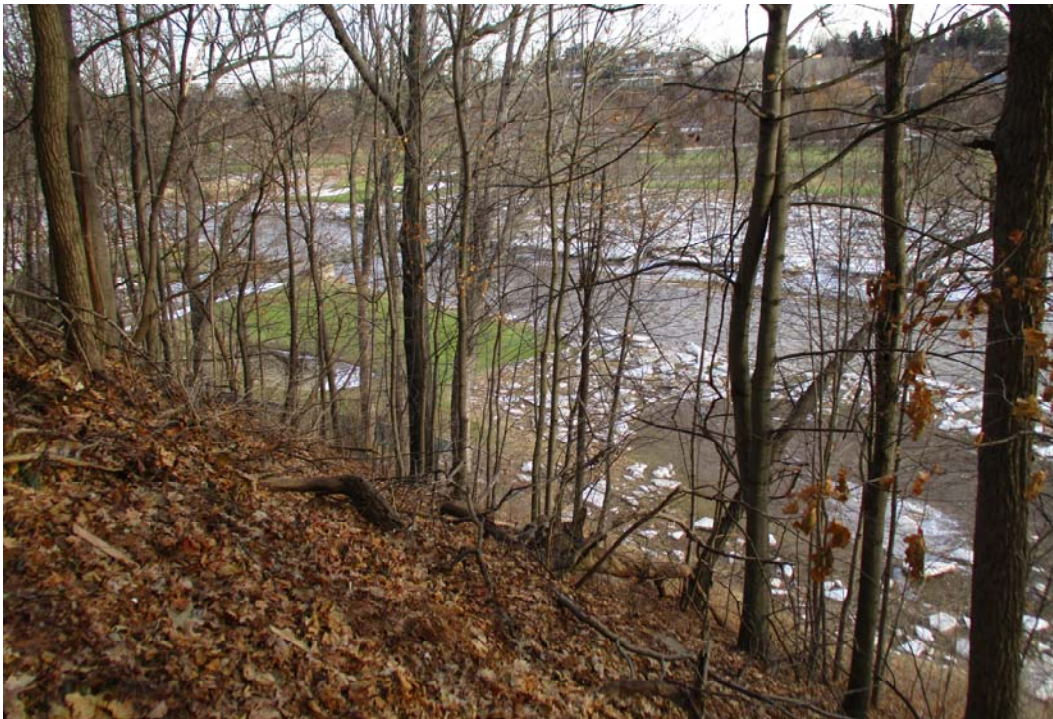
PHOTOGRAPH 4. Looking east, a view of the ravine slope, leaf littered and well vegetated with mature trees and saplings. Credit River located at a significant distance away from the slope toe is visible in the background.

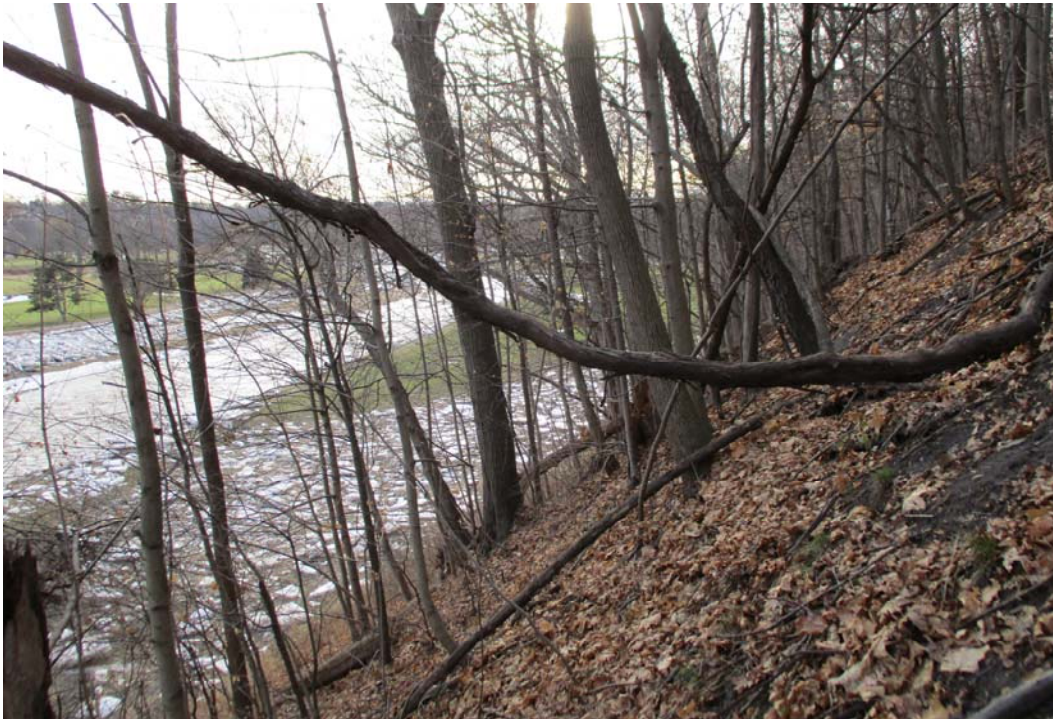
PHOTOGRAPH 5. Looking southwest, another view of the lower portion of the slope. The watercourse is separated from the slope toe by a broad floodplain.

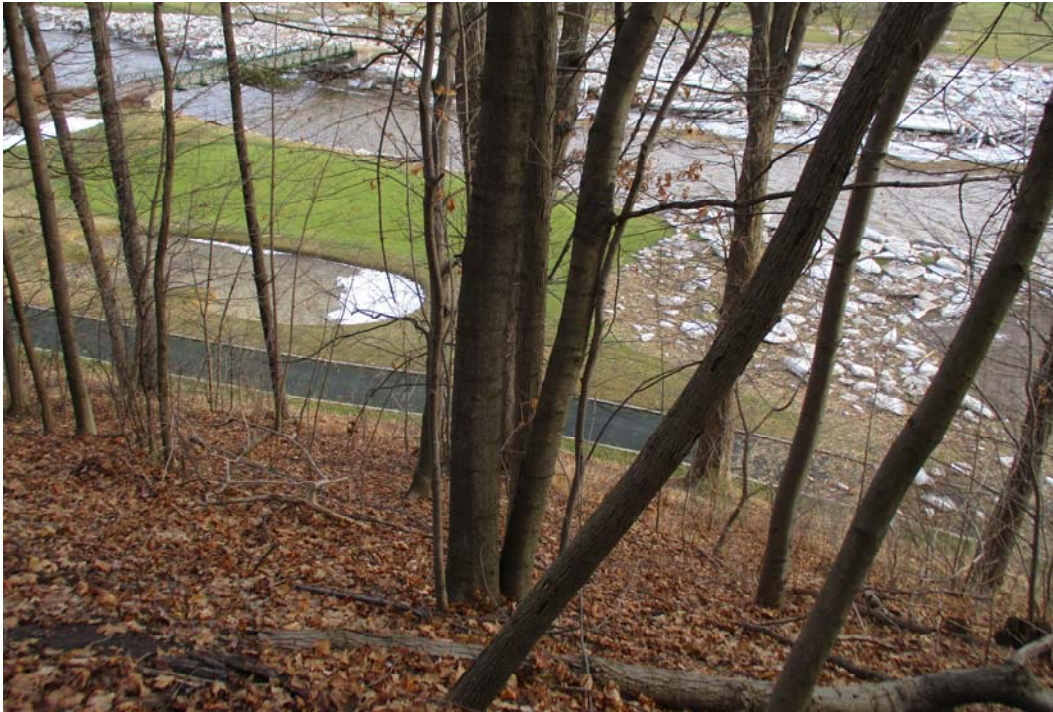
As noted before, a relatively broad floodplain (the golf course) separates the southerly slope toe from Credit River (greater than 15 m). Therefore, a toe erosion allowance is not applicable for the southerly slope.

PHOTOGRAPH 6. Looking south, a view of the slope toe and floodplain. An asphalt trail is situated near the slope toe. Credit River, located more than 15 m away from the slope toe is visible in the background.

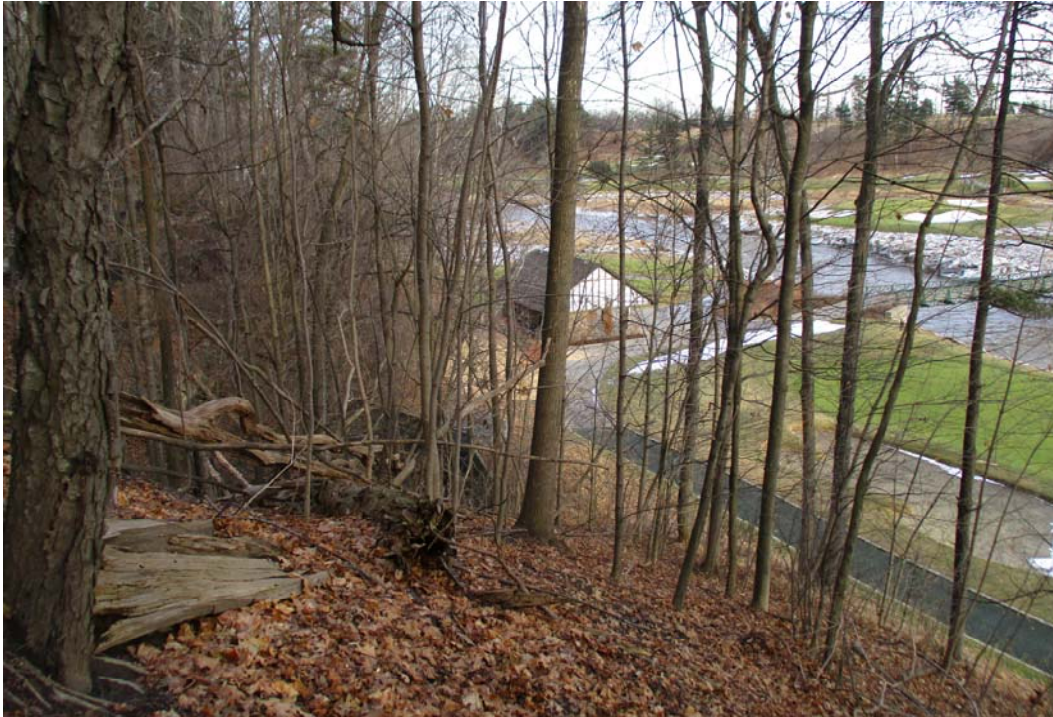
PHOTOGRAPH 7. Looking east, another view of the ravine slope with the floodplain.

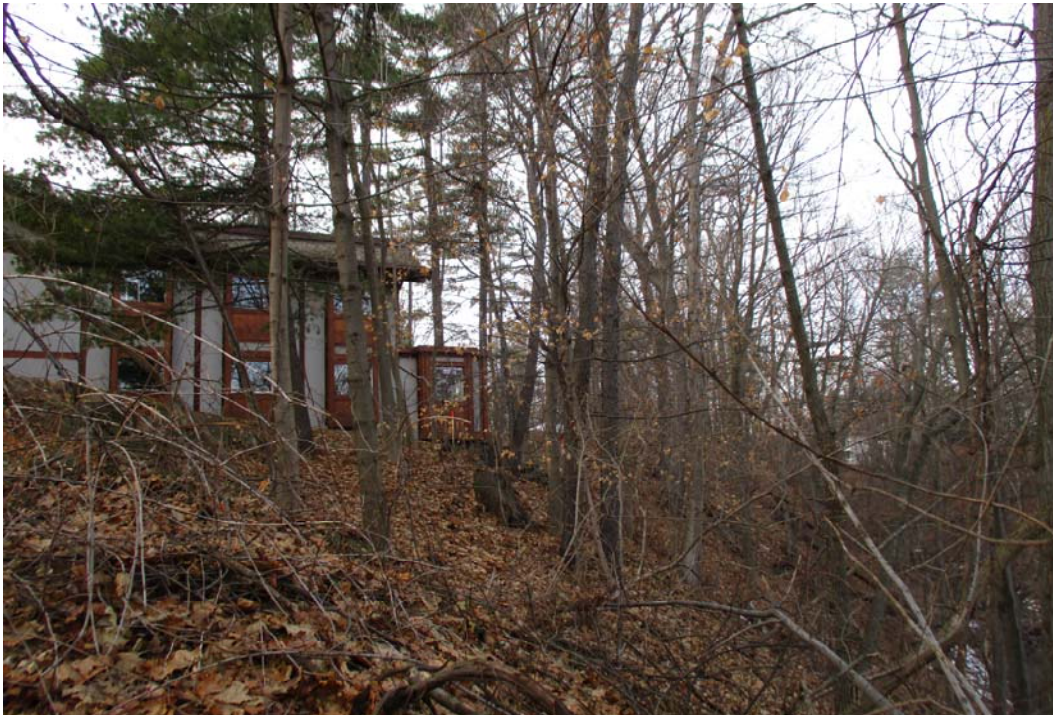
PHOTOGRAPH 8. Looking northwest, another view of the vegetated slope crest. The house located near the slope crest is visible in the background.

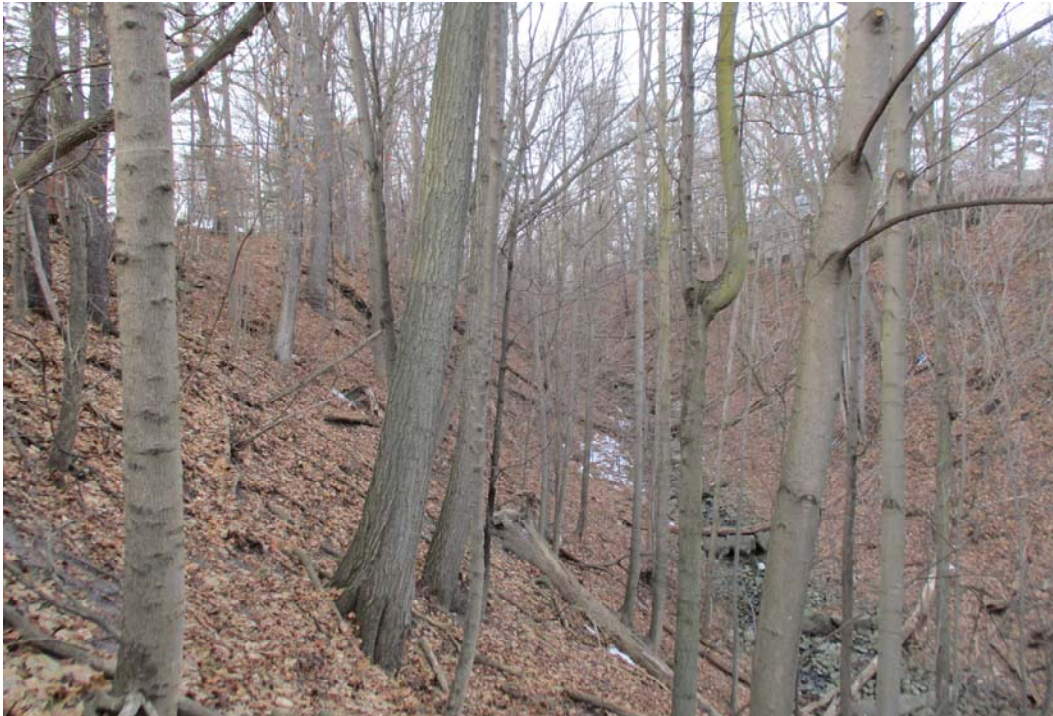
PHOTOGRAPH 10. Looking northwest, general view of the well vegetated ravine slope. Tree trunk growth is generally straight and upright.

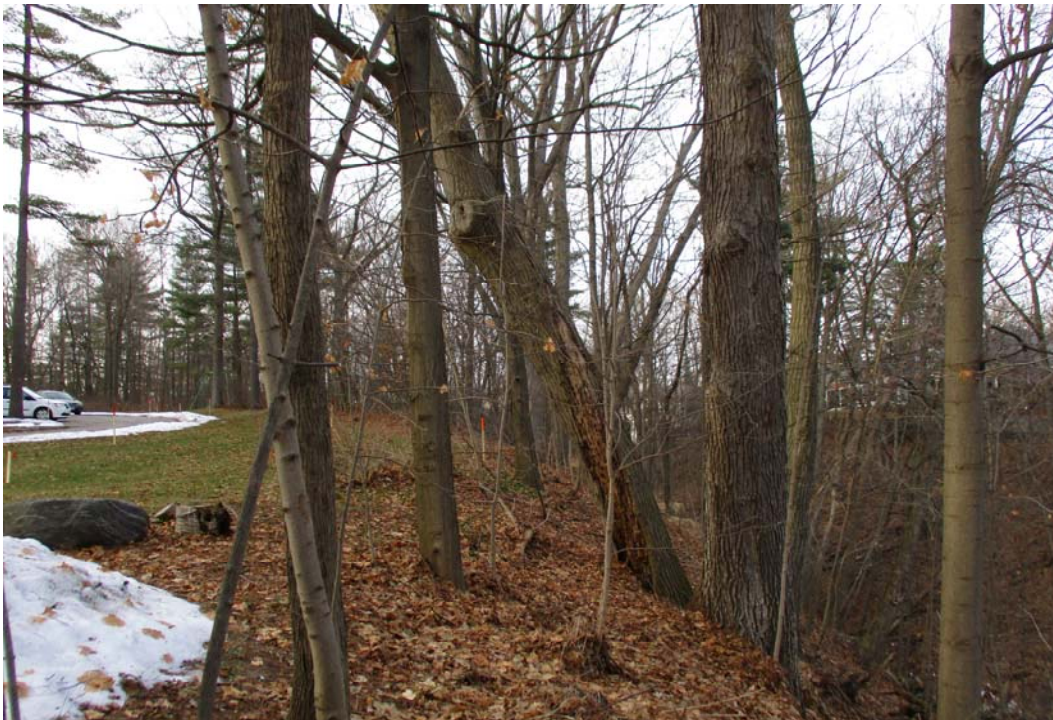
PHOTOGRAPH 12. Looking north, another view of the tableland and slope crest. The slope is vegetated with mature trees and saplings

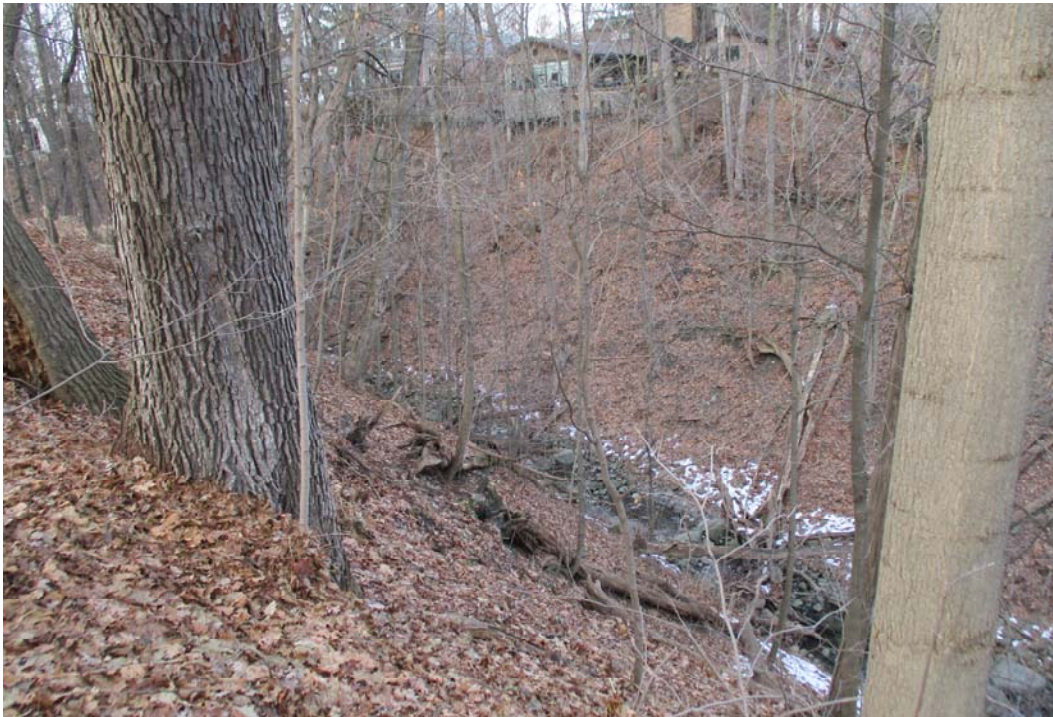
PHOTOGRAPH 13. Looking north, another view of the leaf littered vegetated ravine slope and the drainage swale. The tree trunk growth is generally straight and upright.

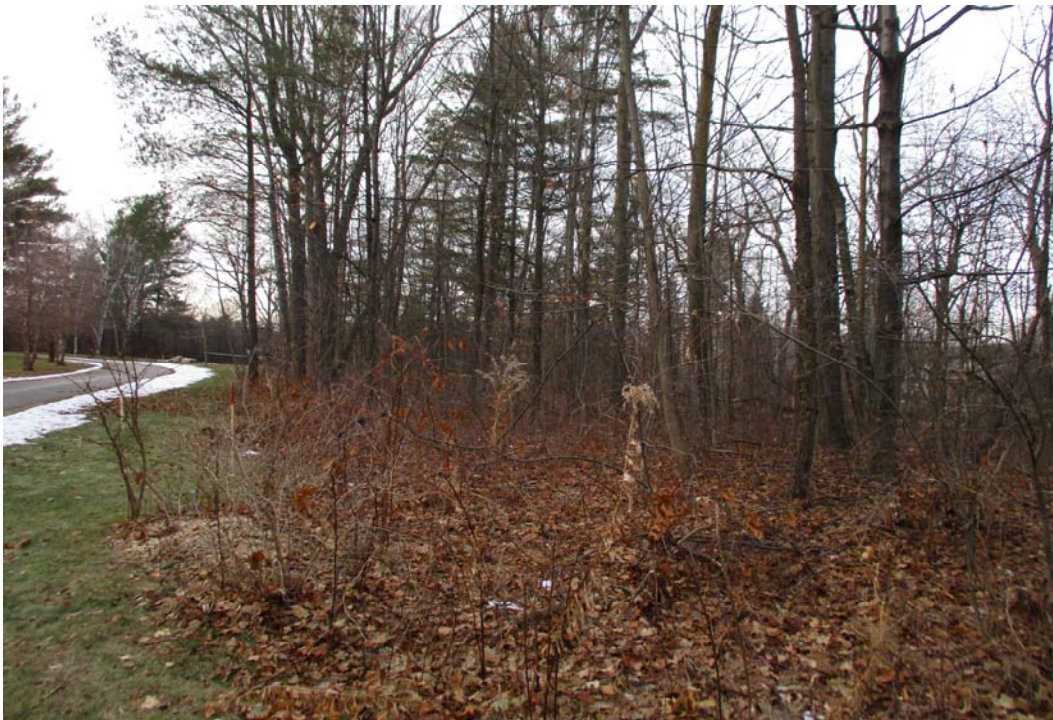
PHOTOGRAPH 16. Looking northwest, another view of the tableland and slope crest vegetated with grass, saplings and mature trees.

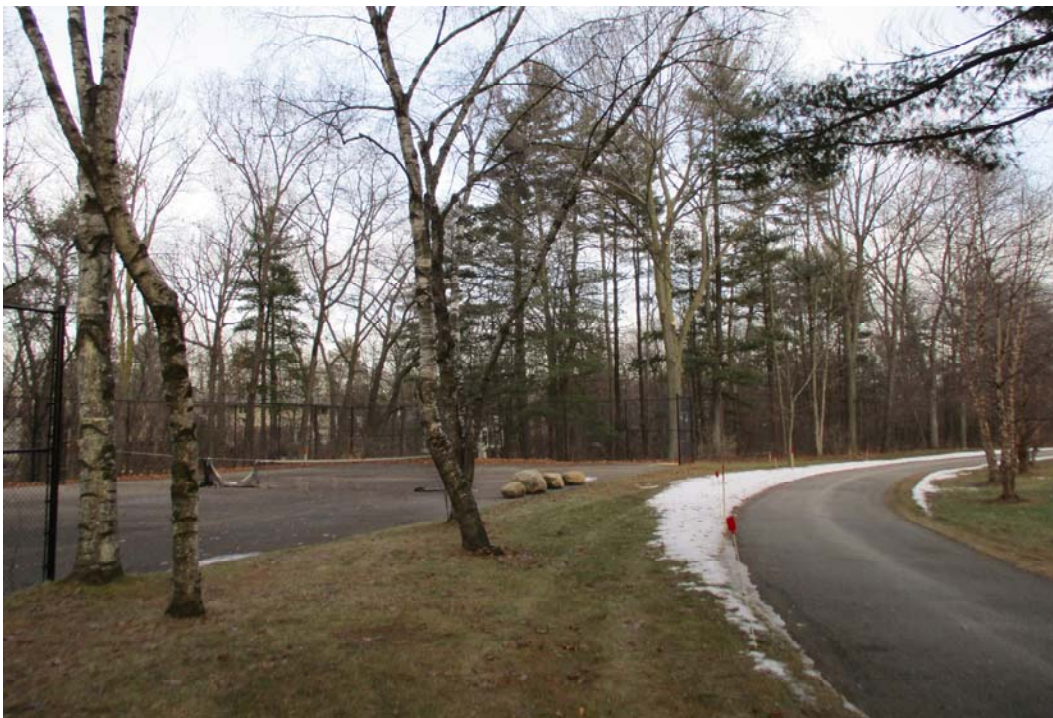
PHOTOGRAPH 20. Looking southeast, another view of the tableland. A tennis court is visible in the foreground.
