APPENDIX C
Fluvial Geomorphology Assessment

**PRELIMINARY FLUVIAL GEOMORPHOLOGY ASSESSMENT OF LITTLE
ETOBICOKE CREEK
DIXIE-DUNDAS FLOOD MITIGATION**

Prepared for:
CITY OF MISSISSAUGA

Prepared by:
MATRIX SOLUTIONS INC.

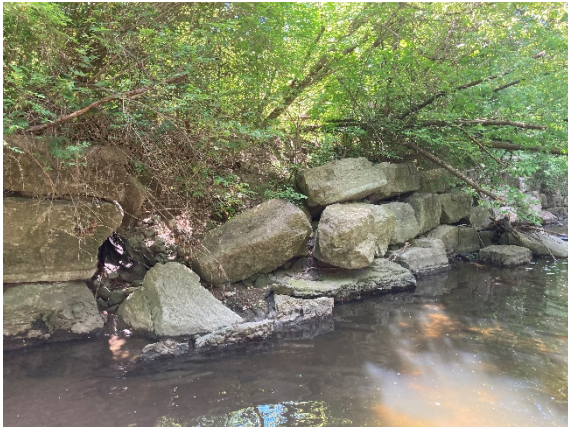
3 – Poor (Armourstone Slump)

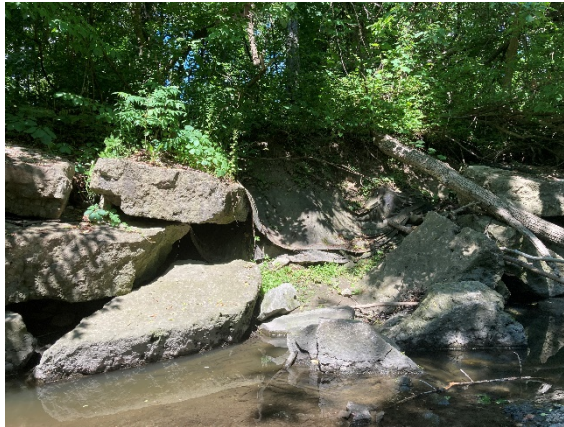
4 – Failure on Bank (Armourstone)

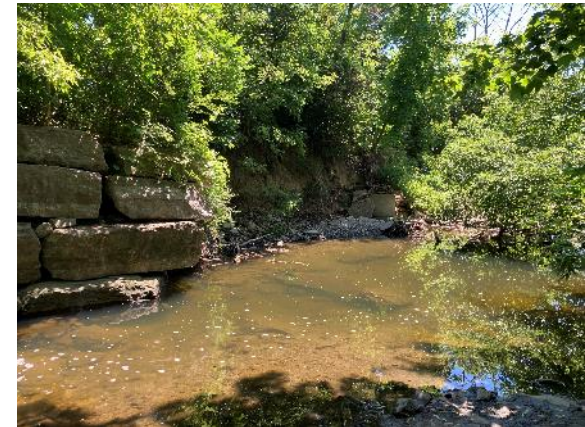
5 – Failure into Channel (Amourstone)

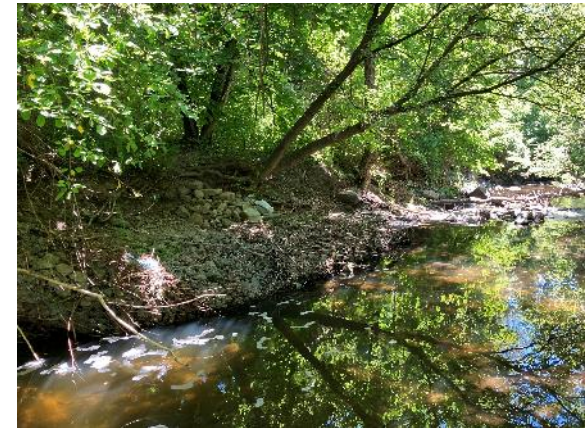
5 – Failure into Channel

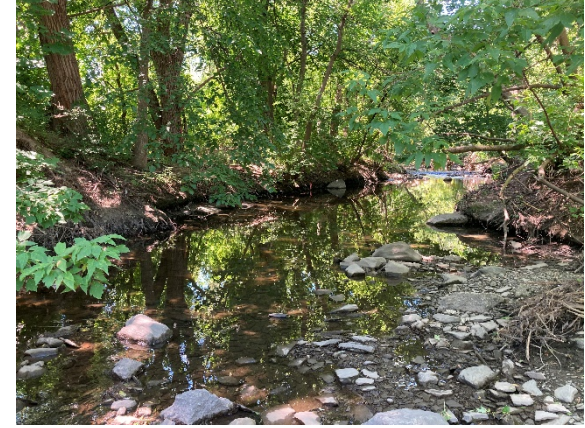
2 – Minor Bank Erosion

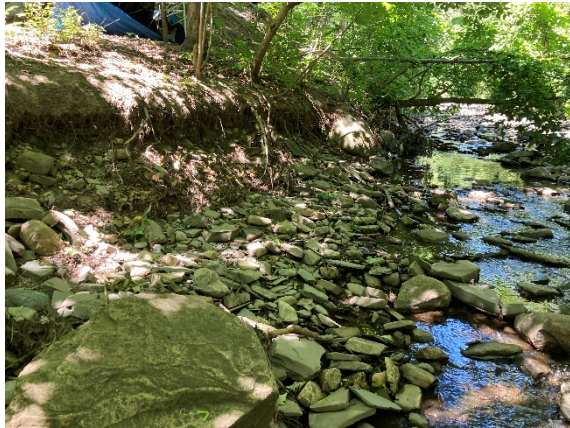
3 – Moderate Bank Erosion

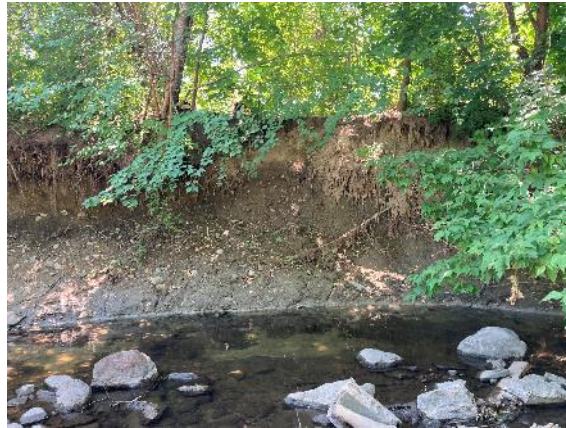
4 – Major Bank Erosion

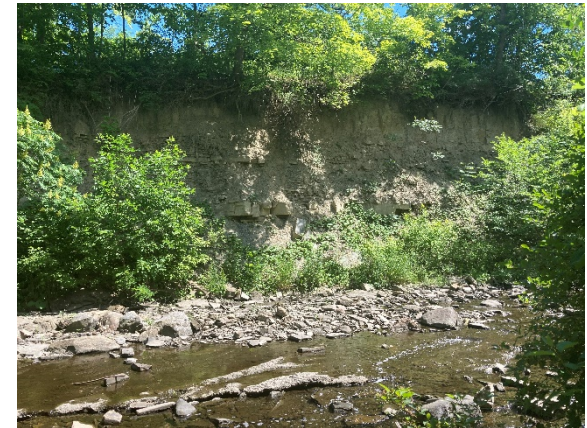
5 – Severe Bank Erosion
