THURBER ENGINEERING LTD.

August 10, 2023

File No.: 25025

**EXPANDED GEOTECHNICAL DESKTOP STUDY
DIXIE-DUNDAS FLOOD MITIGATION
MISSISSAUGA, ONTARIO**

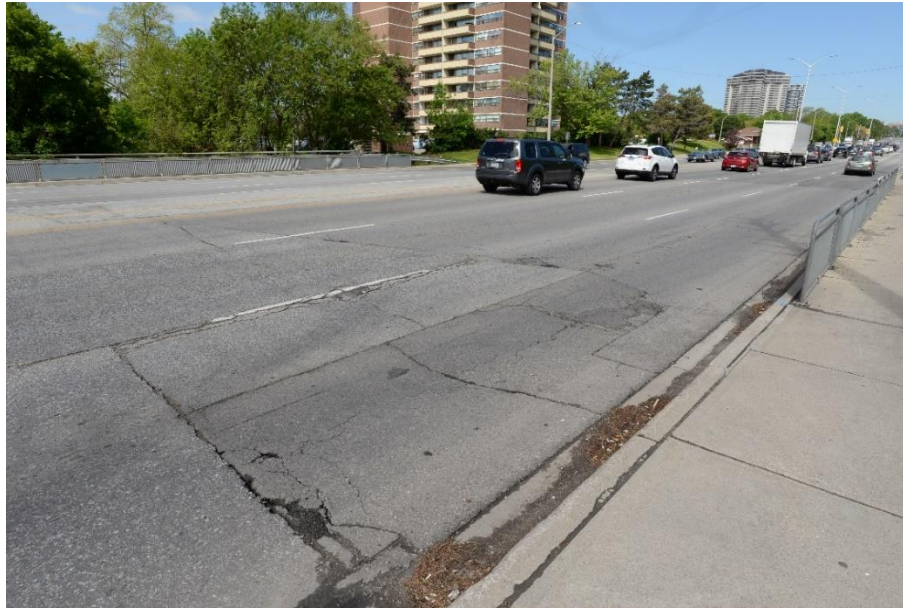
Photo 1. Looking north towards Dixie Road bridge from east sidewalk. [taken June 2019]

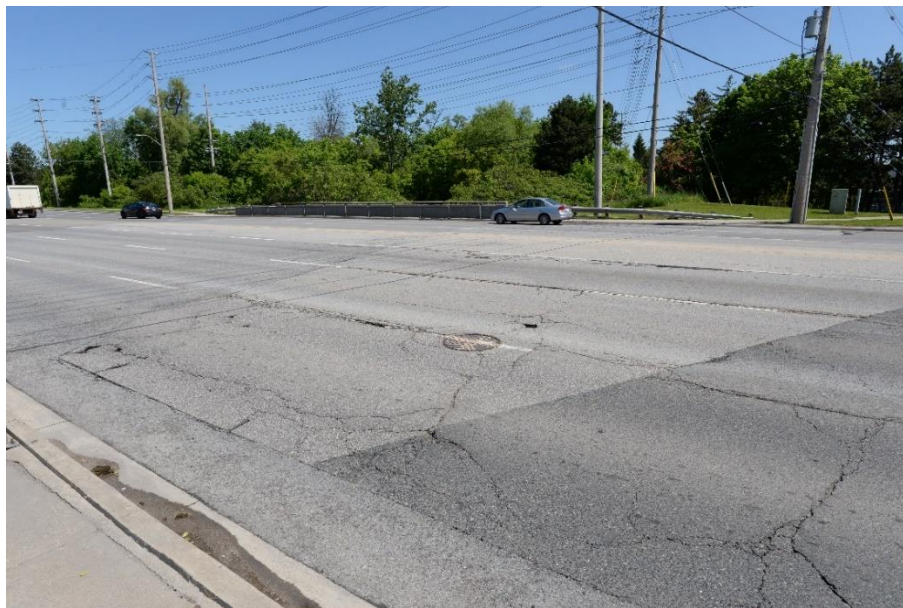
Photo 2: Looking north towards Dixie Road bridge from west sidewalk. [taken June 2019]

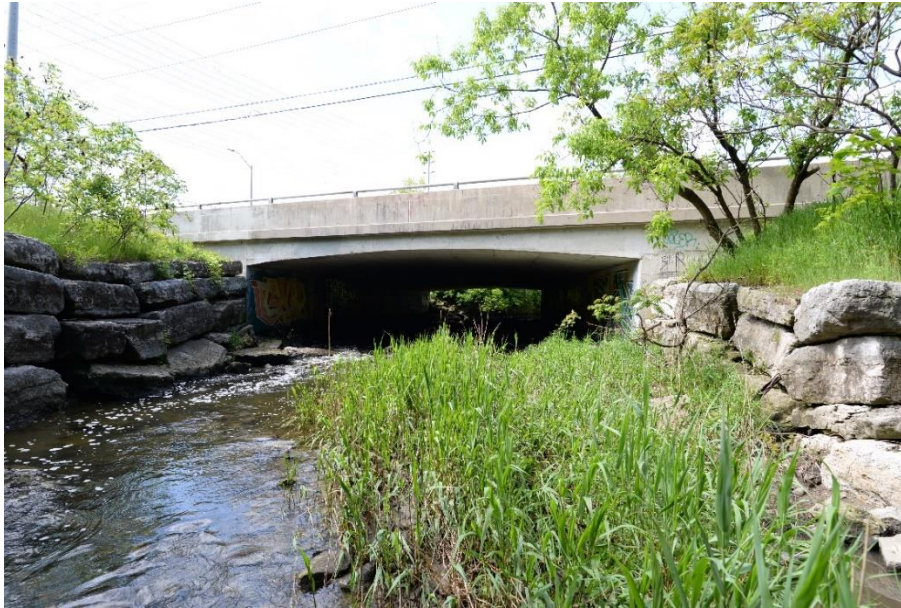
Photo 3: Looking upstream from east side of Dixie Road bridge. [taken June 2019]

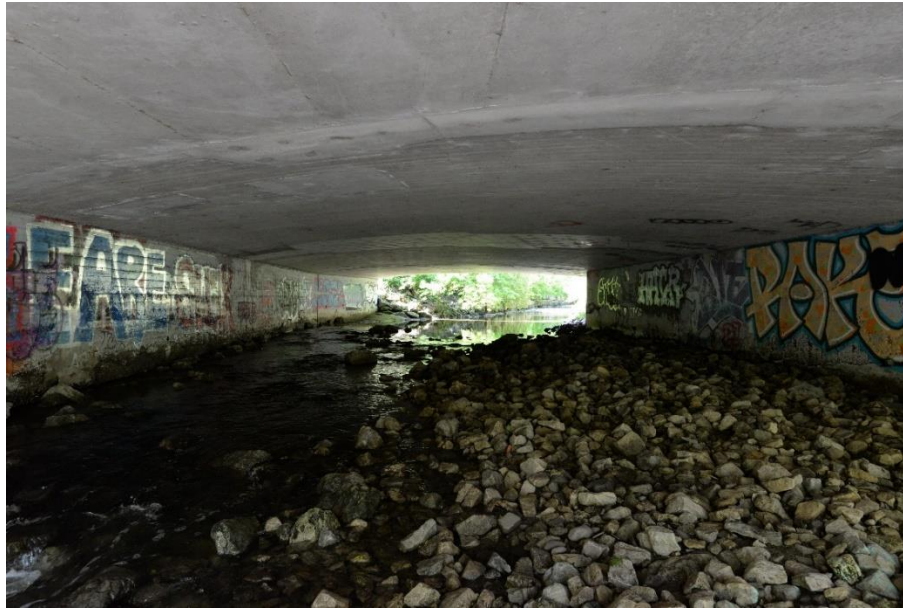
Photo 5: Looking upstream from underneath Dixie Road bridge. [taken June 2019]

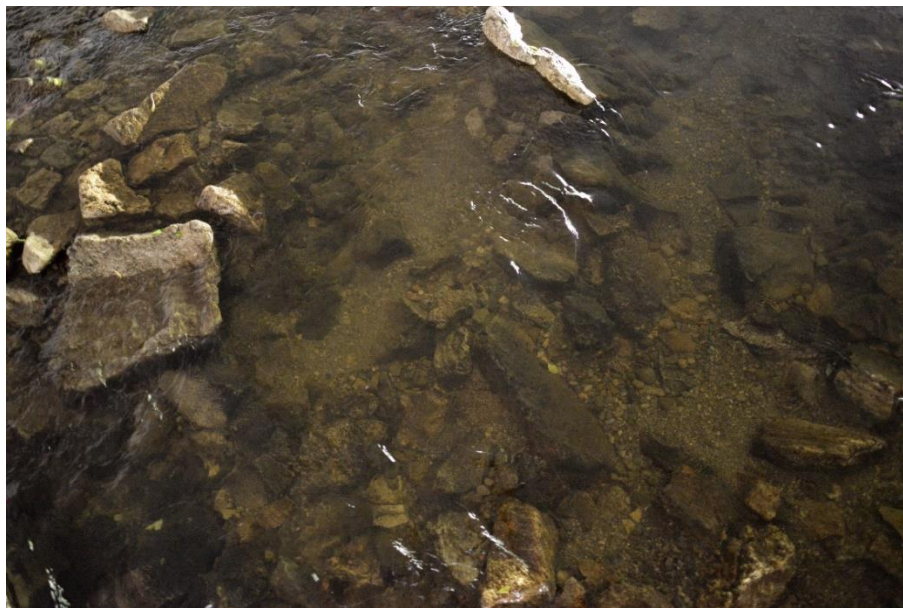
Photo 6: Looking at creek bed from underneath Dixie Road bridge. [taken June 2019]

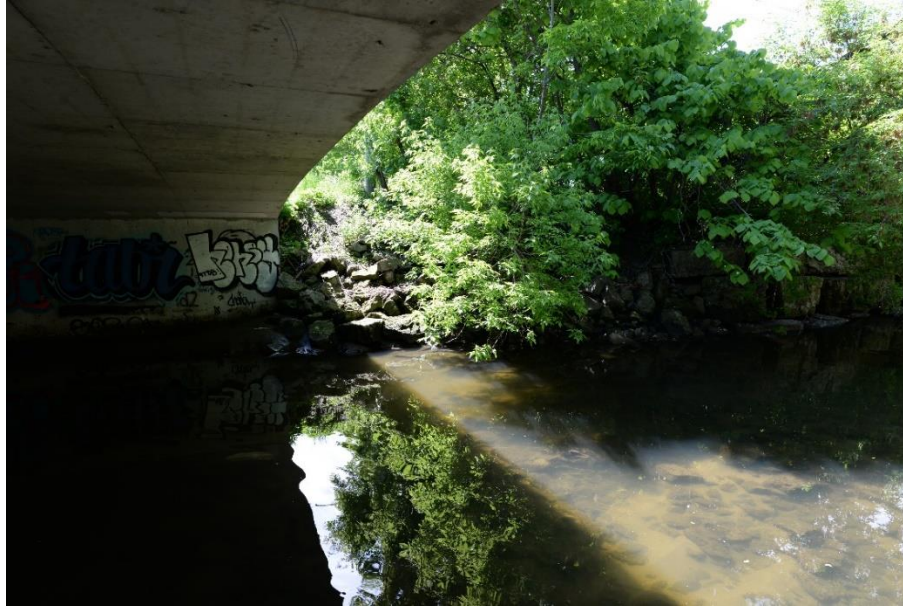
Photog 7: Looking south from west side of Dixie Road bridge. [taken June 2019]

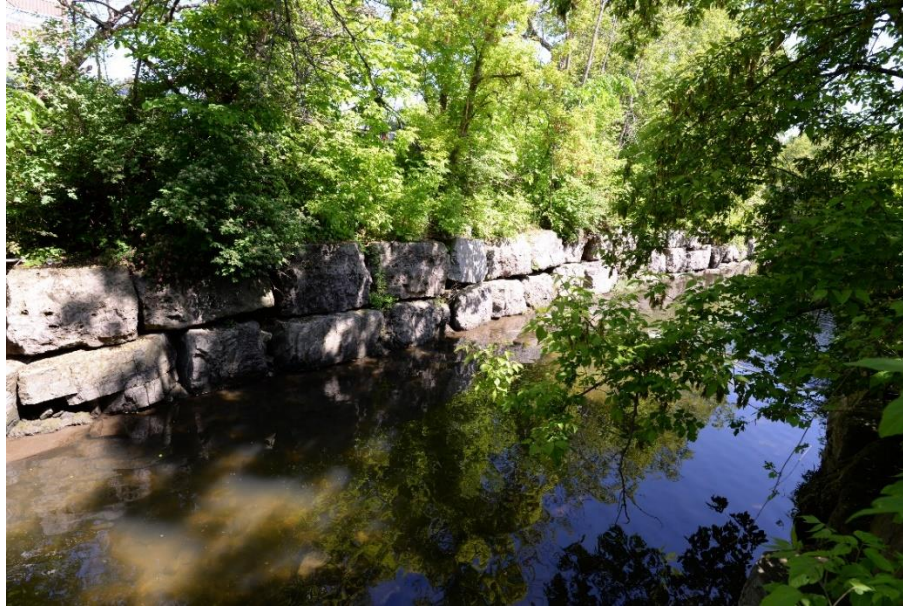
Photo 9: Looking downstream from approximately 50 m west of Dixie Road bridge. [taken June 2019]

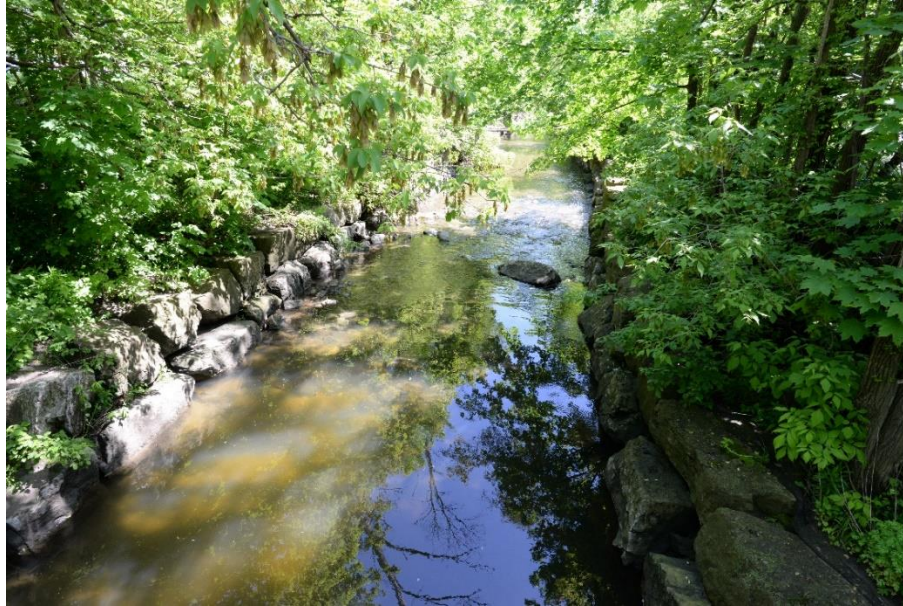
Photo 11: Looking downstream from a pedestrian bridge located approximately 185 m west of Dixie Road bridge. [taken June 2019]

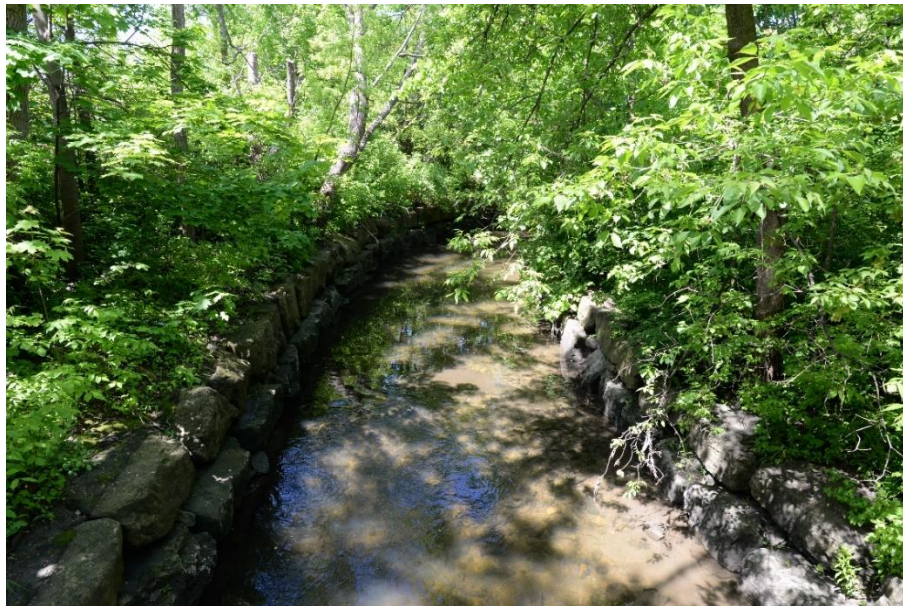
Photo 12: Looking upstream from a pedestrian bridge located approximately 185 m west of Dixie Road bridge. [taken June 2019]

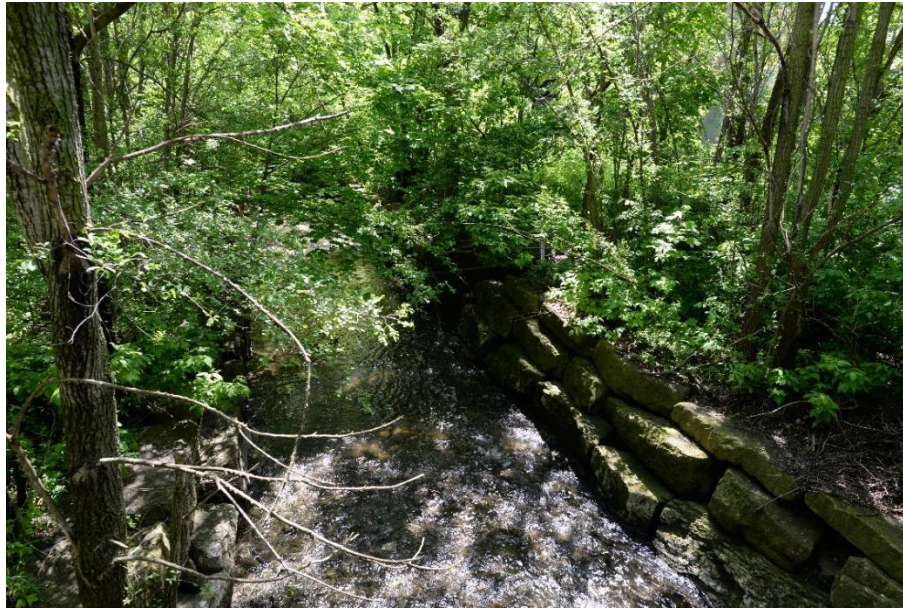
Photo 13: Looking downstream from a pedestrian bridge located approximately 385 m west of Dixie Road bridge. [taken June 2019]

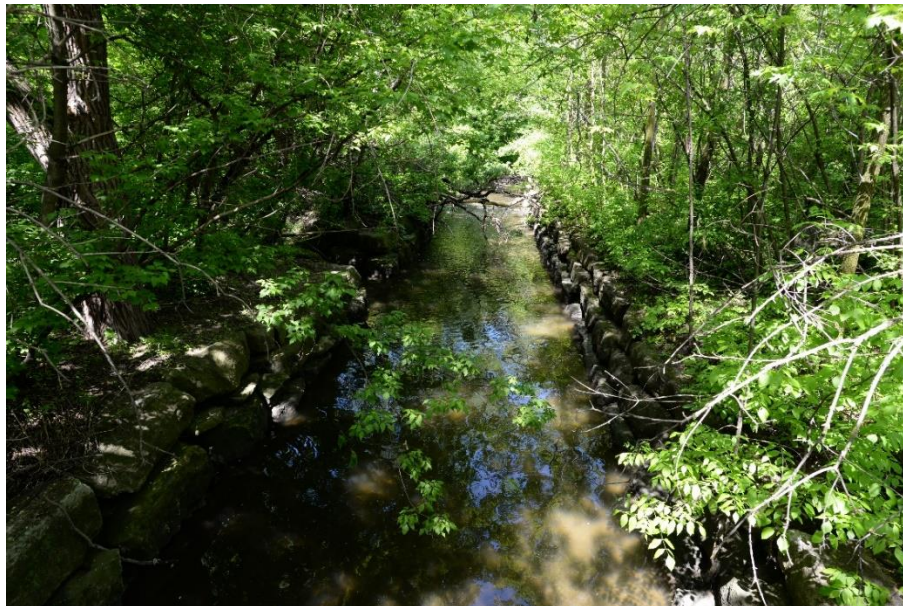
Photo 14: Looking upstream from a pedestrian bridge located approximately 385 m west of Dixie Road bridge. [taken June 2019]

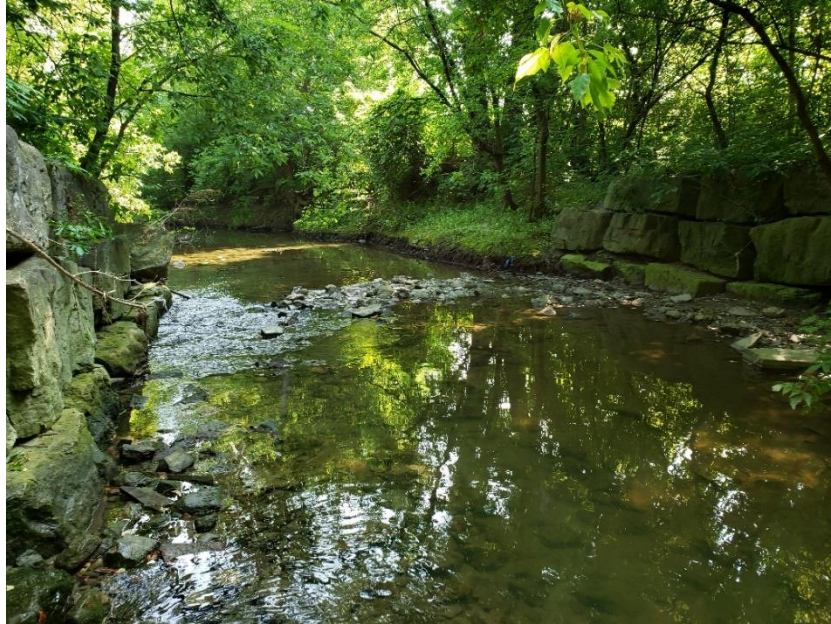
Photo 15: Looking downstream from a walking trail approximately parallel with Goldmar Drive.
[taken June 2019]

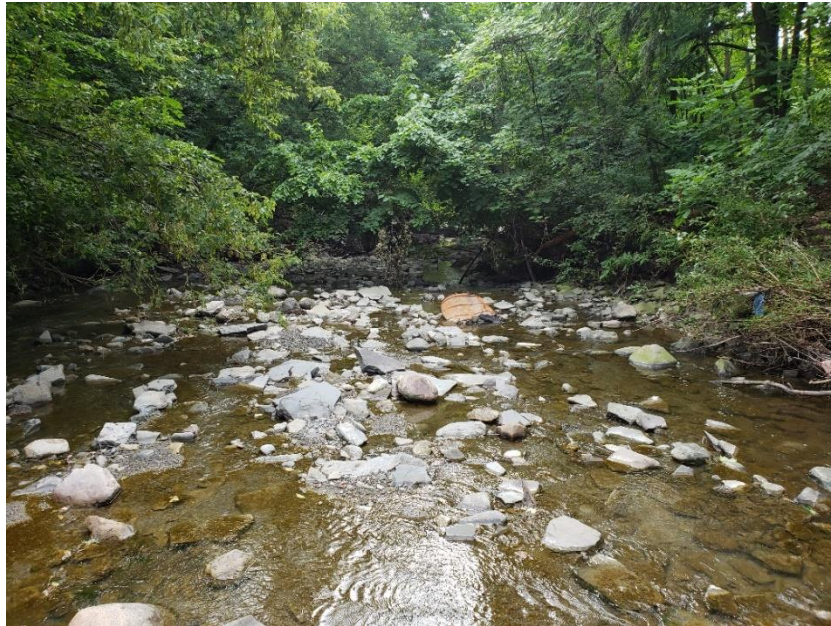
Photo 17: Looking downstream from Willowcreek Park. [taken June 2019]

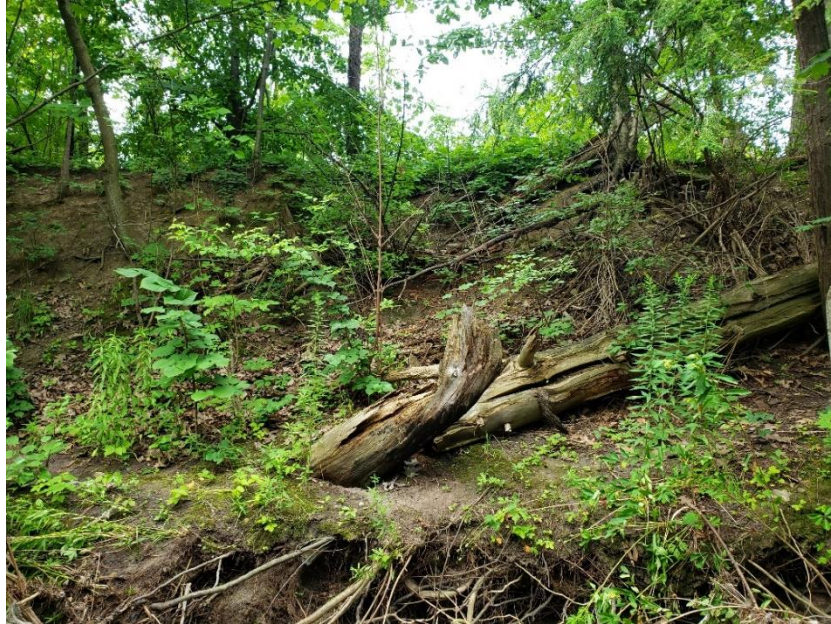
Photo 19: Looking west towards steep slope along west bank opposite Willowcreek Park. [taken June 2019]

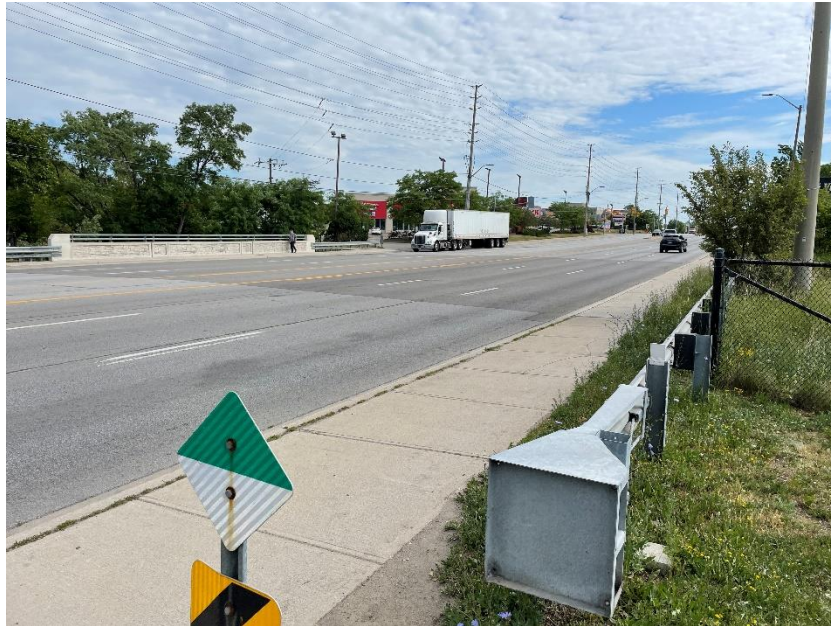
Photo 25. Looking north towards Dundas Street East bridge from south sidewalk. [taken June 2021]

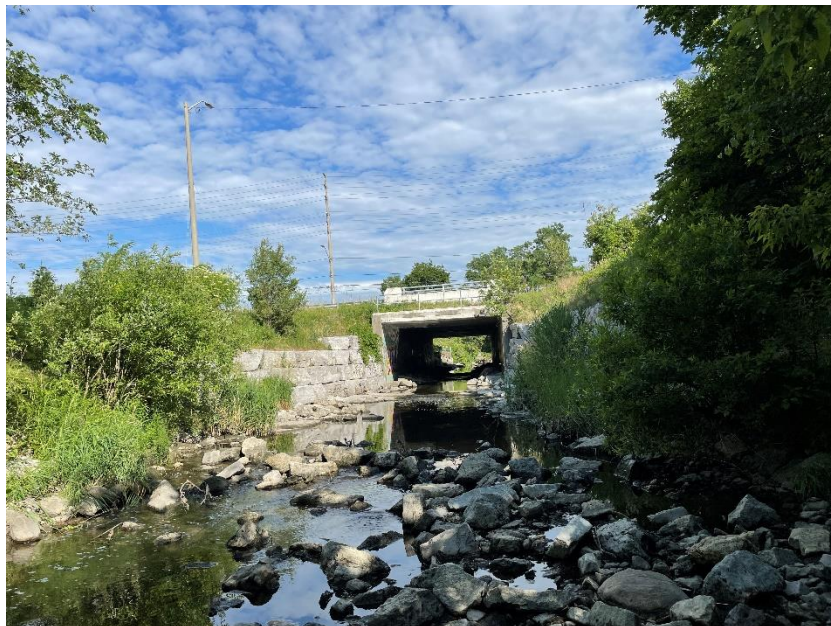
Photo 26: Looking upstream towards Dundas Street East bridge. [taken June 2021]

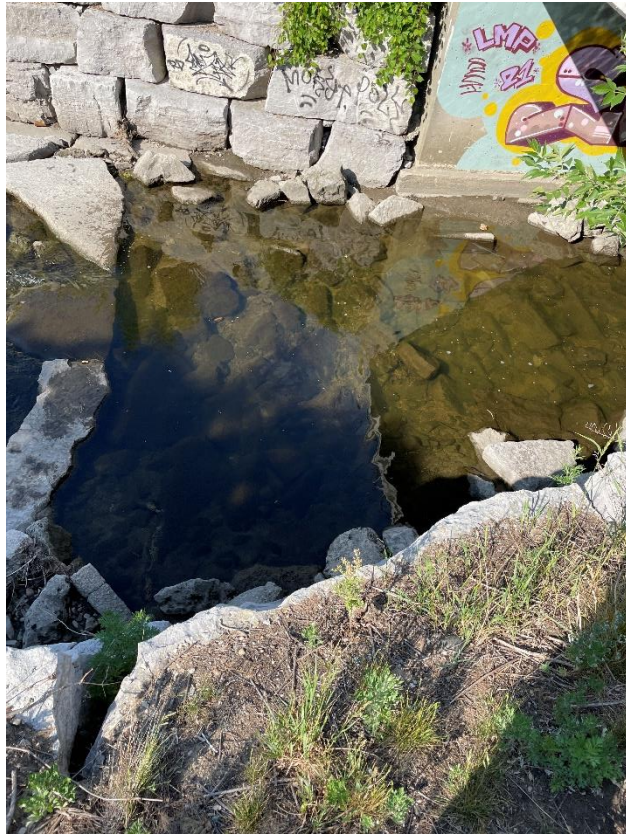
Photo 27: Looking at creek bed from south-east corner of Dundas Street East bridge. [taken June 2021]

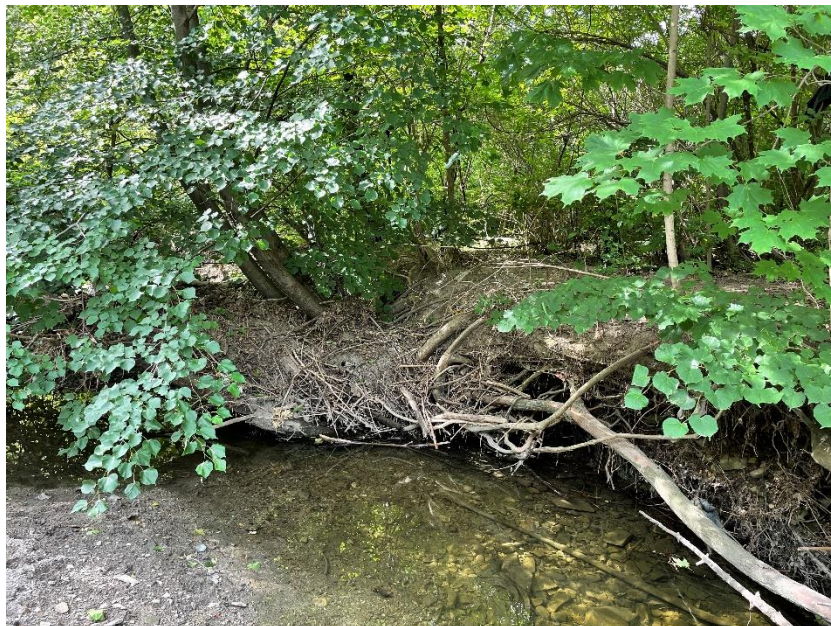
Photo 29: Looking west towards undermining along west bank 300 m downstream from Dundas Street East bridge. [taken June 2021]

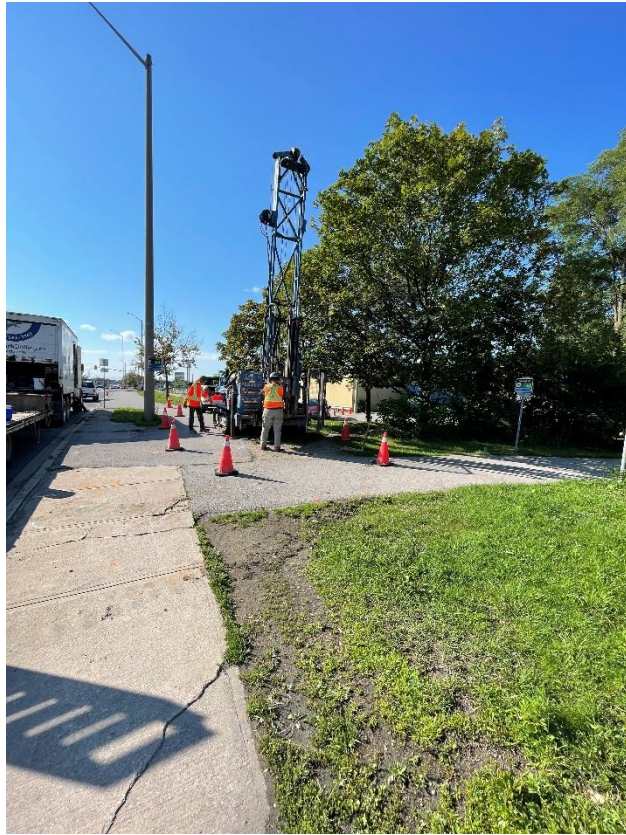
Photo 1. Looking south along Dixie Road towards drill rig setting up at DIX-01. [taken July 2021]

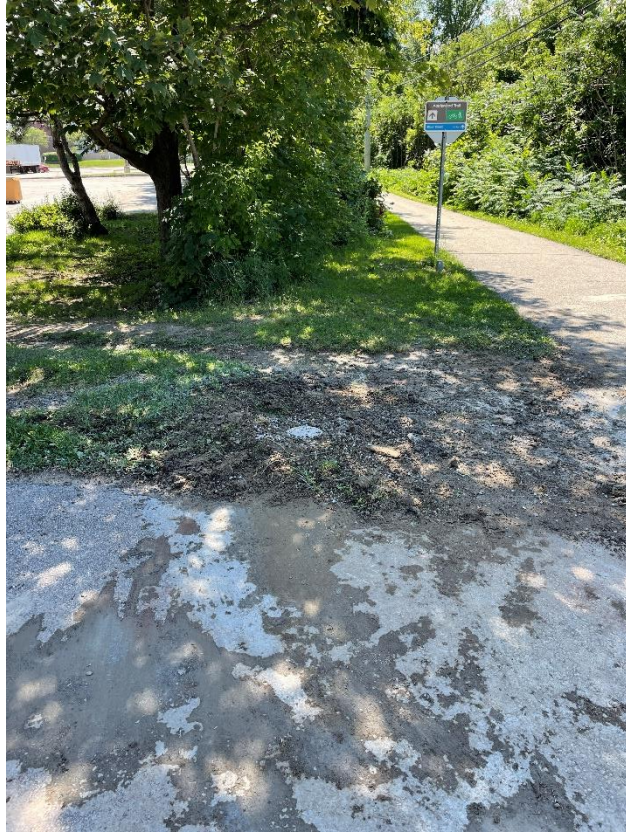
Photo 2. Looking west towards Borehole DIX-01 upon completion of drilling. [taken July 2021]

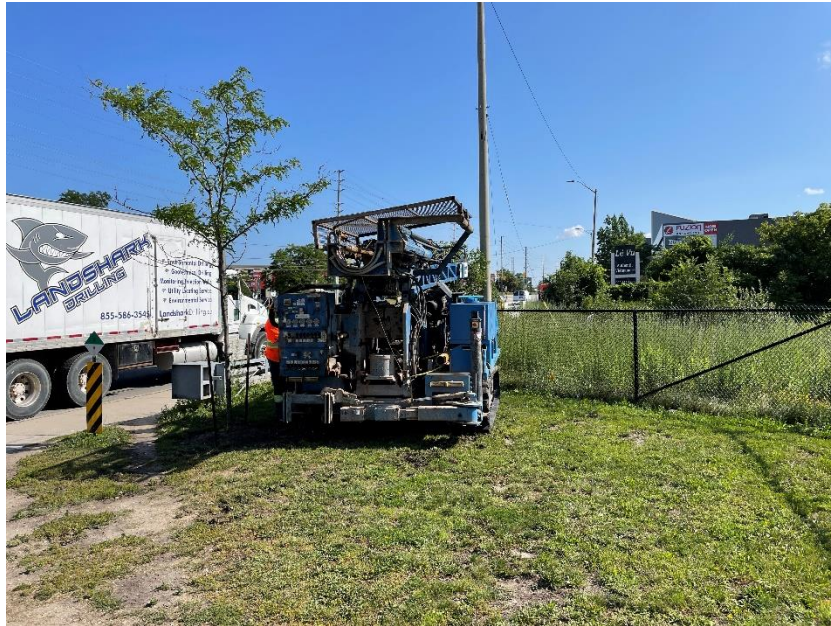
Photo 3. Looking east along Dundas Street East towards drill rig setting up at DUN-01. [taken August 2021]

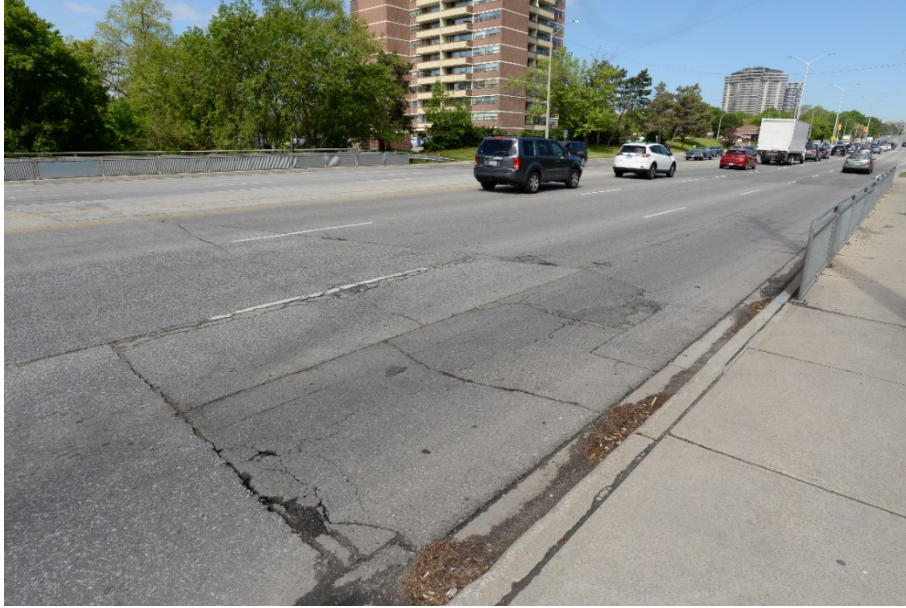
- In general, the pavement condition over the Dixie Road Bridge and on the north approach is considered in good condition, with few areas of visible distress.

Photograph 1: Looking north towards Dixie Dundas Bridge from east sidewalk.

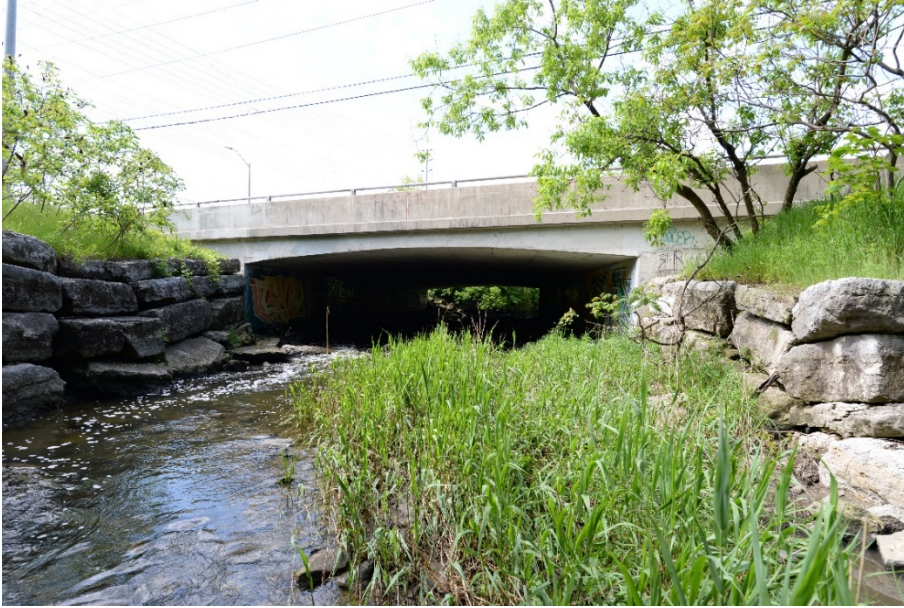
Photograph 3: Looking upstream from east side of Dixie Dundas Bridge.

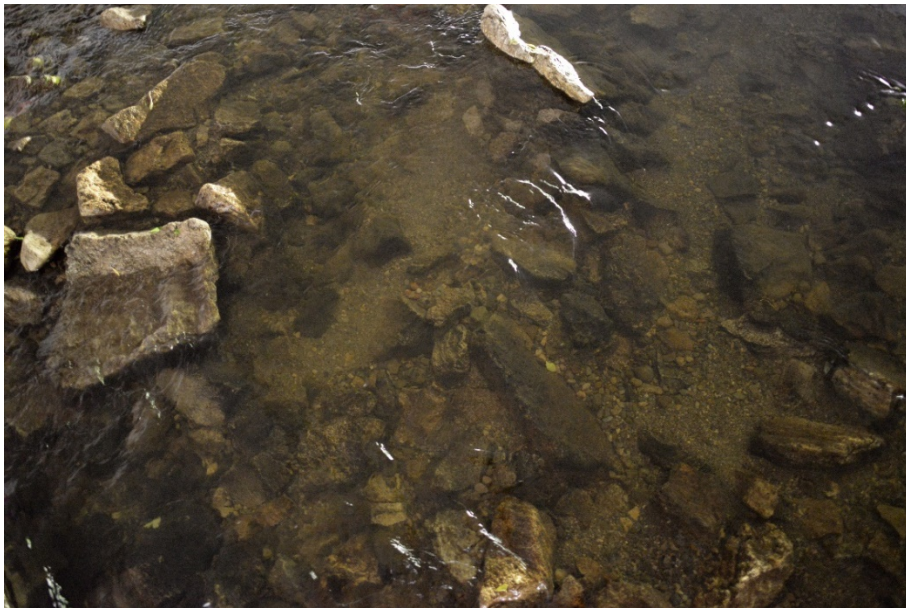
Photograph 6: Looking at creek bed from underneath Dixie Dundas Bridge.

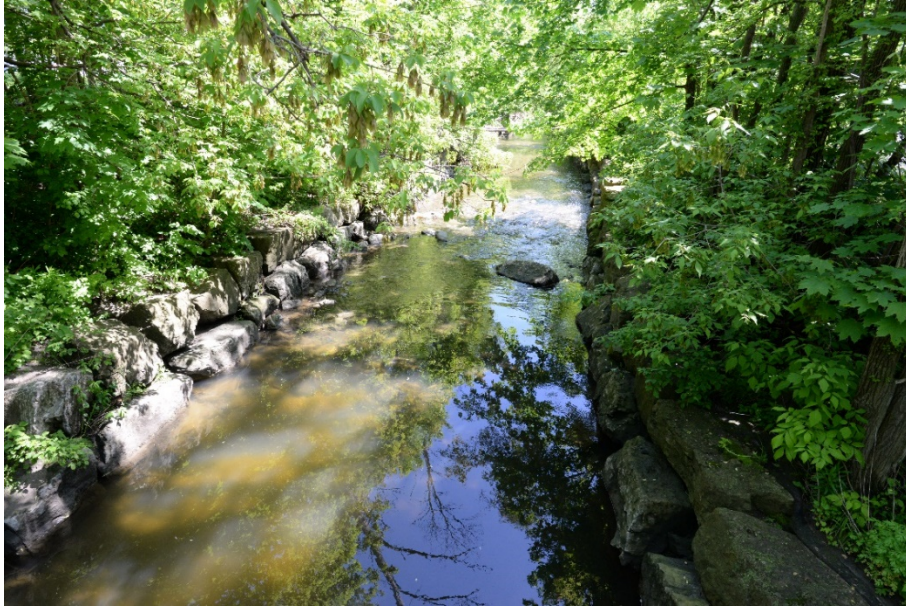
Photograph 11: Looking downstream from a pedestrian bridge located approximately 185 m west of Dixie Dundas Bridge.

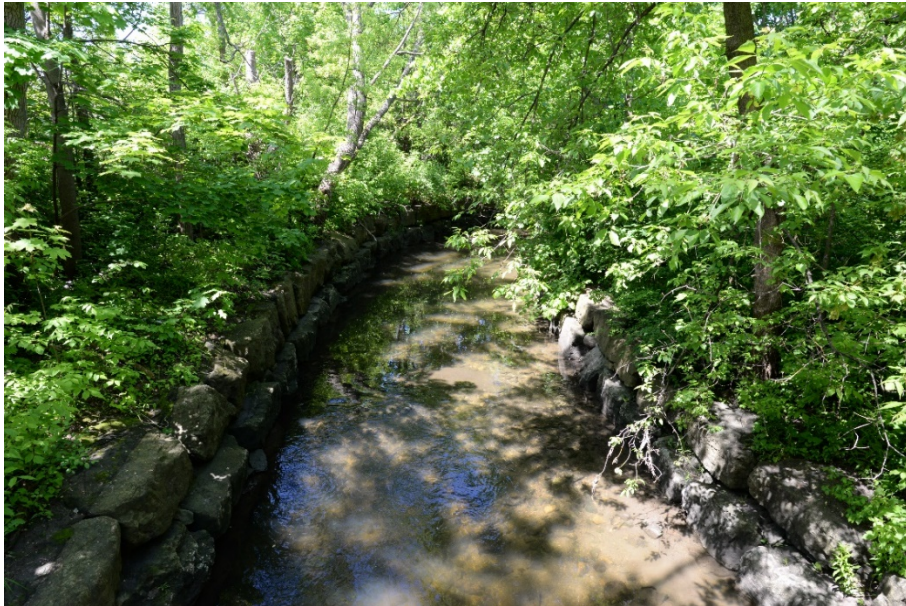
Photograph 12: Looking upstream from a pedestrian bridge located approximately 185 m west of Dixie Dundas Bridge.

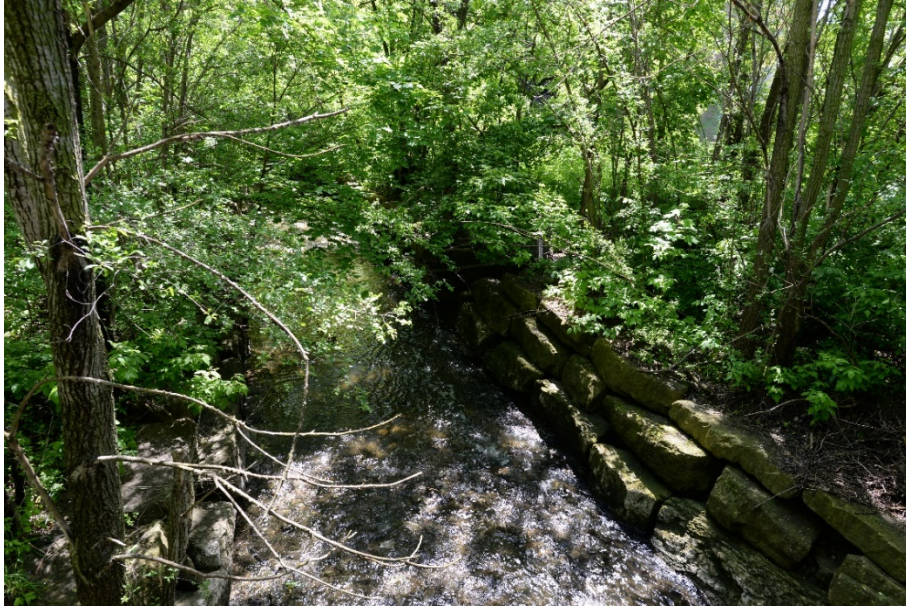
Photograph 13: Looking downstream from a pedestrian bridge located approximately 385 m west of Dixie Dundas Bridge.

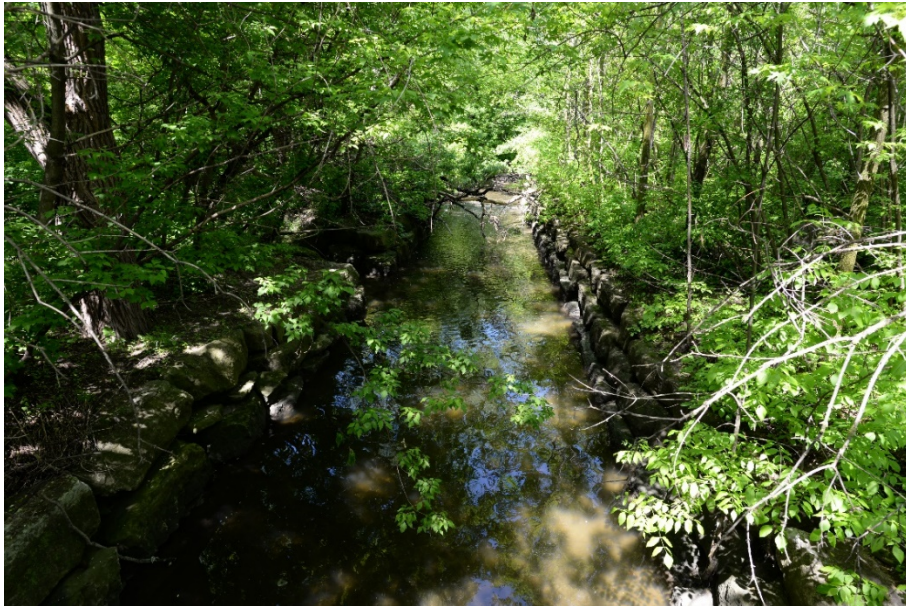
Photograph 14: Looking upstream from a pedestrian bridge located approximately 385 m west of Dixie Dundas Bridge.

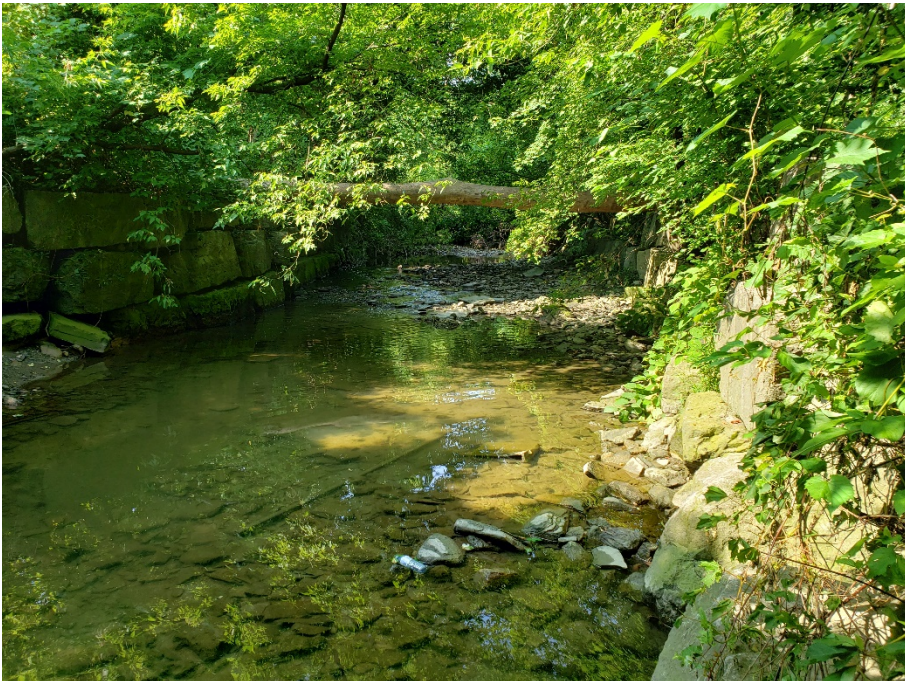
Photograph 16: Looking upstream from a walking trail approximately parallel with Goldmar Drive.

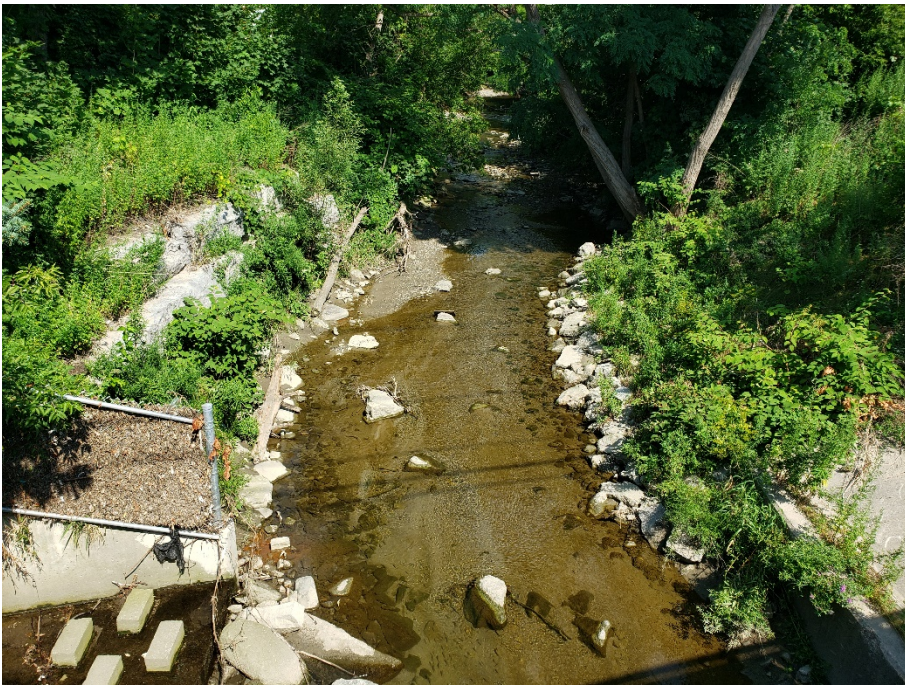
Photograph 24: Looking upstream from Dundas Street East Bridge.
