ARBORIST REPORT & TREE PROTECTION PLAN

900 LAKESHORE ROAD WEST
MISSISSAUGA, ON
L5H 1H9

Date: January 25, 2024

Revised: November 22, 2024

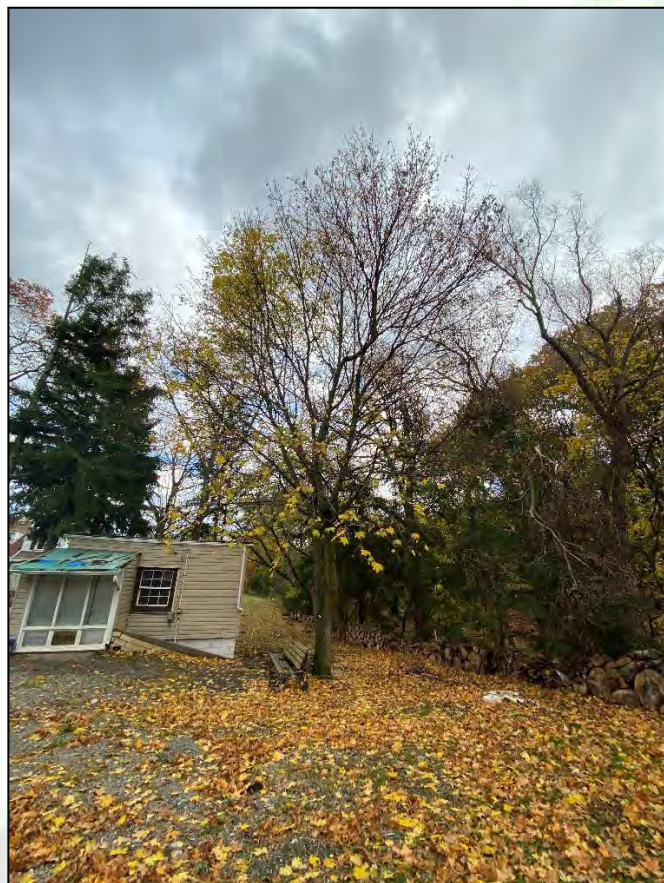
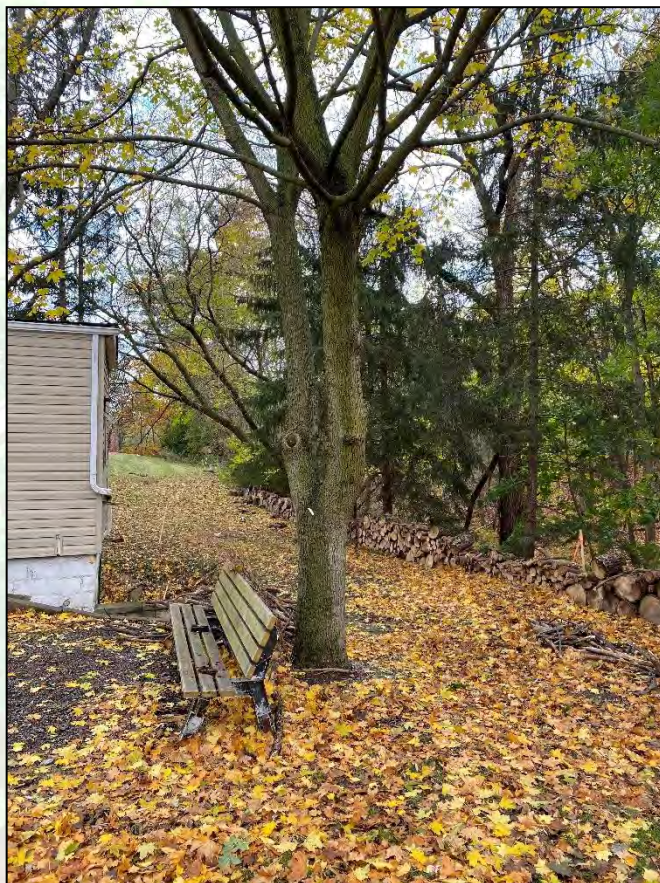
Tree #	Tree Species	Botanical Name	DBH (cm)	Root Zone	Trunk Integrity	Crown Structure	Crown Vitality	Overall Condition
388	Norway Maple	<i>Acer platanoides</i>	46	Fair	Good	Fair	Good	Good

Tree #388, a 46cm DBH Norway Maple (*Acer platanoides*) is a privately owned deciduous tree growing in the west portion of the property. This tree has exposed and girdling roots, is co-dominant at 1.7m with included bark, and has dieback. Overall this tree is in good condition.

Due to the location that this tree is growing and the proposed construction, this tree is recommended for removal. A permit is required for the removal of this tree.

Three (3) replacement trees will require to be planted as compensation. The compensation trees should be at least 6cm diameter (deciduous), or at least 1.8m tall (evergreen). Tree species and quantities will be included in the landscape design drawings.

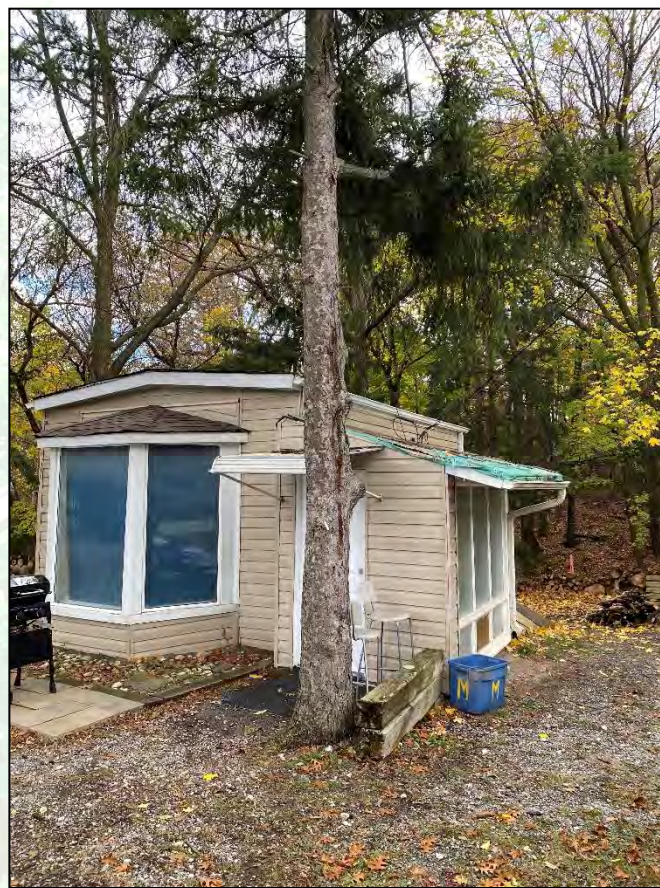
Tree #389 – Norway Spruce (34cm DBH)

Tree #	Tree Species	Botanical Name	DBH (cm)	Root Zone	Trunk Integrity	Crown Structure	Crown Vitality	Overall Condition
389	Norway Spruce	<i>Picea abies</i>	34	Fair	Fair	Poor	Fair	Fair

Tree #389, a 34cm DBH Norway Spruce (*Picea abies*) is a privately owned evergreen tree growing in the west portion of the property. This tree has an uneven crown, unhealed trunk wounds, dieback and deadwood. Overall this tree is in fair condition.

Due to the location that this tree is growing and the proposed construction, this tree is recommended for removal. A permit is required for the removal of this tree.

Two (2) replacement trees will require to be planted as compensation. The compensation trees should be at least 6cm diameter (deciduous), or at least 1.8m tall (evergreen). Tree species and quantities will be included in the landscape design drawings.

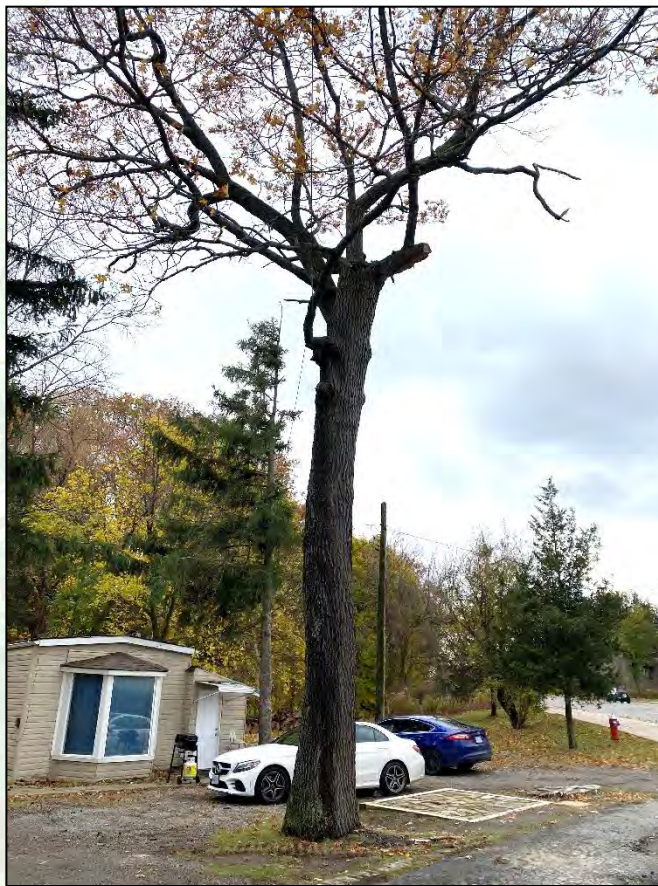
Tree #390 – Red Oak (79cm DBH)

Tree #	Tree Species	Botanical Name	DBH (cm)	Root Zone	Trunk Integrity	Crown Structure	Crown Vitality	Overall Condition
390	Red Oak	<i>Quercus rubra</i>	79	Fair	Poor	Fair	Fair	Fair

Tree #390, a 79cm DBH Red Oak (*Quercus rubra*) is a privately owned deciduous tree growing in the west portion of the property. This tree is growing on a lean, has unhealed trunk wounds, cavities with decay, and has been topped. Overall this tree is in fair condition.

Due to the location that this tree is growing and the proposed construction, this tree is recommended for removal. A permit is required for the removal of this tree.

Five (5) replacement trees will require to be planted as compensation. The compensation trees should be at least 6cm diameter (deciduous), or at least 1.8m tall (evergreen). Tree species and quantities will be included in the landscape design drawings.

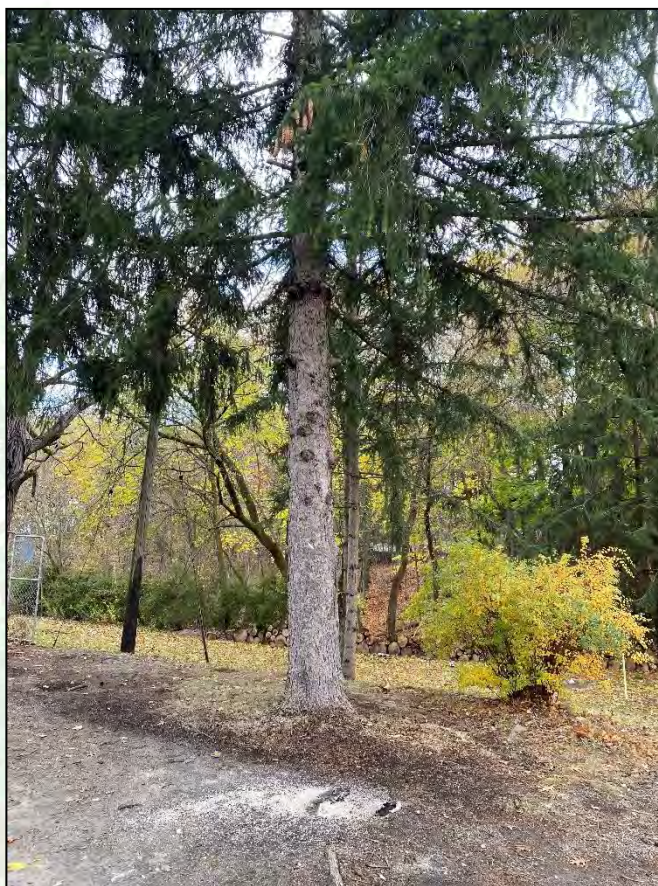
Tree #391 – Norway Spruce (49cm DBH)

Tree #	Tree Species	Botanical Name	DBH (cm)	Root Zone	Trunk Integrity	Crown Structure	Crown Vitality	Overall Condition
391	Norway Spruce	<i>Picea abies</i>	49	Good	Good	Good	Good	Good

Tree #391, a 49cm DBH Norway Spruce (*Picea abies*) is a privately owned evergreen tree growing in the west portion of the property. This tree has exposed and girdling roots, and unhealed pruning wounds. Overall this tree is in good condition.

Due to the location that this tree is growing and the proposed construction, this tree is recommended for removal. A permit is required for the removal of this tree.

Three (3) replacement trees will require to be planted as compensation. The compensation trees should be at least 6cm diameter (deciduous), or at least 1.8m tall (evergreen). Tree species and quantities will be included in the landscape design drawings.

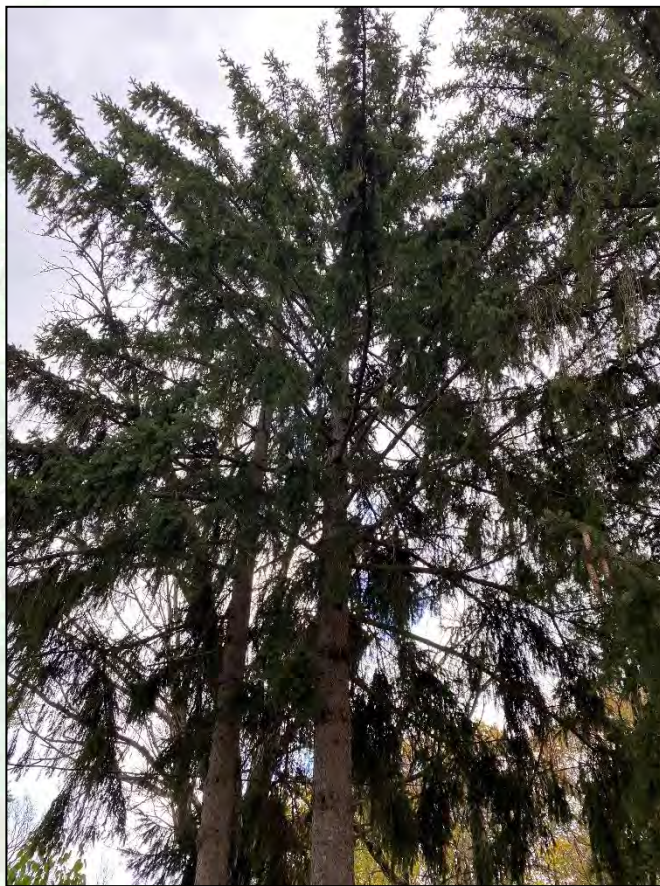
Tree #392 – Norway Spruce (40cm DBH)

Tree #	Tree Species	Botanical Name	DBH (cm)	Root Zone	Trunk Integrity	Crown Structure	Crown Vitality	Overall Condition
392	Norway Spruce	<i>Picea abies</i>	40	Fair	Fair	Good	Good	Fair

Due to the location that this tree is growing and the proposed construction, this tree is recommended for removal. A permit is required for the removal of this tree.

Two (2) replacement trees will require to be planted as compensation. The compensation trees should be at least 6cm diameter (deciduous), or at least 1.8m tall (evergreen). Tree species and quantities will be included in the landscape design drawings.

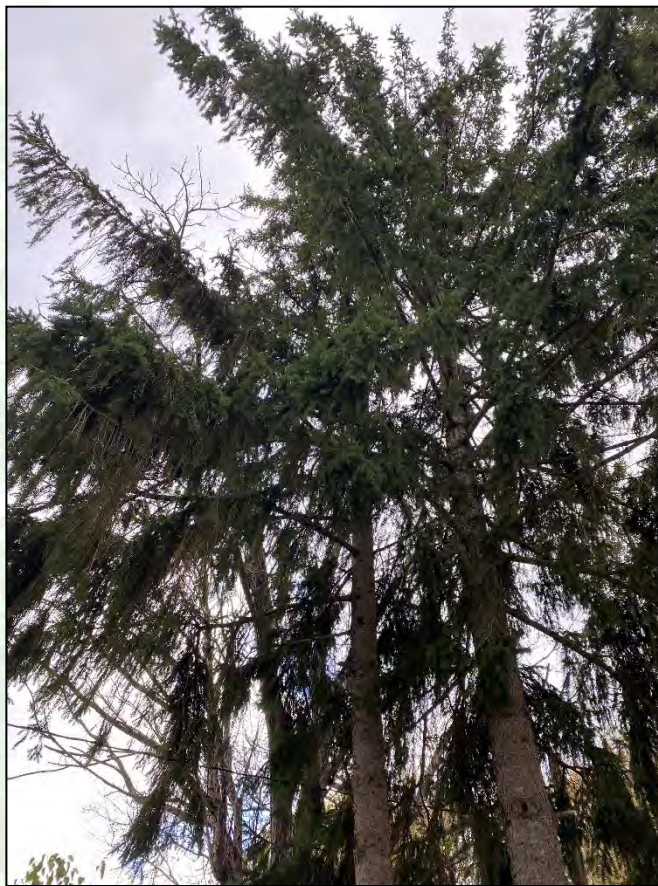
Tree #393 – Norway Spruce (33cm DBH)

Tree #	Tree Species	Botanical Name	DBH (cm)	Root Zone	Trunk Integrity	Crown Structure	Crown Vitality	Overall Condition
393	Norway Spruce	<i>Picea abies</i>	33	Fair	Fair	Good	Good	Fair

Due to the location that this tree is growing and the proposed construction, this tree is recommended for removal. A permit is required for the removal of this tree.

Two (2) replacement trees will require to be planted as compensation. The compensation trees should be at least 6cm diameter (deciduous), or at least 1.8m tall (evergreen). Tree species and quantities will be included in the landscape design drawings.

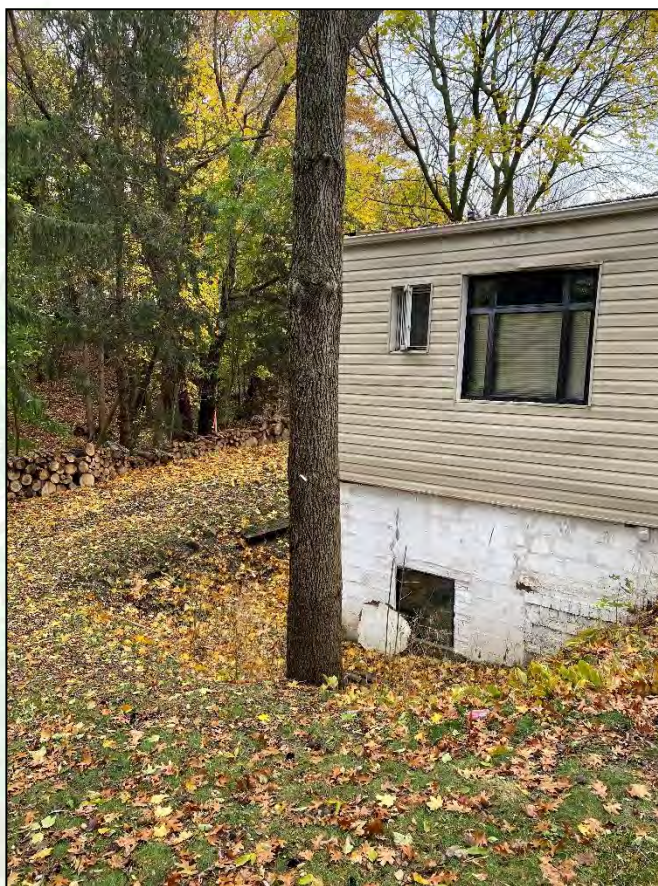
Tree #394 – Black Walnut (41cm DBH)

Tree #	Tree Species	Botanical Name	DBH (cm)	Root Zone	Trunk Integrity	Crown Structure	Crown Vitality	Overall Condition
394	Black Walnut	<i>Juglans nigra</i>	41	Fair	Good	Good	Good	Good

Tree #394, a 41cm DBH Black Walnut (*Juglans nigra*) is a privately owned deciduous tree growing in the west portion of the property. This tree is growing on slope and has minor dieback. Overall this tree is in good condition.

Due to the location that this tree is growing and the proposed construction, this tree is recommended for removal. A permit is required for the removal of this tree.

Two (2) replacement trees will require to be planted as compensation. The compensation trees should be at least 6cm diameter (deciduous), or at least 1.8m tall (evergreen). Tree species and quantities will be included in the landscape design drawings.

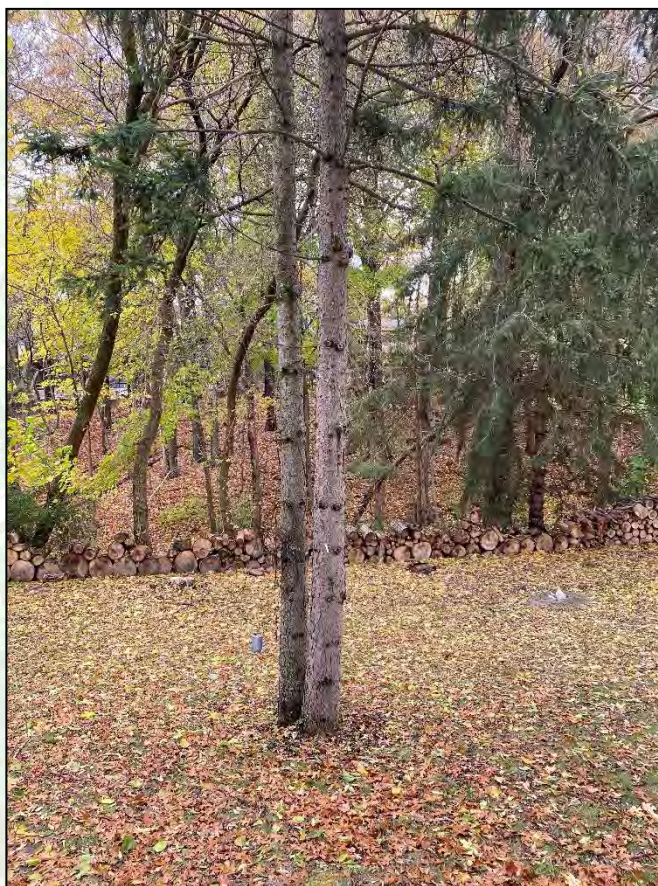
Tree #395 – Norway Spruce (24,29cm DBH)

Tree #	Tree Species	Botanical Name	DBH (cm)	Root Zone	Trunk Integrity	Crown Structure	Crown Vitality	Overall Condition
395	Norway Spruce	<i>Picea abies</i>	24,29	Good	Fair	Fair	Fair	Fair

Due to the location that this tree is growing and the proposed construction, this tree is recommended for removal. A permit is required for the removal of this tree.

Two (2) replacement trees will require to be planted as compensation. The compensation trees should be at least 6cm diameter (deciduous), or at least 1.8m tall (evergreen). Tree species and quantities will be included in the landscape design drawings.

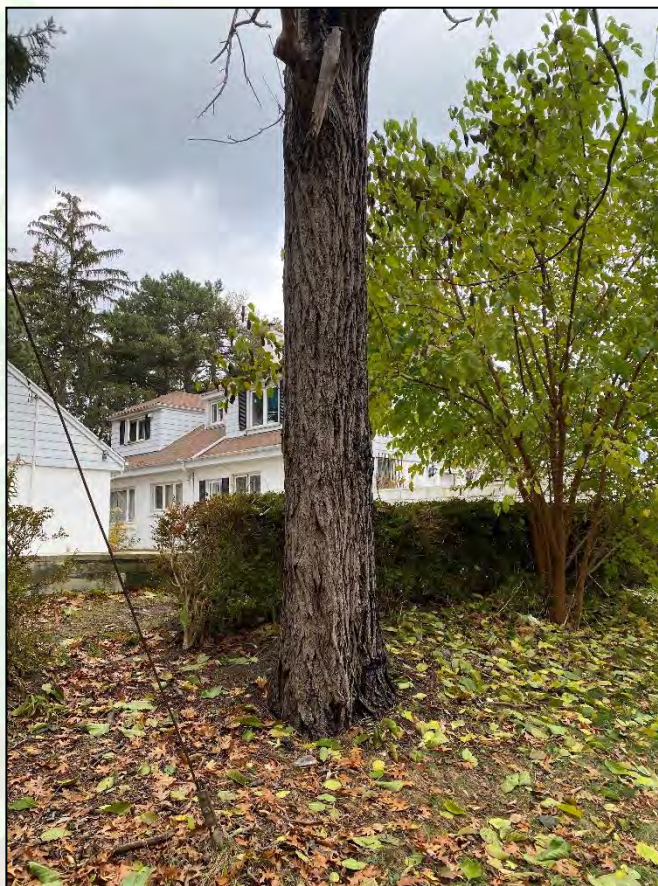
Tree #396 – Butternut (58cm DBH)

Tree #	Tree Species	Botanical Name	DBH (cm)	Root Zone	Trunk Integrity	Crown Structure	Crown Vitality	Overall Condition
396	Butternut	<i>Juglans cinerea</i>	58	Fair	Fair	Poor	Poor	Poor

Due to the location that this tree is growing and the proposed construction, this tree is recommended for removal. A permit is required for the removal of this tree.

Four (4) replacement trees will require to be planted as compensation. The compensation trees should be at least 6cm diameter (deciduous), or at least 1.8m tall (evergreen). Tree species and quantities will be included in the landscape design drawings.

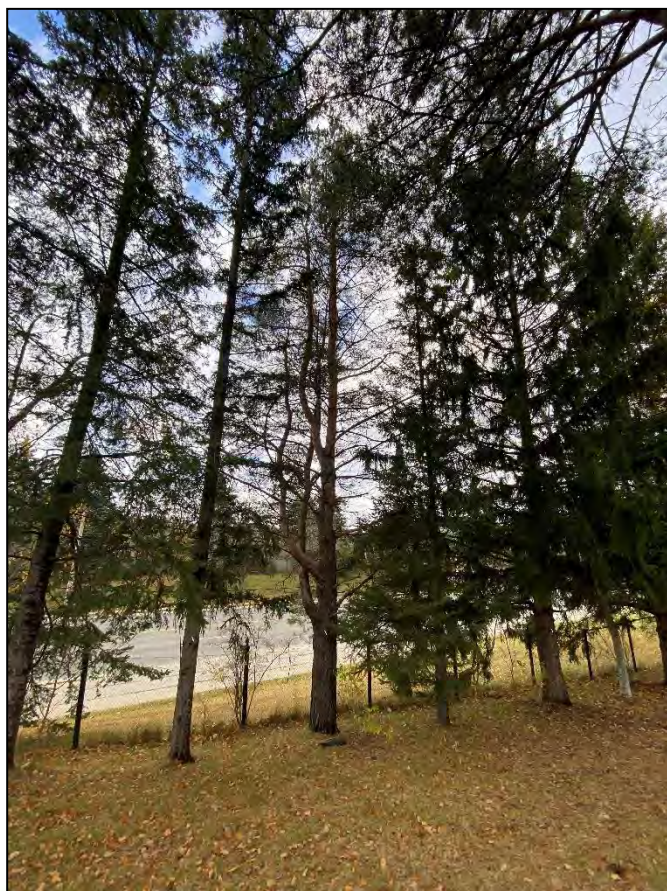
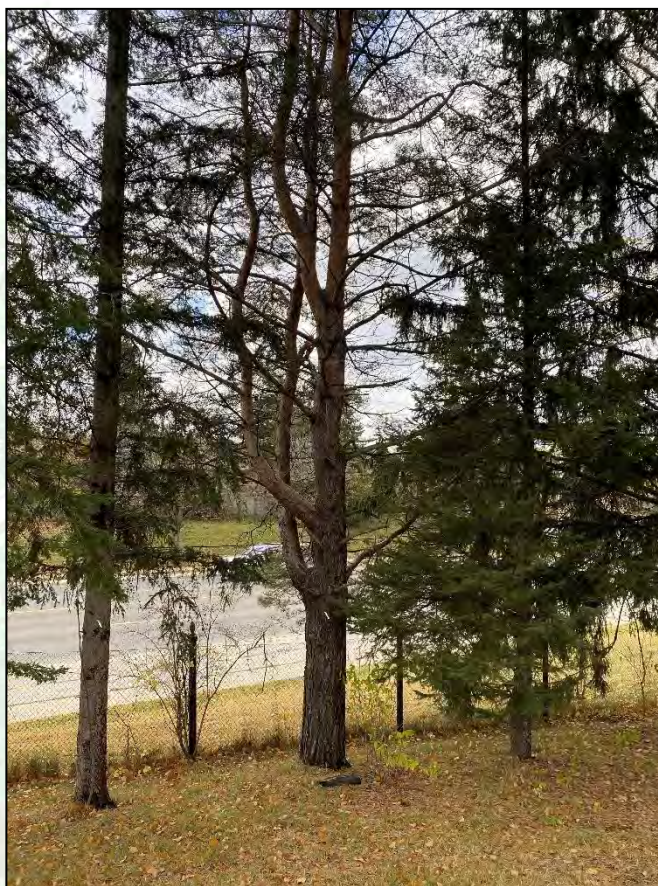
Tree #410 – White Spruce (18cm DBH)

Tree #410, an 18cm DBH White Spruce (*Picea glauca*) is a privately owned evergreen tree growing in the north portion of the property. This tree has minor deadwood. Overall this tree is in good condition.

Due to the location that this tree is growing and the proposed construction, this tree is recommended for removal. A permit is required for the removal of this tree.

One (1) replacement trees will require to be planted as compensation. The compensation trees should be at least 6cm diameter (deciduous), or at least 1.8m tall (evergreen). Tree species and quantities will be included in the landscape design drawings.

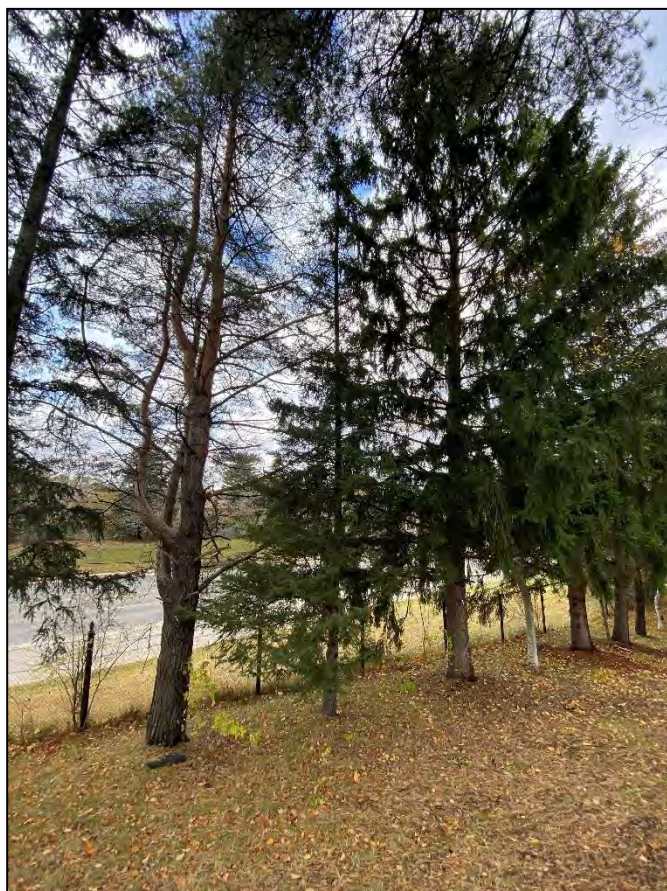
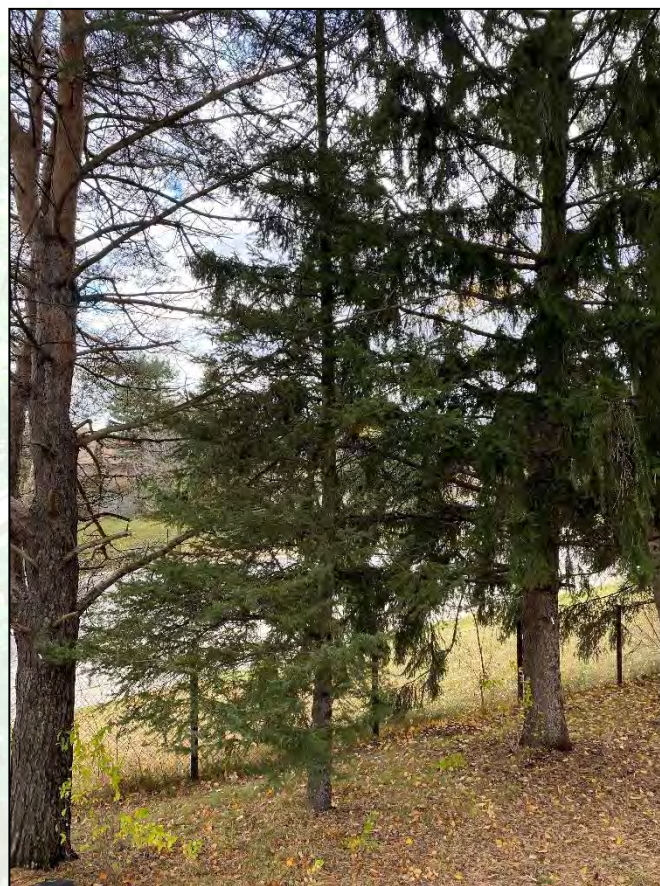
Tree #411 – Norway Spruce (42cm DBH)

Tree #411, a 42cm DBH Norway Spruce (*Picea abies*) is a privately owned evergreen tree growing in the east portion of the property. This tree has exposed roots and unhealed pruning wounds. Overall this tree is in good condition.

Due to the location that this tree is growing and the proposed construction, this tree is recommended for removal. A permit is required for the removal of this tree.

Three (3) replacement trees will require to be planted as compensation. The compensation trees should be at least 6cm diameter (deciduous), or at least 1.8m tall (evergreen). Tree species and quantities will be included in the landscape design drawings.

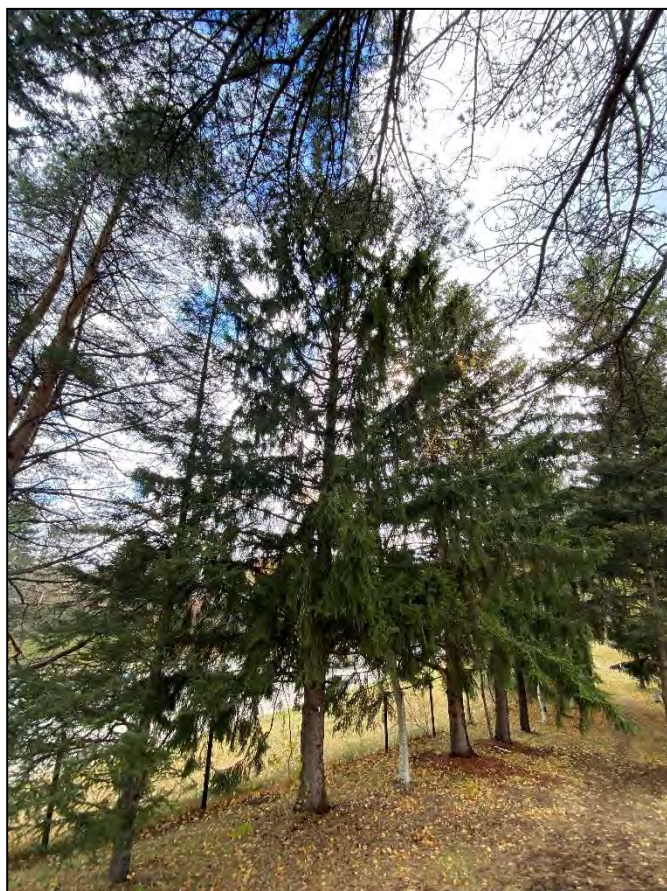
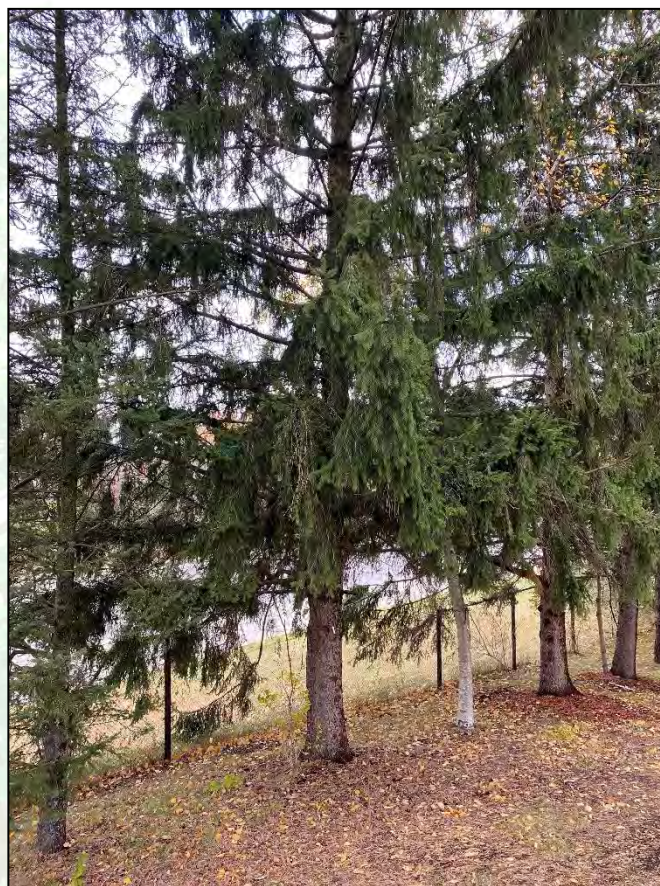
Tree #412 – Scots Pine (70cm DBH)

Tree #412, a 70cm DBH Scots Pine (*Pinus sylvestris*) is a privately owned evergreen tree growing in the east portion of the property. This tree is co-dominant at 7m, has unhealed trunk wounds, dieback and deadwood. Overall this tree is in good condition.

Due to the location that this tree is growing and the proposed construction, this tree is recommended for removal. A permit is required for the removal of this tree.

Five (5) replacement trees will require to be planted as compensation. The compensation trees should be at least 6cm diameter (deciduous), or at least 1.8m tall (evergreen). Tree species and quantities will be included in the landscape design drawings.

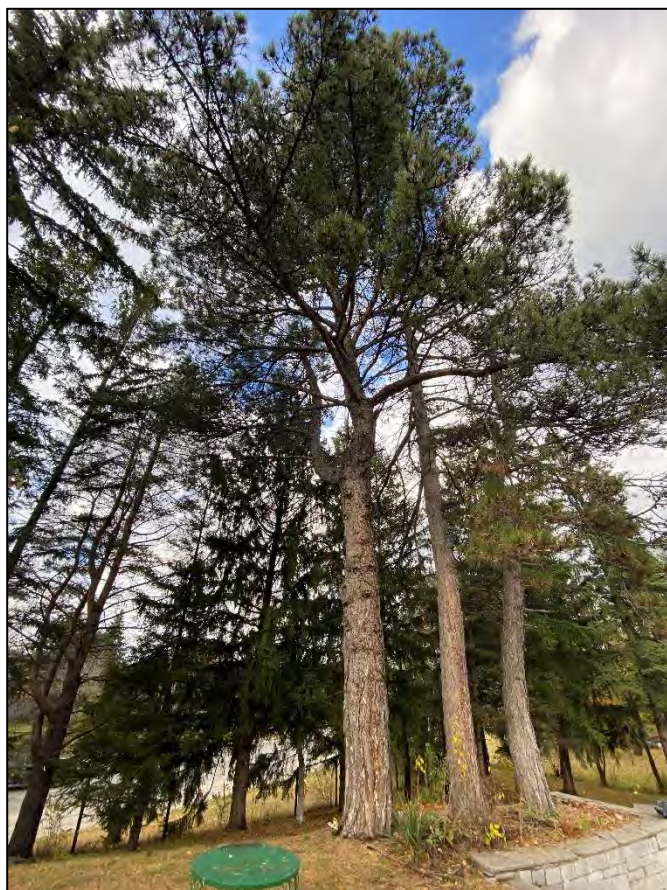
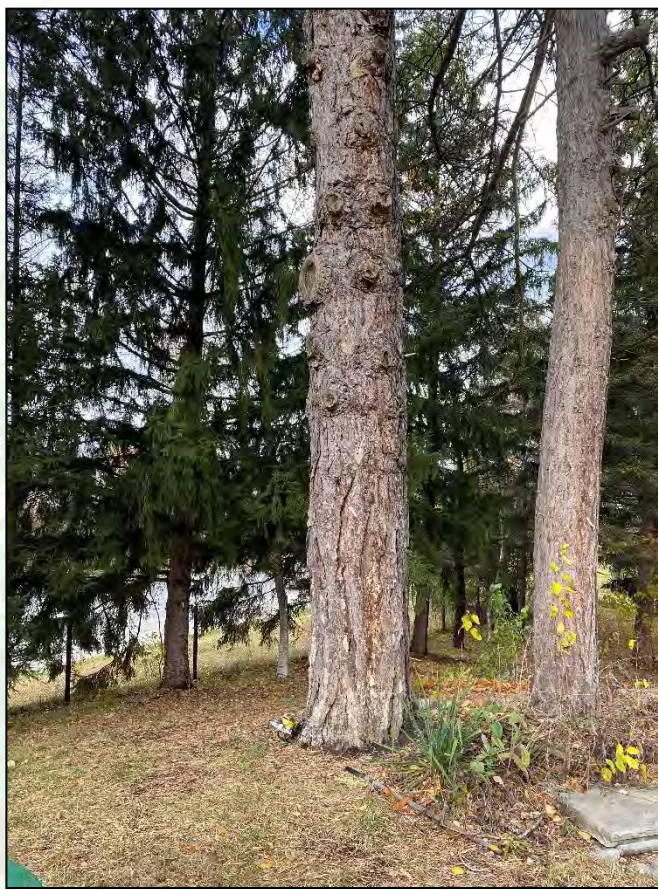
Tree #413 – Scots Pine (46cm DBH)

Tree #413, a 46cm DBH Scots Pine (*Pinus sylvestris*) is a privately owned evergreen tree growing in the east portion of the property. This tree has unhealed trunk wounds, a sparse crown, dieback and deadwood. Overall this tree is in fair condition.

Due to the location that this tree is growing and the proposed construction, this tree is recommended for removal. A permit is required for the removal of this tree.

Three (3) replacement trees will require to be planted as compensation. The compensation trees should be at least 6cm diameter (deciduous), or at least 1.8m tall (evergreen). Tree species and quantities will be included in the landscape design drawings.

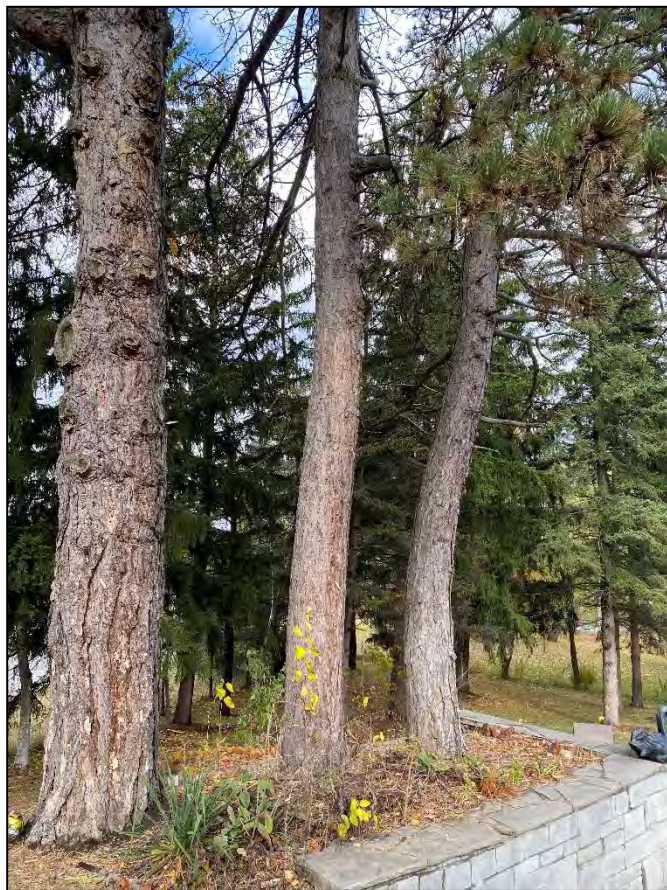
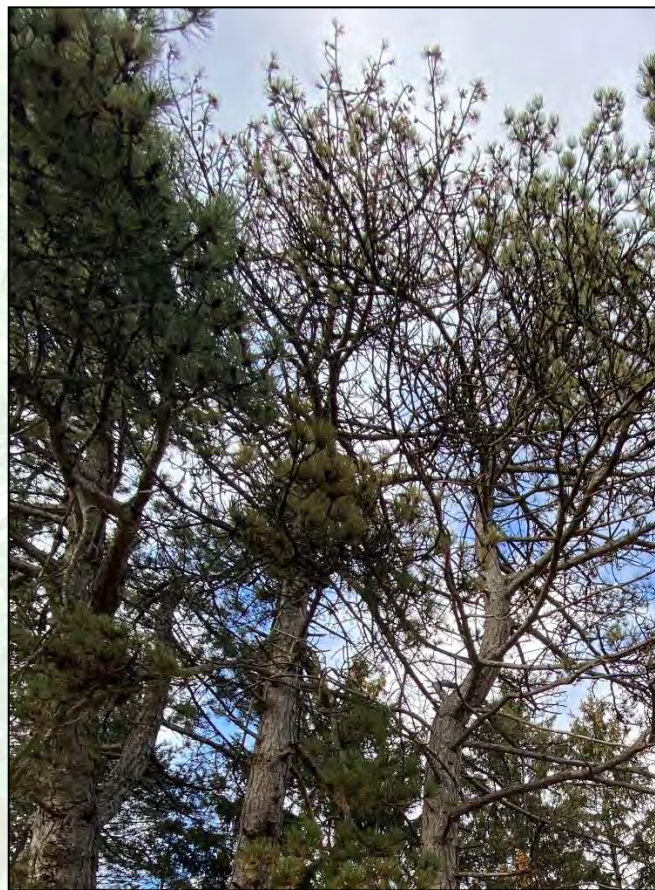
Tree #414 – Scots Pine (46cm DBH)

Tree #414, a 46cm DBH Scots Pine (*Pinus sylvestris*) is a privately owned evergreen tree growing in the east portion of the property. This tree has a bent trunk, unhealed trunk wounds, a sparse crown, dieback and deadwood. Overall this tree is in fair condition.

Due to the location that this tree is growing and the proposed construction, this tree is recommended for removal. A permit is required for the removal of this tree.

Three (3) replacement trees will require to be planted as compensation. The compensation trees should be at least 6cm diameter (deciduous), or at least 1.8m tall (evergreen). Tree species and quantities will be included in the landscape design drawings.

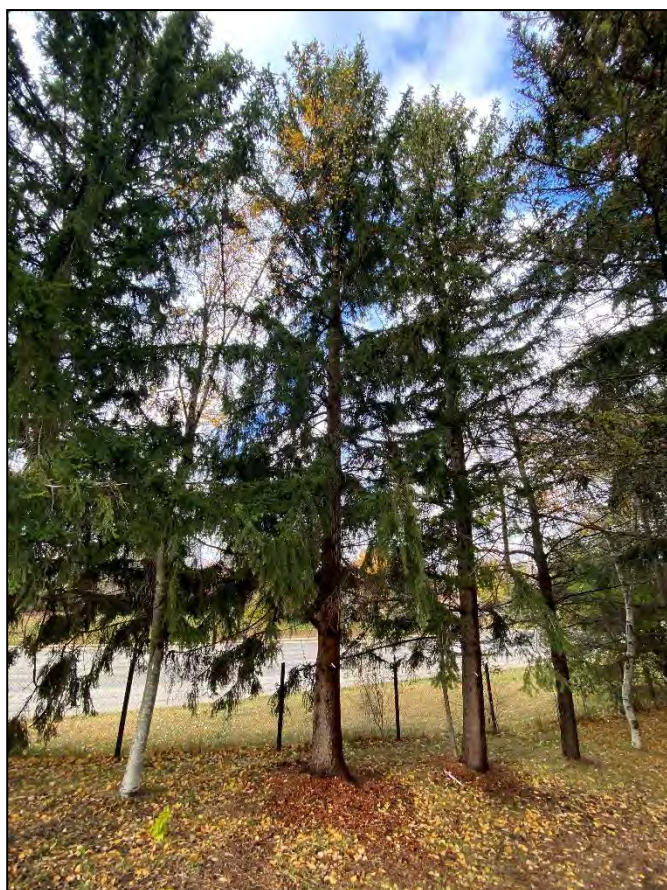
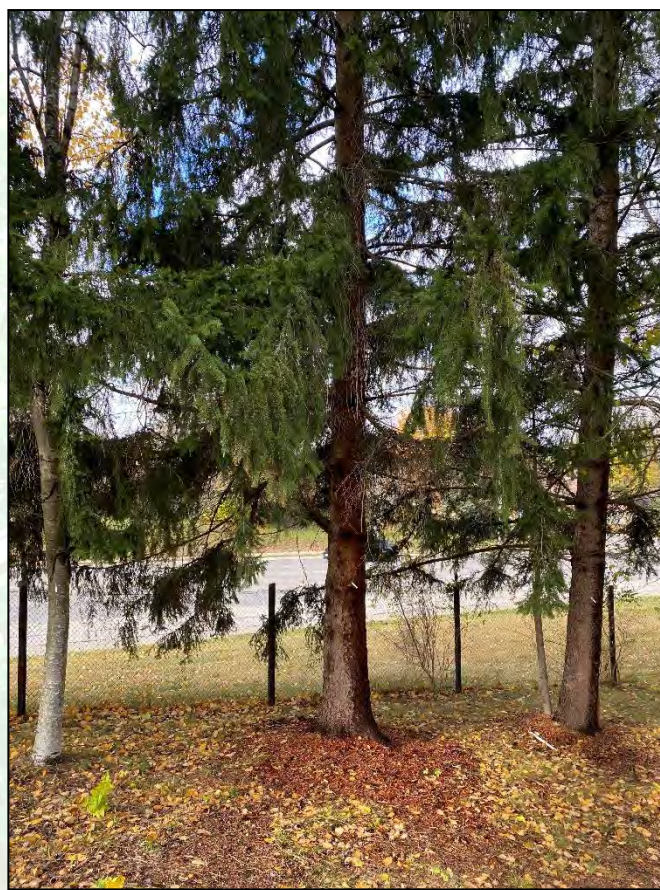
Tree #417 – Norway Spruce (38cm DBH)

Tree #417, a 38cm DBH Norway Spruce (*Picea abies*) is a privately owned evergreen tree growing in the east portion of the property. This tree has minor dieback and deadwood. Overall this tree is in good condition.

Due to the location that this tree is growing and the proposed construction, this tree is recommended for removal. A permit is required for the removal of this tree.

Three (3) replacement trees will require to be planted as compensation. The compensation trees should be at least 6cm diameter (deciduous), or at least 1.8m tall (evergreen). Tree species and quantities will be included in the landscape design drawings.

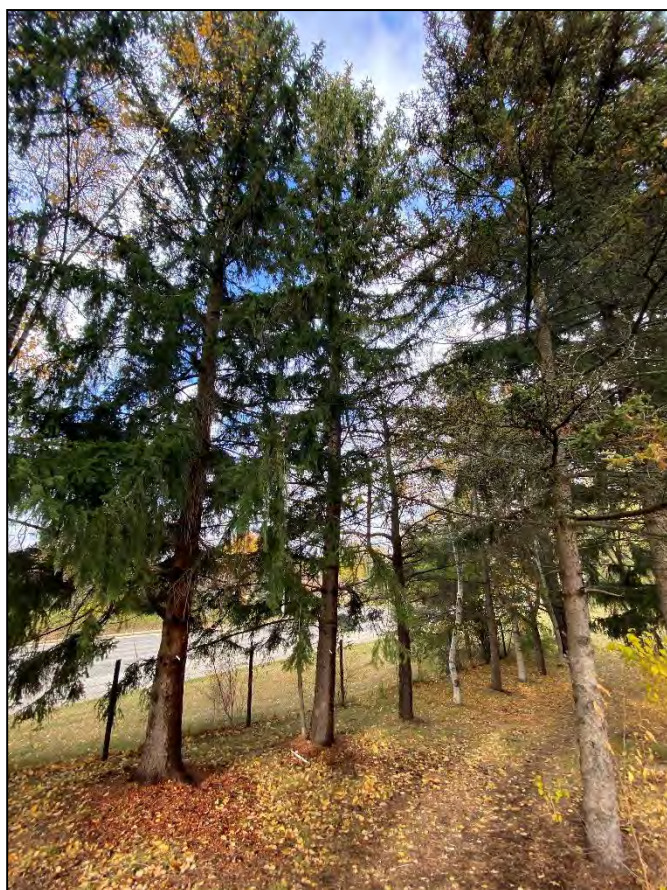
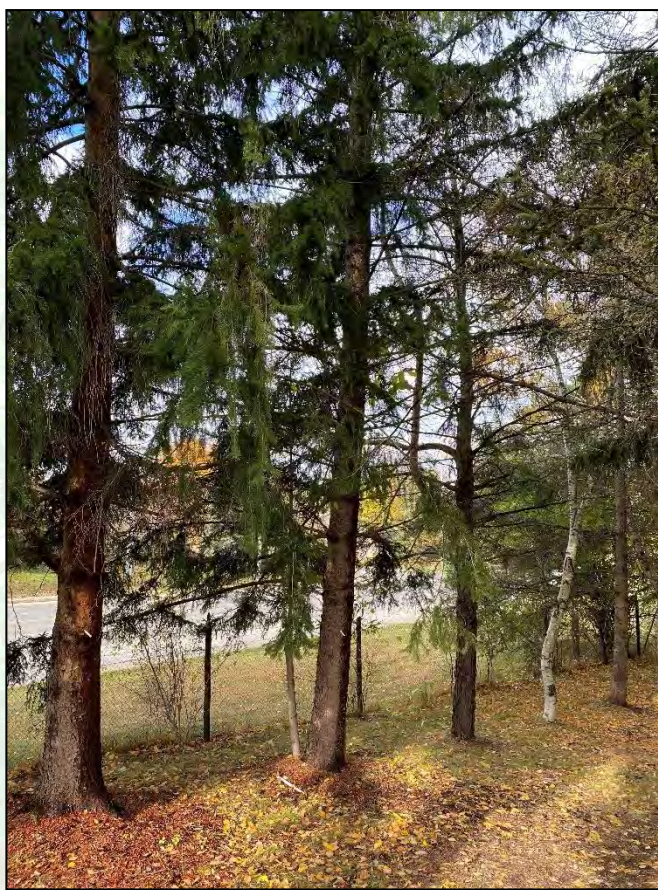
Tree #418 – White Spruce (27cm DBH)

Tree #418, a 27cm DBH White Spruce (*Picea glauca*) is a privately owned evergreen tree growing in the east portion of the property. This tree has dieback, deadwood, and a sparse crown. Overall this tree is in good condition.

Due to the location that this tree is growing and the proposed construction, this tree is recommended for removal. A permit is required for the removal of this tree.

Two (2) replacement trees will require to be planted as compensation. The compensation trees should be at least 6cm diameter (deciduous), or at least 1.8m tall (evergreen). Tree species and quantities will be included in the landscape design drawings.

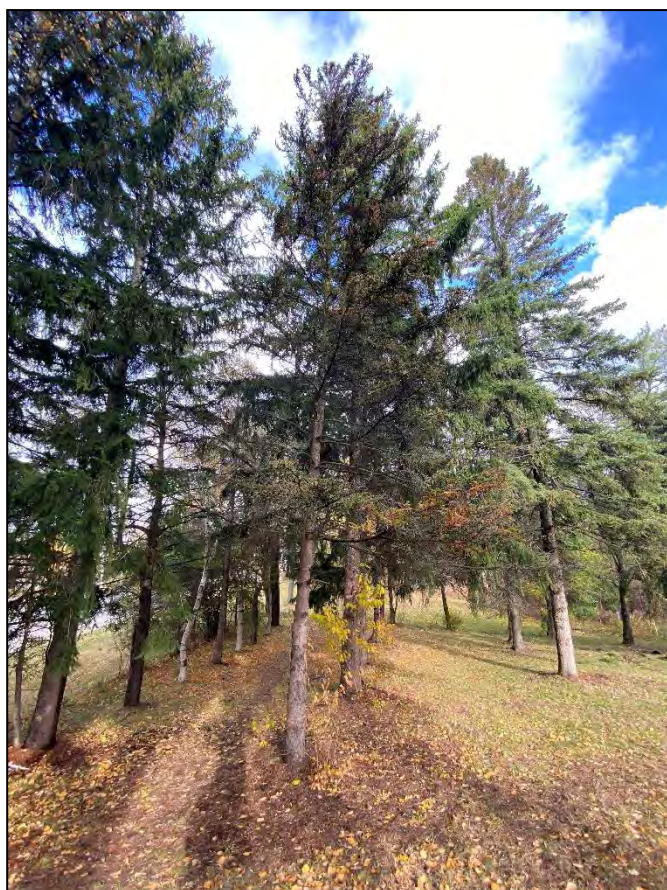
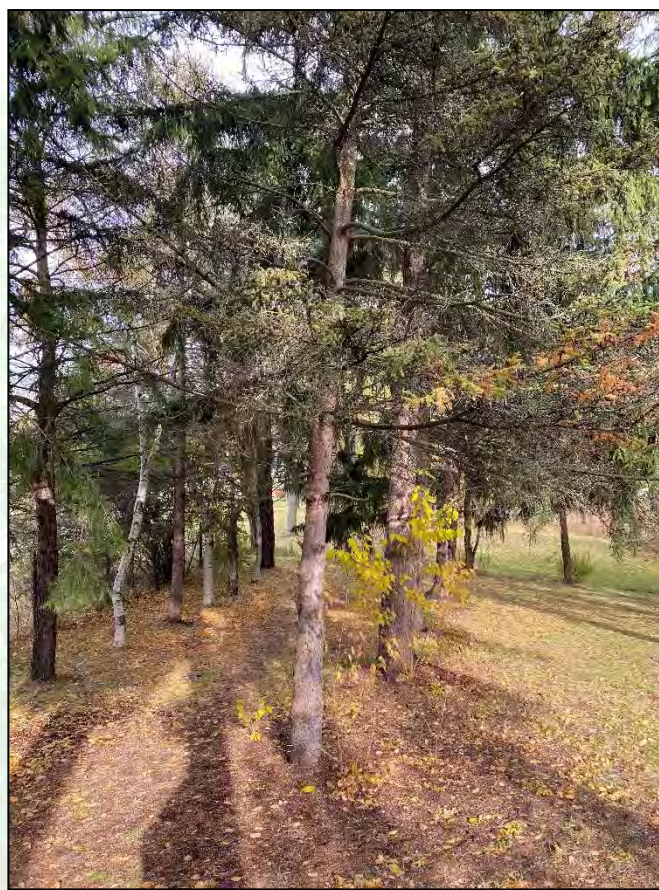
Tree #419 – Scots Pine (30cm DBH)

Tree #419, a 30cm DBH Scots Pine (*Pinus sylvestris*) is a privately owned evergreen tree growing in the east portion of the property. This tree has dieback, deadwood, and a sparse crown. Overall this tree is in good condition.

Due to the location that this tree is growing and the proposed construction, this tree is recommended for removal. A permit is required for the removal of this tree.

Two (2) replacement trees will require to be planted as compensation. The compensation trees should be at least 6cm diameter (deciduous), or at least 1.8m tall (evergreen). Tree species and quantities will be included in the landscape design drawings.

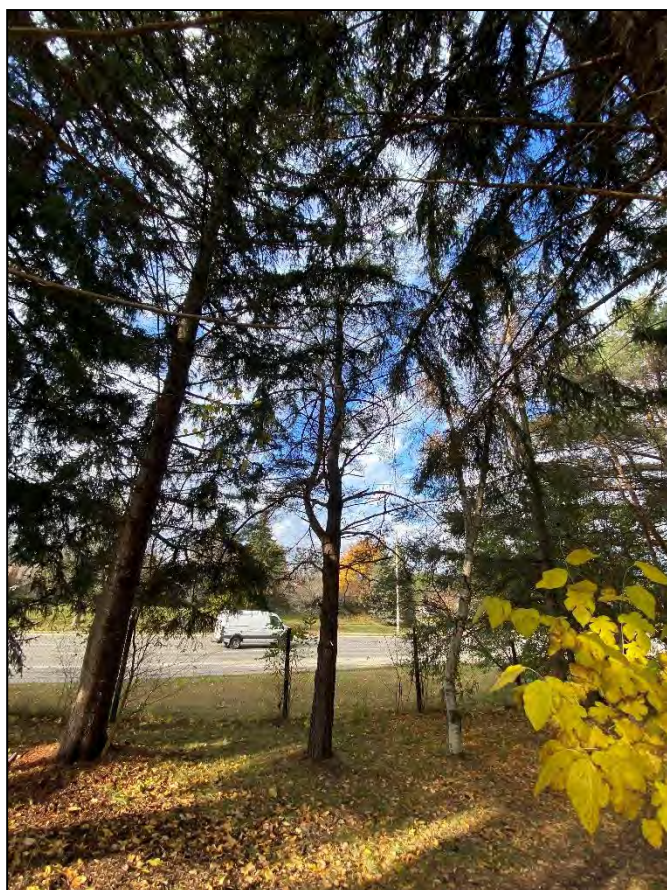
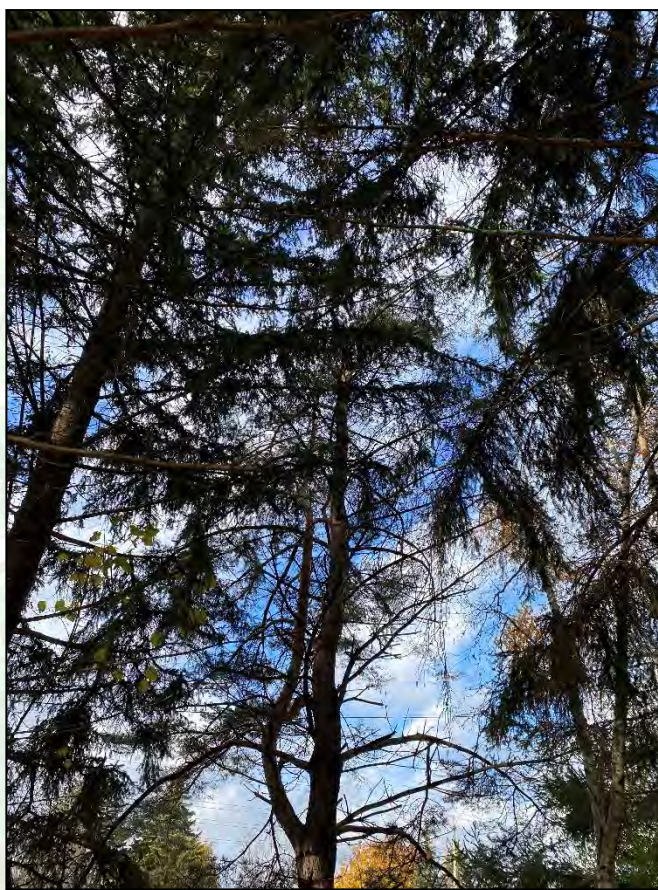
Tree #420 – Norway Spruce (42cm DBH)

Tree #420, a 42cm DBH Norway Spruce (*Picea abies*) is a privately owned evergreen tree growing in the east portion of the property. This tree has exposed roots, dieback and deadwood. Overall this tree is in good condition.

Due to the location that this tree is growing and the proposed construction, this tree is recommended for removal. A permit is required for the removal of this tree.

Three (3) replacement trees will require to be planted as compensation. The compensation trees should be at least 6cm diameter (deciduous), or at least 1.8m tall (evergreen). Tree species and quantities will be included in the landscape design drawings.

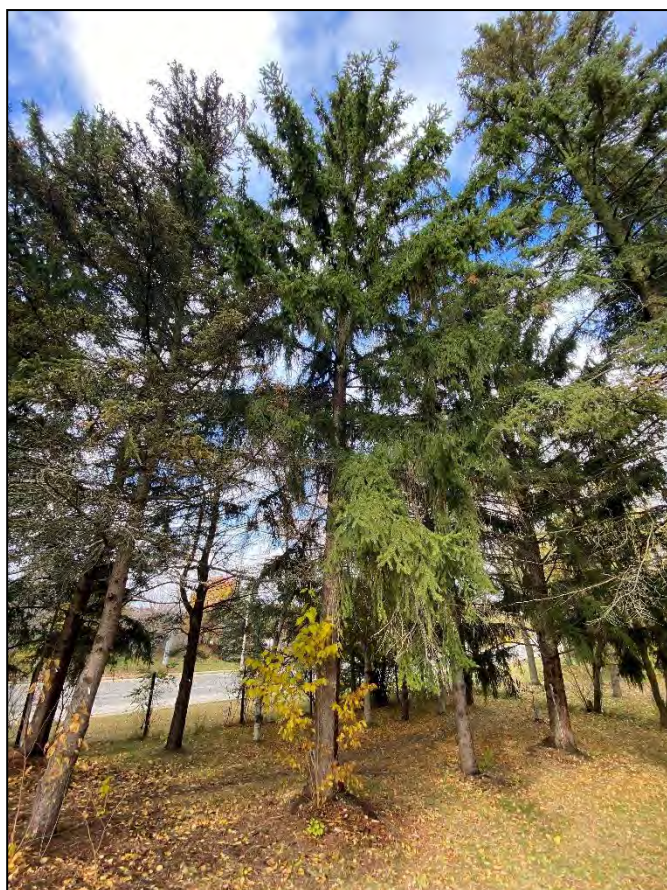
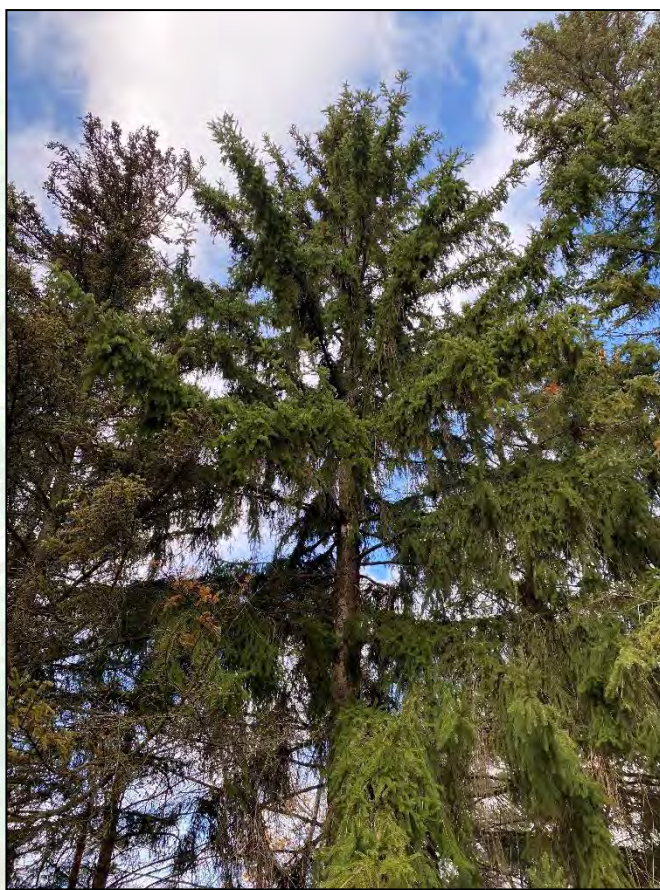
Tree #421 – White Spruce (40cm DBH)

Tree #421, a 40cm DBH White Spruce (*Picea glauca*) is a privately owned evergreen tree growing in the east portion of the property. This tree has exposed roots and deadwood. Overall this tree is in good condition.

Due to the location that this tree is growing and the proposed construction, this tree is recommended for removal. A permit is required for the removal of this tree.

Three (3) replacement trees will require to be planted as compensation. The compensation trees should be at least 6cm diameter (deciduous), or at least 1.8m tall (evergreen). Tree species and quantities will be included in the landscape design drawings.

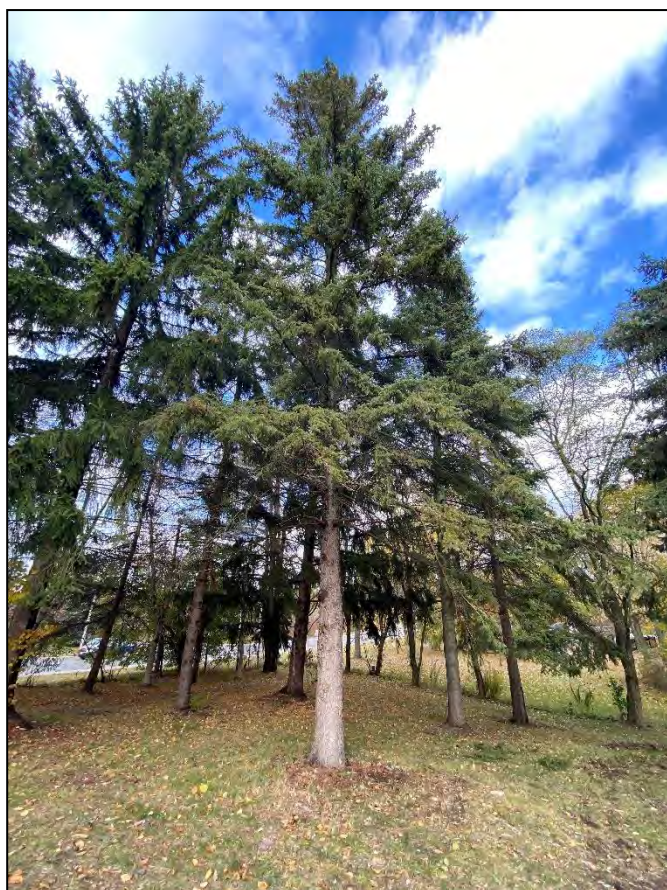
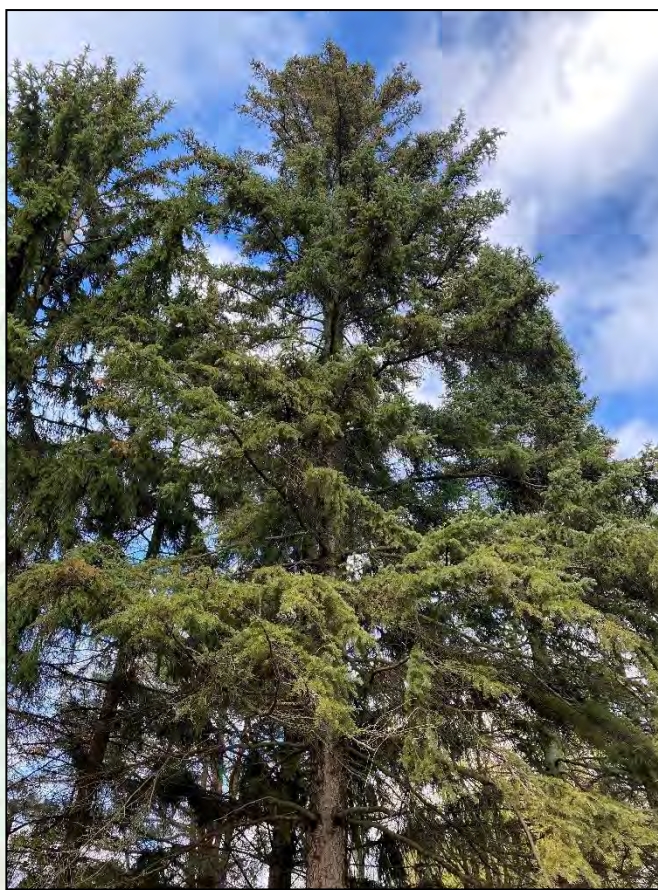
Tree #422 – Norway Spruce (29cm DBH)

Tree #422, a 29cm DBH Norway Spruce (*Picea abies*) is a privately owned evergreen tree growing in the east portion of the property. This tree has exposed and girdling roots, dieback, deadwood, and a sparse crown. Overall this tree is in fair condition.

Due to the location that this tree is growing and the proposed construction, this tree is recommended for removal. A permit is required for the removal of this tree.

Two (2) replacement trees will require to be planted as compensation. The compensation trees should be at least 6cm diameter (deciduous), or at least 1.8m tall (evergreen). Tree species and quantities will be included in the landscape design drawings.
