ARBORIST REPORT & TREE PROTECTION PLAN

900 LAKESHORE ROAD WEST
MISSISSAUGA, ON
L5H 1H9

Date: January 25, 2024

Revised: November 22, 2024

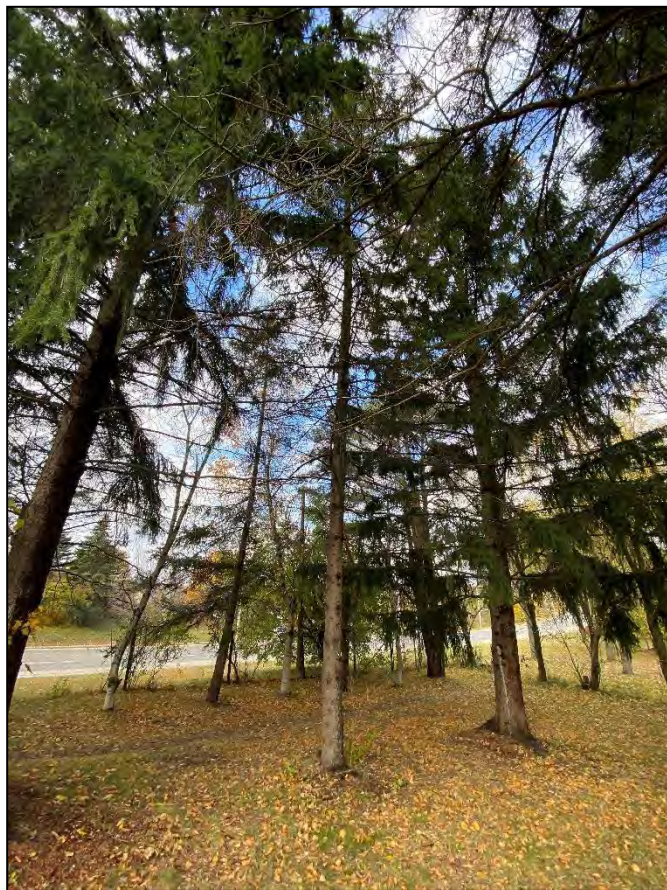
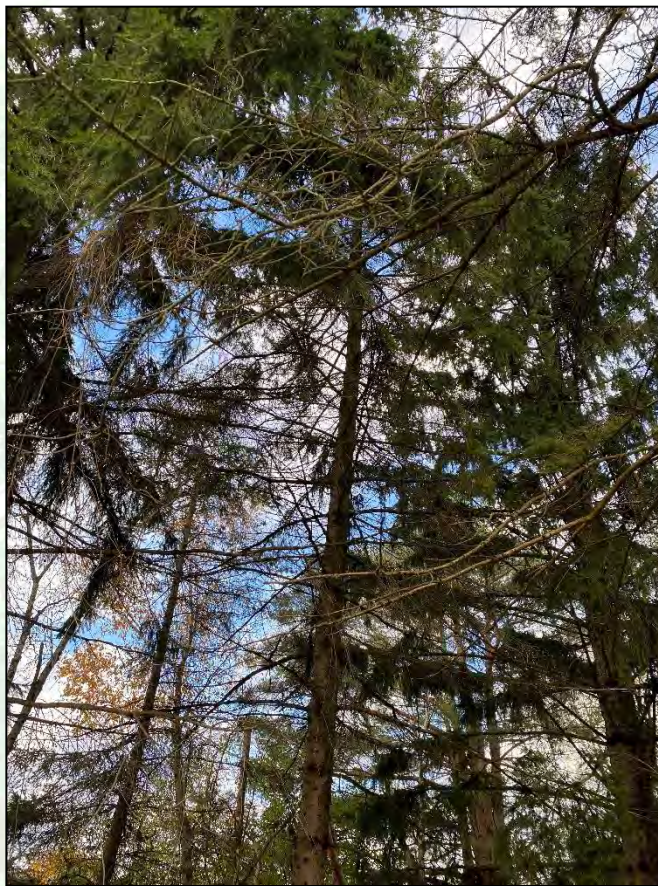
Tree #423 – White Birch (18cm DBH)

Tree #423, a 18cm DBH White Birch (*Betula papyrifera*) is a privately owned deciduous tree growing in the east portion of the property. This tree has a bent trunk, is co-dominant at 5m with included bark, unhealed trunk wounds, dieback and deadwood. Overall this tree is in fair condition.

Due to the location that this tree is growing and the proposed construction, this tree is recommended for removal. A permit is required for the removal of this tree.

One (1) replacement tree will require to be planted as compensation. The compensation trees should be at least 6cm diameter (deciduous), or at least 1.8m tall (evergreen). Tree species and quantities will be included in the landscape design drawings.

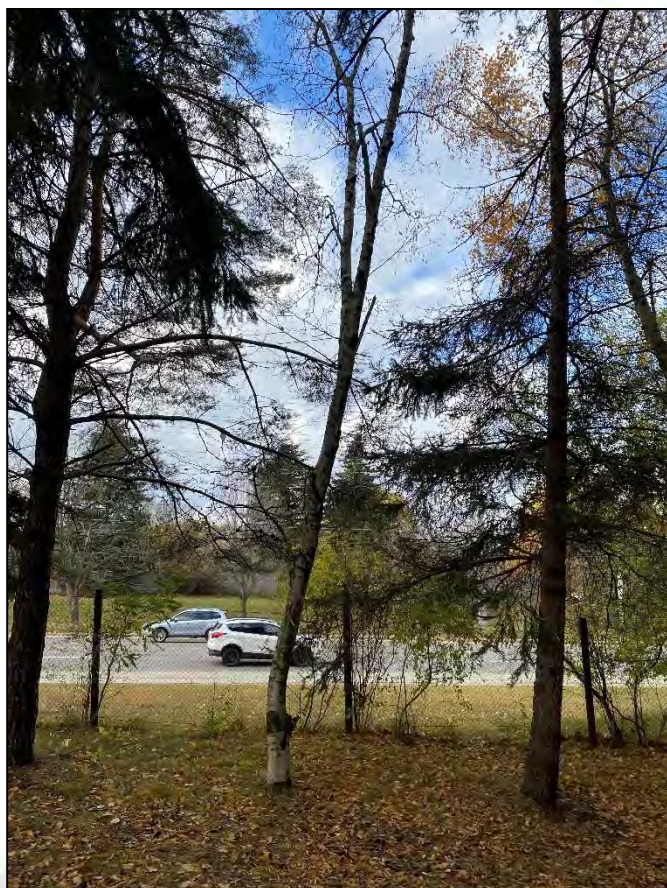
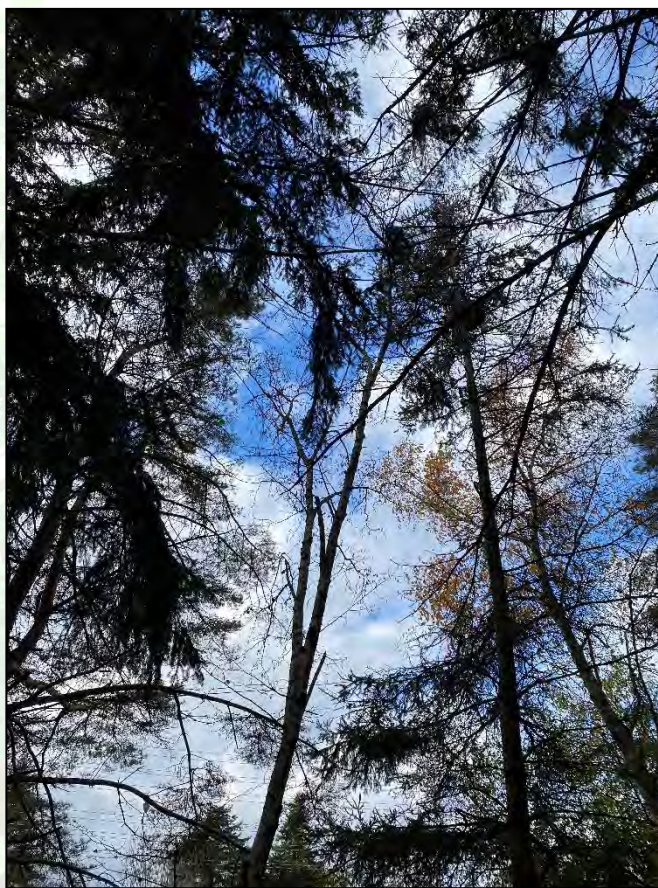
Tree #424 – Norway Spruce (24cm DBH)

Tree #424, a 24cm DBH Norway Spruce (*Picea abies*) is a privately owned evergreen tree growing in the east portion of the property. This tree has girdling roots, significant dieback and deadwood and is 70% dead. Overall this tree is in poor condition.

Due to the location that this tree is growing and the proposed construction, this tree is recommended for removal. A permit is required for the removal of this tree.

Two (2) replacement trees will require to be planted as compensation. The compensation trees should be at least 6cm diameter (deciduous), or at least 1.8m tall (evergreen). Tree species and quantities will be included in the landscape design drawings.

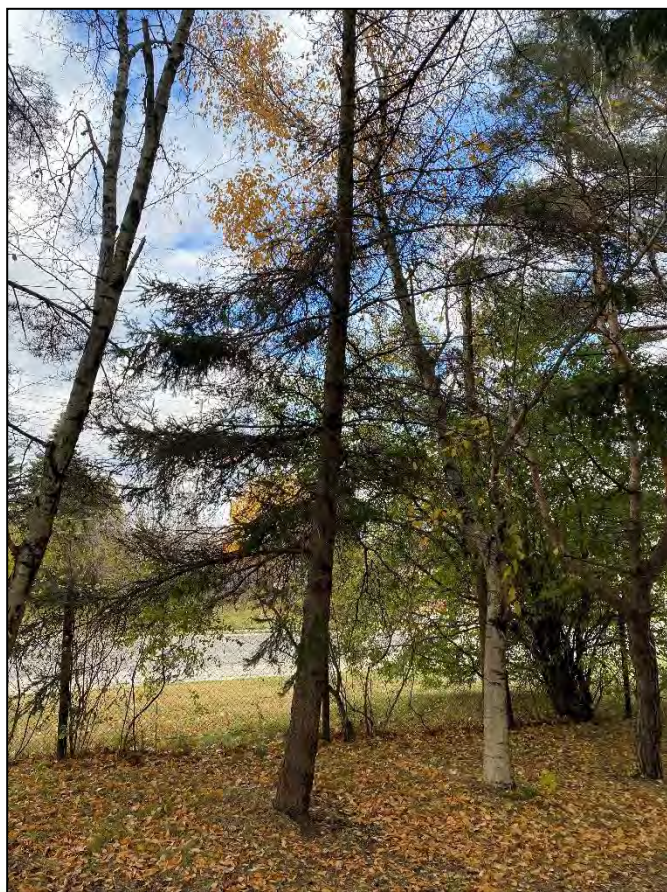
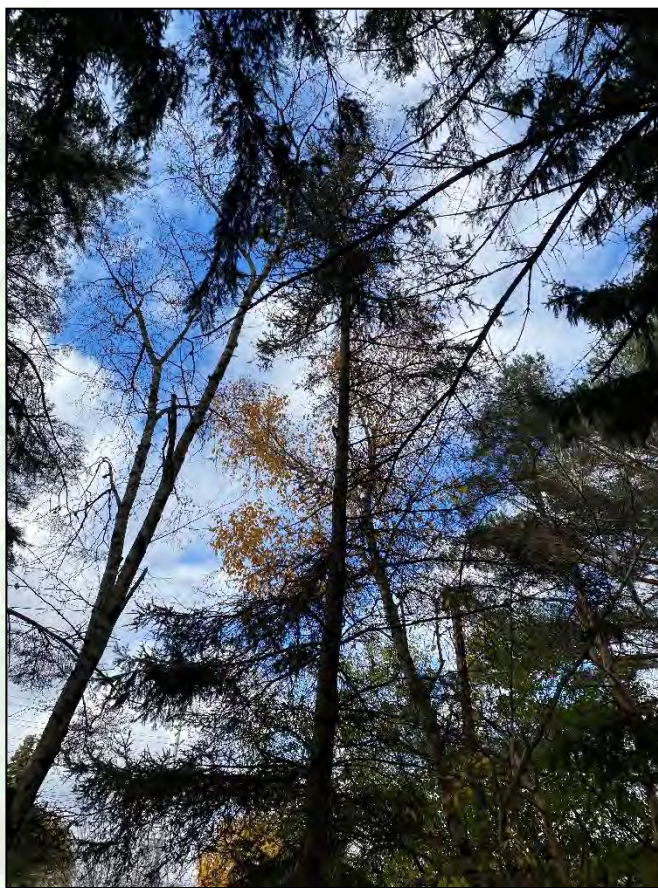
Tree #425 – White Birch (21cm DBH)

Tree #425, a 21cm DBH White Birch (*Betula papyrifera*) is a privately owned deciduous tree growing in the east portion of the property. This tree has an uneven crown, dieback and deadwood. Overall this tree is in fair condition.

Due to the location that this tree is growing and the proposed construction, this tree is recommended for removal. A permit is required for the removal of this tree.

Two (2) replacement trees will require to be planted as compensation. The compensation trees should be at least 6cm diameter (deciduous), or at least 1.8m tall (evergreen). Tree species and quantities will be included in the landscape design drawings.

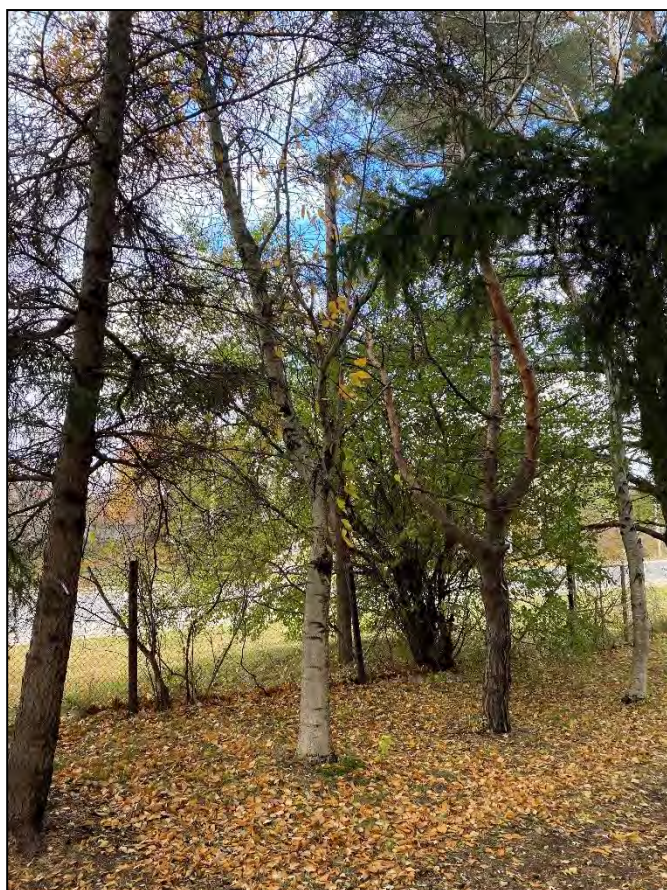
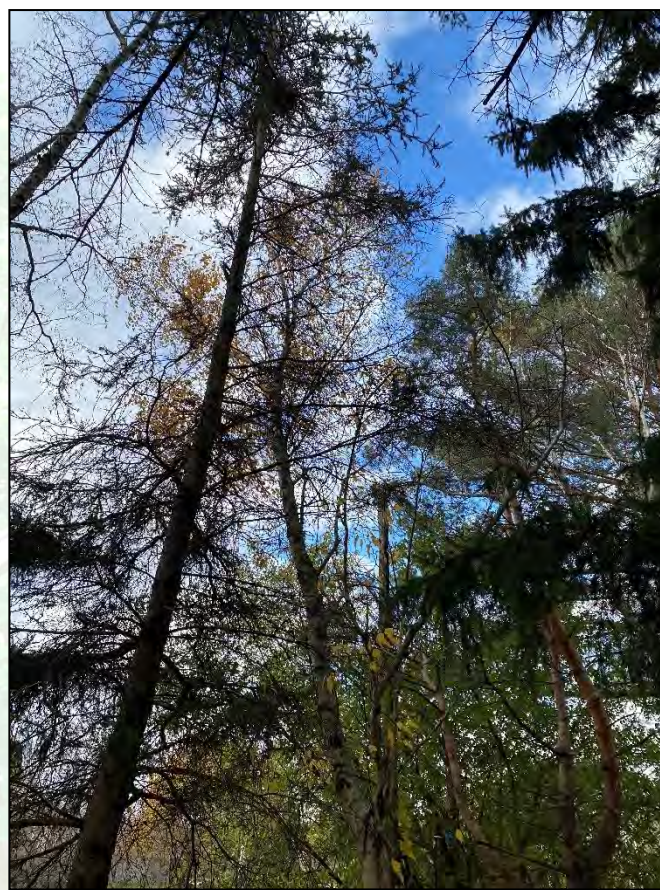
Tree #426 – Scots Pine (26cm DBH)

Tree #426, a 26cm DBH Scots Pine (*Pinus sylvestris*) is a privately owned evergreen tree growing in the east portion of the property. This tree has a bent trunk, unhealed trunk wounds, a cavity, dieback and deadwood. Overall this tree is in fair condition.

Due to the location that this tree is growing and the proposed construction, this tree is recommended for removal. A permit is required for the removal of this tree.

Two (2) replacement trees will require to be planted as compensation. The compensation trees should be at least 6cm diameter (deciduous), or at least 1.8m tall (evergreen). Tree species and quantities will be included in the landscape design drawings.

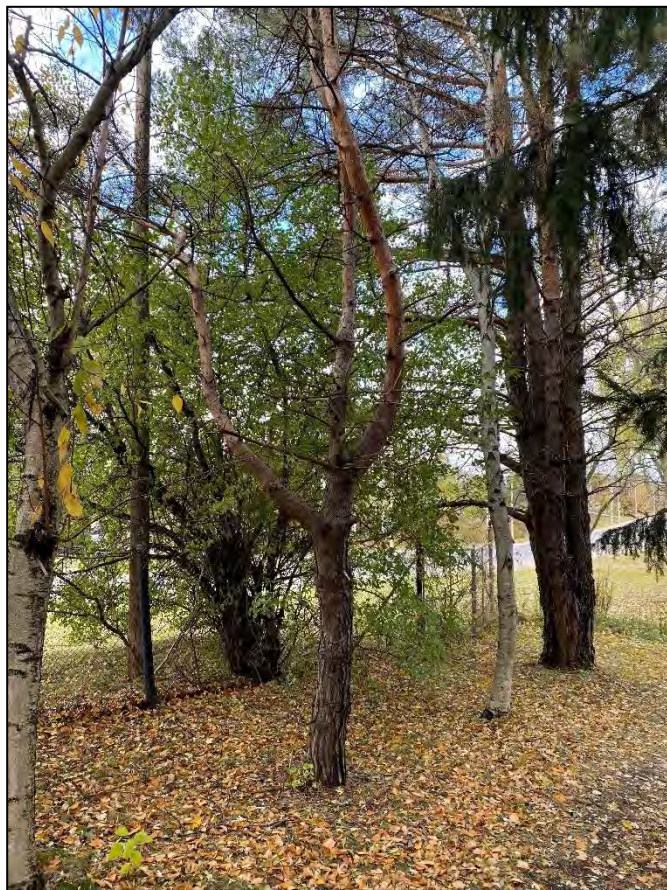
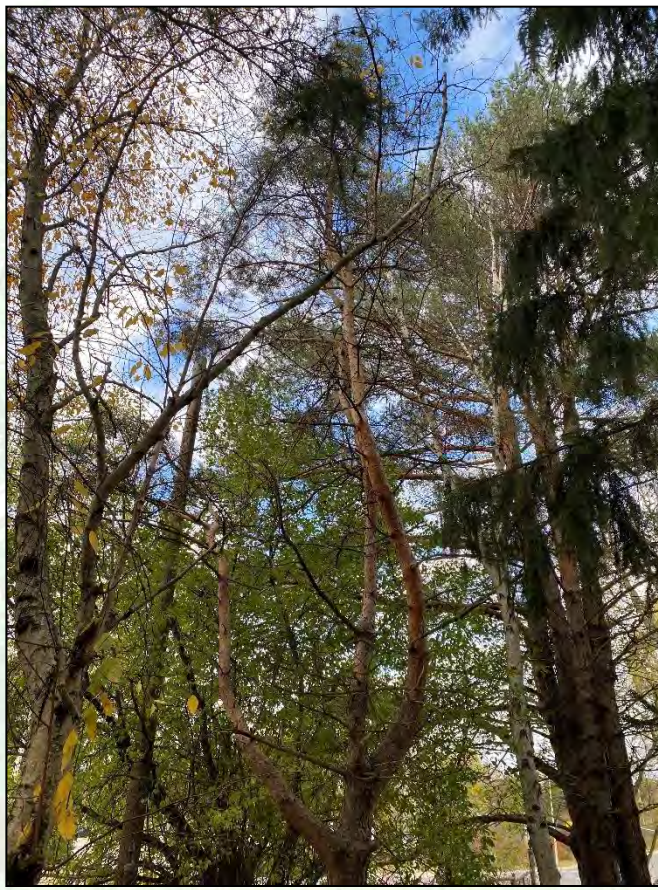
Tree #427 – Norway Spruce (50cm DBH)

Tree #427, a 50cm DBH Norway Spruce (*Picea abies*) is a privately owned evergreen tree growing in the east portion of the property. This tree has exposed roots and minor interior deadwood. Overall this tree is in good condition.

Due to the location that this tree is growing and the proposed construction, this tree is recommended for removal. A permit is required for the removal of this tree.

Three (3) replacement trees will require to be planted as compensation. The compensation trees should be at least 6cm diameter (deciduous), or at least 1.8m tall (evergreen). Tree species and quantities will be included in the landscape design drawings.

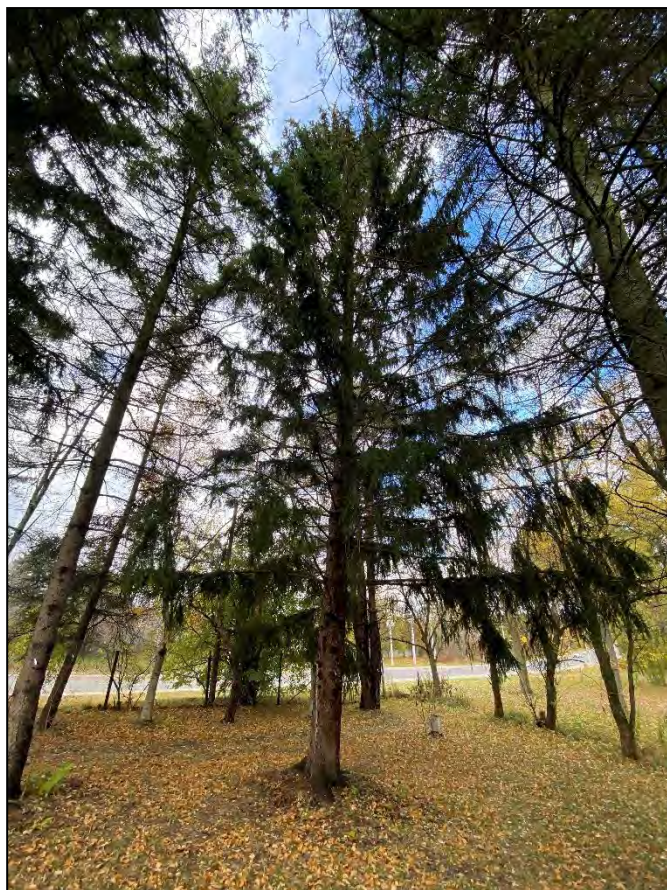
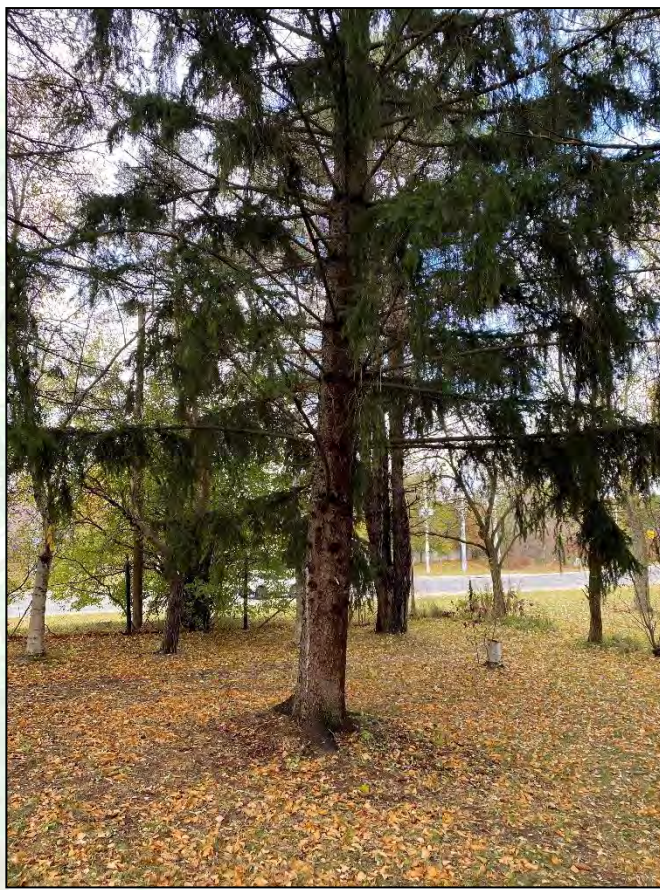
Tree #428 – White Fir (34cm DBH)

Tree #428, a 34cm DBH White Fir (*Abies concolor*) is a privately owned evergreen tree growing in the east portion of the property. This tree has significant dieback and deadwood. Overall this tree is in poor condition.

Due to the location that this tree is growing and the proposed construction, this tree is recommended for removal. A permit is required for the removal of this tree.

Two (2) replacement trees will require to be planted as compensation. The compensation trees should be at least 6cm diameter (deciduous), or at least 1.8m tall (evergreen). Tree species and quantities will be included in the landscape design drawings.

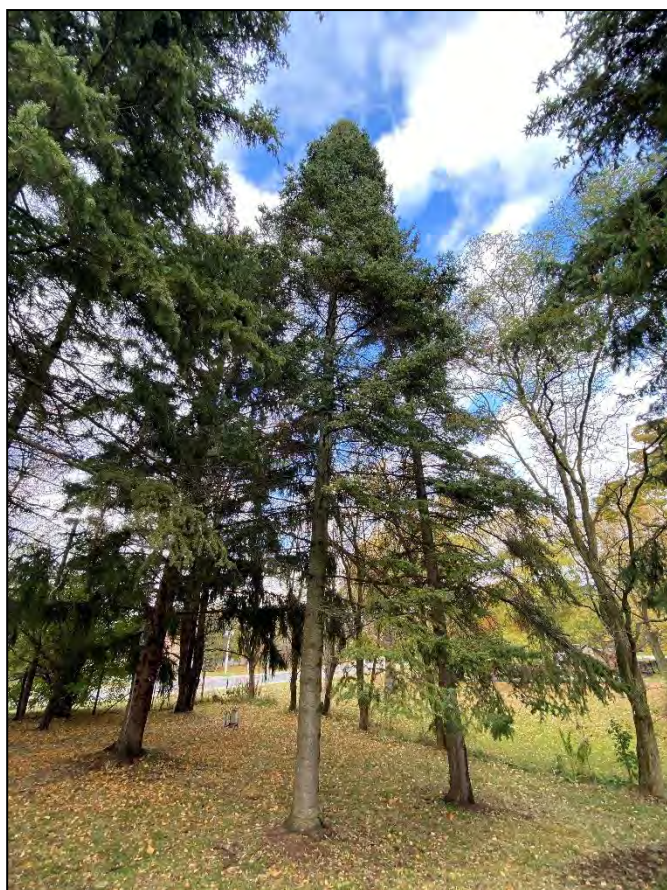
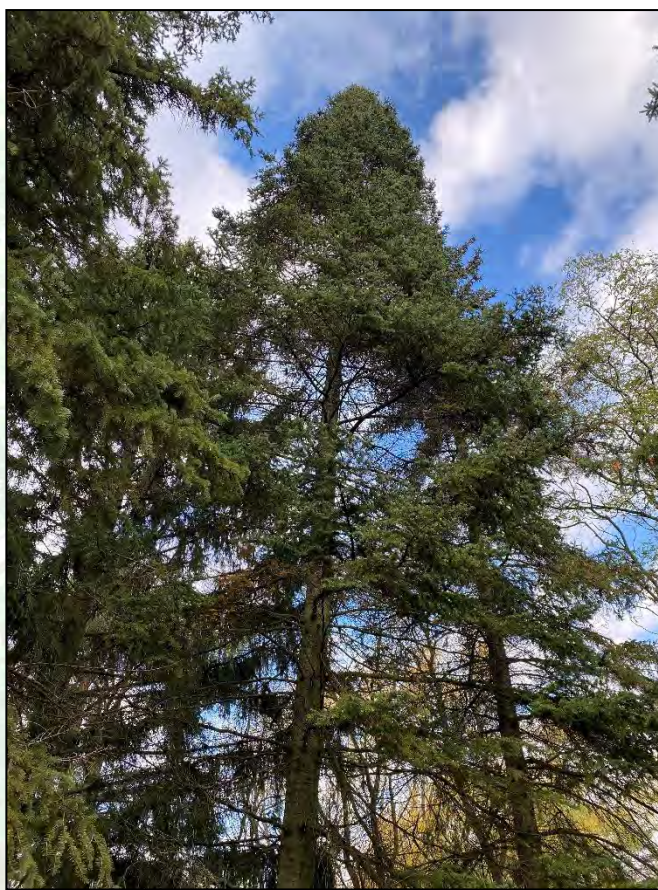
Tree #429 – White Spruce (40cm DBH)

Tree #429, a 50cm DBH White Spruce (*Picea glauca*) is a privately owned evergreen tree growing in the east portion of the property. This tree has exposed and girdling roots, unhealed pruning wounds, dieback, deadwood and has been topped. Overall this tree is in fair condition.

Due to the location that this tree is growing and the proposed construction, this tree is recommended for removal. A permit is required for the removal of this tree.

Three (3) replacement trees will require to be planted as compensation. The compensation trees should be at least 6cm diameter (deciduous), or at least 1.8m tall (evergreen). Tree species and quantities will be included in the landscape design drawings.

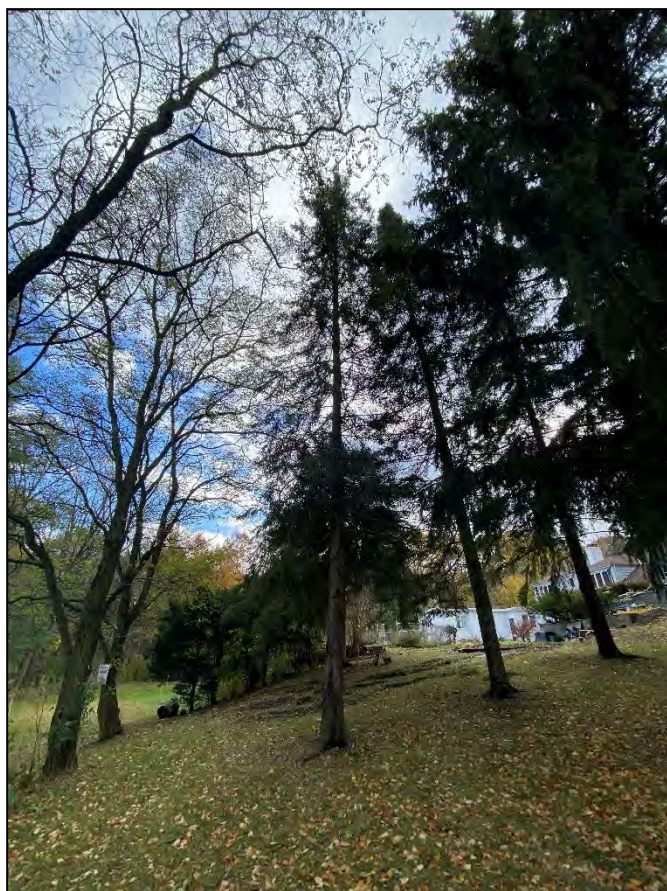
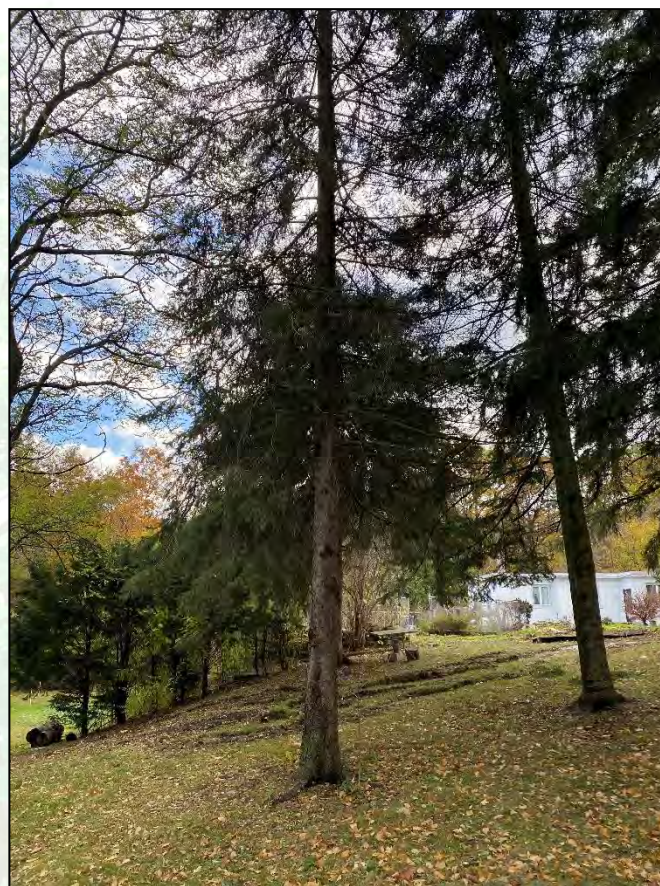
Tree #430 – Norway Spruce (34cm DBH)

Tree #430, a 34cm DBH Norway Spruce (*Picea abies*) is a privately owned evergreen tree growing in the east portion of the property. This tree has an uneven root flare, dieback, deadwood and sparse crown. Overall this tree is in good condition.

Due to the location that this tree is growing and the proposed construction, this tree is recommended for removal. A permit is required for the removal of this tree.

Two (2) replacement trees will require to be planted as compensation. The compensation trees should be at least 6cm diameter (deciduous), or at least 1.8m tall (evergreen). Tree species and quantities will be included in the landscape design drawings.

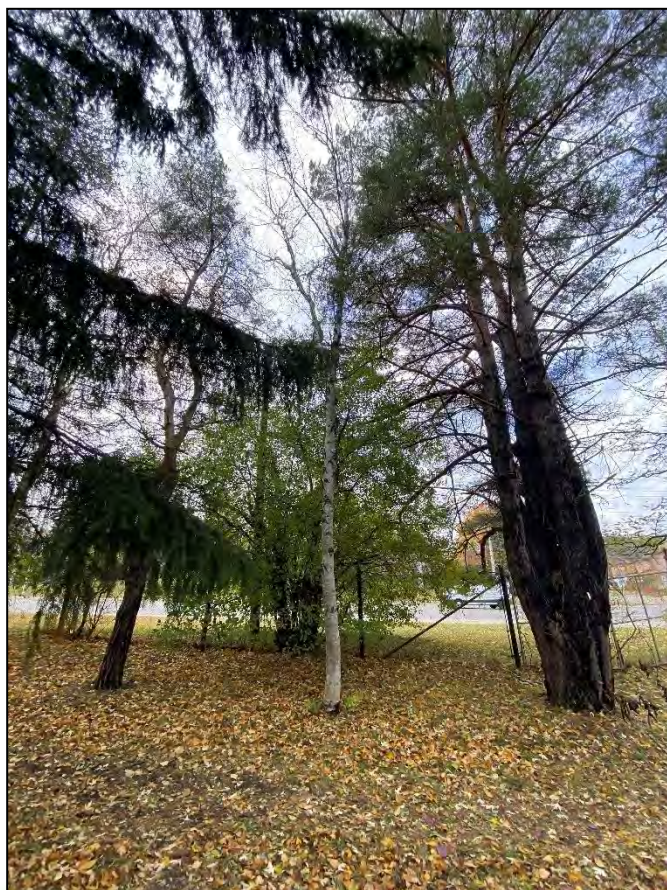
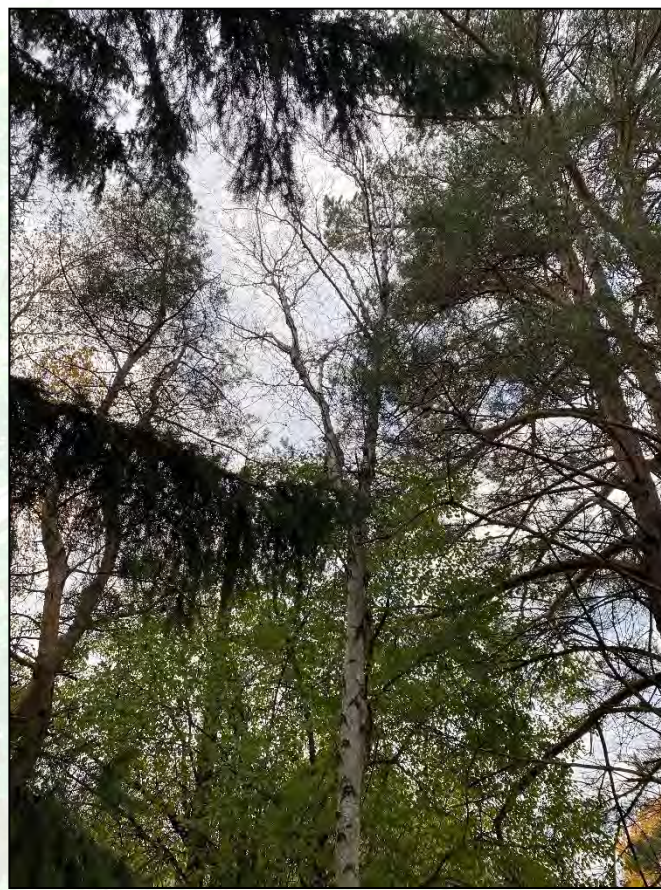
Tree #431 – White Birch (18cm DBH)

Tree #431, an 18cm DBH White Birch (*Betula papyrifera*) is a privately owned deciduous tree growing in the east portion of the property. This tree is co-dominant at 7m, has unhealed trunk wounds, dieback and deadwood. Overall this tree is in good condition.

Due to the location that this tree is growing and the proposed construction, this tree is recommended for removal. A permit is required for the removal of this tree.

One (1) replacement tree will require to be planted as compensation. The compensation trees should be at least 6cm diameter (deciduous), or at least 1.8m tall (evergreen). Tree species and quantities will be included in the landscape design drawings.

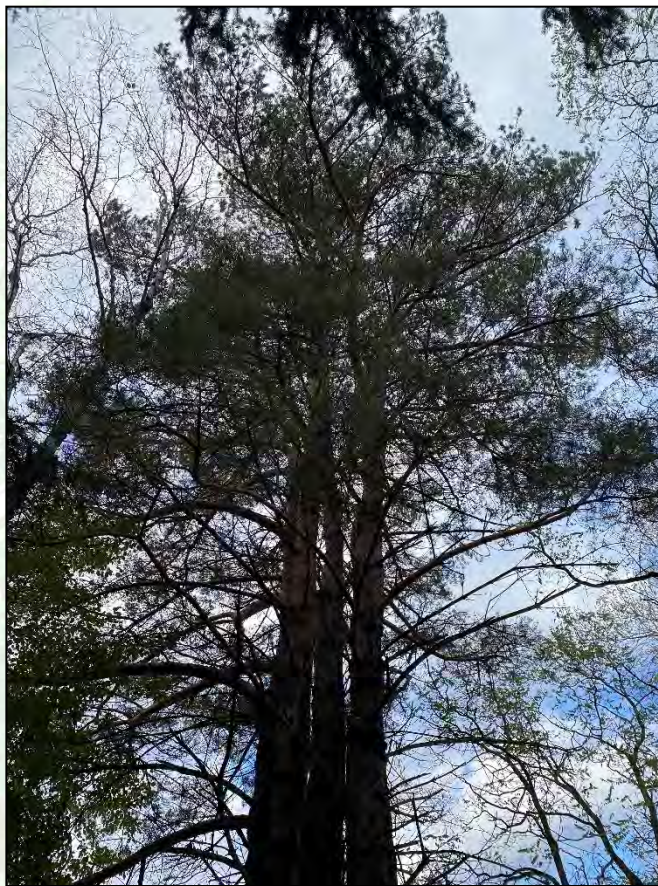
Tree #432 – Scots Pine (32,36,40,49cm DBH)

Tree #432, a 32,36,40,49cm DBH Scots Pine (*Pinus sylvestris*) is a privately owned evergreen tree growing in the east portion of the property. This tree is co-dominant at 1.5m with included bark, dieback and deadwood. Overall this tree is in good condition.

Due to the location that this tree is growing and the proposed construction, this tree is recommended for removal. A permit is required for the removal of this tree.

Four (4) replacement trees will require to be planted as compensation. The compensation trees should be at least 6cm diameter (deciduous), or at least 1.8m tall (evergreen). Tree species and quantities will be included in the landscape design drawings.

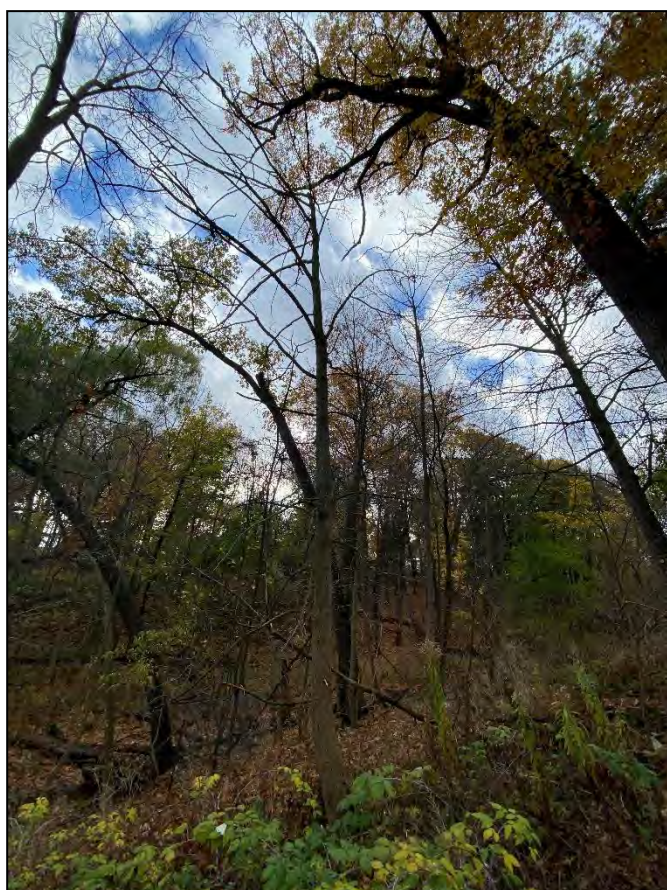
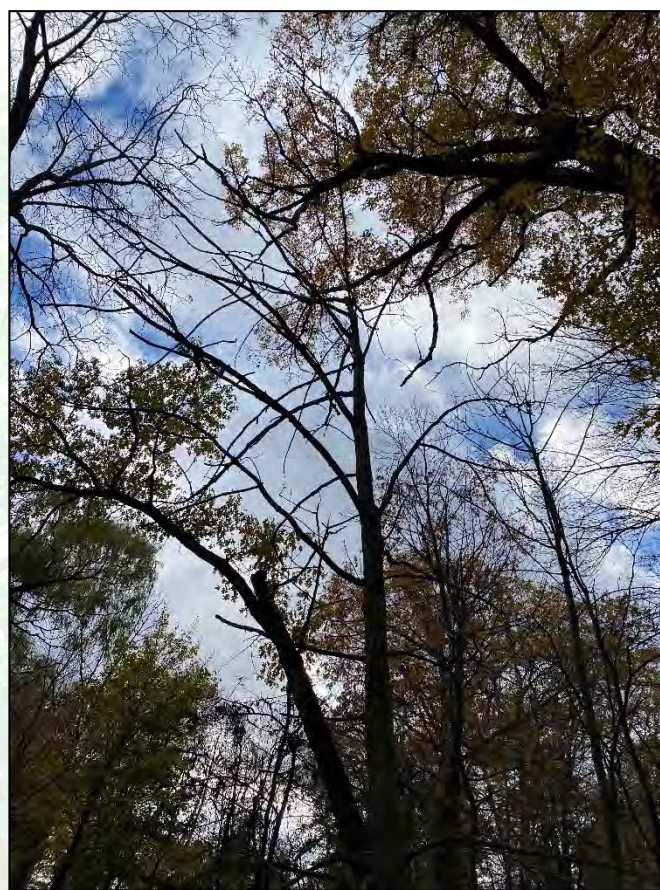
Tree #443 – Green Ash (26cm DBH)

Tree #443, a 26cm DBH Green Ash (*Fraxinus pennsylvanica*) is a privately owned deciduous tree growing in the south portion of the property. This tree has fallen over and is leaning against another tree. This hanger needs attention and should be cut to lay the tree down on grade to make it safe. Overall this tree is in poor condition.

Due to the condition of this tree, this tree is recommended for removal. A permit is required for the removal of this tree.

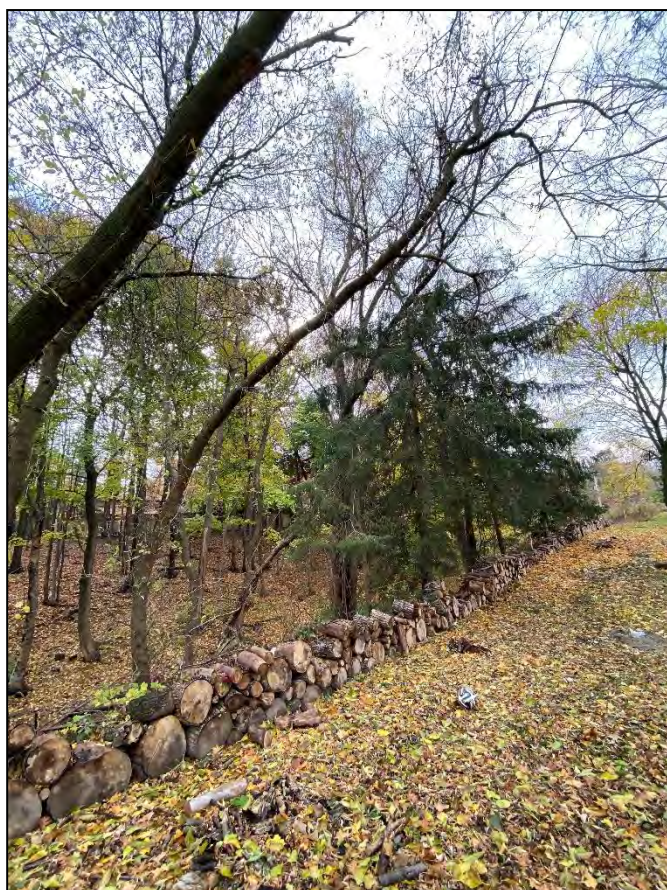
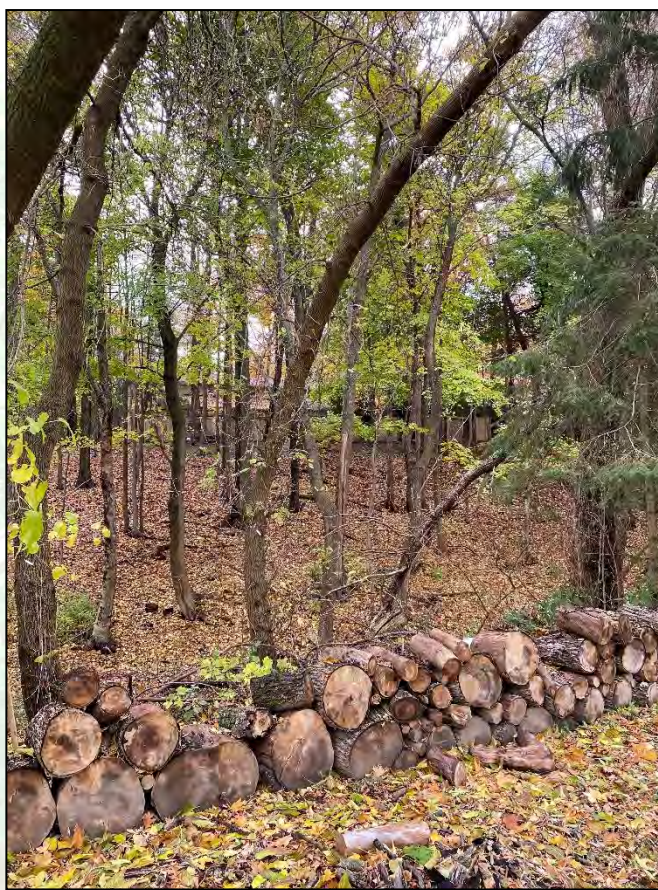
Tree #454 – Manitoba Maple (18cm DBH)

Tree #454, an 18cm DBH Manitoba Maple (*Acer negundo*) is a privately owned deciduous tree growing in the south portion of the property. This tree growing on a lean, and has girdling roots and epicormic growth. Overall this tree is in fair condition.

Due to the location that this tree is growing and the proposed construction, this tree is recommended for removal. A permit is required for the removal of this tree.

One (1) replacement trees will require to be planted as compensation. The compensation trees should be at least 6cm diameter (deciduous), or at least 1.8m tall (evergreen). Tree species and quantities will be included in the landscape design drawings.

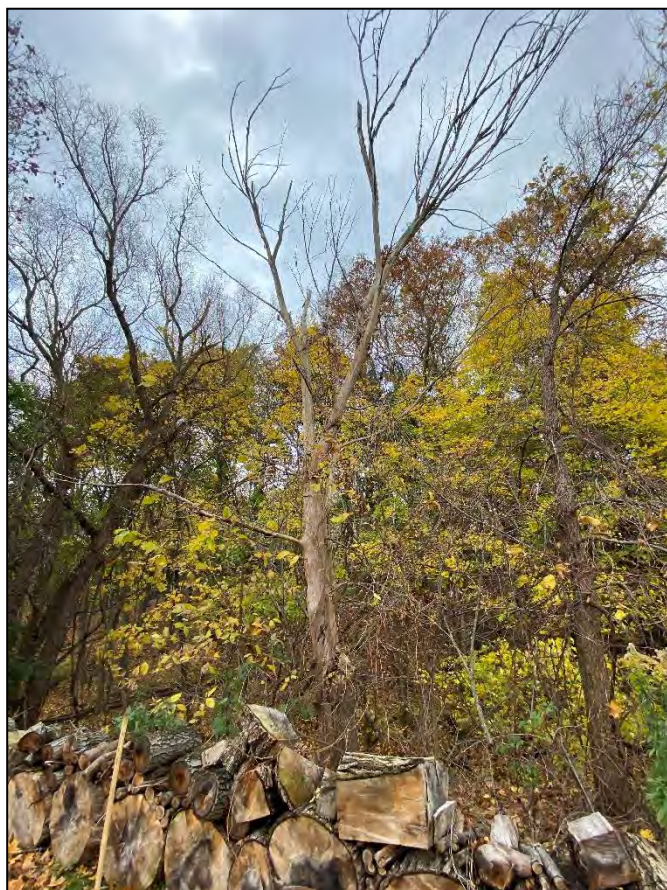
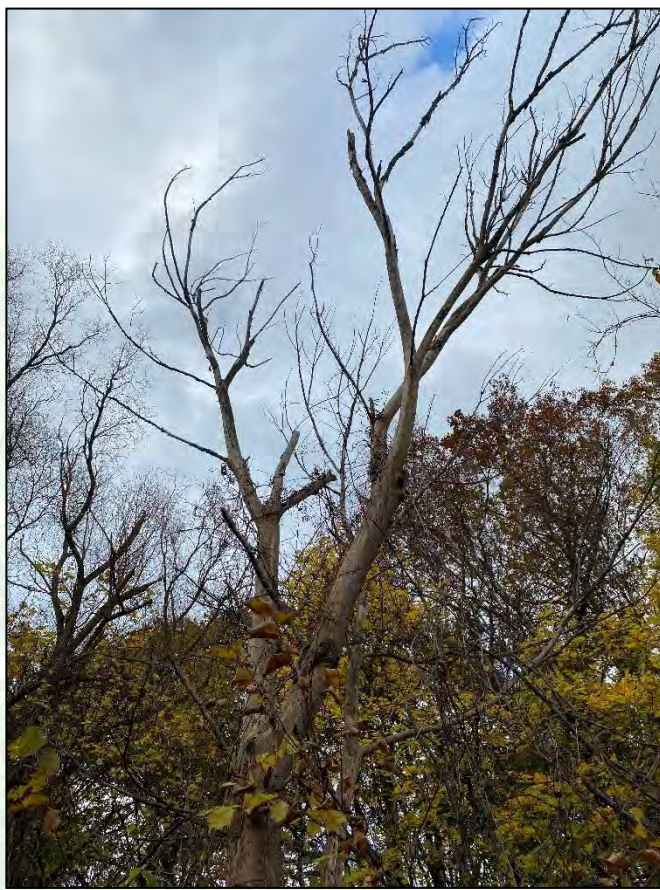
Tree #460 – American Elm (30cm DBH)

Tree #460, an 30cm DBH American Elm (*Ulmus americana*) is a privately owned deciduous tree growing in the west portion of the property. This tree dead.

Due to condition of this tree, this tree is recommended for removal. A permit is required for the removal of this tree.

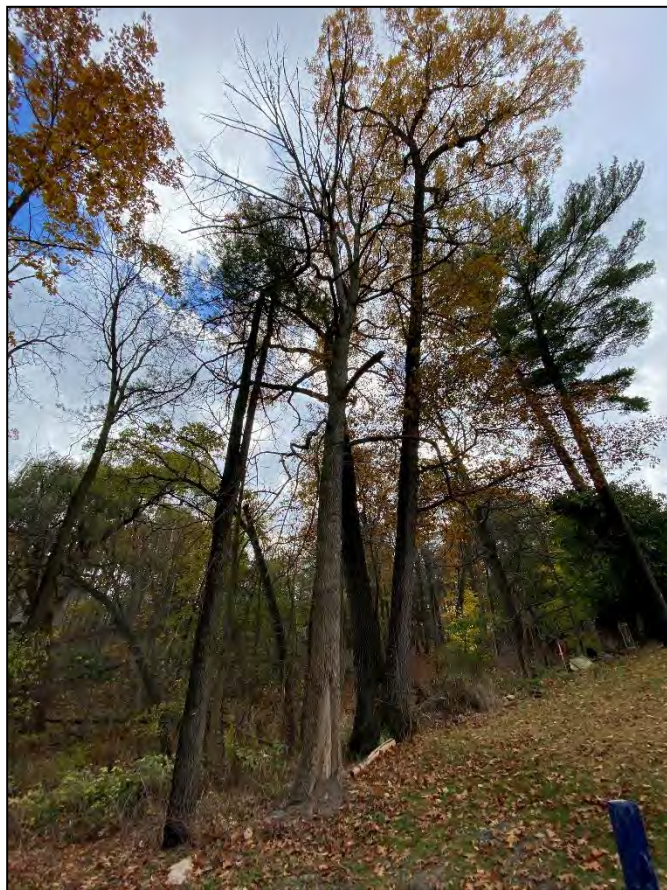
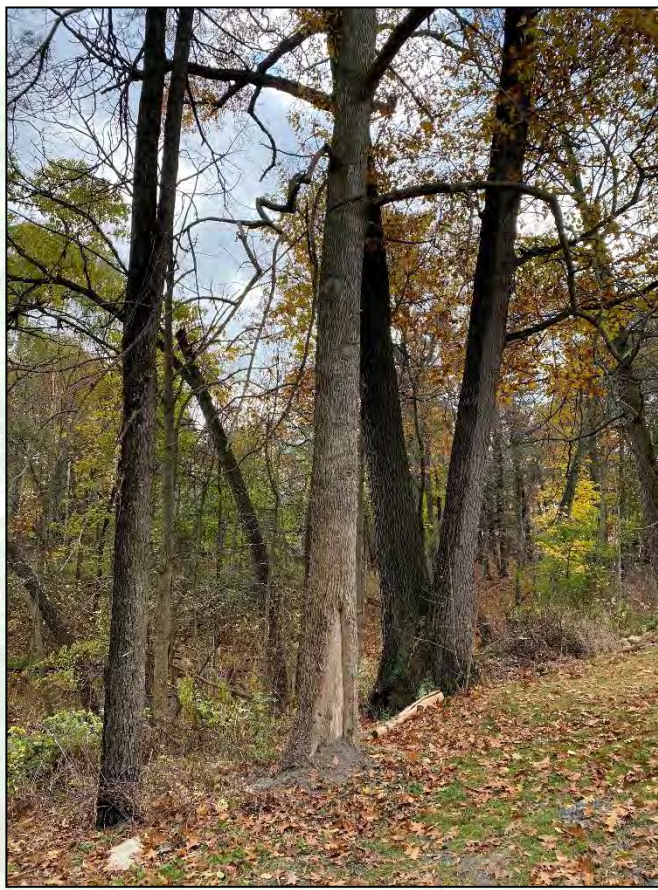
Tree #464 – Green Ash (56cm DBH)

Tree #464, a 56cm DBH American Elm (*Ulmus americana*) is a privately owned deciduous tree growing in the south portion of the property. This tree has an unhealed trunk wound at base, decay at base, and is possibly dead. Overall this tree is in poor condition.

Due to the poor condition of this tree, this tree is recommended for removal. A permit is required for the removal of this tree.

Three (3) replacement trees will require to be planted as compensation. The compensation trees should be at least 6cm diameter (deciduous), or at least 1.8m tall (evergreen). Tree species and quantities will be included in the landscape design drawings.

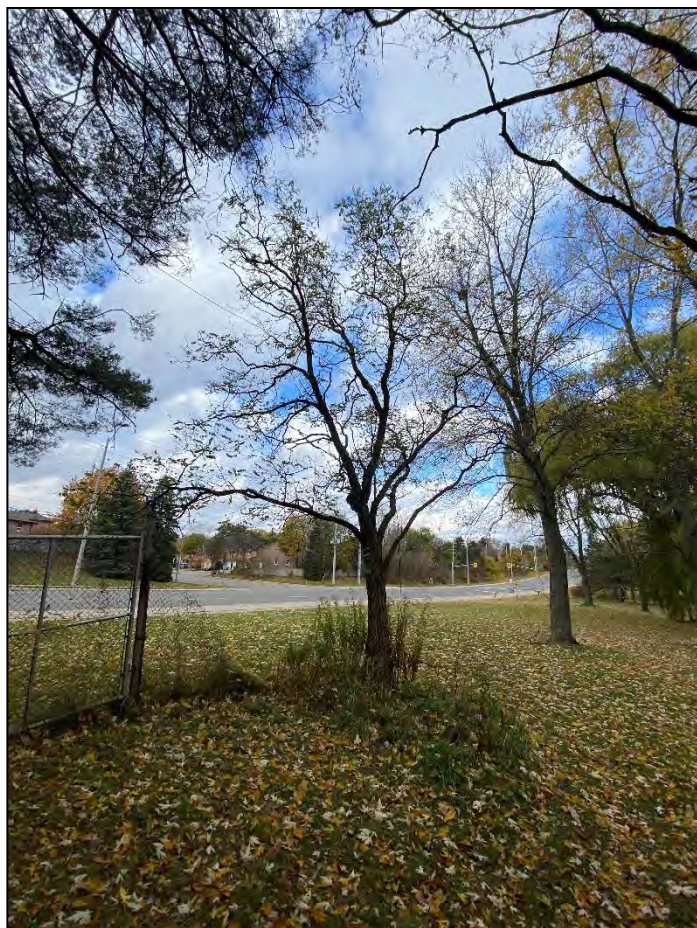
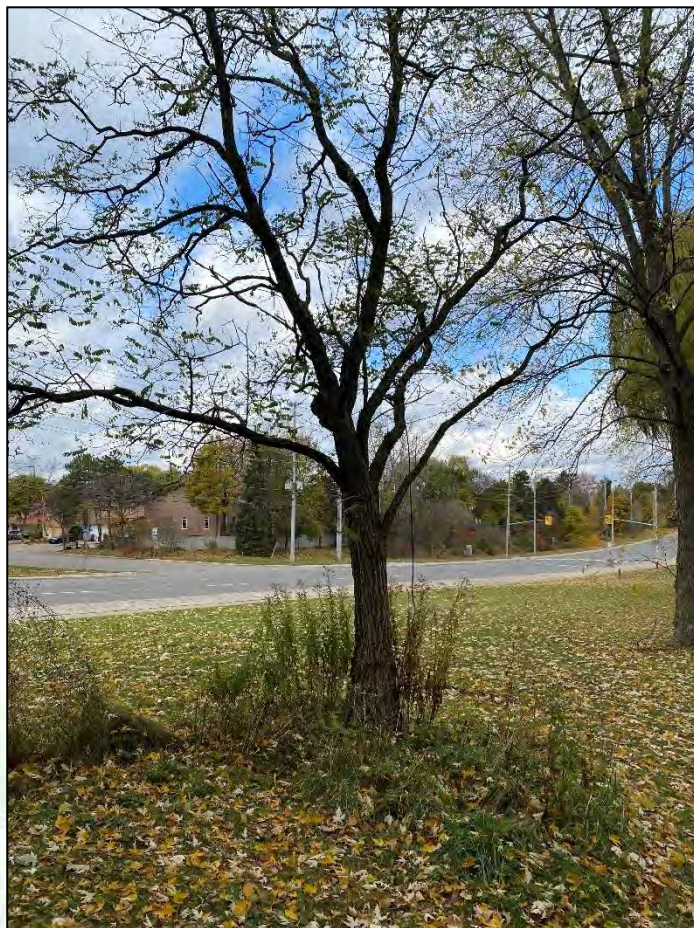
Tree #433 - PHOTOS

Tree #433, a 31cm DBH Black Locust (*Robinia pseudoacacia*) is a park owned deciduous tree growing adjacent to the east portion of the property in Richard's Memorial Park. This tree has unhealed trunk wounds, dieback and deadwood. Overall this tree is in good condition.

All work within the TPZ is to be done by hand and in the presence and under the supervision of an ISA Certified Arborist. Within the edge of the proposed sidewalk, and to mitigate tree injury, the Best Management Practice of day-lighting the tree roots using the Air Spade system is recommended. It is our preferred method to daylight roots without causing damage to the bark of the roots. The line of root exploration should be along the limits of the proposed sidewalk closest to the tree.

The root exploration trench should be 30cm wide by 90cm deep. Typically for an Air Spade excavation around tree roots, a maximum air stream pressure of 100 pounds per square inch (PSI) is utilized to minimize damage to the root bark. If a dense mat of roots is encountered, a large number of smaller feeder roots, or significant roots larger than 5cm diameter are encountered, no roots larger than 5cm in diameter are to be cut. Any root pruning required should follow ISA Best Management Practices.

The 2.4m TPZ of this tree will be protected with 1.2m high plywood tree protection hoarding with silt control on t-bar and wood frame. Tree Protection should be installed prior to any demolition or construction activities as outlined.

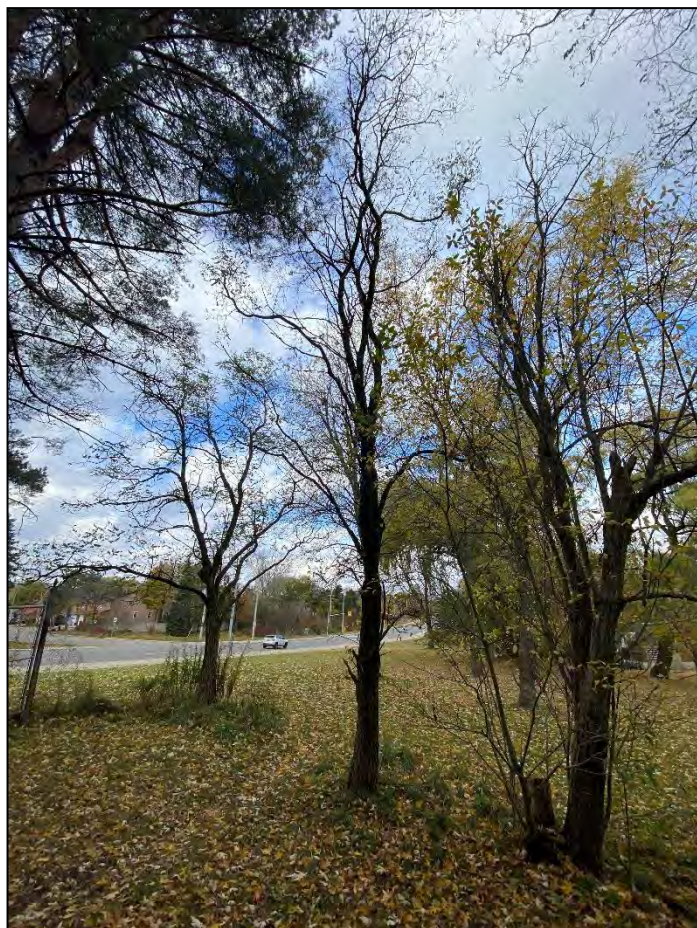
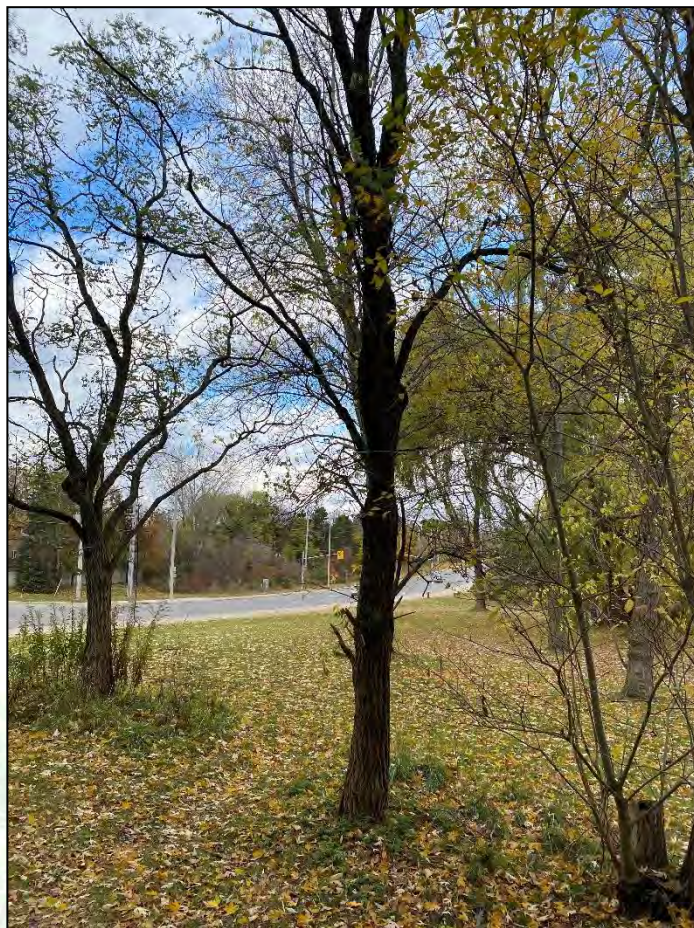
Tree #434 - PHOTOS

Tree #434, a 27cm DBH Black Locust (*Robinia pseudoacacia*) is a park owned deciduous tree growing adjacent to the east portion of the property in Richard's Memorial Park. This tree has co-dominant at 3m, has unhealed trunk wounds, dieback and deadwood. Overall this tree is in good condition.

All work within the TPZ is to be done by hand and in the presence and under the supervision of an ISA Certified Arborist. Within the edge of the proposed sidewalk, and to mitigate tree injury, the Best Management Practice of day-lighting the tree roots using the Air Spade system is recommended. It is our preferred method to daylight roots without causing damage to the bark of the roots. The line of root exploration should be along the limits of the proposed sidewalk closest to the tree.

The root exploration trench should be 30cm wide by 90cm deep. Typically for an Air Spade excavation around tree roots, a maximum air stream pressure of 100 pounds per square inch (PSI) is utilized to minimize damage to the root bark. If a dense mat of roots is encountered, a large number of smaller feeder roots, or significant roots larger than 5cm diameter are encountered, no roots larger than 5cm in diameter are to be cut. Any root pruning required should follow ISA Best Management Practices.

The 1.8m TPZ of this tree will be protected with 1.2m high plywood tree protection hoarding with silt control on t-bar and wood frame. Tree Protection should be installed prior to any demolition or construction activities as outlined.
