ARBORIST REPORT & TREE PROTECTION PLAN

900 LAKESHORE ROAD WEST
MISSISSAUGA, ON
L5H 1H9

Date: January 25, 2024

Revised: November 22, 2024

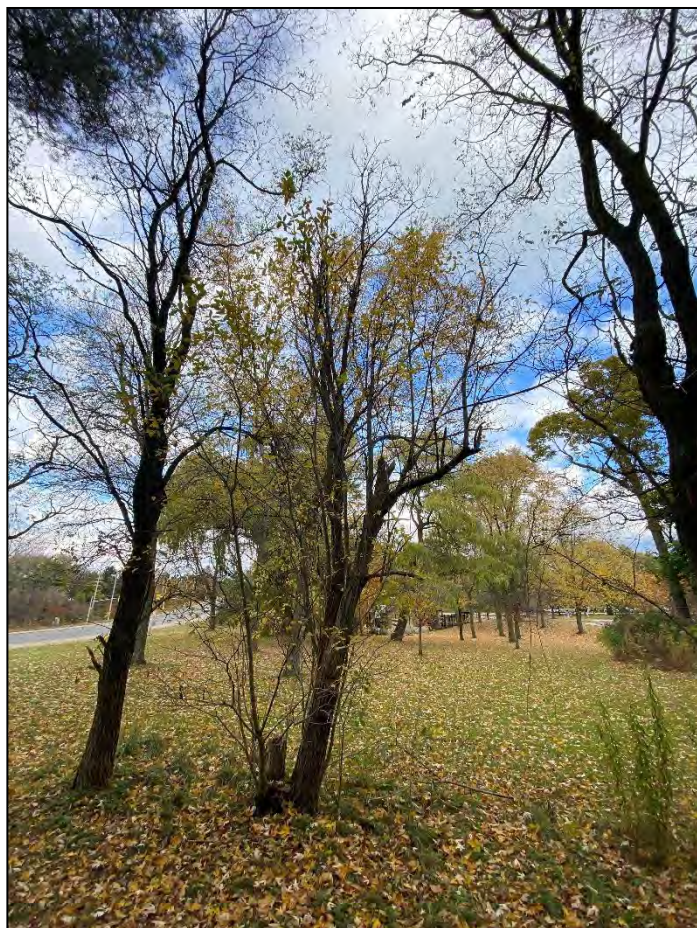
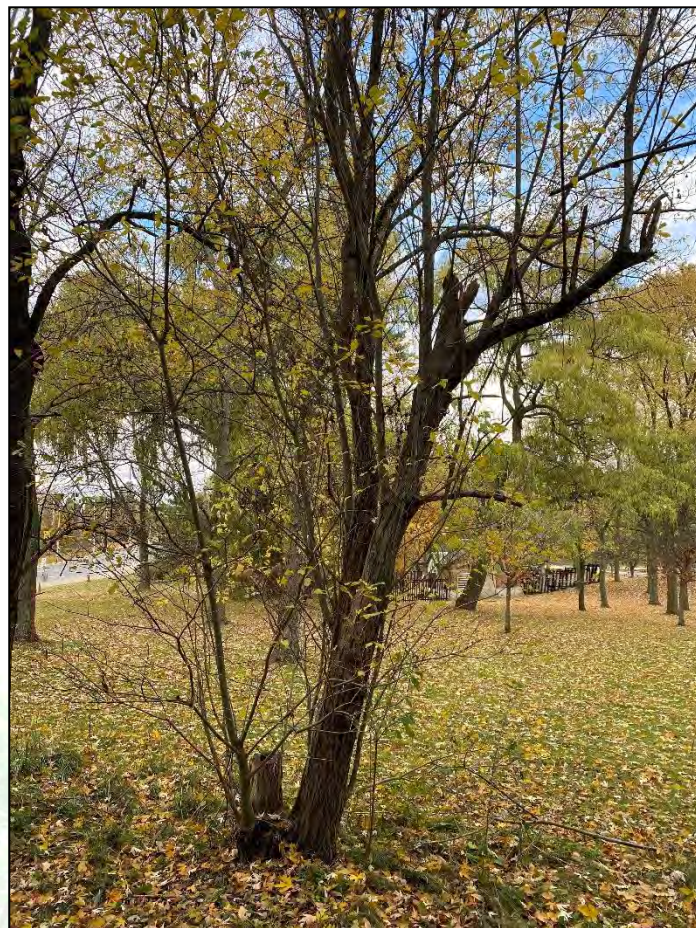
Tree #435 - PHOTOS

Tree #435, a 32cm DBH Green Ash (*Fraxinus pennsylvanica*) is a park owned deciduous tree growing adjacent to the east portion of the property in Richard's Memorial Park. This tree has sucker growth, epicormic growth, unhealed trunk wounds, and deadwood. Overall this tree is in fair condition.

All work within the TPZ is to be done by hand and in the presence and under the supervision of an ISA Certified Arborist. Within the edge of the proposed sidewalk, and to mitigate tree injury, the Best Management Practice of day-lighting the tree roots using the Air Spade system is recommended. It is our preferred method to daylight roots without causing damage to the bark of the roots. The line of root exploration should be along the limits of the proposed sidewalk closest to the tree.

The root exploration trench should be 30cm wide by 90cm deep. Typically for an Air Spade excavation around tree roots, a maximum air stream pressure of 100 pounds per square inch (PSI) is utilized to minimize damage to the root bark. If a dense mat of roots is encountered, a large number of smaller feeder roots, or significant roots larger than 5cm diameter are encountered, no roots larger than 5cm in diameter are to be cut. Any root pruning required should follow ISA Best Management Practices.

The 2.4m TPZ of this tree will be protected with 1.2m high plywood tree protection hoarding with silt control on t-bar and wood frame. Tree Protection should be installed prior to any demolition or construction activities as outlined.

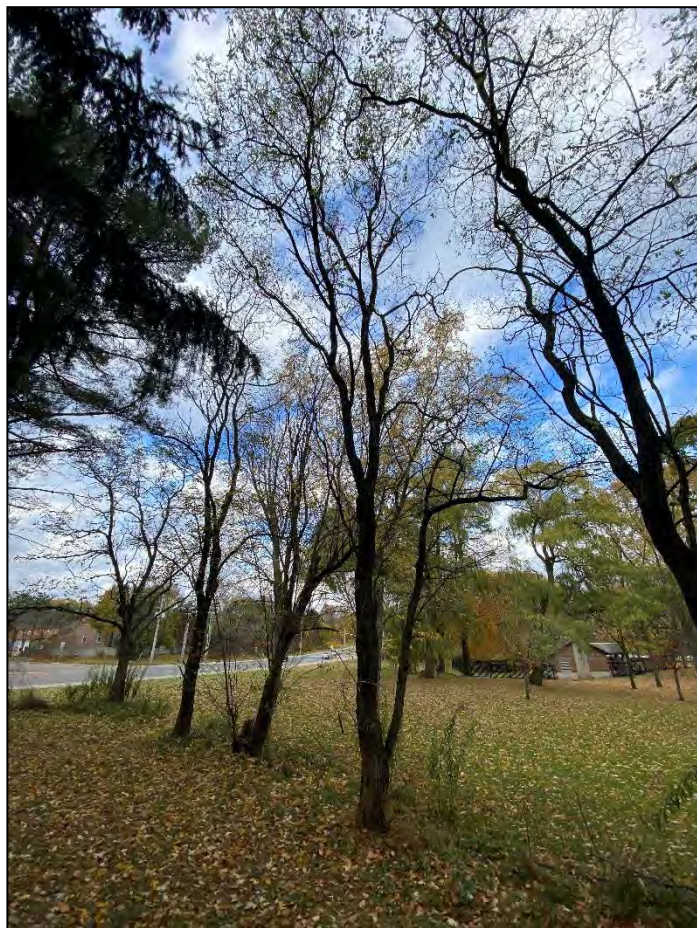
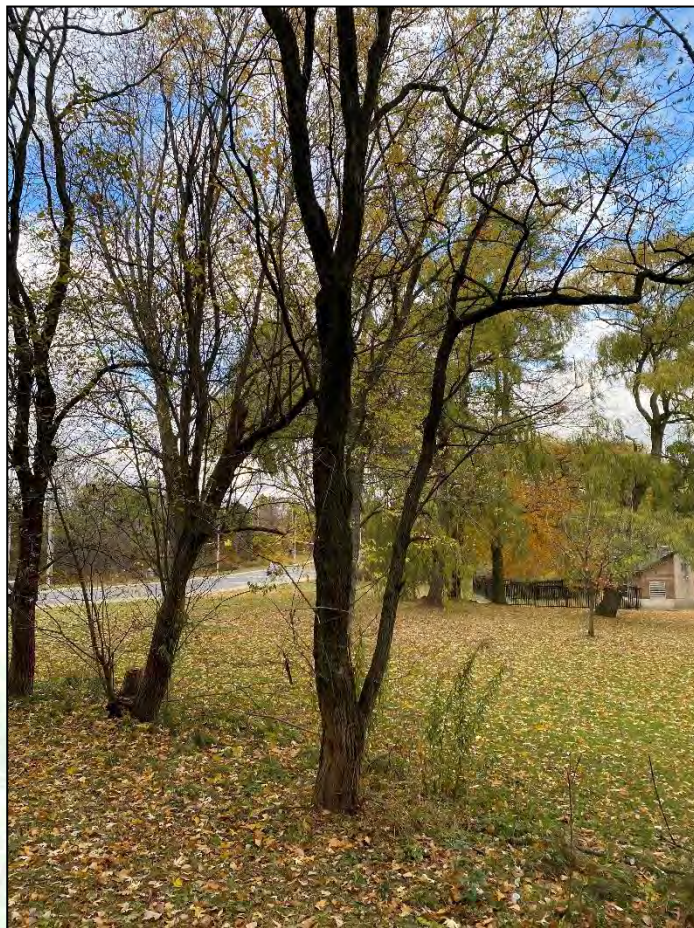
Tree #436 - PHOTOS

Tree #436, a 27cm DBH Black Locust (*Robinia pseudoacacia*) is a park owned deciduous tree growing adjacent to the east portion of the property in Richard's Memorial Park. This tree is co-dominant at 7m, has unhealed trunk wounds, epicormic growth, dieback and deadwood. Overall this tree is in good condition.

All work within the TPZ is to be done by hand and in the presence and under the supervision of an ISA Certified Arborist. Within the edge of the proposed sidewalk, and to mitigate tree injury, the Best Management Practice of day-lighting the tree roots using the Air Spade system is recommended. It is our preferred method to daylight roots without causing damage to the bark of the roots. The line of root exploration should be along the limits of the proposed sidewalk closest to the tree.

The root exploration trench should be 30cm wide by 90cm deep. Typically for an Air Spade excavation around tree roots, a maximum air stream pressure of 100 pounds per square inch (PSI) is utilized to minimize damage to the root bark. If a dense mat of roots is encountered, a large number of smaller feeder roots, or significant roots larger than 5cm diameter are encountered, no roots larger than 5cm in diameter are to be cut. Any root pruning required should follow ISA Best Management Practices.

The 1.8m TPZ of this tree will be protected with 1.2m high plywood tree protection hoarding with silt control on t-bar and wood frame. Tree Protection should be installed prior to any demolition or construction activities as outlined.

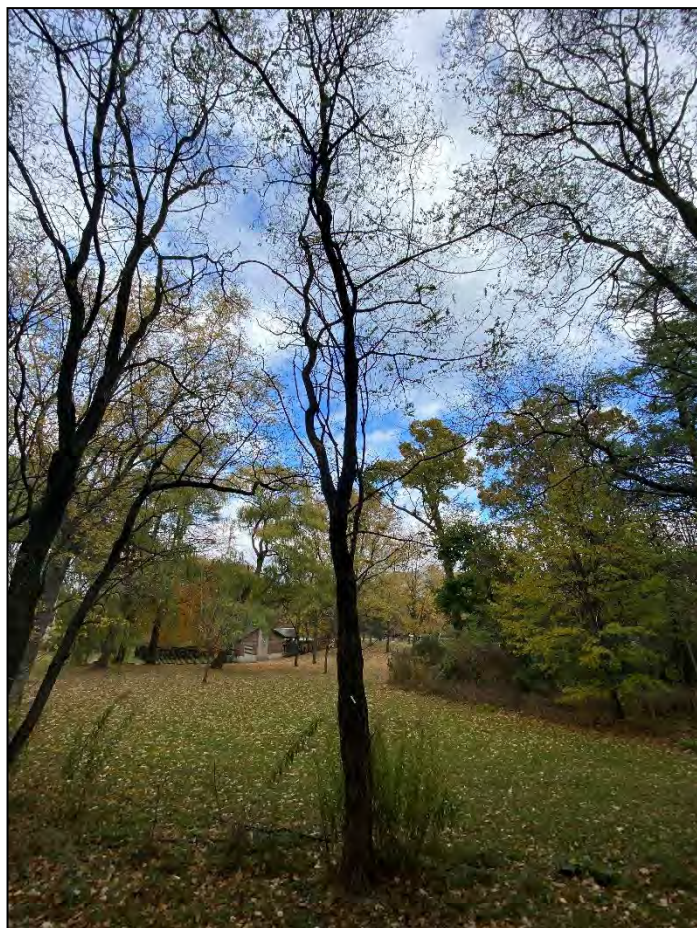
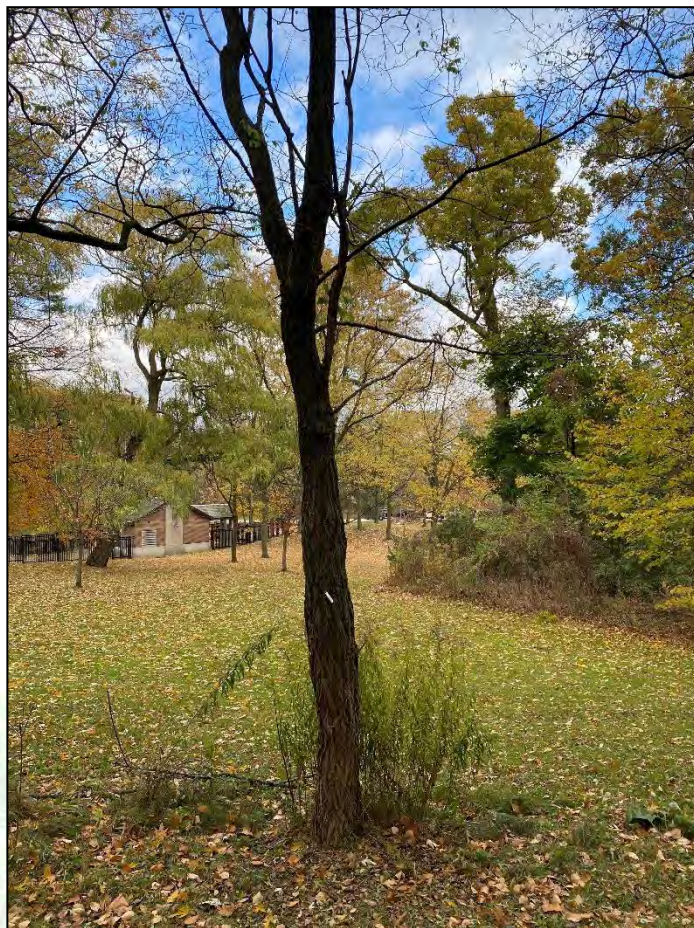
Tree #437 - PHOTOS

Tree #437, a 29cm DBH Black Locust (*Robinia pseudoacacia*) is a park owned deciduous tree growing adjacent to the east portion of the property in Richard's Memorial Park. This tree is co-dominant at 6m, has unhealed trunk wounds, dieback and deadwood. Overall this tree is in good condition.

All work within the TPZ is to be done by hand and in the presence and under the supervision of an ISA Certified Arborist. Within the edge of the proposed sidewalk, and to mitigate tree injury, the Best Management Practice of day-lighting the tree roots using the Air Spade system is recommended. It is our preferred method to daylight roots without causing damage to the bark of the roots. The line of root exploration should be along the limits of the proposed sidewalk closest to the tree.

The root exploration trench should be 30cm wide by 90cm deep. Typically for an Air Spade excavation around tree roots, a maximum air stream pressure of 100 pounds per square inch (PSI) is utilized to minimize damage to the root bark. If a dense mat of roots is encountered, a large number of smaller feeder roots, or significant roots larger than 5cm diameter are encountered, no roots larger than 5cm in diameter are to be cut. Any root pruning required should follow ISA Best Management Practices.

The 1.8m TPZ of this tree will be protected with 1.2m high plywood tree protection hoarding with silt control on t-bar and wood frame. Tree Protection should be installed prior to any demolition or construction activities as outlined.

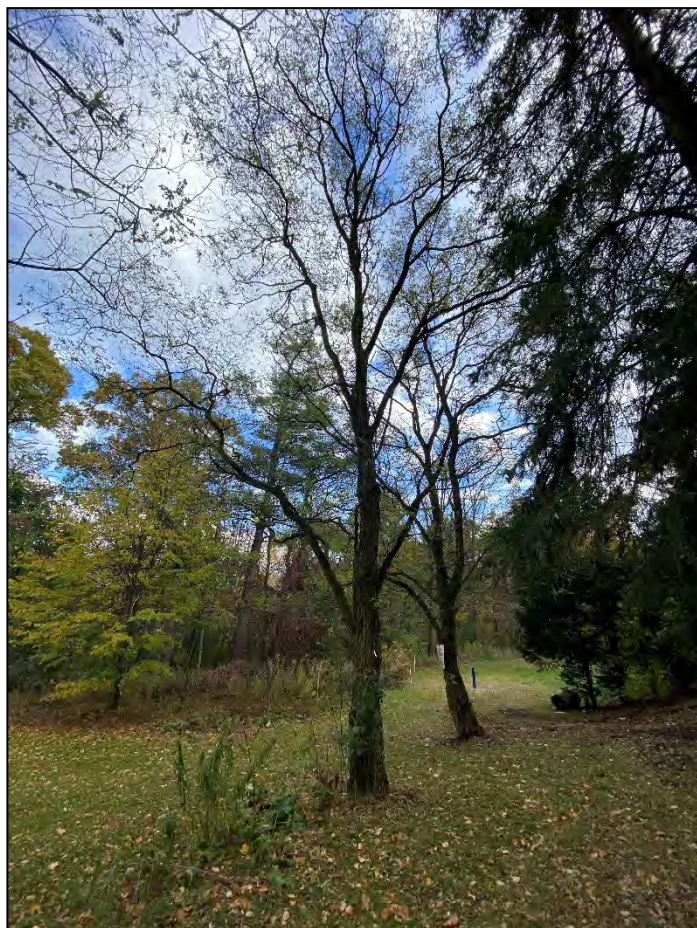
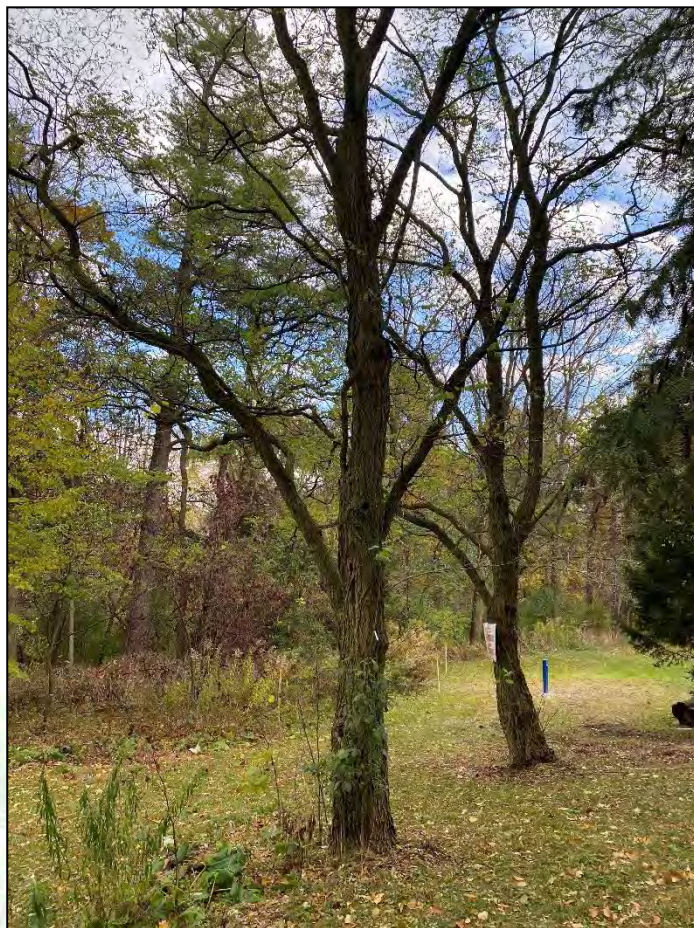
Tree #438 - PHOTOS

Tree #438, a 37cm DBH Black Locust (*Robinia pseudoacacia*) is a park owned deciduous tree growing adjacent to the east portion of the property in Richard's Memorial Park. This tree has unhealed trunk wounds, dieback and deadwood. Overall this tree is in good condition.

All work within the TPZ is to be done by hand and in the presence and under the supervision of an ISA Certified Arborist. Within the edge of the proposed sidewalk, and to mitigate tree injury, the Best Management Practice of day-lighting the tree roots using the Air Spade system is recommended. It is our preferred method to daylight roots without causing damage to the bark of the roots. The line of root exploration should be along the limits of the proposed sidewalk closest to the tree.

The root exploration trench should be 30cm wide by 90cm deep. Typically for an Air Spade excavation around tree roots, a maximum air stream pressure of 100 pounds per square inch (PSI) is utilized to minimize damage to the root bark. If a dense mat of roots is encountered, a large number of smaller feeder roots, or significant roots larger than 5cm diameter are encountered, no roots larger than 5cm in diameter are to be cut. Any root pruning required should follow ISA Best Management Practices.

The 2.4m TPZ of this tree will be protected with 1.2m high plywood tree protection hoarding with silt control on t-bar and wood frame. Tree Protection should be installed prior to any demolition or construction activities as outlined.

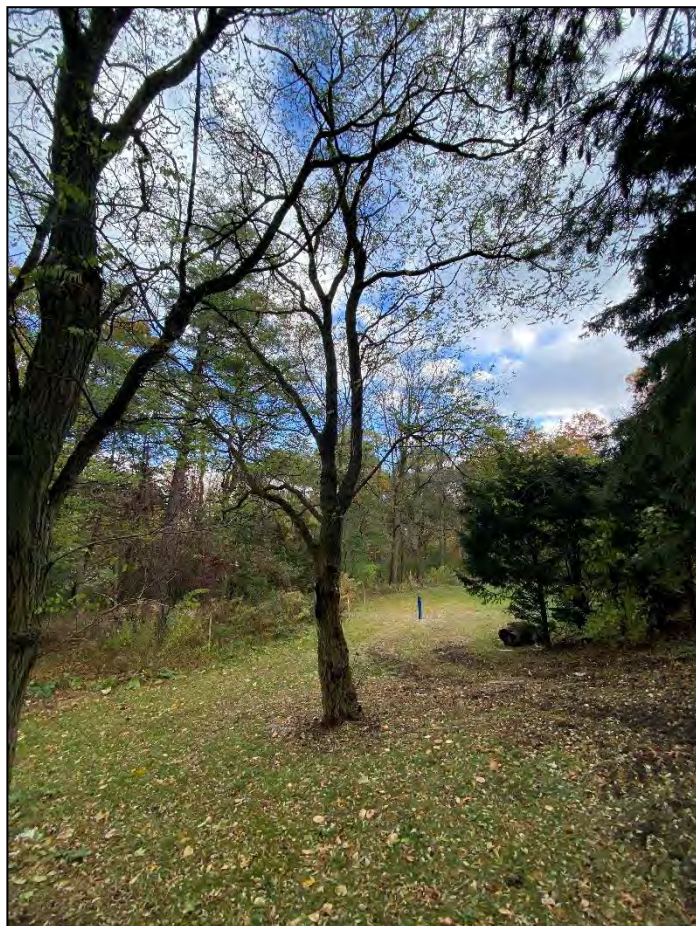
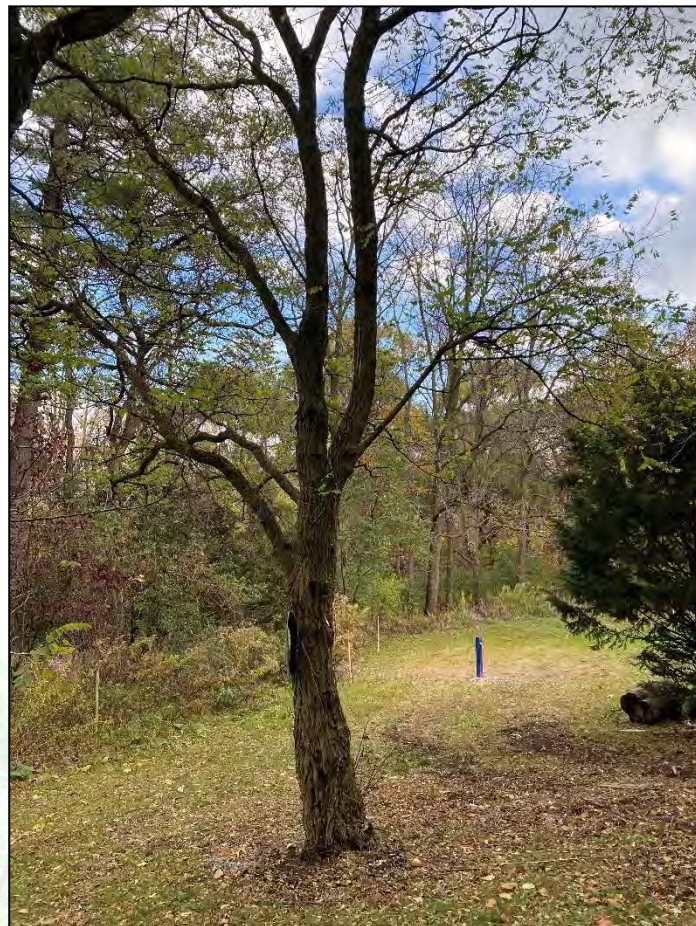
Tree #439 - PHOTOS

Tree #439, a 32cm DBH Black Locust (*Robinia pseudoacacia*) is a park owned deciduous tree growing adjacent to the east portion of the property in Richard's Memorial Park. This tree is co-dominant at 4m, has unhealed trunk wounds, dieback and deadwood. Overall this tree is in good condition.

The 2.4m TPZ of this tree will be protected with 1.2m high plywood tree protection hoarding with silt control on t-bar and wood frame. Tree Protection should be installed prior to any demolition or construction activities as outlined.
