## **ARBORIST REPORT**

### **PROPOSED MIXED-USE HIGH-RISE DEVELOPMENT 2555 ERIN CENTRE BOULEVARD, MISSISSAUGA**

**November 18, 2024**

**Revised December 17, 2024**

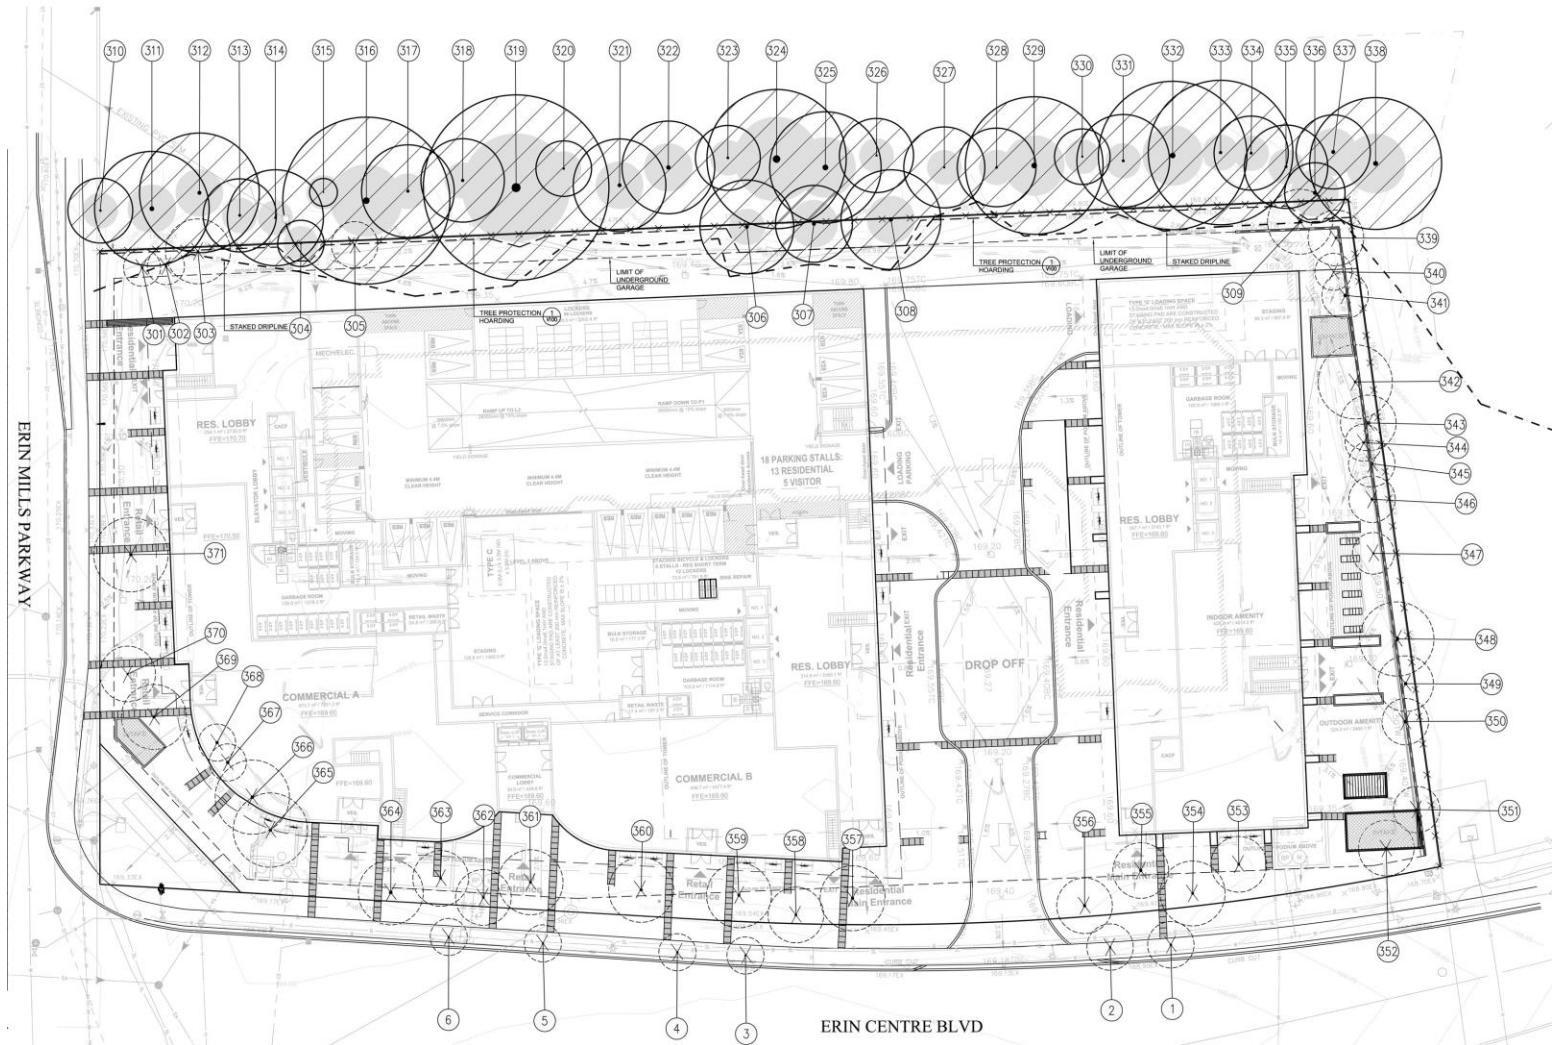
**APPENDIX A – CONTEXTUAL TREE INVENTORY & PRESERVATION PLAN (for context only)**

The proposal for this property will see the construction of a new, mixed-use, high-rise development with underground parking facilities. Based on the required site plan, servicing, grading and construction works, forty-four (44) trees, subject to the Private Tree Bylaw require removal. This includes the existing boulevard trees along Erin Centre Drive which are all in poor condition. Based on the City's compensation requirements, a total of seventy-four (74) compensation trees are required. All trees associated with the adjacent woodlands will be preserved and protected throughout the development process. In addition, a robust edge management planting plan is proposed for the north limit which will enhance the woodlot edge and provide for compensation plantings.

City approved tree protection hoarding is to be installed at the minimum TPZ limits for all neighbouring woodland trees to be preserved as noted on the Tree Inventory & Preservation Plans.
