# ARBORIST REPORT & TREE PROTECTION PLAN

**900 LAKESHORE ROAD WEST**  
MISSISSAUGA, ON  
L5H 1H9

Date: January 25, 2024

Revised: January 30, 2026

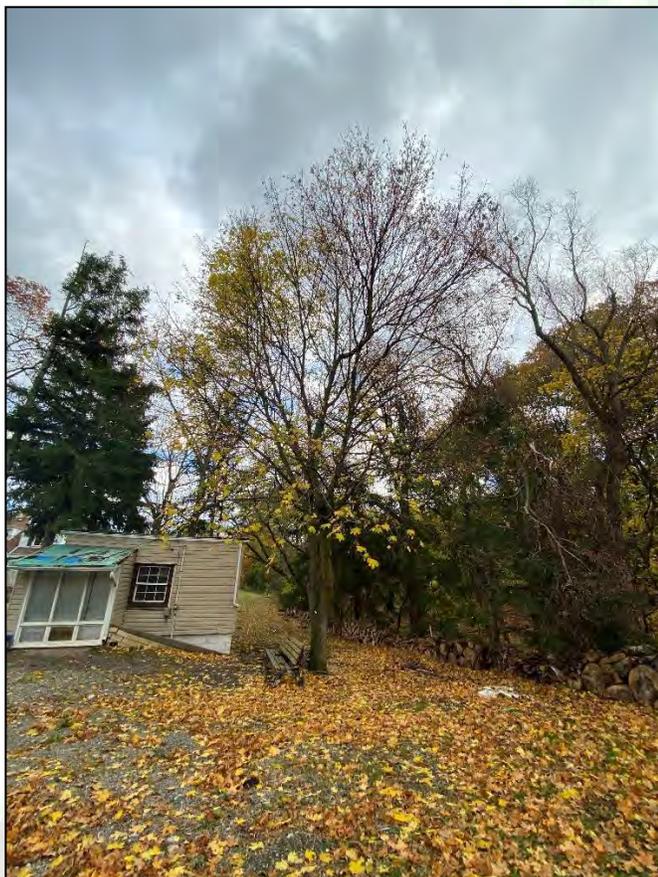
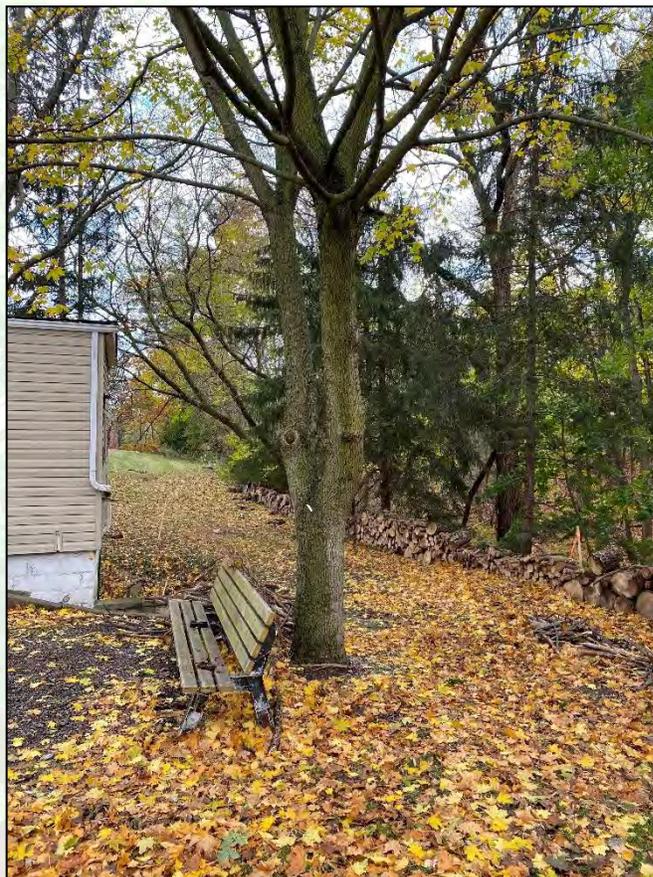
Tree #388, a 46cm DBH Norway Maple (*Acer platanoides*) is a privately owned deciduous tree growing in the west portion of the property. This tree has exposed and girdling roots, is co-dominant at 1.7m with included bark, and has dieback. Overall this tree is in good condition.

Due to the location that this tree is growing and the proposed construction, this tree is recommended for removal. A permit is required for the removal of this tree.

Three (3) replacement trees will require to be planted as compensation. The compensation trees should be at least 6cm diameter (deciduous), or at least 1.8m tall (evergreen). Tree species and quantities will be included in the landscape design drawings.

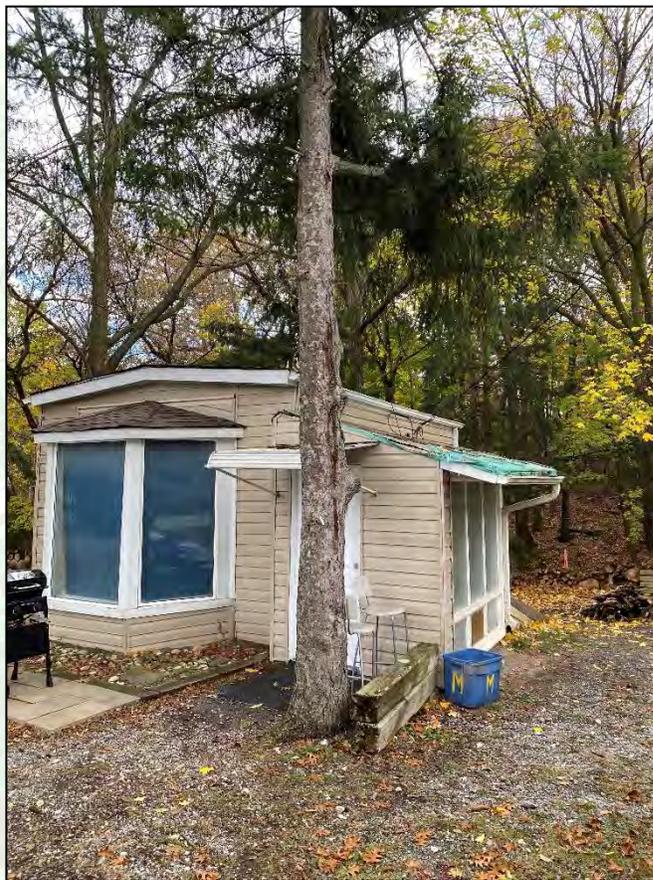
### Tree #389 – Norway Spruce (34cm DBH)

Tree #389, a 34cm DBH Norway Spruce (*Picea abies*) is a privately owned evergreen tree growing in the west portion of the property. This tree has an uneven crown, unhealed trunk wounds, dieback and deadwood. Overall this tree is in fair condition.

Due to the location that this tree is growing and the proposed construction, this tree is recommended for removal. A permit is required for the removal of this tree.

Two (2) replacement trees will require to be planted as compensation. The compensation trees should be at least 6cm diameter (deciduous), or at least 1.8m tall (evergreen). Tree species and quantities will be included in the landscape design drawings.

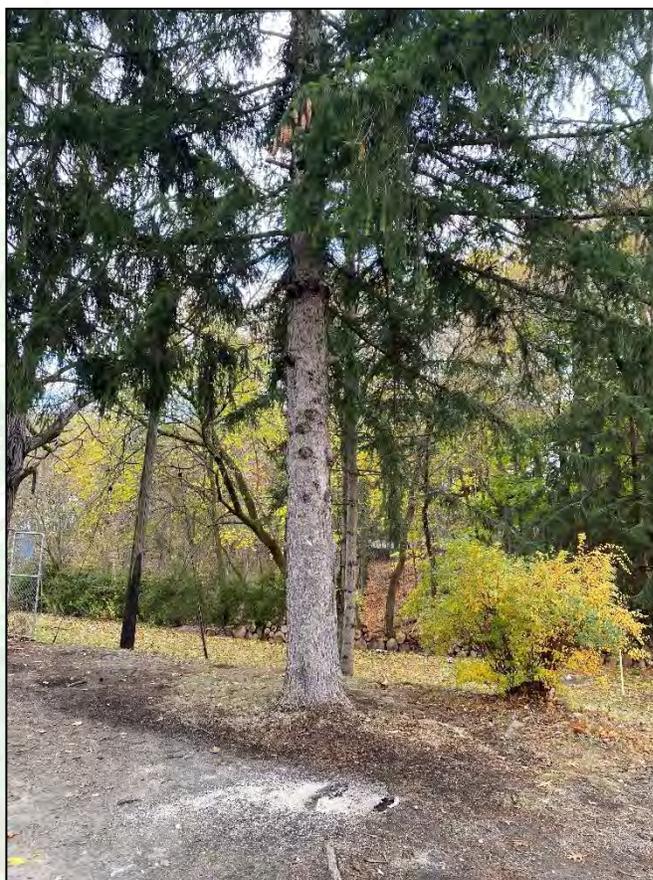
### Tree #392 – Norway Spruce (40cm DBH)

Tree #392, a 40cm DBH Norway Spruce (*Picea abies*) is a privately owned evergreen tree growing in the west portion of the property. This tree is growing into a stone wall and has exposed and girdling roots, and unhealed pruning wounds. Overall this tree is in fair condition.

Due to the location that this tree is growing and the proposed construction, this tree is recommended for removal. A permit is required for the removal of this tree.

Two (2) replacement trees will require to be planted as compensation. The compensation trees should be at least 6cm diameter (deciduous), or at least 1.8m tall (evergreen). Tree species and quantities will be included in the landscape design drawings.

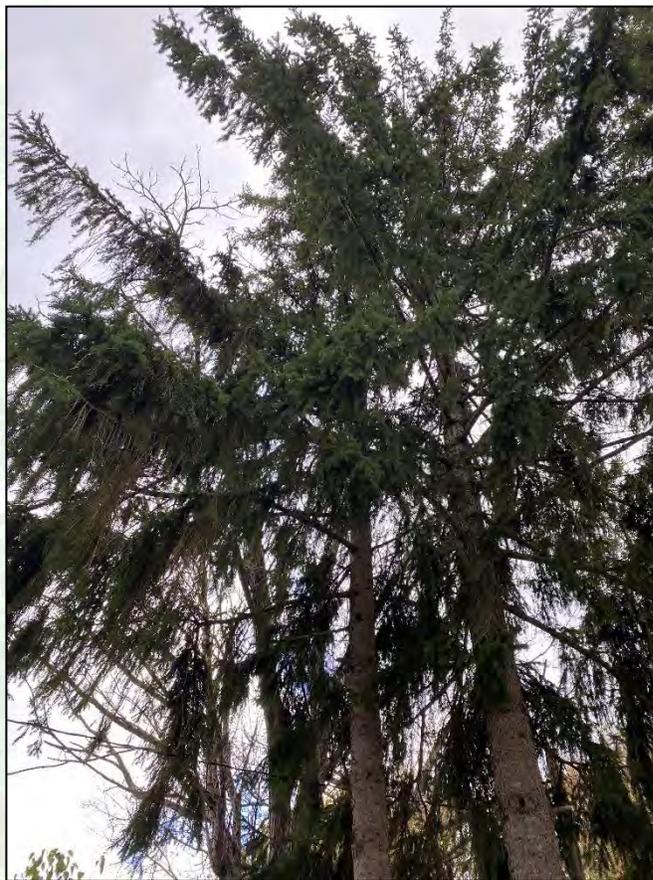
### Tree #394 – Black Walnut (41cm DBH)

Tree #394, a 41cm DBH Black Walnut (*Juglans nigra*) is a privately owned deciduous tree growing in the west portion of the property. This tree is growing on slope and has minor dieback. Overall this tree is in good condition.

Due to the location that this tree is growing and the proposed construction, this tree is recommended for removal. A permit is required for the removal of this tree.

Two (2) replacement trees will require to be planted as compensation. The compensation trees should be at least 6cm diameter (deciduous), or at least 1.8m tall (evergreen). Tree species and quantities will be included in the landscape design drawings.

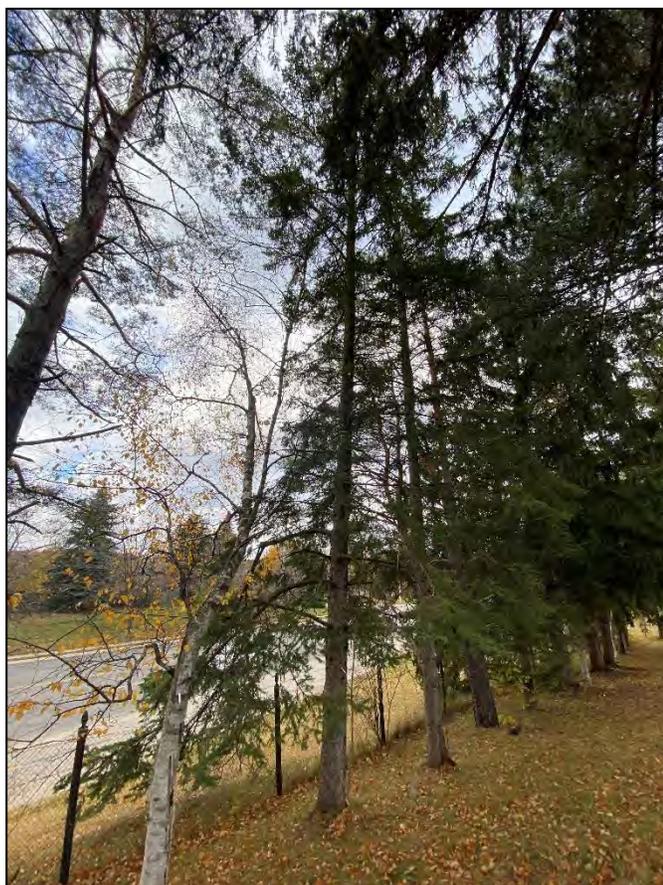
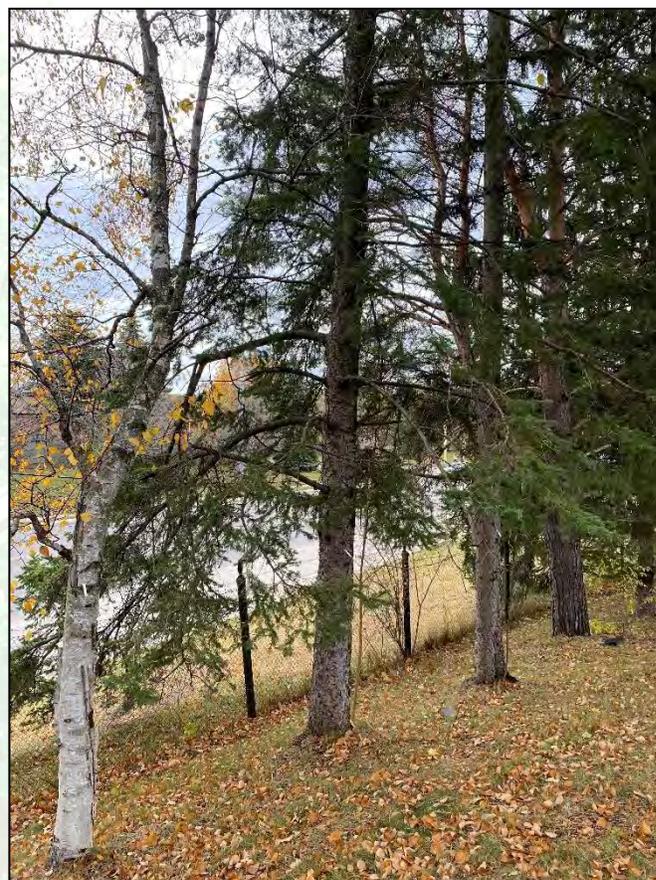
Tree #408, a 23cm DBH Norway Spruce (*Picea abies*) is a privately owned evergreen tree growing in the north portion of the property. This tree has exposed roots and an uneven crown. Overall this tree is in good condition.

Due to the location that this tree is growing and the proposed construction, this tree is recommended for removal. A permit is required for the removal of this tree.

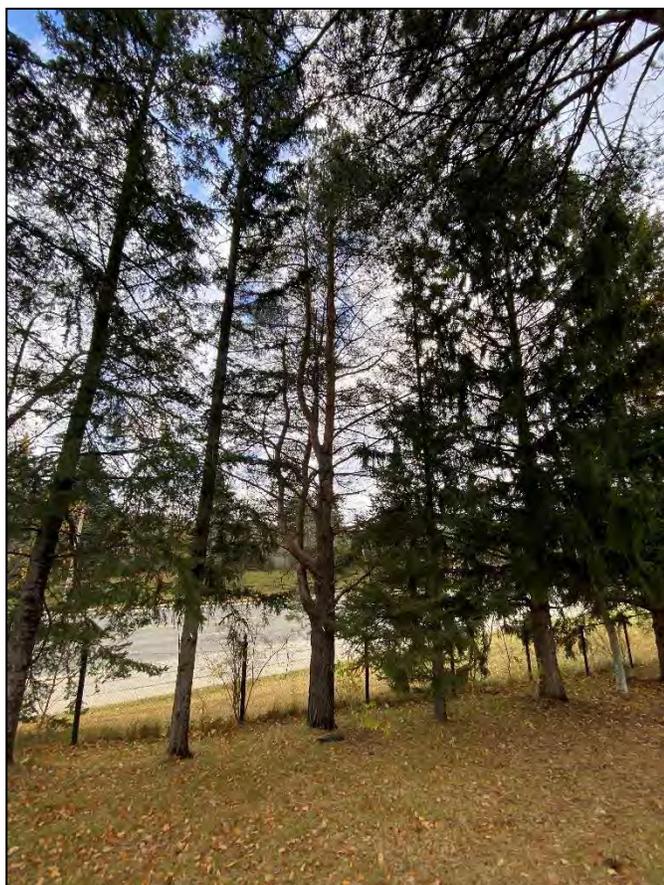
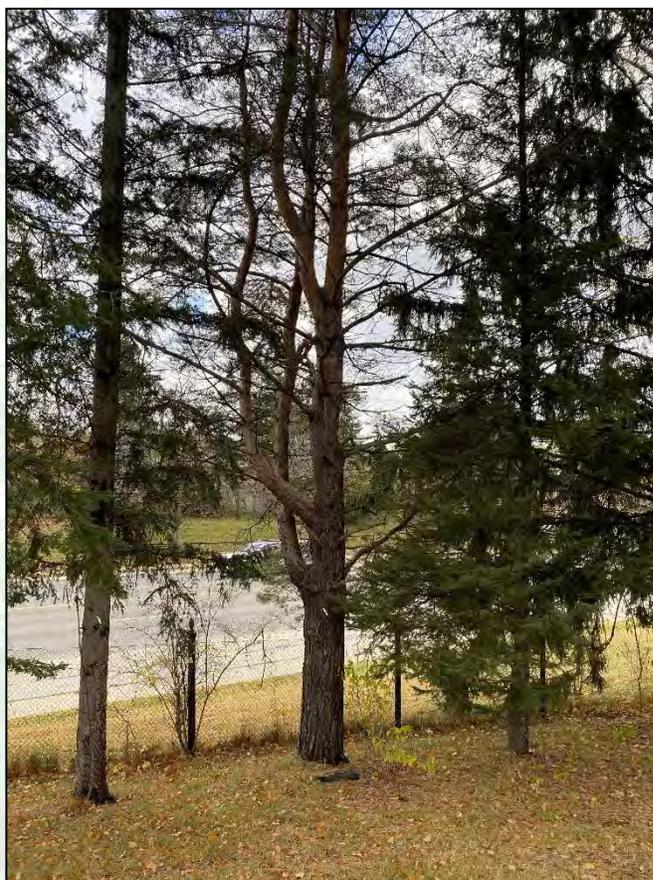
### Tree #409 – Scots Pine (43cm DBH)

Tree #409, a 43cm DBH Scots Pine (*Pinus sylvestris*) is a privately owned evergreen tree growing in the north portion of the property. This tree has unhealed trunk wounds, dieback, and deadwood. Overall this tree is in good condition.

Due to the location that this tree is growing and the proposed construction, this tree is recommended for removal. A permit is required for the removal of this tree.

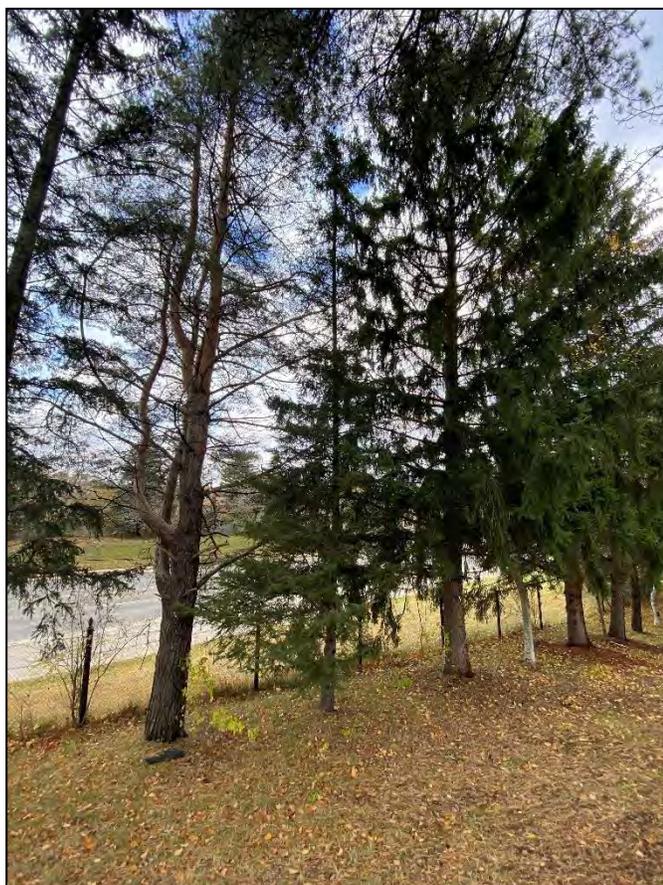
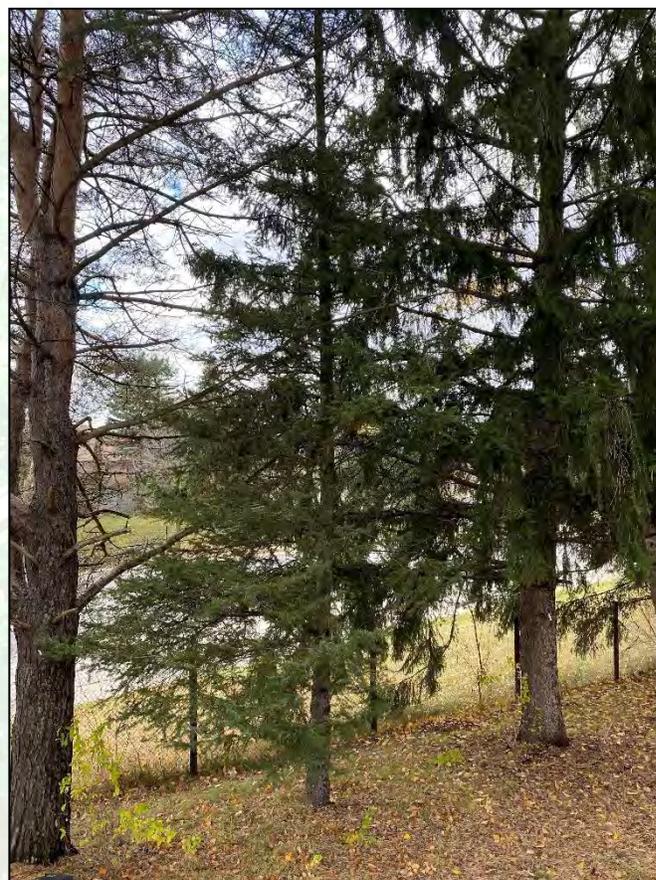
### Tree #410 – White Spruce (18cm DBH)

Tree #410, an 18cm DBH White Spruce (*Picea glauca*) is a privately owned evergreen tree growing in the north portion of the property. This tree has minor deadwood. Overall this tree is in good condition.

Due to the location that this tree is growing and the proposed construction, this tree is recommended for removal. A permit is required for the removal of this tree.

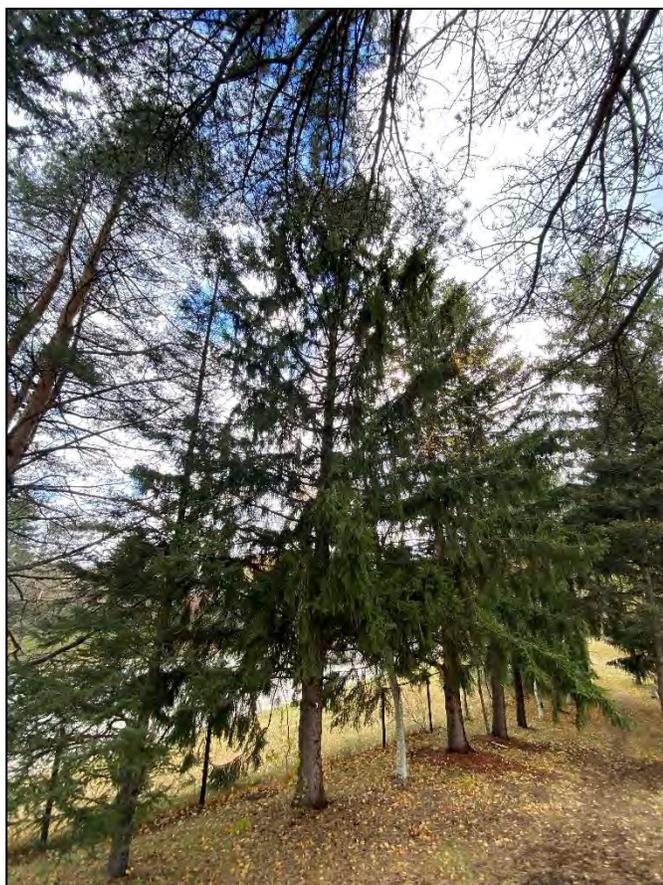
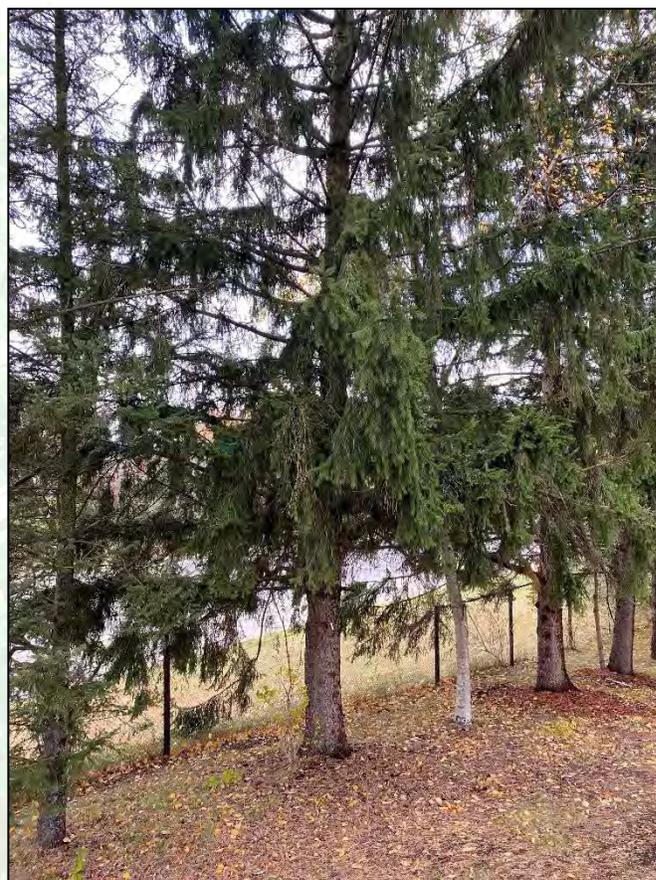
### Tree #411 – Norway Spruce (42cm DBH)

Tree #411, a 42cm DBH Norway Spruce (*Picea abies*) is a privately owned evergreen tree growing in the east portion of the property. This tree has exposed roots and unhealed pruning wounds. Overall this tree is in good condition.

Due to the location that this tree is growing and the proposed construction, this tree is recommended for removal. A permit is required for the removal of this tree.

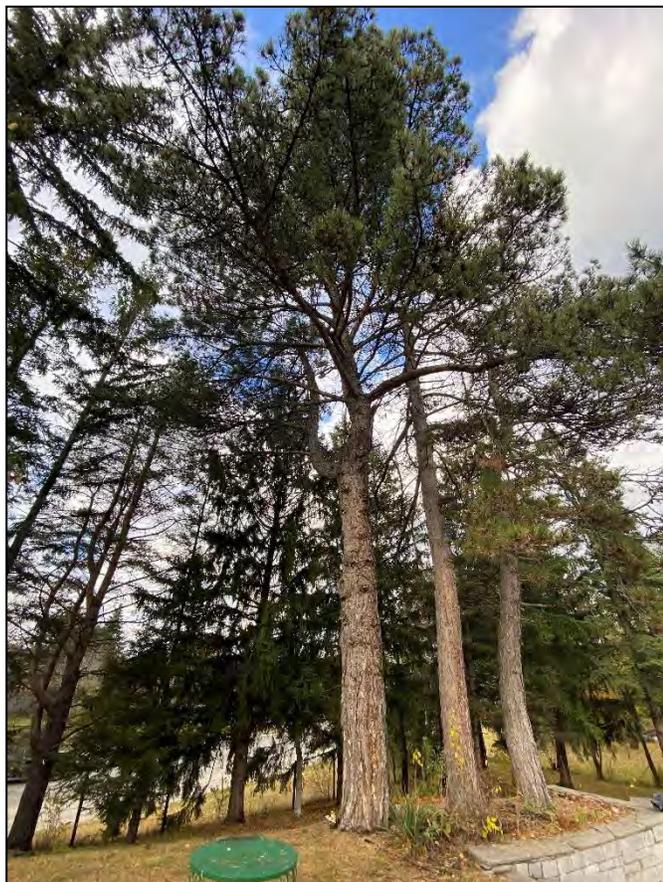
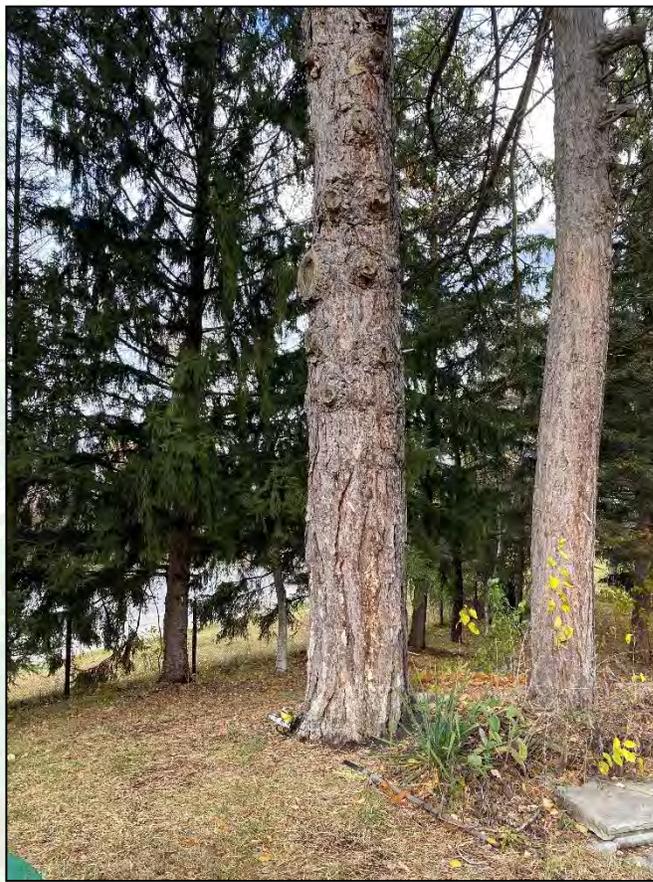
### Tree #412 – Scots Pine (70cm DBH)

Tree #412, a 70cm DBH Scots Pine (*Pinus sylvestris*) is a privately owned evergreen tree growing in the east portion of the property. This tree is co-dominant at 7m, has unhealed trunk wounds, dieback and deadwood. Overall this tree is in good condition.

Due to the location that this tree is growing and the proposed construction, this tree is recommended for removal. A permit is required for the removal of this tree.

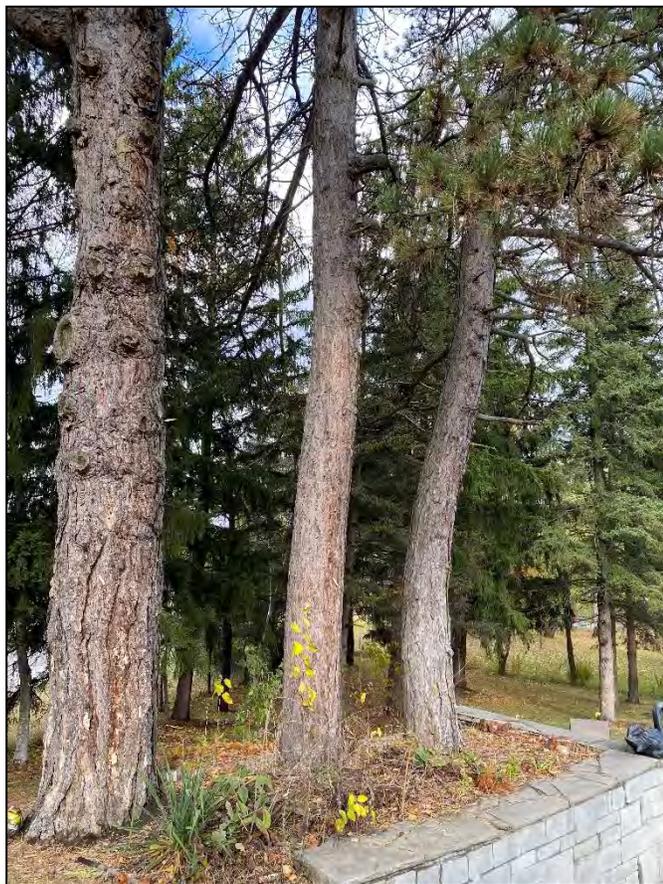
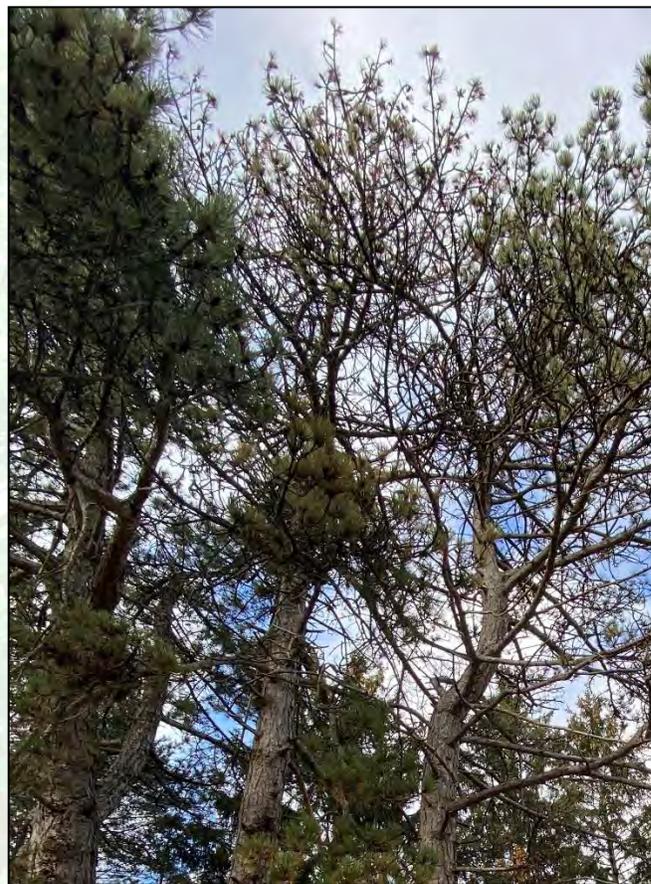
### Tree #413 – Scots Pine (46cm DBH)

Tree #413, a 46cm DBH Scots Pine (*Pinus sylvestris*) is a privately owned evergreen tree growing in the east portion of the property. This tree has unhealed trunk wounds, a sparse crown, dieback and deadwood. Overall this tree is in fair condition.

Due to the location that this tree is growing and the proposed construction, this tree is recommended for removal. A permit is required for the removal of this tree.

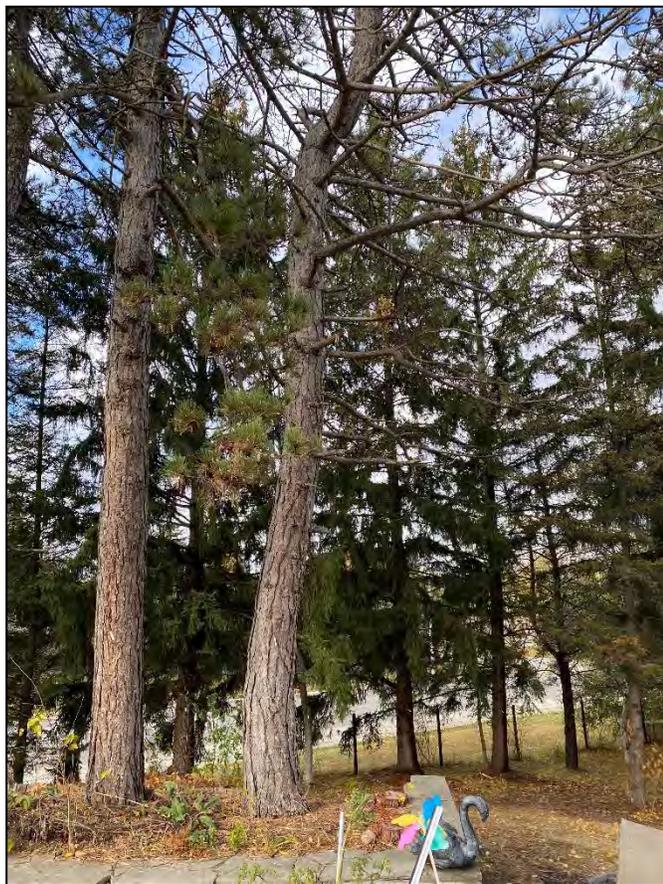
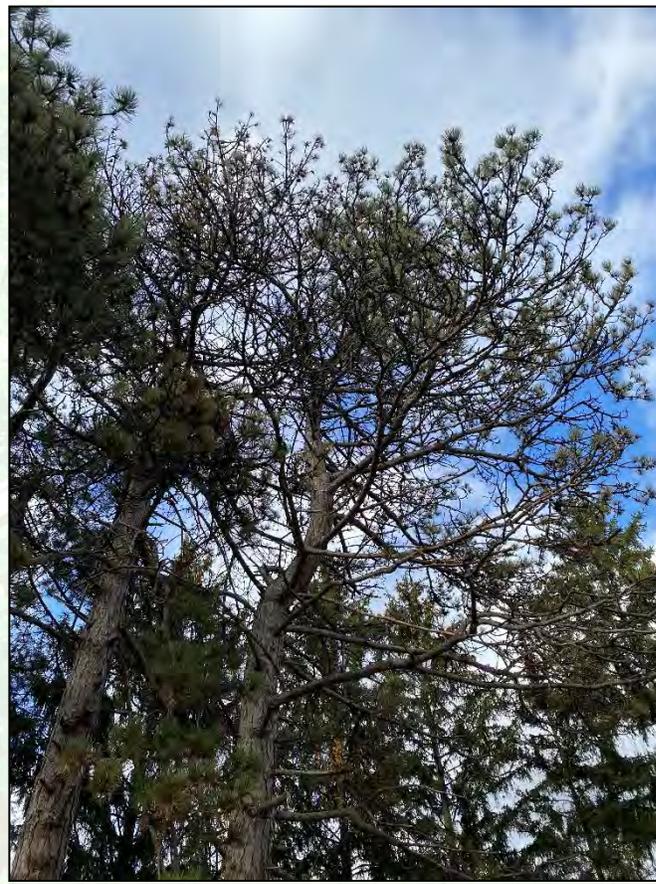
### Tree #414 – Scots Pine (46cm DBH)

Tree #414, a 46cm DBH Scots Pine (*Pinus sylvestris*) is a privately owned evergreen tree growing in the east portion of the property. This tree has a bent trunk, unhealed trunk wounds, a sparse crown, dieback and deadwood. Overall this tree is in fair condition.

Due to the location that this tree is growing and the proposed construction, this tree is recommended for removal. A permit is required for the removal of this tree.

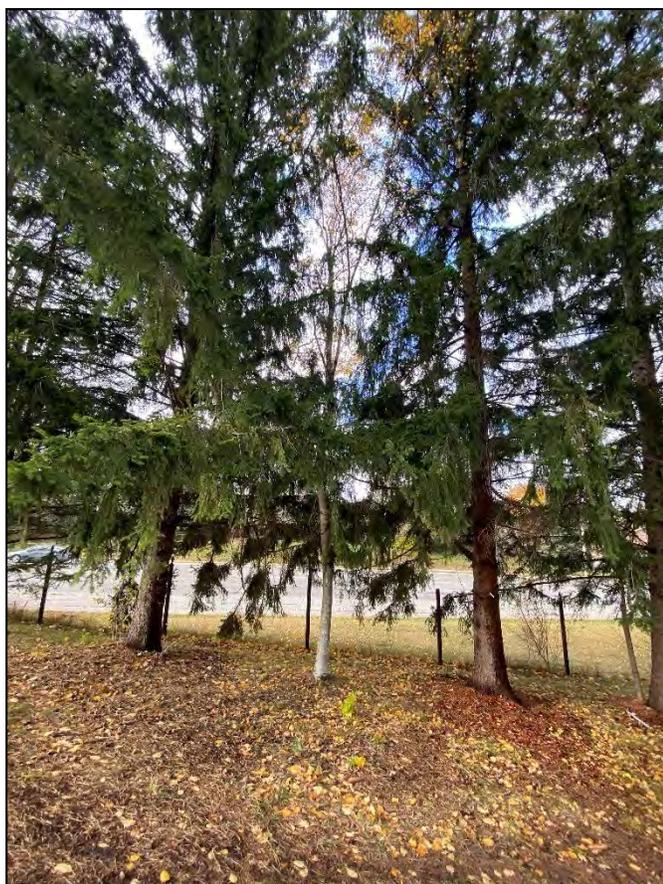
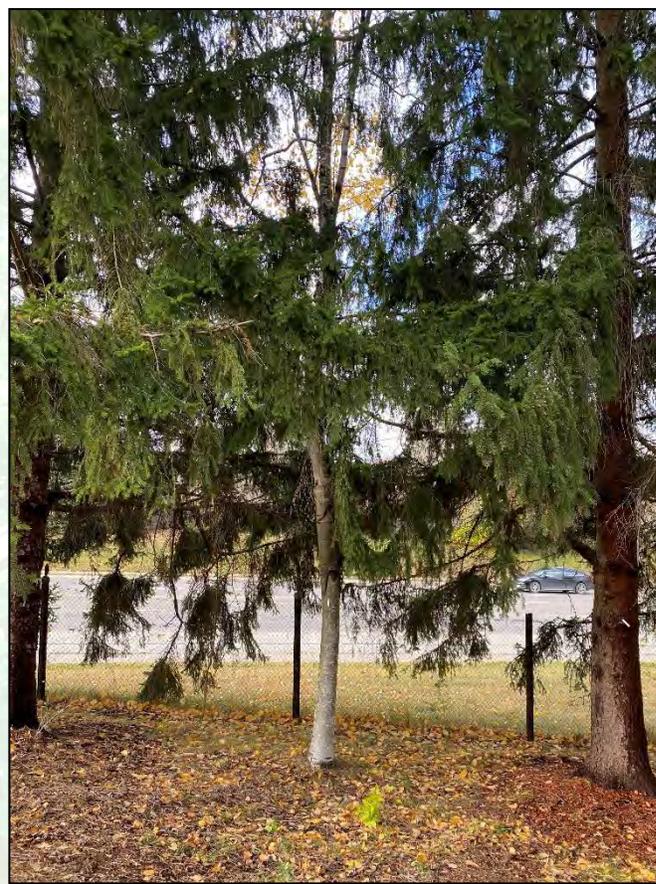
### Tree #415 – White Birch (18cm DBH)

Tree #415, an 18cm DBH White Birch (*Betula papyrifera*) is a privately owned deciduous tree growing in the north portion of the property. This tree has an uneven crown, dieback and deadwood. Overall this tree is in good condition.

Due to the location that this tree is growing and the proposed construction, this tree is recommended for removal. A permit is required for the removal of this tree.

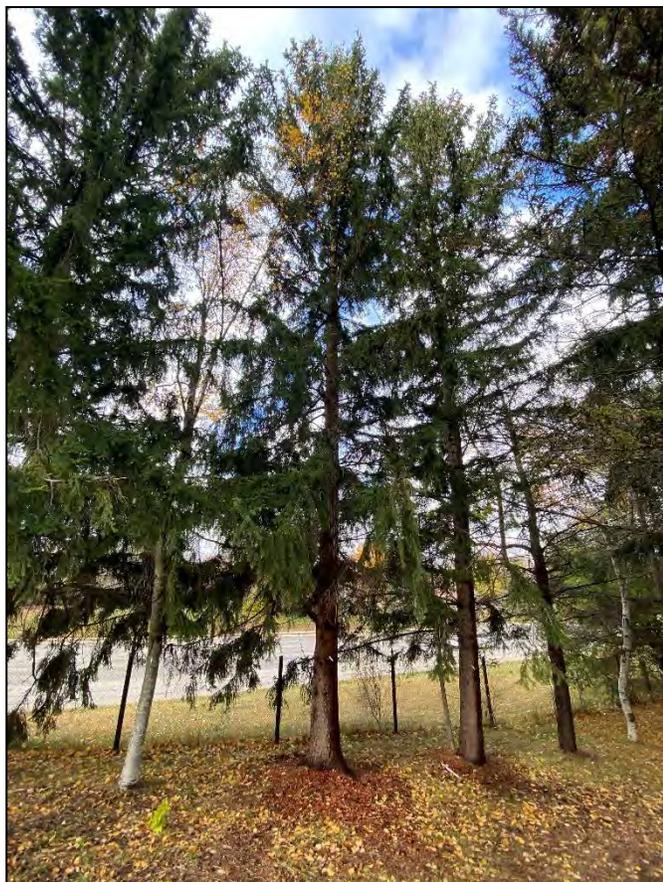
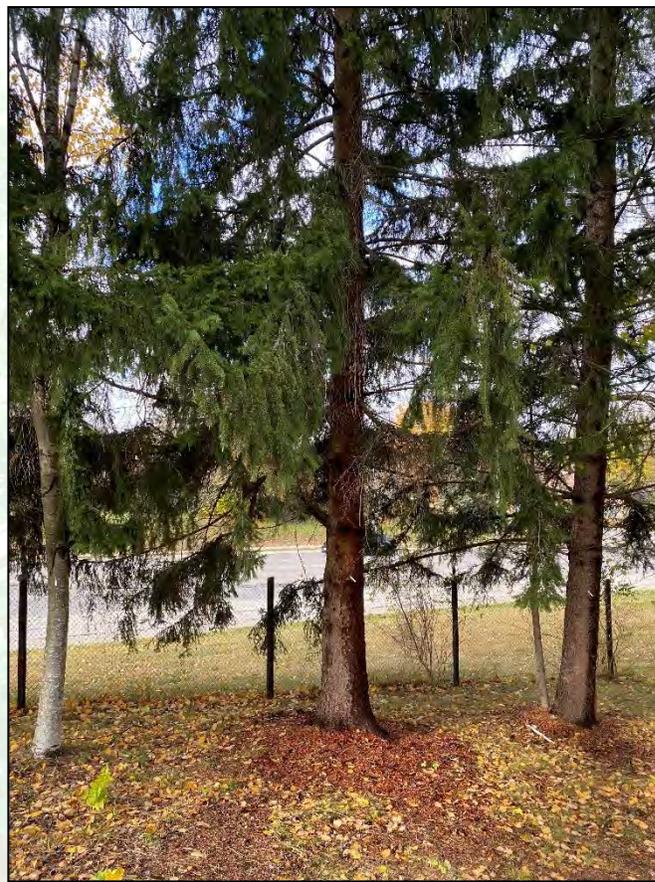
### Tree #416 – Norway Spruce (42cm DBH)

Tree #416, a 42cm DBH Norway Spruce (*Picea abies*) is a privately owned evergreen tree growing in the east portion of the property. This tree has minor interior deadwood. Overall this tree is in good condition.

Due to the location that this tree is growing and the proposed construction, this tree is recommended for removal. A permit is required for the removal of this tree.

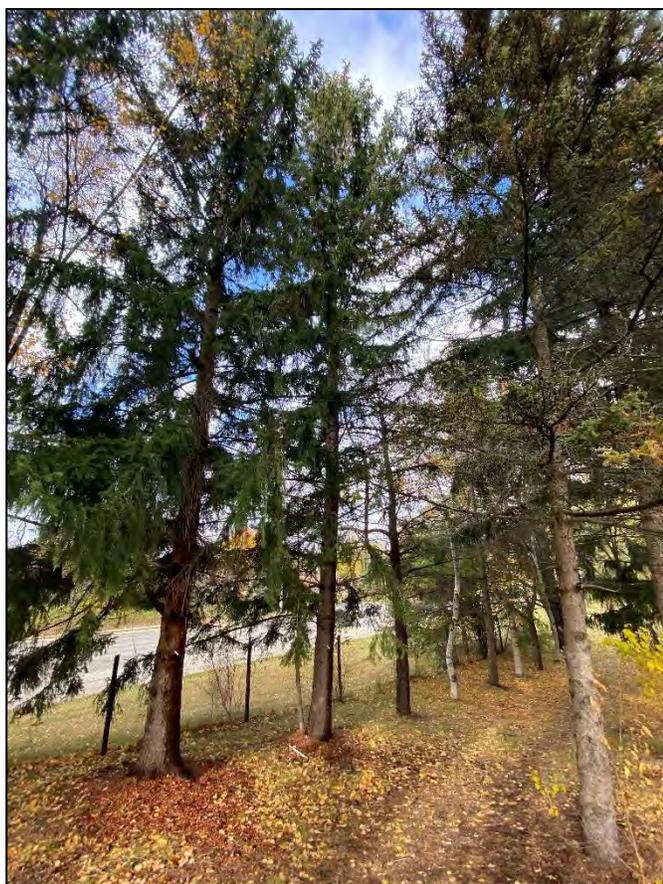
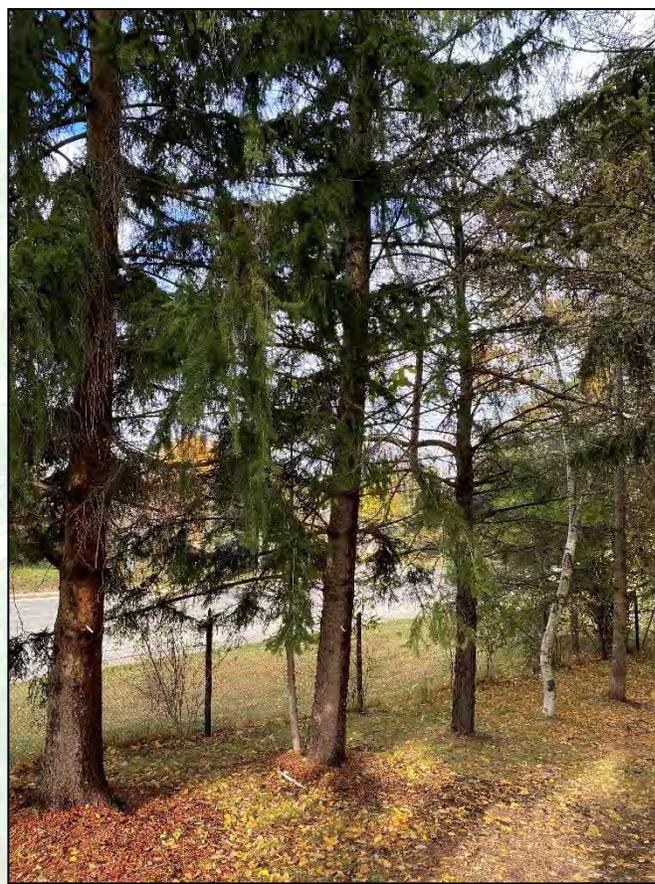
### Tree #417 – Norway Spruce (38cm DBH)

Tree #417, a 38cm DBH Norway Spruce (*Picea abies*) is a privately owned evergreen tree growing in the east portion of the property. This tree has minor dieback and deadwood. Overall this tree is in good condition.

Due to the location that this tree is growing and the proposed construction, this tree is recommended for removal. A permit is required for the removal of this tree.

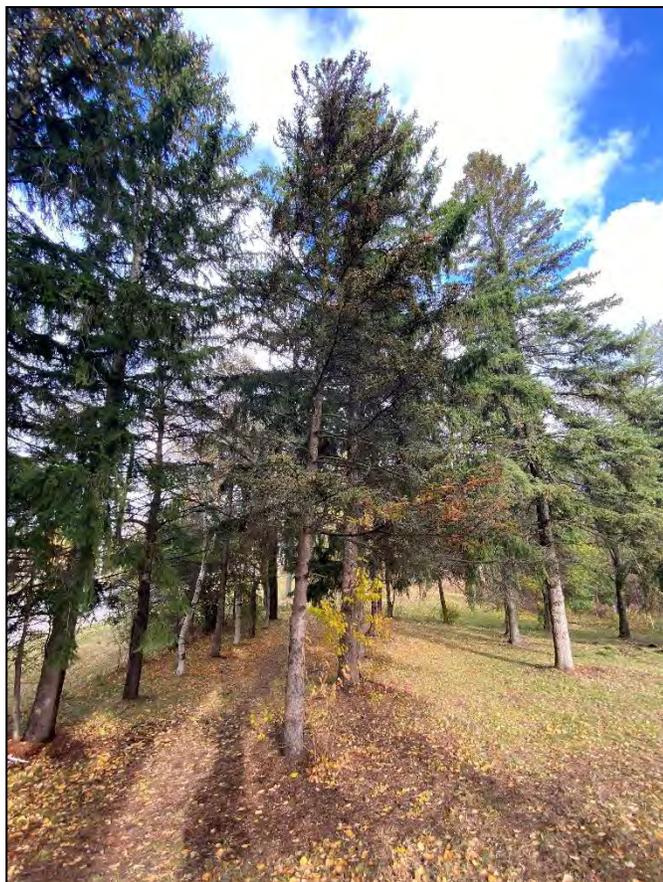
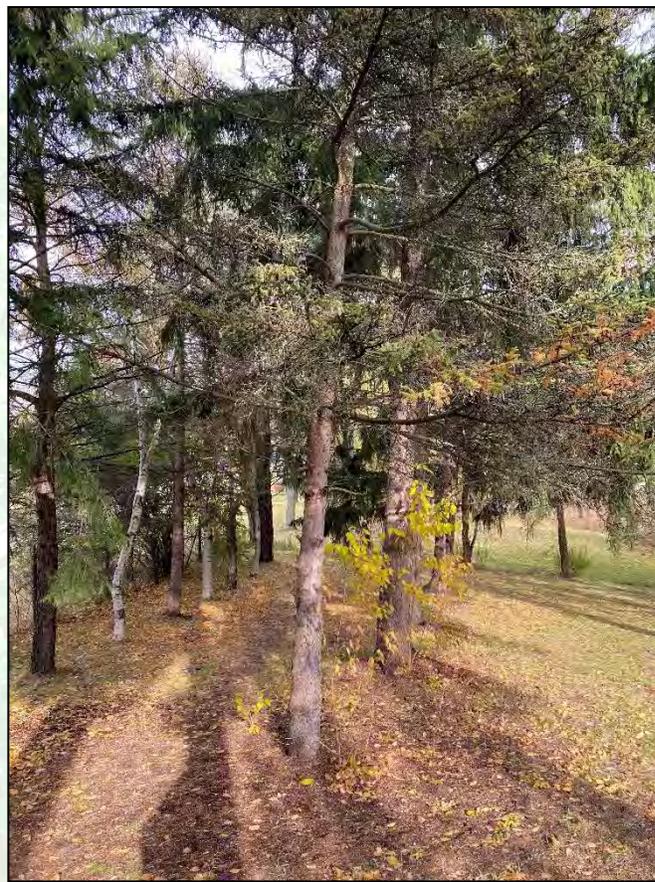
### Tree #418 – White Spruce (27cm DBH)

Tree #418, a 27cm DBH White Spruce (*Picea glauca*) is a privately owned evergreen tree growing in the east portion of the property. This tree has dieback, deadwood, and a sparse crown. Overall this tree is in good condition.

Due to the location that this tree is growing and the proposed construction, this tree is recommended for removal. A permit is required for the removal of this tree.

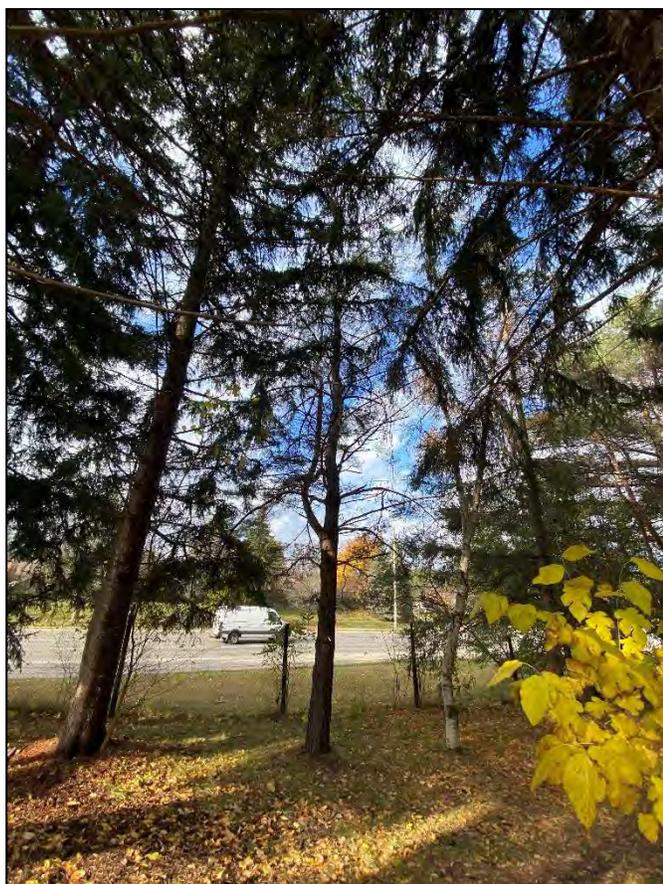
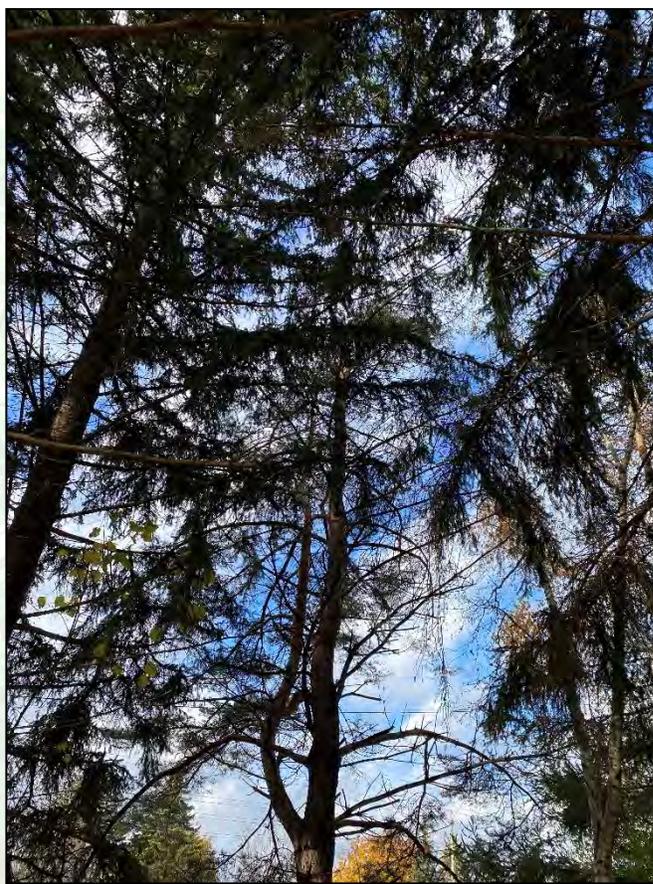
### Tree #419 – Scots Pine (30cm DBH)

Tree #419, a 30cm DBH Scots Pine (*Pinus sylvestris*) is a privately owned evergreen tree growing in the east portion of the property. This tree has dieback, deadwood, and a sparse crown. Overall this tree is in good condition.

Due to the location that this tree is growing and the proposed construction, this tree is recommended for removal. A permit is required for the removal of this tree.

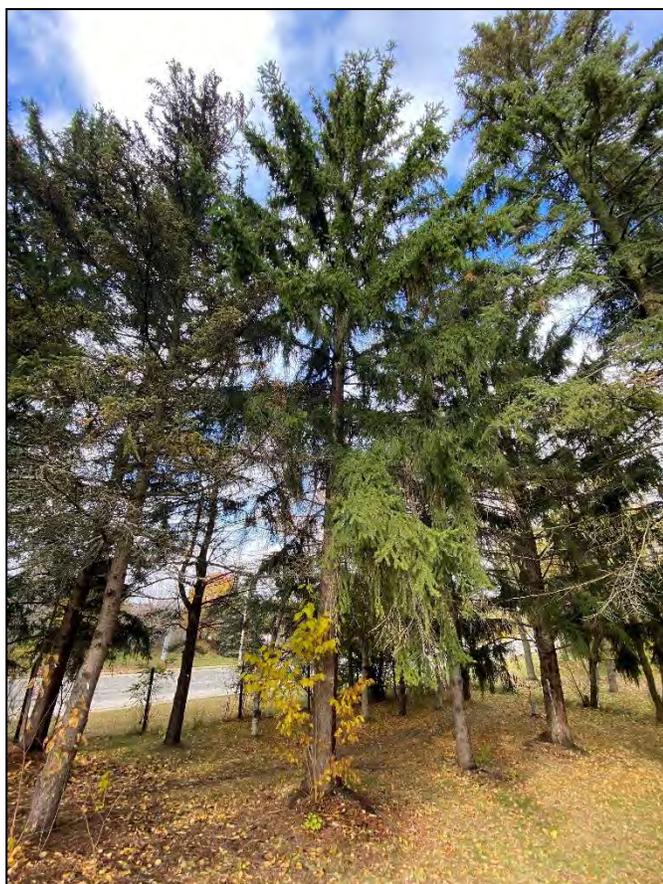
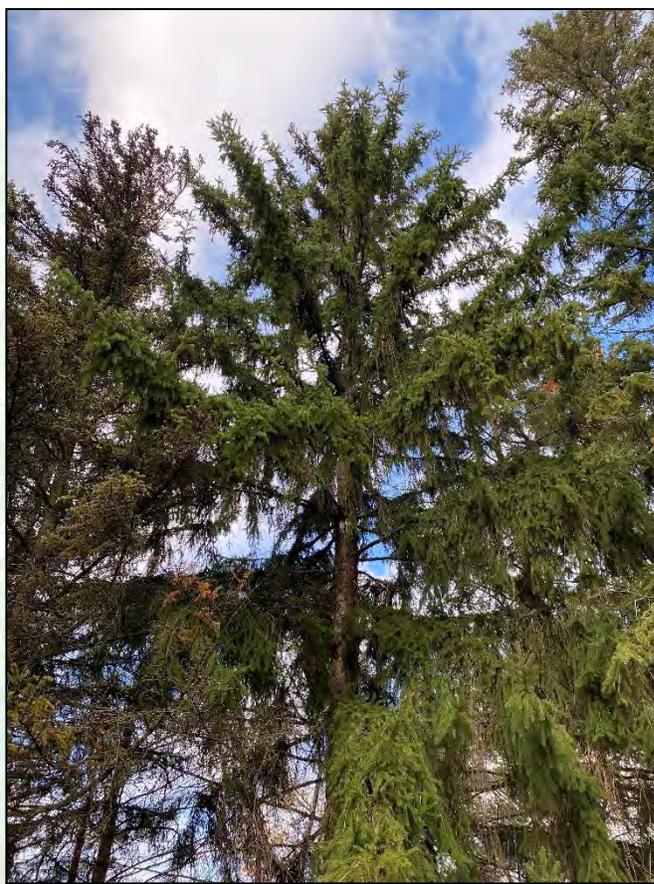
### Tree #420 – Norway Spruce (42cm DBH)

Tree #420, a 42cm DBH Norway Spruce (*Picea abies*) is a privately owned evergreen tree growing in the east portion of the property. This tree has exposed roots, dieback and deadwood. Overall this tree is in good condition.

Due to the location that this tree is growing and the proposed construction, this tree is recommended for removal. A permit is required for the removal of this tree.

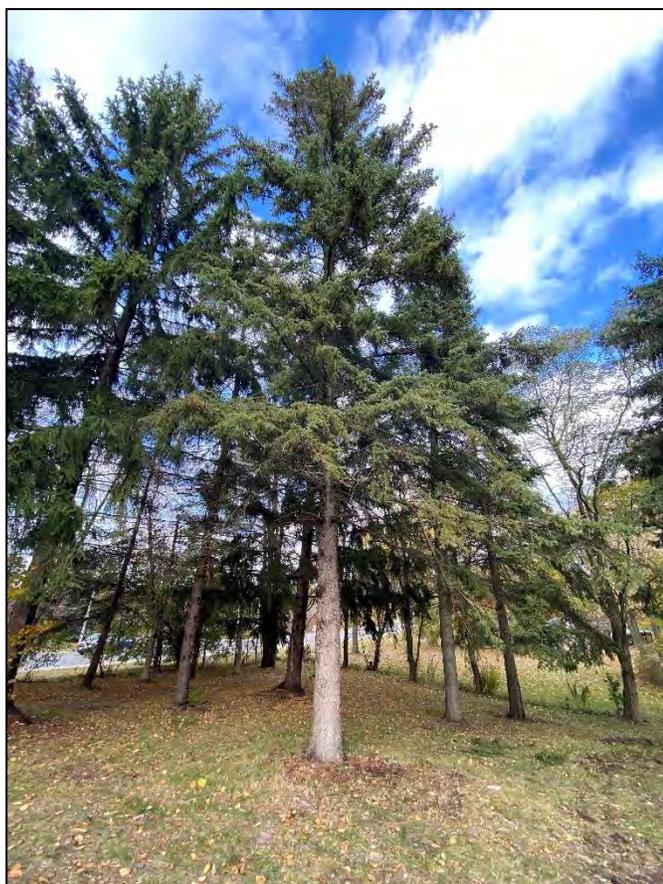
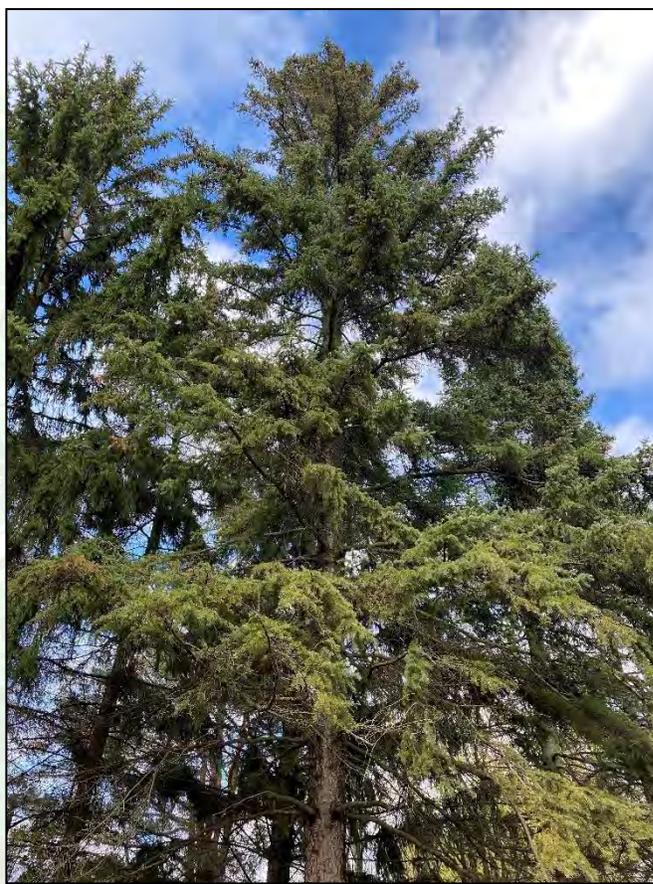
### Tree #421 – White Spruce (40cm DBH)

Tree #421, a 40cm DBH White Spruce (*Picea glauca*) is a privately owned evergreen tree growing in the east portion of the property. This tree has exposed roots and deadwood. Overall this tree is in good condition.

Due to the location that this tree is growing and the proposed construction, this tree is recommended for removal. A permit is required for the removal of this tree.

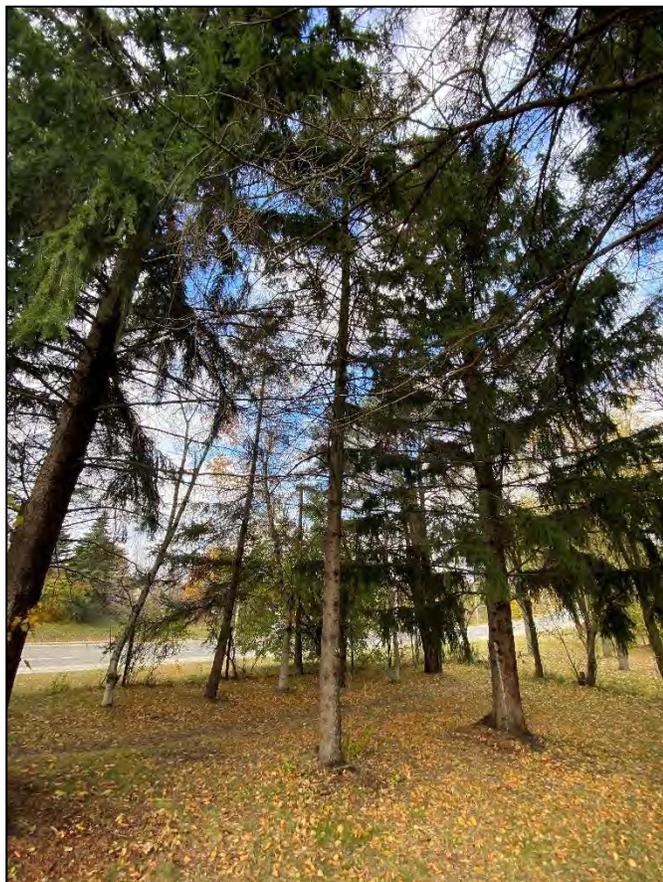
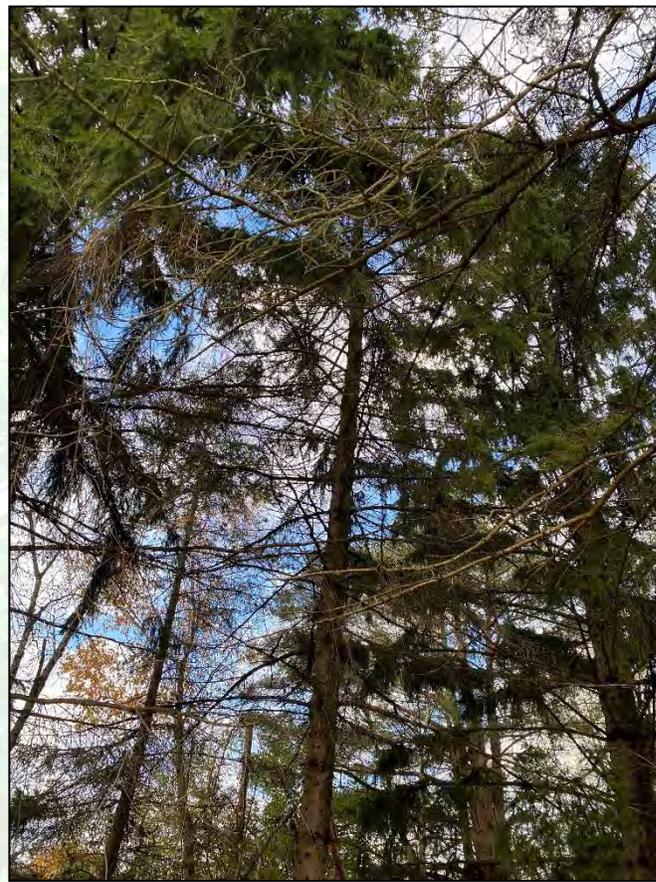
### Tree #422 – Norway Spruce (29cm DBH)

Tree #422, a 29cm DBH Norway Spruce (*Picea abies*) is a privately owned evergreen tree growing in the east portion of the property. This tree has exposed and girdling roots, dieback, deadwood, and a sparse crown. Overall this tree is in fair condition.

Due to the location that this tree is growing and the proposed construction, this tree is recommended for removal. A permit is required for the removal of this tree.
