# ARBORIST REPORT & TREE PROTECTION PLAN

**900 LAKESHORE ROAD WEST**  
MISSISSAUGA, ON  
L5H 1H9

Date: January 25, 2024

Revised: January 30, 2026

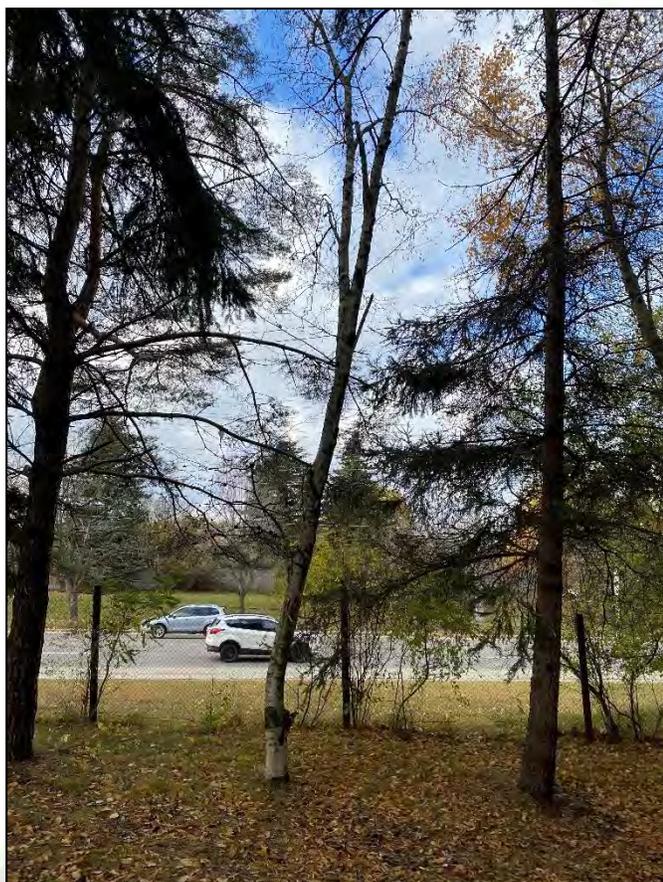
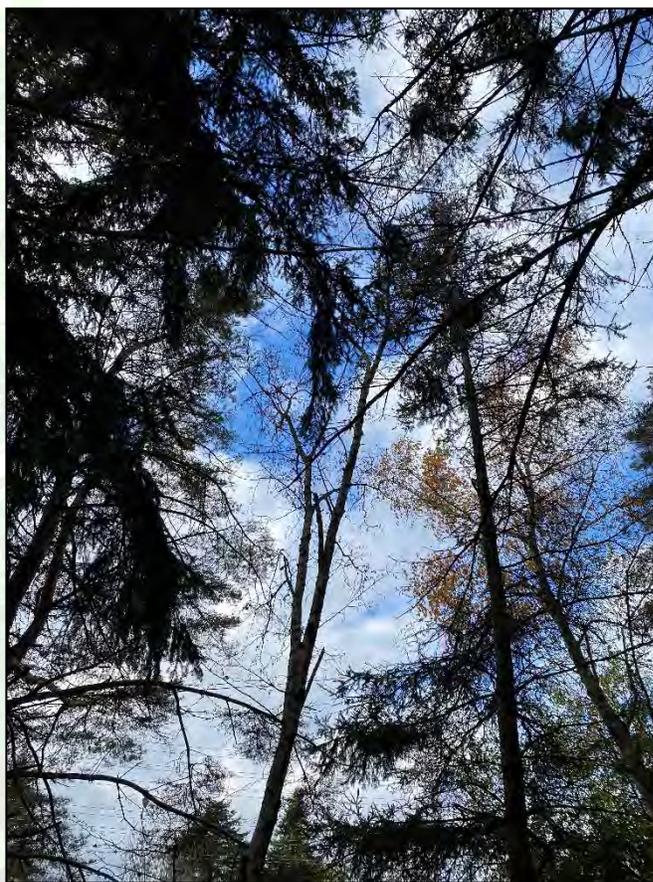
### Tree #423 – White Birch (18cm DBH)

Tree #423, a 18cm DBH White Birch (*Betula papyrifera*) is a privately owned deciduous tree growing in the east portion of the property. This tree has a bent trunk, is co-dominant at 5m with included bark, unhealed trunk wounds, dieback and deadwood. Overall this tree is in fair condition.

Due to the location that this tree is growing and the proposed construction, this tree is recommended for removal. A permit is required for the removal of this tree.

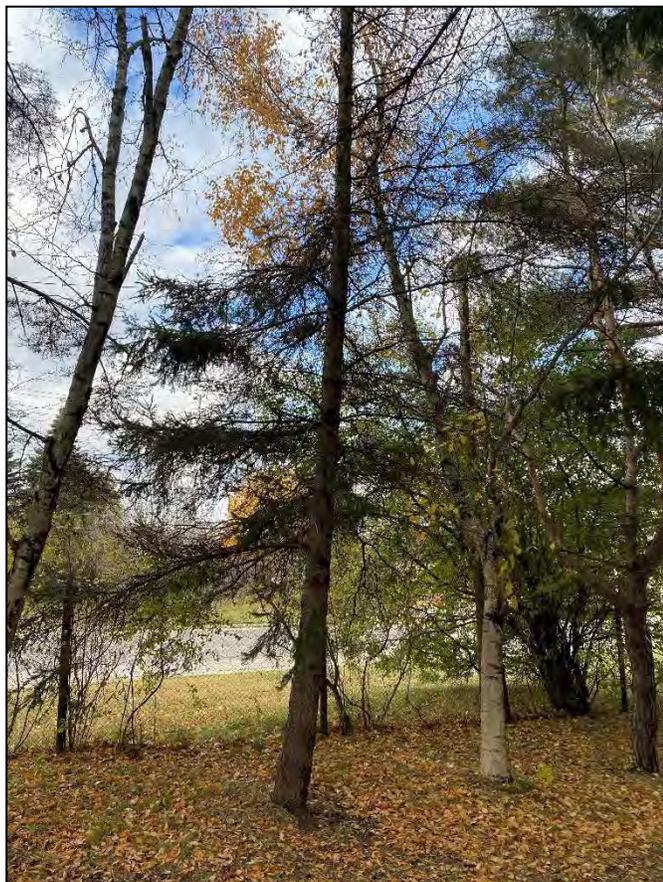
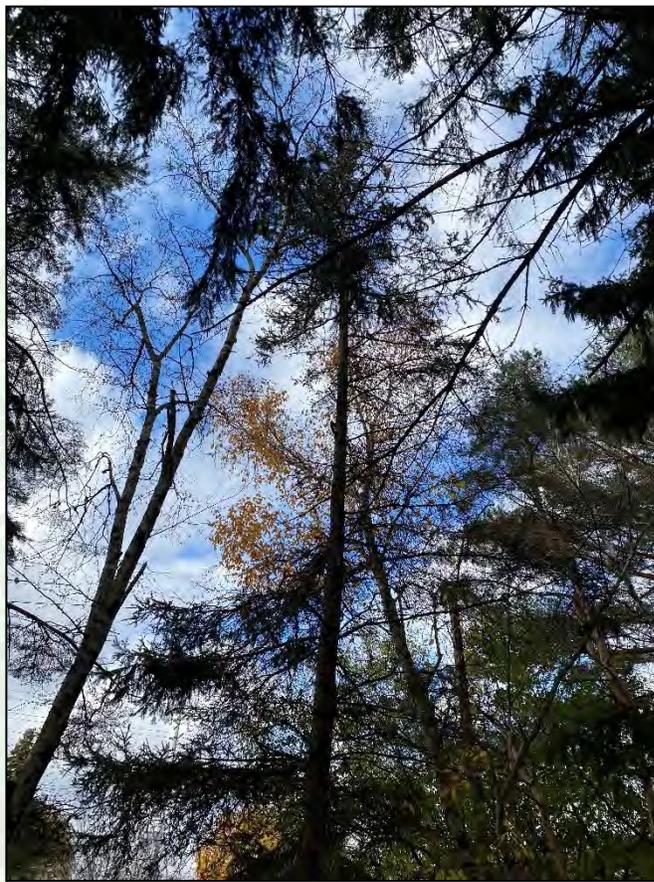
### Tree #424 – Norway Spruce (24cm DBH)

Tree #424, a 24cm DBH Norway Spruce (*Picea abies*) is a privately owned evergreen tree growing in the east portion of the property. This tree has girdling roots, significant dieback and deadwood and is 70% dead. Overall this tree is in poor condition.

Due to the location that this tree is growing and the proposed construction, this tree is recommended for removal. A permit is required for the removal of this tree.

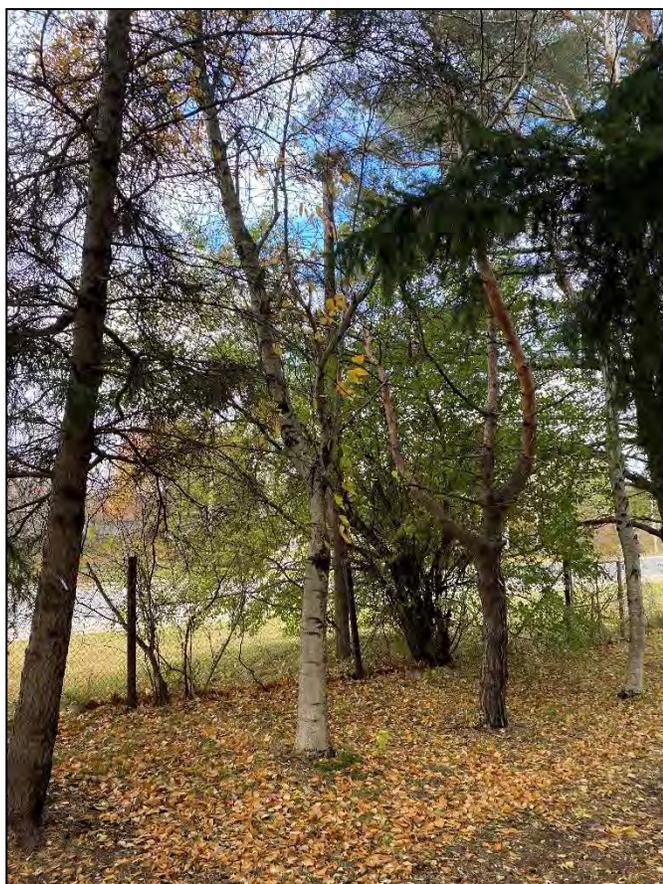
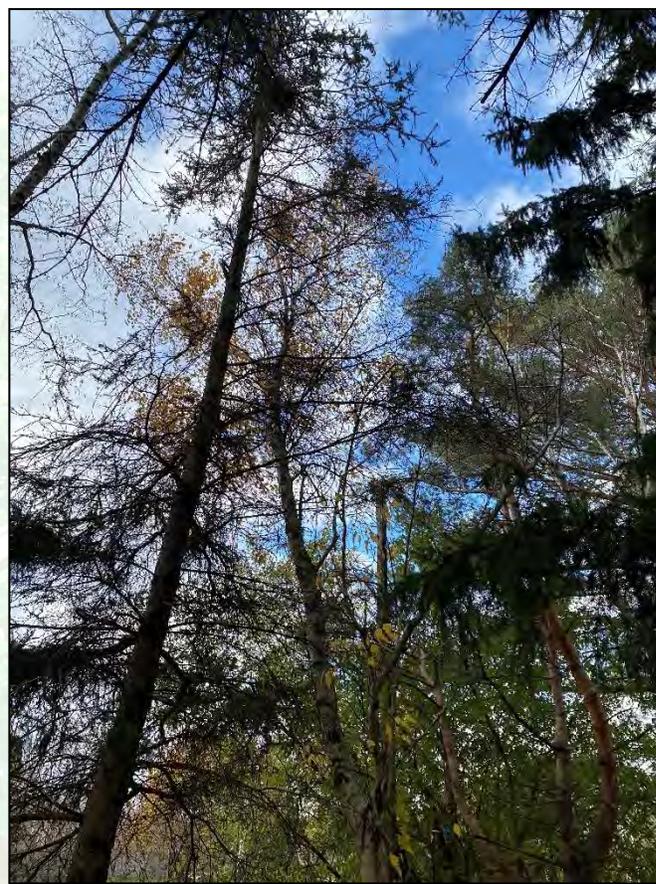
### Tree #425 – White Birch (21cm DBH)

Tree #425, a 21cm DBH White Birch (*Betula papyrifera*) is a privately owned deciduous tree growing in the east portion of the property. This tree has an uneven crown, dieback and deadwood. Overall this tree is in fair condition.

Due to the location that this tree is growing and the proposed construction, this tree is recommended for removal. A permit is required for the removal of this tree.

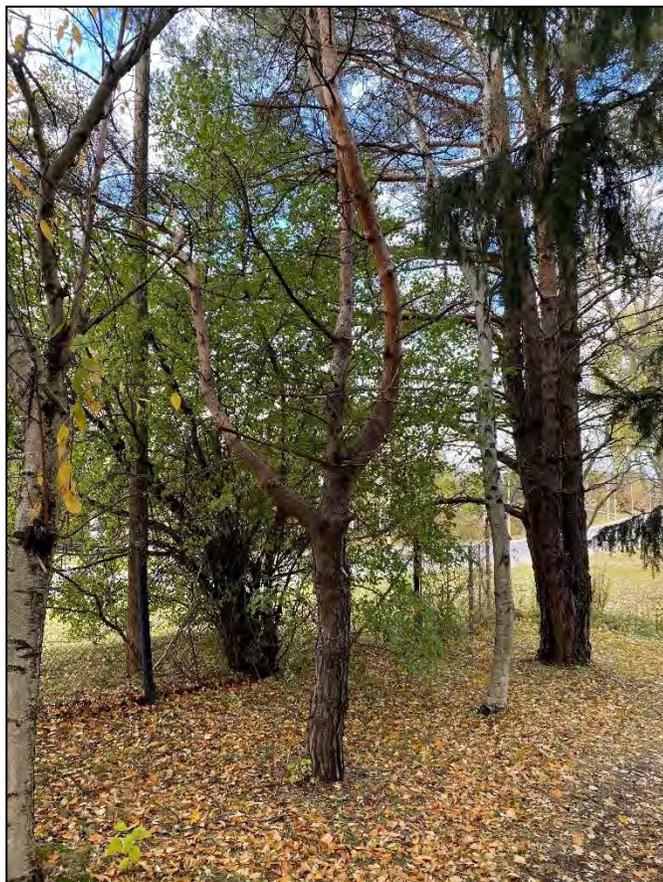
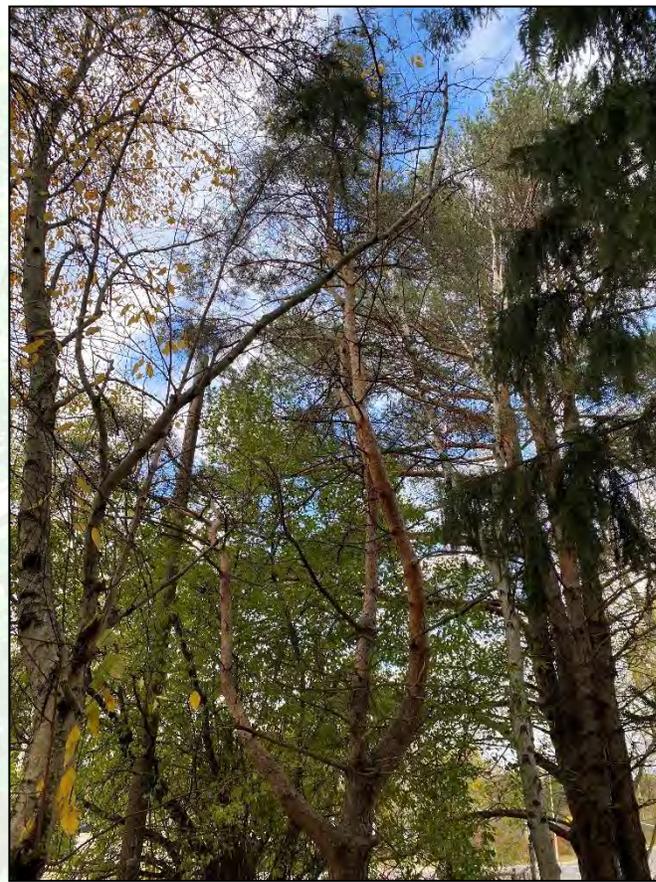
### Tree #426 – Scots Pine (26cm DBH)

Tree #426, a 26cm DBH Scots Pine (*Pinus sylvestris*) is a privately owned evergreen tree growing in the east portion of the property. This tree has a bent trunk, unhealed trunk wounds, a cavity, dieback and deadwood. Overall this tree is in fair condition.

Due to the location that this tree is growing and the proposed construction, this tree is recommended for removal. A permit is required for the removal of this tree.

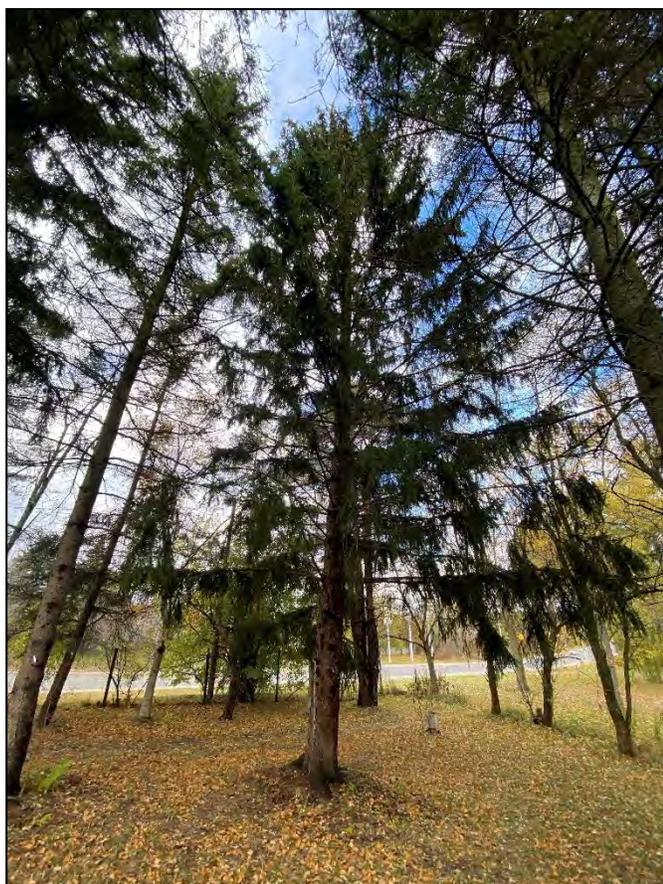
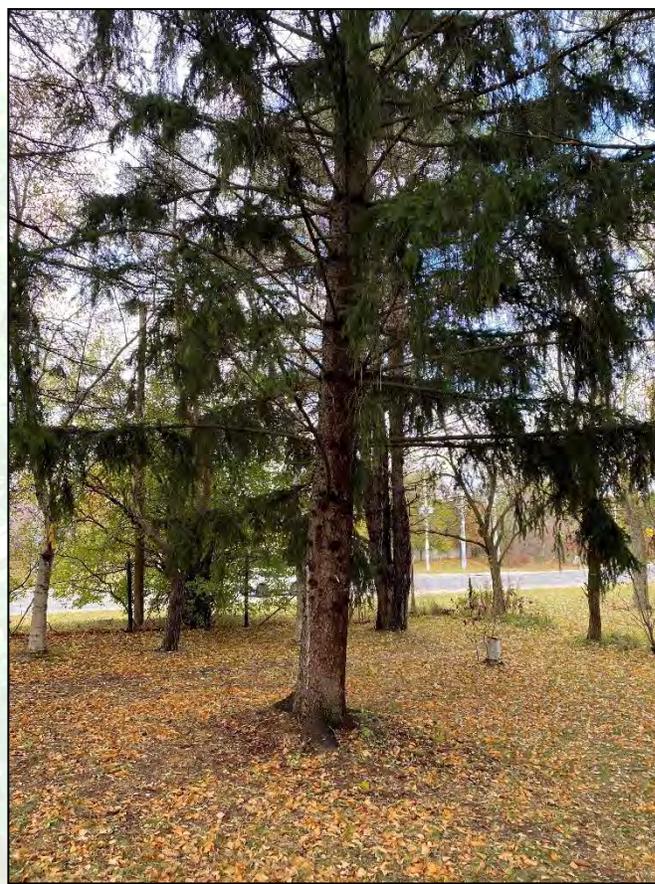
### Tree #427 – Norway Spruce (50cm DBH)

Tree #427, a 50cm DBH Norway Spruce (*Picea abies*) is a privately owned evergreen tree growing in the east portion of the property. This tree has exposed roots and minor interior deadwood. Overall this tree is in good condition.

Due to the location that this tree is growing and the proposed construction, this tree is recommended for removal. A permit is required for the removal of this tree.

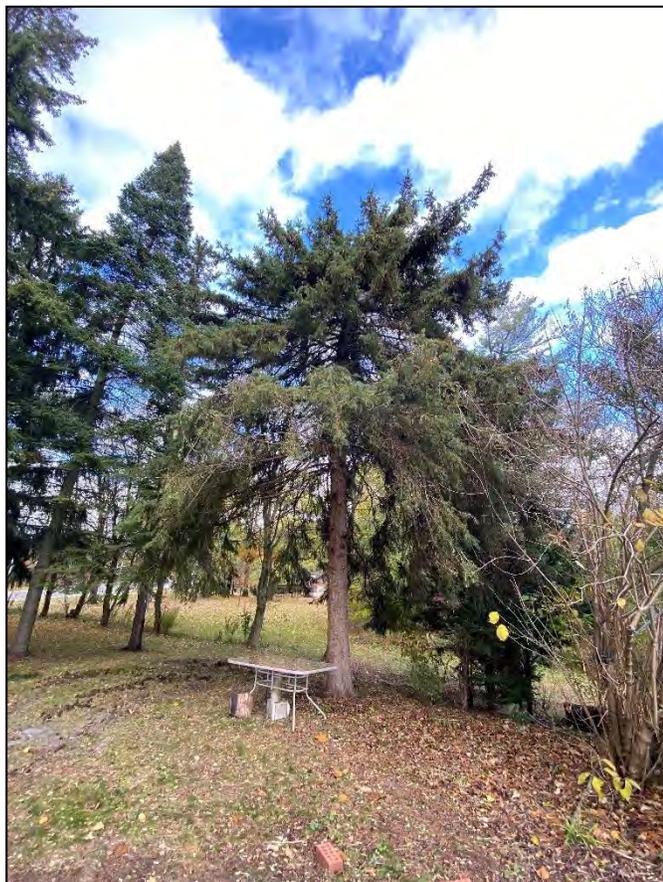
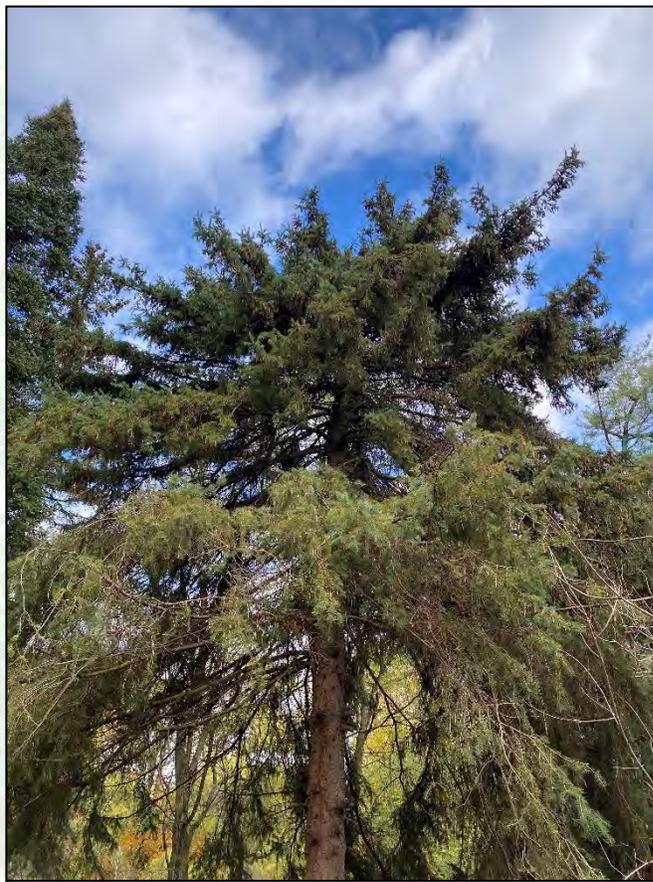
### Tree #429 – White Spruce (40cm DBH)

Tree #	Tree Species	Botanical Name	DBH (cm)	Root Zone	Trunk Integrity	Crown Structure	Crown Vitality	Overall Condition
429	White Spruce	<i>Picea glauca</i>	40	Fair	Good	Fair	Good	Fair

Tree #429, a 50cm DBH White Spruce (*Picea glauca*) is a privately owned evergreen tree growing in the east portion of the property. This tree has exposed and girdling roots, unhealed pruning wounds, dieback, deadwood and has been topped. Overall this tree is in fair condition.

Due to the location that this tree is growing and the proposed construction, this tree is recommended for removal. A permit is required for the removal of this tree.

Three (3) replacement trees will require to be planted as compensation. The compensation trees should be at least 6cm diameter (deciduous), or at least 1.8m tall (evergreen). Tree species and quantities will be included in the landscape design drawings.

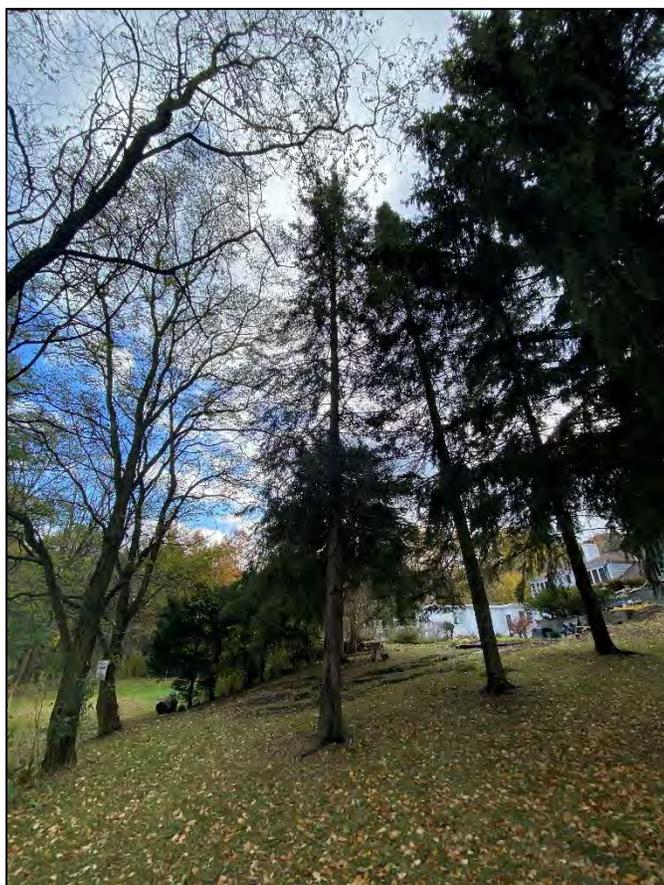
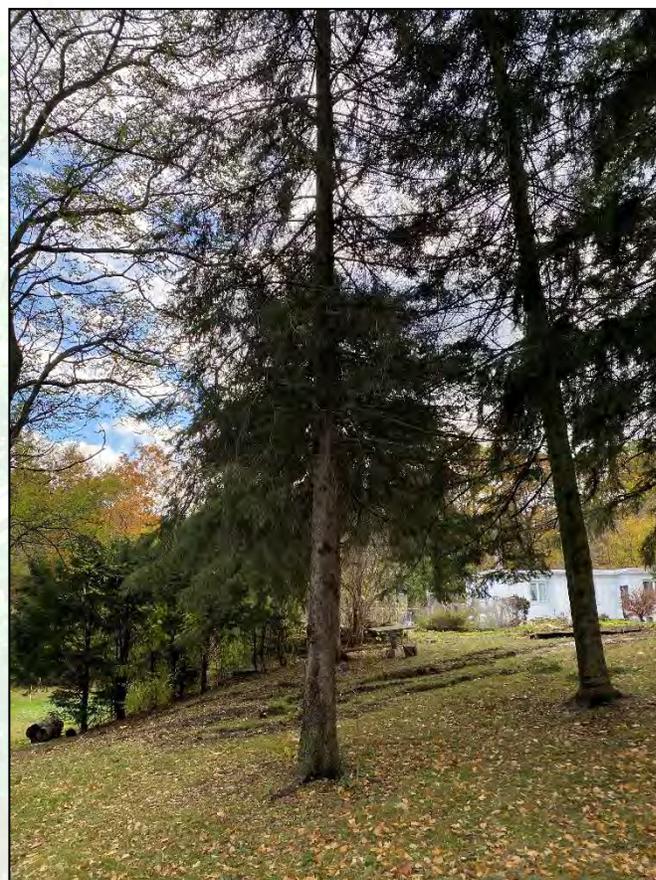
### Tree #430 – Norway Spruce (34cm DBH)

Tree #	Tree Species	Botanical Name	DBH (cm)	Root Zone	Trunk Integrity	Crown Structure	Crown Vitality	Overall Condition
430	Norway Spruce	<i>Picea abies</i>	34	Good	Good	Good	Fair	Good

Tree #430, a 34cm DBH Norway Spruce (*Picea abies*) is a privately owned evergreen tree growing in the east portion of the property. This tree has an uneven root flare, dieback, deadwood and sparse crown. Overall this tree is in good condition.

Due to the location that this tree is growing and the proposed construction, this tree is recommended for removal. A permit is required for the removal of this tree.

Two (2) replacement trees will require to be planted as compensation. The compensation trees should be at least 6cm diameter (deciduous), or at least 1.8m tall (evergreen). Tree species and quantities will be included in the landscape design drawings.

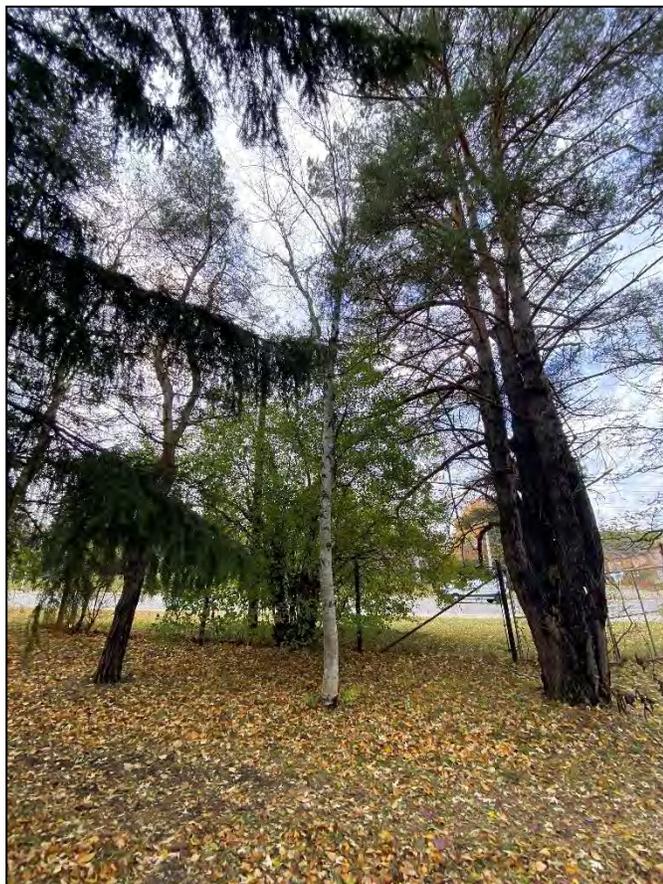
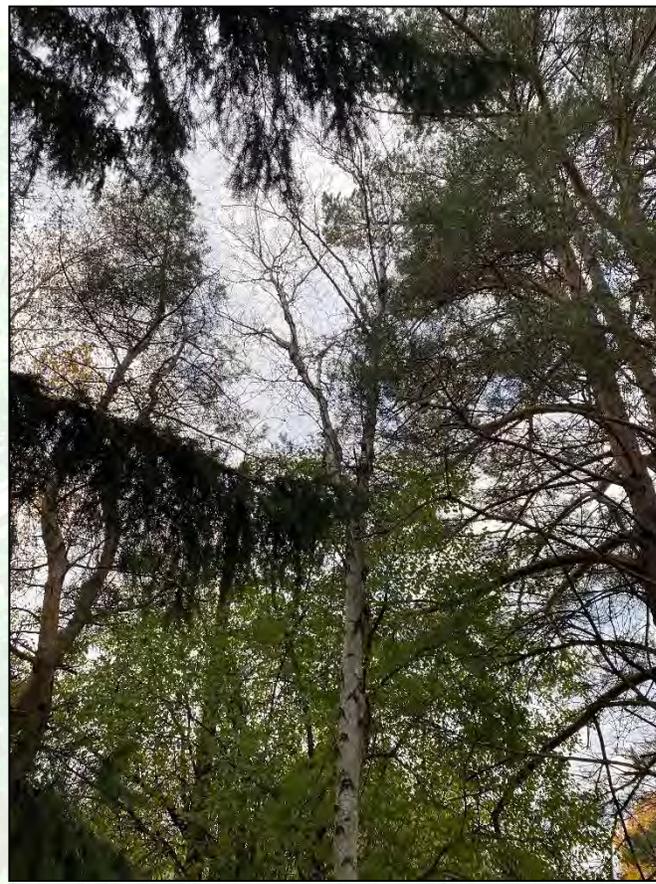
### Tree #431 – White Birch (18cm DBH)

Tree #	Tree Species	Botanical Name	DBH (cm)	Root Zone	Trunk Integrity	Crown Structure	Crown Vitality	Overall Condition
431	White Birch	<i>Betula papyrifera</i>	18	Good	Good	Fair	Good	Good

Tree #431, an 18cm DBH White Birch (*Betula papyrifera*) is a privately owned deciduous tree growing in the east portion of the property. This tree is co-dominant at 7m, has unhealed trunk wounds, dieback and deadwood. Overall this tree is in good condition.

Due to the location that this tree is growing and the proposed construction, this tree is recommended for removal. A permit is required for the removal of this tree.

One (1) replacement tree will require to be planted as compensation. The compensation trees should be at least 6cm diameter (deciduous), or at least 1.8m tall (evergreen). Tree species and quantities will be included in the landscape design drawings.

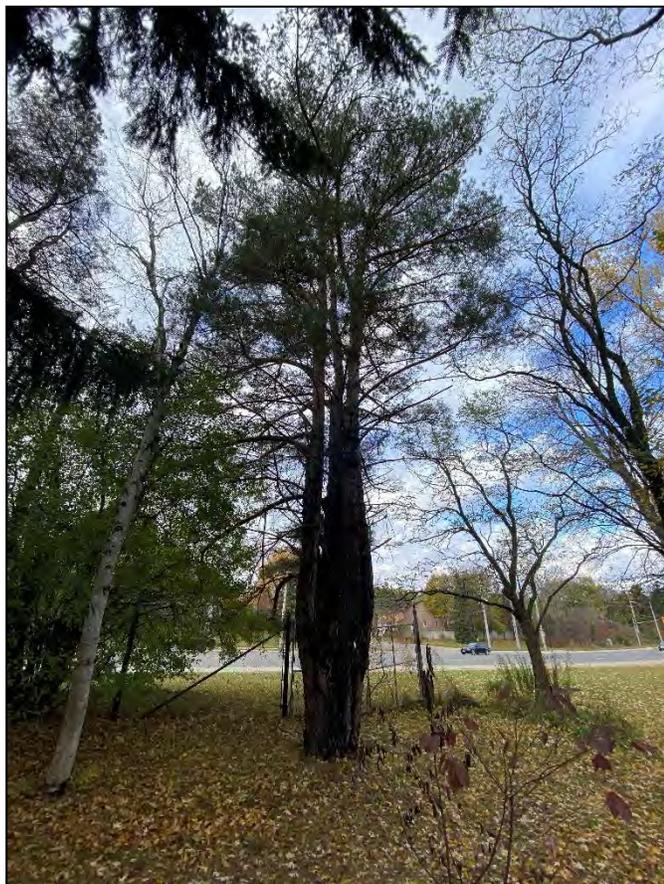
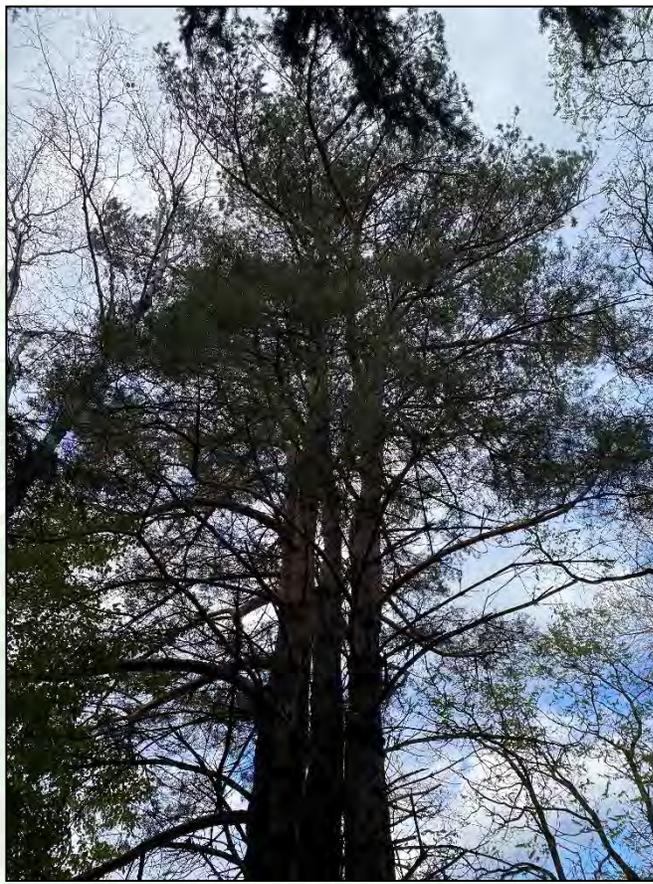
### Tree #432 – Scots Pine (32,36,40,49cm DBH)

Tree #	Tree Species	Botanical Name	DBH (cm)	Root Zone	Trunk Integrity	Crown Structure	Crown Vitality	Overall Condition
432	Scots Pine	<i>Pinus sylvestris</i>	32,36,40,49	Good	Good	Fair	Good	Good

Tree #432, a 32,36,40,49cm DBH Scots Pine (*Pinus sylvestris*) is a privately owned evergreen tree growing in the east portion of the property. This tree is co-dominant at 1.5m with included bark, dieback and deadwood. Overall this tree is in good condition.

Due to the location that this tree is growing and the proposed construction, this tree is recommended for removal. A permit is required for the removal of this tree.

Four (4) replacement trees will require to be planted as compensation. The compensation trees should be at least 6cm diameter (deciduous), or at least 1.8m tall (evergreen). Tree species and quantities will be included in the landscape design drawings.

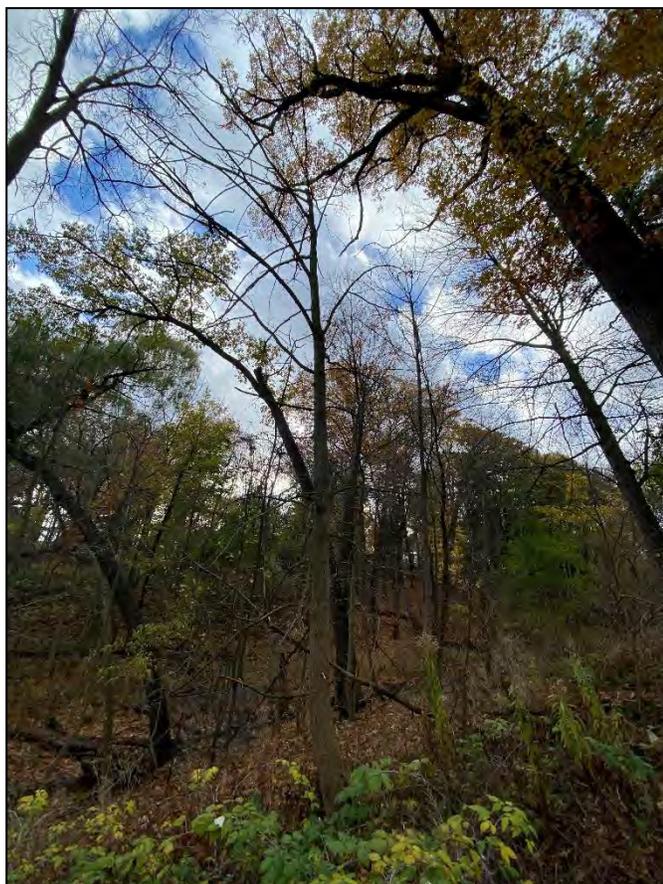
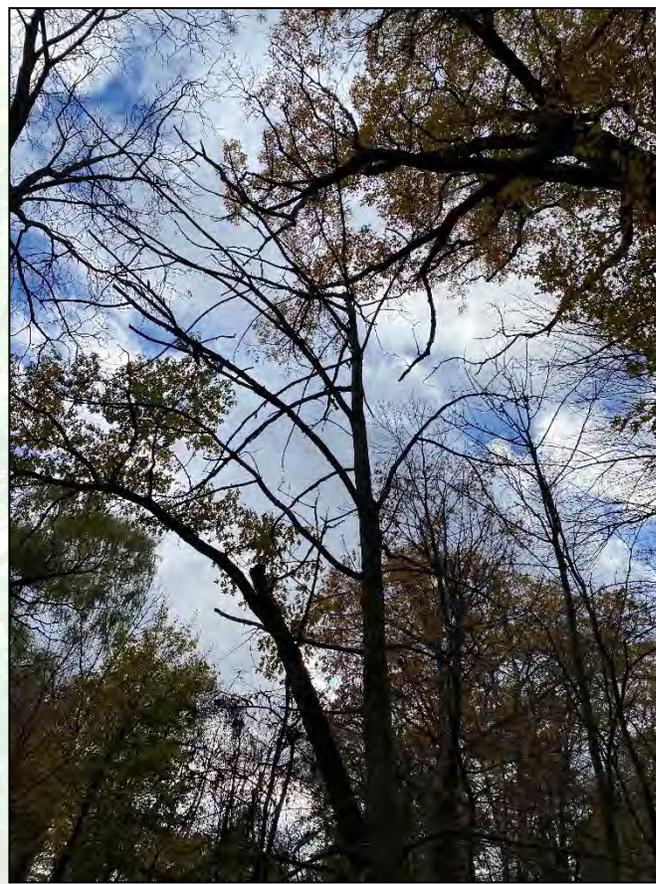
### Tree #443 – Green Ash (26cm DBH)

Tree #	Tree Species	Botanical Name	DBH (cm)	Root Zone	Trunk Integrity	Crown Structure	Crown Vitality	Overall Condition
443	Green Ash	<i>Fraxinus pennsylvanica</i>	26	Good	Poor	Poor	Poor	Poor

Tree #443, a 26cm DBH Green Ash (*Fraxinus pennsylvanica*) is a privately owned deciduous tree growing in the south portion of the property. This tree has fallen over and is leaning against another tree. This hanger needs attention and should be cut to lay the tree down on grade to make it safe. Overall this tree is in poor condition.

Due to the condition of this tree, this tree is recommended for removal. A permit is required for the removal of this tree.

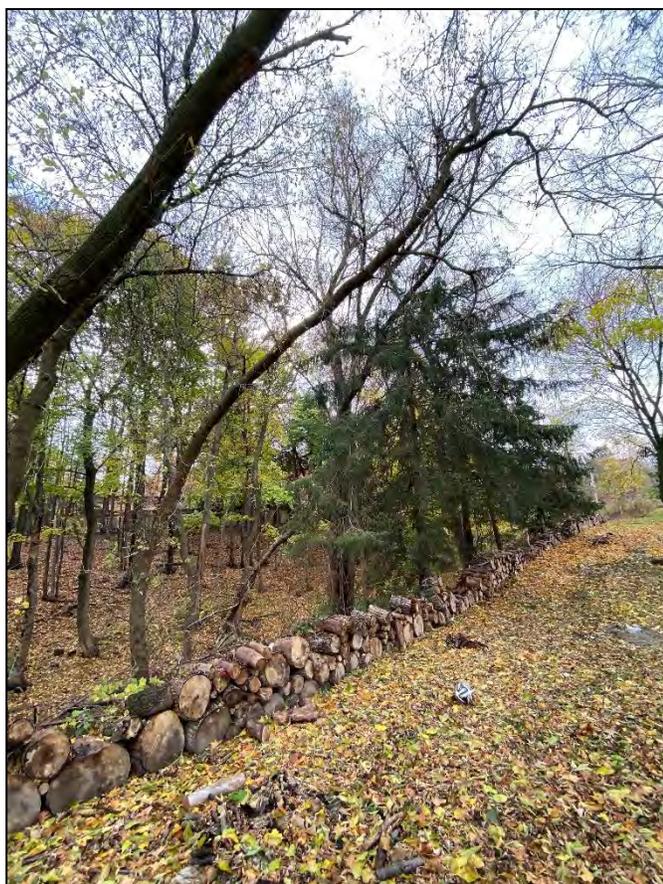
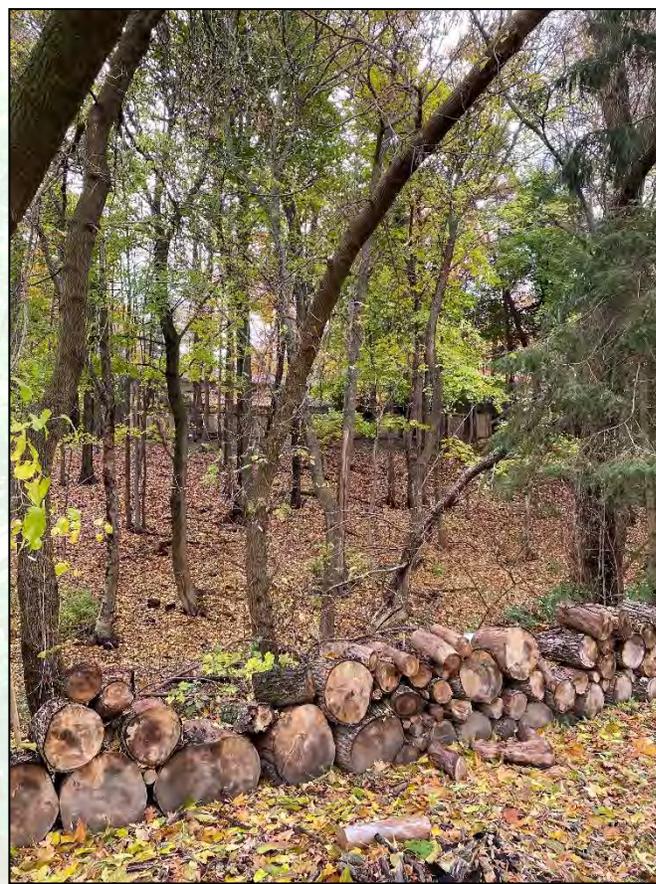
### Tree #454 – Manitoba Maple (18cm DBH)

Tree #	Tree Species	Botanical Name	DBH (cm)	Root Zone	Trunk Integrity	Crown Structure	Crown Vitality	Overall Condition
454	Manitoba Maple	<i>Acer negundo</i>	18	Fair	Fair	Fair	Fair	Fair

Tree #454, an 18cm DBH Manitoba Maple (*Acer negundo*) is a privately owned deciduous tree growing in the south portion of the property. This tree growing on a lean, and has girdling roots and epicormic growth. Overall this tree is in fair condition.

Due to the location that this tree is growing and the proposed construction, this tree is recommended for removal. A permit is required for the removal of this tree.

One (1) replacement trees will require to be planted as compensation. The compensation trees should be at least 6cm diameter (deciduous), or at least 1.8m tall (evergreen). Tree species and quantities will be included in the landscape design drawings.

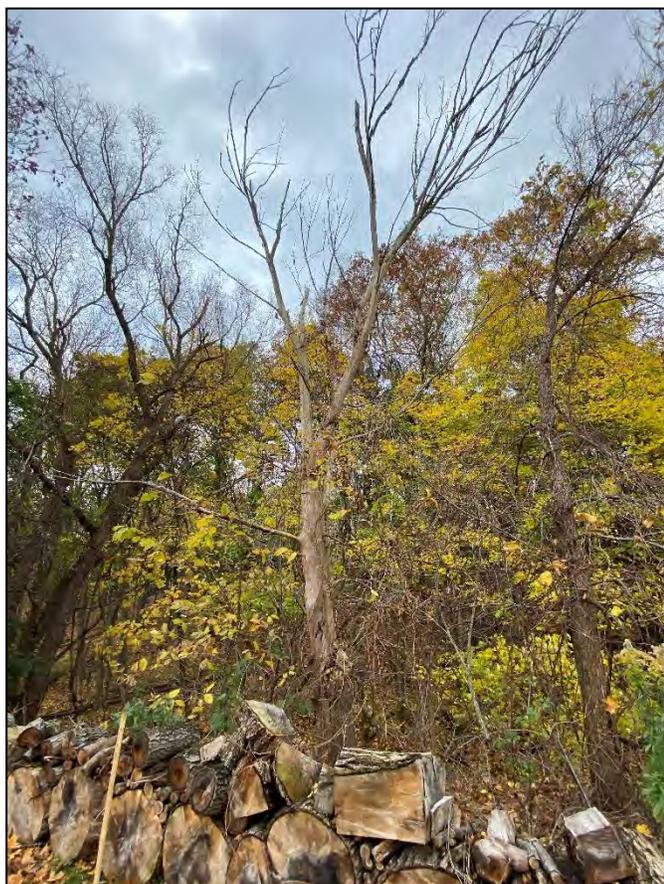
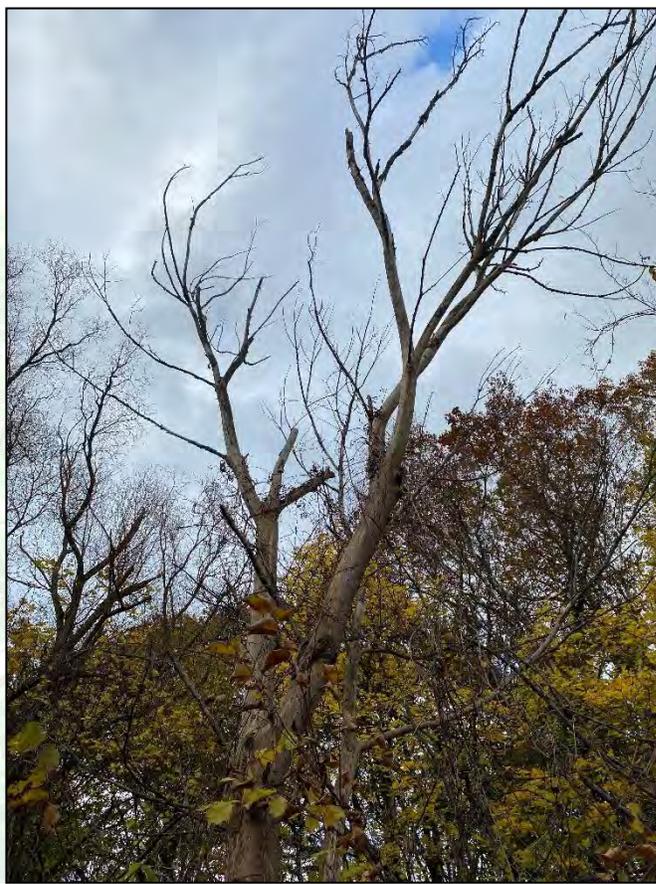
### Tree #460 – American Elm (30cm DBH)

Tree #	Tree Species	Botanical Name	DBH (cm)	Root Zone	Trunk Integrity	Crown Structure	Crown Vitality	Overall Condition
460	American Elm	<i>Ulmus americana</i>	30	Poor	Poor	Poor	Poor	Poor

Tree #460, an 30cm DBH American Elm (*Ulmus americana*) is a privately owned deciduous tree growing in the west portion of the property. This tree dead.

Due to condition of this tree, this tree is recommended for removal. A permit is required for the removal of this tree.

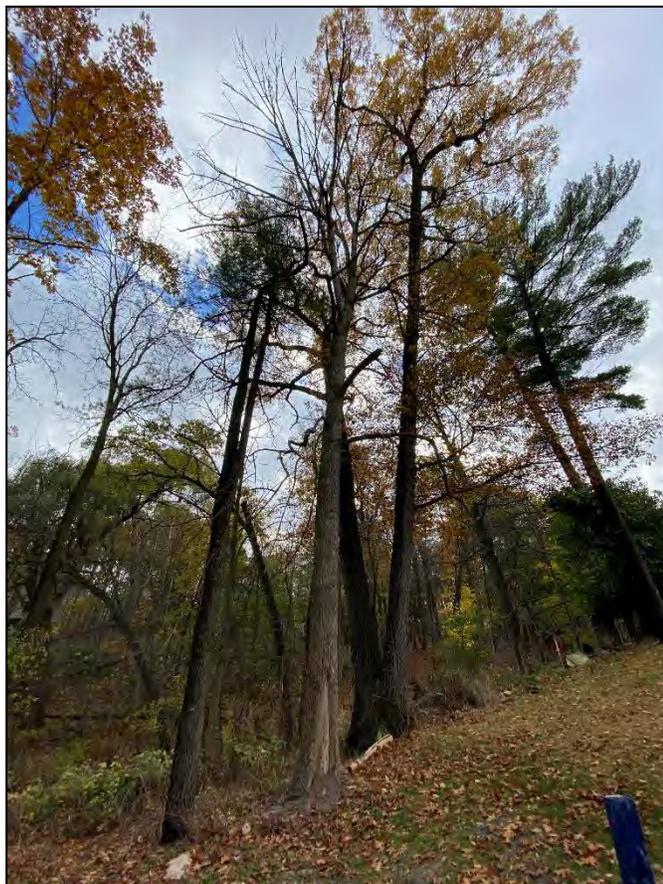
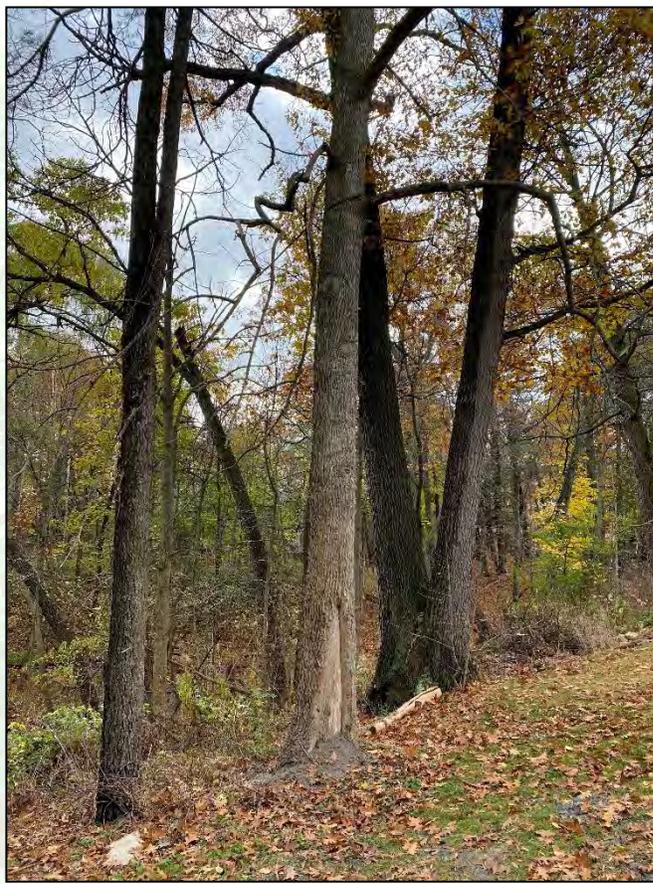
### Tree #464 – Green Ash (56cm DBH)

Tree #	Tree Species	Botanical Name	DBH (cm)	Root Zone	Trunk Integrity	Crown Structure	Crown Vitality	Overall Condition
464	Green Ash	<i>Fraxinus pennsylvanica</i>	56	Good	Fair	Fair	Poor	Poor

Tree #464, a 56cm DBH American Elm (*Ulmus americana*) is a privately owned deciduous tree growing in the south portion of the property. This tree has an unhealed trunk wound at base, decay at base, and is possibly dead. Overall this tree is in poor condition.

Due to the poor condition of this tree, this tree is recommended for removal. A permit is required for the removal of this tree.

Three (3) replacement trees will require to be planted as compensation. The compensation trees should be at least 6cm diameter (deciduous), or at least 1.8m tall (evergreen). Tree species and quantities will be included in the landscape design drawings.
