# Tributary of Fletcher's Creek Fluvial Geomorphological Assessment

**DeZen Lands Development**  
7140 Hurontario Street, Mississauga

Submitted:  
September 12, 2025

GEO Morphix Project No. 25102

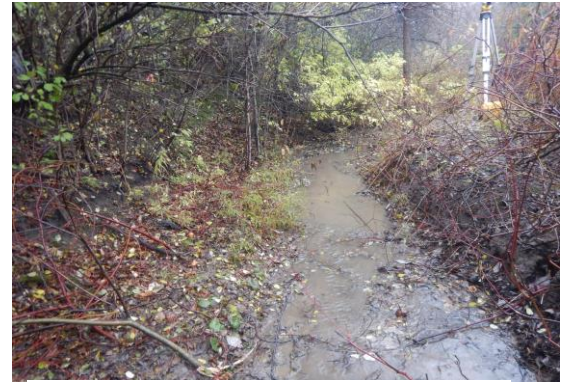
Photograph at cross section 4 (looking downstream)

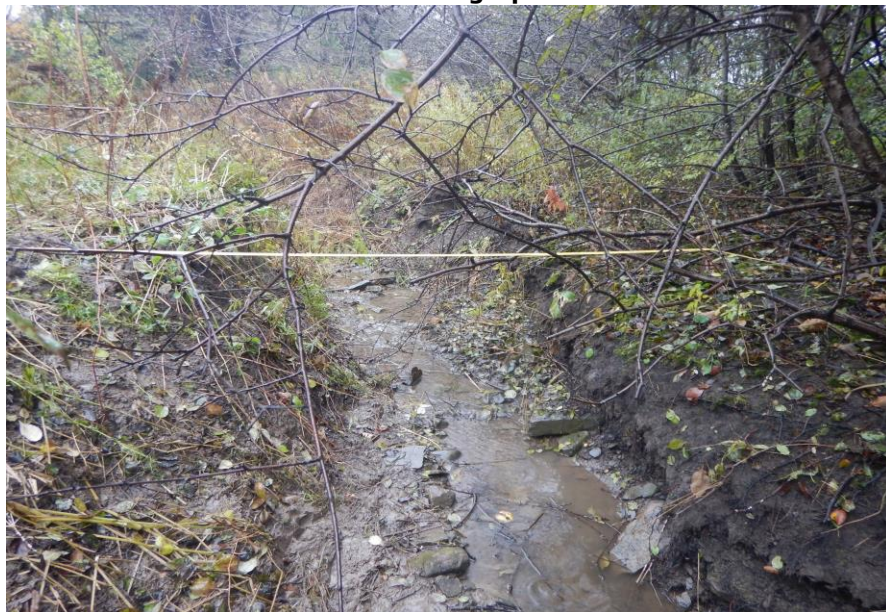
### Cross Section 6 - Facing Upstream

Reach FCT-1 was a mixed-load meandering channel, with a moderate gradient that sits within a confined valley. The channel flowed through a continuous riparian buffer zone that extended 4 to 10 times the channel width and contained predominately trees and herbaceous vegetation. The channel was heavily encroached by vegetation. High density of woody debris was observed in the channel. The average bankfull width and depth were 2.44 m and 0.50 m. The average wetted width and depth were 0.93 m and 0.05 m. Bank angles ranged from 25 to 90 degrees, with undercutting measured up to 0.4 m. Bed materials ranged from clay to cobbles in riffles, and clay to gravel in pools. Bank material consisted of clay and silt.
