Soil Engineers Ltd.

Reference No. 2006-S167

**Re: A Slope Stability Assessment for
Proposed Residential Development
44-45 Longview Place
City of Mississauga**

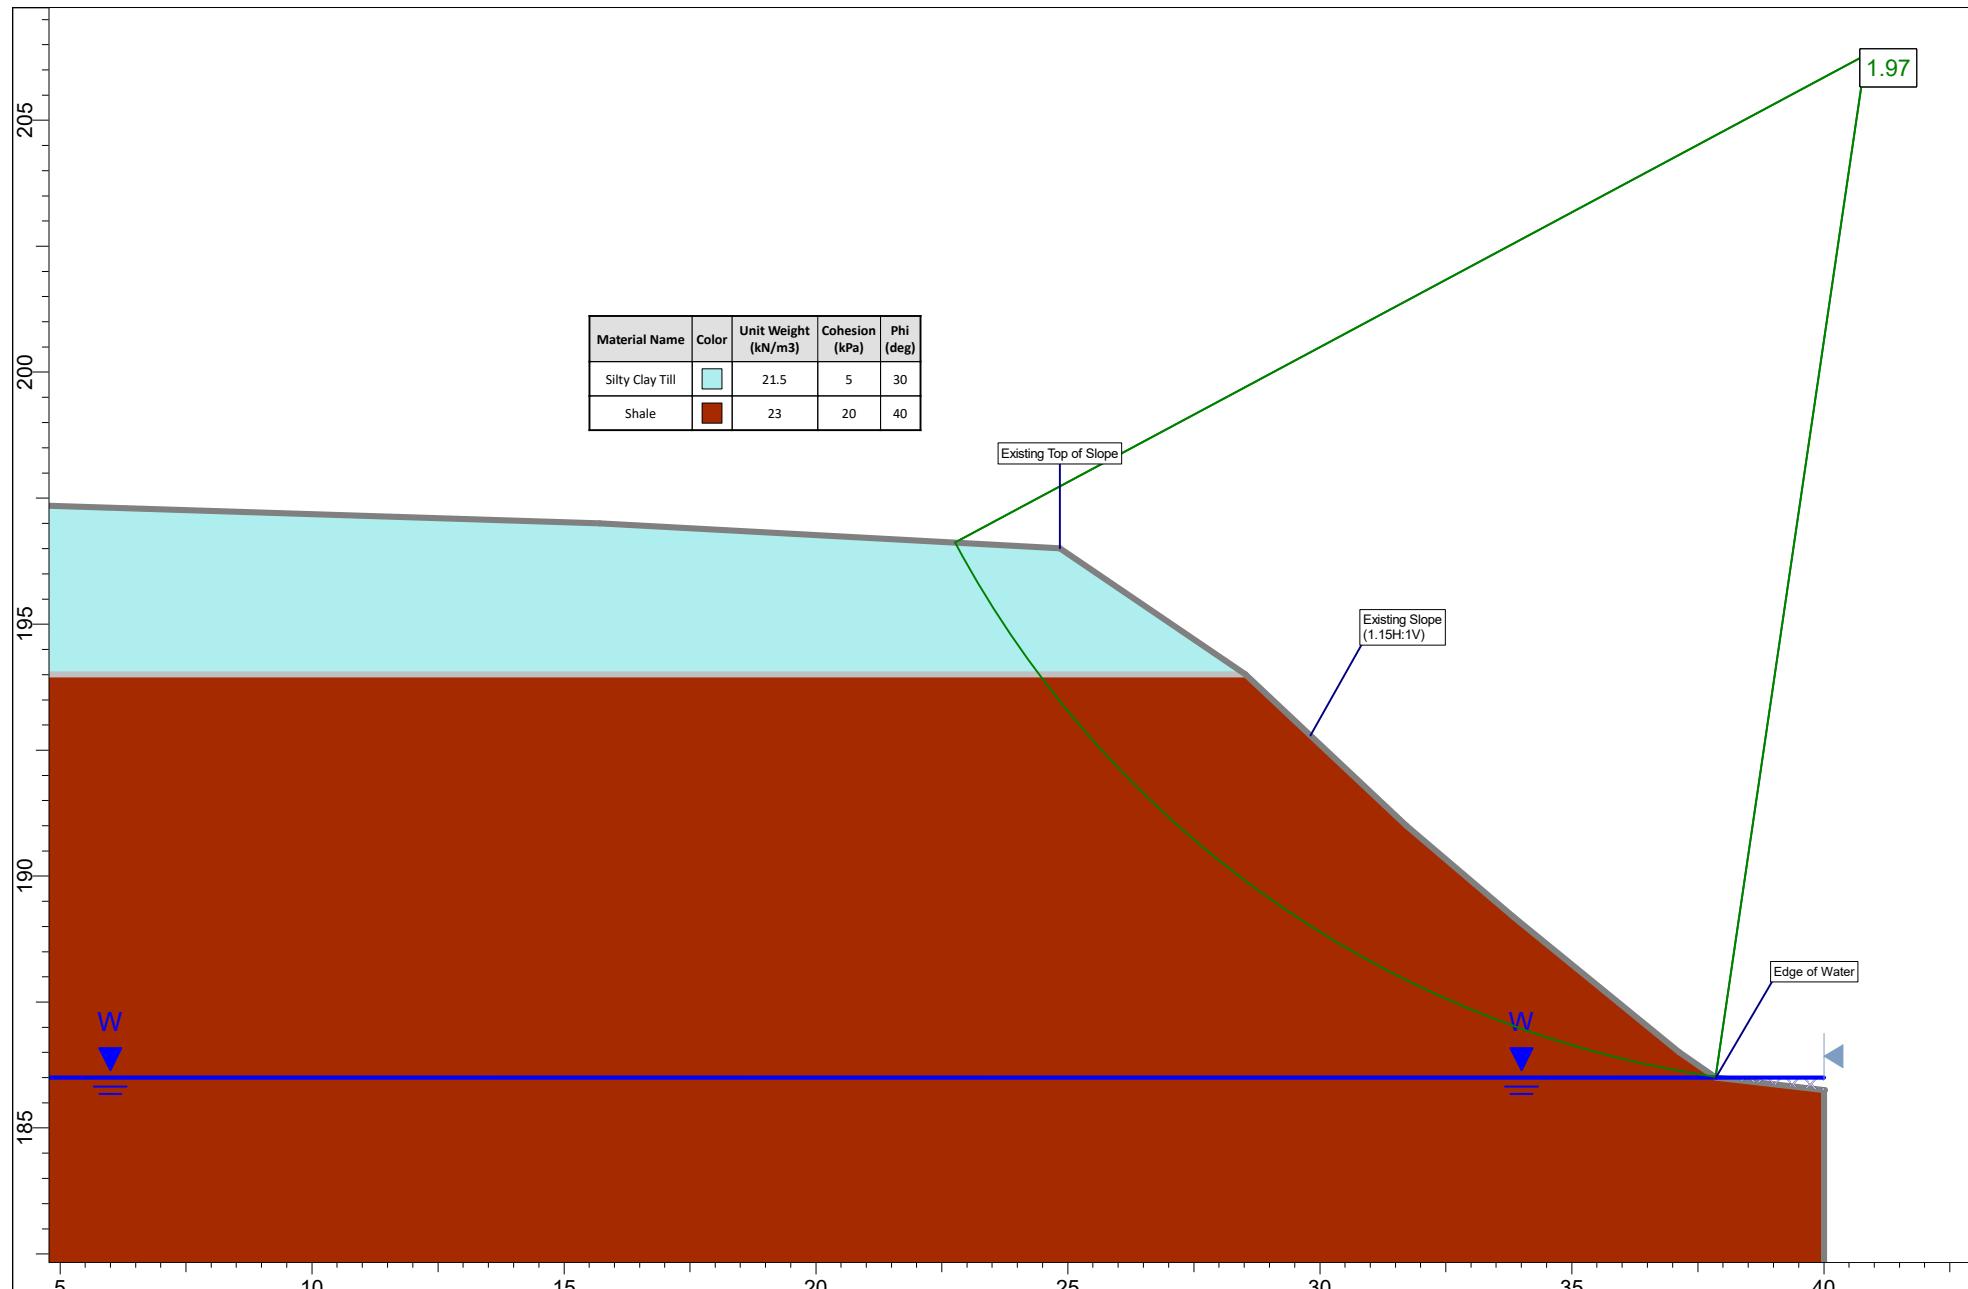
Cross-Section	Existing Gradient (H:V)	Existing FOS	FOS under Elevated Groundwater Condition
A-A	0.97 to 1.66:1	2.04	1.53
B-B	0.65:1	1.67	1.31
C-C	1.15:1	1.97	1.48

The resulting FOS of the analyses at Cross-Sections A-A, B-B and C-C at existing conditions meet the Ontario Ministry of Natural Resources (OMNR) and the Credit Valley Conservation (CVC) guideline requirements (minimum FOS of 1.5). In addition, the resulting FOS for all cross-sections also meet the required FOS under elevated groundwater condition (minimum FOS of 1.3). The results are presented in Drawing Nos. 2 to 7.

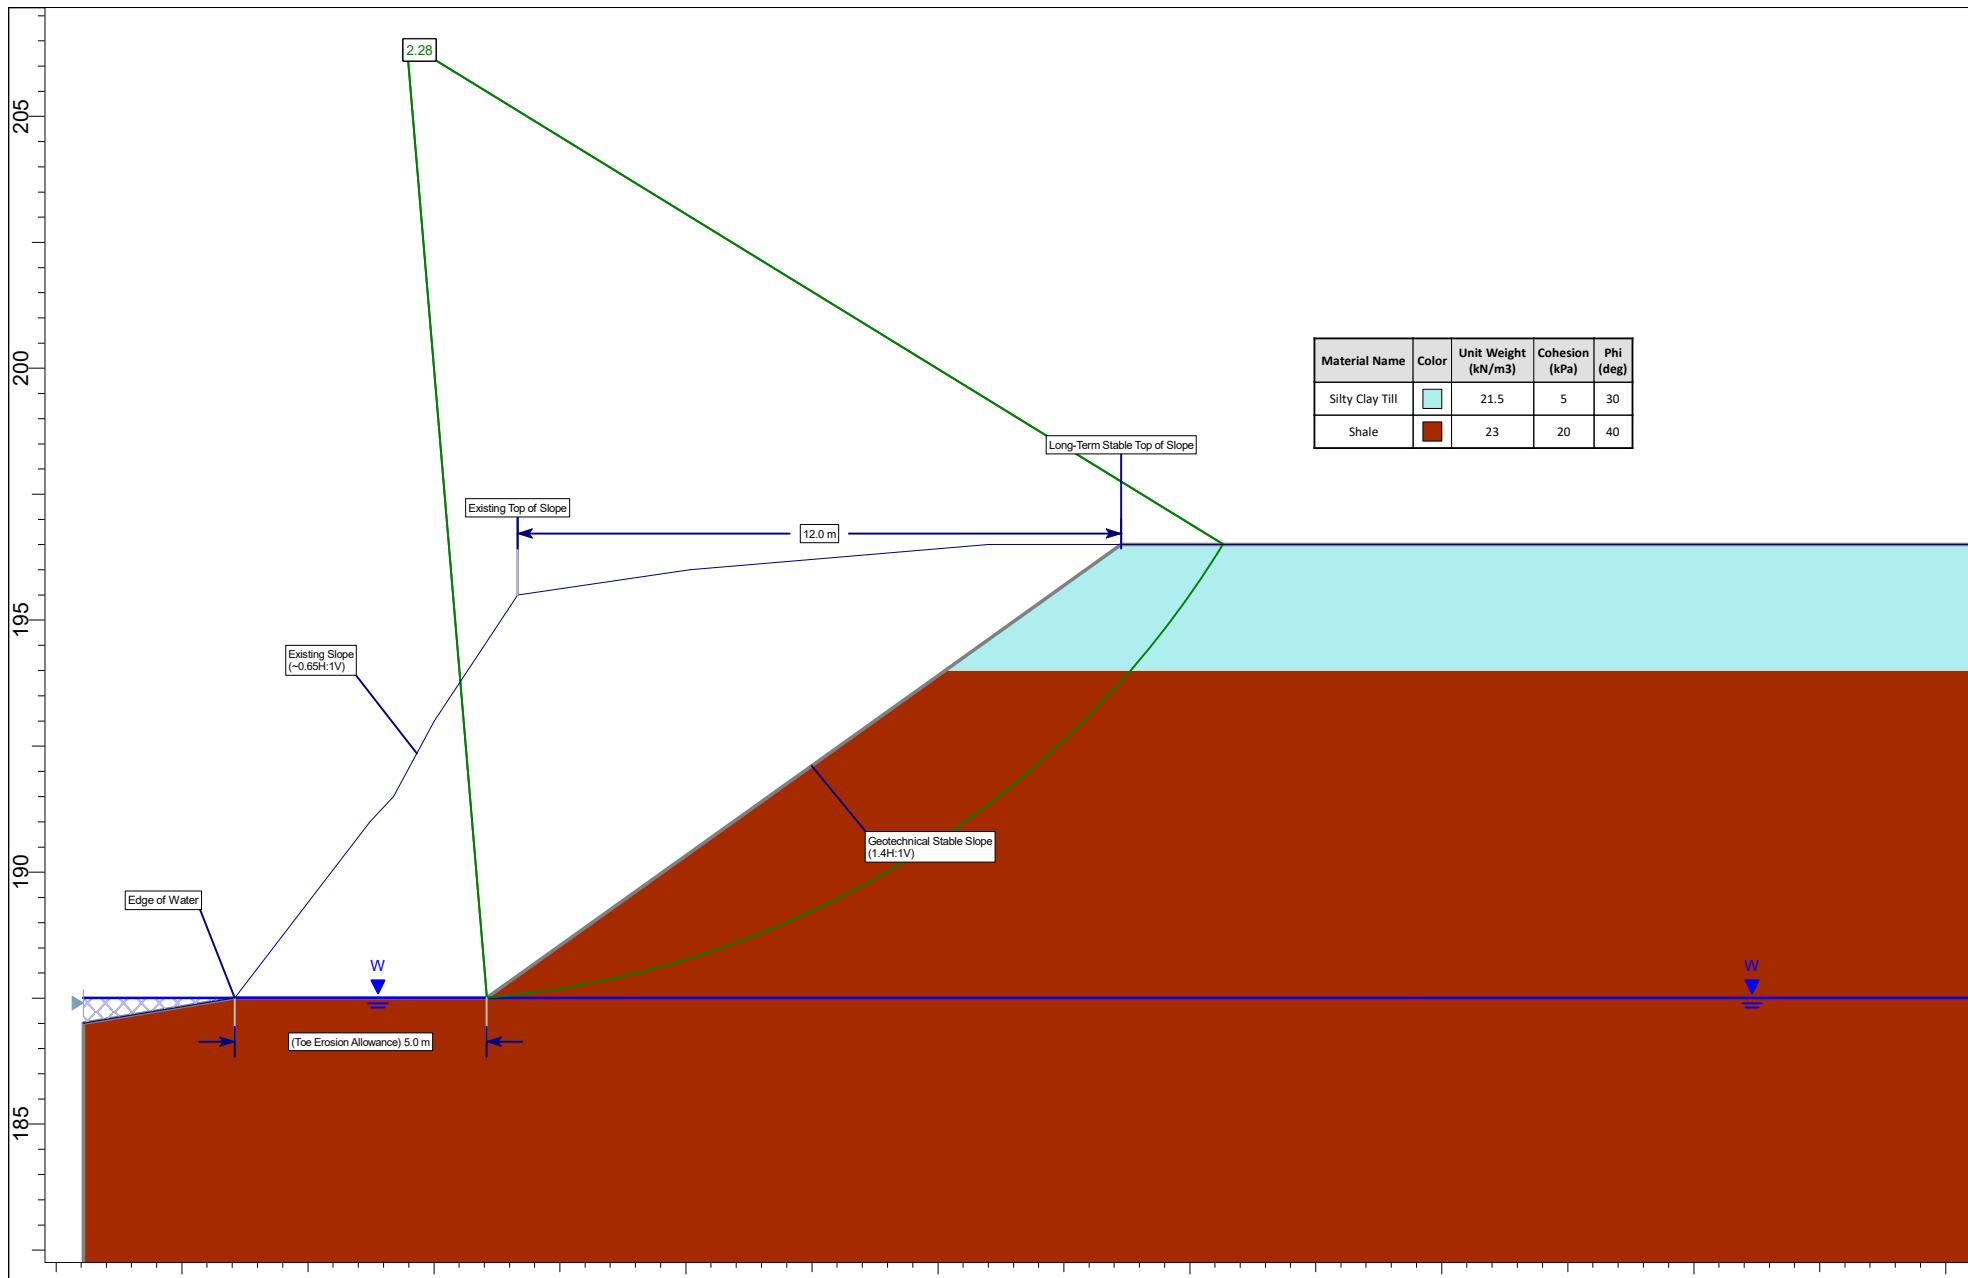
Cross-Sections	FOS (normal water condition)	FOS (elevated water condition)
A-A	2.15	1.63
B-B	2.28	1.73
C-C	2.13	1.58
