# Credit River Erosion Control Project Behind Kenninghall Blvd and Plainsman Rd

Municipal Class Environmental  
Assessment

**Public Information Centre**

Date: February 2026

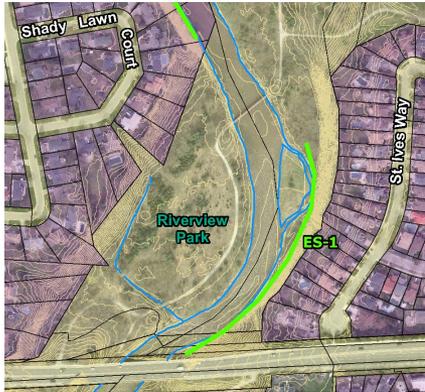
## Erosion Site 1 (ES-1)

Stable toe of valley slope behind St. Ives Way.

- Previously identified as CRAMS Erosion Site 7
- ES-1 is located along the outside of a meander bend where it contacts the valley wall
- Approximately 250 m in length
- No erosion protection
- No evidence of active erosion
- Secondary channel in upstream portion of site that travels along the toe of valley wall, but potential hazard is apparently decreasing over time as suggested by the channel width decrease from 14 m to <3 m between 1954 and 2022

**Hazard Level: 2**

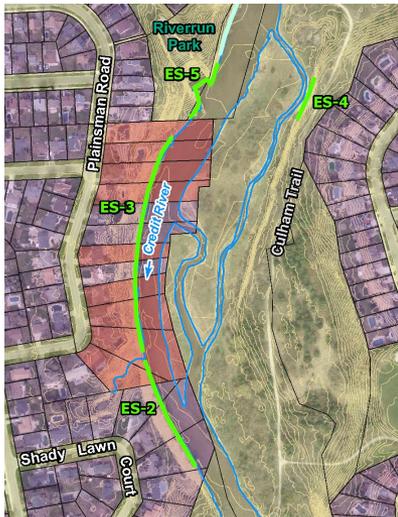
## Erosion Site 2 (ES-2)

Gabion protected toe of valley wall behind properties along Shady Lawn Court

- Previously identified as CRAMS Erosion Site 6A
- Straight section of channel with gabion installed along toe of valley wall
- Gabion wire in frequent contact with flow was mostly missing, but there was no notable displacement of gabion stone
- Erosion protection continues to be effective

**Hazard Level: 2**

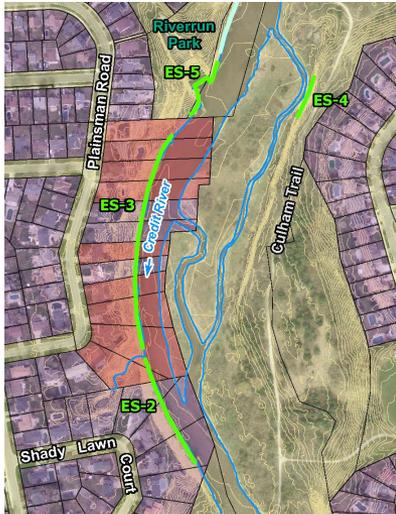
## Erosion Site 3 (ES-3)

Eroding toe of valley wall at 19  
Plainsman Road

- Previously identified as CRAMS Erosion Site 6B
- Located along the outside of a low-radius meander bend
- Observations limited to two properties as most are non-participating properties along Plainsman Road
- Erosion and toe instability were observed at 19 Plainsman Road

**Hazard Level: Not assessed  
due to limited observations**

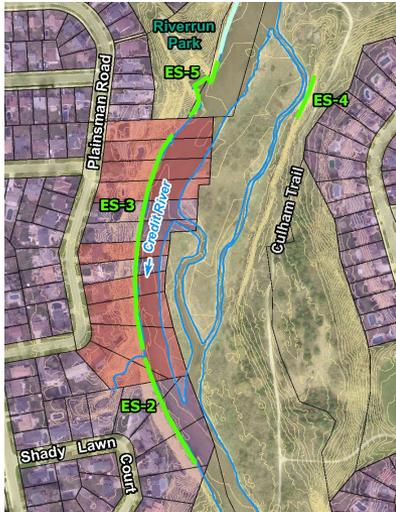
## Erosion Site 4 (ES-4)

Armourstone retaining wall  
between secondary channel and  
Culham Trail

- Previously identified as CRAMS Erosion Site 5B
- 50 m long, ~1.5 m high armourstone retaining wall to support Culham Trail
- Minimum separation of 2 m between wall and secondary channel
- Width of secondary channel has decreased from 11 m to 3.0 between 1954 and 2022, suggesting decreasing hazard over time

**Hazard Level: 3**

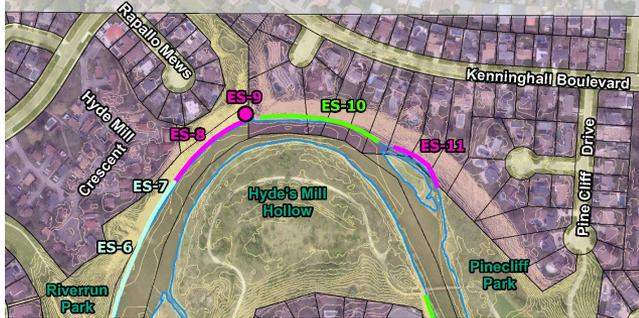
## Erosion Site 6 (ES-6)

Gabion and vegetation along toe of valley wall behind Hyde Mill Crescent

- Straight section of channel with 130 m of gabion installed along toe of valley wall
- Gabion wire in frequent contact with flow was partially missing, but there was no notable displacement of gabion stone
- Erosion protection continues to be effective

**Hazard Level: 2**

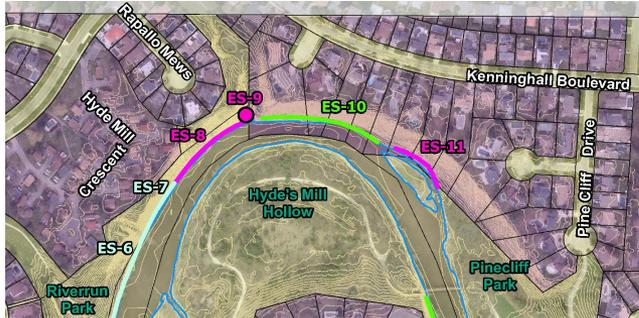
## Erosion Site 7 (ES-7)

- Unprotected valley wall approximately 35 m in length behind Hyde Mill Crescent
- Toe is eroded and steepened
- Lower portion of toe is comprised of shale, which offers erosion protection only during periods of low-flow
- Less than 20 m between Hyde Mill Crescent properties and toe of valley wall

**Hazard Level: 5**

- Erosion Site 7 - 33 m of eroded toe of valley wall creating a risk to residential properties along Hyde Mill Crescent
- Erosion Site 9 - a storm sewer outfall and channel, between Rapallo Mews and Colbert Gardens, with failed bank armoring that has resulted in erosion into private property

- Bioengineering in the form of a vegetated rock buttress will be constructed to protect the exposed toe of valley wall at Erosion Site 7 and to replace the failing erosion protection measures along the storm sewer outfall channel at Erosion Site 9 and failing gabion at Erosion Site 5.
- At Erosion Sites 9 and 12, the armourstone at Erosion Site 9 will be re-used to construct a drop structure at the end of each outfall structure to prevent bed scouring and headwall undermining.
- At Erosion Site 8, the gabion at the toe of the armoured valley wall will be repaired with the installation of new gabion wire on the damaged face to contain the gabion stone. If any displaced gabion stone needs to be replaced, it can be sourced from Erosion Site 9 or Erosion Site 5.

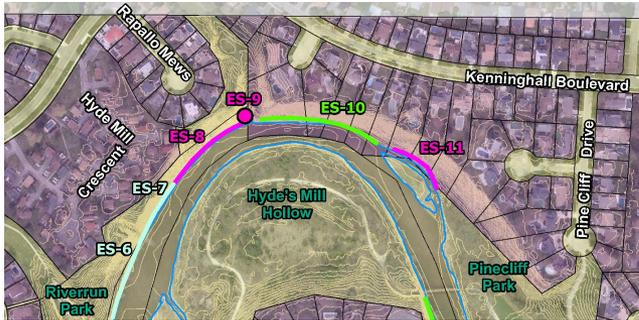
## Erosion Site 8 (ES-8)

Exposed shale under gabion toe

- Existing City monitoring site
- 100 m of gabion protecting valley wall near apex of meander bend
- Gabion at toe in poor condition with stone loss
- Gabion sits atop shale which provides erosion resistance

**Hazard Level: 4**

- Erosion Site 5 - a failed gabion at the outlet of the Mullet Creek diversion structure
- Erosion Site 8 - 100 m of failing gabion at the toe of an armoured valley wall behind the residential properties at the end of Rapallo Mews
- Erosion Site 12 – a failed bed scour protection at a storm sewer outfall in Pinecliff Park

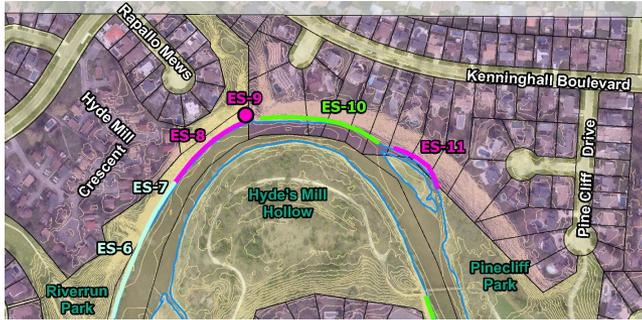
## Erosion Site 9 (ES-9)

- Existing City monitoring site
- Bed scouring of storm sewer outfall channel resulted in armourstone wall undermining and failure
- The armourstone wall protected the adjacent private property
- Outfall channel is in generally poor condition

**Hazard Level: 5**

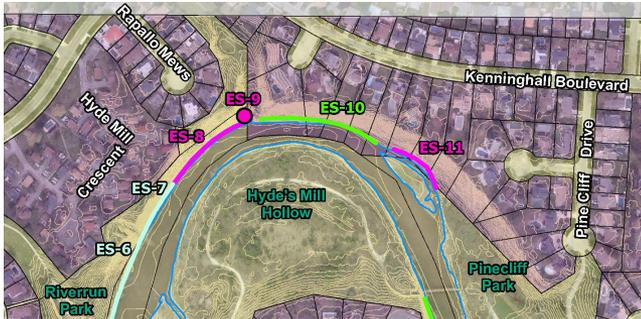
## Erosion Site 10 (ES-10)

Unprotected valley wall behind  
Kenninghall Boulevard

- Previously identified as CRAMS Erosion Site 4
- Armourstone along the toe of valley wall was in good condition with no contact with flow
- The unprotected portion of valley wall just upstream of the meander bend apex shows no evidence of erosion

**Hazard Level: 1**

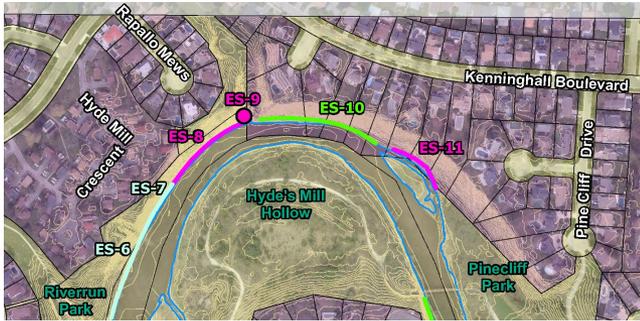
## Erosion Site 11 (ES-11)

Vegetated buffer between channel and toe of slope

- Existing City monitoring site
- Secondary channel width decreased from 8.5 m to 5.5 m between 2005 and 2022 suggesting decreasing hazard to properties
- Fine bed materials in secondary channel indicates low erosive forces

**Hazard Level: 2**

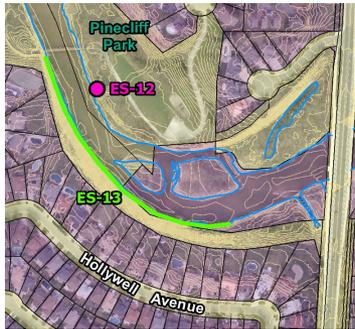
## Erosion Site 12 (ES-12)

Storm sewer outfall structure at main channel

- Existing City monitoring site
- Bed scour protection at the end of the storm sewer outfall structure has failed
- Potential for structure undermining with further deterioration of bed scour protection

**Hazard Level: 4**

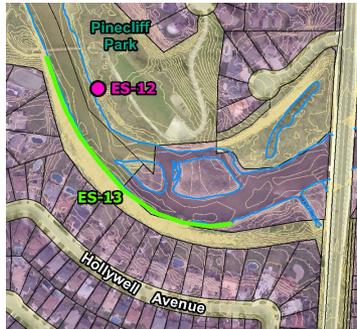
## Erosion Site 13 (ES-13)

Armourstone in good, stable condition

**Hazard Level: 1**
