WATERSIDE
EXECUTIVE CENTRE
31 Lakeshare Road East
Missiassauga, Ontario

Item 3. Appendix 3
Heritage Advisory Committee
Agenda – November 20, 2012

PORT CREDIT POST OFFICE AND ARMOURY 31 Lakeshore Road East, Mississauga **CONSERVATION PLAN**

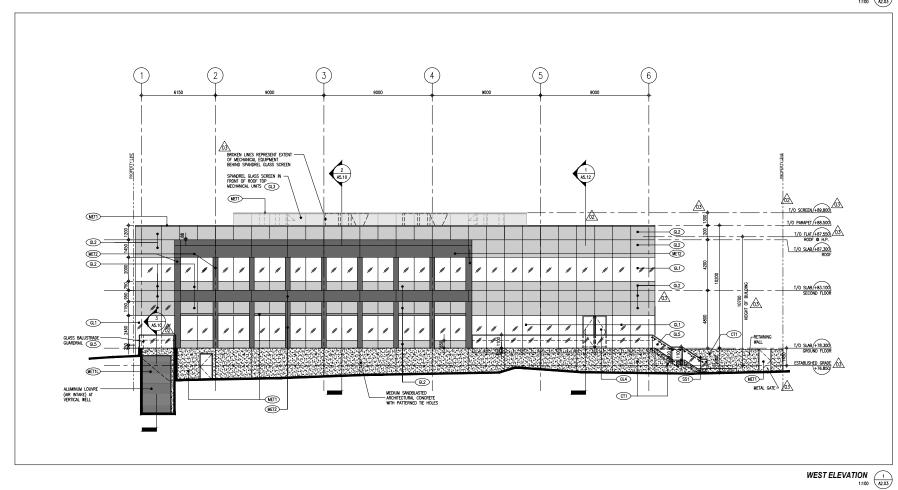
A5.02

EAST AND WEST **BUILDING ELEVATIONS** Site Plan Application #: SP 12/074 W1 Waterside Executive Centre & Office Building 31 Lakeshore Road East, Mississauga, Ontario 1:100 1051-00

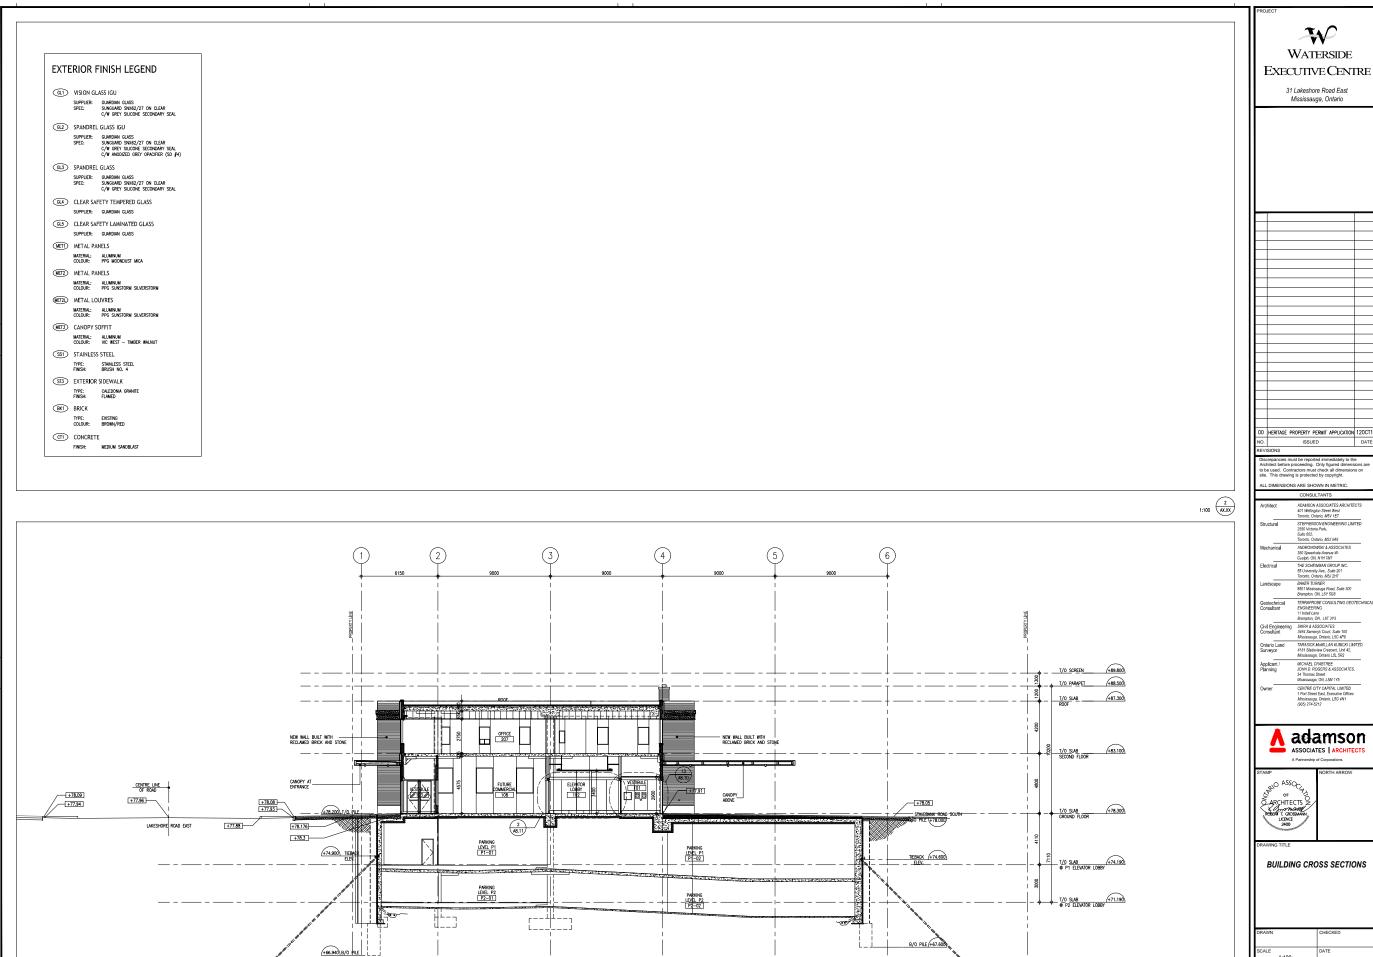
CENTRE CITY CAPITAL LIMITED
1 Port Street East, Executive Offices
Mississauga, 1911
(905) 274-5212 **∧** adamson **BUILDING CROSS SECTIONS** 1:100 1051-00 00 A5.03

NORTH-SOUTH CROSS SECTION (LOOKING EAST) 1:100 (A203)

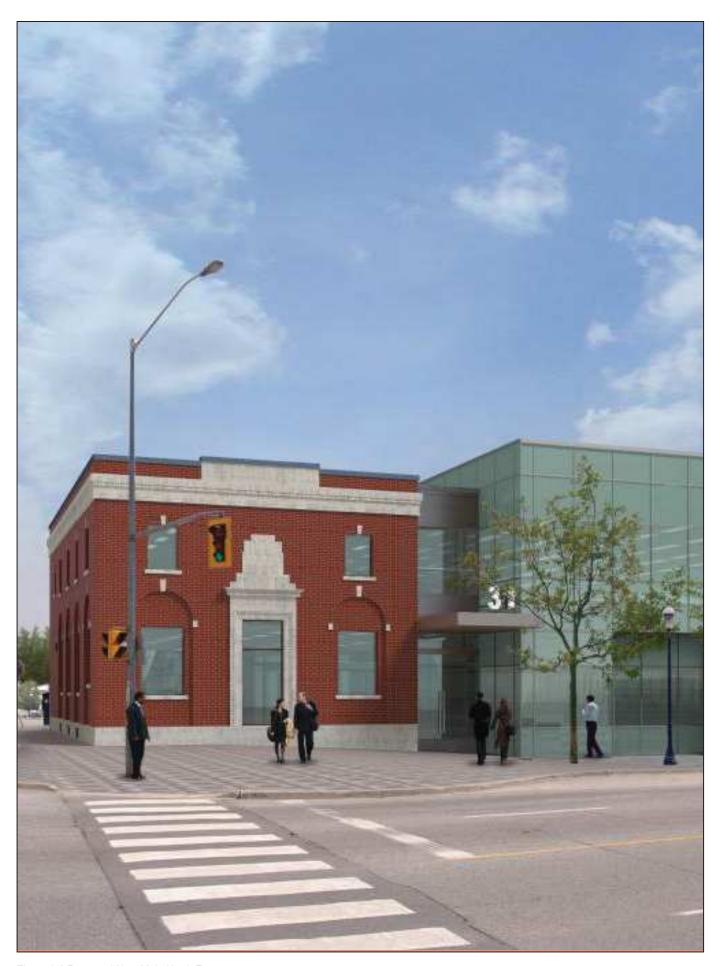
Figure 0.2 Proposed New Main North Entry

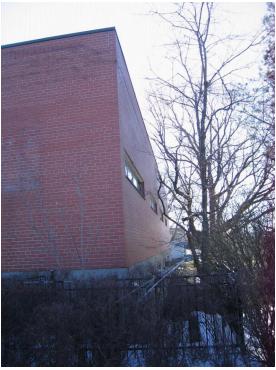
Figure 3.10 West Strip Windows

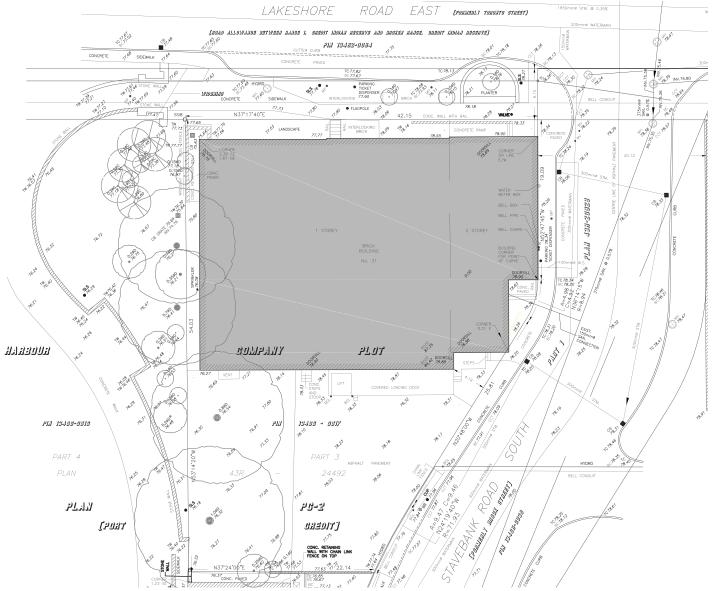
Figure 4.1 - Existing Site Plan Showing Landscaping

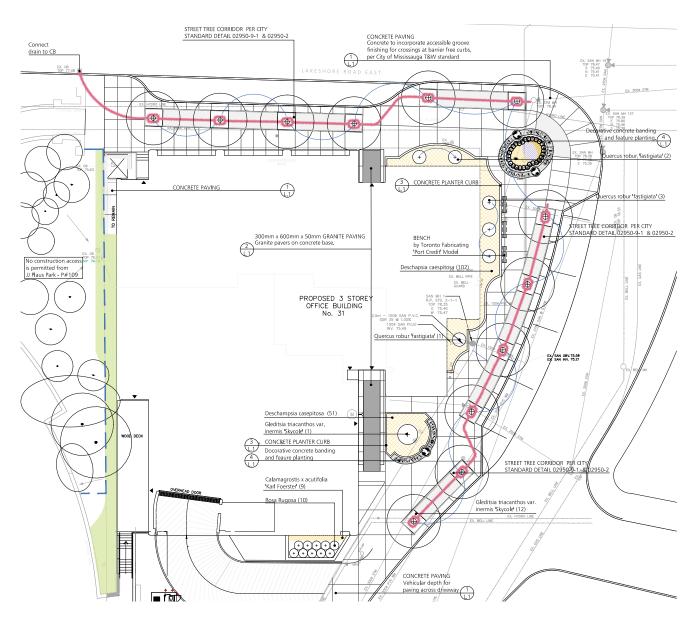
Figure 4.4 Proposed Landscape Plan

The proposed replaces west side Willows and London planes (due to proposed excavation) with shading deciduous integrated with proposed deck area. Most of the Norway Pine will be maintained. Landscaping along Lakeshore is to be intensified with 6 tree wells with large deciduous. There is a proposal to widened Stavebank sidewalk facing East with a focus piece raised garden and bench area at the corner, with the elimination of the concrete entry ramp and steps. 6 tree wells are proposed for along Stavebank and edge landscape beds around the Post Office building. This landscaping would occur with the realignment of Stavebank South with Stavebank North.

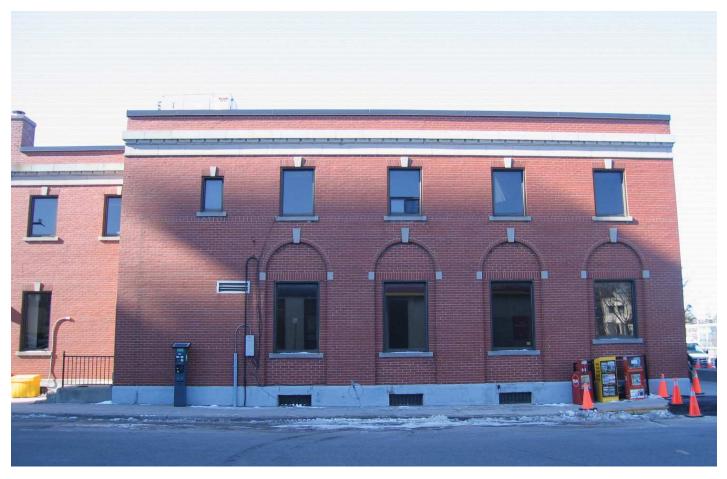
Figure 5.1 - East Elevation to be Preserved and Restored

The North, East and South return walls of the 1931 post office are in generally good condition owing largely to the good workmanship and quality of the brick, mortar and stone components.

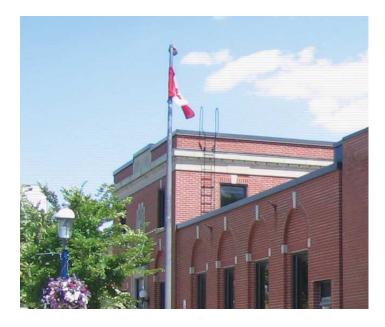
Figure 5.2 - Brick and limestone masonry to be salvaged from upper 2nd Floor

Limestone frieze bands, window keys and sills are to be salvaged from the upper storey of the 1931 west elevation (currently obscured by the latter additions). Brick from this wall is to be salvaged as well for reuse replicating the walls to the east and south. Care will need to be taken in the mortar removal given the mortar density. The west upper storey contains enough brick and limestone components to rebuild the portion of the East and South wall complete with matching windows and frieze band limestone components. The salvage brick would be limited to the face brick and the backing brick salvaged from the later additions which have a matching brick size.

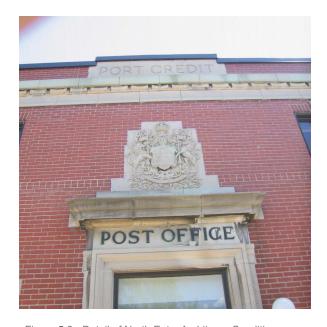
Figure 5.3 - Detail of North Entry Architrave Condition

Both the original entries to the 1931 building were highly emphasized with limestone architraves and distinctive signage. Both the architraves and the signage are to be conserved and restored, however the entries are no longer functional in the proposed scheme and will have their steps and landings removed. It would be incongruous to maintain or replicate inoperative doors in these locations and the openings are significantly larger and extend lower then the window openings. The intent is to replace these doors with large glass voids that mark the door opening and draw attention to the architraves, but do not try to recreate a period type window or replicate inactive doors suspended above the ground. The removal of steps and ramp at both doors will expose areas of foundation wall which will be repaired to match the adjacent cemetitious facing.

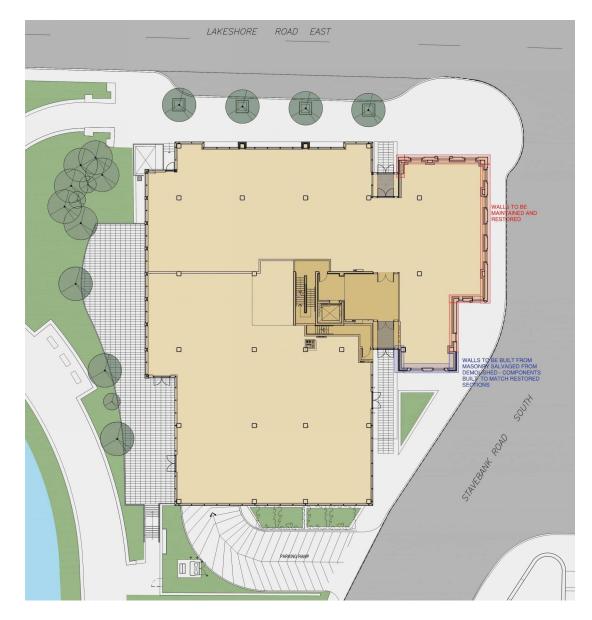
Figure 6.1 - Ground Floor Plans showing preserved and rebuilt walls

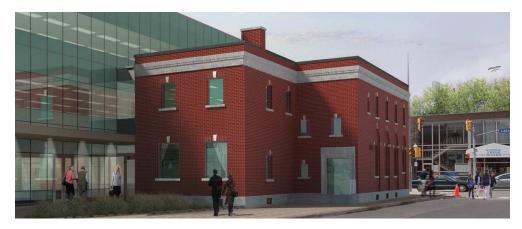
Figure 6.2 - South and East rebuilt walls to match existing 1931 window openings and masonry details

Prior to or concurrent with the masonry restoration work, using the salvaged masonry, the portions of the South and East Walls can be built tying into the existing walls. The tie-in joint will be 'toothed' in to the existing to blend with the existing building. The toothed joint should be treated as a control joint and not mortared but caulked with a matching coloured sealant, then sand dusted with mortar sand. This will accommodate likely movement between the 2 structures and subtly demarcate the original from the replica.

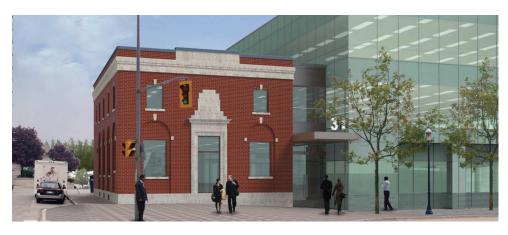
Figure 6.3 - East, North and a portion of the West wall preserved and restored

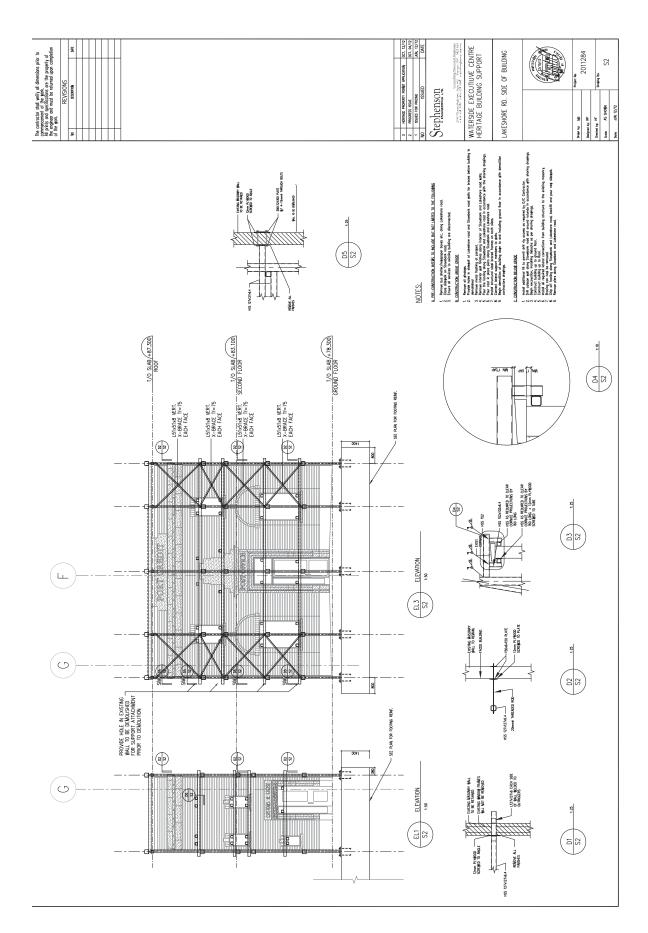
Figure 9.1 - Support Amature Design for North and South Walls

Construction of support will be carried out by restoration subtrades experienced in this form of masonry support structure. The armature itself is to be designed and inspected by a structural engineer again experienced in this form of shoring and maintenance of heritage masonry walls. Figures 9.1, 9.2 and 9.2 illustrate the proposed design of this structure. All opening are to be blocked with wood braces supporting both vertically and horizontally.

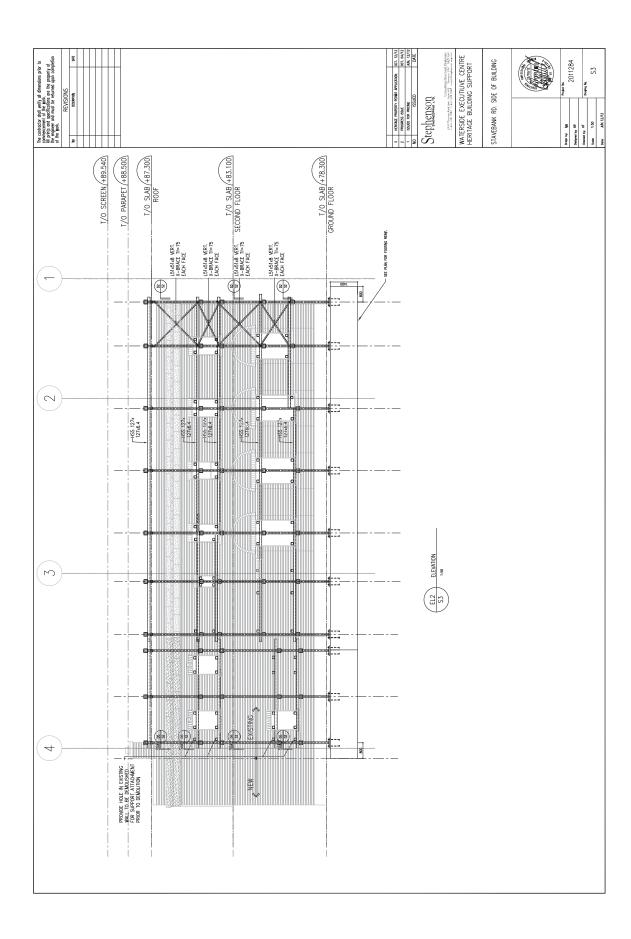
Figure 9.2 - Support amature Design for East Wall

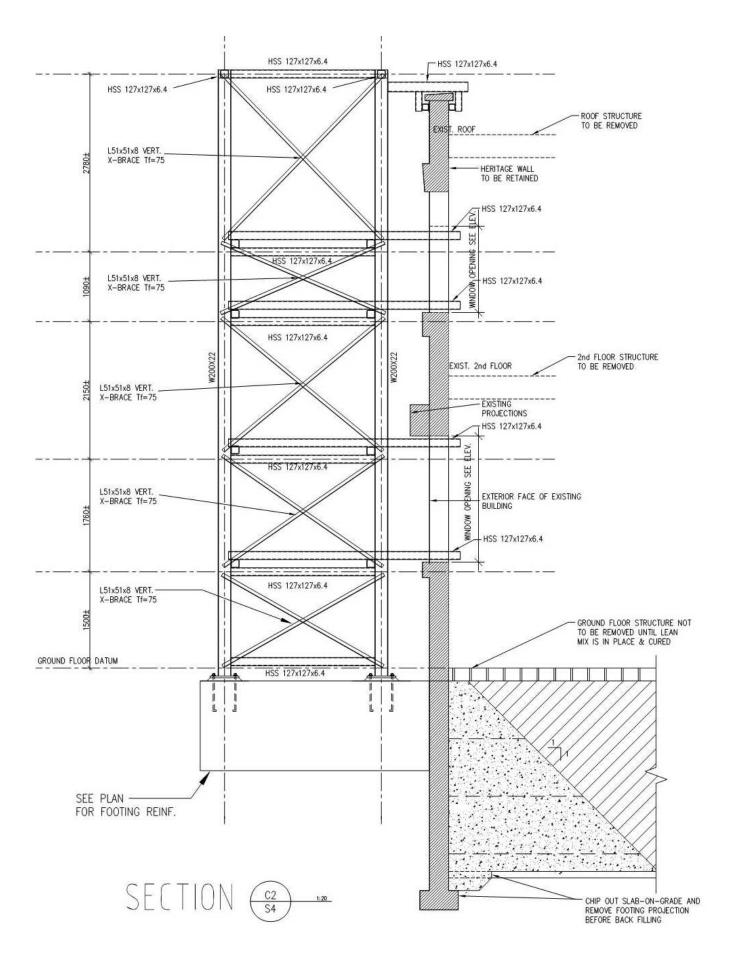
Figure 9.3 Proposed Wall Shoring Section
