Proposed Mixed-Use Redevelopment:

17 & 19 Ann Street, 84 & 90 High Street East and Part of 91 Park Street
East, Mississauga, ON

Type of Document: Geotechnical Investigation

BRM-00239423-E0

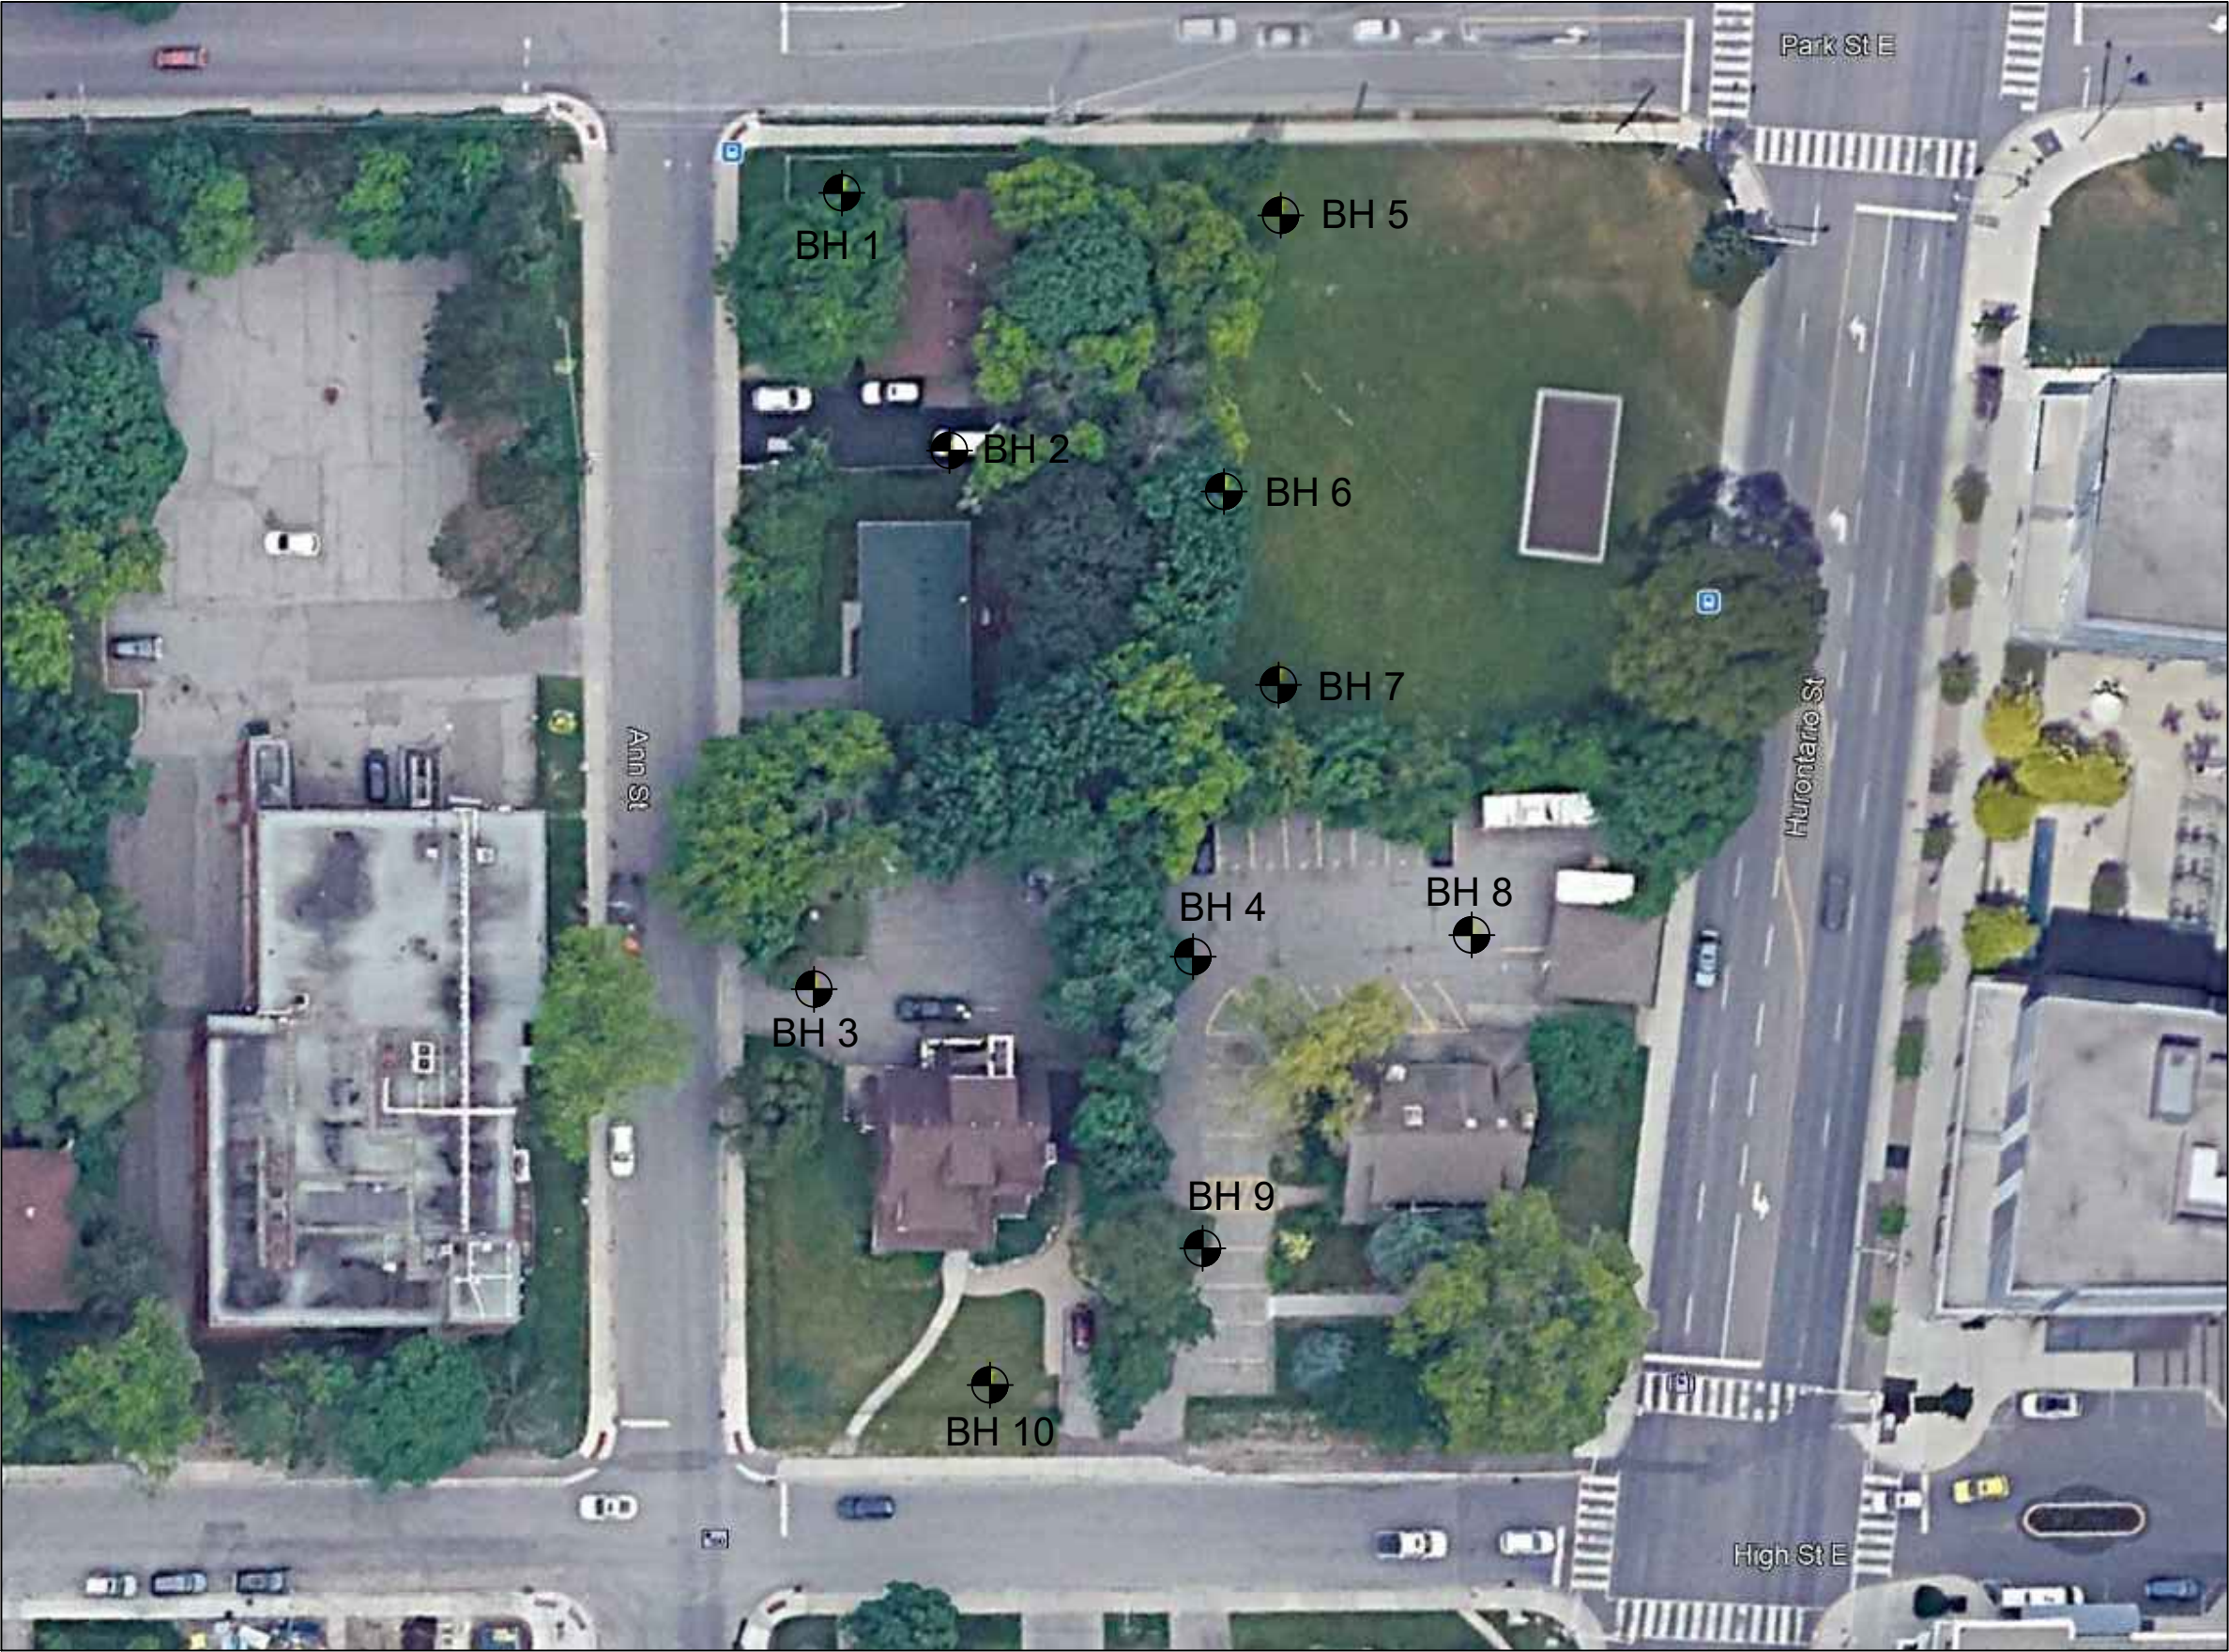
DRAWING TITLE: BOREHOLE LOCATION PLAN	
PROJECT NAME: Geotechnical Investigation	
SITE LOCATION: Ann St and High St E Mississauga, ON	
PROJECT No. BRM-00239423-E0	
<div>exp Services Inc. t: +1.905.793.9800 f: +1.905.793.0641 1595 Clark Boulevard Brampton, ON L6T 4V1 Canada www.exp.com</div> <div>
