# Cooksville Creek Erosion Control Project at Camilla Road

**Online Public Information Centre (PIC)**

## Study Purpose

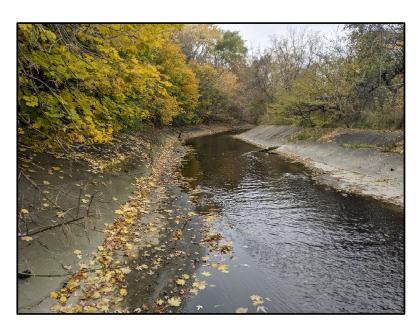
Upstream of Camilla Road Trapezoidal concrete channel (Looking Upstream facing West)

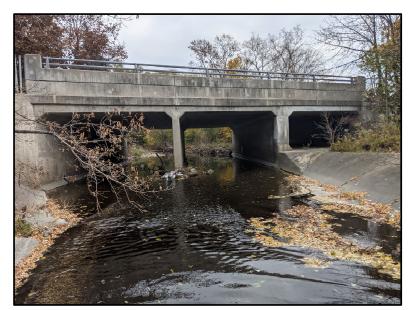
Bridge at Camilla Road 3-cell culvert (Looking Downstream facing East)

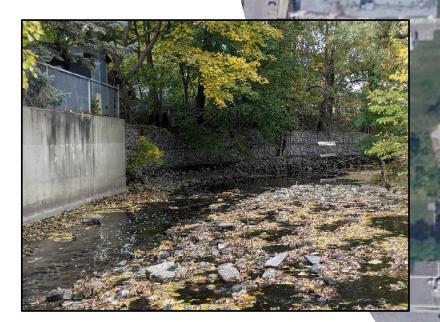
Downstream of Camilla Road
Channel banks transition from concrete
vertical wall to Gabion baskets
(Looking Downstream facing East)

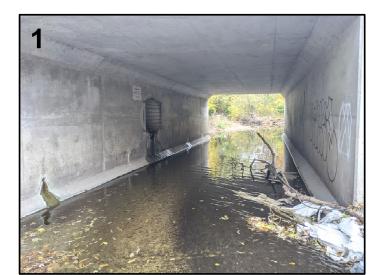
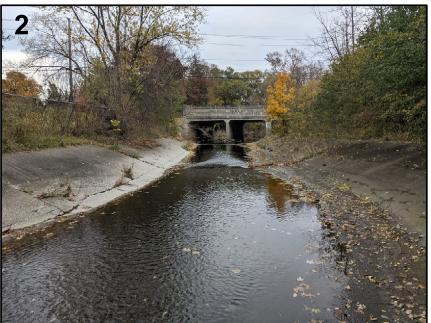
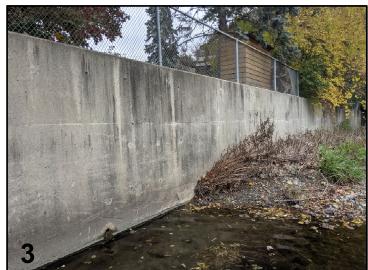
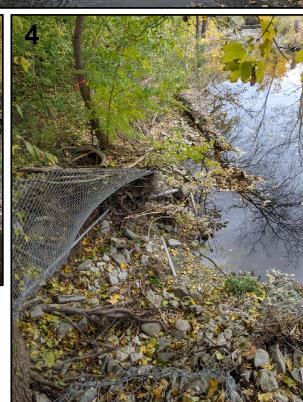
- The channel includes a 3-cell culvert at Camilla Road, with an overflow cell along the south bank. The culvert appears to be in good condition, but sediment and debris has begun to accumulate within the structure.
- Cooksville Creek upstream (west) of Camilla Road consists of a trapezoidal concrete structure in poor condition.
- Downstream (east) of Camilla Road, the creek has banks that transition from a concrete vertical wall to a Gabion basket wall. The Gabion baskets have either failed or are at risk of failure due to undermining along the bank.
- The nearby Hydro One corridor is outside the study area.

- 1. View inside Camilla Road culvert
- 2. Trapezoidal concrete channel (looking downstream)
- 3. Concrete wall along creek bank
- 4. Failed Gabion baskets along creek bank

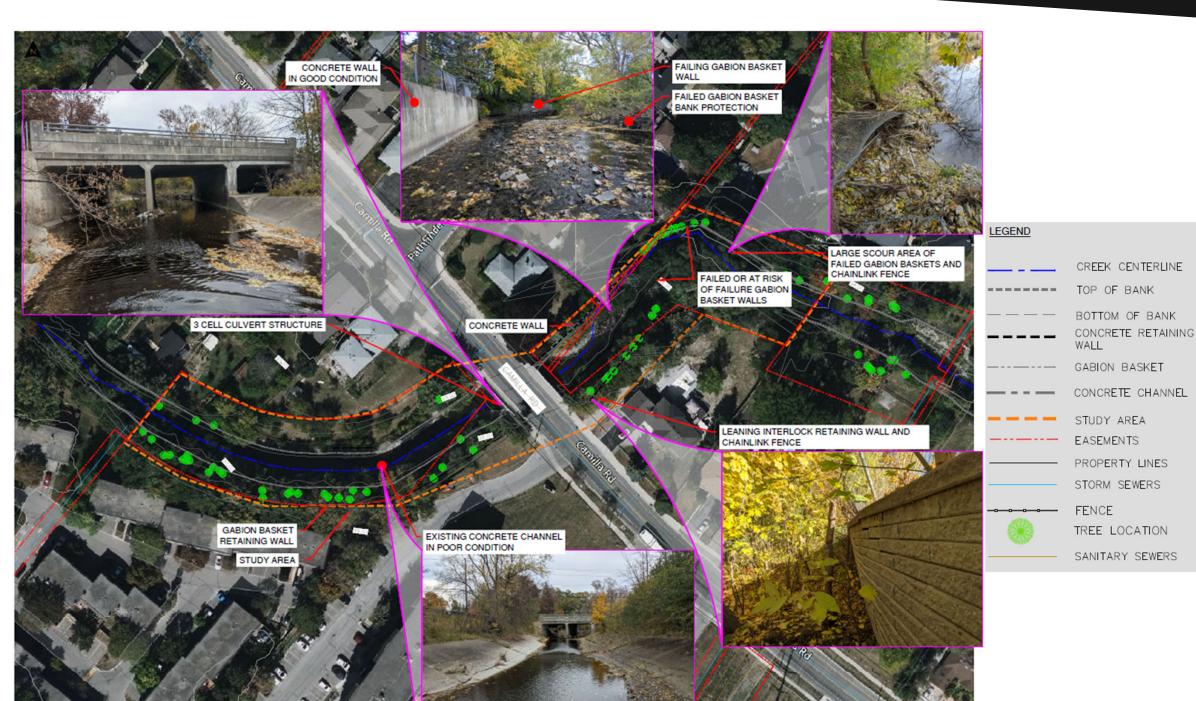
#### 'Do Nothing'

- No changes to the existing channel.
- This alternative is used for comparison purposes when evaluating the other alternatives.
- Required as per the Municipal Class EA process.
- Failing channel structures will continue to degrade and increase risk to property and infrastructure.
- No environmental benefit is provided.

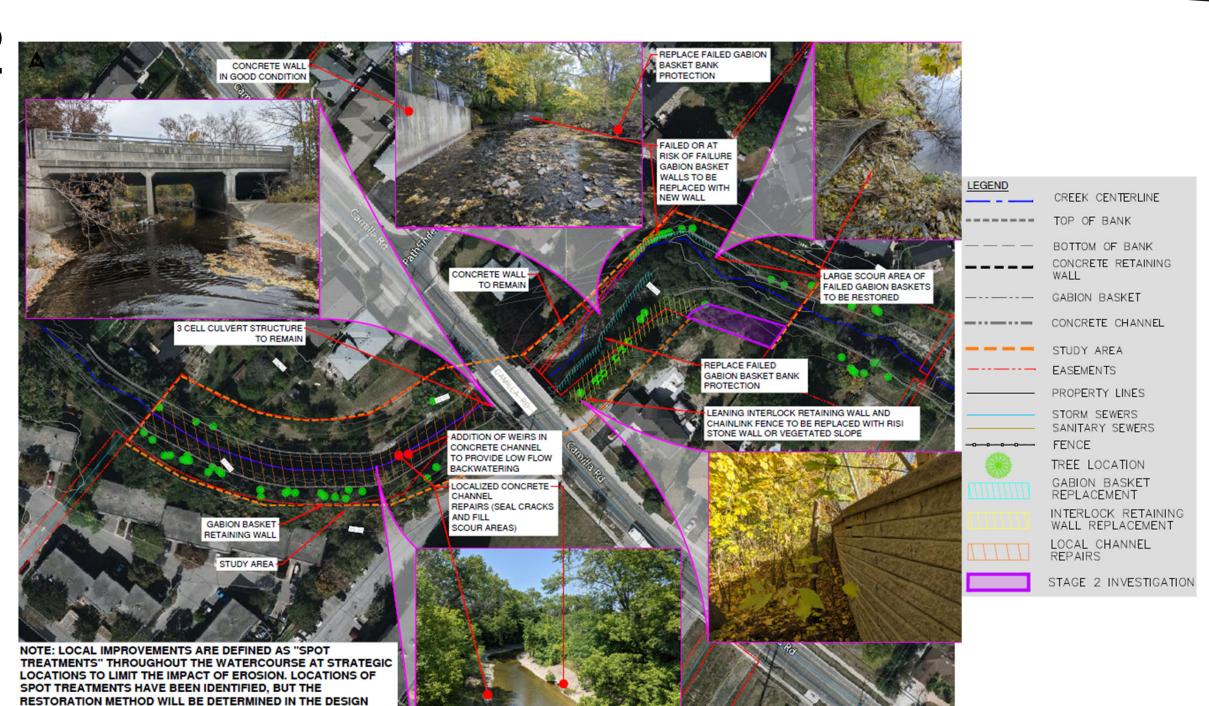
#### Local Improvements

- Includes "spot treatments" along the channel at strategic locations to limit the impact of erosion.
- Includes filling/repairing cracks and scours in the concrete, replacement of the failed Gabion walls and bank protection with new erosion protection and replacing the leaning interlocking wall with a new protected slope or wall.

PHASE. THE PROPOSED SOLUTIONS ON THIS DRAWING WOULD

BE EVALUATED DURING DESIGN.

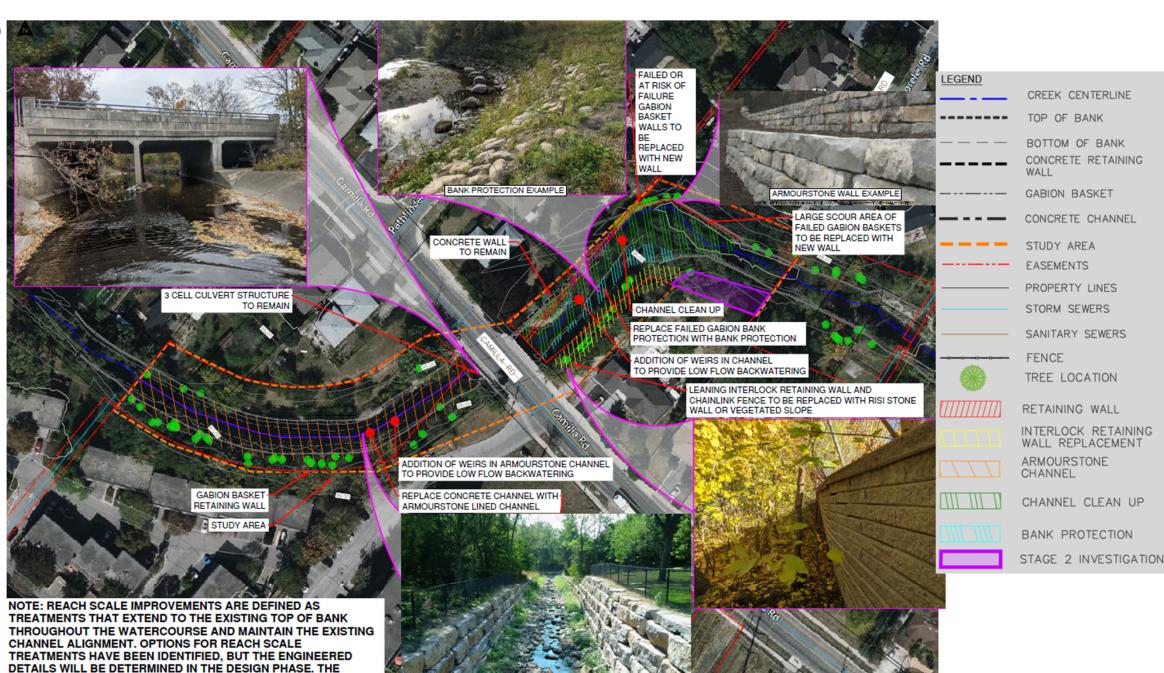
Reach Scale Improvements

- Includes treatments that extend to the existing top of bank and maintain the existing channel alignment.
- Includes replacement of the concrete channel with an armourstone-lined channel west of Camilla Road and channel improvements east of Camilla Road.
- Includes replacement of the failed Gabion walls and bank protection with new erosion protection and replacing the leaning interlocking wall with a new protected slope or wall.

PROPOSED SOLUTIONS ON THIS DRAWING WOULD BE

**EVALUATED DURING DESIGN.**

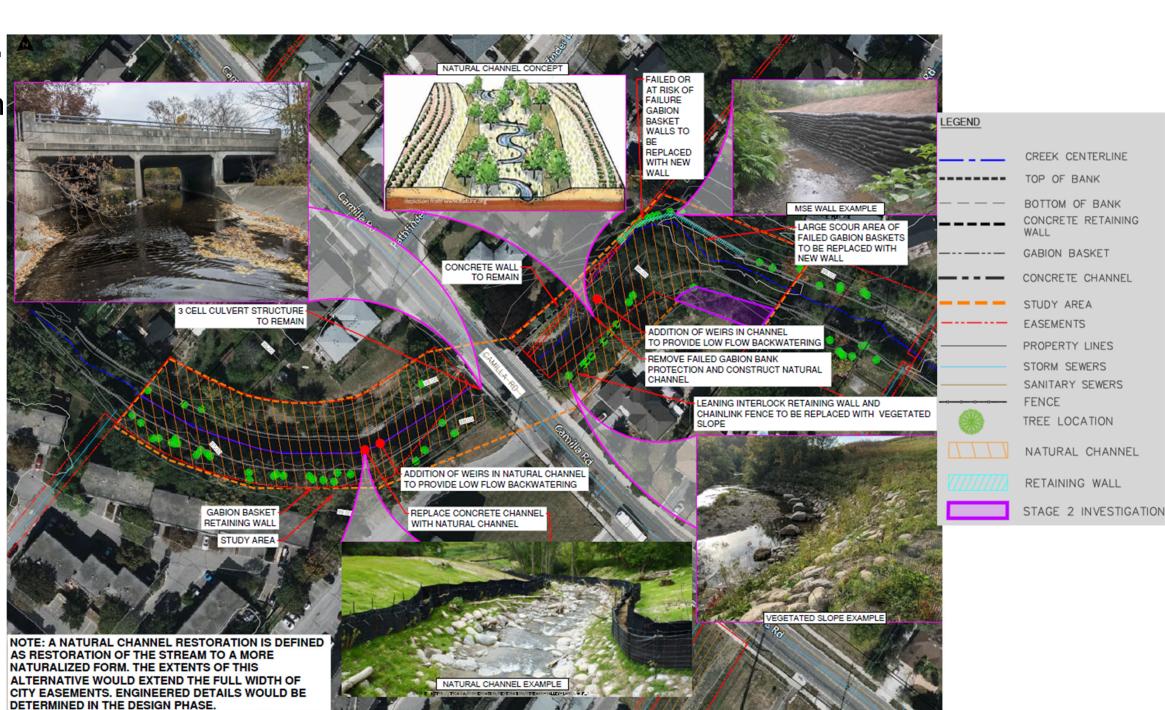
Natural Channel Restoration

- Stream restoration to a naturalized form.
- Includes watercourse expansion on both sides of Camilla Road to incorporate channel meander and bank protection.
- Failed Gabion walls would be replaced with new sloping walls, extending the full width of the City's easement.

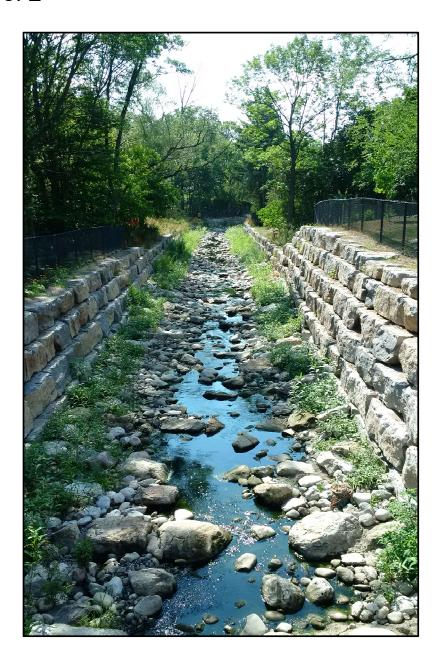
Channel with Armourstone Example

- Provides a moderately natural and "green" solution
- Minimizes disturbance area and vegetation removal
- Reduces erosion risks
- Promotes removal of debris in the channel
- Improves fish habitat and passage through the watercourse
- No loss to private property table land
- Moderate capital costs and low future maintenance costs
- Blends with existing erosion protection surrounding the site
