Tree Hoarding Notes

MARTON SMITH LANDSCAPE ARCHITECTS
170 The Donway W Suite 206
Toronto, Ontario, Canada. M3C 2G3
tel. 416.492.9966 | email. info@msla.ca

Project:
Proposed Residential Development
Queen St. S. & Britannia Rd.
Mississauga, Ontario

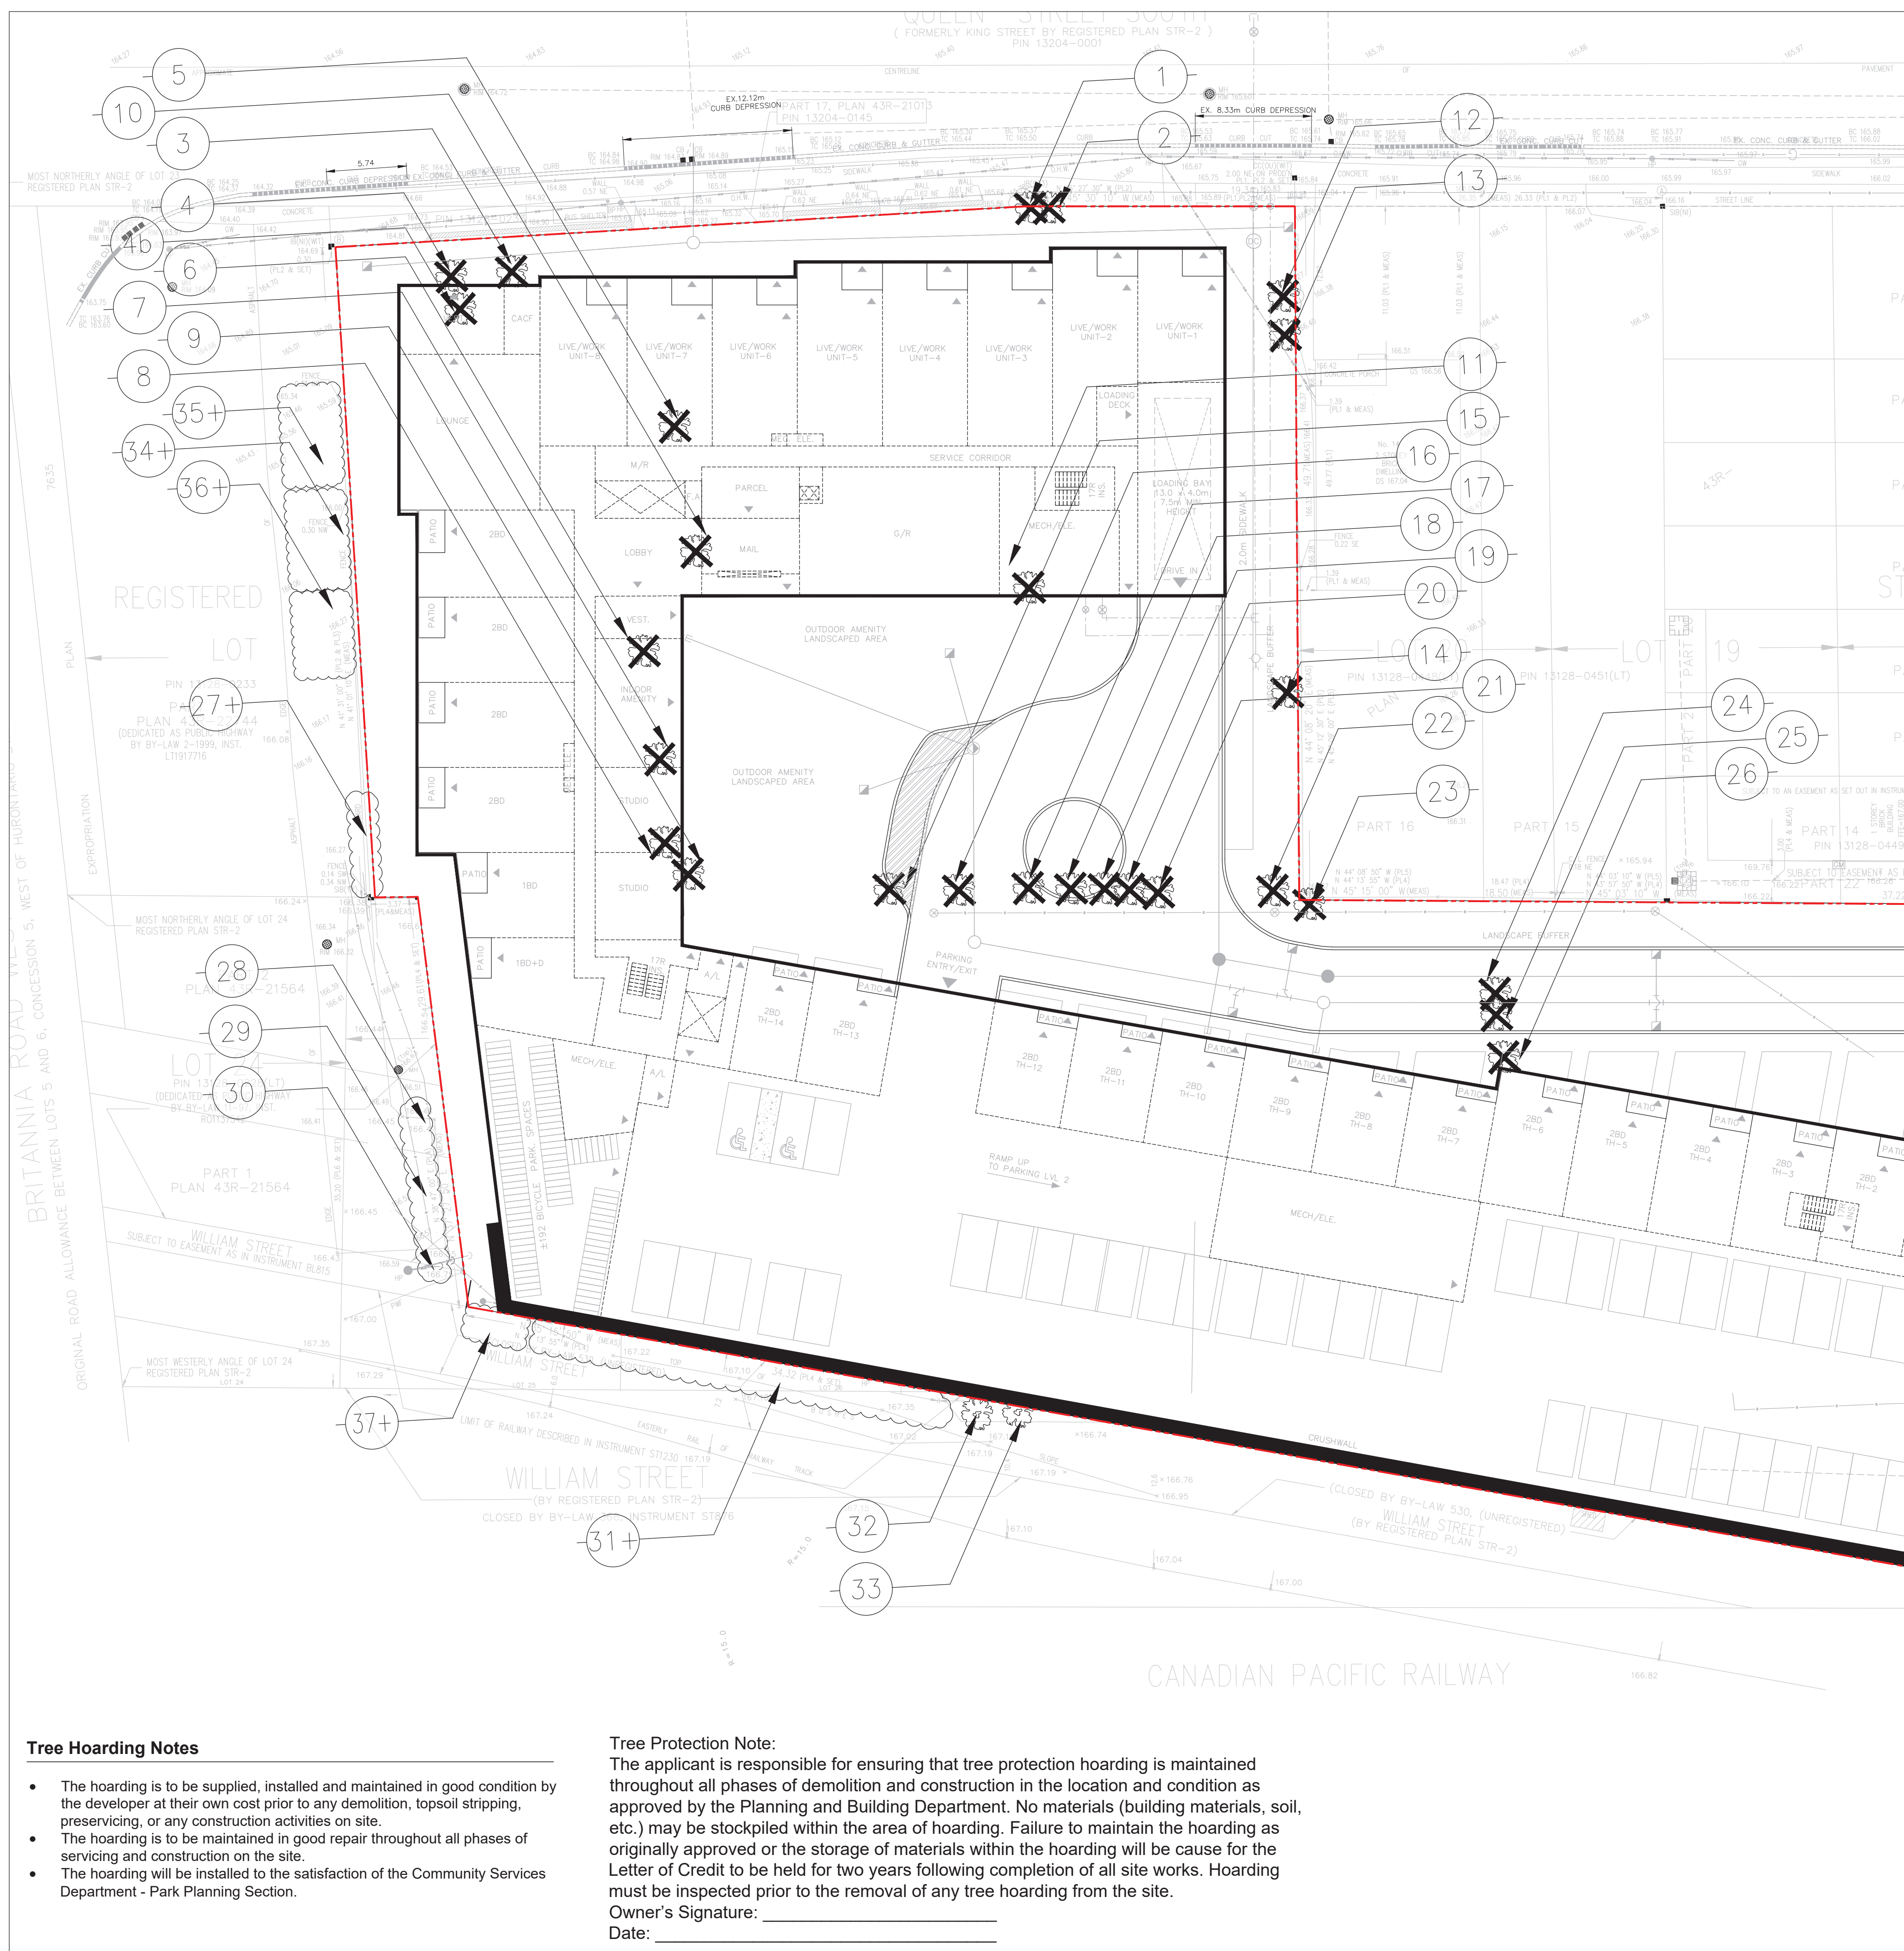
- The hoarding is to be supplied, installed and maintained in good condition by the developer at their own cost prior to any demolition, topsoil stripping, preserving, or any construction activities on site.
- The hoarding is to be maintained in good repair throughout all phases of servicing and construction on the site.
- The hoarding will be installed to the satisfaction of the Community Services Department - Park Planning Section.

Tree Protection Note:

The applicant is responsible for ensuring that tree protection hoarding is maintained throughout all phases of demolition and construction in the location and condition as approved by the Planning and Building Department. No materials (building materials, soil, etc.) may be stockpiled within the area of hoarding. Failure to maintain the hoarding as originally approved or the storage of materials within the hoarding will be cause for the Letter of Credit to be held for two years following completion of all site works. Hoarding must be inspected prior to the removal of any tree hoarding from the site.

Existing Tree Schedule
