Phase Two Environmental Site Assessment Conceptual Site Model

PARTs 1 and 2, Reference Plan 43R-39995 Representing Part of 208 Emby Drive Mississauga, Ontario L5M 1H6

September 25, 2023

OHE Project No.: 27835

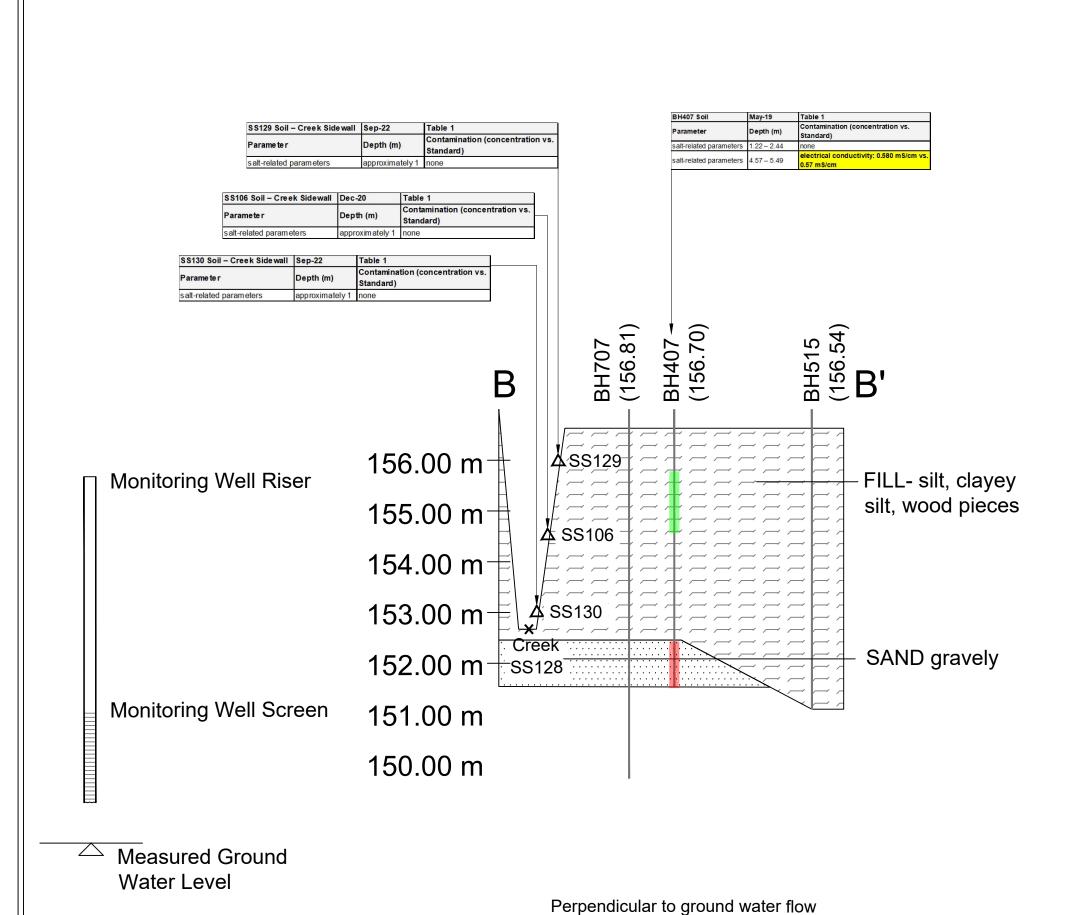
Bedrock Non-Contaminated Soil Sample Contaminated Soil Sample Surface elevation Locations of property features based upon field measurements Drawing Title: Cross Section B-B' - Soil Contamination, Salt-Related Client Address: NYX Tannery Ltd. Suite 400 - 1131 Leslie Street Toronto, ON Project Location: PARTs 1 and 2 Reference Plan 43R - 39995

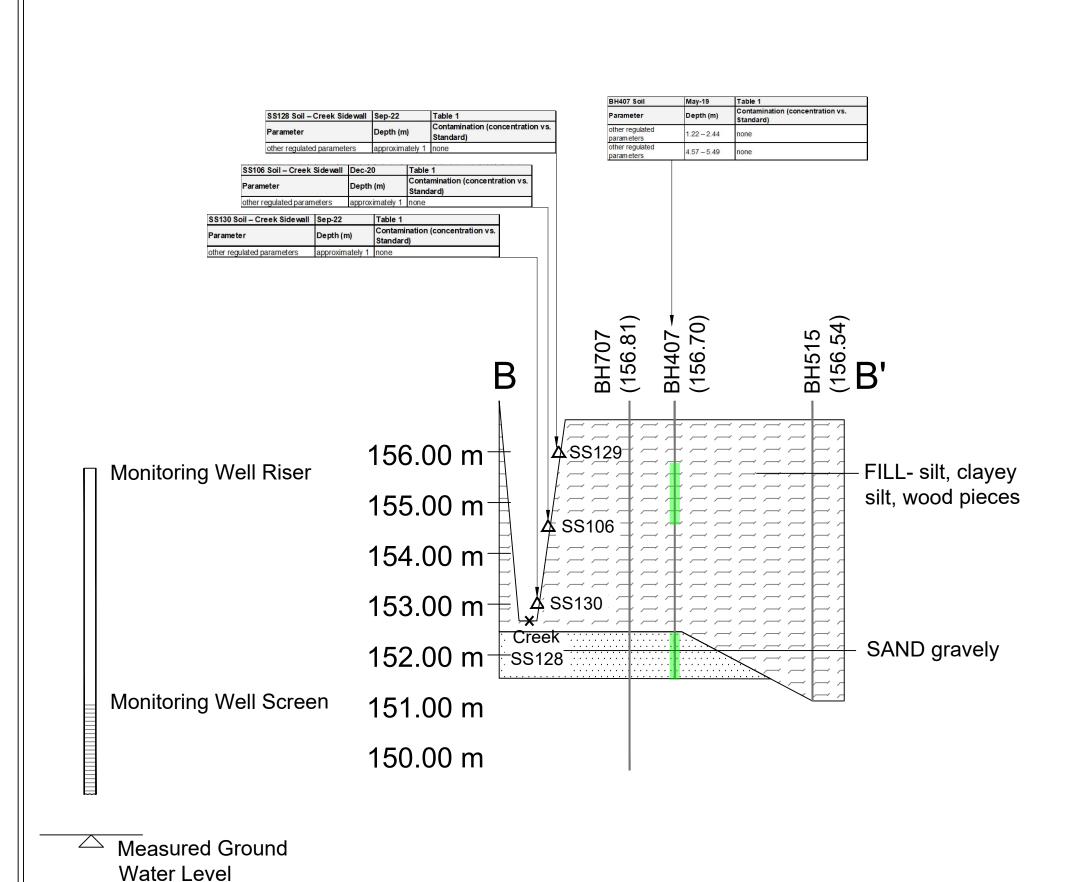
Bedrock Non-Contaminated Soil Sample Contaminated Soil Sample Surface elevation Other Regulated Parameters consist of: Cyanide Chromium VI, Mercury, pH Locations of property features based upon field measurements Drawing Title: Cross Section B-B' - Soil Contamination, Other **Regulated Parameters** Client Address: Project Location:

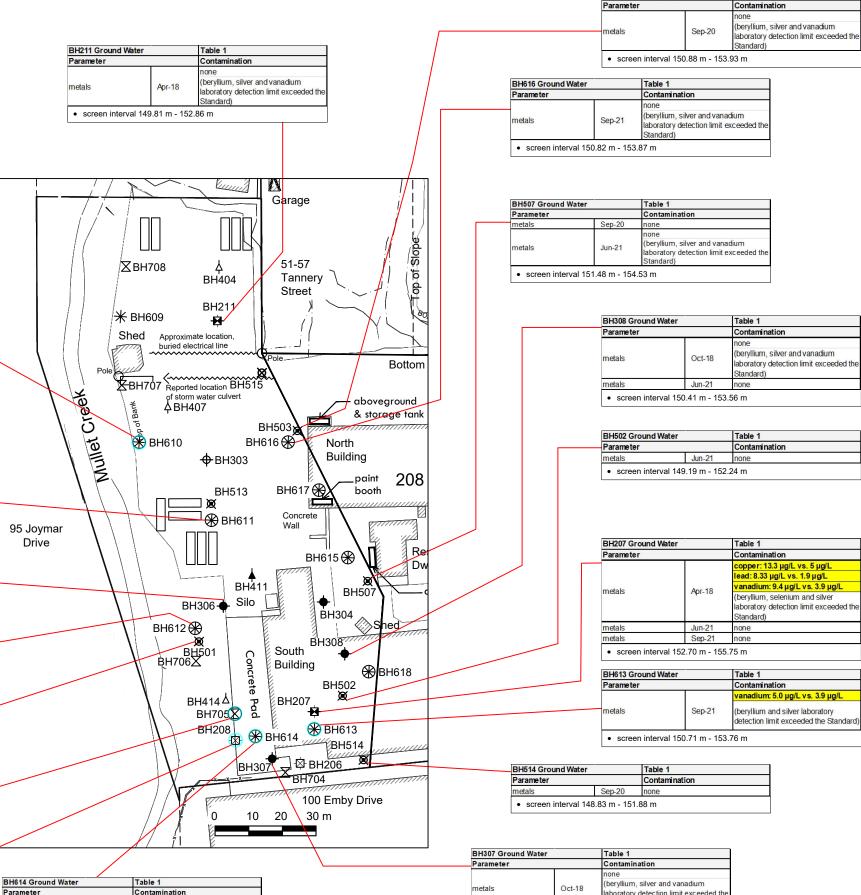
copper: 5.1 µg/L vs. 5 µg/L aboratory detection limit exceeded the

screen interval 150.60 m - 153.65 m

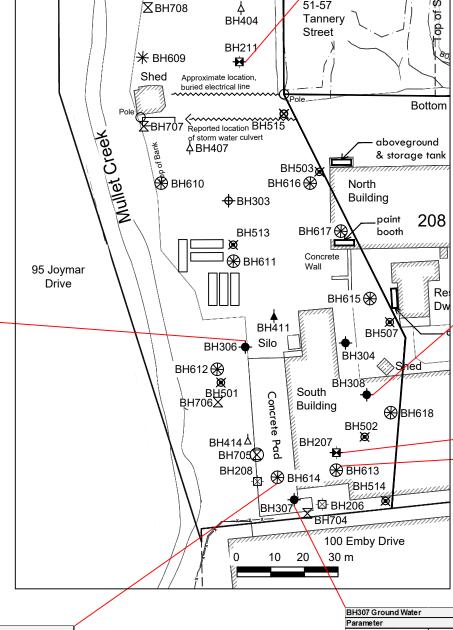
/	BH308 Ground Water Parameter		Table 1 Contamination
	other regulated parameters	Oct-18	none
	• screen interval 150.41 m - 153		.56 m

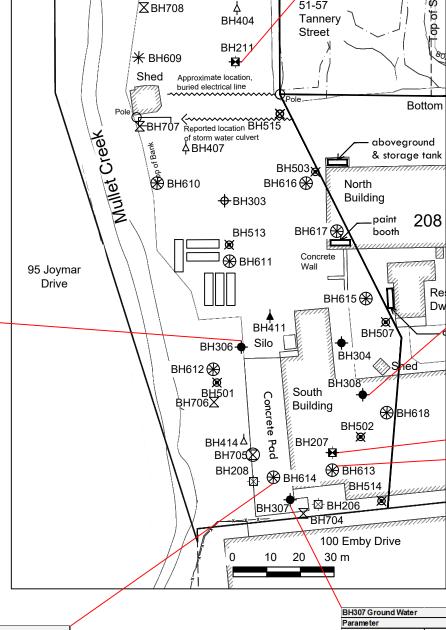
/	BH308 Ground Water Parameter		Table 1 Contamination
	other regulated parameters	Oct-18	none
	screen interval 150	0.41 m - 153	.56 m

BH207 Ground Water		Table 1	
Parameter		Contamination	
other regulated parameters	Apr-18	none	
screen interva	I 152.70 m - 1	55.78 m

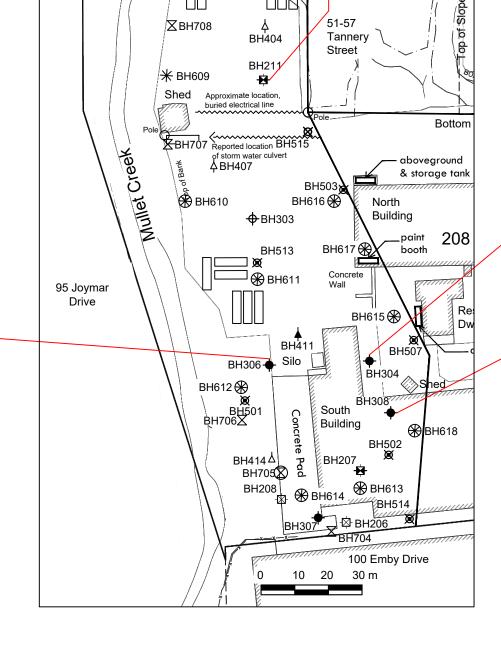
BH211 Ground Water Parameter		Table 1 Contamination	
BTEX	Jul-19	none

BH304 Ground Water		Table 1
Parameter		Contamination
BTEX	Oct-18	none
screen interval 149	.18 m - 152.2	23 m

BH308 Ground Water		Table 1
Parameter		Contamination
BTEX	Oct-18	none
screen interval 150	.41 m - 153.	56 m

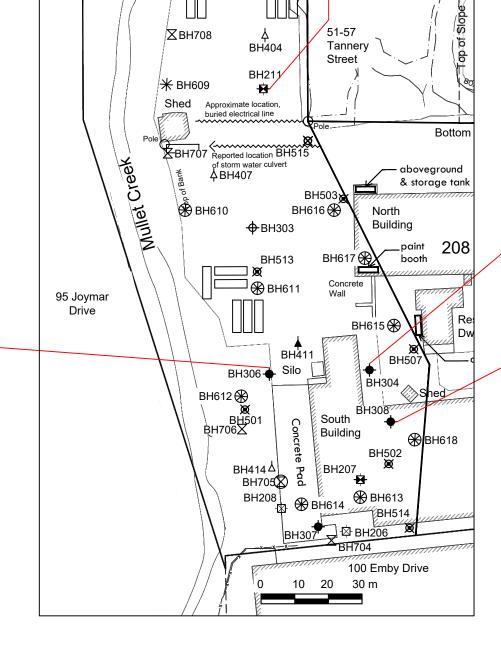
Parameter		Contamination	
BTEX	Jul-19	none

BH304 Ground Water		Table 1
Parameter		Contamination
BTEX	Oct-18	none
screen interval 149	.18 m - 152.2	23 m

BH308 Ground Water		Table 1
Parameter		Contamination
BTEX	Oct-18	none
screen interval 150	.41 m - 153.5	56 m

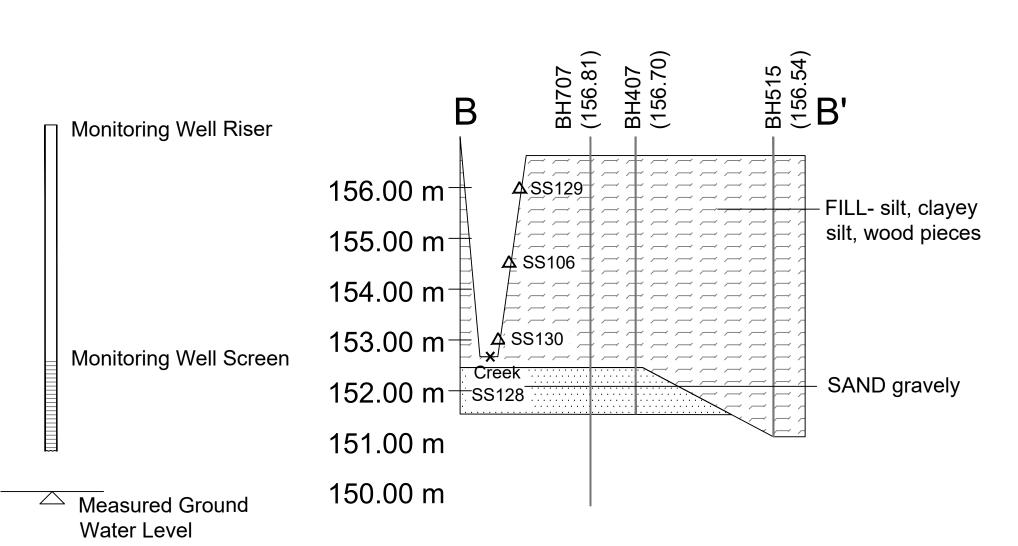
Perpendicular to ground water flow
0 10 20 30 m

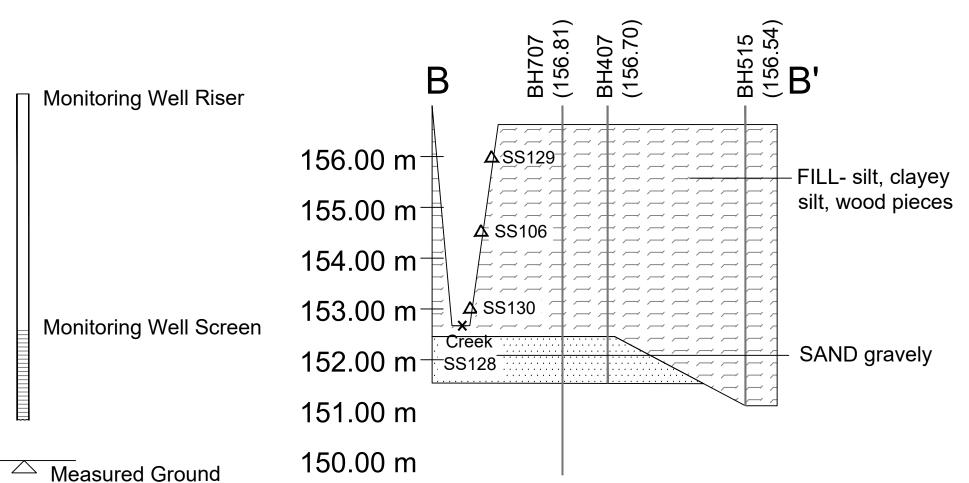
Perpendicular to ground water flow

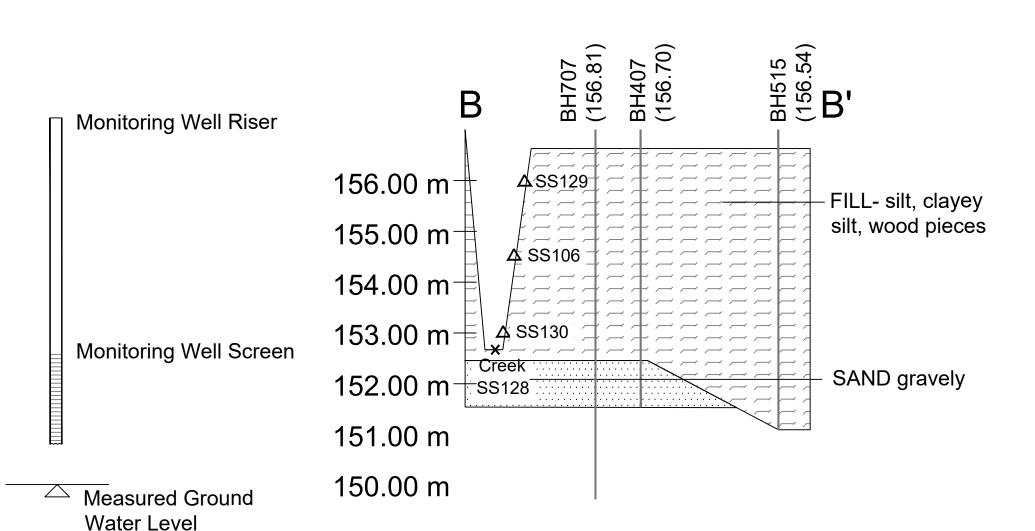
Perpendicular to ground water flow 0 10 20 30 m

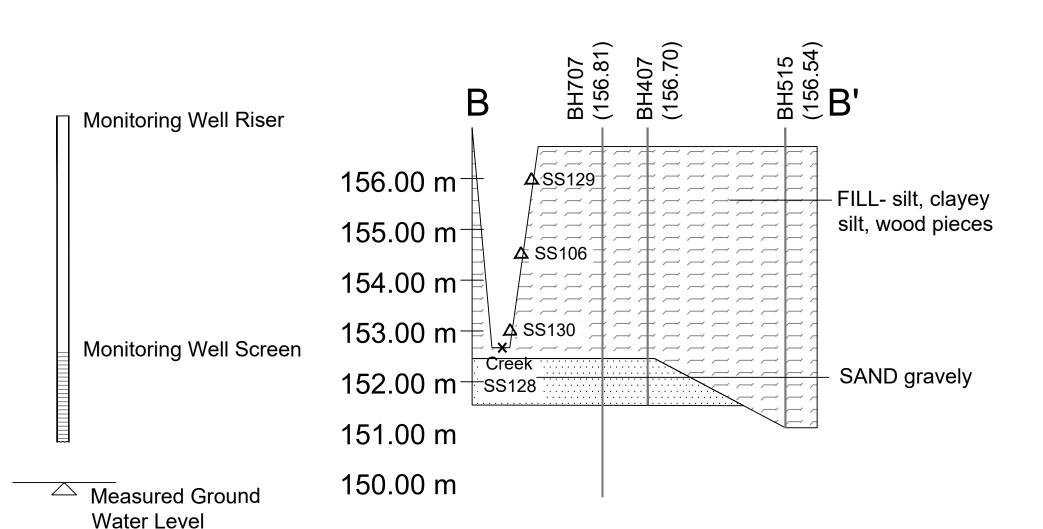
No benzene, toluene, ethylbenzene, xylenes ground water samples in cross section.

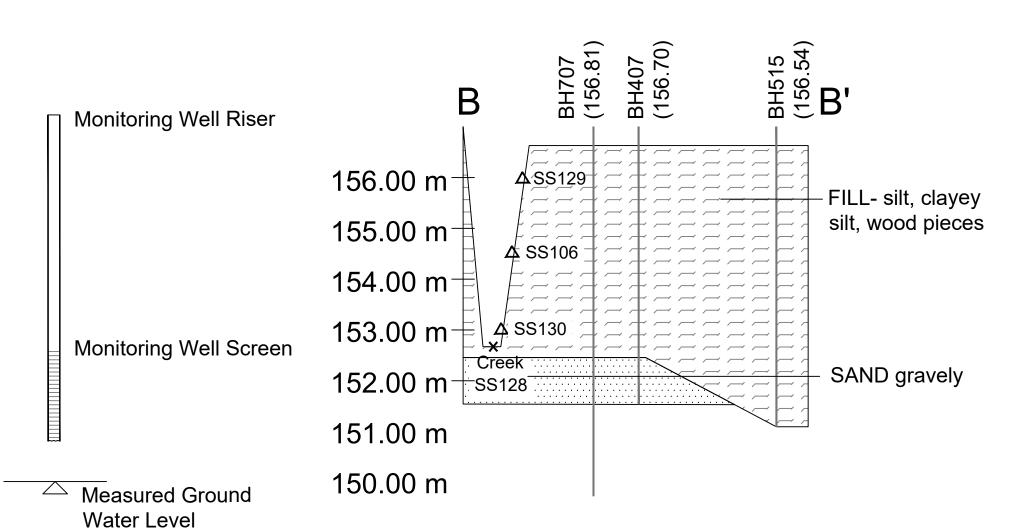
No polycyclic aromatic hydrocarbons ground water samples in cross section.

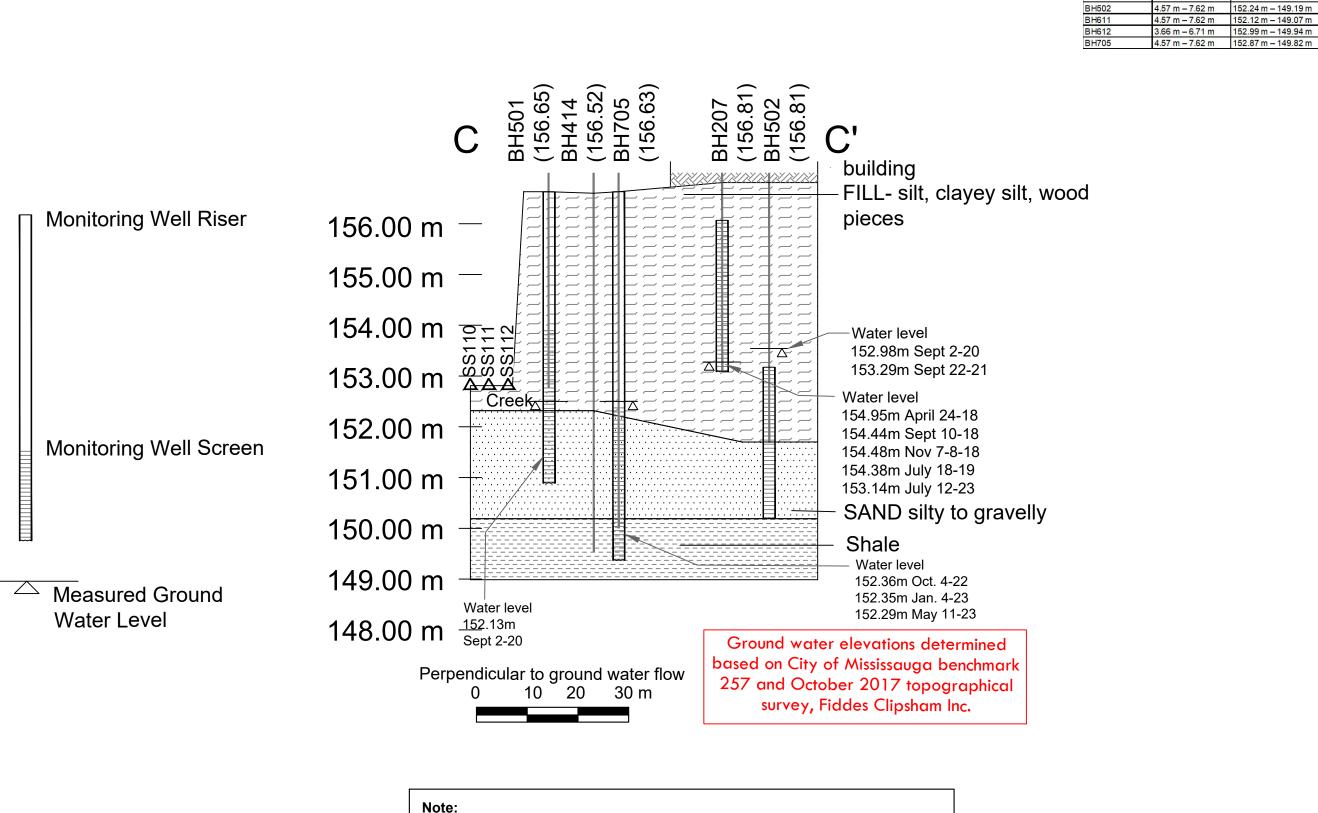
No polycyclic aromatic hydrocarbons ground water samples in cross section.

Elevation Relative to 1.06 m - 4.11 m 155.75 m - 152.70 m 3.96 m - 7.11 m BH306 BH501 3.66 m - 6.71 m 152 94 m - 149 89 m 3.05 m - 6.10 m 153.60 m - 150.55 m 4.57 m - 7.62 m 3.66 m - 6.71 m 152.99 m - 149.94 m
