Phase Two Environmental Site Assessment Conceptual Site Model

PART 3, Reference Plan 43R-39995 Representing Part of 208 Emby Drive Mississauga, Ontario L5M 1H6

OHE Project No.: 27835

OHE Consultants

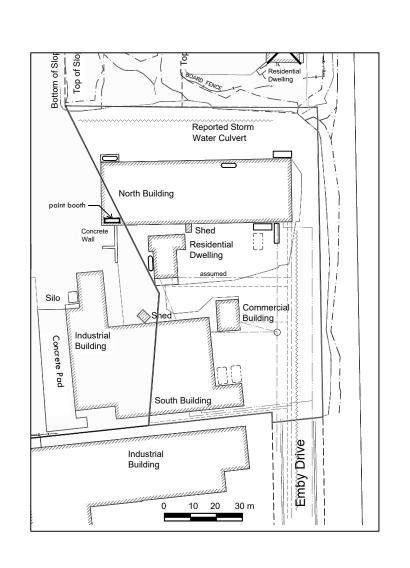
- Water - buried Bell Canada and Enersource - overhead - Enbridge - buried - Storm Sewer (loaction difficult to confirm)	Former underground storage tank Aboveground storage tank Trailers
	Notes: Locations of site features are approximate and may vary from that
	shown Drawing Title: Site Plan
	NYX Tannery Ltd. Suite 400- 1131 Leslie Street Toronto, ON Project Location: PART 3 Reference Plan 43R- 39995 208 Emby Drive Mississauga, ON
	Project No: 29044

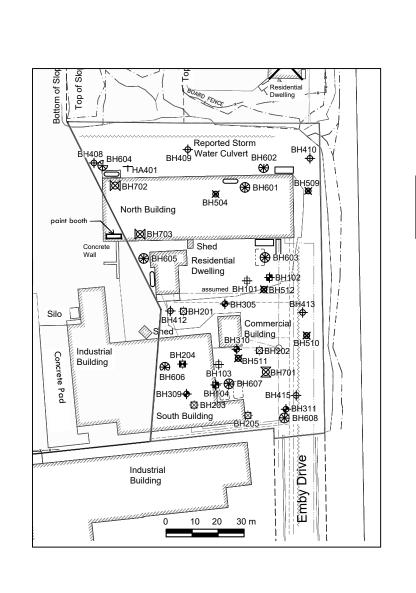
Water - buried Monitoring Well - installed by others Bell Canada and Enersource - overhead OHE borehole - January 2017 Enbridge - buried OHE monitoring well - January 2017 Sanitary Sewer (loaction difficult OHE borehole - April/May 2018 OHE monitoring well - April/May 2018 Former underground storage tank Aboveground storage OHE borehole - October 2018 OHE monitoring well - October 2018 OHE borehole - May to 2019 OHE monitoring well - May to July 2019 OHE hand auger sample - May 2019 to October 2020 OHE borehole - August 2020 OHE monitoring well - August 2020 OHE borehole / monitoring well August / September 2021 Note: monitory wells were all initiated OHE borehole September 2022 図 OHE monitoring well September 2022 Notes: shown Drawing Title:

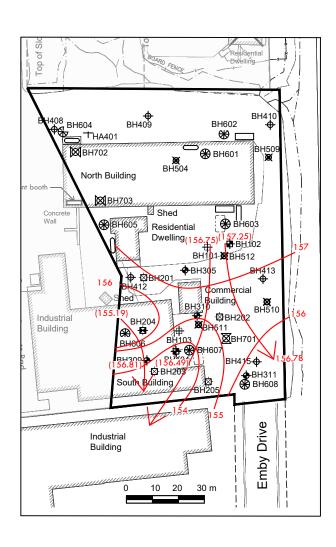
Ground water elevations determined based on City of Mississauga benchmark 257 and October 2017 topographical survey, Fiddes Clipsham Inc.

Drawing 9:	Cross-Section Locations
Drawing 10:	Cross-Sections – edits provided
Drawing 11a:	Ground Water Contours and Flow Direction – September 10, 2018

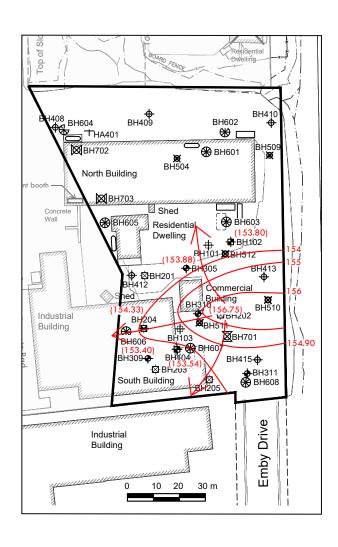
Ground water elevations determined based on City of Mississauga benchmark 257 and October 2017 topographical survey, Fiddes Clipsham Inc.

Drawing 11b:	Ground Water Contours and Flow Direction – November 7 – 8, 2018
Drawing 11c:	Ground Water Contours and Flow Direction – July 18, 2019
Drawing 11d:	Ground Water Contours and Flow Direction – September 22, 2021

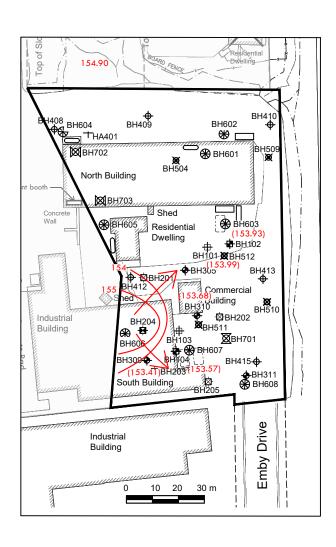
Ground water elevations determined based on City of Mississauga benchmark 257 and October 2017 topographical survey, Fiddes Clipsham Inc.

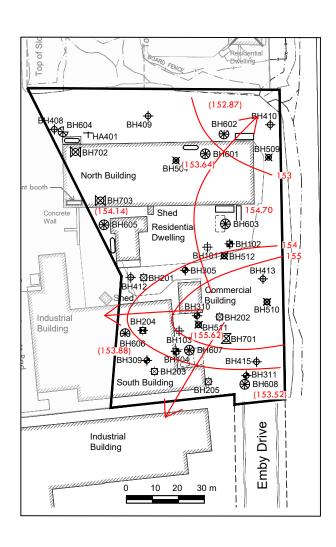
Ground water elevations determined based on City of Mississauga benchmark 257 and October 2017 topographical survey, Fiddes Clipsham Inc.

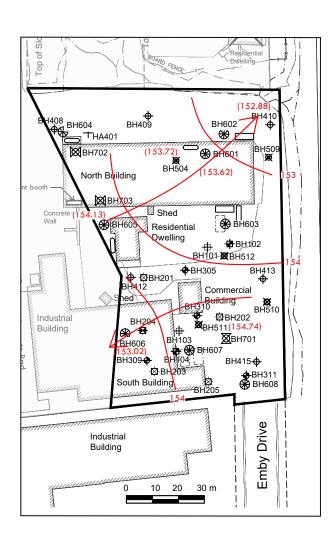
Ground water elevations determined based on City of Mississauga benchmark 257 and October 2017 topographical survey, Fiddes Clipsham Inc.

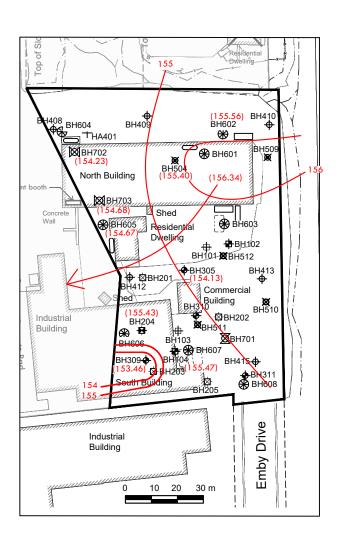
Ground water elevations determined based on City of Mississauga benchmark 257 and October 2017 topographical survey, Fiddes Clipsham Inc.

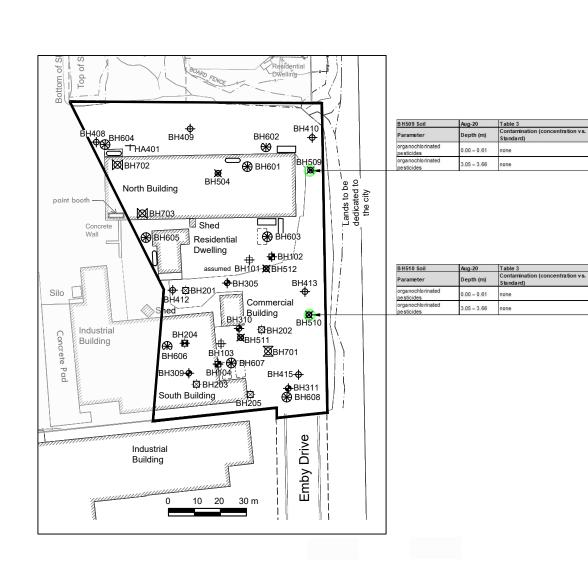
Note:

No organochlorinated pesticide contamination in soil.
