# **FUNCTIONAL SERVICING REPORT**

DE ZEN INDUSTRIAL LANDS 6678604 ONTARIO INC. & 1105239 ONTARIO INC.

> CITY OF MISSISSAUGA REGIONAL MUNICIPALITY OF PEEL

> > FILE No. 224-M62

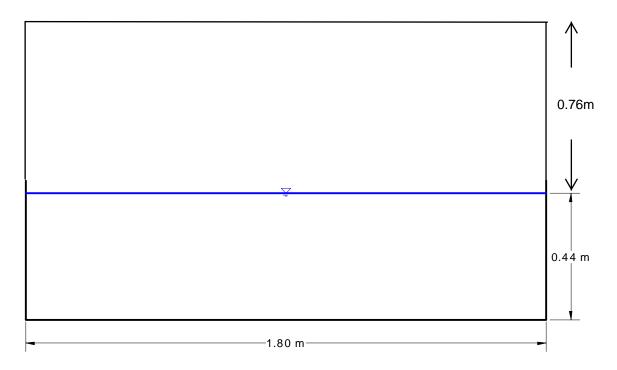
Mannings Coeffic 0.013 Slope 000500 m/m Depth 0.44 m Bottom Width 1.80 m Discharge 0.6000 m<sup>3</sup>/s

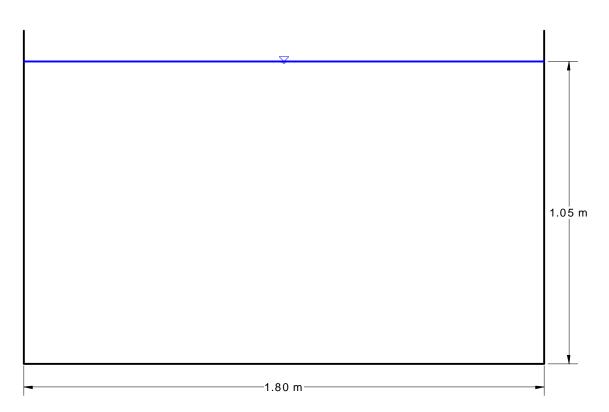
# **Cross Section Cross Section for Rectangular Channel**

Project Description	
Worksheet	Rectangular Chann
Flow Element	Rectangular Chann
Method	Manning's Formula
Solve For	Channel Depth

Section Data		
Mannings Coeffic	0.013	
Slope	000500	m/m
Depth	1.05	m
Bottom Width	1.80	m
Discharge	2.0000	m³/s

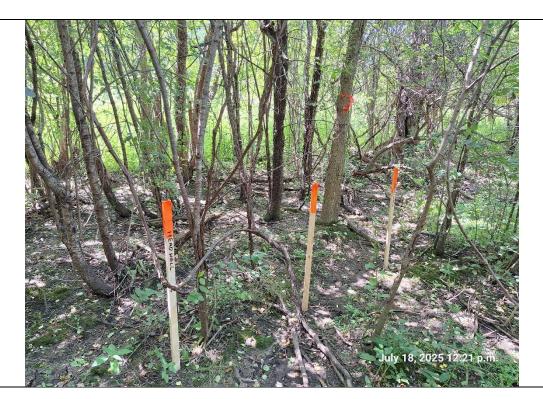
Photo 1
Outlet Headwall Location, 7140 Hurontario Street,
Mississauga, ON

Photograph of staked headwall location facing the direction of the tie-in location.

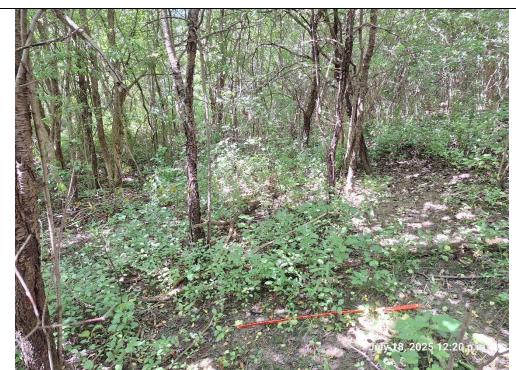
Photograph of the valley wall behind the headwall location. The slope is well vegetated and showed a lack of erosion at the time of assessment.

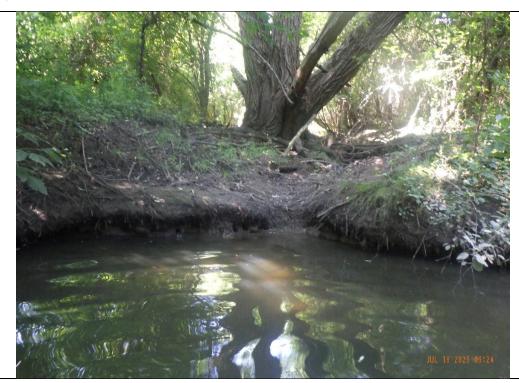
Photograph showing the confluence between the historic channel and **Reach FC-2**. The confluence was located at an outer meander bend along **Reach FC-2**.

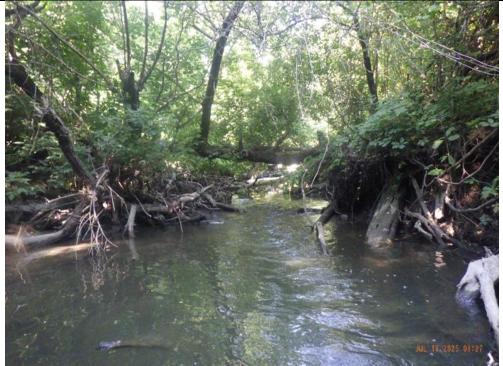
Photograph of **Reach FC-2** facing upstream. Leaning trees and woody debris jams that impacted flow were common throughout the reach.

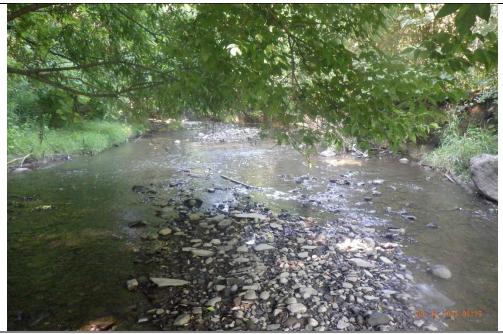
Coarse material was commonly observed along the channel bed. A suspended armour layer was observed in the channel banks as well. The bank materials consisted of clay, silt materials with some coarse materials due to the suspended armour layer.

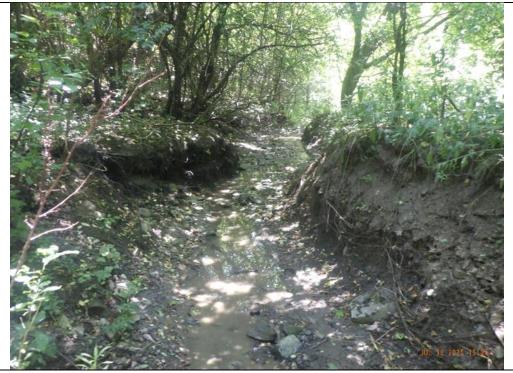
Photo 6 Reach FCT-1, 7140 Hurontario Street, Mississauga, ON

Photograph of **Reach FCT-1** facing upstream. The channel was confined and had low flow conditions at the time of assessment. Exposed roots and undercutting were commonly observed. The bed was also eroded into parent material (till) in a localized portion of the reach upstream.

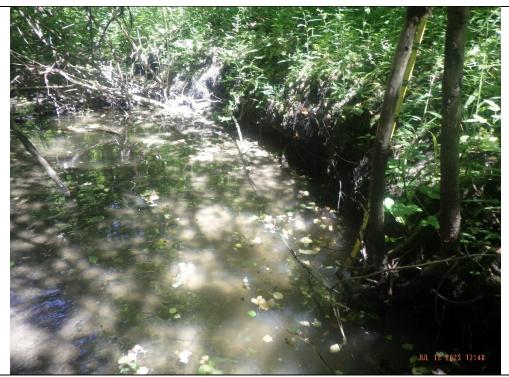
Photograph of **Reach FCT-1**. Active erosion was noted along this reach however; the channel banks were observed to be well vegetated. Some fallen and leaning trees were also observed, indicating some widening along the reach.

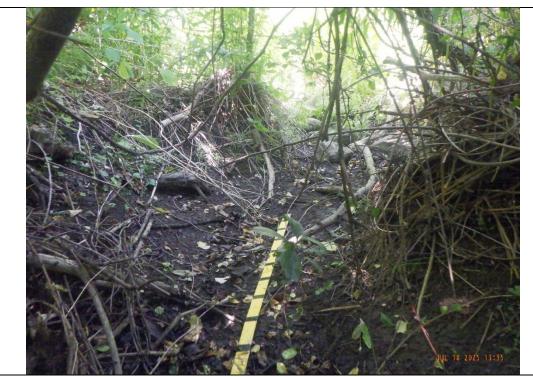
Photograph of **Reach FCT-2** facing upstream. The reach was partially confined and had a high density of woody debris and exposed roots.

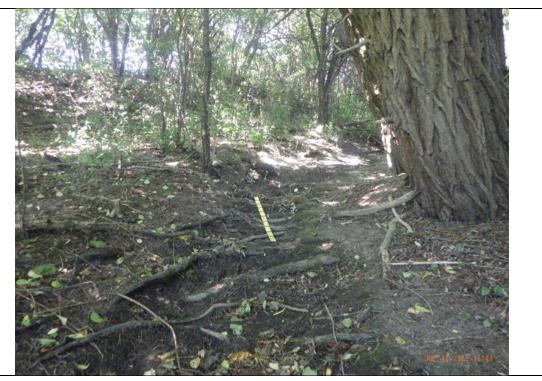
Photo 9
Reach FCT-2, 7140 Hurontario Street, Mississauga, ON

Photograph of **Reach FCT-2** located at the upstream extent. Note that banks are less defined as the channel moved upstream towards **FCT-3**.

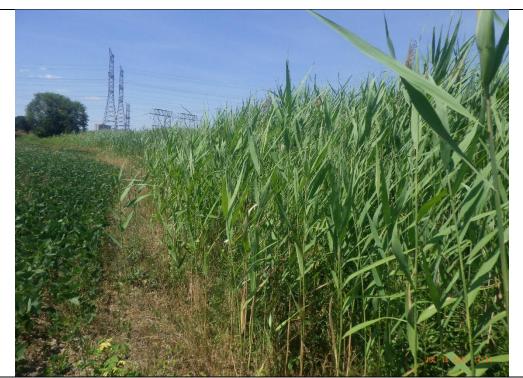
Photo 10
Reach FCT-3, 7140 Hurontario Street, Mississauga, ON

Photograph of **Reach FCT-3** facing upstream towards the pond. Though dry at the time of assessment, much of the reach was comprised of an online wetland containing cattails and phragmites.

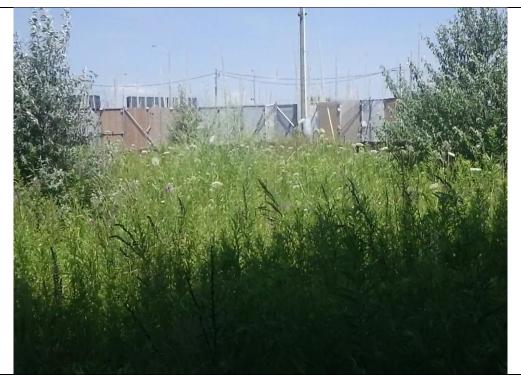
Photo 11
FCT-3 Approx. Crossing Location, 7140 Hurontario Street, Mississauga, ON

The proposed water crossing location is situated across **Reach FCT-3.** The location's topography was unconfined, flat, and the feature was poorly defined. Herbaceous plants and tall grasses dominated the area.

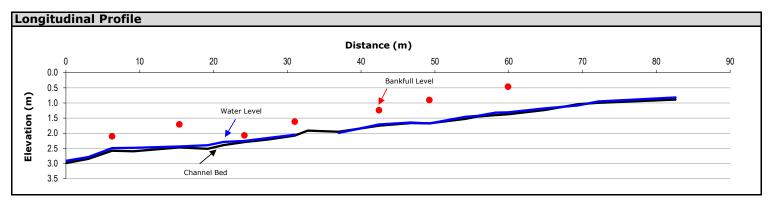
Profile Characteristics	
Bankfull Gradient (%):	3.33
Channel Bed Gradient (%):	2.55
Riffle Gradient (%):	Not measured
Riffle Length (m):	Not measured
Riffle-Pool Spacing (m):	Not measured

Planform Characteristics					
Sinuosity:	1.10				
Meander Belt Width (m):	Not measured				
Radius of Curvature (m):	Not measured				
Meander Amplitude (m):	Not measured				
Meander wavelength (m):	Not measured

<b>Bank Characteristi</b>	cs						
	Minimum	Maximum	Average		Minimum	Maximum	Average
Bank Height (m):	0.2	1.30	0.91				
Bank Angle (deg):	25	90	72	Torvane Value (kg/cm²):	1	Not measured	
Root Depth (m):	0.00	0.45	0.22	Penetrometer Value (kg/cm <sup>3</sup> ):	1	Not measured	
Root Density (%):	0	10	6	Bank Material (range):		Clay to silt	
Bank Undercut (m):	0	0.4	0.10

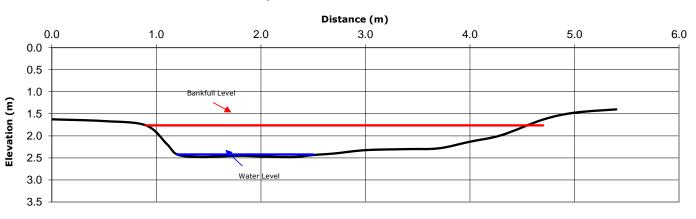
## **Representative Cross-Section 2**

Particle Size (mm)		:	Subpavement:	Till	
D <sub>10</sub> :	2.0	I	Particle shape:	Platy	
D <sub>50</sub> :	3.2	1	Embeddedness (%):	10 to 50	
D <sub>84</sub> :	15.0	1	Particle range (riffle):	Clay to cobble	
		1	Particle Range (pool):	Clay to gravel	
100 90 80		Cumulative Partic	le Size Distribution		
70					
60

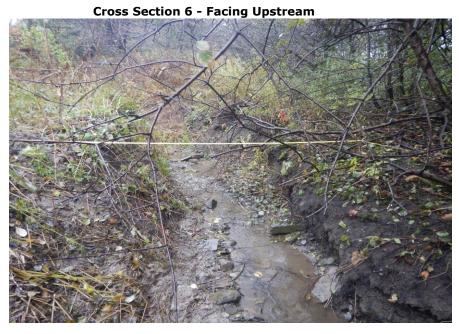
Reach FCT-1 was a mixed-load meandering channel, with a moderate gradient that sits within a confined valley. The channel flowed through a continuous riparian buffer zone that extended 4 to 10 times the channel width and contained predominately trees and herbaceous vegetation. The channel was heavily encroached by vegetation. High density of woody debris was observed in the channel. The average bankfull width and depth were 2.44 m and 0.50 m. The average wetted width and depth were 0.93 m and 0.05 m. Bank angles ranged from 25 to 90 degrees, with undercutting measured up to 0.4 m. Bed materials ranged from clay to cobbles in riffles, and clay to gravel in pools. Bank material consisted of clay and silt.

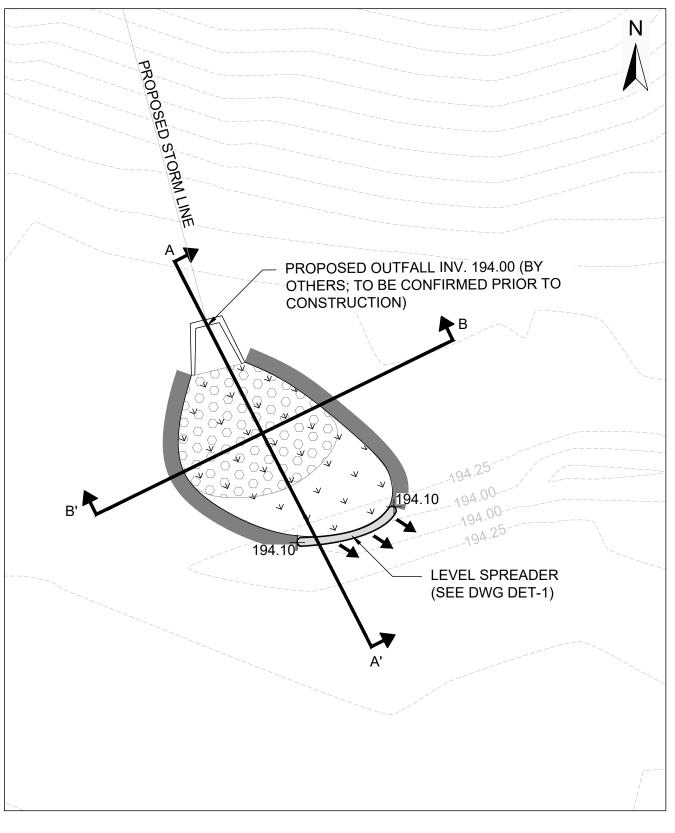
## **PLANFORM** 1:250

<u>LEGEND</u> SCONED (SEE DWG GEO-1) SCONED (SEE DWG GEO-1) 100% BIODEGRADABLE EROSION CONTROL BLANKET AND LIVE STAKES (SEE DWG DET-1) LEVEL SPREADER (SEE DWG DET-1)

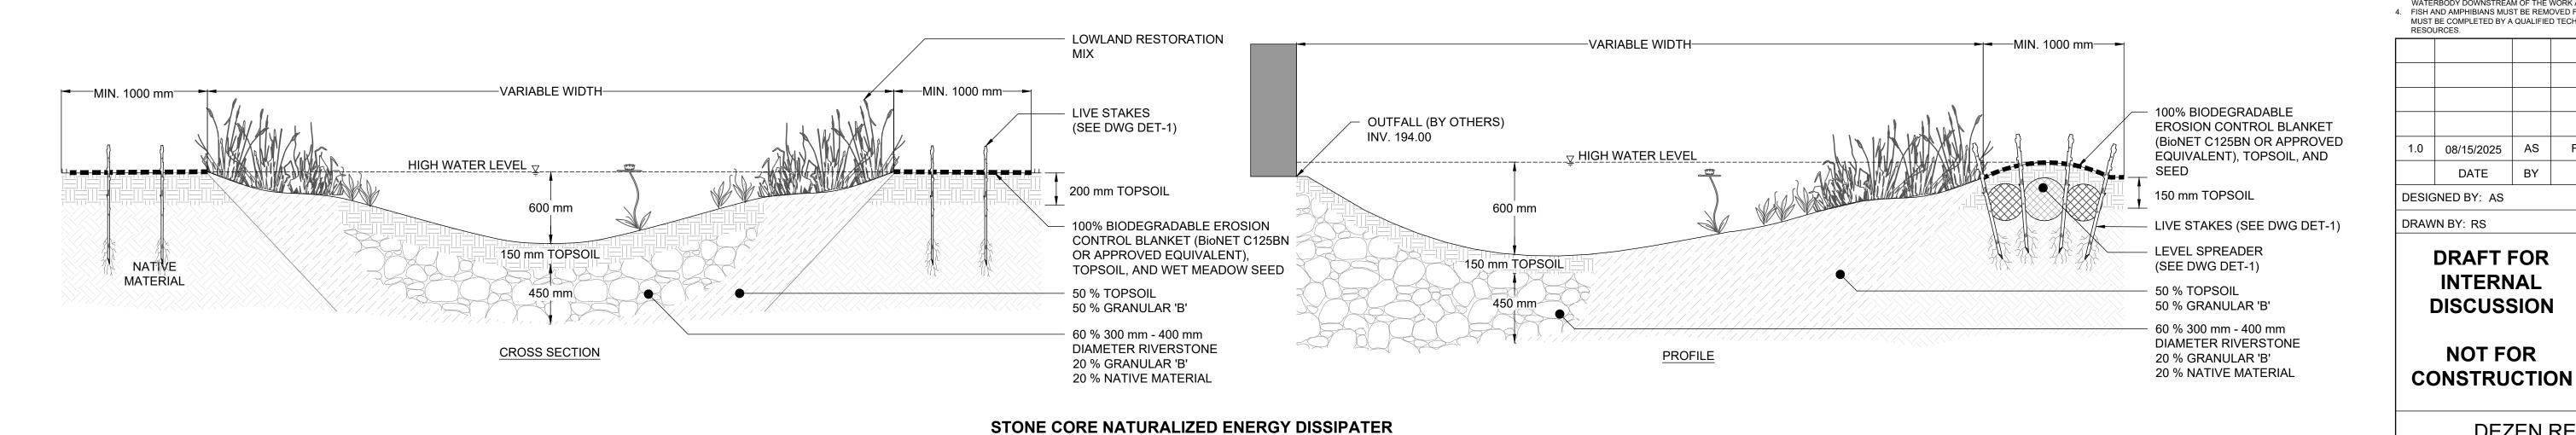
TOPSOIL

STONE CORE (SEE DWG GEO-1)

₩ 100% BIODEGRADABLE EROSION CONTROL BLANKET, WET MEADOW SEED AND LIVE STAKES (SEE DWG DET-1)

LEVEL SPREADER (SEE DWG DET-1)

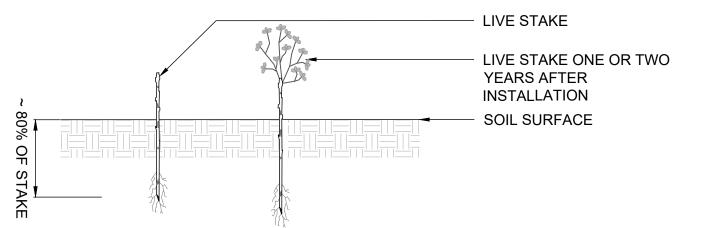
SCIENTIFIC NAME	COMMON NAME	QTY	CONDITION
CORNUS STOLONIFERA	RED OSIER DOGWOOD	34	1 m, LIVE STAKE
SALIX BEBBIANA	BEBB'S WILLOW	34	1 m, LIVE STAKE
SALIX DISCOLOR	PUSSY WILLOW	34	1 m, LIVE STAKE
SALIX INTERIOR	SANDBAR WILLOW	34	1 m, LIVE STAKE
SALIX LUCIDA	SHINING WILLOW	34	1 m, LIVE STAKE

- QUANTITY TO BE DETERMINED BASED ON AREA OF DISTURBANCE TO BE RESTORED
- LIVE STAKES SHOULD BE FROM AT MINIMUM 2-YEAR OLD STOCK.
- 3. LIVE STAKES ARE TO BE INSTALLED AT A DENSITY OF 3 STAKES PER SQUARE METRE.

- 8. CUT ANGLE AT THE BOTTOM OF THE STAKE AND FLAT ON THE TOP.
- 9. TRIM ALL SIDE BRANCHES WHILE TAKING CARE NOT TO DAMAGE THE BARK.
- 10. INSTALL STAKES WITH BUDS POINTING UPWARDS AND THICKER STEM IN THE BED.

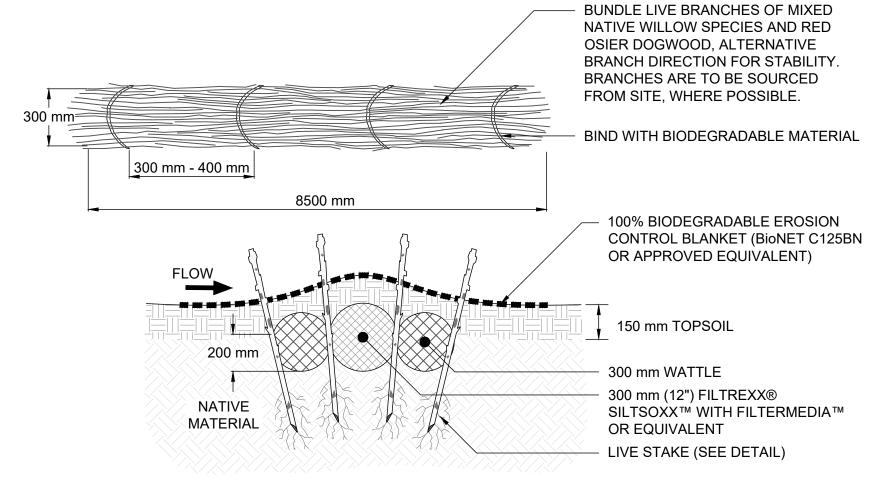
## WATTLE AND FILTREXX® SILTSOXX™ (OR EQUIVALENT) DETAIL

- 1. WATTLE AND SILTSOXX TO BE INSTALLED IN A 200 mm WIDE TRENCH AND STAKED
- 2. WATTLE, SILTSOXX AND GRADING INSTALLATION TO RESULT IN A LEVEL BERM WITHOUT BREAKS.

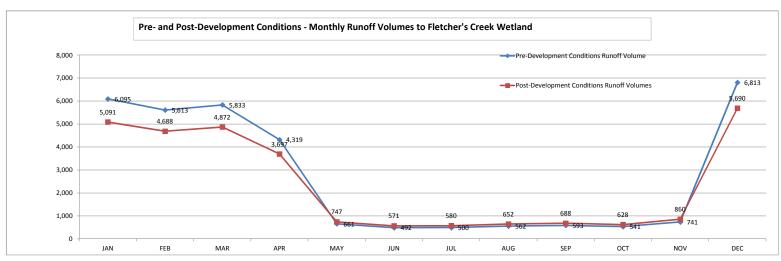
#### Post-Development Conditions Monthly Runoff

JAN	FEB	MAR	APR	MAY	JUN	JUL	AUG	SEP	OCT	NOV	DEC	YEAR
Monthly Depth (m) - Shortrooted	0.039	0.036	0.037	0.026	0.000	0	0	0	0	0	0.000	0.043	0.181
Area (m <sup>2</sup> ) - Shortrooted	115,319												
Runoff Volume (m <sup>3)</sup> - Shortrooted	4,480	4,126	4,286	2,971	45	0	0	0	0	0	0	5,008	20,915
Impervious Monthly Depth (m)	0.052	0.048	0.050	0.062	0.060	0.048	0.049	0.055	0.058	0.053	0.073	0.058	0.666
Impervious Area (m²)	11,785												
Impervious Area Volume (m <sup>3)</sup>	610	562	586	727	702	571	580	652	688	628	860	682	7,847
Post- Development Conditions	5,091	4,688	4,872	3,697	747	571	580	652	688	628	860	5,690	28,762

JAN	FEB	MAR	APR	MAY	JUN	JUL	AUG	SEP	OCT	NOV	DEC
Pre- Development Conditions Total Runoff (m3)	6,095	5,613	5,833	4,319	661	492	500	562	593	541	741	6,813
Post- Development Conditions Total Runoff (m3)	5,091	4,688	4,872	3,697	747	571	580	652	688	628	860	5,690
Volume Change m3 per month	-1,004	-925	-961	-622	86	79	80	90	95	87	119	-1,123
Total Runoff Volume (Post / Pre x 100)	84%	84%	84%	86%	113%	116%	116%	116%	116%	116%	116%	84%
