**Re: DRAFT Letter - Pedestrian Wind Assessment  
3115 Hurontario Street  
RWDI Reference No. 2406897**

Rowan Williams Davies & Irwin Inc. (RWDI) has conducted a pedestrian wind study for the proposed development at 3115 Hurontario Street in Mississauga, Ontario. The assessment was based on the wind-tunnel testing conducted for the proposed development site with existing and future surroundings. The wind tunnel model was constructed based on the drawings received in January 2025 (Image 1). The wind tunnel test included proposed landscaping on-site, but trees were modelled without leaves to better represent wind conditions during the winter season. Our findings and recommendations were summarized in the following final report:

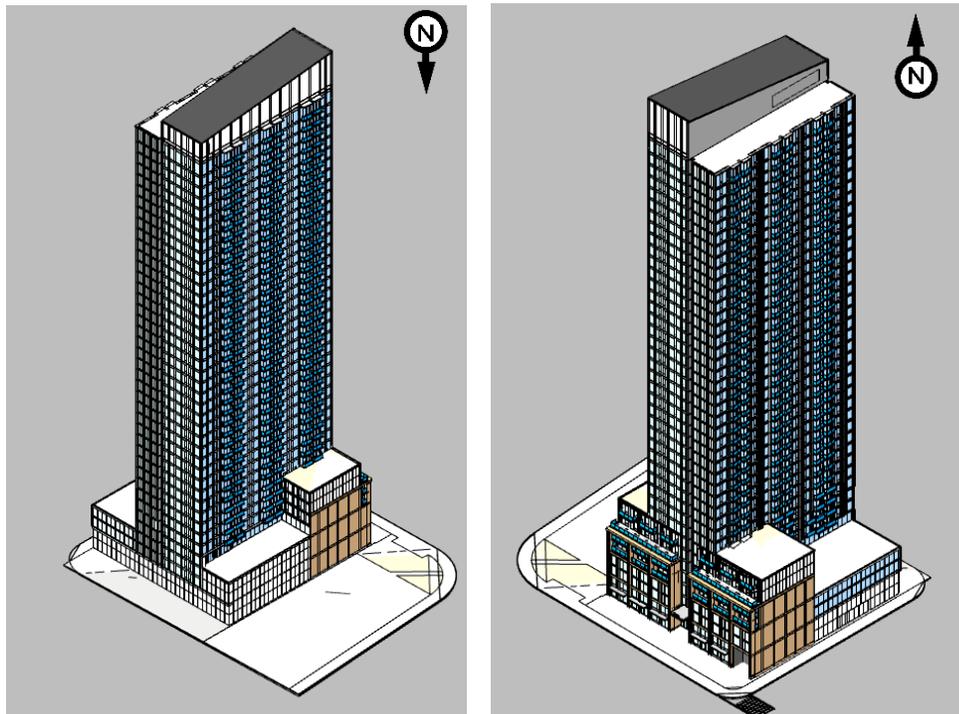
**Image 1: 3D Model of the Original Design of the Proposed Development**

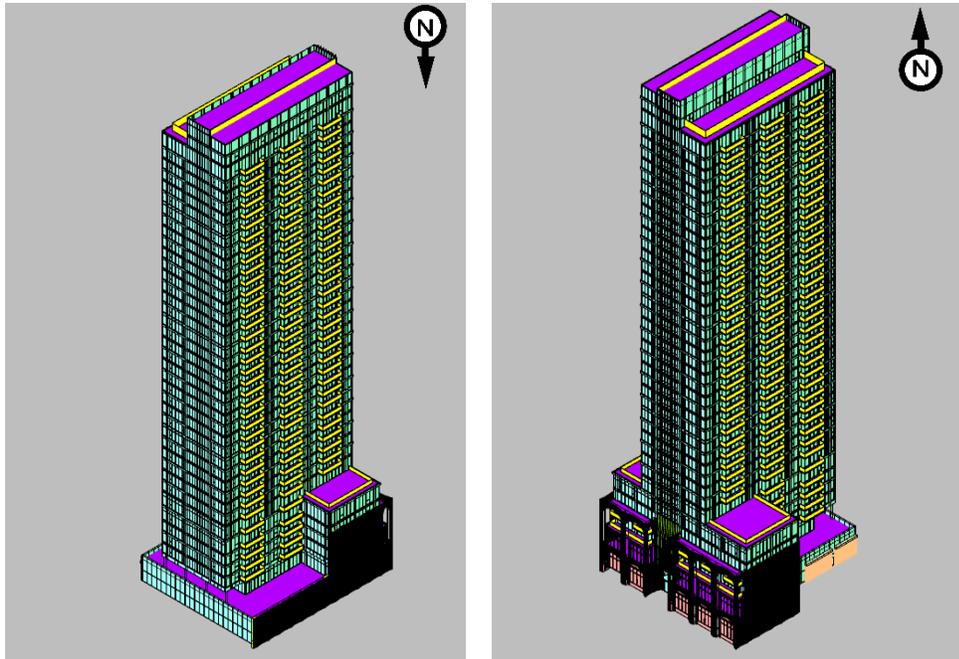
**Image 2: 3D Model of the Updated Design of the Proposed Development**

Following the wind study, RWDI received an updated 3D model on July 23, 2025 (Image 2). Major design changes that may potentially affect the predicted wind conditions include:

Since the overall design, height, and orientation of the proposed development have not changed significantly relative to the design studied previously, similar wind conditions to those presented in the March 4, 2025 report are expected with the new design. The downwashing off the towers' façades and the subsequent corner acceleration flows associated with the latest design of the project are expected to occur in a similar manner to that of the initial design. The 6 m setbacks on the north and east sides are considered significant design changes. While the setback on the east side of the building is not expected to change wind conditions significantly since the prevailing winds are from westerly and northwesterly directions, the setback on the north side is expected to improve the wind conditions north of the proposed building. However, its impact on the areas south of the proposed building is expected to be minimal. Generally, the areas with exceeding wind conditions along Hurontario Street, as indicated in the March 4, 2025, report, are expected to remain unchanged with the new design.

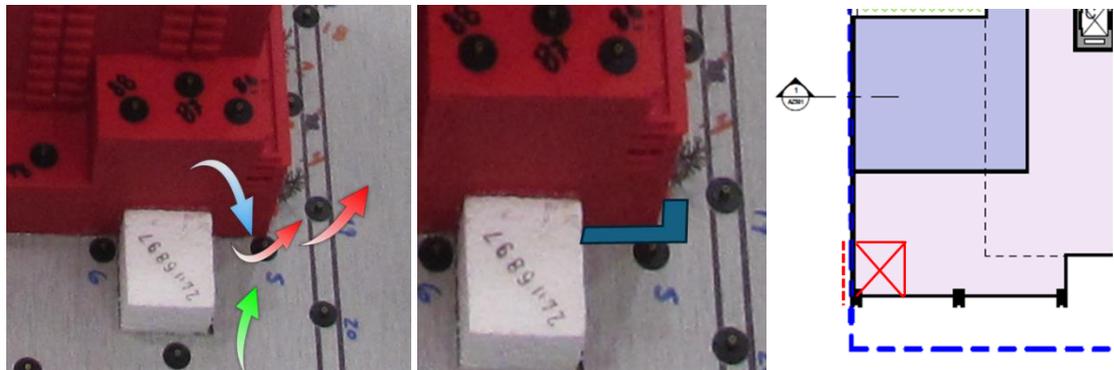
**Image 3: Wind Pattern and Proposed Mitigation Strategies**

1. Sensor 18 – Southwest Building Corner
  - a. The marginally exceeded wind condition at this location is driven by corner accelerations resulting from the interaction of prevailing northwest winds with the building’s exposed west façade. These winds are deflected downward due to downwash effects, then redirected horizontally around the southwest corner, creating a zone of intensified flow. Secondary contributions from horizontal winds along Hurontario Street further amplify wind speeds in this area (Image 3).

- c. Recommended Mitigation Strategies (Image 3):
    - i. Incorporate wind-breaking elements such as coniferous trees, porous screens, or trellises near the southwest corner to disrupt acceleration zones.

- ii. If landscaping is not feasible, consider installing a continuous canopy or trellis along the west façade, wrapping around the southwest corner to intercept downwash flows.

- iii. Introducing a re-entrant corner at grade, combined with a porous screen, can reduce wind convergence and lower peak velocities.
  - d. The latest drawings, AZ204, have incorporated the recommended “iii.” wind mitigation measure. We only note that this windscreen should be at least 2 m high. Wind speeds at Sensor 18 are expected to meet the safety criteria.
