**Re: Pedestrian Wind Conditions
2570 Argyle Road
RWDI Reference No. 2000888**

Rowan Williams Davies & Irwin Inc. (RWDI) has prepared this addendum letter for your next submission to the City of Mississauga. The intent of this letter is to address comments from the city planners with respect to the pedestrian wind conditions for the proposed 2570 Argyle Road development in Mississauga, ON as assessed in a report issued by RWDI on July 22, 2020.

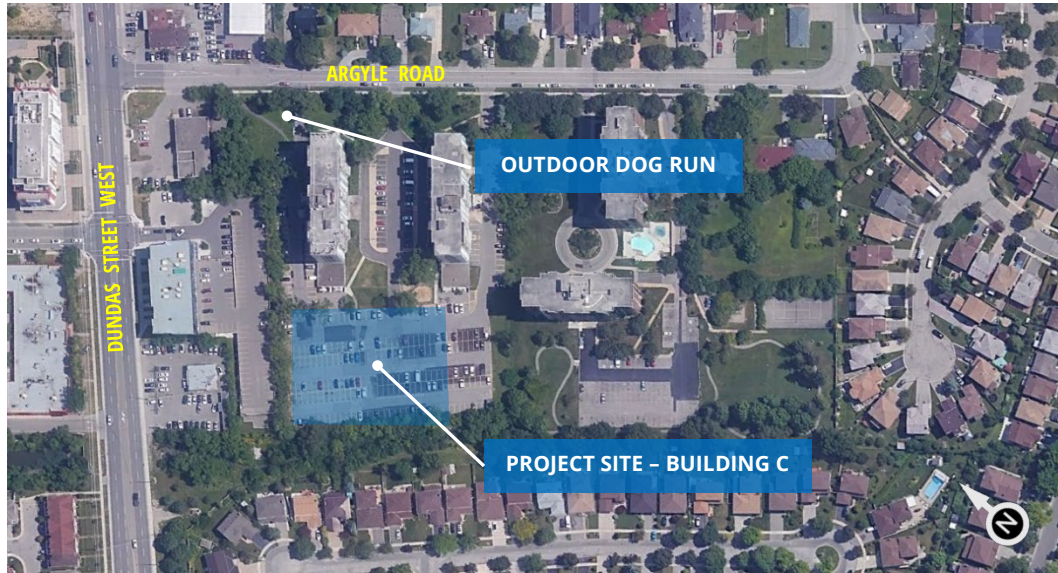
Image 1: Annotated Site Plan (Image Courtesy of Google Earth™)

A dog run park exists between Argyle Road and the existing developments at the site (Image 1). On the existing site, the outdoor dog run is comfortable for standing in the summer and walking in the winter. These conditions are typical for Mississauga and are considered appropriate for active pedestrian usage of this area. With the addition of the proposed building, conditions remain relatively unchanged. Although not required, if there is a desire for calmer wind conditions during the winter months, incorporating mature coniferous trees around the perimeter of the park would improve wind conditions. Priority should be given to the northwest and southwest sides, if pursued.
