6333 Hurontario Street
MISSISSAUGA, ON

File Name TREE INVENTORY, PROTECTION, AND REMOVALS

Dwg No. TI-1

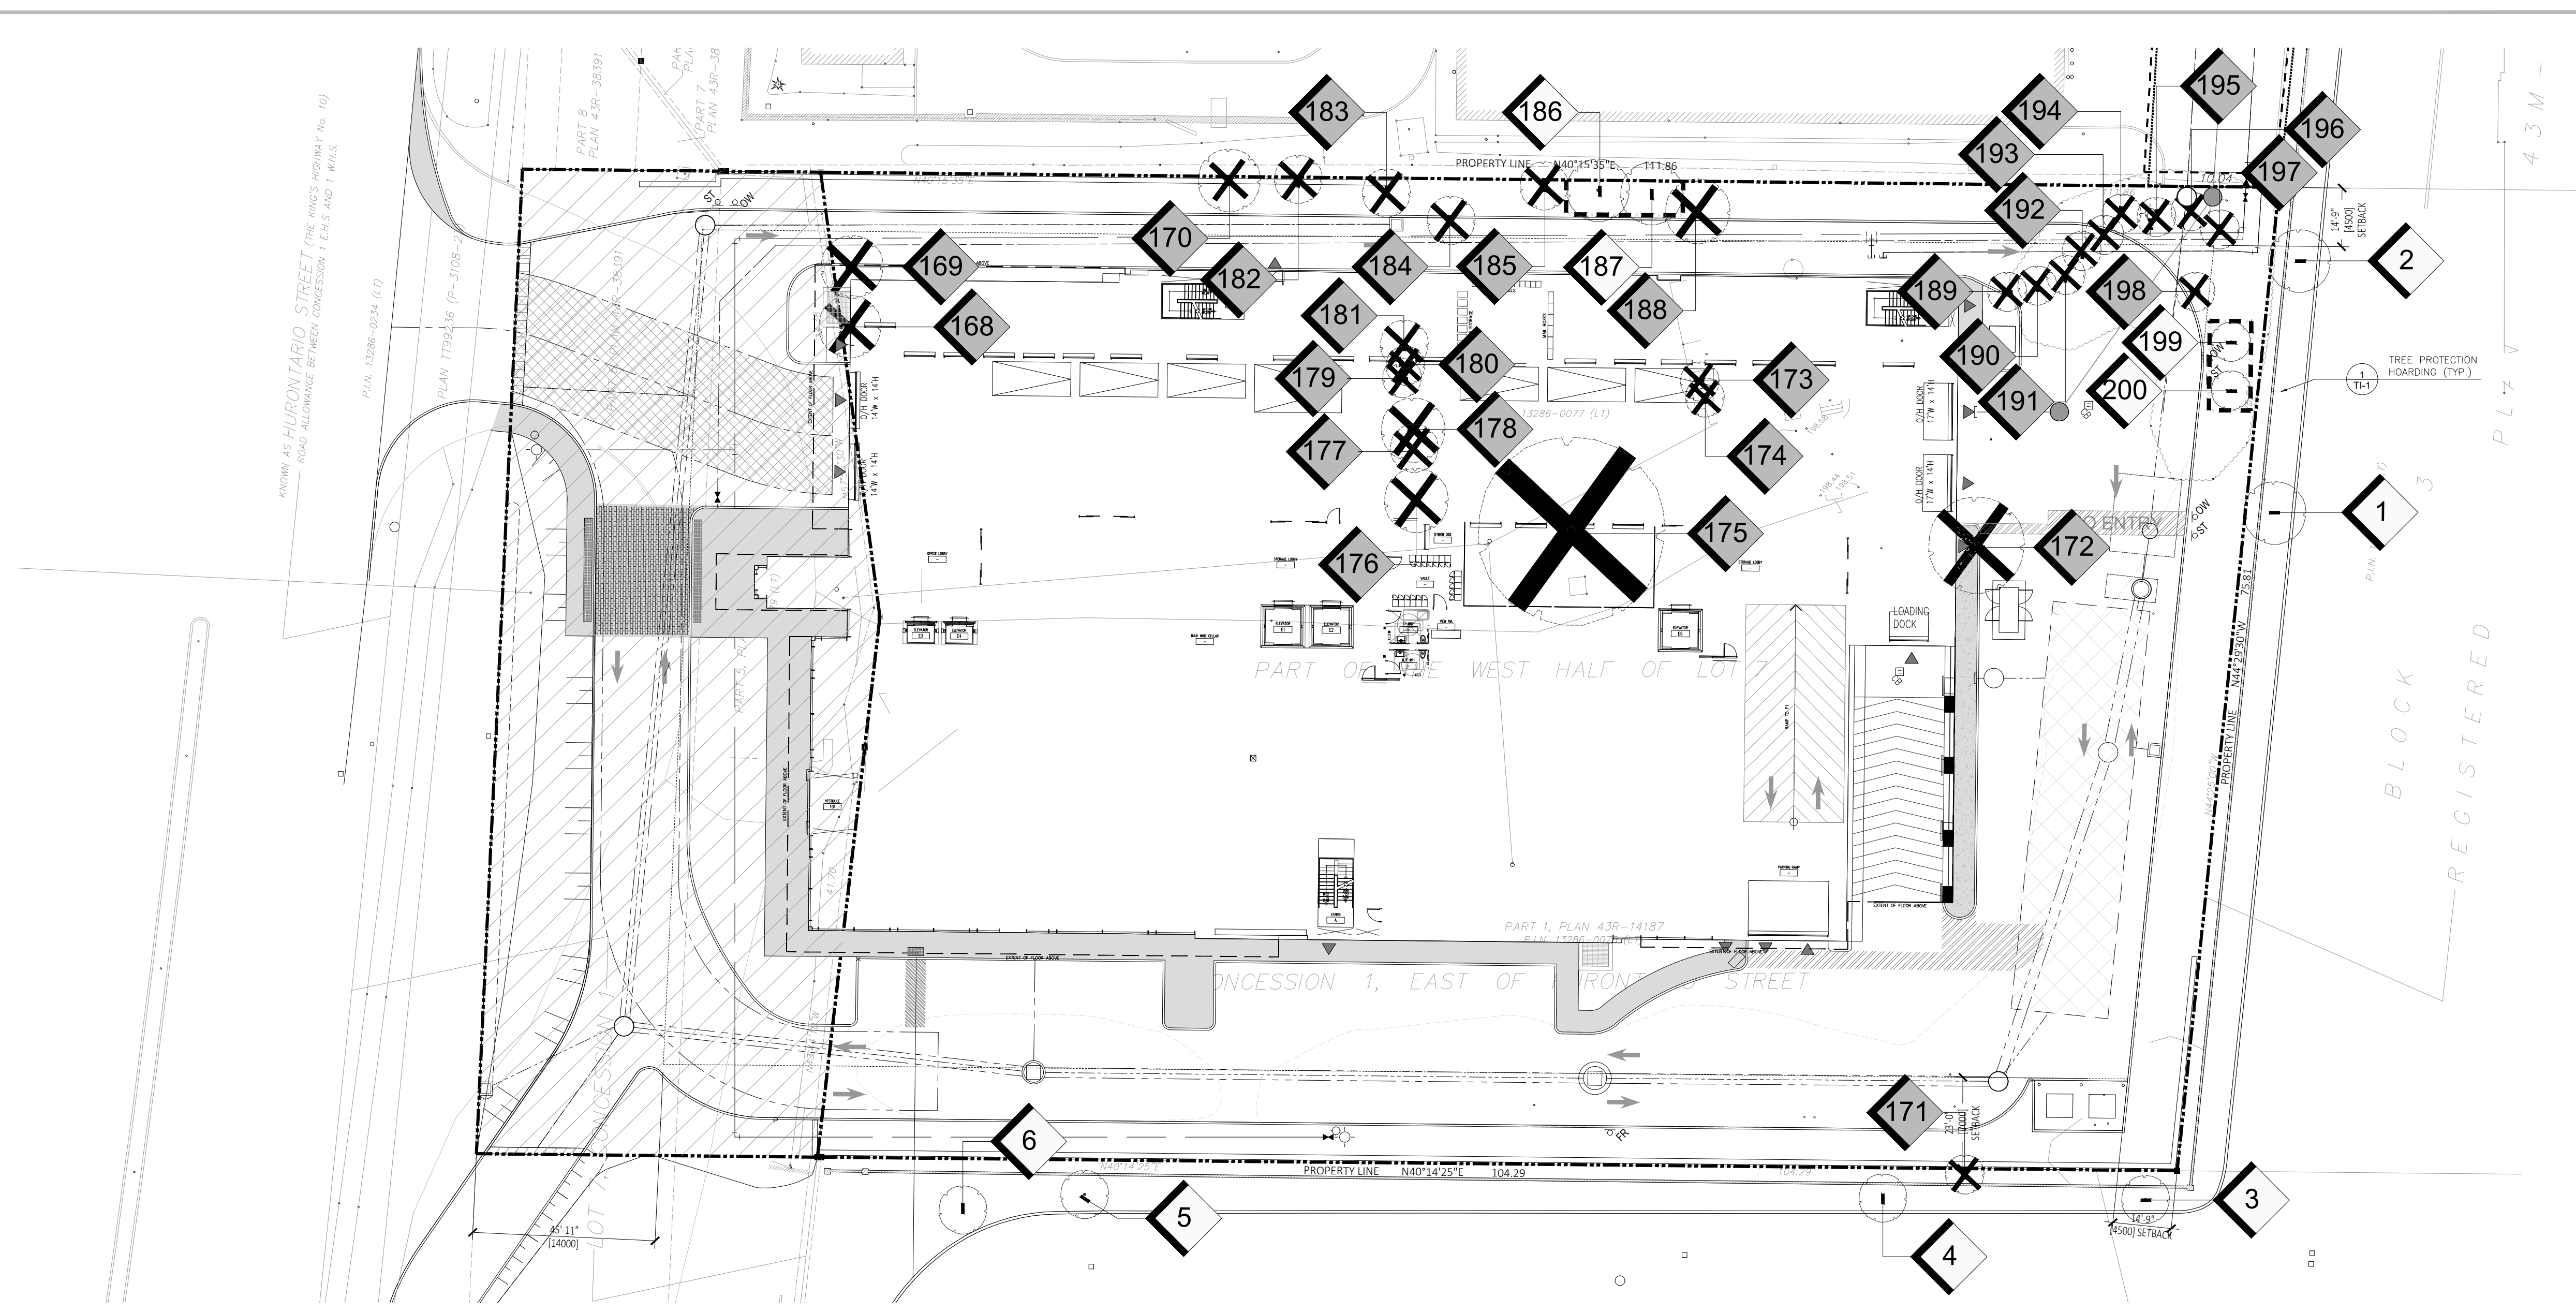
TREE INVENTORY NOTES

NOTE:
NEIGHBOUR'S CONSENT WILL BE REQUIRED PRIOR TO THE REMOVAL OF TREE 171.
